Mustinka River Watershed

Red River of the North Basin

Summary

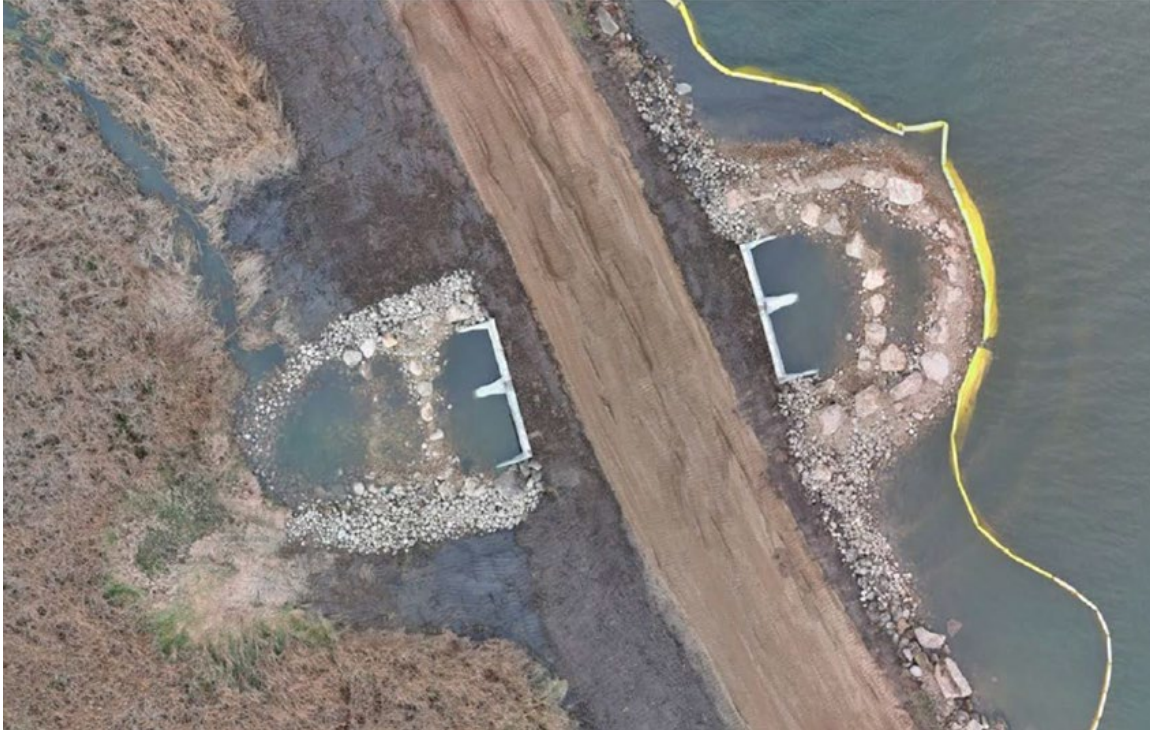
Aerial photo of the paired box culvert and riffle improvements on the outlet of Lightning Lake 11/10/2023

- The Bois de Sioux River Watershed District has replaced a failing outlet structure on Lightning Lake with a series of rock riffles and two new box culverts. These improvements will reduce flood risk, reduce erosion, and improve fish passage to and from the Mustinka River.

The Bois de Sioux River Watershed District has replaced a failing outlet structure on Lightning Lake with a series of rock riffles and two new box culverts. These improvements will reduce flood risk, reduce erosion, and improve fish passage to and from the Mustinka River.

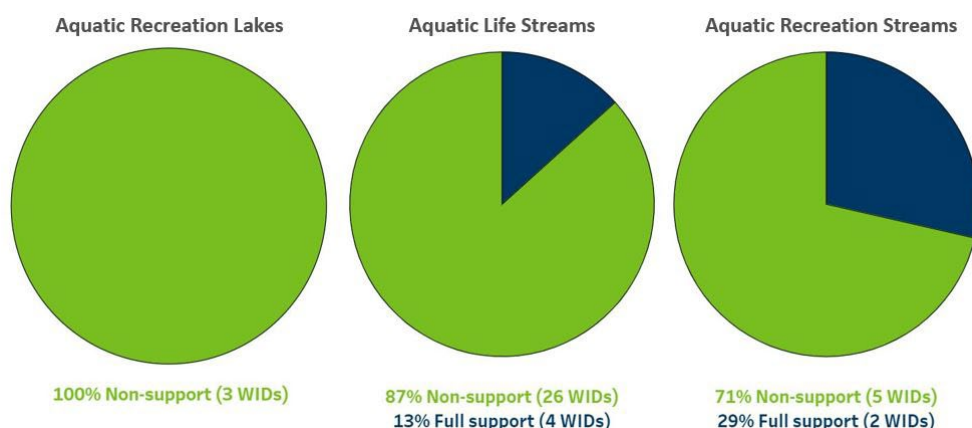
Figure 3. Mustinka River Watershed assessment results for aquatic life use in streams and aquatic recreation use in streams and lakes. Aquatic life use was assessed in one lake within this watershed but was found to be inconclusive.

Of the stream reaches in the Mustinka River Watershed that were assessed for aquatic life use, 87% are impaired. High turbidity levels, low dissolved oxygen, and excess nutrient levels are common across the watershed and fish and macroinvertebrate communities are significantly degraded, with a few exceptions. Five of the seven stream reaches assessed for aquatic recreation use are impaired due to excess *E. coli* levels.

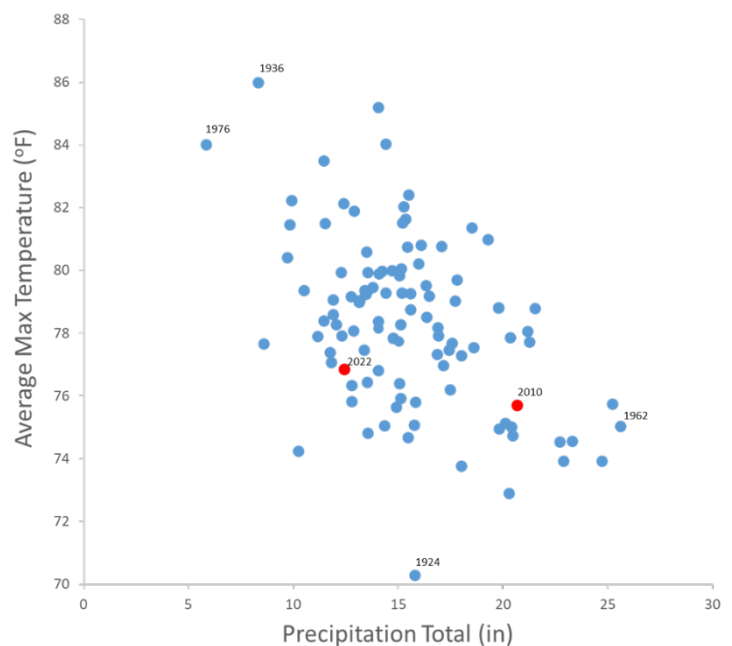
Figure 9. Characterization of air temperature and rainfall conditions for May-September period across historical record for the Mustinka River Watershed. Biological monitoring years for the watershed highlighted in red.

In 2010, the Mustinka River Watershed experienced above normal rainfall (+4.5 in) with abnormally cool temperatures (-2.6°F) during the time that the biological surveys were being conducted (May to September). In comparison, the watershed was in a moderate to severe drought for the majority of the summer in 2021 (-3.5 in), forcing biological monitoring activities to be suspended until the following summer. Stream flows during the summer of 2022 returned to near normal conditions primarily because of above normal winter precipitation, lessening the impacts of another summer with below normal rainfall. Overall, given the wet/cool conditions affecting the watershed in 2010 and the drought conditions present during monitoring in 2021-22, there is a high likelihood that observed changes in biological condition at either the watershed or individual site scale are at least partially due to differences in climatic conditions between the two periods.
