Summary of Clearwater River Watershed Monitoring / Assessment Report

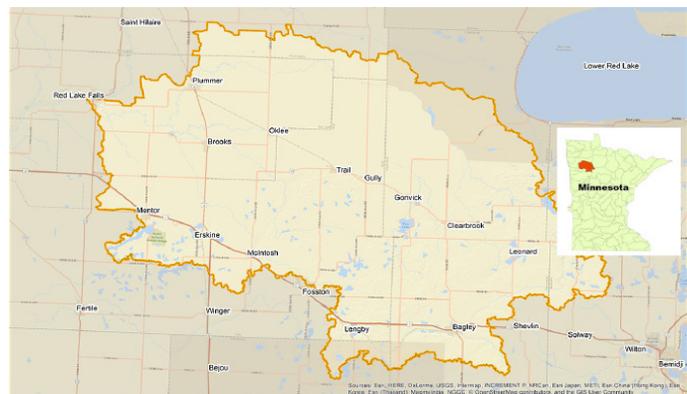
Watershed Approach

Phase 1: Monitor and assess health of waters

Phase 2: Identify conditions stressing biological life

Phase 3: Determine maximum pollutant loads

Phase 4: Determine Watershed Restoration and Protection Strategies

Start process over every 10 years

This report summarizes past assessment and diagnostic work and outlines ways to prioritize actions and implement strategies. This is phase one of a four phase process outlined at right.
