Draft Big Fork River Watershed Restoration and Protection Strategy Report Update 2025

m MINNESOTA POLLUTION
CONTROL AGENCY

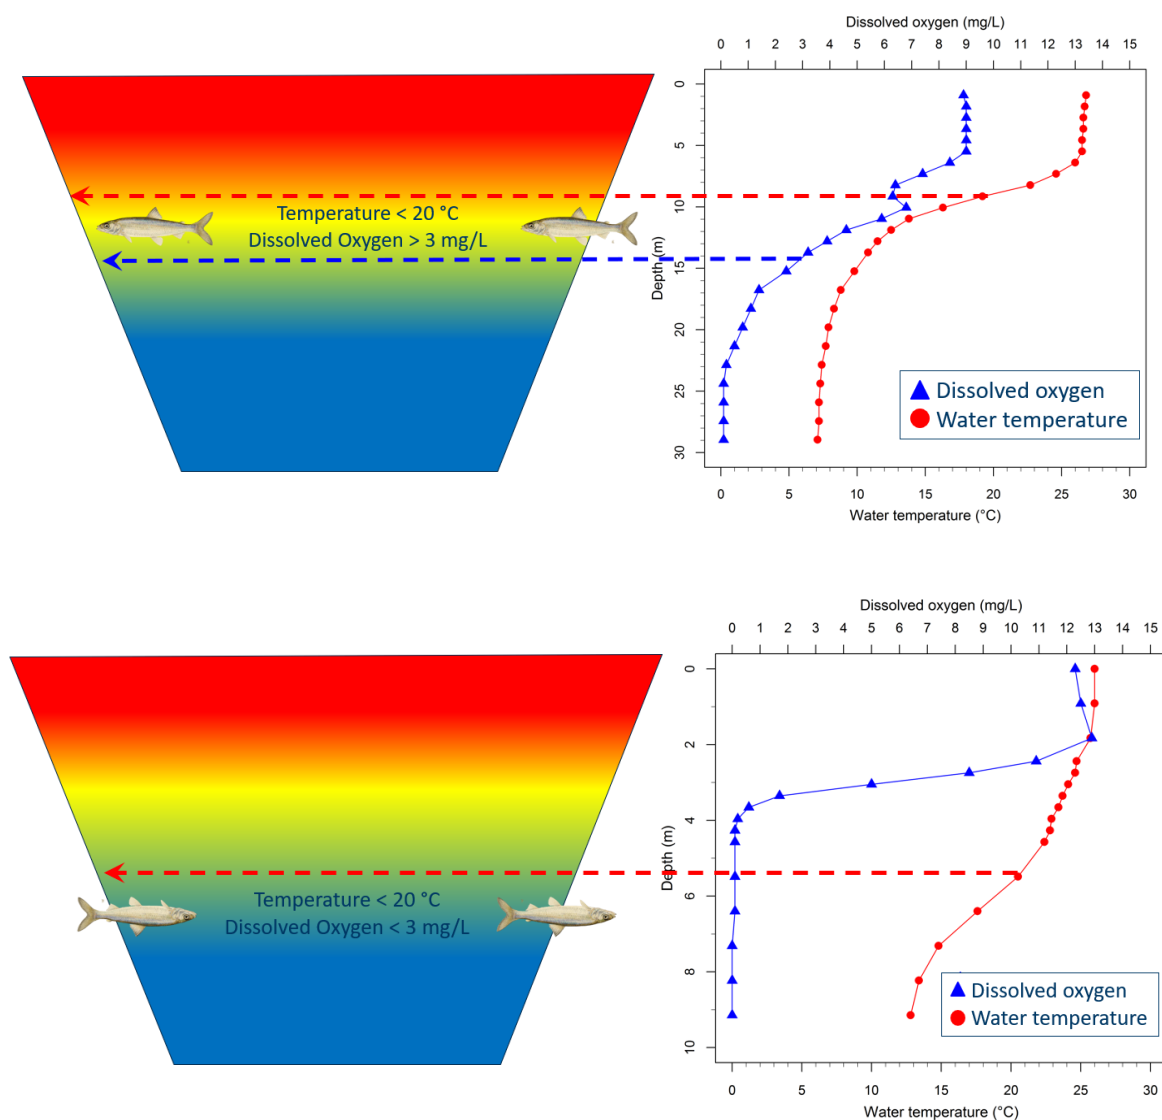
Figure 10. Cold-water fish requirements. They differ from warm-water and cool-water fishes by requiring cooler water and higher oxygen levels (MPCA 2024c).

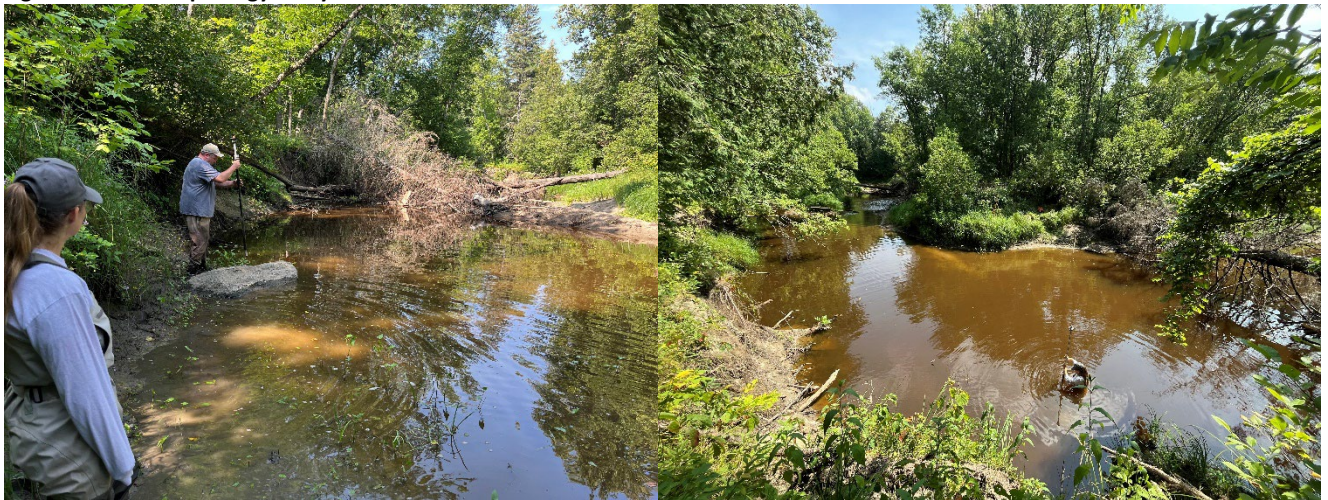
Figure 38. Geomorphology study on Caldwell Brook in 2024.

Additionally, the BFRW SID Report explains that “the symptoms of this instability found at Caldwell Brook noted in the report were:

- A Pfankuch Stability Index score of 130, with a condition rating of “Poor”.
- High, steep unvegetated and sloughing banks.
- Unstable channel bottom that is in a frequent state of flux.
- Excessive tree toppling into the stream channel, including creation of large debris jams.
- Measurements that classify the stream as an “F” channel type (Rosgen 1996).
- Disconnection of the channel to its floodplain, leading to more erosive conditions in the channel.
- Accelerated lateral channel migration.
- Gravel in riffles is embedded by sand and fine particles” (MPCA 2025a).

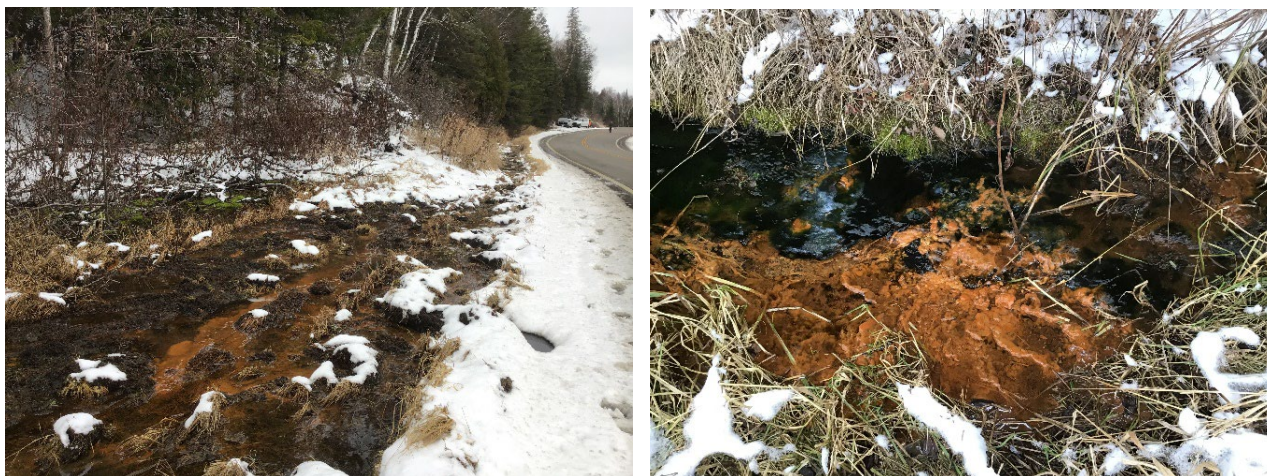
North Star Lake groundwater springs. This is a series of springs running North to South located just off the East side of highway 38 near Marcell, Minnesota. These springs flow from the ground with noticeable discharge areas, vibrant areas of moss in the flow area, with bright copper colored staining of iron mineral precipitate in other areas. The springs flow from numerous areas of the base of a hill at approximately 5 gallons per minute (GPM) in approximately 250ft length, flow north/south along the ditch of the highway and then into culverts, which run under Hwy 38 and deposit into North Star Lake. The temperature of the springs are from 5.70 to 6.10 degrees Celsius, the conductivity is 333.7-338.7 microsiemens per centimeter ($\mu\text{S}/\text{cm}$), the DO is 0.29-4.93 mg/L, and there is iron deposition and sulfur odor. North Star Lake has an average Secchi depth of approx. 13ft, chl-*a* of about 2.5, and TP mean of about 11.

Figure 64. North Star Lake Springs.

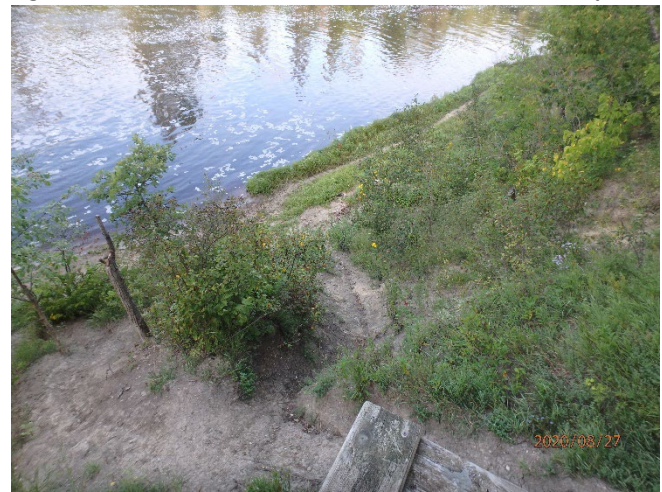
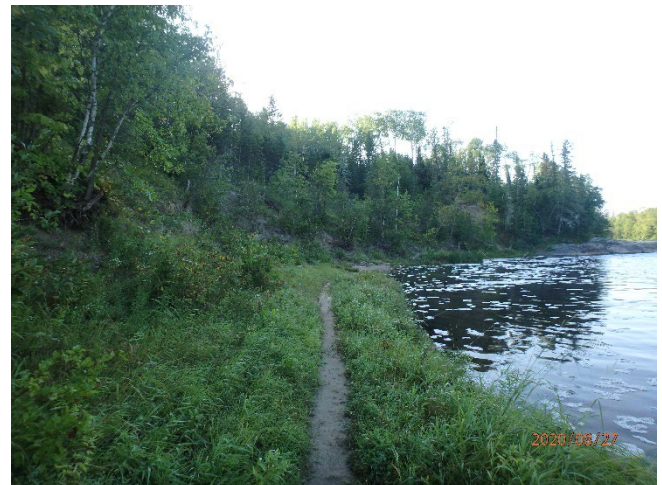
Figure 69. Streambank erosion at Little American Falls campsite.

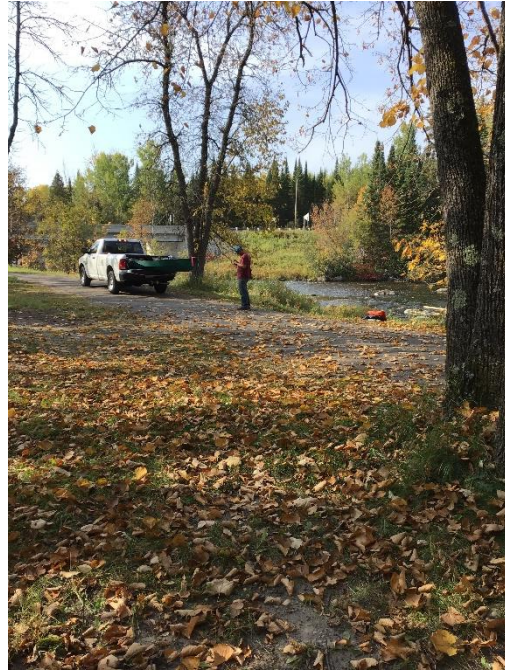
State site with gully erosion leading down into river from road.

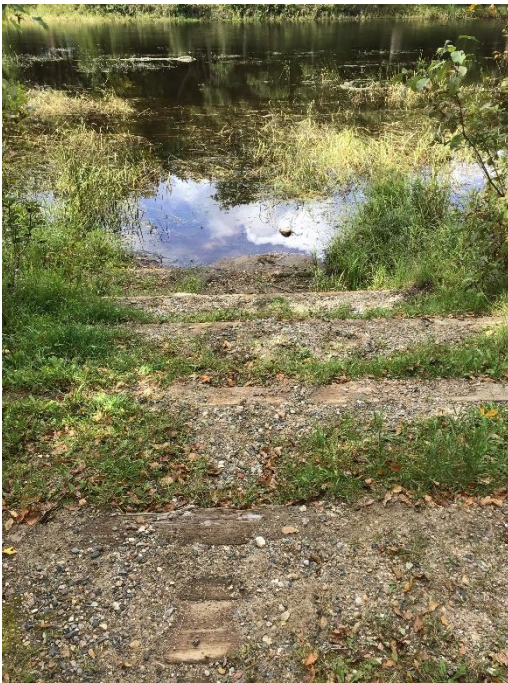
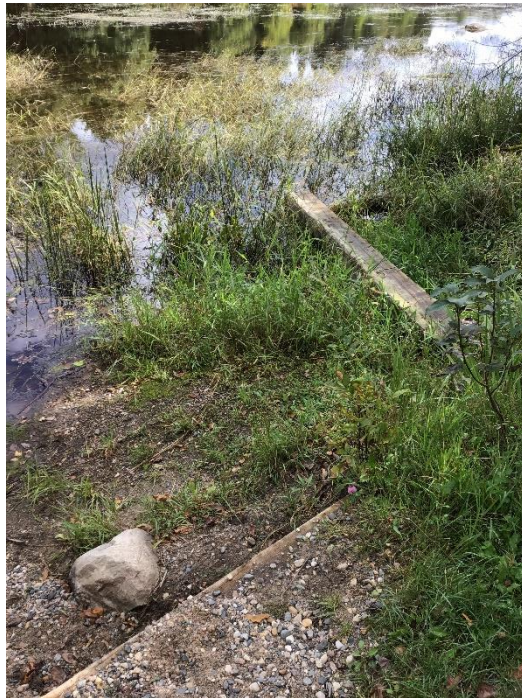
Hwy 14 summary:

State access site for canoe launch, water bars need to be replaced and sediment removed. Lack of maintenance has allowed erosion to occur.
