July 2025

Big Fork River Watershed Restoration and Protection Strategy Report Update 2025

mn MINNESOTA POLLUTION
CONTROL AGENCY

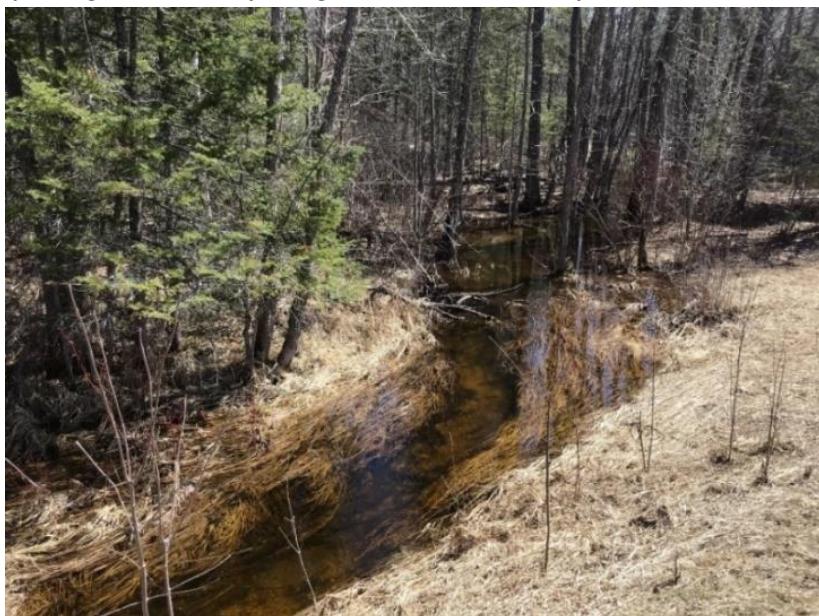
Figure 18. The east Island Lake tributary (site S016-692). There were dozens of walleye, northern pike, and white sucker spawning in this tributary during a routine site visit in May 2022. Photo credit: MPCA and Itasca SWCD

Monitored TSS concentrations for the east tributary were occasionally high (mean = 8 mg/L; range = 1-32 mg/L) while the north (mean = 1 mg/L; range = 1-2 mg/L) and west (mean = 2 mg/L; range = 1-4 mg/L) tributaries were consistently lower. The TSS concentration of 32 mg/L from the east site was collected on October 14, 2022, after a 1" snow event. The increase in TSS could have been the result of the snowmelt and stirred up sediment that occurred above a beaver dam located upstream of the sample site. DO field measurements for the east and west tributaries were lower than the north tributary in 2022. However, it should be noted that no DO measurements were collected from the north tributary after the stream went stagnant from June through October. Figure 19 and Figure 20 show the two parameters of concern, TP and DO, on graphs.

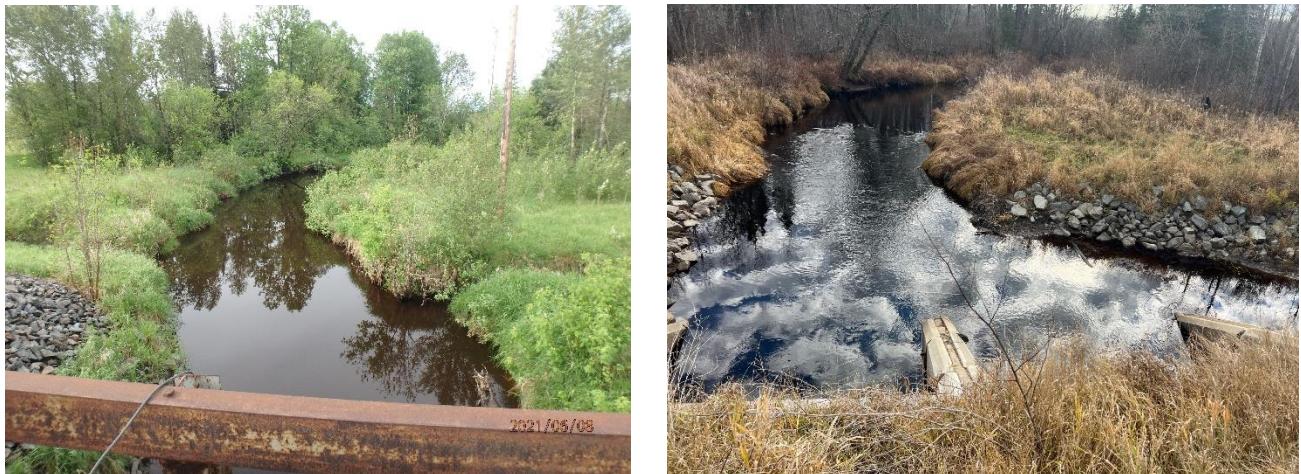
Figure 37. The Bear River before replacing the bridge to a culvert, on the left, June 8, 2021. The Bear River after culvert installation, November 12, 2024.

It was determined that in 2024 more *E. coli* data would need to be collected to help determine if there is an impairment. Table 14 shows the 2024 *E. coli* data in addition to the *E. coli* data collected during IWM in the years of 2020 and 2021. Overall, the 2024 data collected shows lower levels than the previous data collected during the assessment window (2013-2022). The Minnesota *E. coli* standard is not to exceed the monthly geometric mean of 126 organisms per 100 mL or not to exceed the individual standard of 1,260 organisms per 100 mL (MPCA 2024a). In 2022/2023, the bridge crossing at the sampling site, Bear River and CR 1, was replaced with three box culverts that allow the streamflow to move through the crossing much better, especially during high flows. Figure 37 shows the Bear River before and after the bridge was replaced.

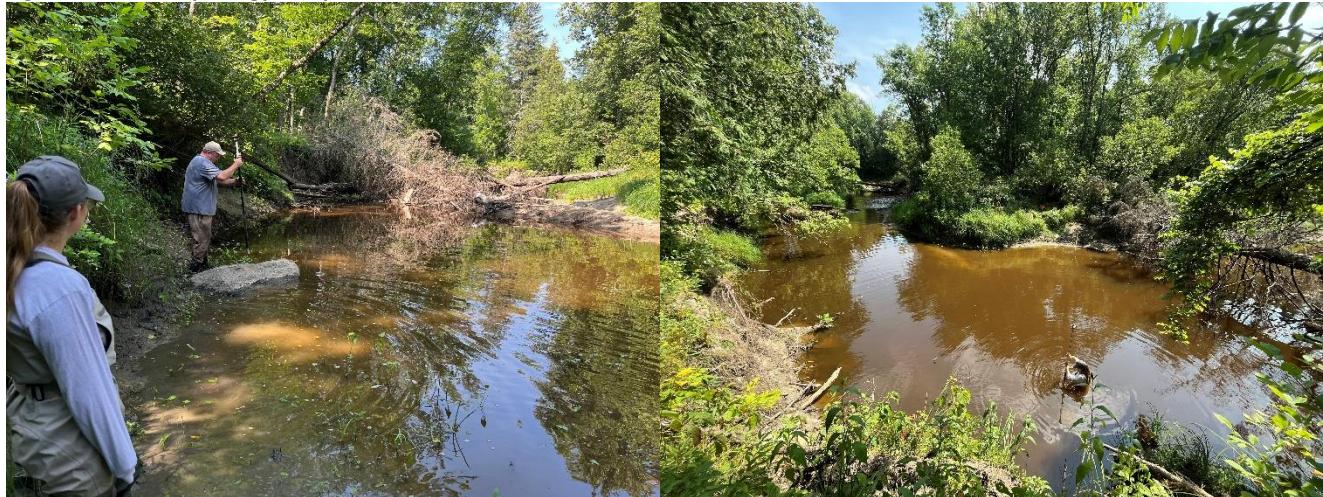
Figure 39. Geomorphology study on Caldwell Brook in 2024.

Additionally, the BFRW SID Report explains that "the symptoms of this instability found at Caldwell Brook noted in the report were:

- A Pfankuch Stability Index score of 130, with a condition rating of "Poor".
- High, steep unvegetated and sloughing banks.
- Unstable channel bottom that is in a frequent state of flux.
- Excessive tree toppling into the stream channel, including creation of large debris jams.
- Measurements that classify the stream as an "F" channel type (Rosgen 1996).
- Disconnection of the channel to its floodplain, leading to more erosive conditions in the channel.
- Accelerated lateral channel migration.
- Gravel in riffles is embedded by sand and fine particles" (MPCA 2025a).

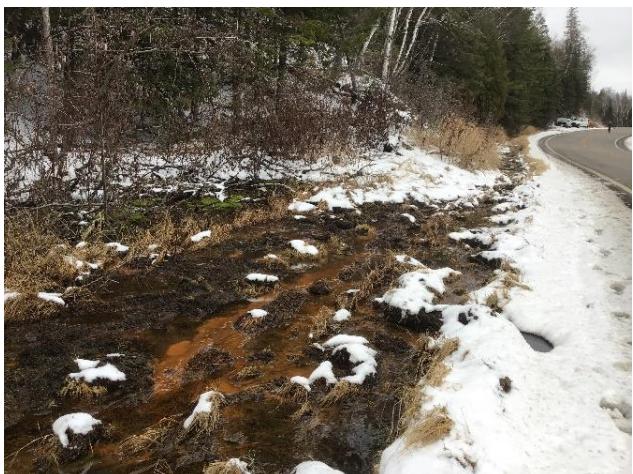
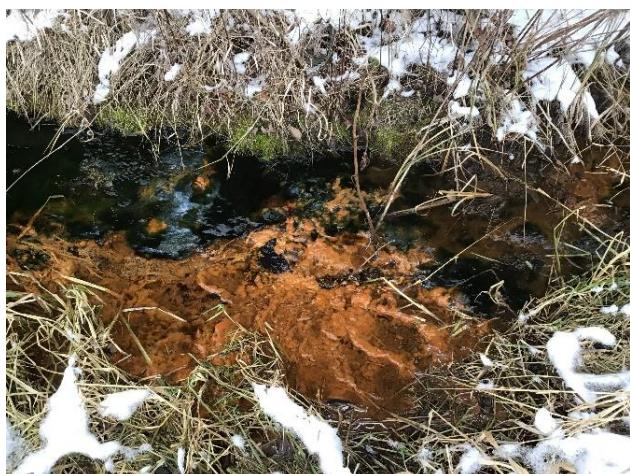
Figure 65. North Star Lake Springs.

North Star Lake groundwater springs. This is a series of springs running North to South located just off the East side of highway 38 near Marcell, Minnesota. These springs flow from the ground with noticeable discharge areas, vibrant areas of moss in the flow area, with bright copper colored staining of iron mineral precipitate in other areas. The springs flow from numerous areas of the base of a hill at approximately 5 gallons per minute (GPM) in approximately 250ft length, flow north/south along the ditch of the highway and then into culverts, which run under Hwy 38 and deposit into North Star Lake. The temperature of the springs are from 5.70 to 6.10 degrees Celsius, the conductivity is 333.7-338.7 microsiemens per centimeter ($\mu\text{S}/\text{cm}$), the DO is 0.29-4.93 mg/L, and there is iron deposition and sulfur odor. North Star Lake has an average Secchi depth of approx. 13ft, chl- α of about 2.5, and TP mean of about 11.

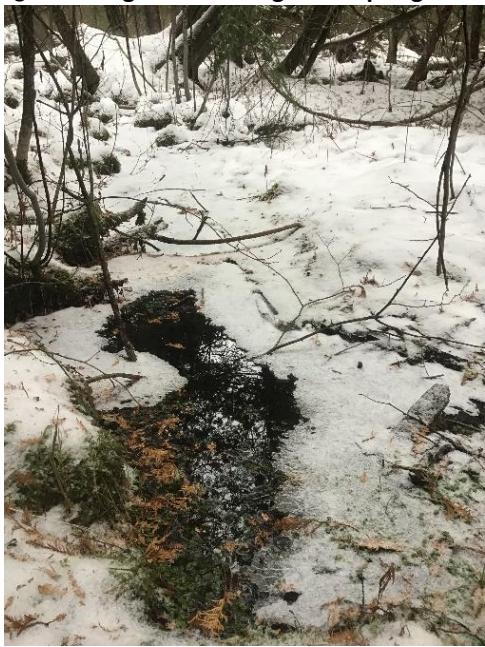
Figure 66. Big Fork Hocking Road Spring.

This spring is located on Itasca County land near the town of Bigfork, Minnesota. The groundwater bubbles to the surface and flows North (generally) about $\frac{1}{4}$ of a mile and then making its way into the Big Fork River. This area has a significant amount of moss vegetation, is lined with cedar trees, and the spring is quickly noticed through the winter snow. This spring has an estimated flow of 1 gallon per minute (GPM). The temperature is 0.6 degrees Celsius, the conductivity is 209 $\mu\text{S}/\text{cm}$, the DO is 7.44 mg/L, and there are marsh marigolds growing in the spring water.

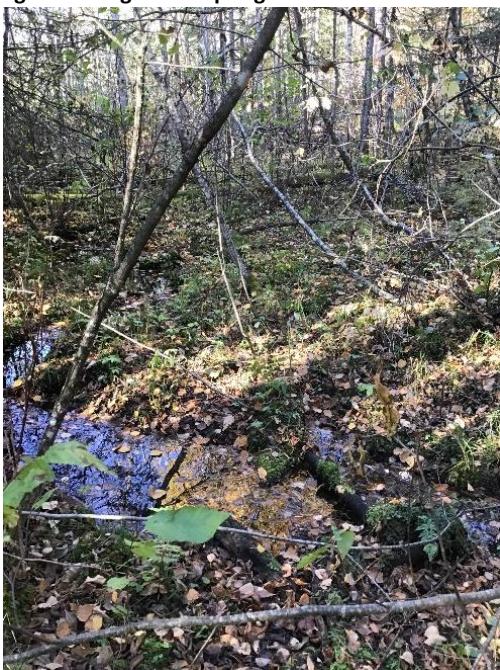
Figure 67. Big Falls 1 spring.

Big Falls 1 is a spring located east of the town of Big Falls and on the north side of the Big Fork River. This spring is off County Road 31 and located in a freshwater forested/shrub wetland. This spring is roughly 700 ft from the Big Fork River and provides a source of coldwater to the river. This spring is located on state land with low risk of disturbance. The highest risk to this stream would be logging and equipment use in the vicinity of the spring. This spring has an estimated flow of 1 GPM. The temperature is 8.80 degrees Celsius, the conductivity is 384.5 $\mu\text{S}/\text{cm}$, the DO is 5.96 mg/L, and there is moss growing near the spring.

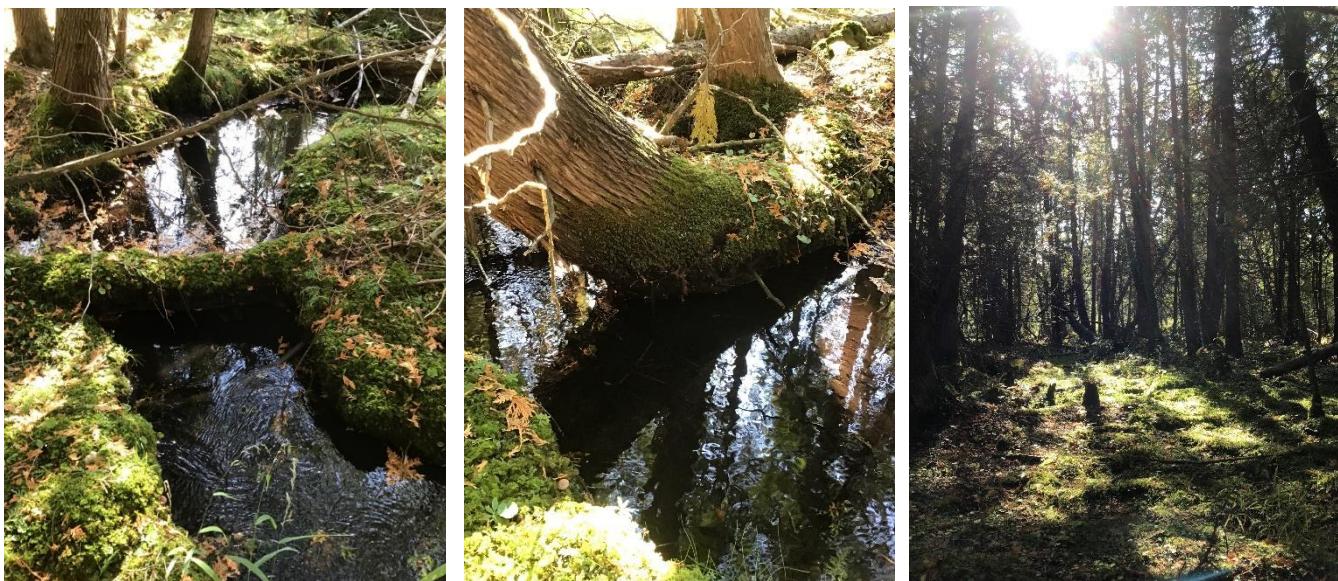
Figure 68. Big Falls 2 spring.

Big Falls 2 is a spring located east of the town of Big Falls and at the headwaters of Trout Brook. Trout Brook is a DNR designated trout stream. This spring is located in a freshwater forested/shrub wetland and located at the base of a ridge line that runs east to west. This area has a significant amount of moss vegetation lined with cedar trees. This spring is located on state land with low risk of disturbance. The highest risk to this stream would be logging and equipment use in the vicinity of the spring. This spring has an estimated flow of 1 GPM. The temperature is 6.70 degrees Celsius, the conductivity is 301.8 $\mu\text{S}/\text{cm}$, the DO is 4.74 mg/L, and there is moss growing near the spring.

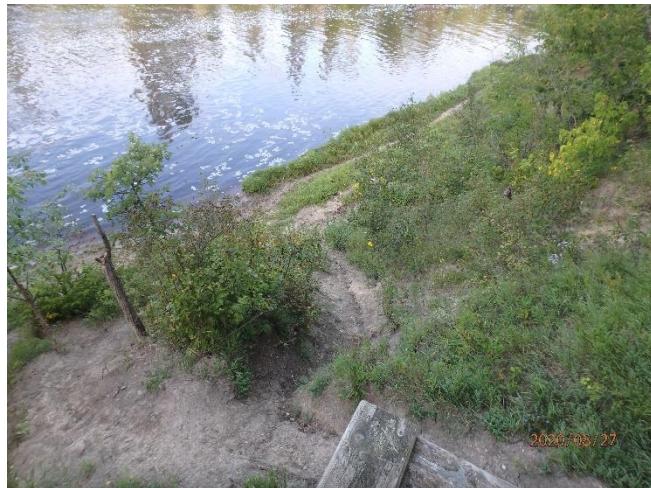
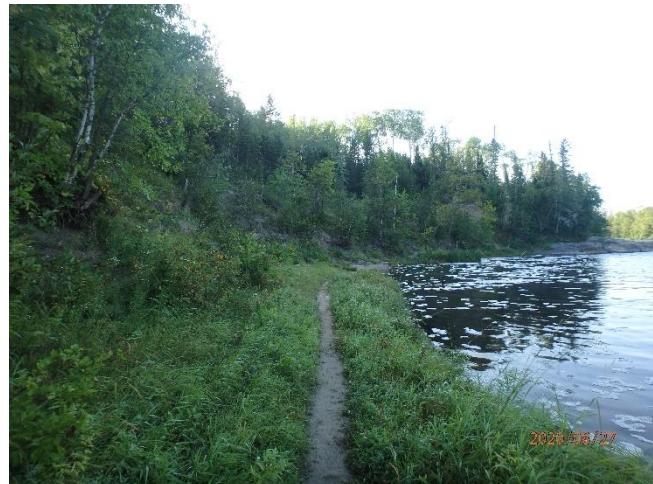
Figure 70. Streambank erosion at Little American Falls campsite.

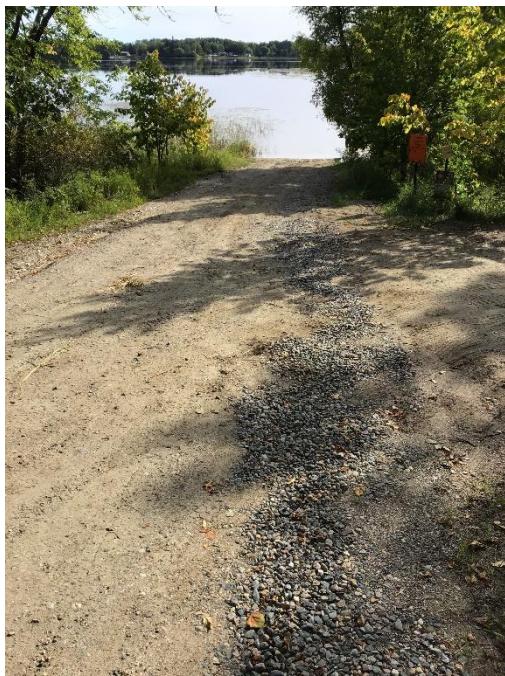
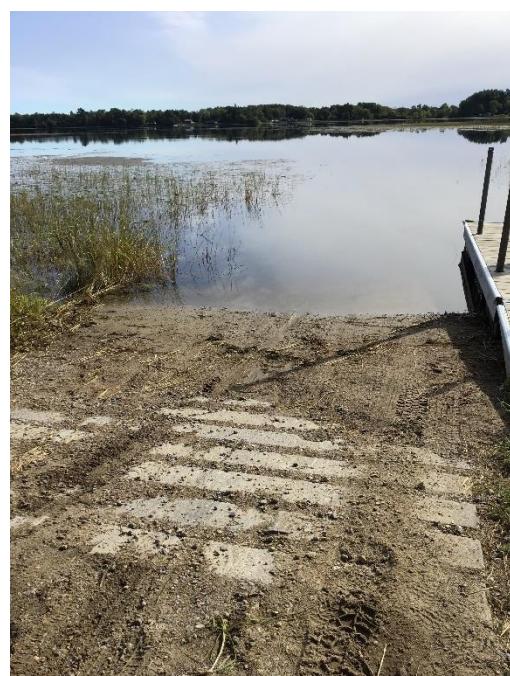
Dora Lake summary:

Federal boat launch that has gully erosion leading into Dora Lake.

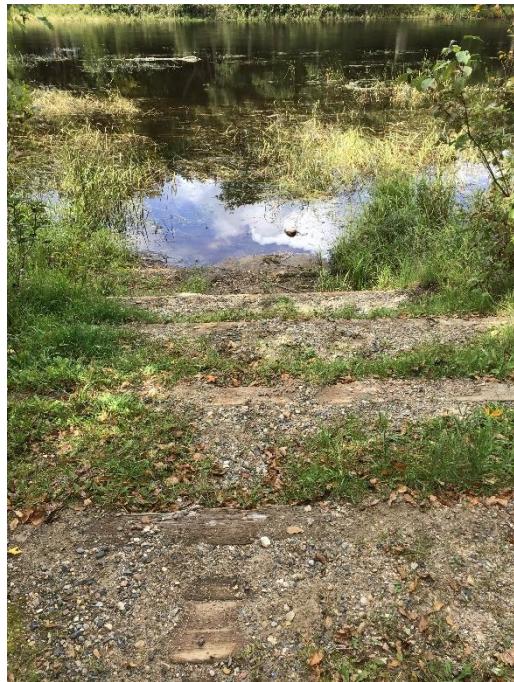
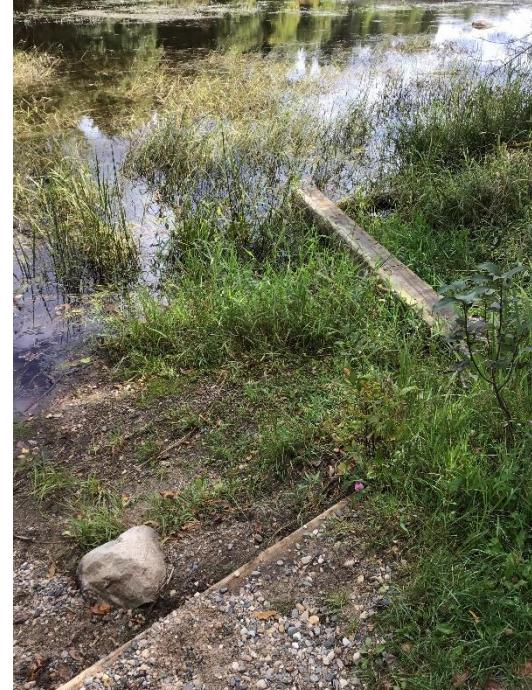
Hwy 14 summary:

State access site for canoe launch, water bars need to be replaced and sediment removed. Lack of maintenance has allowed erosion to occur.

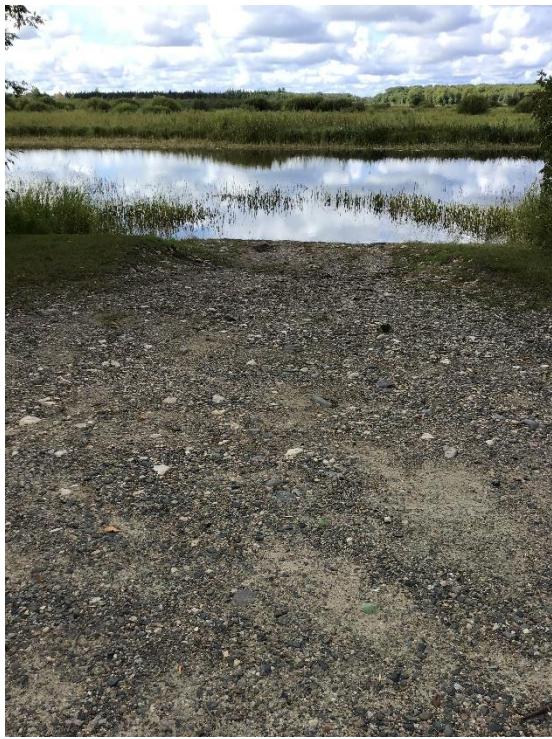
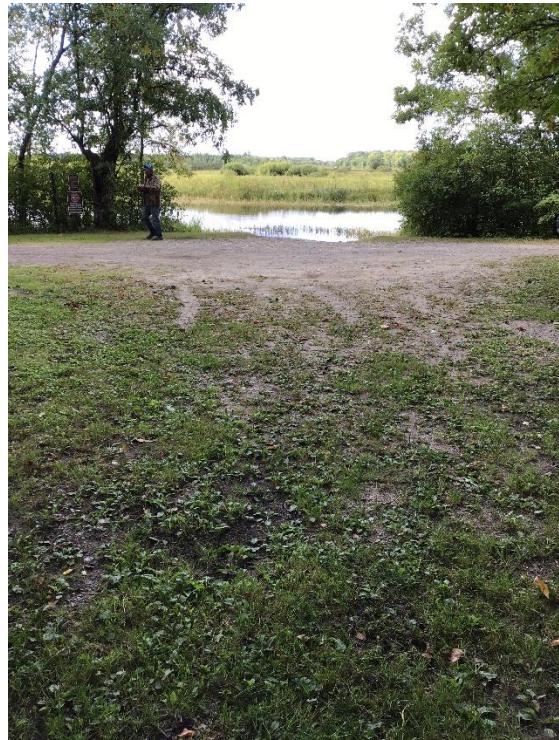
Harrison Landing summary:

State access campsite and boat launch. Campsite well vegetated. Boat launch is channelized, but slope is relatively flat.

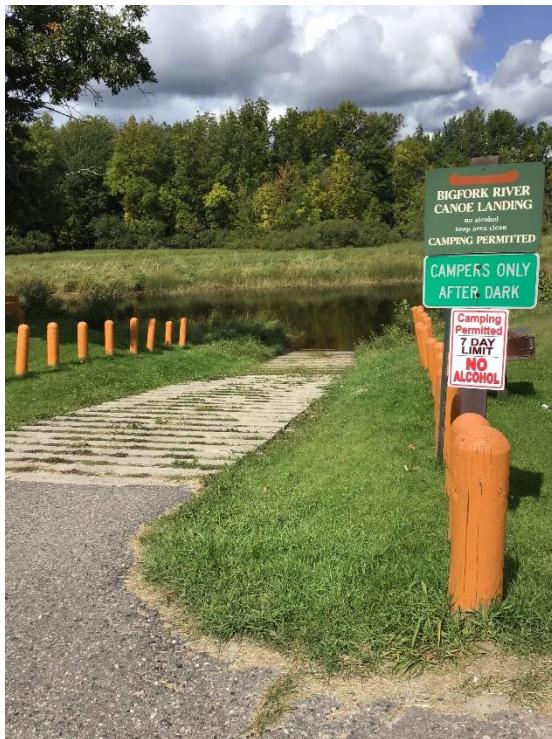
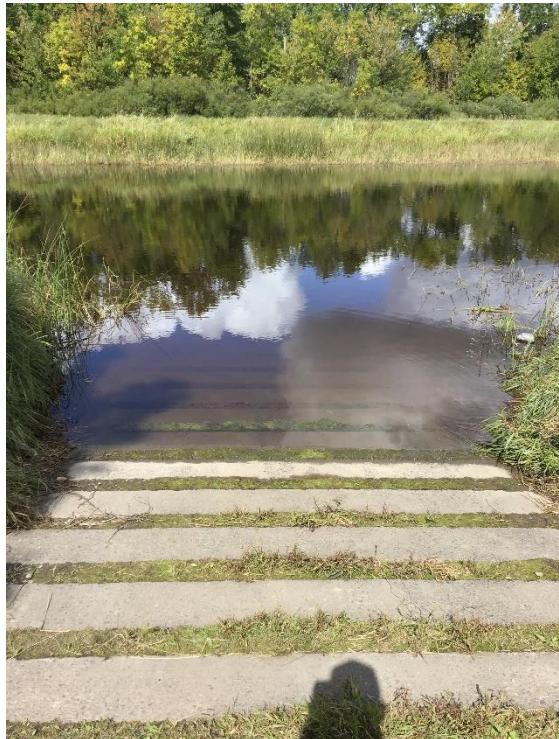
Bigfork Landing summary:

City access site with paved parking lot. Banks are well vegetated.

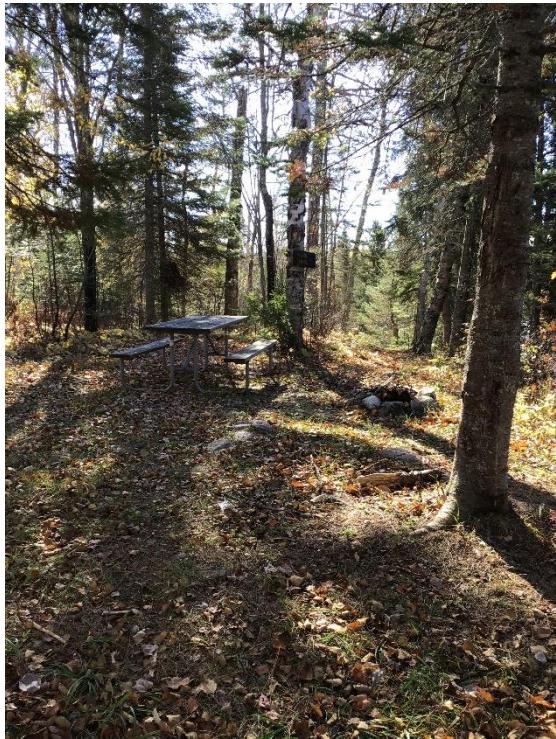
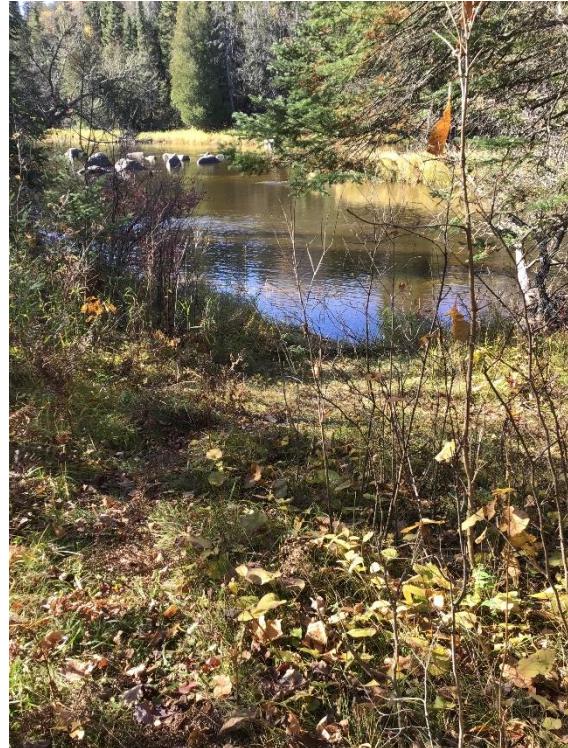
Muldoon Campsite summary:

State site with campsite above Big Fork River, also has a canoe portage that is poorly marked while floating river.

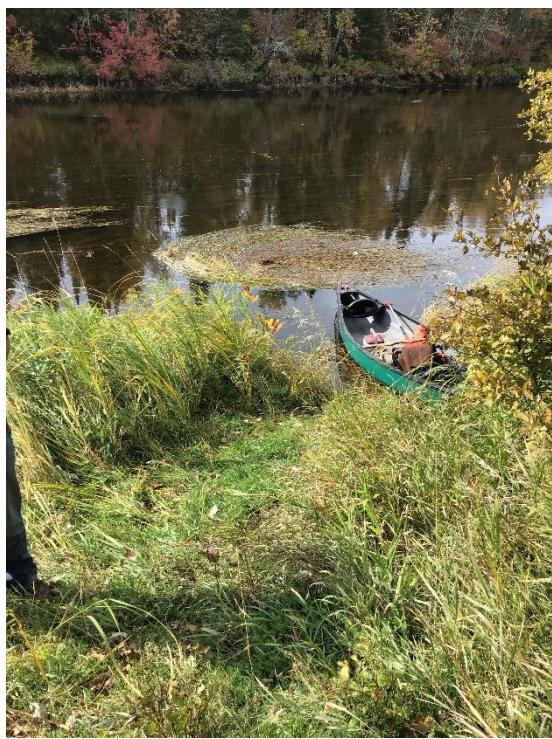
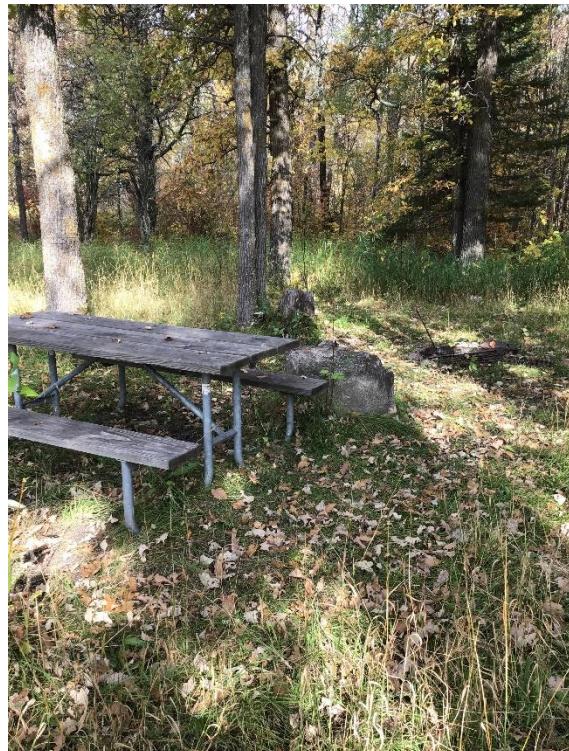
Busticogan Campsite summary:

State site with campsite. Site is well vegetative, and single access point to river.

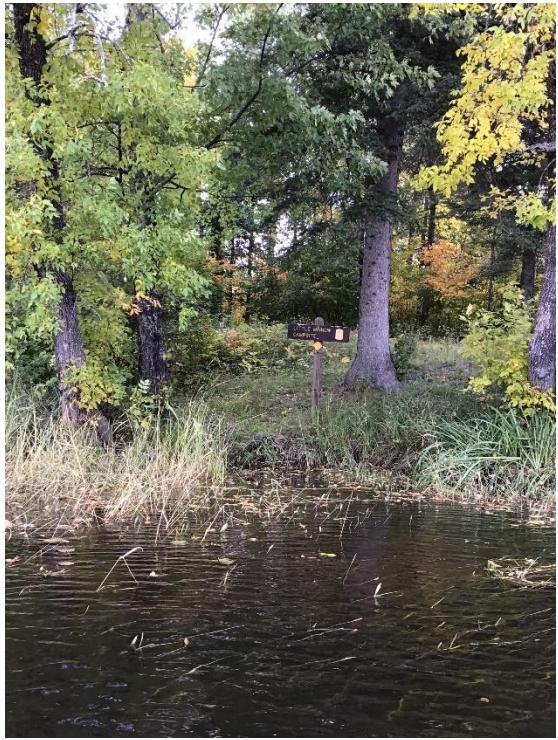
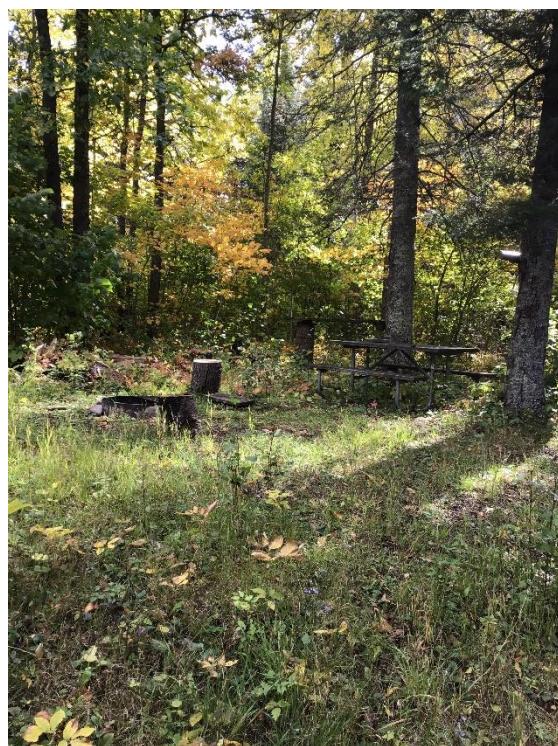
Little Minnow Campsite summary:

State site with campsite. Single access point is vegetated.

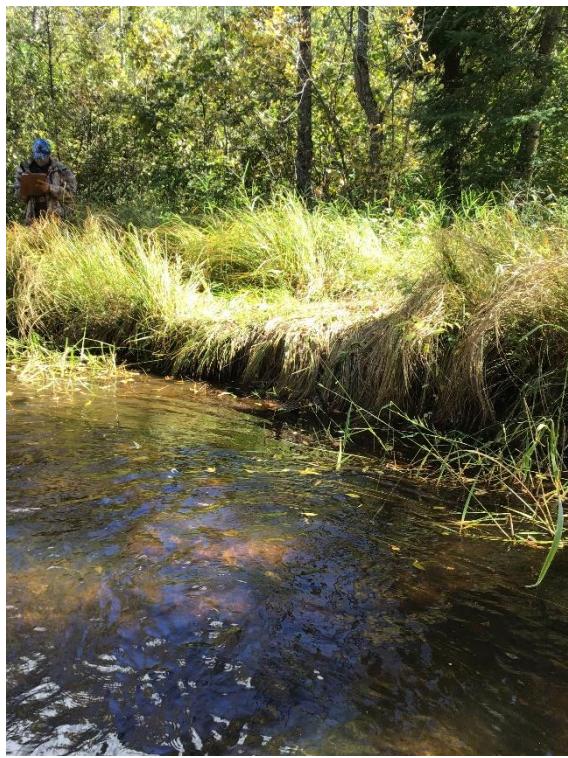
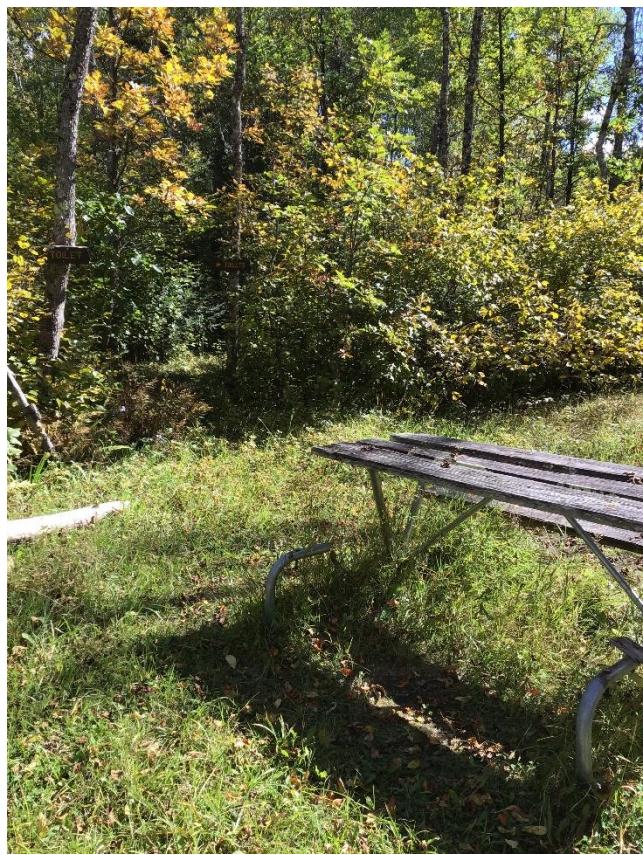
Rice River Campsite summary:

State site with campsite. Access point from river is vegetated.

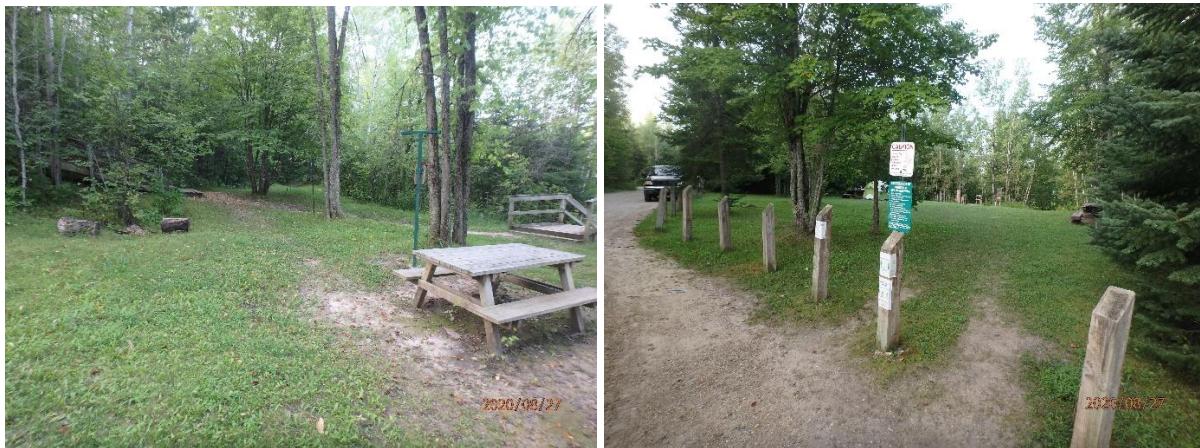
Little American Falls:

Little American Falls is situated in the upper half of the Big Fork watershed. It consists of multiple campsites and multiple trails leading down to the river. The shoreline is steep with sparse vegetation. Erosion is present throughout the shoreline which is the reason why this site tops the ranking system. This site would benefit the most from implementing BMP's to mitigate and manage erosion issues present at the site.

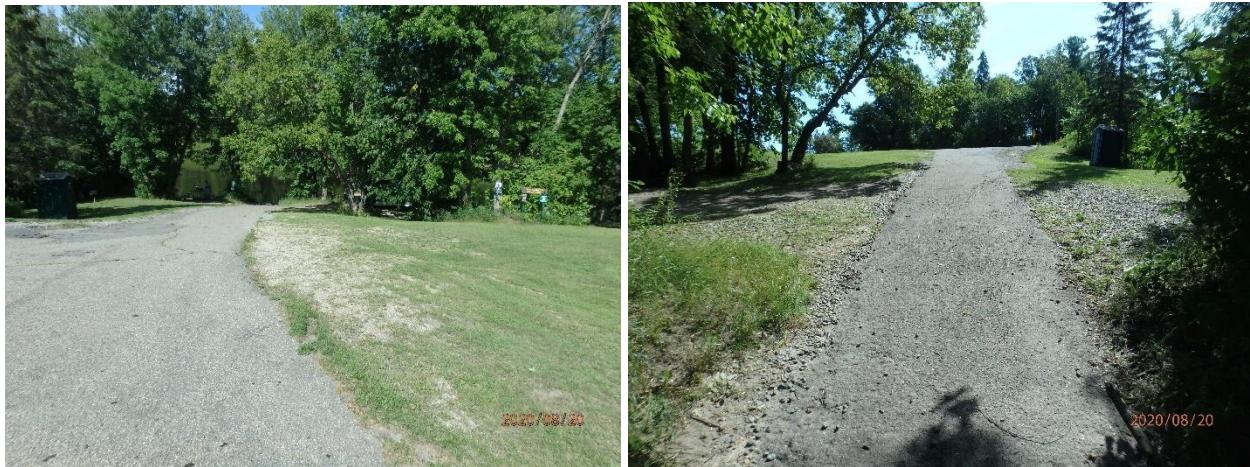
Ivan Crawford Landing:

Ivan Crawford Landing is situated 7 miles from the mouth of the Big Fork River. The landscape has much lower banks with a widespread flood plain. This landing has sparsely vegetated shoreline with potential for erosion. Some erosion present on the shoreline and throughout the landing/campsite. Shoreline BMP's would benefit this site to establish vegetation and eliminate erosion.

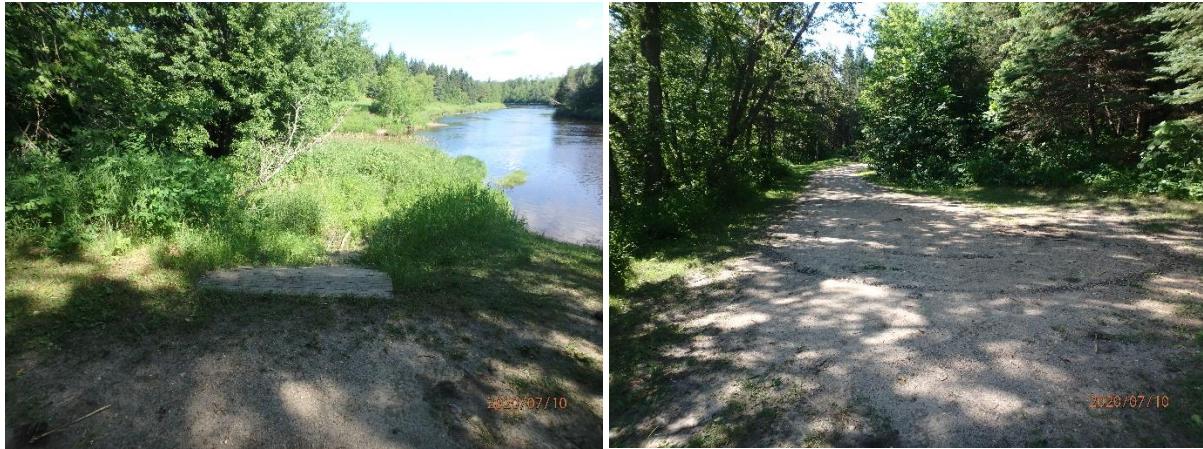
Sturgeon River Landing:

Sturgeon River Landing is just downstream of Big Falls at the confluence of the Sturgeon River and Big Fork River. This site is a campsite/canoe carry-down access point. This site had good vegetation present along the shoreline with the exception of some bar soils next to the stairs and rivers edge.

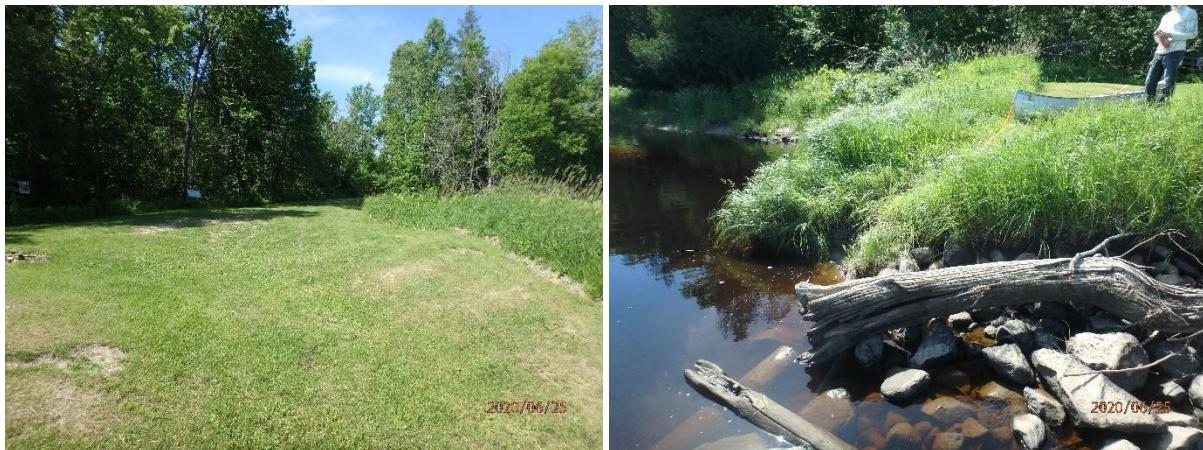
Gowdy Landing:

Gowdy Landing is situated in the bottom fourth of the watershed. This site is a carry-down canoe access with no steps or launch present. The shoreline is fully vegetated with low slopes. The parking lot is grassed/gravel with no signs of erosion. There is a crib present in the river to ease access in and out of the river. This site has low potential for erosion.

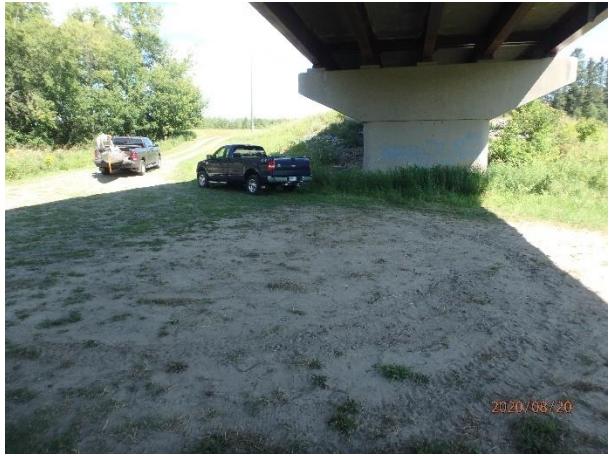
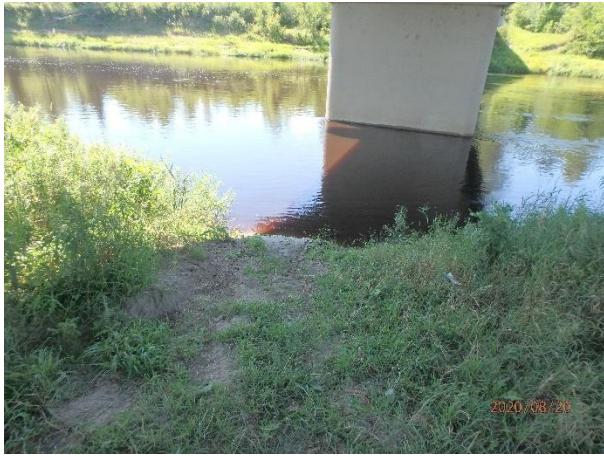
Hwy 1 Bridge:

Hwy 1 Bridge Landing is in the lower fourth of the watershed roughly 20 miles upstream from the mouth of the Big Fork. Vegetation is present along the shoreline except for an area where traffic is entering and exiting the river. This site has low slopes and is situated under the bridge. The parking lot is a grass/gravel mixture with no signs of erosion. This site has low potential for erosion.

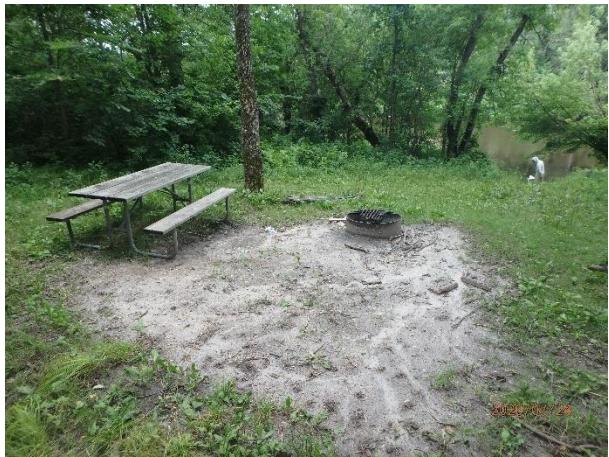
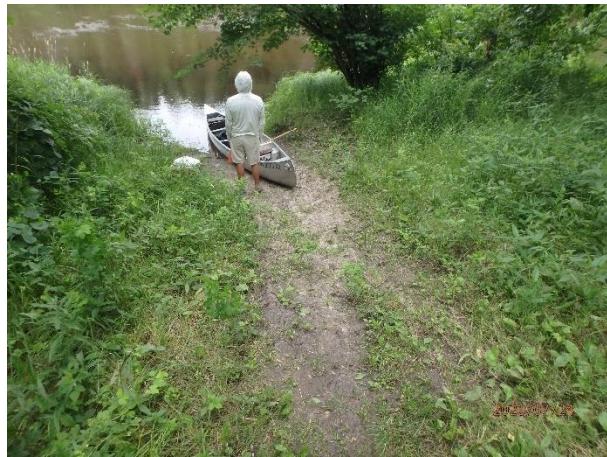
Easy Half Campsite:

Easy Half Campsite is in the middle of the Big Fork watershed and only accessible by boat. The shoreline is vegetated with the exception of a portion of the river's edge where entry and exit of the river is taking place. There is a portion of exposed soil due to foot traffic near the campfire and picnic table but shows a low potential for erosion.

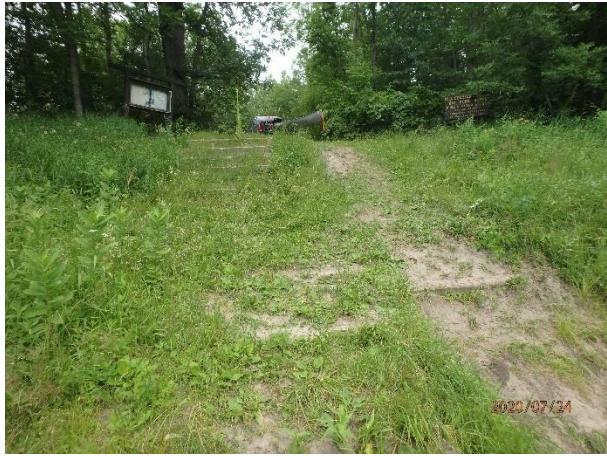
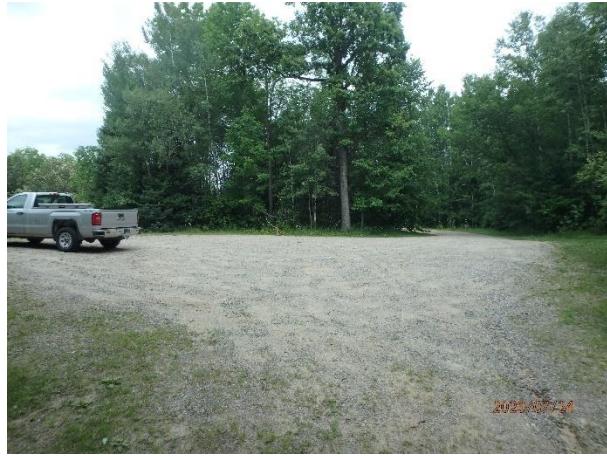
St Hwy 6 S Landing:

State hwy 6 South landing is in the middle of the watershed. This shoreline is vegetated except for a path next to the stairs where entry and exit of the river is happening. The parking lot consists of gravel and has low potential for erosion.

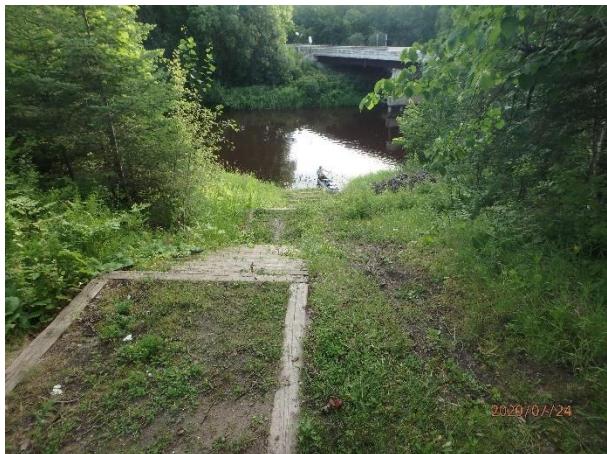
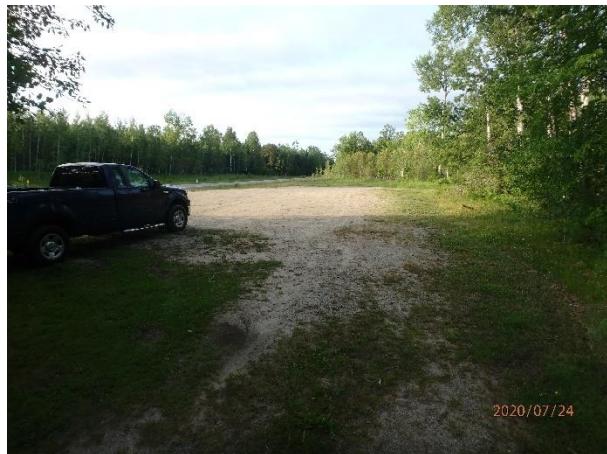
St Hwy 6 Landing:

State hwy 6 landing is in the middle of the watershed. This shoreline is vegetated except for a path next to the stairs where entry and exit of the river is happening. The parking lot consists of gravel and has low potential for erosion.

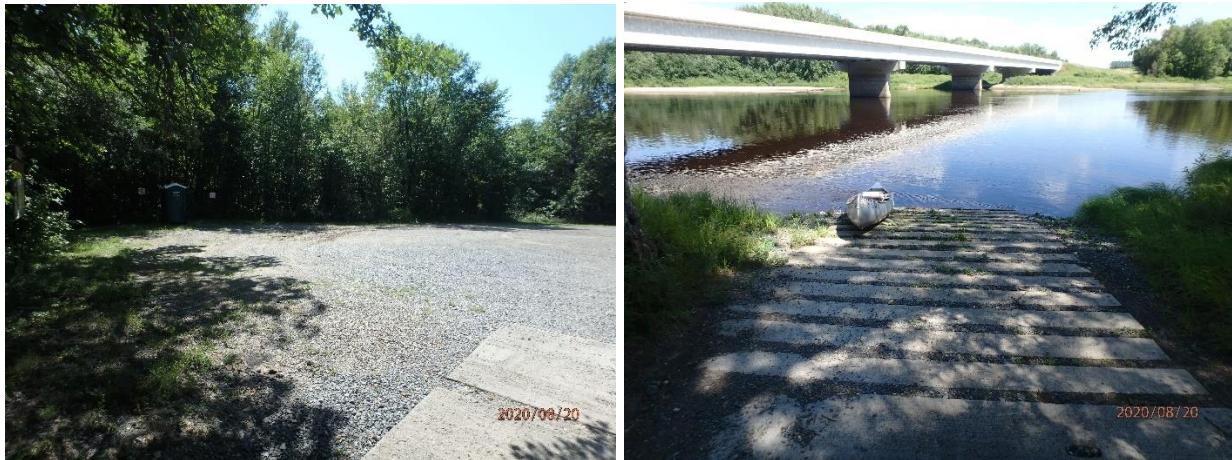
Reedy Flats Landing:

Reedy Flats is just upstream from the mouth of the Big Fork River. This site has vegetated shorelines with little to no erosion present. A concrete landing is in place at the site. The parking lot is gravel and shows no signs of erosion.

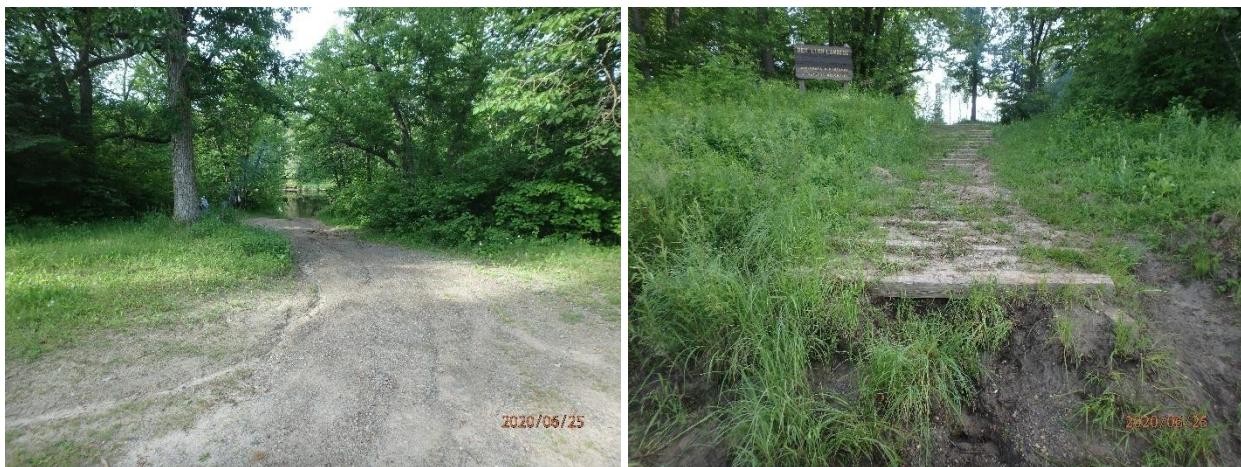
Ben Lynn Landing/Campsite:

Ben Lynn Landing/campsite is in the lower third of the watershed. The shoreline has great vegetation with some bare soils at the end of the stairs leading down to the water's edge. The parking lot and path towards the water has some erosion potential with minor rill erosion.

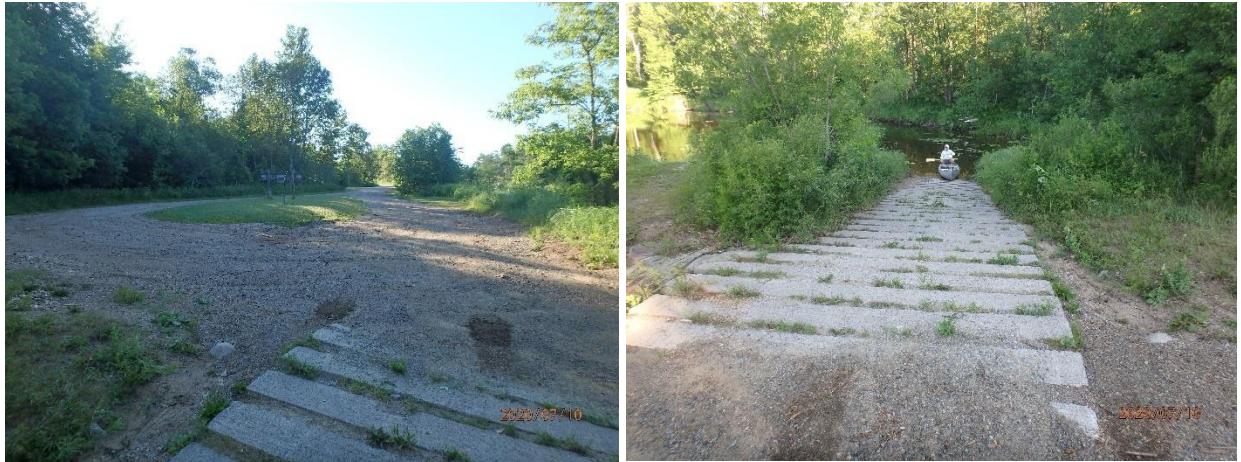
Big Falls Landing E:

Big Falls Landing East is in Big Falls downstream of the rapids. This site is vegetated with a gravel parking lot. There is a boat ramp present with some erosion and exposed soils next to it. This site has low potential for erosion.

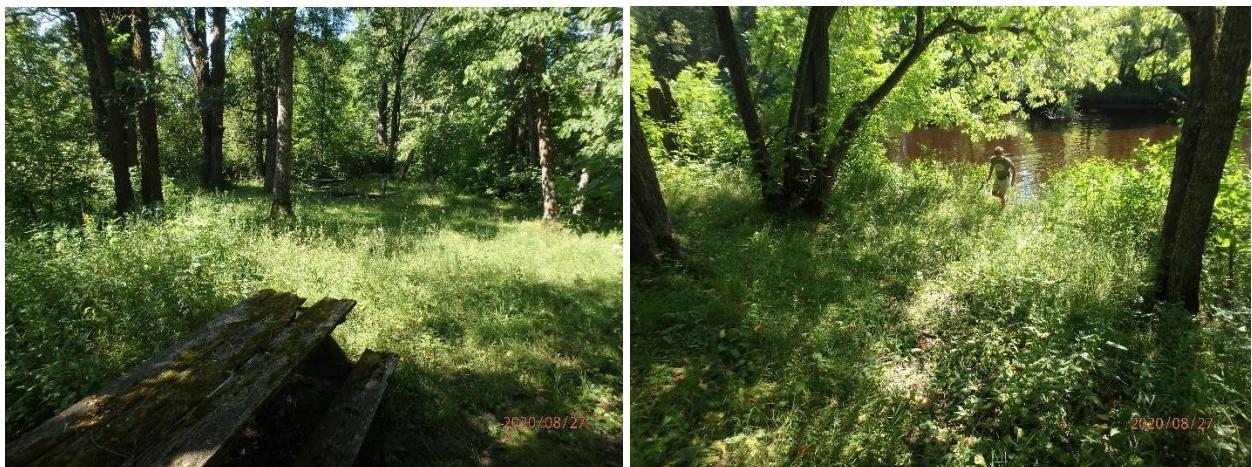
Old Hudson Bay Farm Campsite:

Old Hudson Bay Farm Campsite is in the middle of the watershed and only accessible by boat. This site is fully vegetated with no signs of erosion. There is a firepit and picnic table on site. This site has little to no potential for erosion.
