# Midway River Watershed Protection Study

Strategies to protect and restore critical habitats for Brook Trout and other coldwater species

**m** MINNESOTA POLLUTION  
CONTROL AGENCY

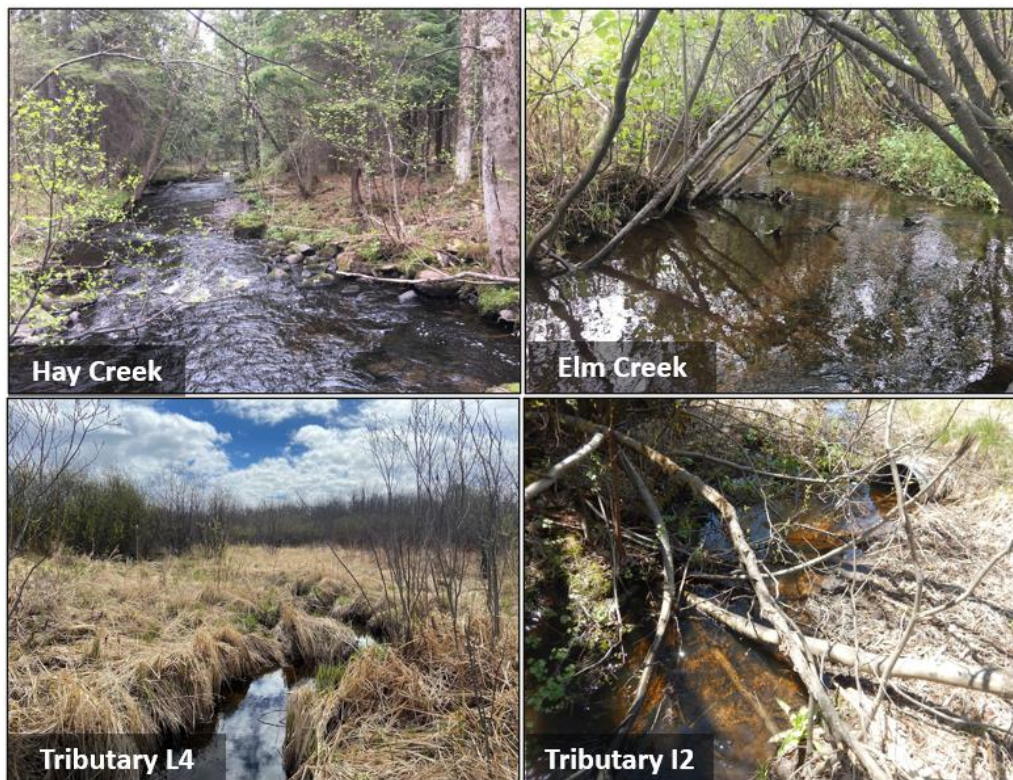
Figure 7: Photos of four WITS within the Midway River Watershed showing the range of stream sizes and conditions.

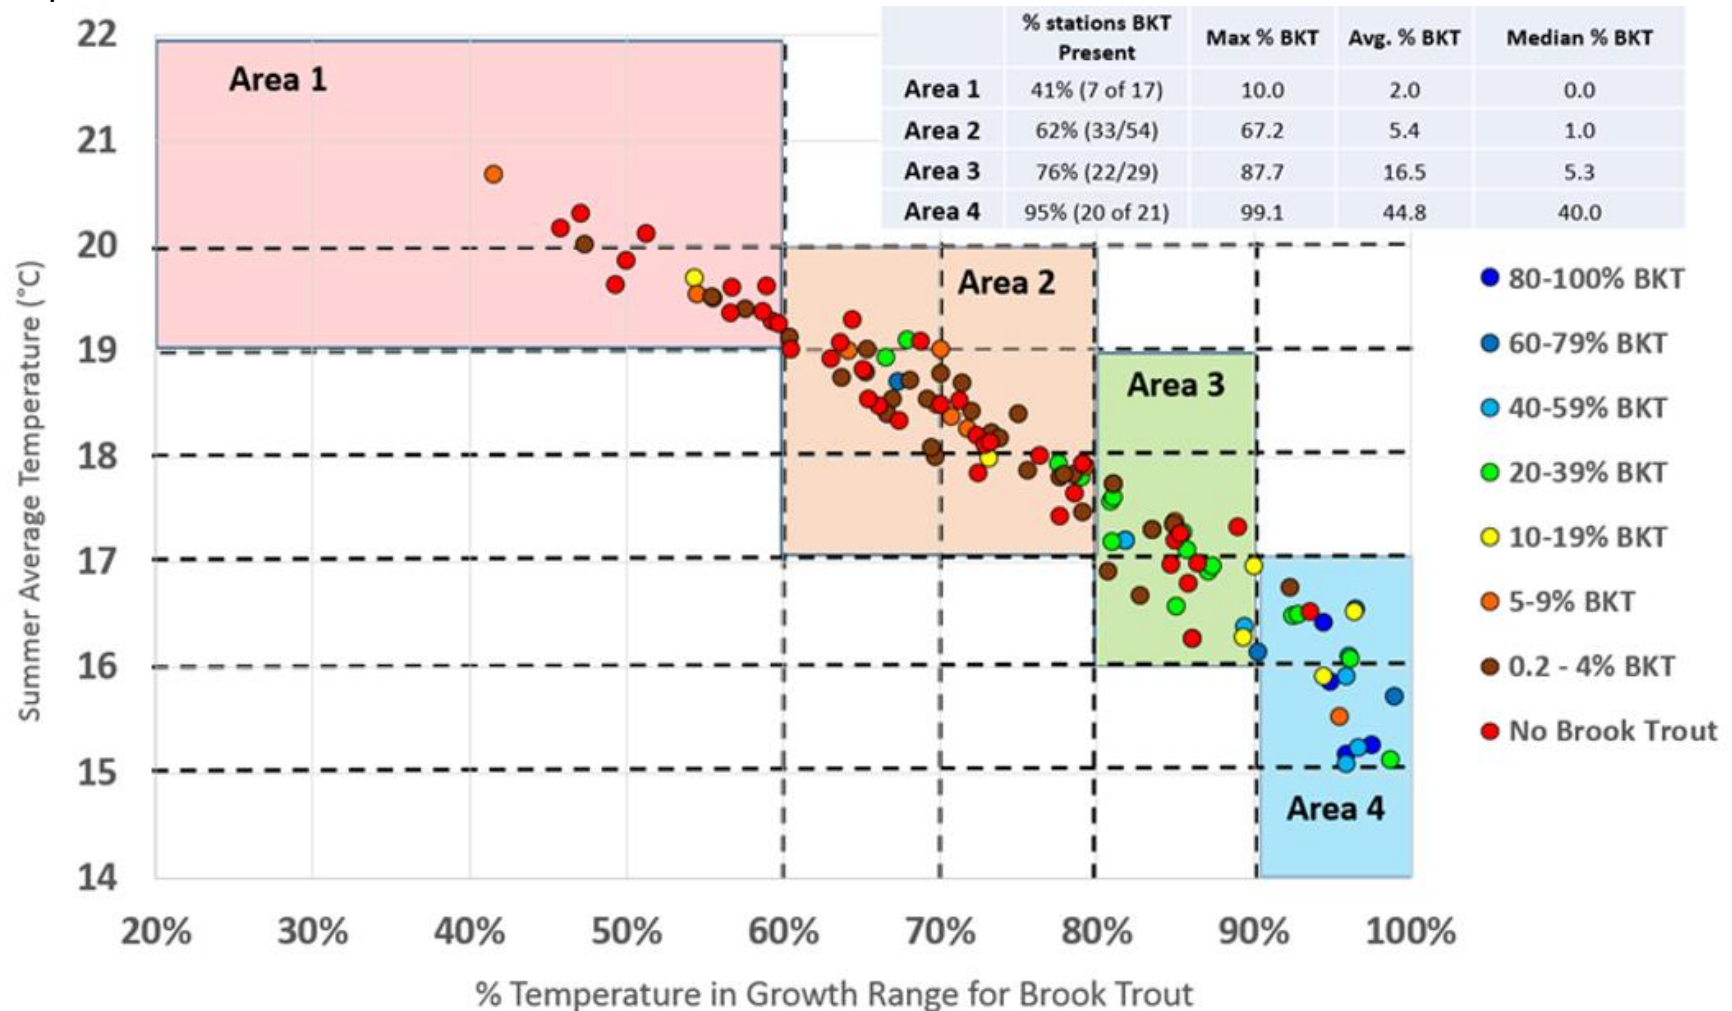
Figure 8: Scatter-plot of summer average temperature vs percentage of time temperature was within Brook Trout growth range. Marker colors correspond to percent of Brook Trout in the sample. Data include all Lake Superior South and Lake Superior North HUC-8 Watershed stations with biological and temperature data from same season.

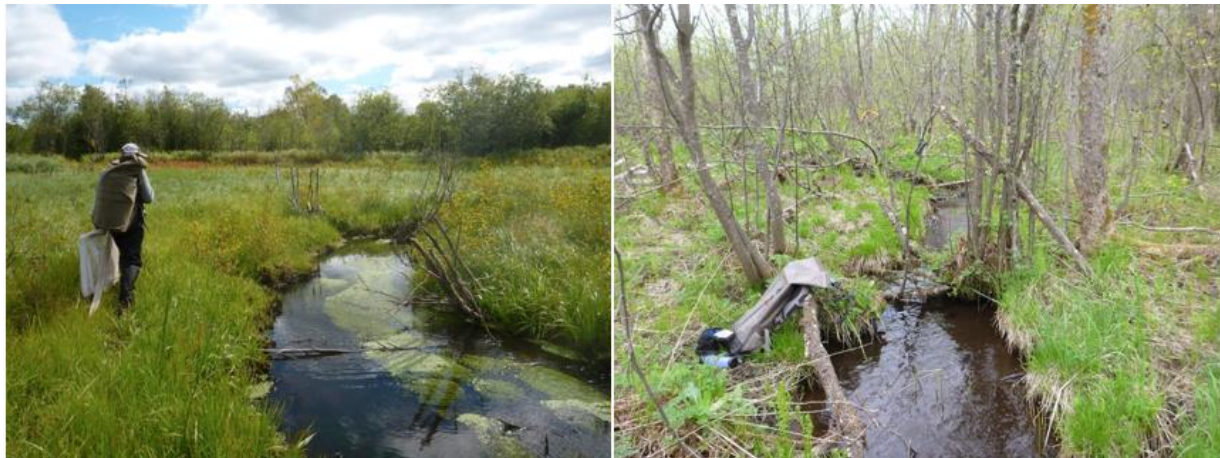
**Figure 20: Examples of CPA in the Midway River Watershed. (Left) Reach J1-011 of West Rocky Run is fed by numerous groundwater springs. Note watercress growths in the channel indicating strong groundwater presence. (Right) Reach K2-005 of Adolph Creek. Small spring-fed tributaries like this remain suitable for Brook**

**Trout year-round and provide thermal refuge during mid-summer months, productive spawning in the fall, and rearing habitat in the winter/spring**

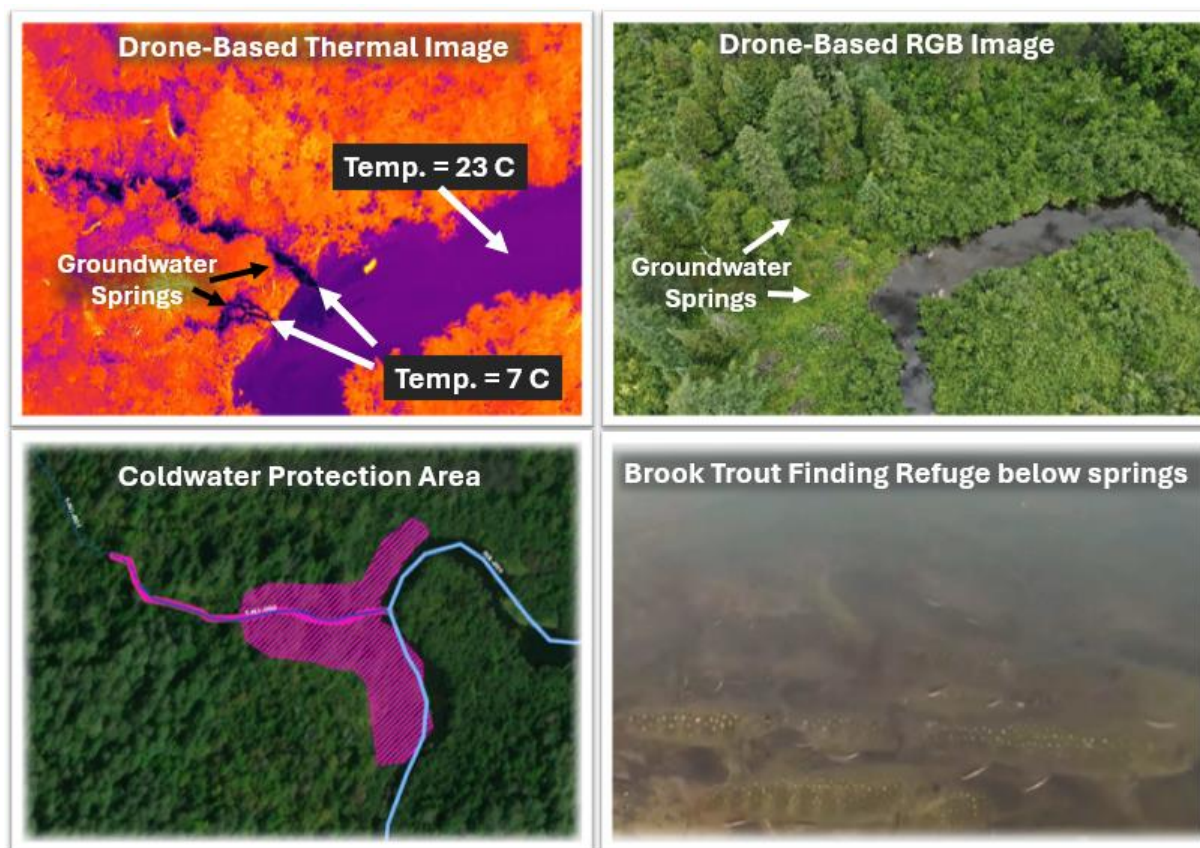
**Figure 20: Drone imagery (thermal and RGB), Coldwater Protection Area (CPA), and underwater footage of Brook Trout collected at a bend of the Midway River fed by numerous groundwater springs. Protection of these areas is paramount for the preservation of Brook Trout and other coldwater species in this river system.**

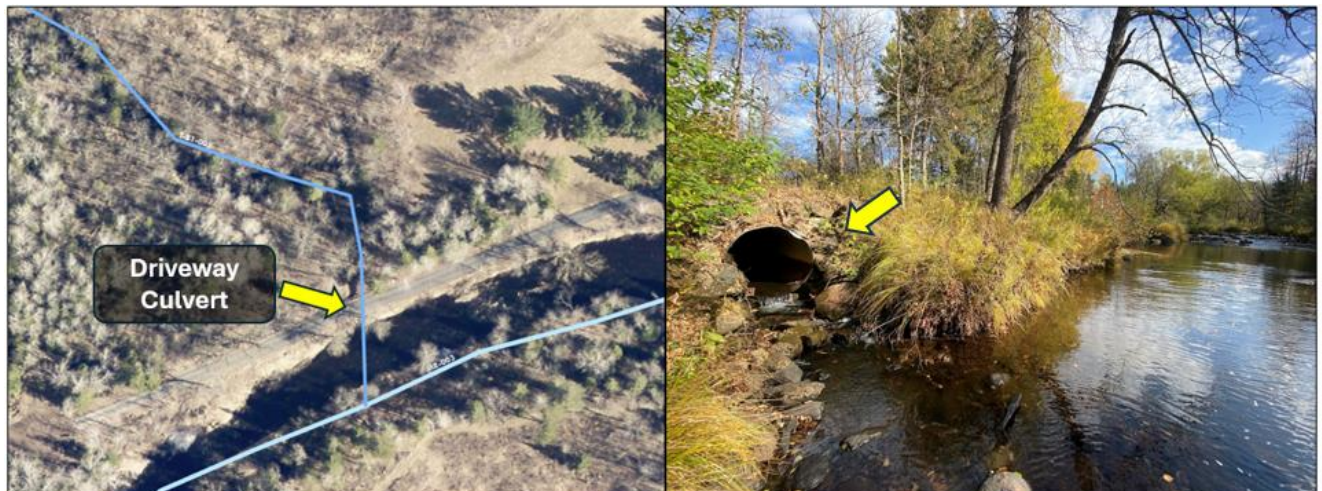
**Figure 24: Perched driveway culvert limits fish passage between Midway River and cold tributary stream**

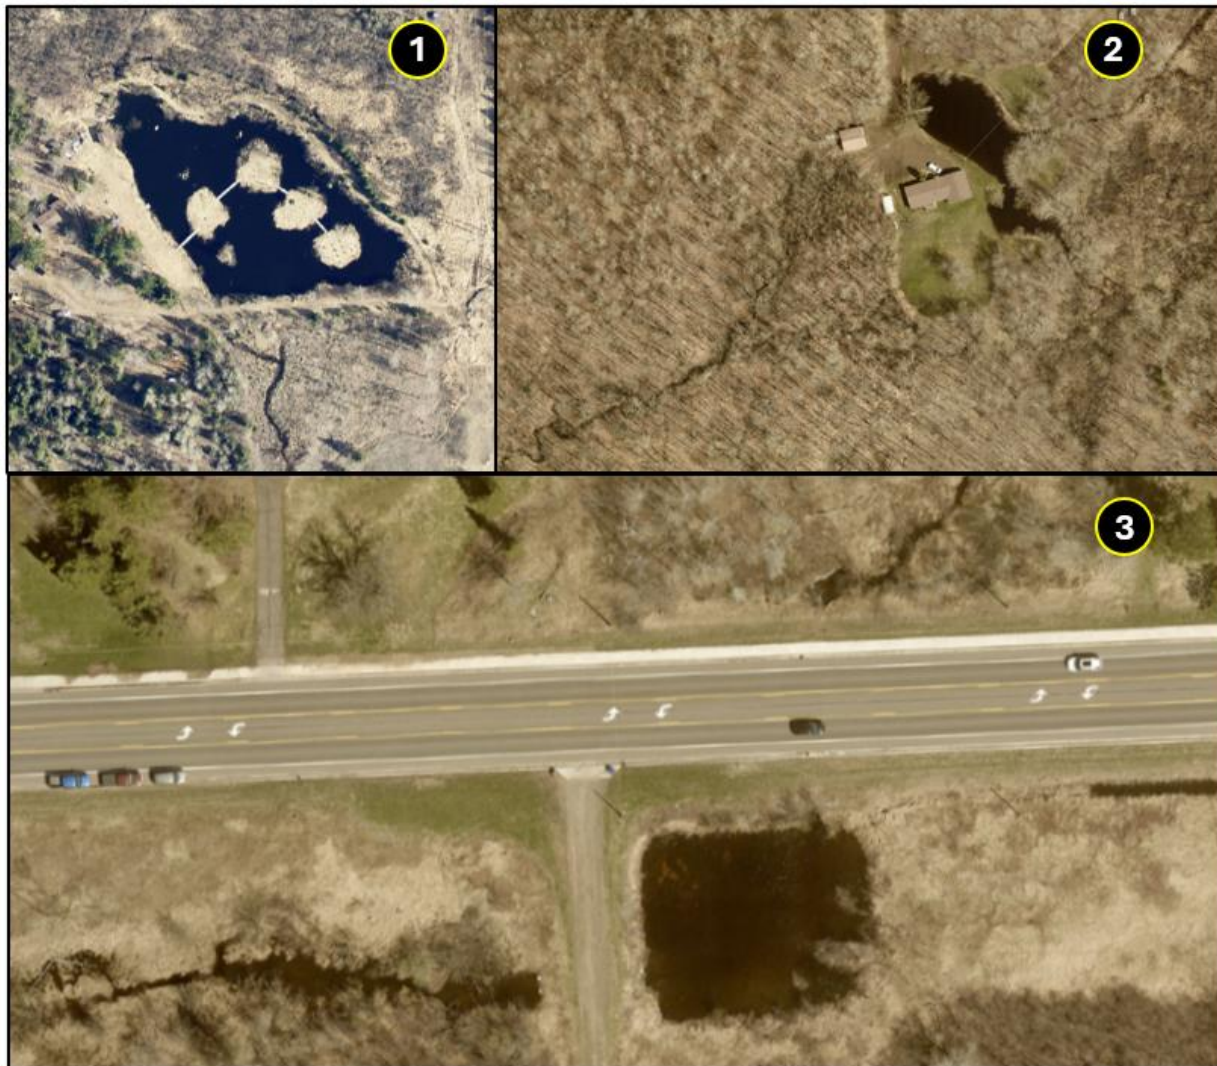
**Figure 25: Examples of impacts to stream connectivity and aquatic organism passage within the Midway River Watershed. 1) impoundment of Tributary B4-001; 2) impoundment of Tributary AG-005; 3) impoundment of Tributary A11-002**

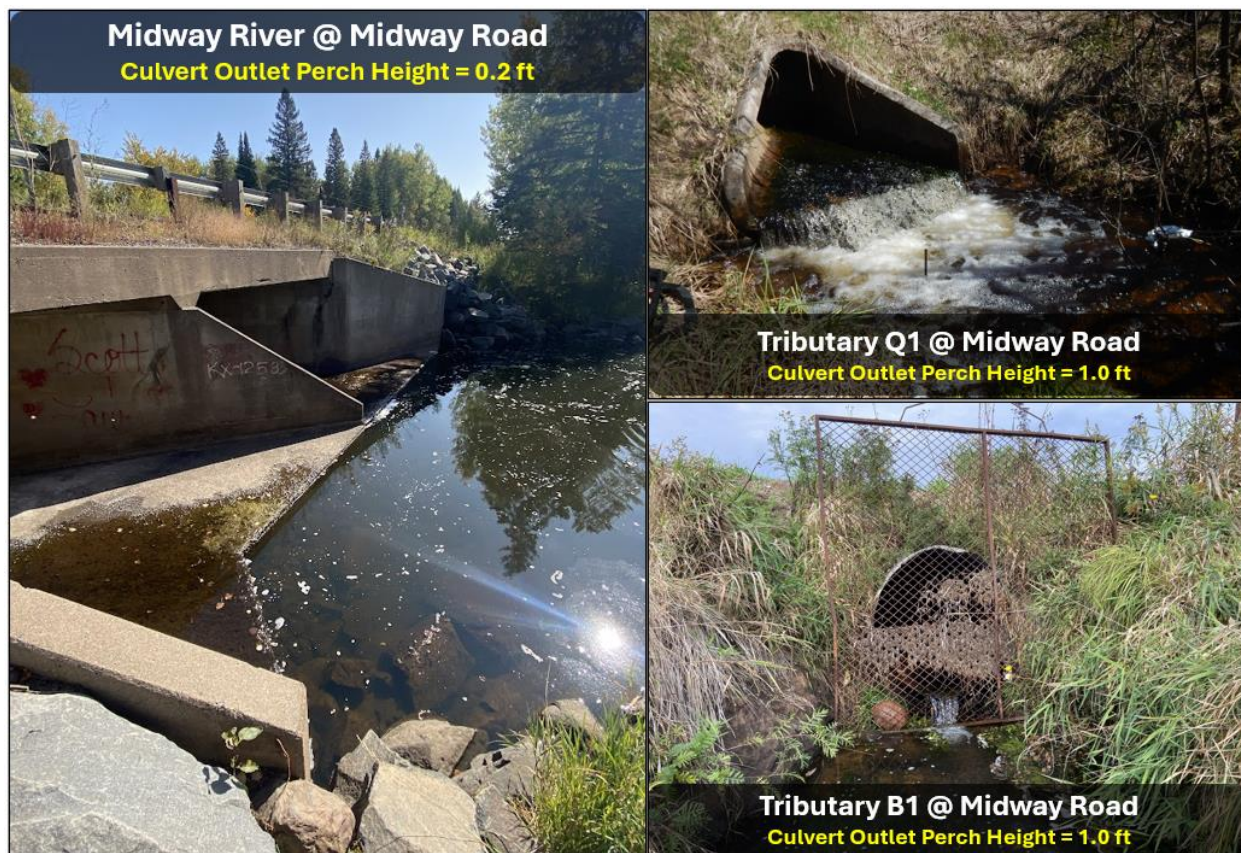
Figure 26: Examples of culverts with perched outlets (e.g. outlet drop) within the Midway River Watershed.

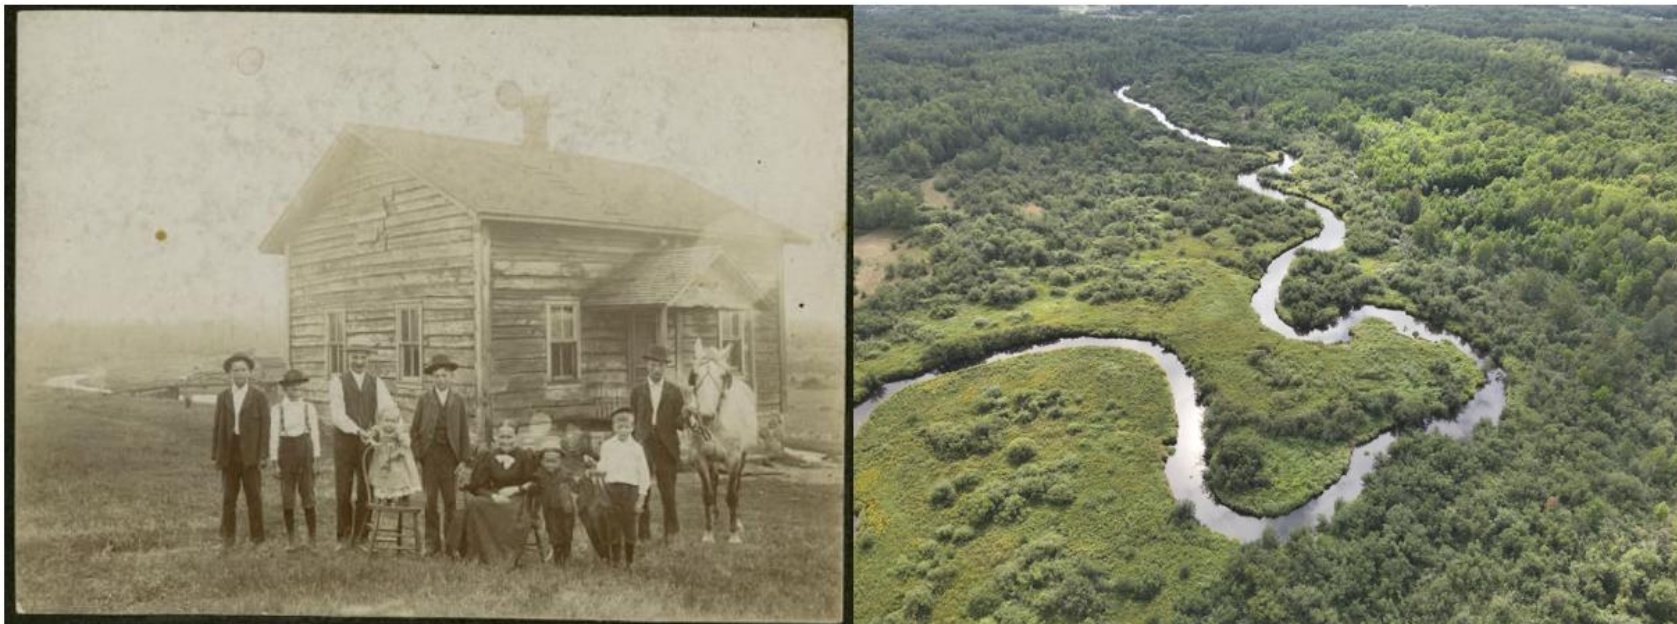
**Figure 34: (Left) Farmhouse of Alex and Georgina Esko on the banks of the Midway River circa 1900. Note the lack of trees and other vegetation within the riparian corridor. (Right) Drone-based imagery representative of present-day riparian corridor conditions along much of the Midway River**

Historic farming practices and wildfires significantly altered the landscape and current riparian corridor of the Midway River from its pre-settlement or early settlement condition (Figure 34). Currently, few corridors of old-growth forest line the banks of the Midway. Instead, undeveloped sections of the river course through riparian corridors dominated by younger stands of aspen or birch, and more commonly shrub species like tag alder, willow, and dogwood, mixed in with native and invasive herbaceous vegetation. These buffers provide considerable protection from streambank erosion and overland runoff, but do not offer significant canopy shading or inputs of large woody debris (e.g. fallen trees or limbs), which provide important fish cover and habitat complexity. Over the last 30 to 40 years, landscapes within the Midway River have transitioned from agricultural (grassland/pasture) to residential or suburban, further altering riparian corridors, wetlands, and stream networks (Figure 35). Long term restoration and protection goals for the Midway River Watershed should focus on preserving remaining riparian old growth forests and working to re-establish corridors of mature trees within riparian zones.

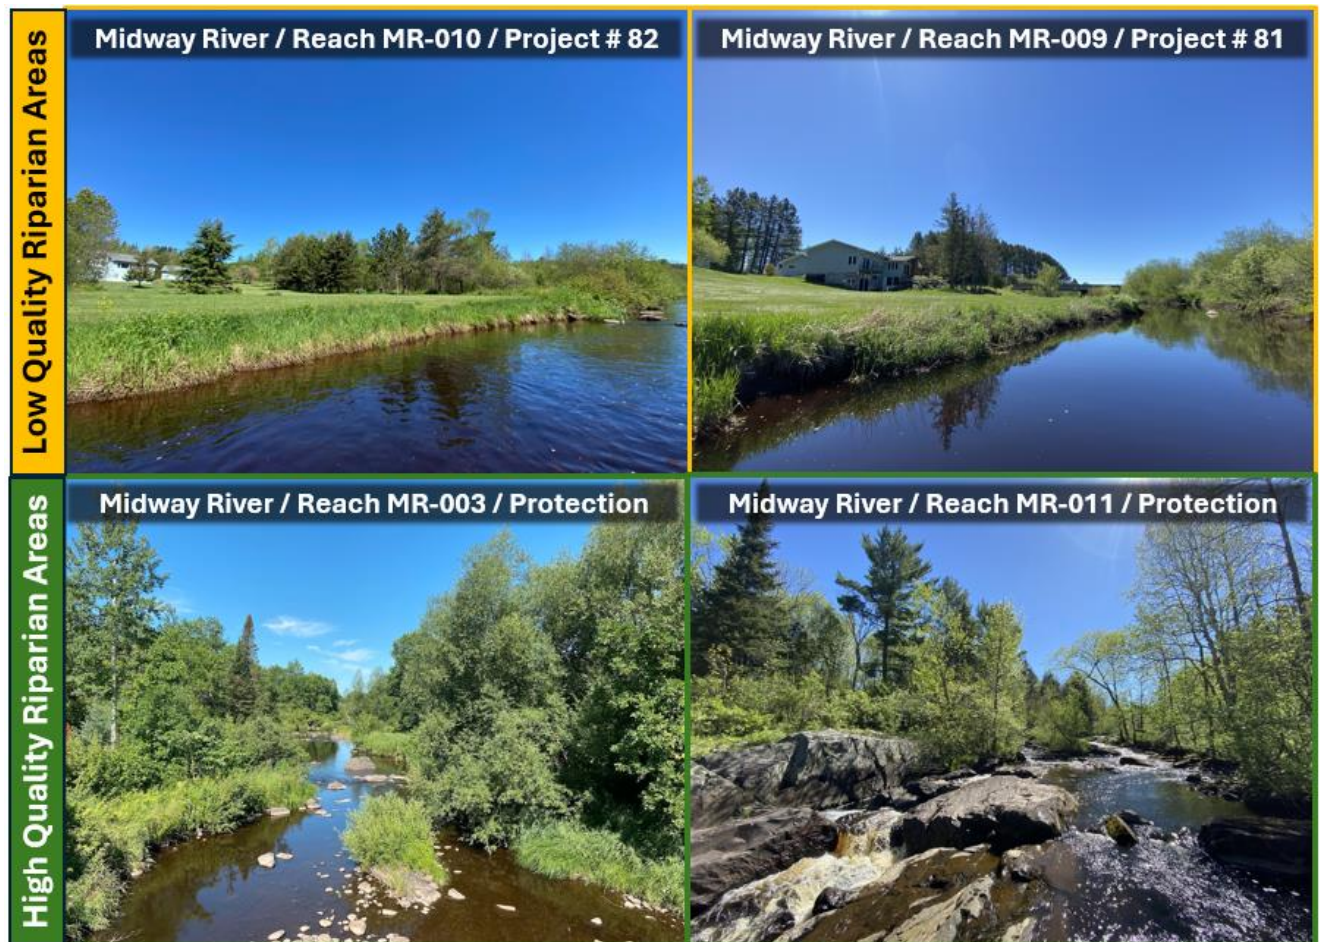
Figure 35: Examples of high quality and degraded riparian corridors observed along the mainstem of the Midway River.

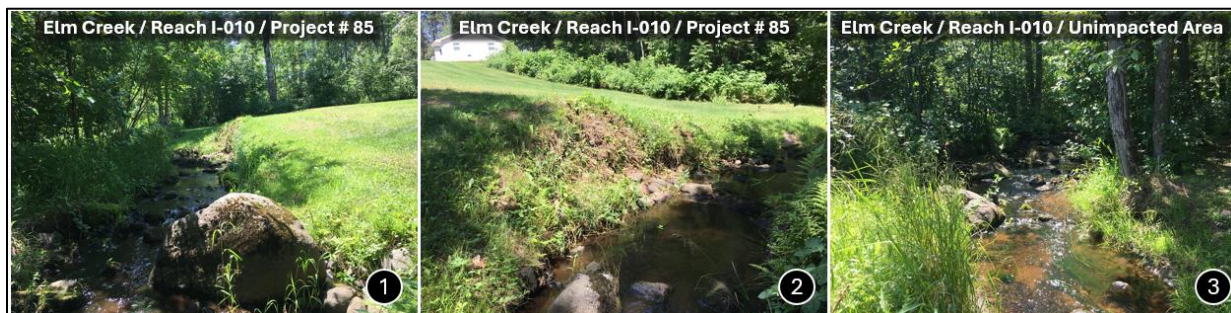
Figure 36: Examples of poor riparian management (left and center) and high quality/unimpacted riparian conditions (right) within the same reach of Elm Creek (I1-010). This is a good example of a high priority candidate for small-scale riparian corridor restoration.
