Redeye River

Watershed Restoration and Protection Strategies (WRAPS) Report Summary

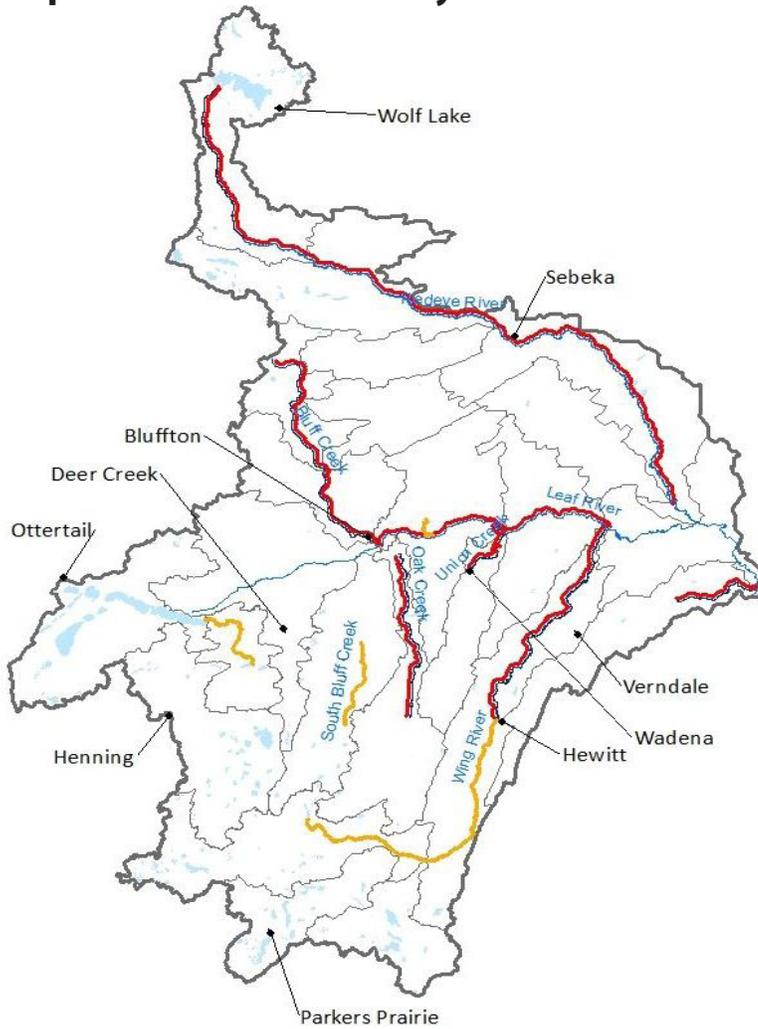
Impairments in the Redeye River Watershed

Waters are “impaired” if they fail to meet standards. The map on the next page shows the impairments for streams in the Redeye River watershed. Under federal and state laws, impaired waters must have Total Maximum Daily Load (TMDL) studies to determine reductions of pollutants needed to again meet water quality standards. In this first WRAPS cycle, the MPCA and local partners completed TMDL studies for 8 stream sections.

- No lakes were found to be impaired in the Redeye River Watershed.
- 8 stream sections were found to have impairments.
- Bacteria: E.coli and/or fecal coliform can indicate sewage or manure in water and makes the water unsafe for swimming.
- Biology: (fish and/or macroinvertebrates): The number and type of fish and bugs are indicators of water's health.

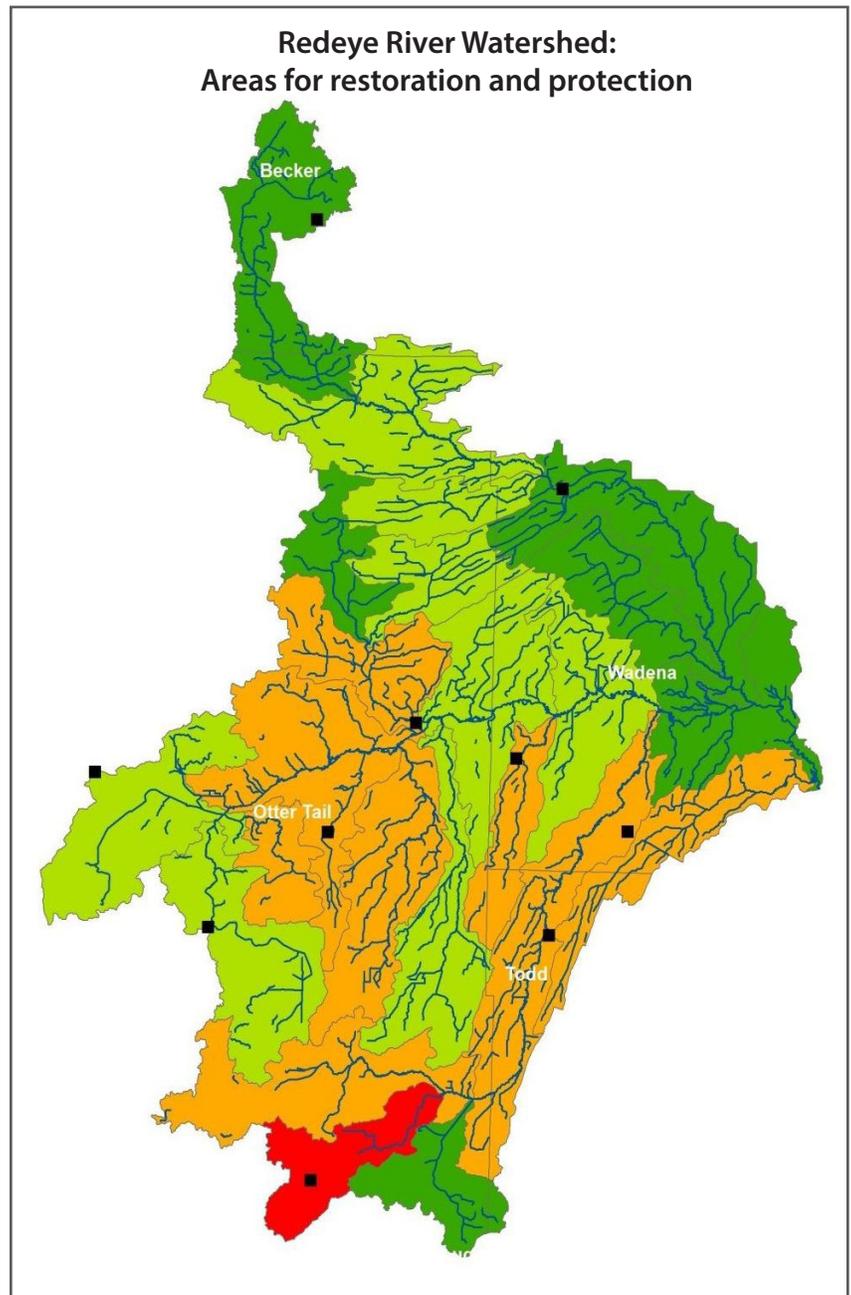
The MPCA created the strategy map to the right using HUC-12 subwatersheds – drainage areas within the larger HUC-8 Redeye River watershed – to help identify priority areas for targeting actions to improve water quality. Multiple sources of data, maps and analysis tools including HSPF, were combined to create this map. The colors on the map indicate:

- Red – High priority restoration (water is Impaired, needs highest attention)
- Orange – Medium priority restoration (water is Impaired)
- Light green – Protection/monitoring (water quality is good but declining or faces threats)
- Dark green – Protect (water quality is good)

- Stewardship/education programs and activities for restoration and protection efforts in the watershed should be continued.
- The subwatershed of highest priority for restoration is County Ditch No 13 in the southern end of the watershed. Some of the restoration strategies include nutrient management, improving existing water quality through protection of riparian habitat and increasing forest acreage.
