Nemadji River

Watershed Restoration and Protection Strategies (WRAPS) Report Summary

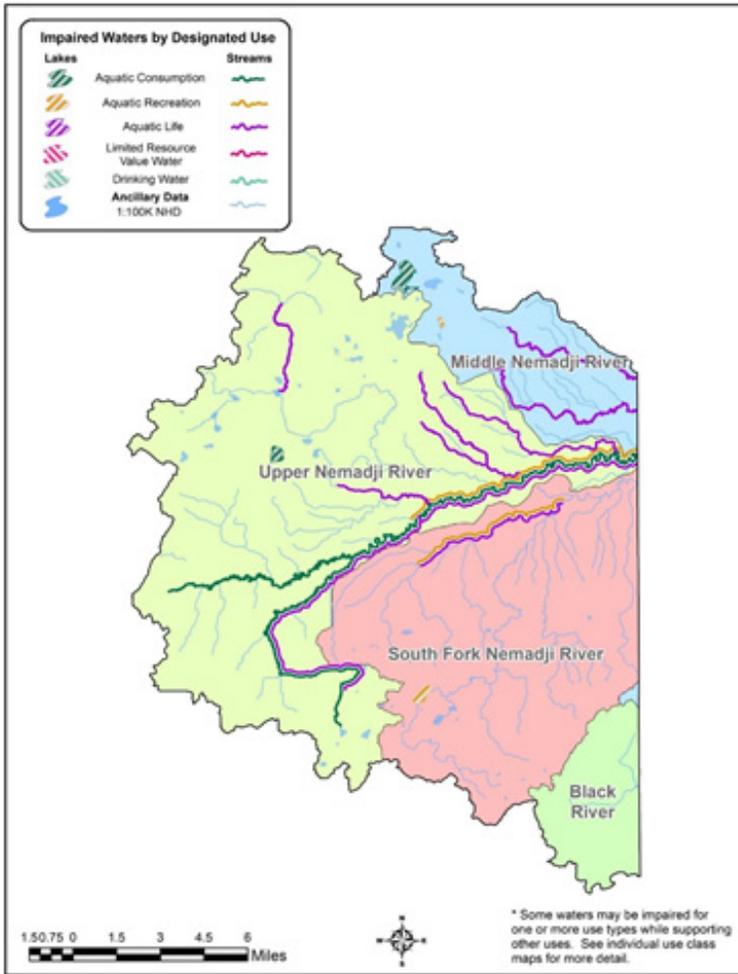
Impairments in the Nemadji River Watershed

- Two lakes do not meet water quality standards.
- Twelve stream sections do not meet water quality standards.
- Lac La Belle, Net Lake, and Deer, Elim, Mud and Skunk Creeks are examples of waterbodies listed as “impaired,” or polluted by high levels of phosphorus, sediment or bacteria.
- The remaining assessed water bodies meet all water quality standards.
- More information is available in the water quality monitoring and assessment report.

Waters are “impaired” if they fail to meet standards. The map on the next page shows the watershed’s impairments for streams and lakes in the Nemadji River Watershed. Under federal and state laws, impaired waters must have total maximum daily load (TMDL) studies to determine reductions of pollutants needed to again meet water quality standards. In this first WRAPS cycle, the MPCA and local partners completed TMDL studies for 10 stream sections and two lakes.

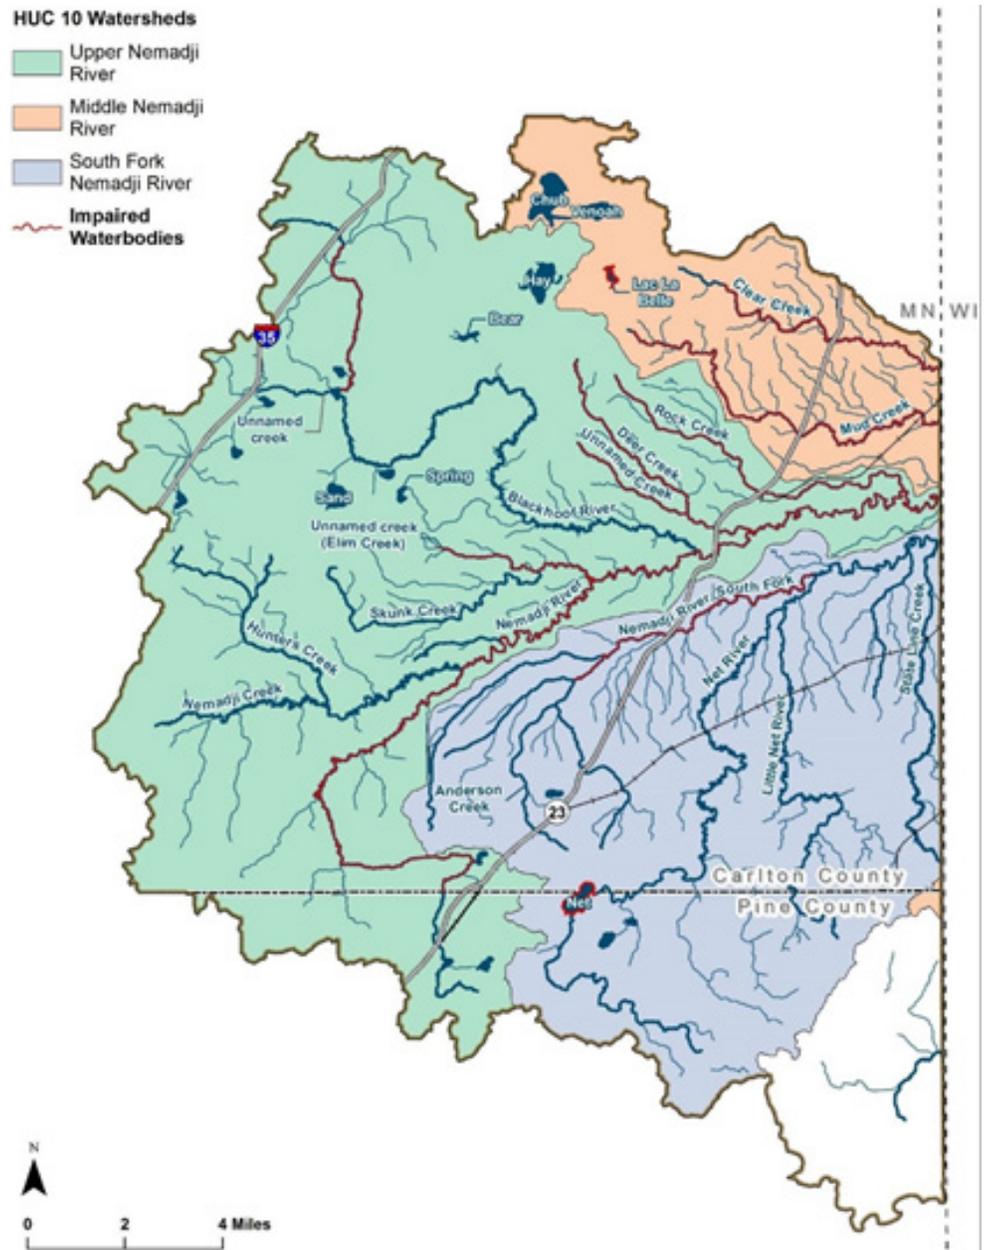
- Three subwatersheds within the Upper Nemadji are prioritized for both restoration and protection work in the first 10 years of targeted implementation and water quality improvement work. They are the Deer Creek, Skunk Creek and BlackHoof River subwatersheds. Three lakes are the focus of targeted work, Lac La Belle, Net Lake and Chub Lake. Multiple sources of data, maps and evaluative tools including HSPF watershed analysis were combined to select the targeted subwatersheds.

- Other maps of individual pollutants, such as phosphorus and nitrogen, can be found in the full report. Stressor or pollutant impact maps are also part of the report and provide more detail as to where projects may be best focused.

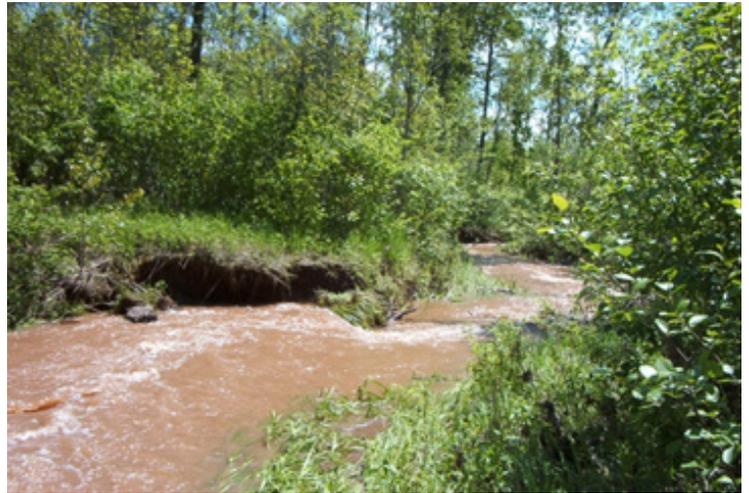
Deer Creek at high flow.
