Summary - Upper Red River Watershed Restoration and Protection Strategies (WRAPS) Report

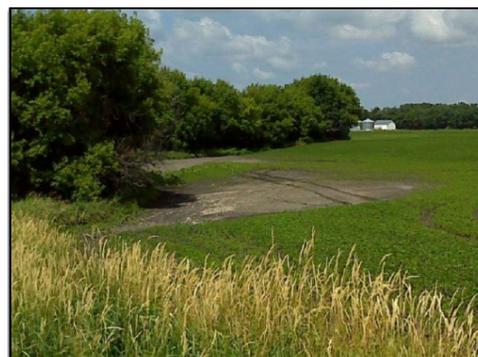
Example of Whiskey Creek floodplain area being farmed.
