Thief River Watershed Restoration and Protection Strategy Report

March 2019

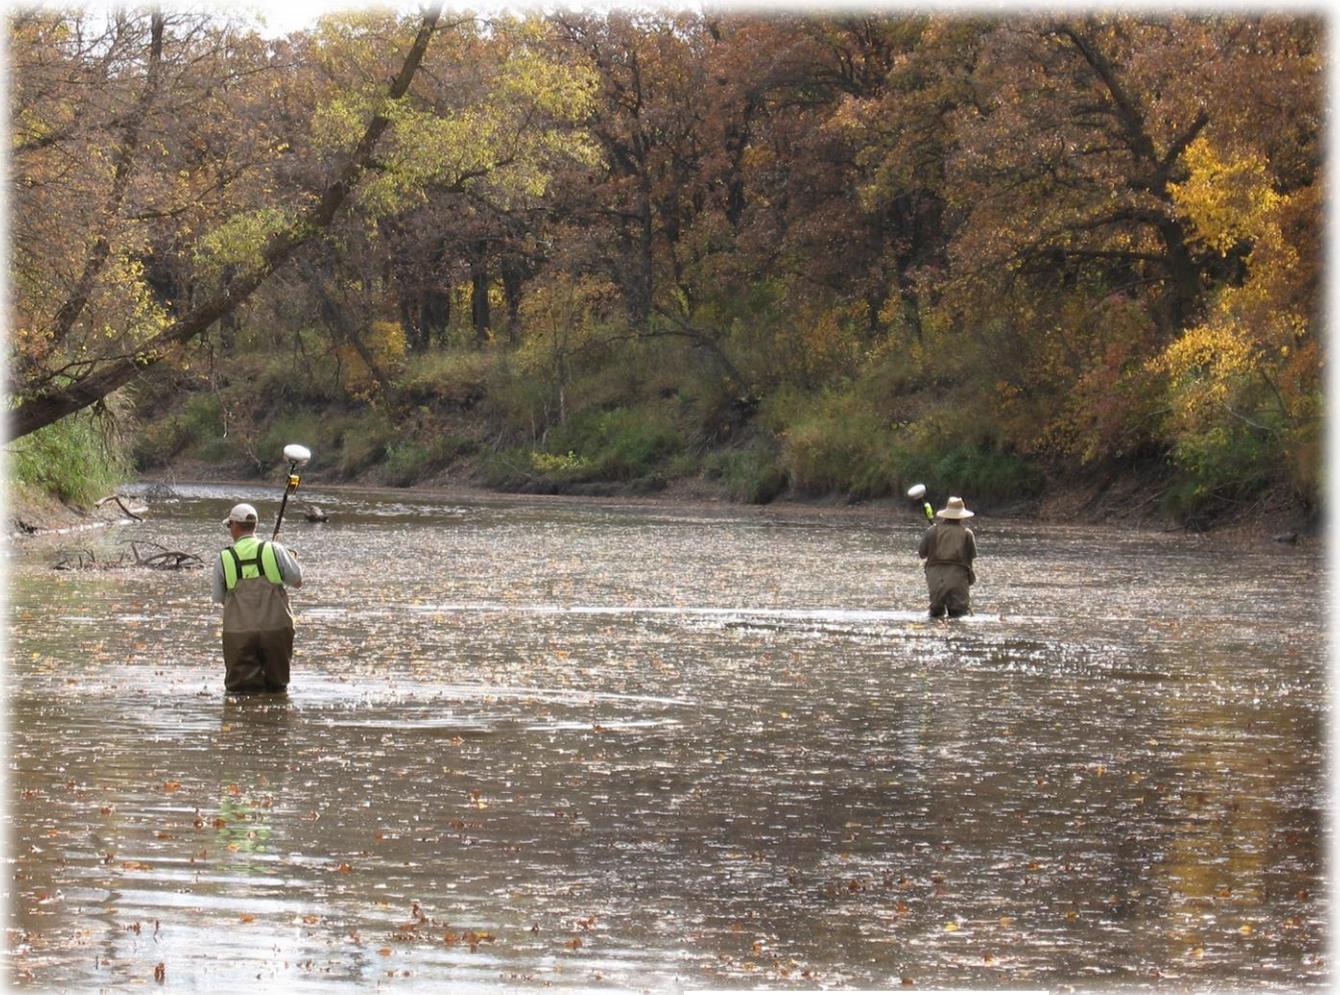
Cover Photo

In the photo, Red Lake Watershed District and Minnesota Department of Natural Resources staff are surveying longitudinal profiles of the Thief River (upstream of the 05076000 USGS gaging station) for the fluvial geomorphology study of the watershed. The picture was taken by Red Lake Watershed District staff.

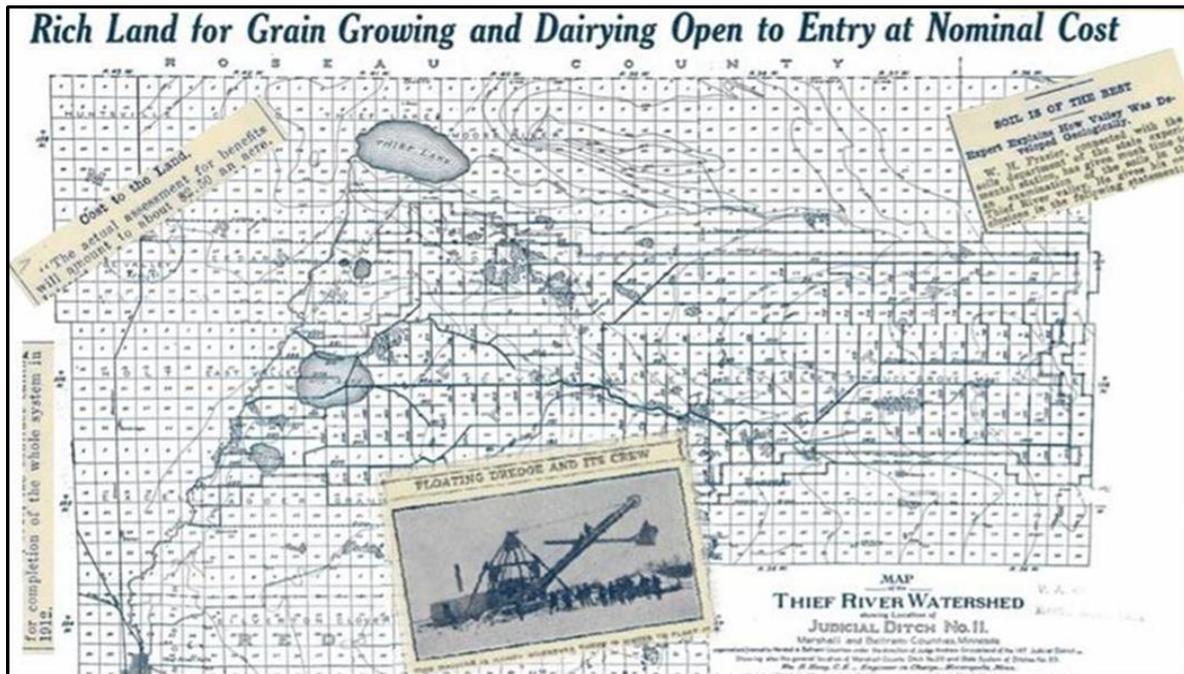
Figure 1-1. Historical map and newspaper clippings about the dredging that occurred in the early 1900s.

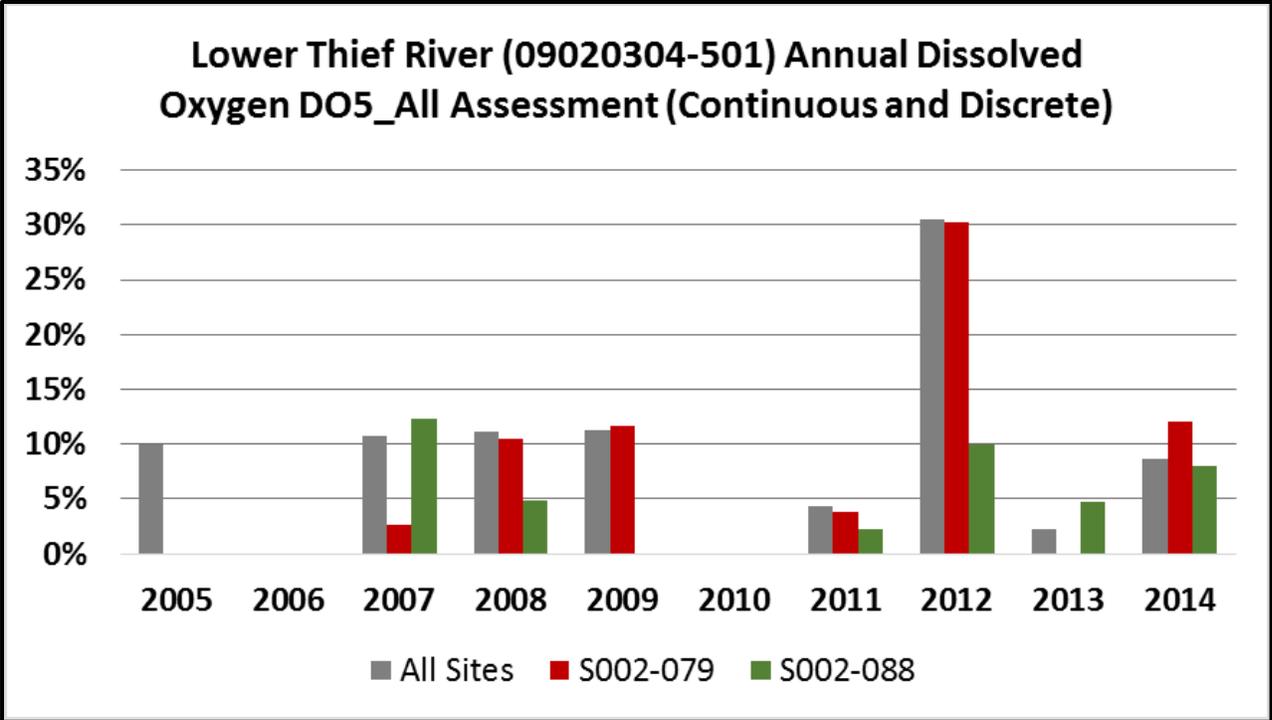
Figure 2-2. Yearly rates at which the DO standard is violated in the lower Thief River (09020304-501)

The Thief River between Agassiz Pool and the Red Lake River (09020304-501) was listed as impaired by low DO on the 2006 303(d) List of Impaired Waters. It was delisted during the 2013 assessment due to satisfactory assessment of discrete monitoring data, along with fish and macroinvertebrate data that indicated that the reach was sufficiently supporting aquatic life (Figure 2-2). Data from DO loggers suggests that the overall frequency of low DO concentrations in the Thief River is higher than what discrete data suggests. DO loggers captured more violations of the standard than regular discrete sampling because they record the true daily minimum DO levels that occur during the early morning, prior to work hours. The continuous DO record is significantly influenced by a high rate of low DO concentrations measured during the 2012 monitoring season when flows were unusually low. The high quality direct measurements of fish and macroinvertebrate biotic integrity override the contradictory DO record by proving that the river is supporting aquatic life.

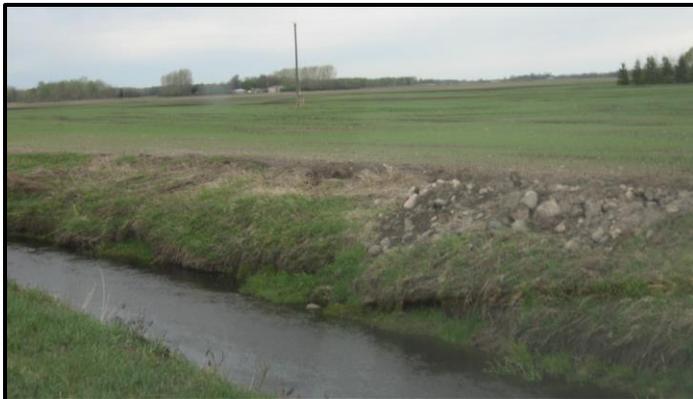
woody vegetation makes stream banks more vulnerable to erosion. Insufficient buffers and unstable ditch outlets also increase the amount of sediment that enters rivers from overland erosion. The photo in Figure 2-12 shows a portion of the Mud River (JD11), 2.5 miles east of Grygla, that is being farmed up to and into the edge of the ditch bank. There are also good examples (Figure 2-13) throughout the watershed of how trees and their roots (especially willows) are doing a lot to protect the streambanks by holding soil in place, despite being subjected to great erosive force during high flows. Fine roots from shrubs, willows, native plants are especially effective at holding soil in place, because their root systems have greater surface area. Traveling along the rivers, streams, and ditches in the watershed provides an opportunity to observe the importance of riparian buffers for channel stability and reduction of pollutant transport from agricultural fields. Often, stretches of well-buffered and vegetated streambank are followed by stretches that have been farmed to their edge and are severely failing. A distinct contrast in stream bank stability can be observed when comparing a bank that is well buffered and vegetated with a nearby bank that has had its riparian forest buffer removed. (Figures 2-14 and 2-15) are examples of channels that are in violation of the Buffer Law and should be a priority areas for the establishment of buffer strips. Much discussion about riparian buffers focuses on their ability to filter overland runoff, but their importance for also maintaining streambank stability should not be overlooked.

Figure 2-12. Example of a portion of the Mud River that needs a better buffer.

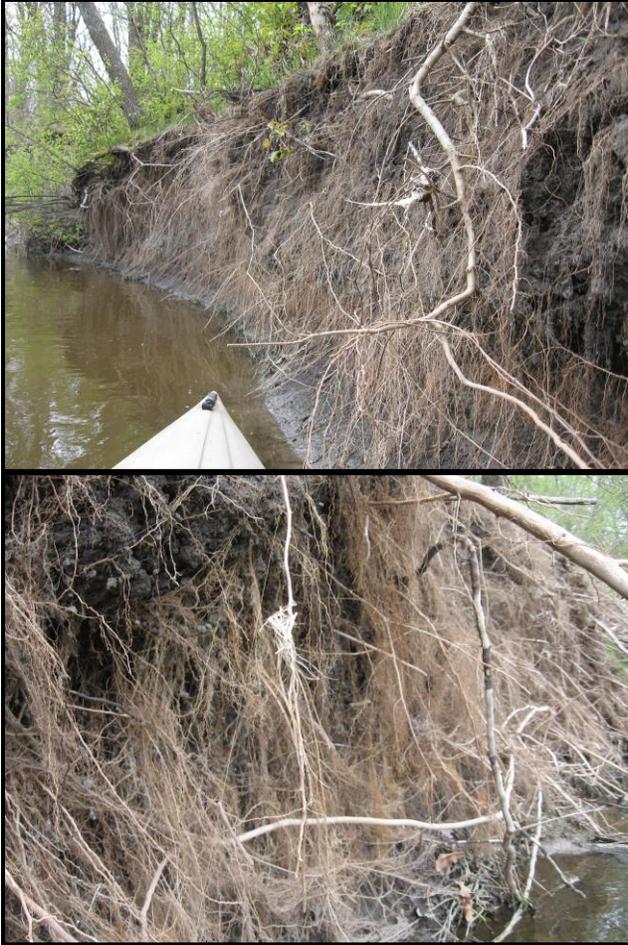
Figure 2-13. Roots protecting a stream bank along the Thief River

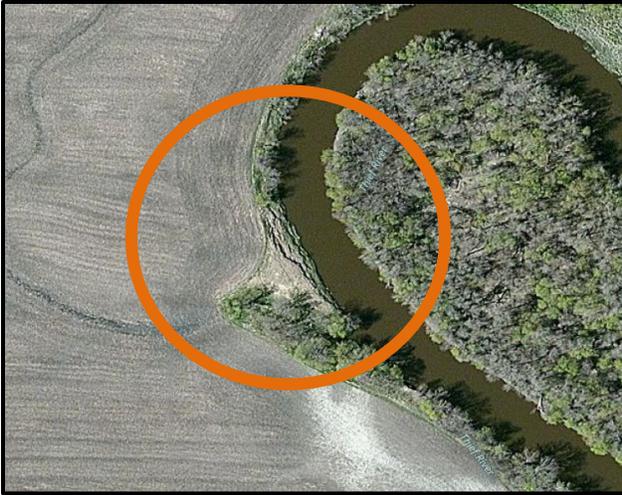
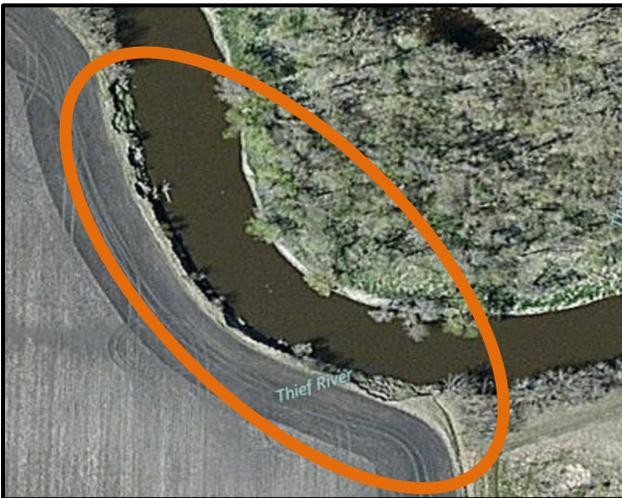
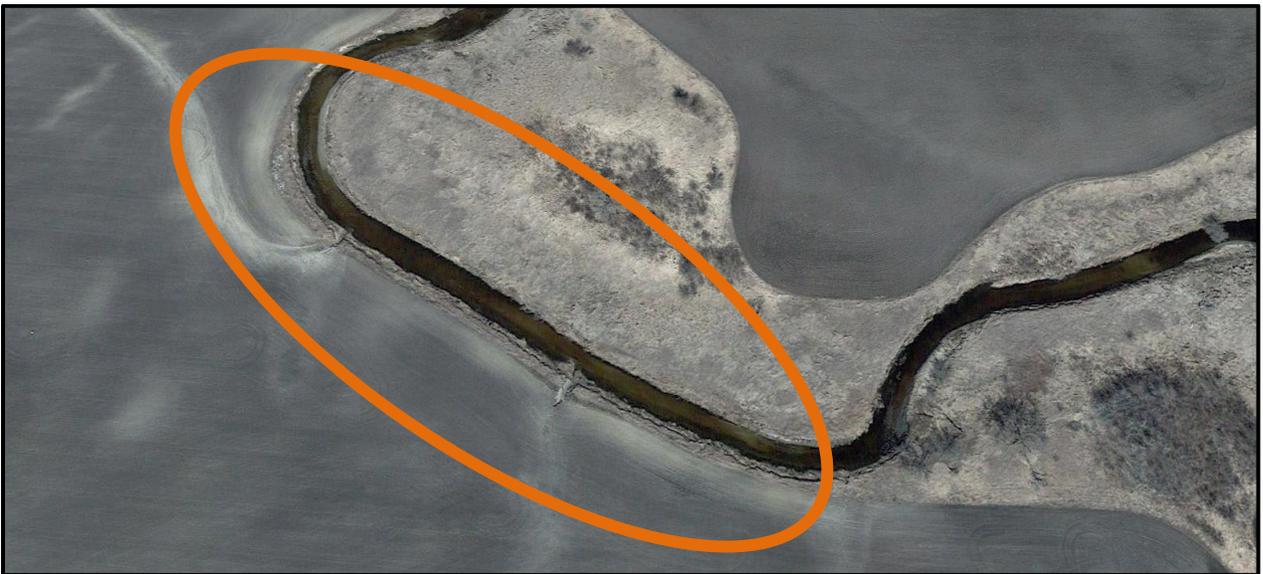
Figure 2-15. Examples of streambanks along the lower Thief River (top two photos) and the Mud River (bottom photo) that were badly eroding due to a lack of a buffer and a lack of deep-rooted vegetation

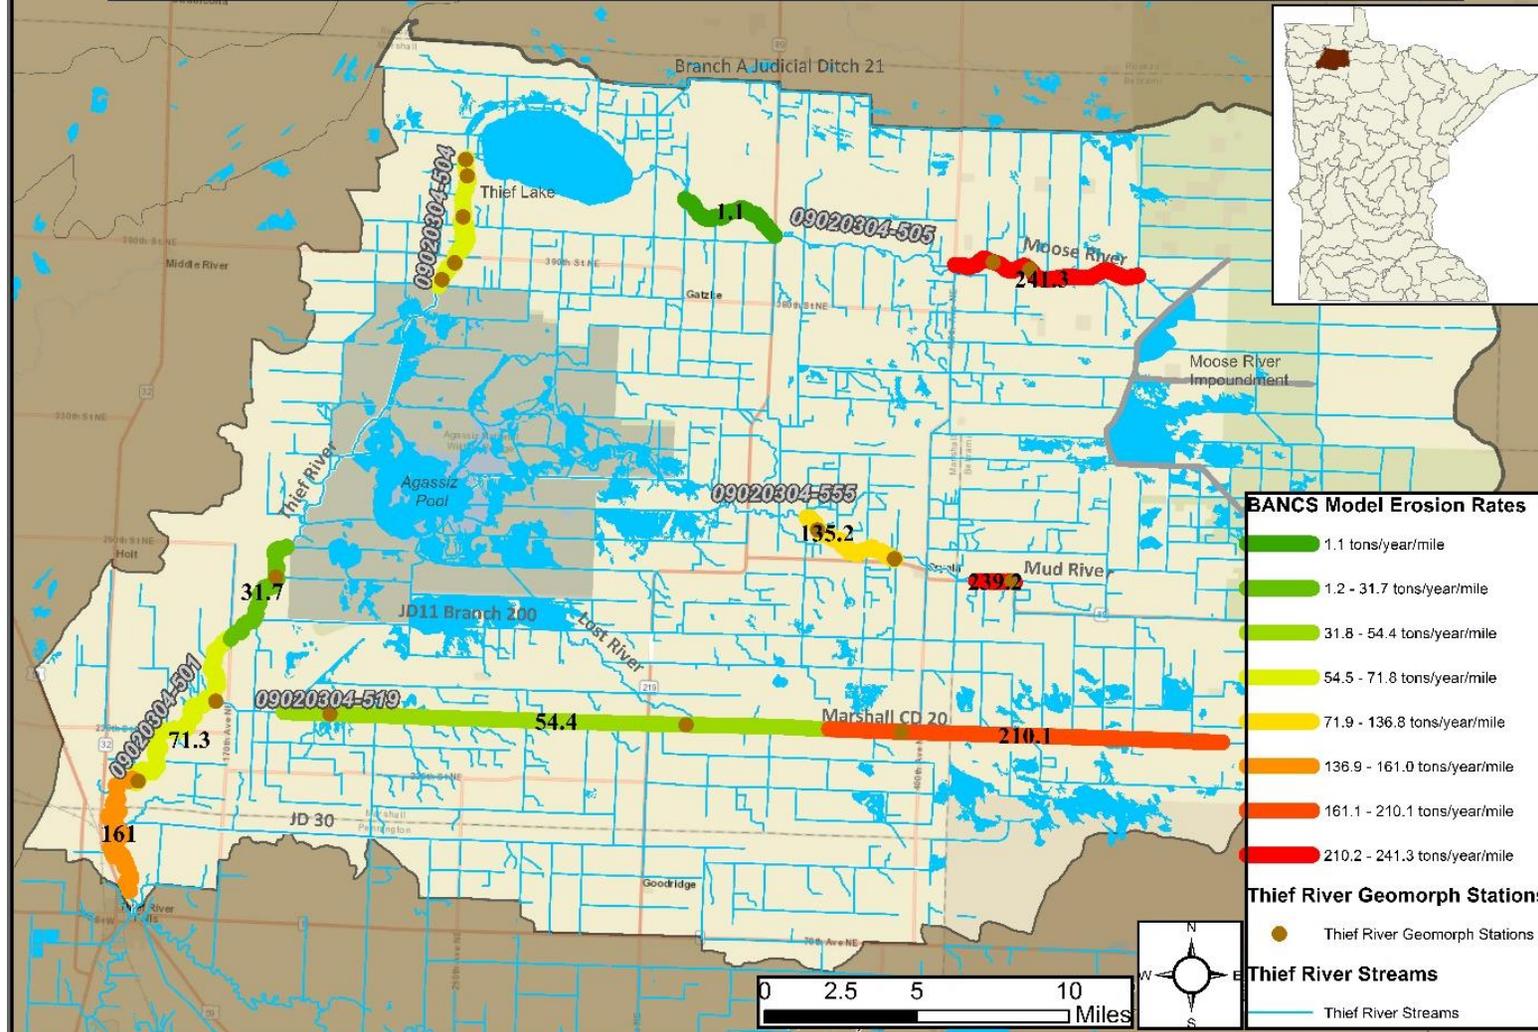
Figure 2-16. BANCS Model stream bank erosion predictions from the Thief River Watershed Fluvial Geomorphology Report. The circles and ovals encompass the reaches that were evaluated.

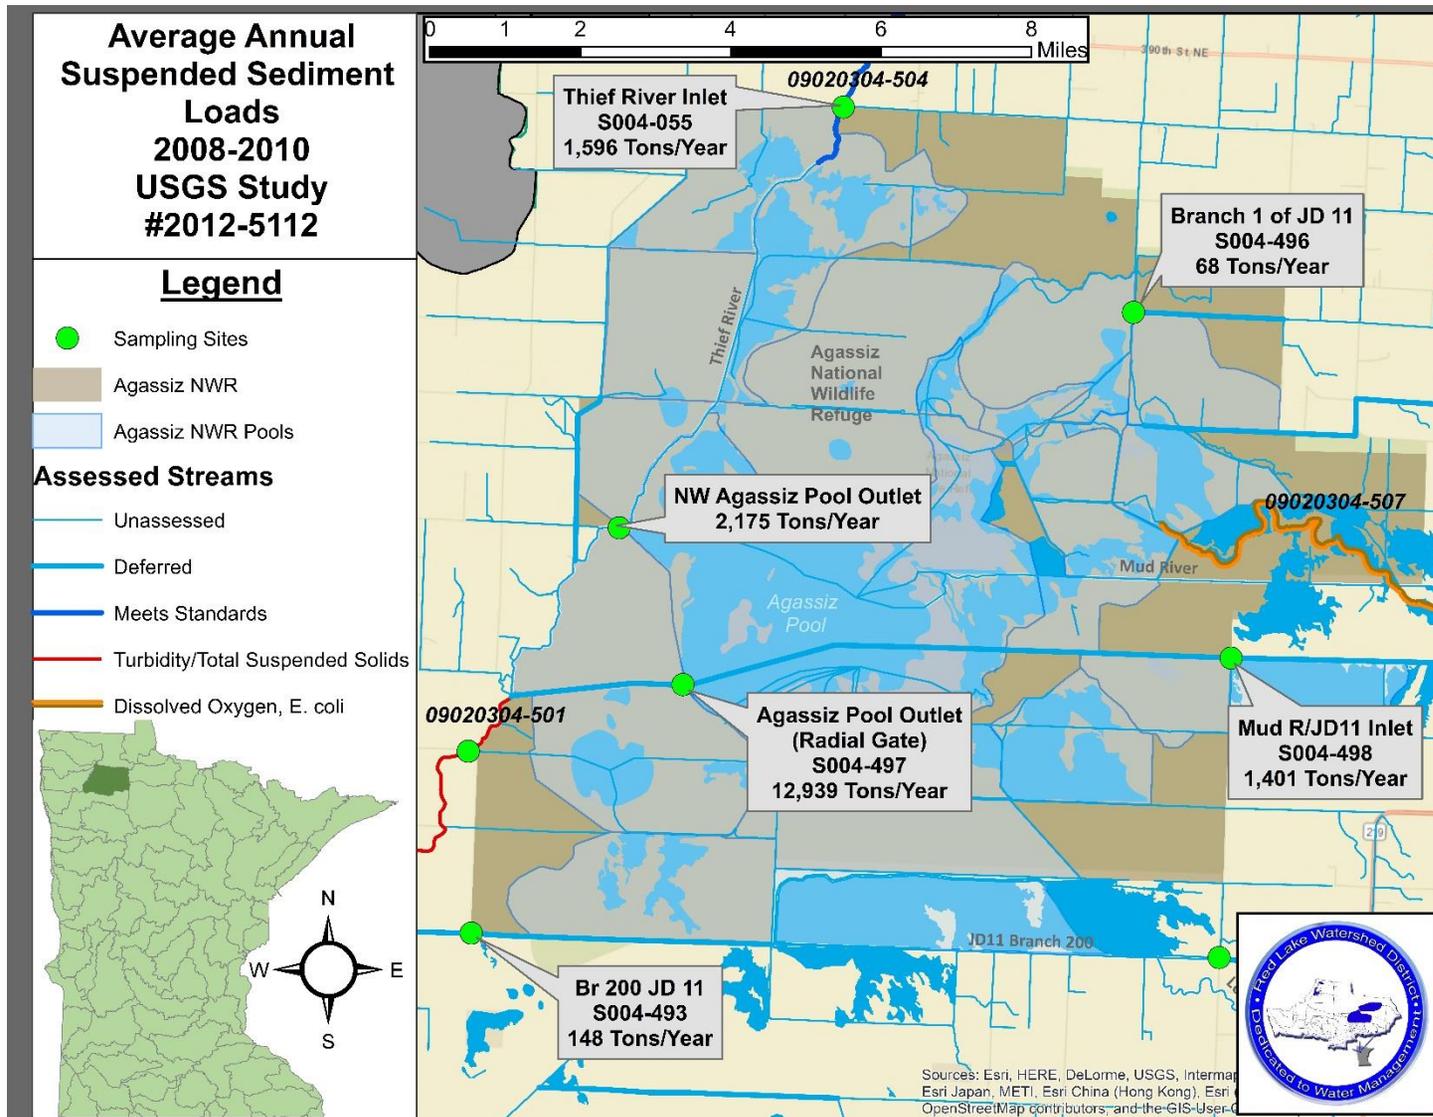
Figure 2-18. Average annual sediment loads (2008-2010 Tons/Year) from the USGS Assessment of Nutrients and Suspended Sediment Conditions in and near the Agassiz National Wildlife Refuge, Northwest Minnesota, 2008-2010 study.

pool (Figure 2-17). The USGS, USFWS, and RLWD cooperated to study sediment loads flowing into and out of Agassiz NWR. The sediment loading results (shown in Figure 2-18) at the radial gate outlet were much higher than the loading rate at any inlet. The combined sediment loading at the two Agassiz Pools was more than 4.7 times higher than the combined loading rate from the three inlets that were monitored. A 2009-2010 drawdown of Agassiz Pool, the first in over 10 years, contributed to the elevated sediment loads at the outlets.

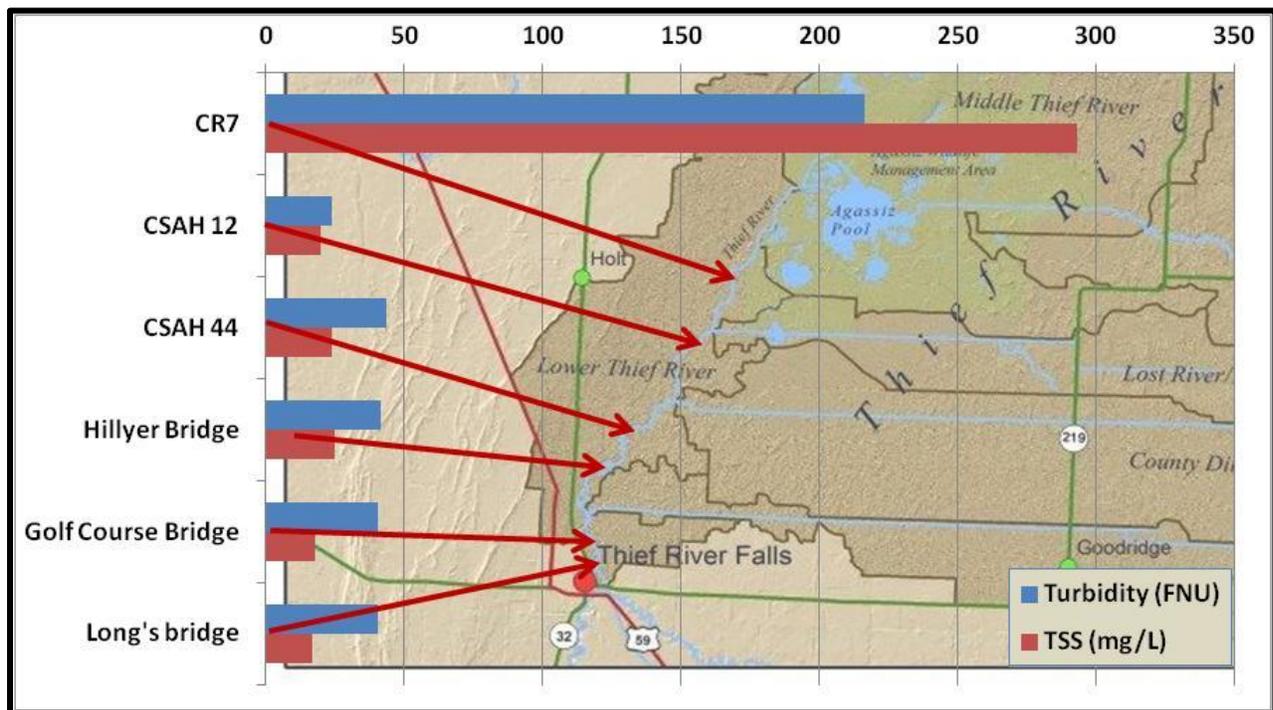
Figure 2-22. Longitudinal turbidity and TSS levels during a May 20, 2013 runoff event

erosion occurs along the Thief River and its tributaries during a runoff event, sediment can be discharged from Agassiz Pool at an extremely high rate. Concentrations of TSS gradually increased from upstream to downstream within the free-flowing portions of the Thief River with one exception. The TSS reading at the CSAH 7 Bridge (Station S002-088, closest crossing to the outlet of Agassiz Pool) was 293 mg/L at 3:00 pm. The TSS concentration at the next crossing downstream, CSAH 12 (S004-052), was 20 mg/L. It seemed unusual to see TSS (and turbidity) decrease that greatly from an upstream site to a downstream site during a runoff event. This indicated that a large amount sediment was being discharged from the Agassiz Pool outlet(s). According to USFWS staff, the radial gate outlet was opened on May 20, 2013, which likely created a “flush” of sediment from the pool. Multiple samples with high TSS were recorded that day, so the flush of sediment was not brief. Relatively large, dark-colored particles were visible in the CSAH 7 sample, but not in samples from other sites. The duration of that high concentration and the downstream extent of the heavily sediment-laden water are unknown. Another organization had collected a sample at CSAH 7 for a different sampling program 30 minutes earlier on May 20, 2013 (2:30 pm), and recorded a TSS concentration of 392 mg/L. The larger particles of rapidly-settling sediment found in the CSAH 7 samples likely contributed to the sedimentation problems that have been observed along the Thief River between the CSAH 7 and CSAH 12. Additionally, the TSS concentration in CD20 (30 mg/L) was higher than the concentration in the Thief River at either crossing upstream (20 mg/L at CSAH 12) or downstream (24 mg/L at CSAH 44) of its confluence. Concentrations of TSS began to decrease within the influence of the decreased flow velocity within the Thief River Falls reservoir at the Golf Course Bridge (S003-945) and Long’s Bridge (S008-131).

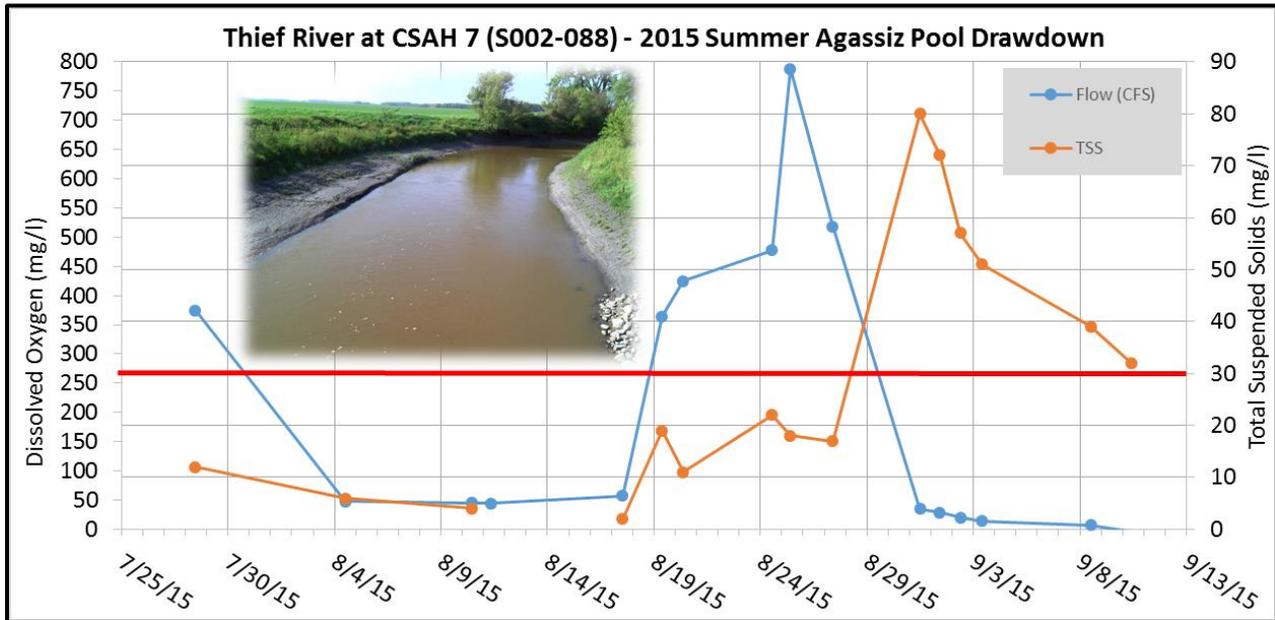
Figure 2-24. 2015 intensive sampling on the Thief River during the Agassiz Pool Drawdown. The red line represents the 30 mg/L TSS standard.

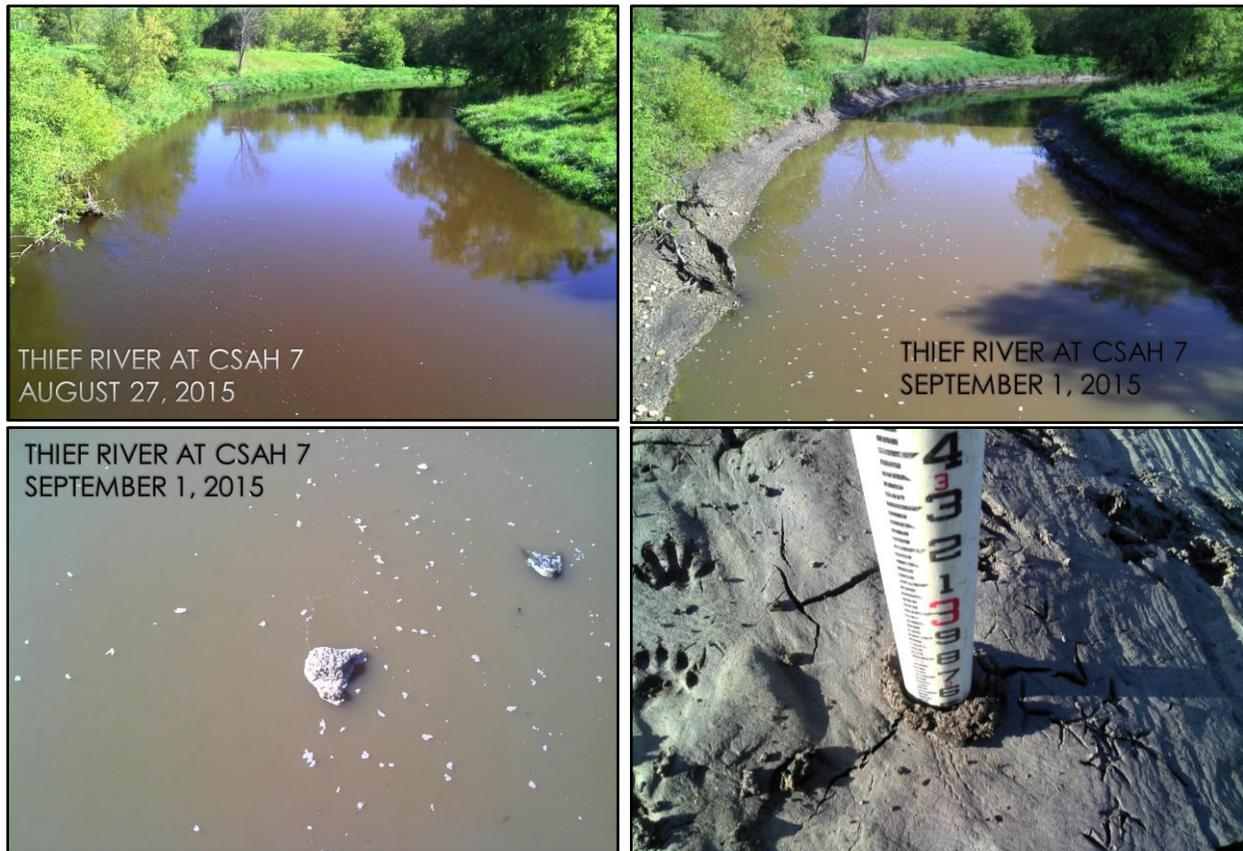
Figure 2-25. Photos of the Thief River during the late-summer 2015 drawdown of Agassiz Pool

The pattern observed in the 2013 sampling was also observed when the Thief River was intensively sampled during the 2015 late-summer drawdown of Agassiz Pool. TSS concentrations spiked during the receding limb of the hydrograph once again (Figure 2-24). The river was sampled at two sites: S002-079 near the downstream end of the 09020304-501 reach and S002-088 near the upstream end of the reach. Flows peaked in late August, as shown in Figure 2-14. High TSS concentrations (>30 mg/l) were found at the CSAH 7 crossing of the Thief River on six days during this effort (every sample collected from August 31, 2015 through September 10, 2015). When the river was sampled on August 31 and in early September, flows had decreased, but turbidity and TSS levels increased (Figure 2-24). Turbidity levels in the Thief River at CSAH 7 (S002-088) rose to 100 NTRU and DO levels fell below 5 mg/l. As flows decreased during the latter stages of the drawdown, concentrations of pollutants increased. Receding water levels revealed deep, freshly deposited sediment along the banks of the river (Figure 2-25, lower right). The dark, mucky sediment was over 2.5 feet deep in some places. The 2015 intensive sampling

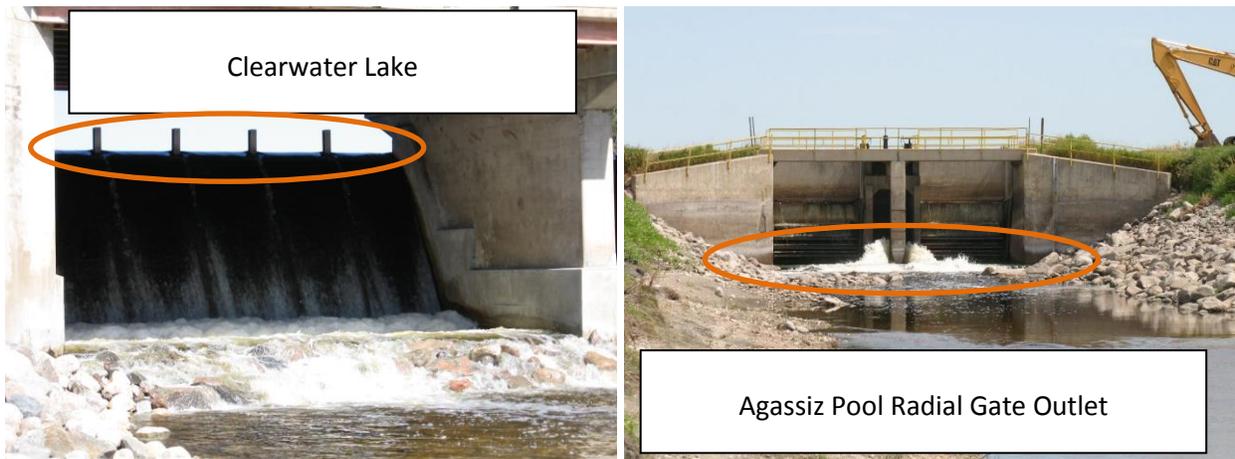
Often, the water leaving natural outlets of large bodies of water is relatively clean. In many cases, surface water needs to flow over something to leave a pool, pond, or lake. For example, Clearwater Lake (Figure 2-26, left) happens to be a lake in which water levels are maintained by a dam. Pollutants from the Clearwater River are deposited into the lake at the inlet and consistently clean water from the surface of the lake leaves the lake through the Clearwater Lake Dam (S002-119). The outlet of Agassiz Pool along JD11 (Figure 2-26, right) is different because it uses a radial gate outlet that is positioned so that it opens at the bottom of the channel. This allows more movement of water along the bottom of the pond and the remains of JD11. The dam in Thief River Falls (Figure 2-27) also has radial gates, but they are positioned above a concrete dam. The top of the concrete dam in Thief River Falls is 2.75 feet above the upstream river bottom (according to plans shown in the 1992 Thief River Falls Reservoir Study).

Figure 2-26. Photos showing the differences between a concrete and stop-log dam on a reservoir and the Tainter radial gates at the primary outlet of Agassiz Pool.

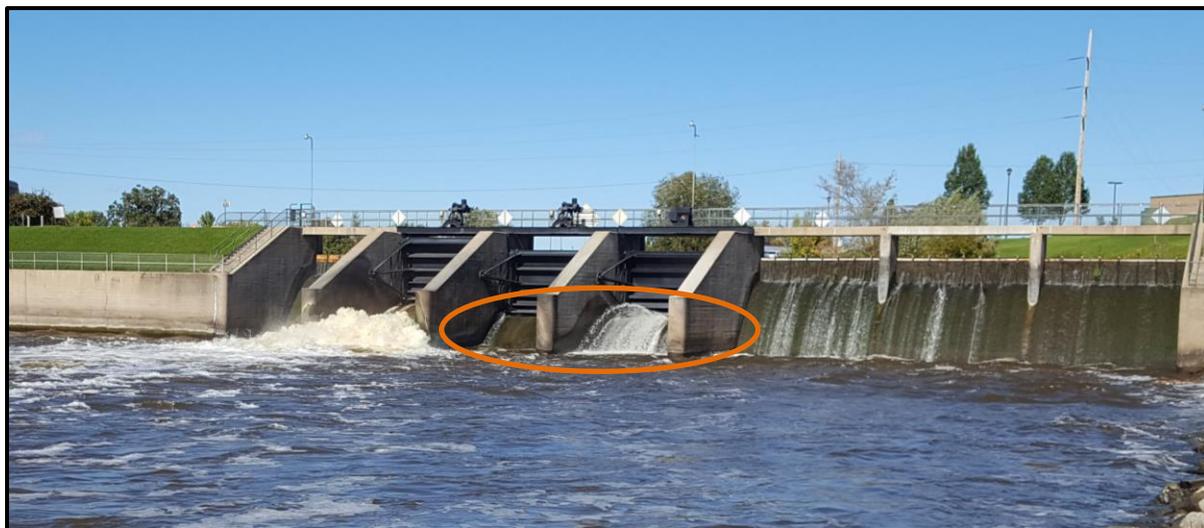
Figure 2-27. Thief River Falls Dam on the Red Lake River

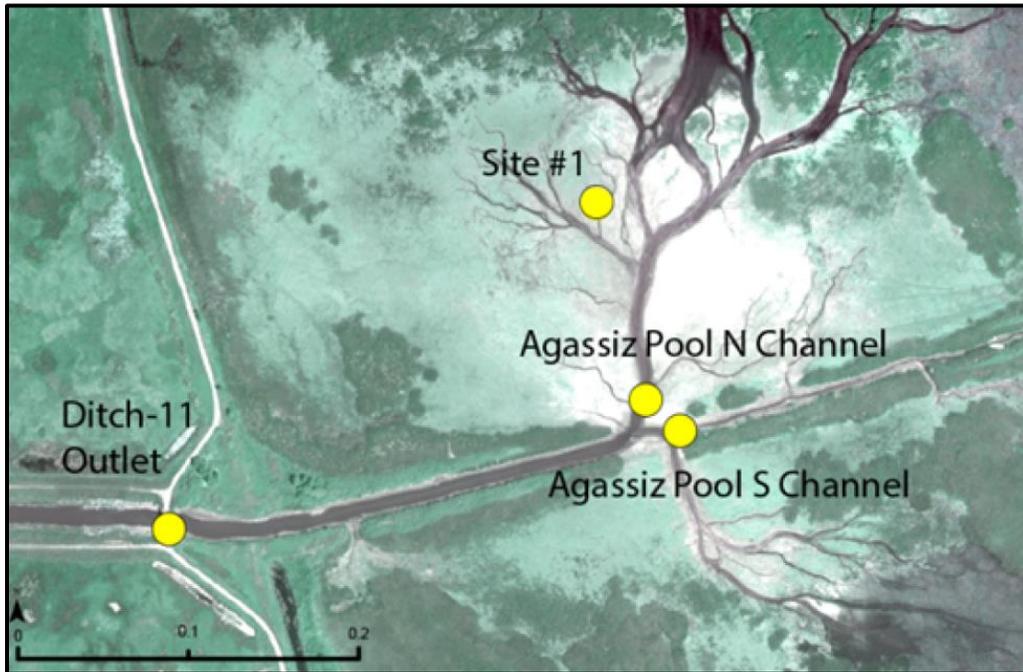
Figure 2-28. Scouring of sediment and gully formation within Agassiz Pool (Eash 2012)

throughout the summer. More of the moving water will be concentrated in channels and gullies, giving it more erosive power within the pool.

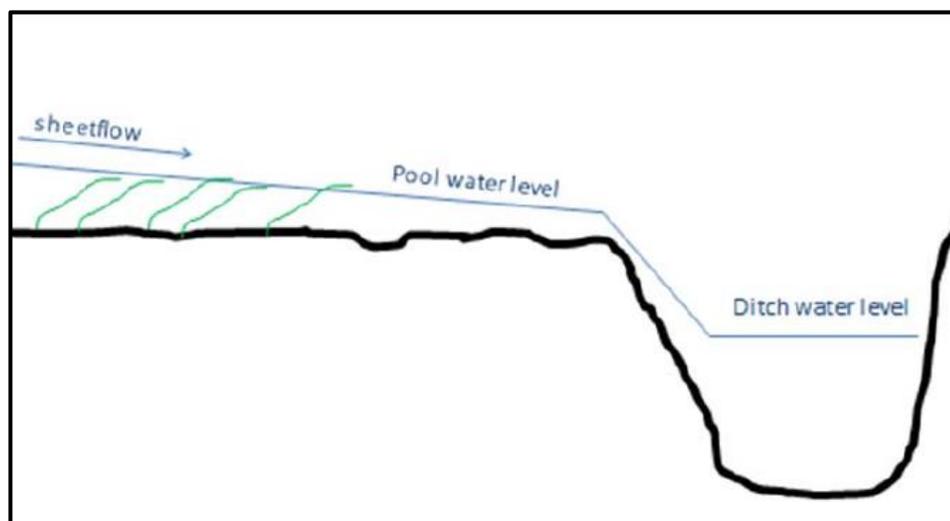
Figure 2-30. Diagram of hypothetical water surface profile within Agassiz Pool during periods of sheet flow (Eash 2012).

concentrations increased significantly as a greater percentage of water began flowing within the internal surface drainage ditches. TSS concentrations peaked at extremely high levels (>1,000 mg/l) at some paddy outlets. The loose sediment that had been deposited within the ditches by wave action and other processes throughout the summer was being flushed out of the pool with a diminishing amount of dilution from water that was pooled above the “ground level” within the paddy. In the case of Agassiz Pool, this includes sediment deposited by the Mud River and Thief River, decaying vegetation, waterfowl waste, organic soil, and disturbed sediment from excavation activities. The concentrations in both cases eventually decrease toward the end of the drawdown. The decrease may occur because of lower flow velocities, a depleted supply of easily moveable sediment, the pool goes dry, or a combination of those factors.

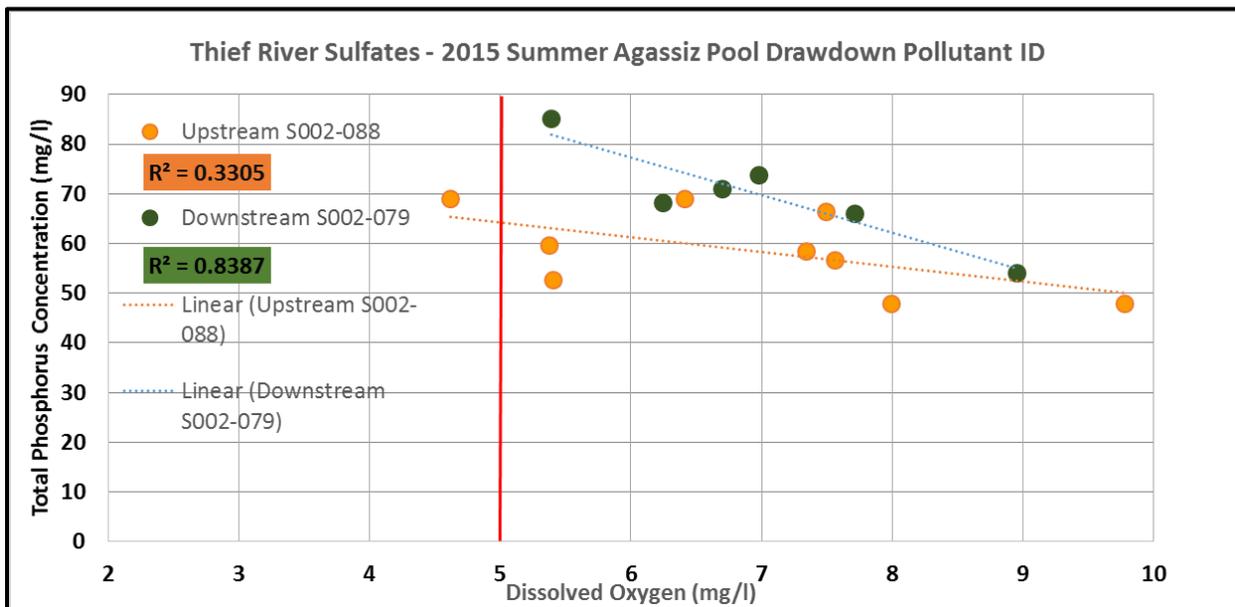
Figure 2-32. The strength of the correlation (R^2) between dissolved oxygen and total sulfates increases from the upstream end of the reach to the downstream end of the 09020304-501 reach of the Thief River.

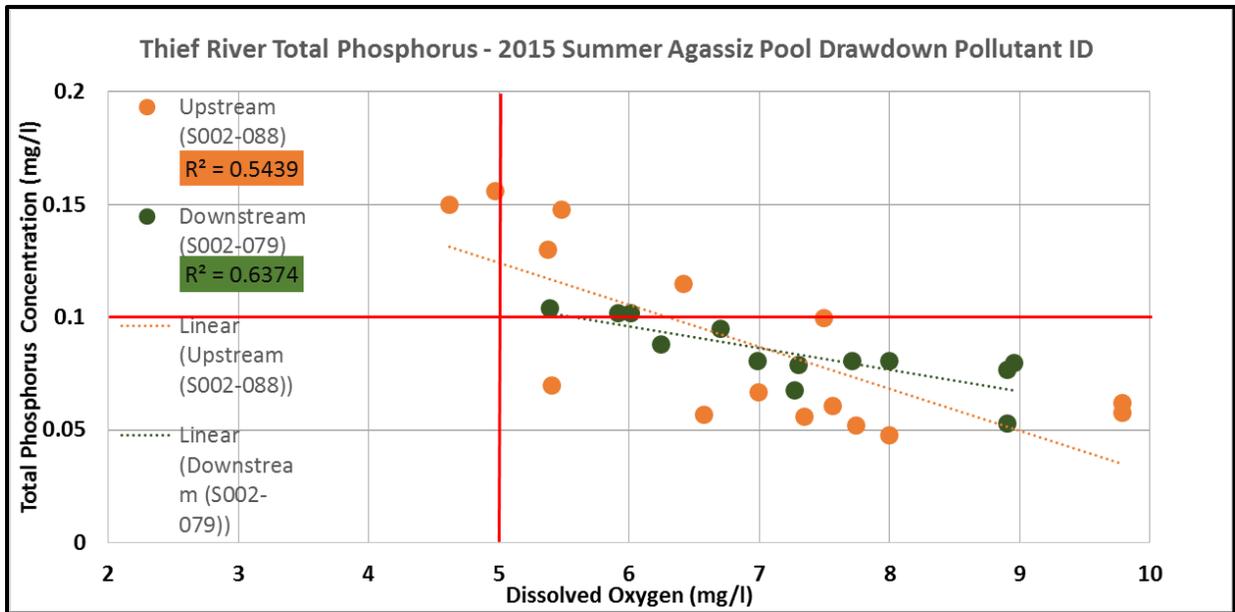
Figure 2-33. The strength of the correlation (R^2) between dissolved oxygen and total phosphorus increases from the upstream end of the reach to the downstream end of the 09020304-501 reach of the Thief River.

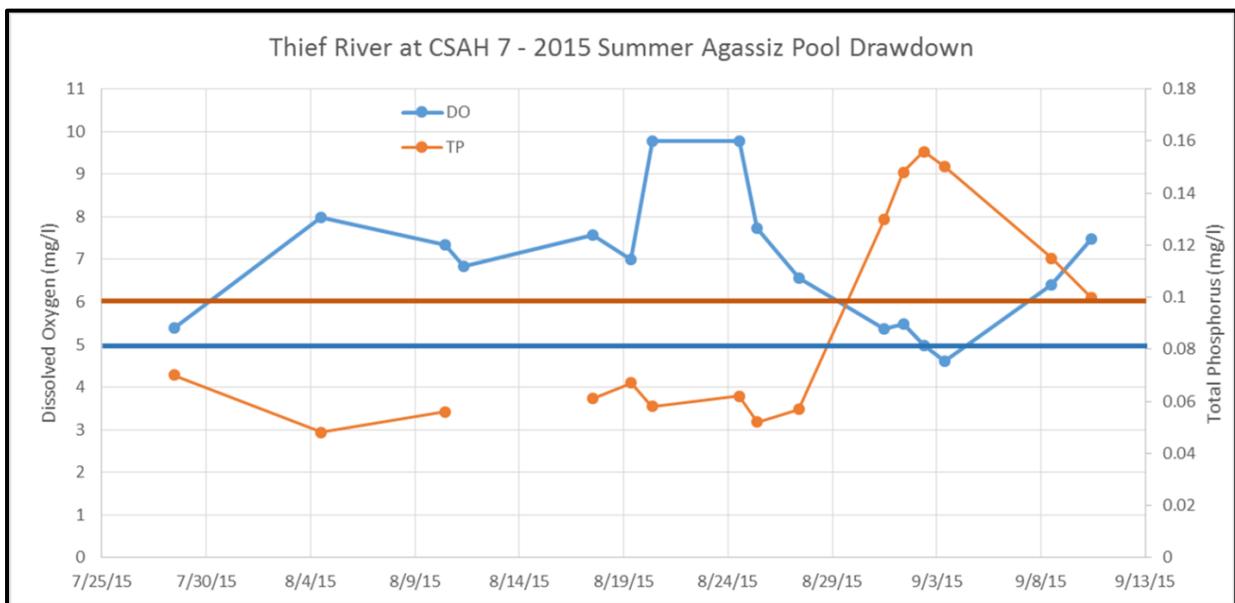
Figure 2-34. Dissolved oxygen and total phosphorus concentrations mirrored each other during the late summer 2015 drawdown of Agassiz Pool.

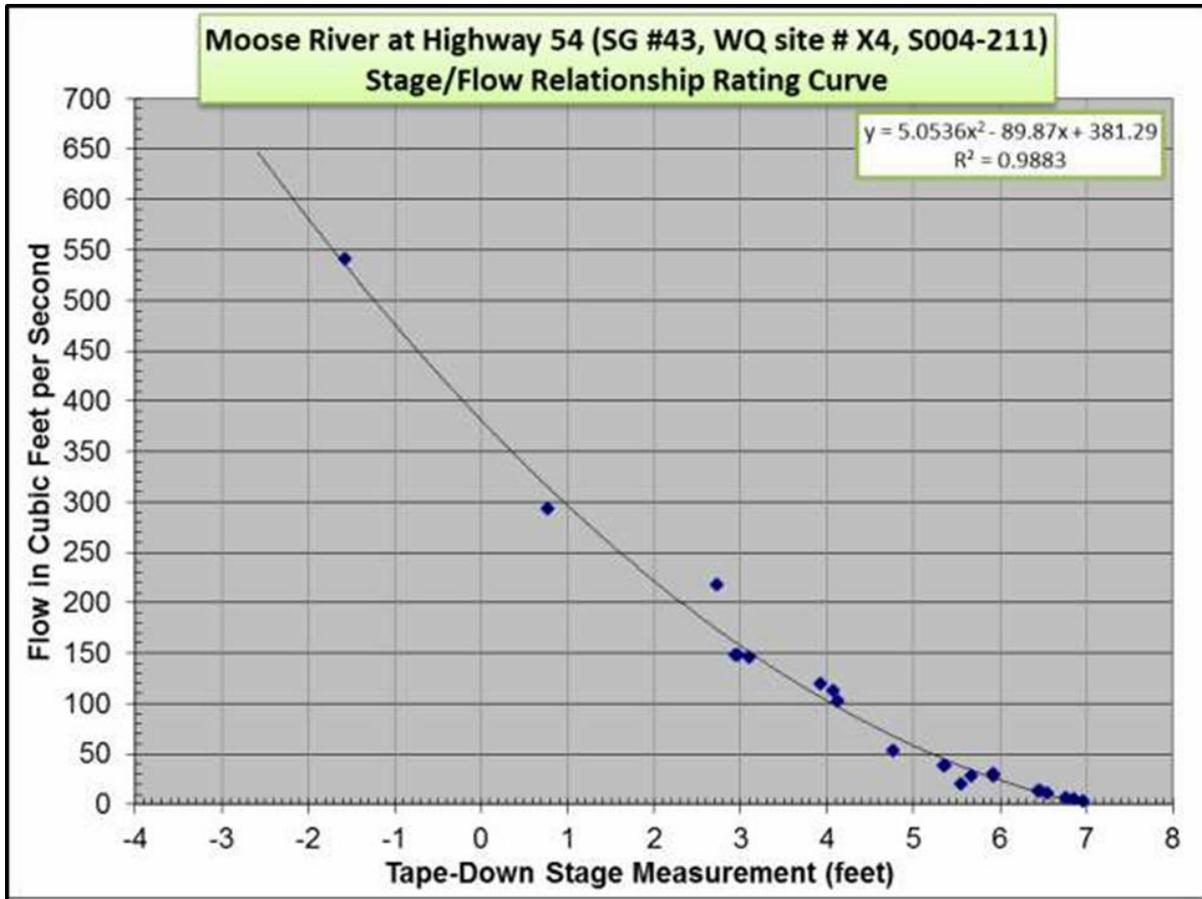
1167.32 ft. NADV88 elevation = 5.56 CFS of flow

Figure 2-35. Moose River at Highway 54 (S004-211) Flow Rating Curve

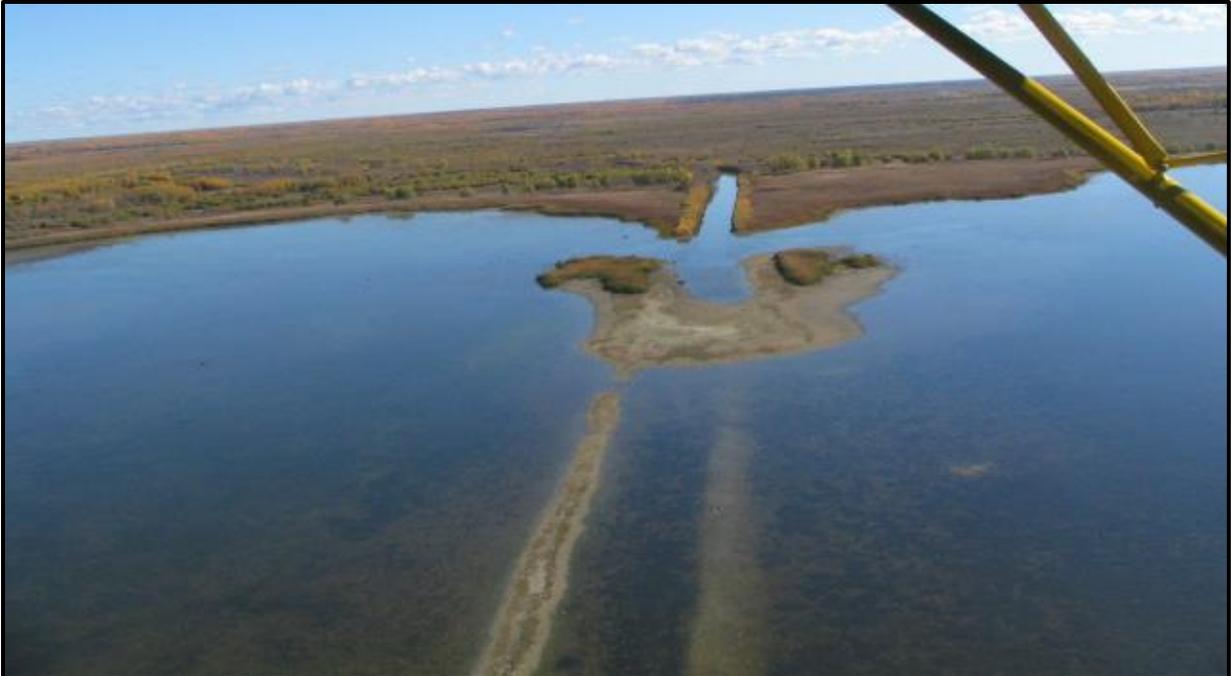
Figure 2-40. Some sedimentation within the main pool of Thief Lake has been noted with aerial photography.

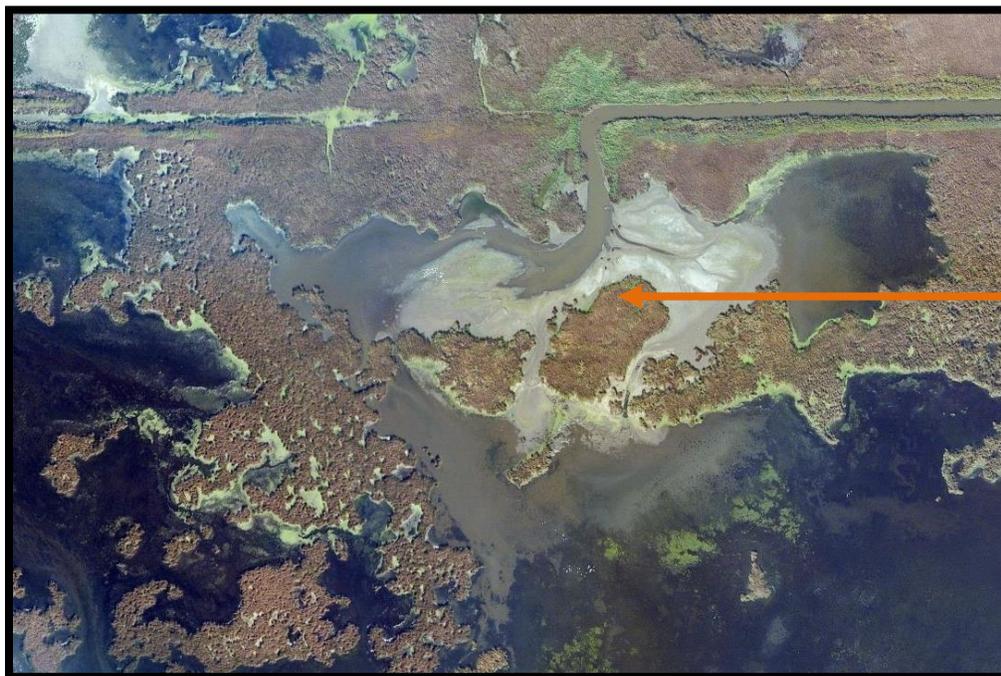
Figure 2-41. Judicial Ditch 11 delta within Agassiz Pool (via Bing Maps 2015)

Sediment plumes from the Mud River (Figure 2-41) and the Thief River (Figure 2-42) are visible in aerial photos. Sedimentation has resulted in shallower depths, expanded cattail growth and degraded nesting habitat in portions of Agassiz Pool. Local agencies have made efforts to reduce sediment contributions from agricultural runoff and stream bank erosion along the Mud River and the Thief River upstream of Agassiz NWR. The new outlet on the west side of Agassiz Pool may help reduce the amount of sediment

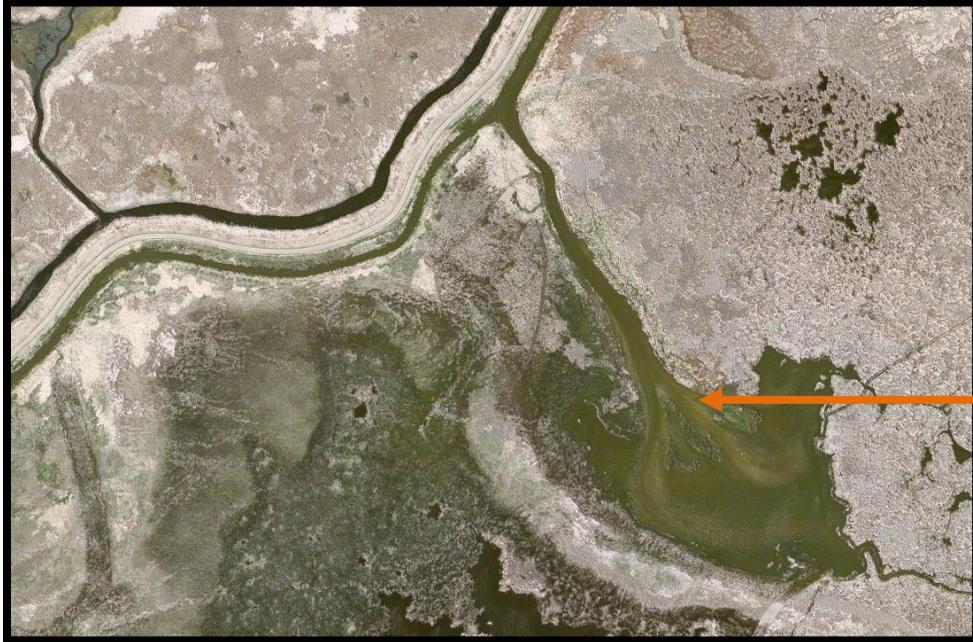
Figure 2-42. Thief River delta in Agassiz Pool and partial bypass flow along the west dike (via Bing Maps, 2015)

deposition within the pool. A portion of the flow from the Thief River can bypass the pool by flowing along the western dike of the pool and return to the Thief River (SD 83) channel.
