Thief River Watershed Restoration and Protection Strategy Report

March 2019

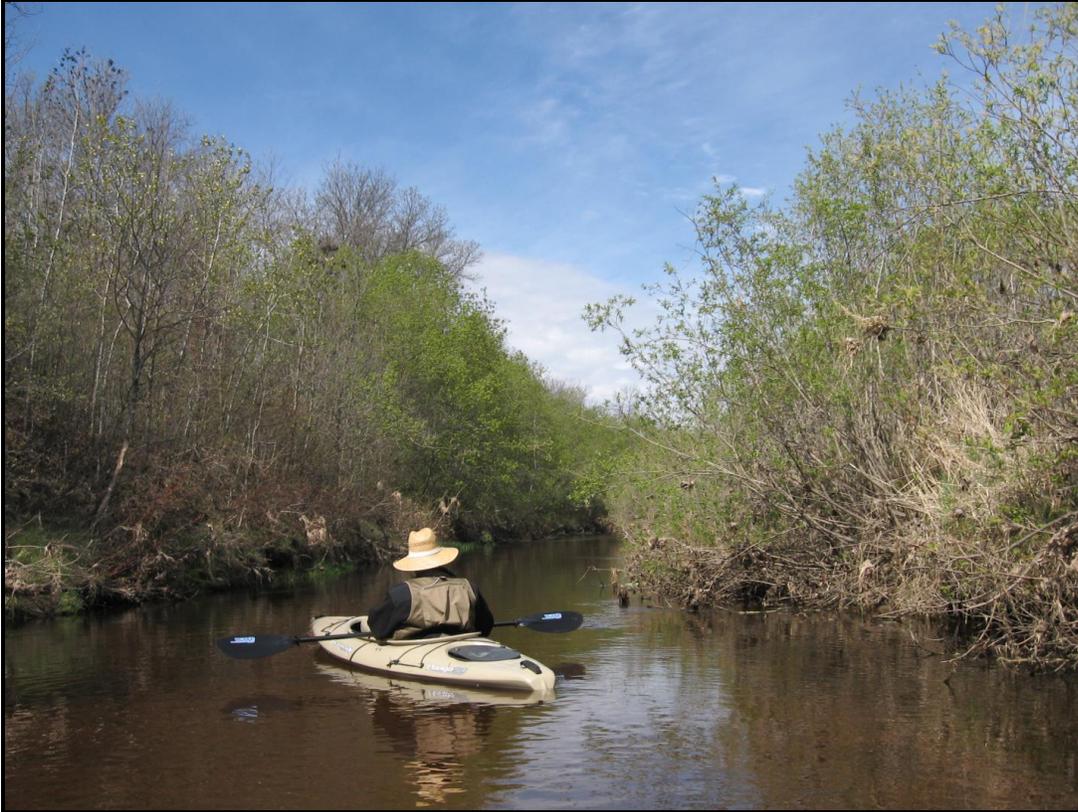
Figure 2-43. Kayaking on a willow-lined reach of the Mud River

A reach of the Mud River just downstream of the town of Grygla from 390th Avenue Northeast to 360th Avenue Northeast was examined for the geomorphologic study. The reach was found to be relatively stable due to a diverse vegetated riparian corridor (Figure 2-43). This corridor should be protected. This reach is part of the JD11 legal ditch system. Portions of the Mud River and JD11 channel are lacking proper buffers upstream of Grygla. Buffers along the Mud River should, at minimum, be maintained and improved.

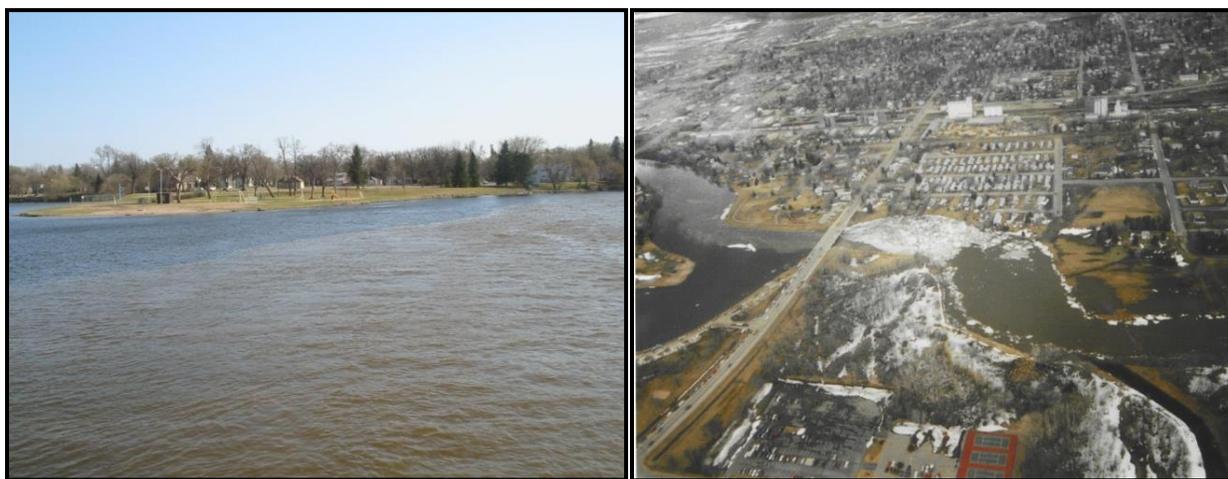
Figure 2-44. Sediment plumes from the Thief River at its confluence with the Red Lake River in Thief River Falls

(Figure 2-44), particularly during Agassiz pool drawdowns and runoff events. Poor water quality in source water costs the city significantly more money to treat. It can also cause violations of the disinfection byproduct standards for drinking water. This causes regulatory issues and potential health concerns. During late-summer drawdowns of Agassiz Pool, the water becomes nearly undrinkable due to the amount of treatment that is needed to address the turbid water entering the reservoir from the Thief River. Reducing total organic carbon levels, in addition to the sediment and phosphorus recommendations made by the TMDL, will be beneficial to drinking water in the city of Thief River Falls. Sediment and nutrient sources are described in Sections 2.3.4 and 2.3.5, respectively. Because the lower reach of the Thief River is impaired at its furthest upstream monitoring station, water quality in this reach is heavily influenced by upstream subwatersheds (Upper Thief River, Middle Thief River, and Mud River in particular). Reducing sediment export from those watersheds will be a necessary part of improving water quality within the Lower Thief River.

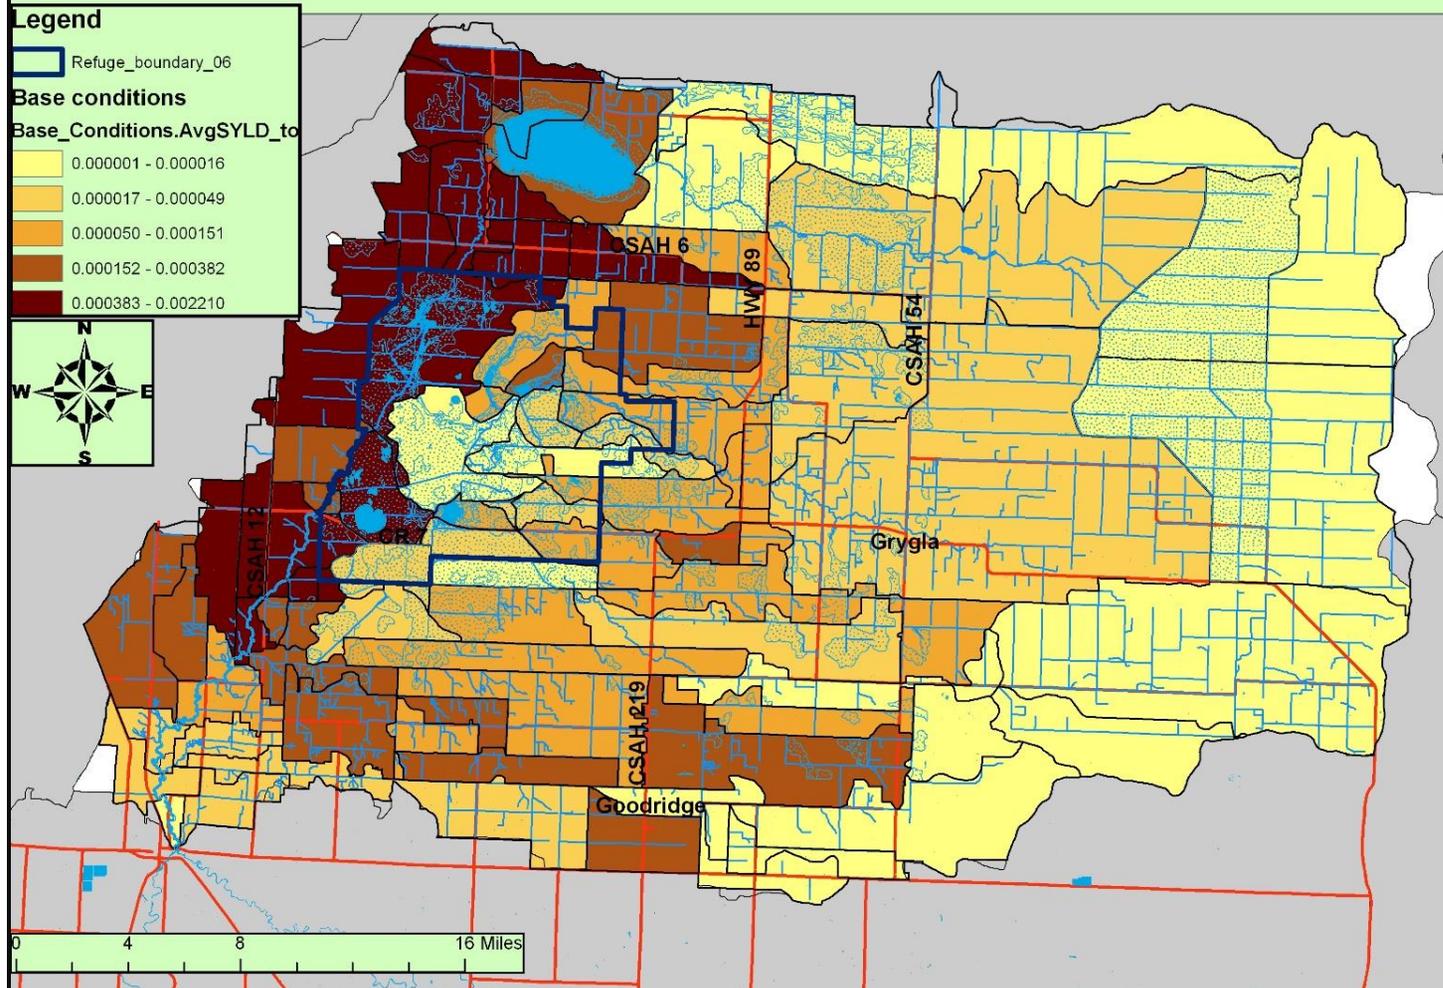
Figure 3-1. Thief River Watershed SWAT-Modeled Sediment Yields.

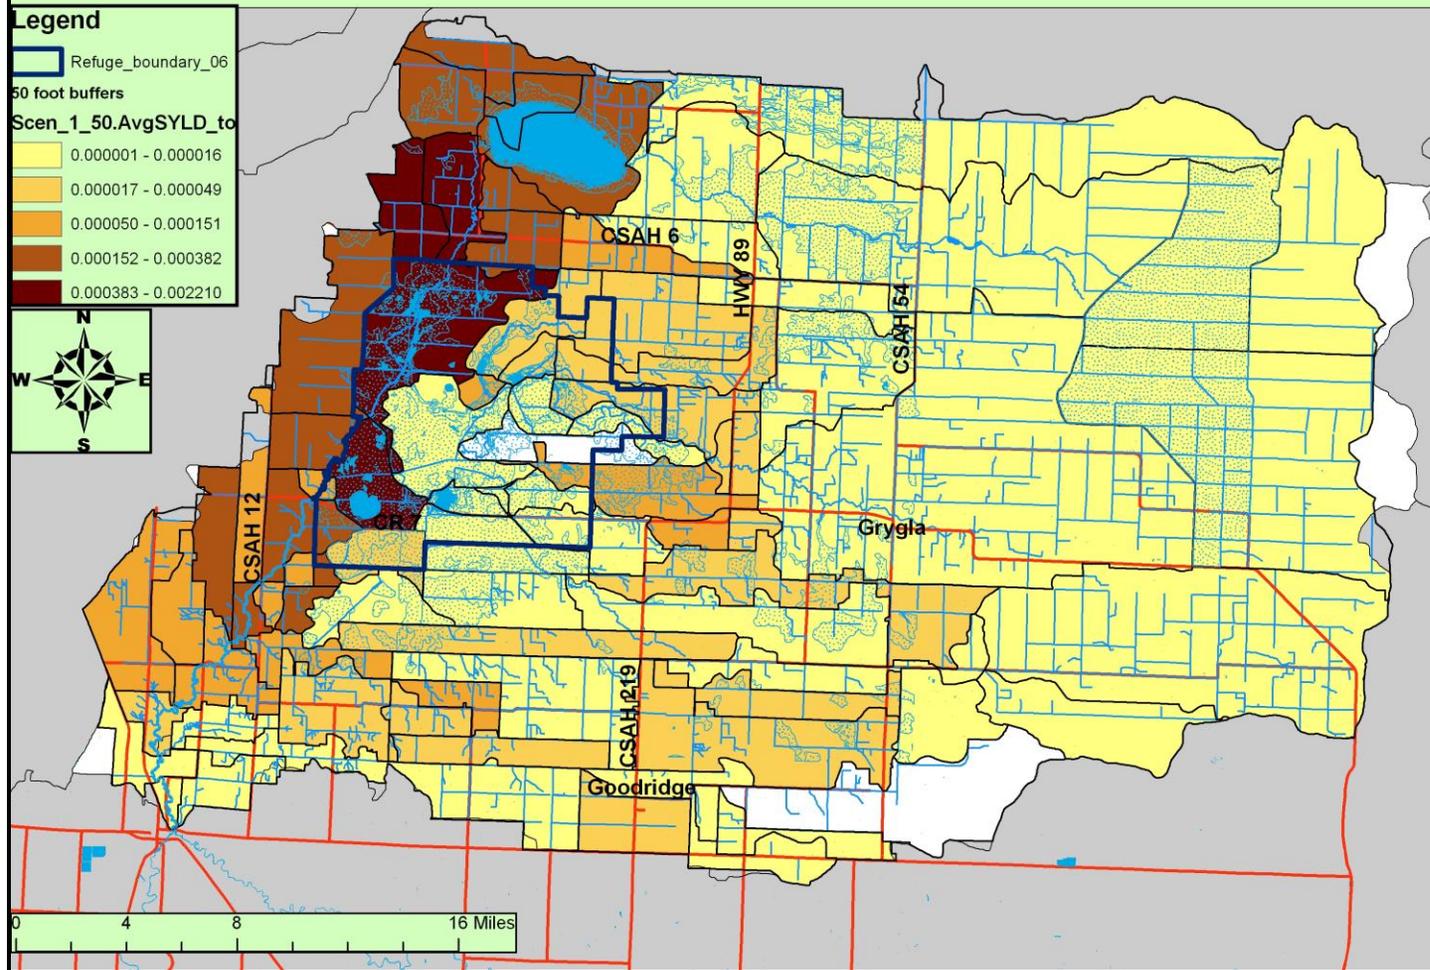
Figure 3-2. Thief River SWAT - Sediment Yield After 50-Foot Buffer Implementation

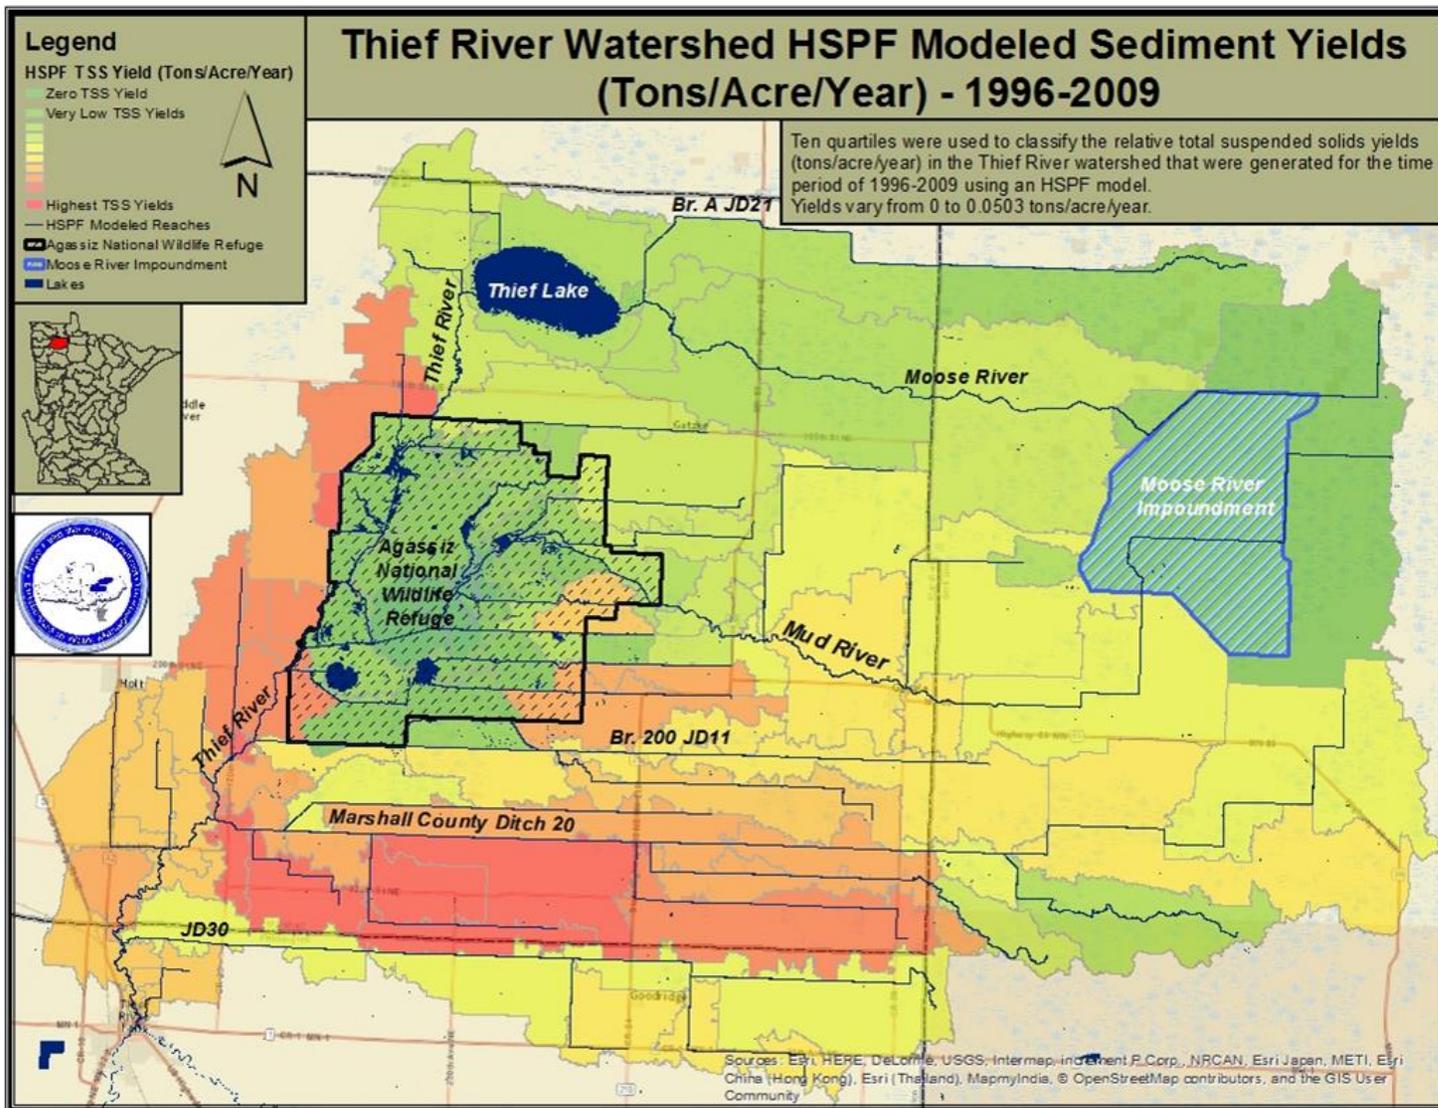
Figure 3-3. Thief River Watershed HSPF-Modeled Total Suspended Solids Yields (Tons/Acre/Year)

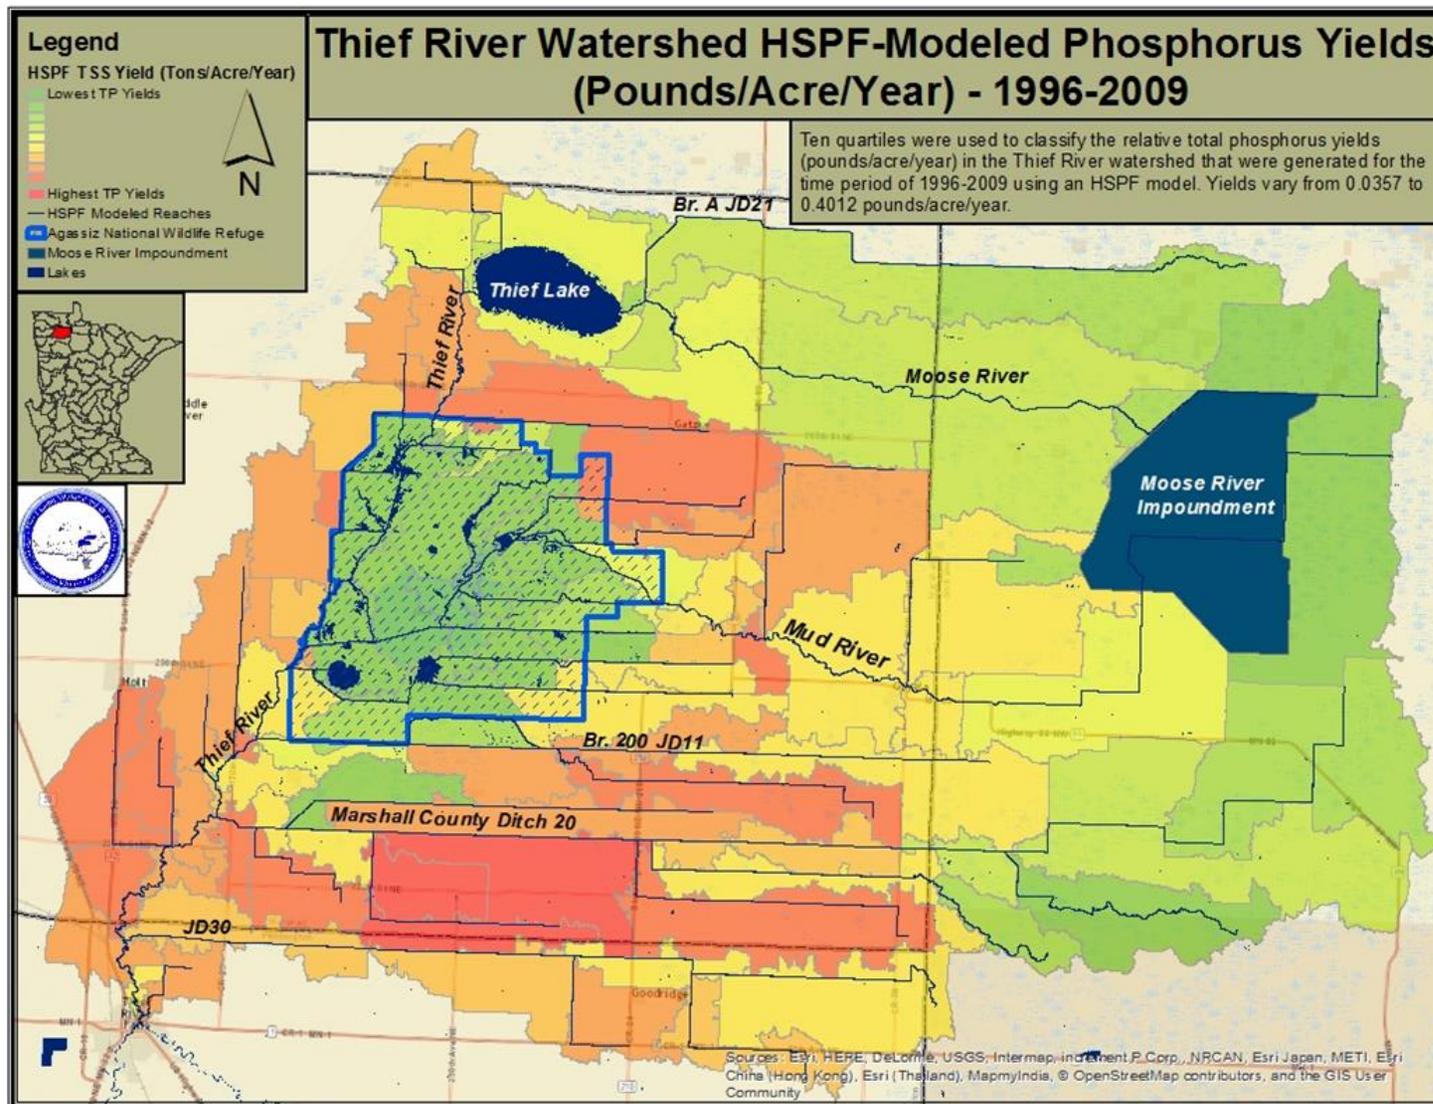
Figure 3-4. Thief River Watershed HSPF-Modeled Total Phosphorus Yields (Pounds/Acre/Year)

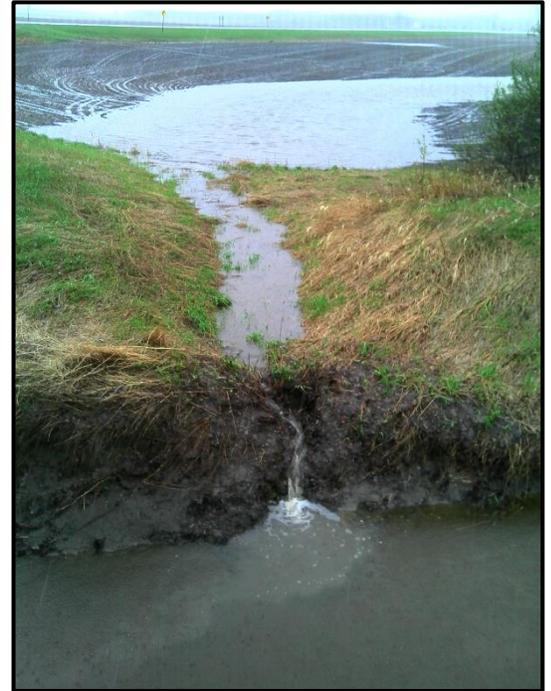
The photo to the right shows May 20, 2013, runoff and a plume of sediment entering the Thief River from a field near the 150 Avenue Northeast crossing.

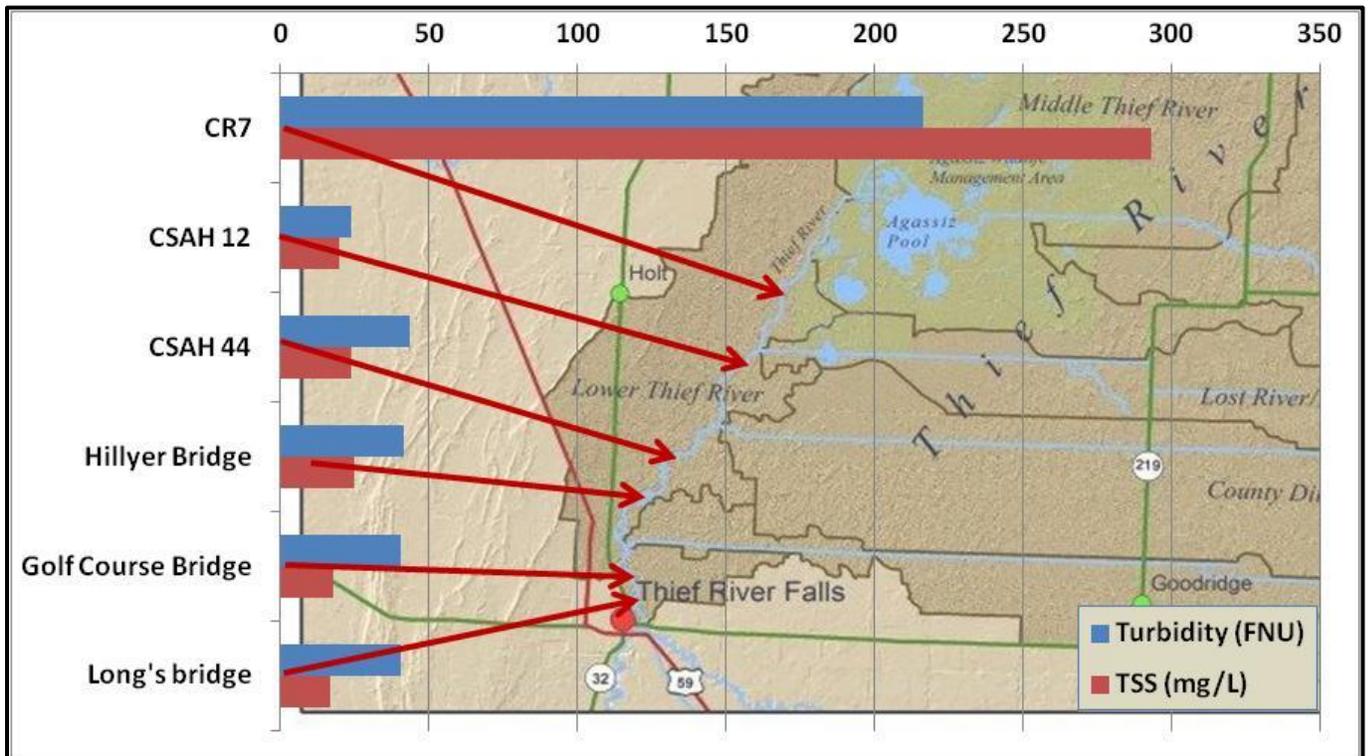
Figure 3-14. May 20, 2013 longitudinal sampling along the Thief River during a runoff event

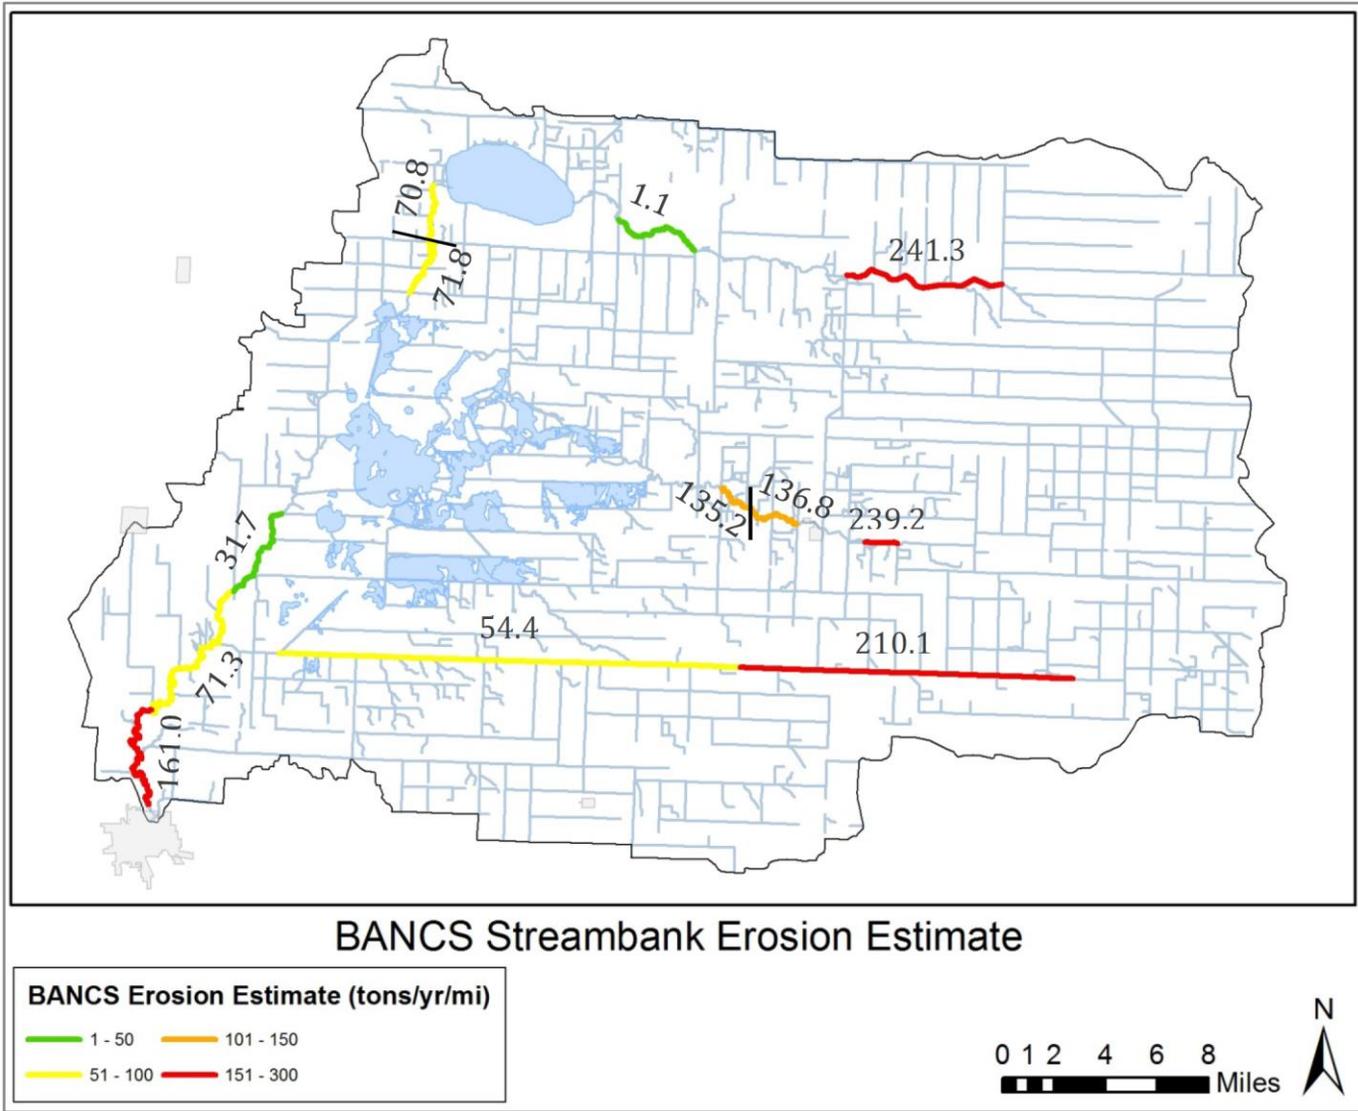
Figure 3-16. Stream bank erosion predictions from the BANCS model

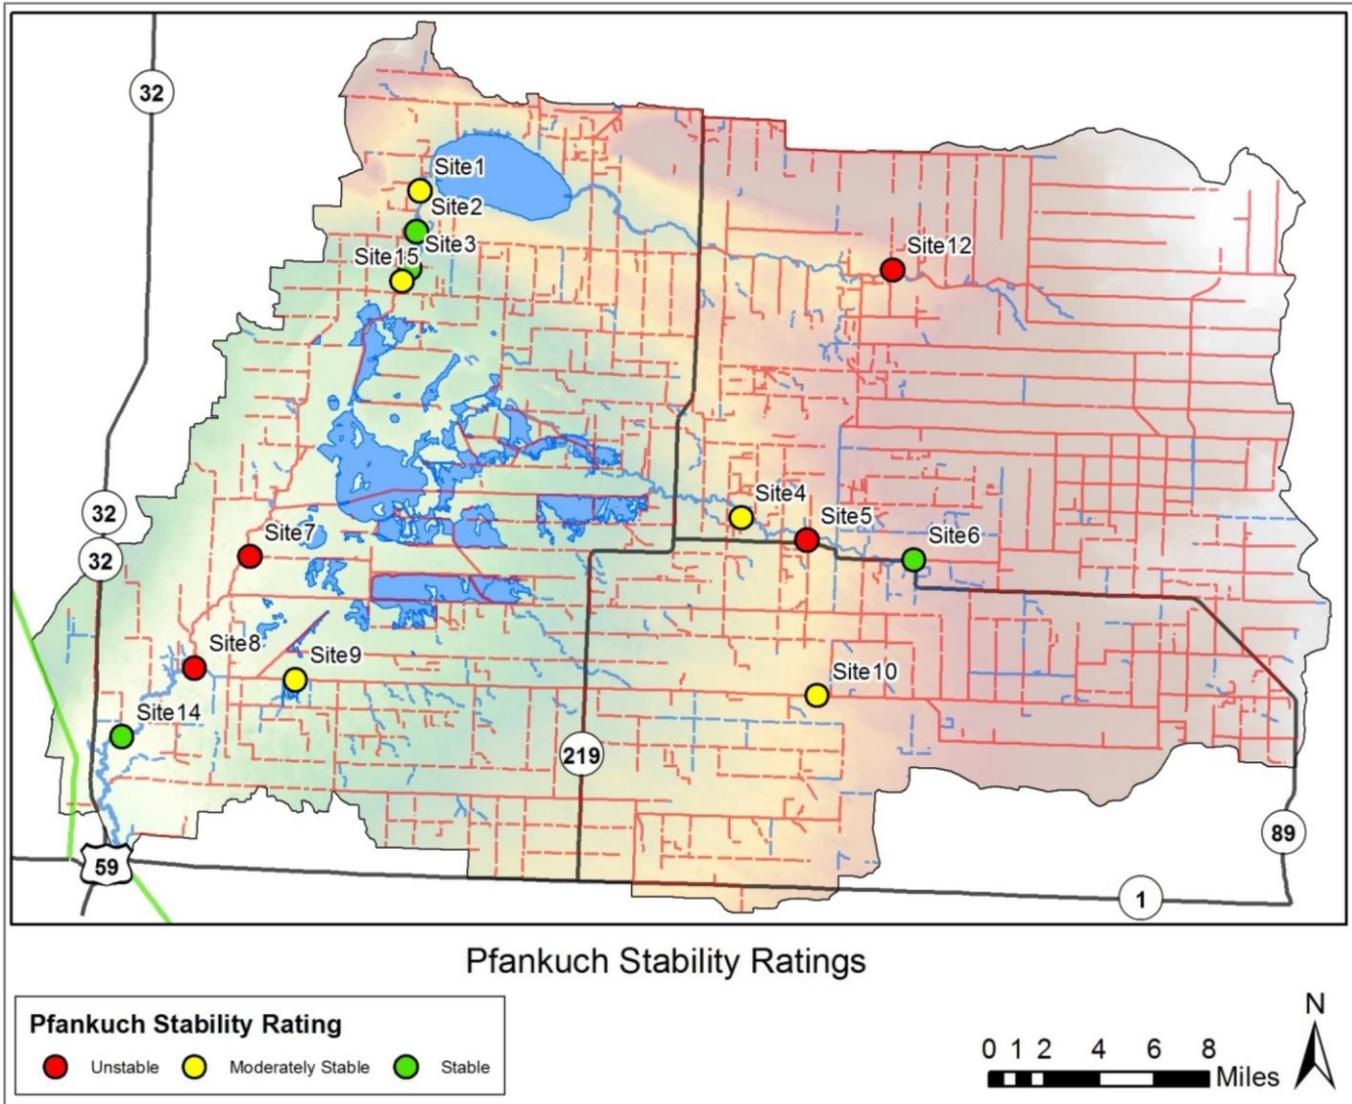
Figure 3-17. Pfankuch Stability Ratings at geomorphology study sites.
