# Red Lake River

## Watershed Restoration and Protection Strategy Report

November 2019

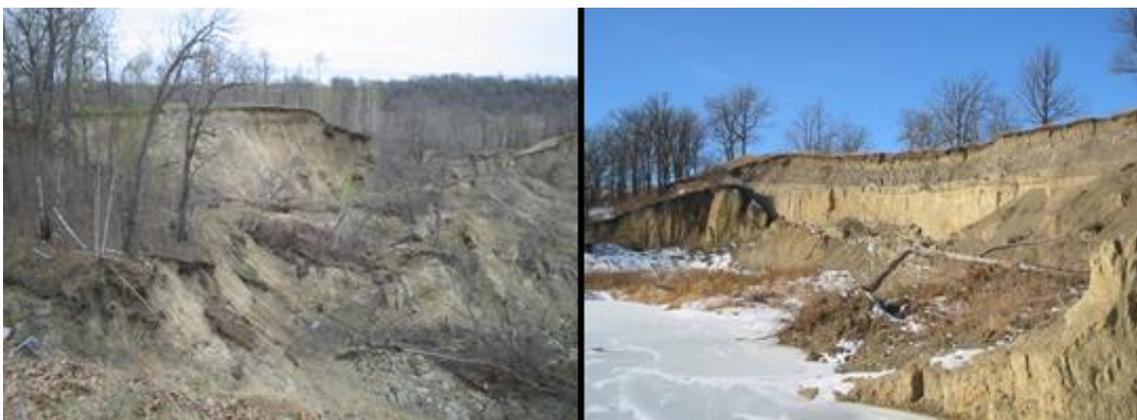
**Figure 2-25. Photos of eroding bluffs along the Red Lake River near Red Lake Falls.**

*“increased drainage of agricultural land during the last 50 years and record precipitation during the past decade have led to frequent and significant flooding in the valley. The precipitation and flooding, especially during frost-free months, has drastically increased groundwater levels and soil moisture. These changes in discharge and flooding have caused the river channels to downcut and widen as they adjust to new flow regimes. The combined effect of the above factors has been a rapid increase in the number of slope failures across the Red River Valley. This effect has been noted in the Red Lake River Watershed as channel incision has created situations where floodwaters do not have immediate access to a floodplain. This creates instability because high velocity floodwaters are confined to the stream channel and not allowed to dissipate energy over a larger area.*

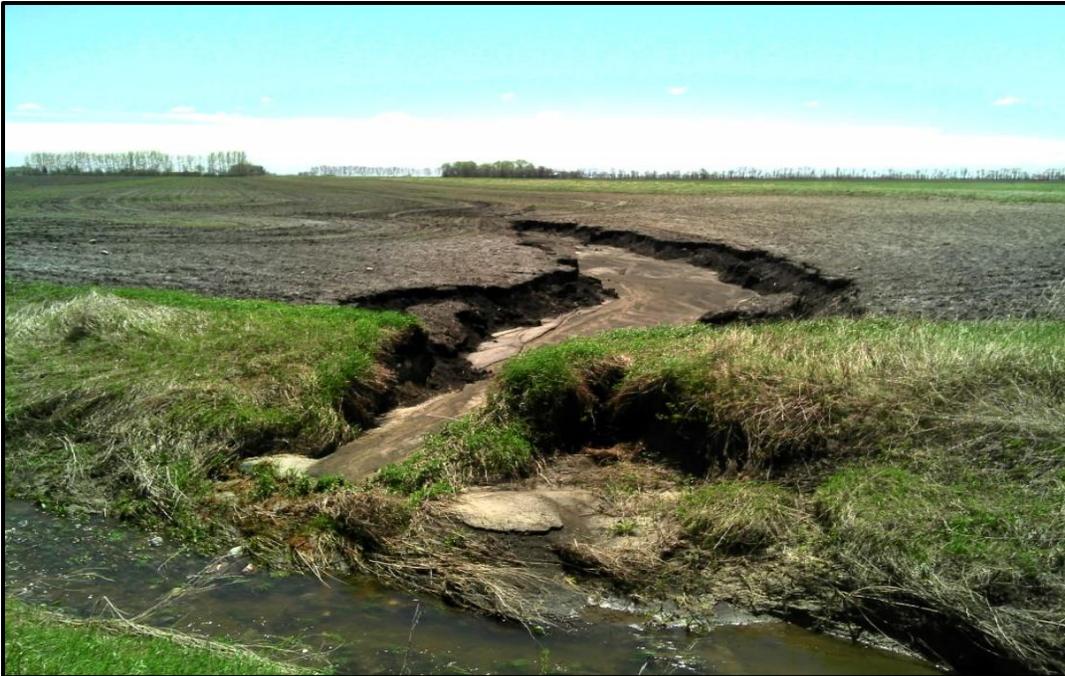
**Figure 2-27. Large gully in the Burnham Creek Watershed.**

Overland erosion has been documented in many forms. Gully erosion is occurring within cultivated fields. The outlets of ditches are unstable and actively eroding. Gully erosion of private field ditch outlets has been documented in the watershed. Side water inlets and other BMPs need to be implemented to prevent future gully formation. SPI layers have been created to identify all flow paths that are highly susceptible to erosion. Section 3.1.3 provides additional discussion and outputs of the SPI done in the Red Lake River Watershed. During windshield surveys, individual erosion sites like the one in Figure 2-27 were documented with georeferenced photographs by the RLWD.

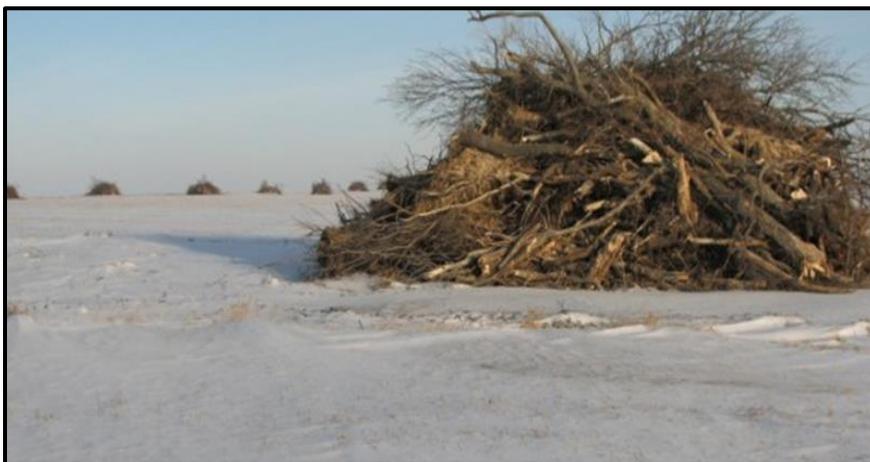
Figure 2-32. Photo of a field windbreak that is in the process of being removed.

1. *The relatively flat topography allowing wind to pick up speed and intensity.* In the Red Lake River Watershed, tree rows and windbreaks are dying and being removed (Figure 2-32). This has the effect of increasing the amount of fetch on fields and leading to exacerbated wind erosion. According to Marshall County SWCD staff, small root systems, chemicals, and fungus issues are contributing to this problem. Some species of trees are reaching the end of their life cycles and are being removed (Chinese elms). Hybrid poplar trees only last about 20 years because they grow too fast and then break.

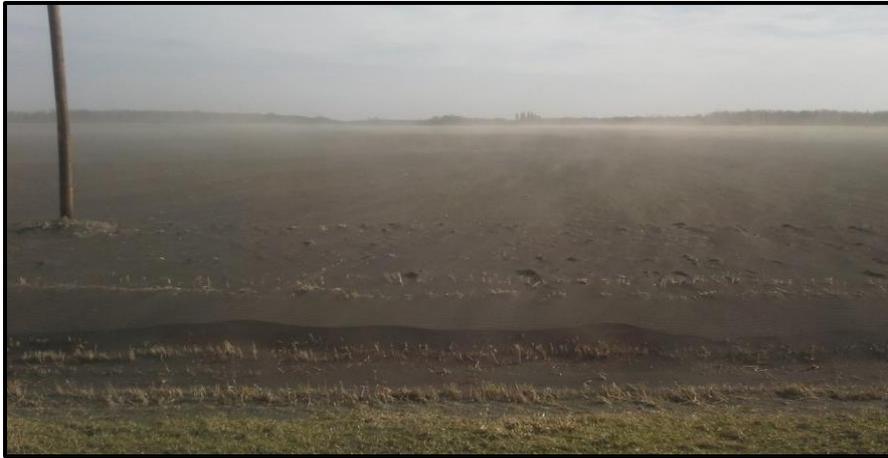
Figure 2-33. April 2015 wind erosion from a recently rolled field near St. Hilaire.

2. *Aggressive tillage breaks apart soil aggregates allowing for lighter individual soil particles, which can be moved by the wind.* Besides tillage, a farming practice called “ground rolling” for soybean fields has effected soil aggregates. Soybean fields are compacted and smoothed with heavy rollers after planting to prevent damage to harvesting equipment. Rolling pushes rocks into the ground and breaks up clumps of dirt that might damage equipment that is set close to the ground. According to an article from the University of Minnesota Extension Service (Dejong-Hughes 2016), rolling crushes surface soil aggregates, leaves the field smooth and loosens residue from the soil, reducing the soil conservation benefits of less tillage. Figure 2-33 shows the effect from ground rolling when the weather turns dry and windy.

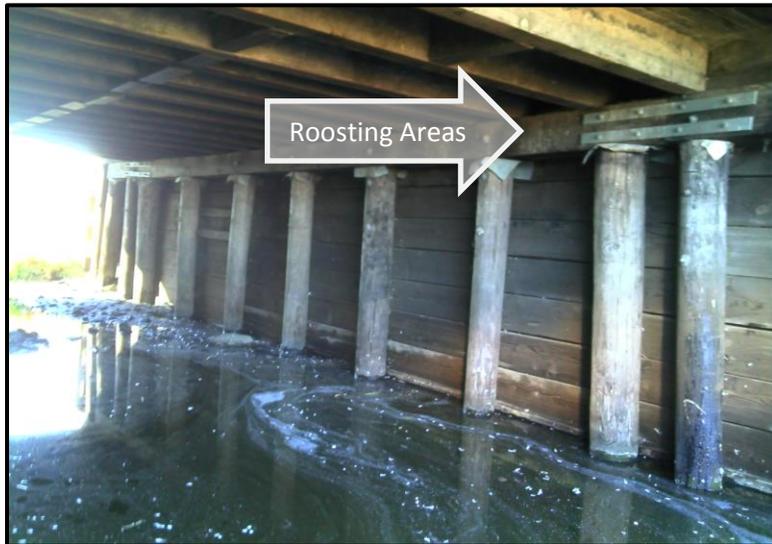
Figure 2-37. Roosting areas, stagnant water, scum, and feathers under the CSAH 17 Bridge over Pennington County Ditch 21.

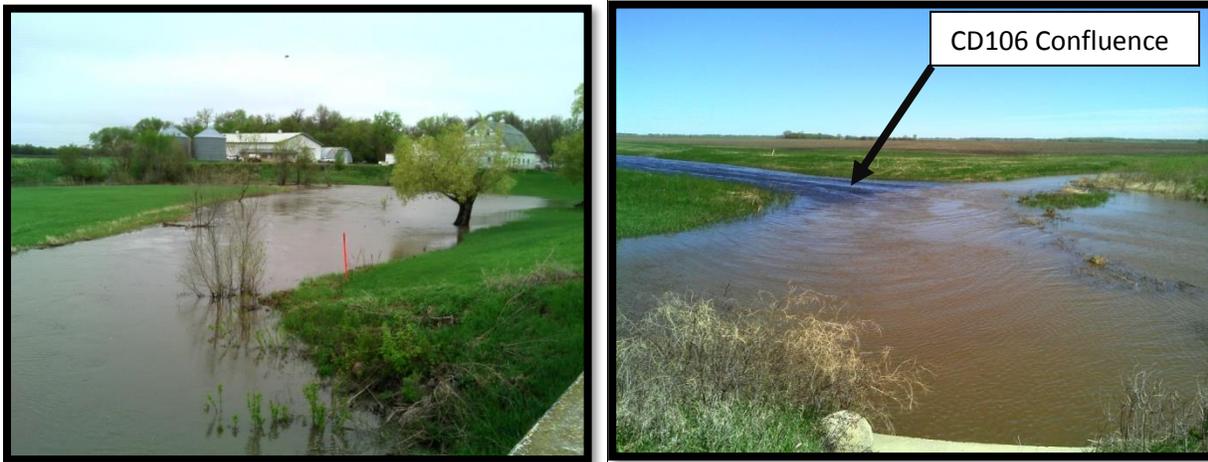
Figure 3-12. Photos of Burnham Creek during a runoff event.

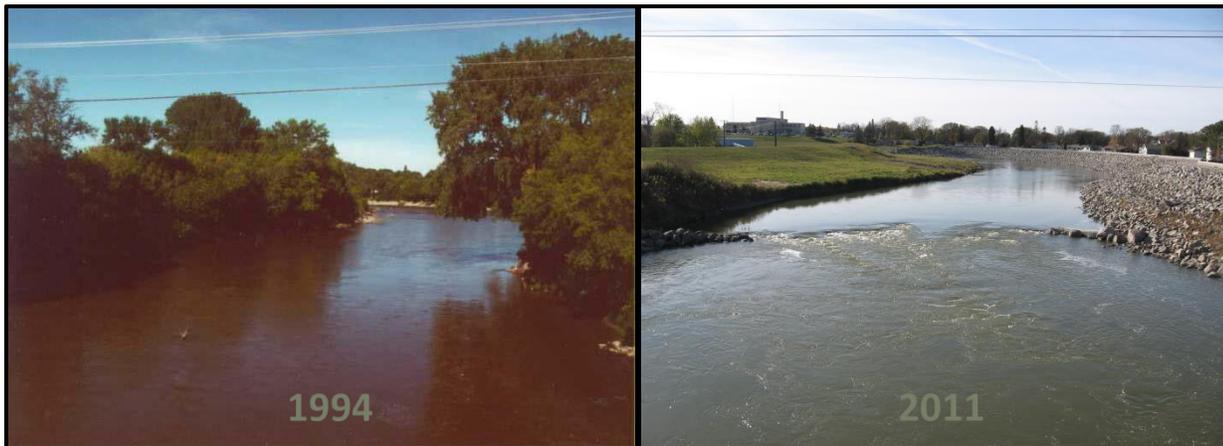
Figure 3-27. Changes in the Red Lake River corridor within the city of Crookston: photos taken of the Red Lake River, facing upstream from the Sampson (Woodland Ave) Bridge in Crookston (S002-080).
