Mississippi River- Grand Rapids Watershed (MRGRW)

Watershed approach

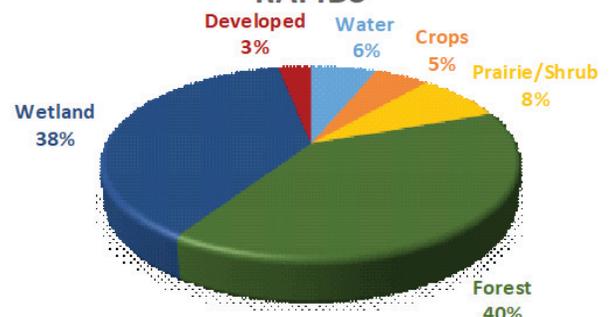
LAND USE-MISSISSIPPI RIVER-GRAND RAPIDS

- Size: 1,332,797 acres or 2,082 square miles
- Counties: Itasca, Aitkin, Cass, Carlton, St. Louis
- Ecoregion: Northern Lakes and Forest
- Most of the land is wetland and forested (chart at right)
- 625 lakes over 10 acres and almost 2000 miles of streams
- The 8-digit hydrologic unit code (HUC): 07010103

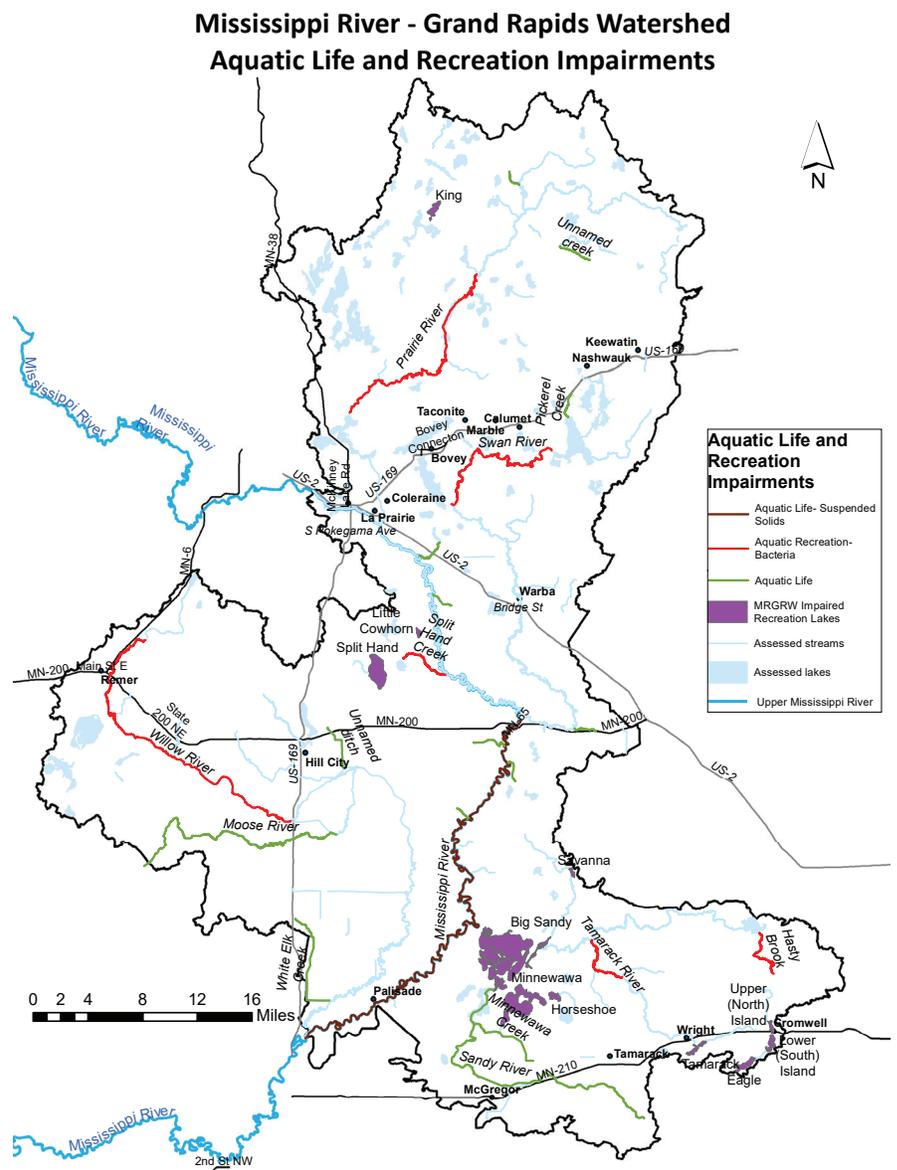
During the first phase of the watershed approach – intensive watershed monitoring – the Minnesota Pollution Control Agency (MPCA) and local partners collect data about biology such as fish populations, chemistry such as pollutant levels, and flow. Waters are “impaired” if they fail to meet standards. The map to the right shows all of the aquatic life and recreation impairments in the Mississippi River Grand Rapids Watershed, including those determined to be impaired prior to the latest assessment cycle.

Seventy-three of the 203 uniquely identified stream/river reaches in the watershed were assessed in 2017. Throughout the watershed, 23 streams do not support aquatic life and/or recreation. Of those, 17 do not support aquatic life (see ‘Conditions stressing fish and bugs’, below) and 6 do not support aquatic recreation. The streams that do not support recreation all show chronically elevated bacteria concentrations.

One hundred and six lakes fully supported aquatic recreation and 11 did not support aquatic recreation due to elevated levels of phosphorus and algae. Forty-four of the 49 lakes that were assessed for aquatic life supported the use; one lake (Lower Island Lake, near Cromwell) failed to meet the aquatic life standards.

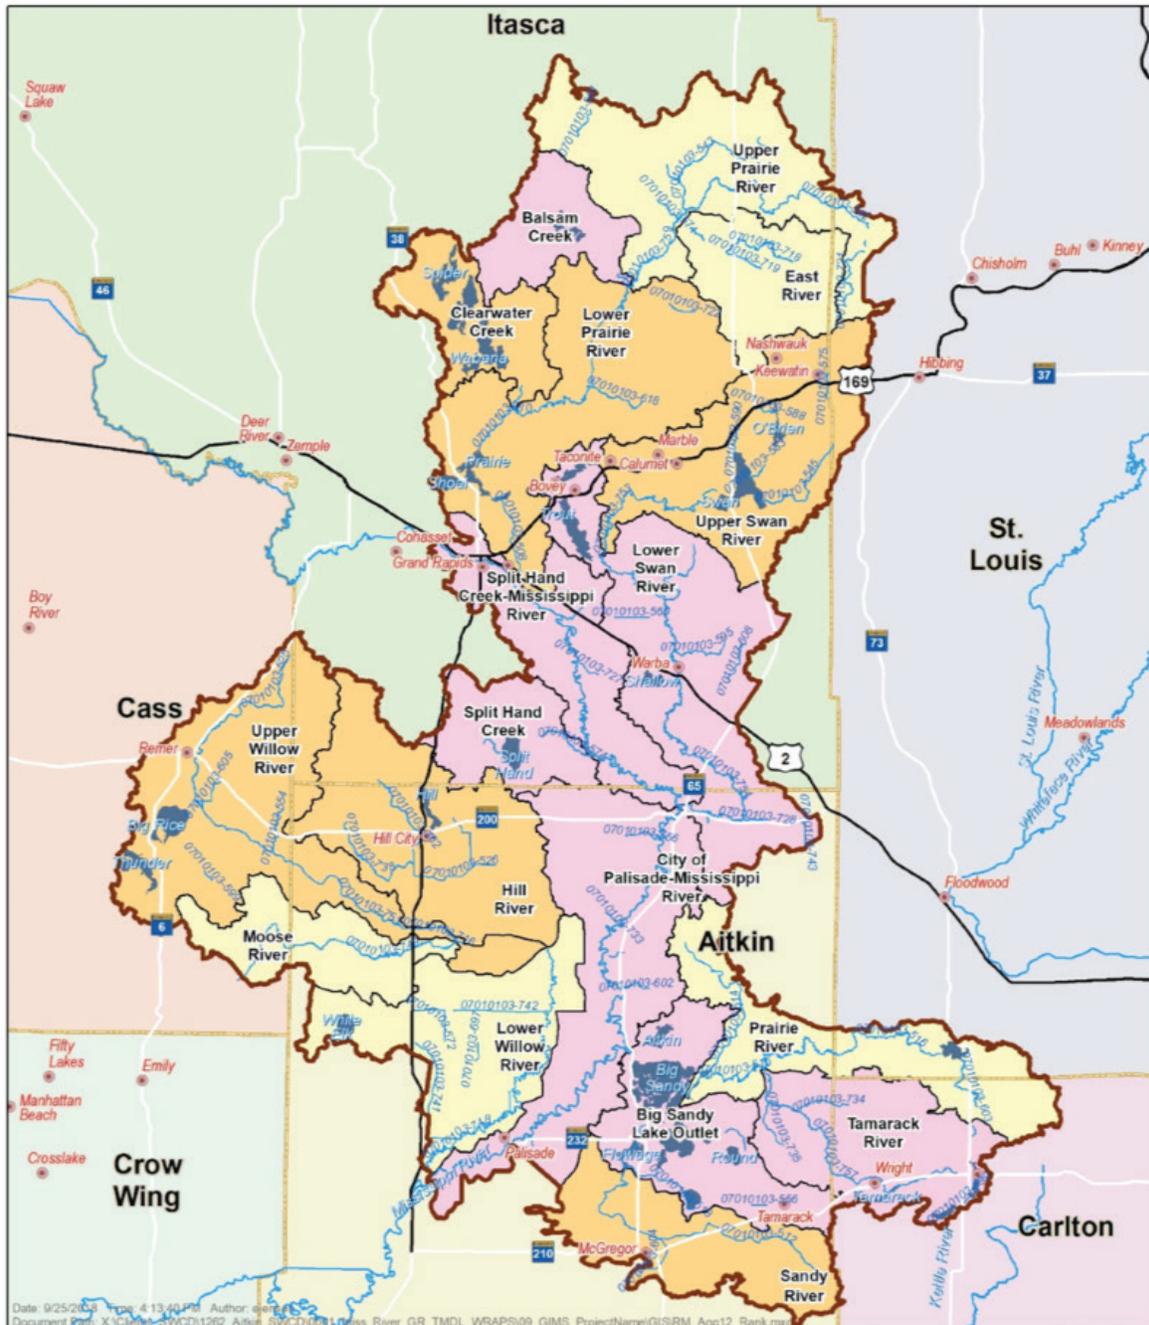
Mississippi River - Grand Rapids WRAPS

Strategies for addressing the identified issues in the Mississippi River – Grand Rapids Watershed include promoting shoreland protection, implementing programs for forest protection to maintain healthy working forests, restoring altered stream hydrology, and performing wetland streams restoration, primarily in peatlands due to the substantial ditching which has occurred in those habitats. The map below displays priority areas for restoration and protection.

Agg HUC 12 Priority Rank

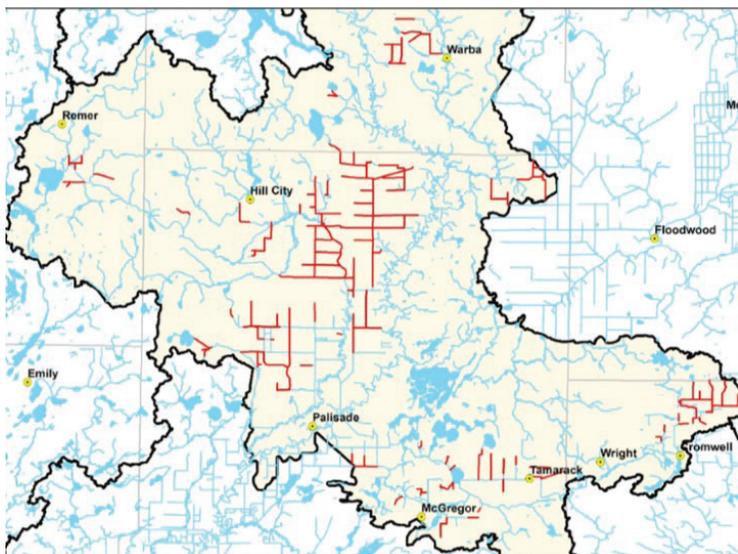
Tentative assessment of unneeded legacy ditches in the southern half of the watershed

- Key watershed-wide strategies that will improve the water quality of impaired and unimpaired lakes and streams include protecting forested lands, non-functioning ditch decommissioning, and shoreland ordinance enforcement, education, and updating.
