# Shell Rock River Watershed

## Watershed approach

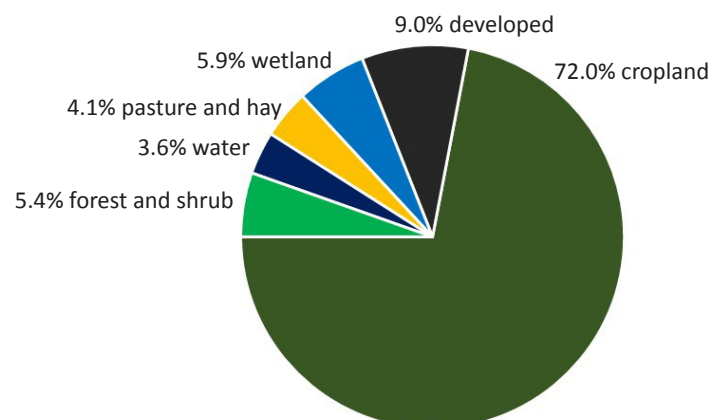
## Land use in the Shell Rock Watershed

- Size: 246 square miles in Minnesota
- Counties: Freeborn
- Ecoregion: Western Corn Belt Plains
- Municipalities: Albert Lea, Glenville, Hayward, Manchester, Twin Lakes
- Most of the land is cropland
- Tributary to the Cedar River
- The 8-digit hydrologic unit code (HUC): 07080202

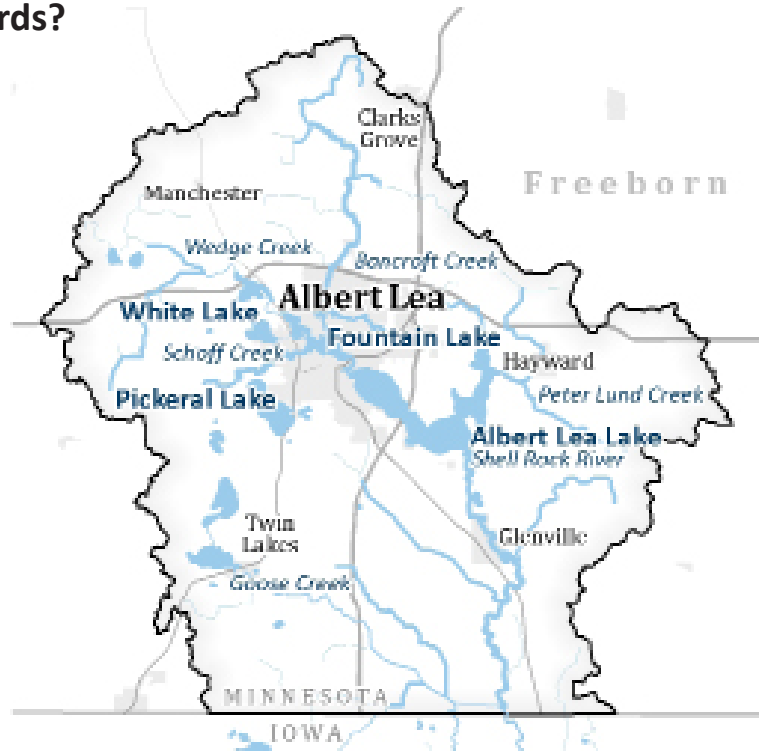
The Shell Rock River Watershed is comprised of several lakes and streams, all within Freeborn County in southern Minnesota.

The MPCA and partners determined the following impairments:

- Bancroft Creek and part of Wedge Creek have bacteria levels too high to meet standards. Bacteria can make water unsafe for contact recreation such as wading.

- Part of Schoff Creek has nutrient and sediment levels too high to meet standards. Nutrients can cause algae while sediment can make the water too cloudy for fish and other aquatic species.

- The Shell Rock River has low dissolved oxygen at times, making it hard for fish and other aquatic species to survive.
- The river also has nutrient, sediment and pH levels too high to meet standards. All these factors result in the number of fish and bug species being lower than expected for similar rivers. Phosphorus in the river needs to decrease by as much as 75%, depending on flow and other conditions, to meet standards. The river also has bacteria levels too high to meet standards, an impairment addressed by a 2002 study.

- Pickerel, White, Fountain and Albert Lea lakes all have nutrient levels too high to meet standards. Phosphorus levels need to decrease by 46-71% in the lakes.

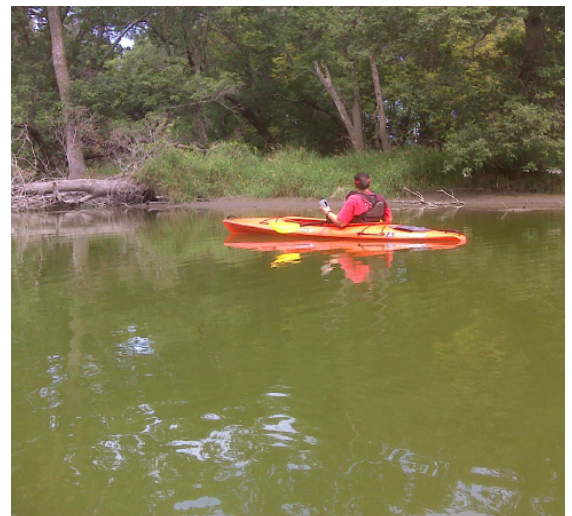
The Shell Rock River faces several water quality challenges, including high nutrient levels that lead to excessive algae growth that hurts aquatic life and recreation.

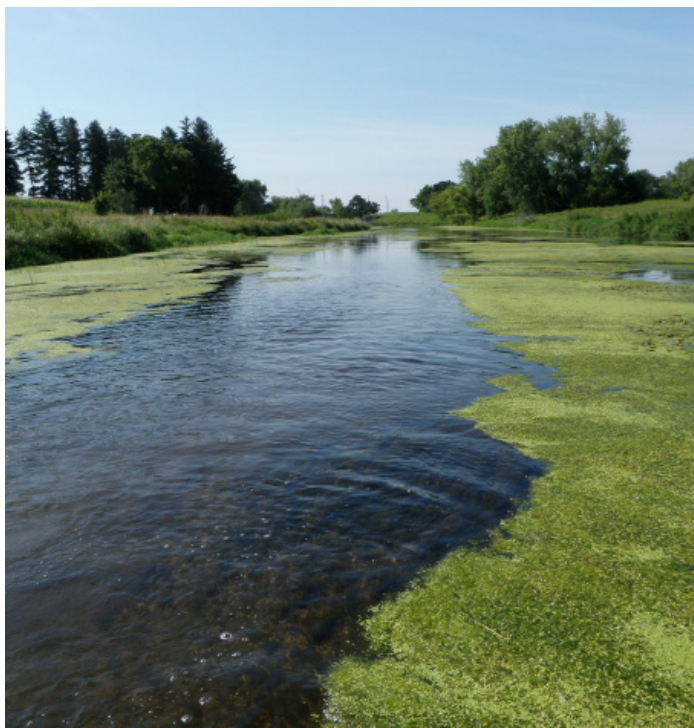
**Water monitoring shows high levels of phosphorus that cause algae throughout waters in the Shell Rock River Watershed.**
