WRAPS report summary

Watershed Restoration and Protection Strategy

Snake-Middle Rivers Watershed

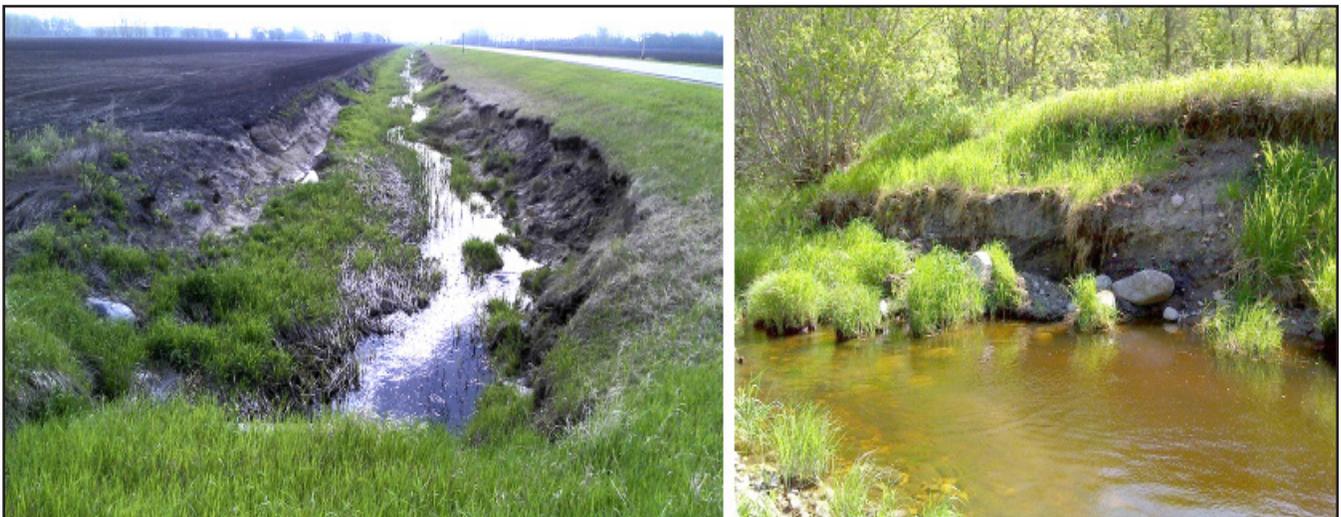
Images of sediment sources, including bank slumping along an unnamed ditch at the 200th Avenue NW and CSAH 14 intersection on May 28, 2014 (left); and streambank erosion on May 29, 2014 (right).
