# Clearwater River Watershed

## Watershed approach

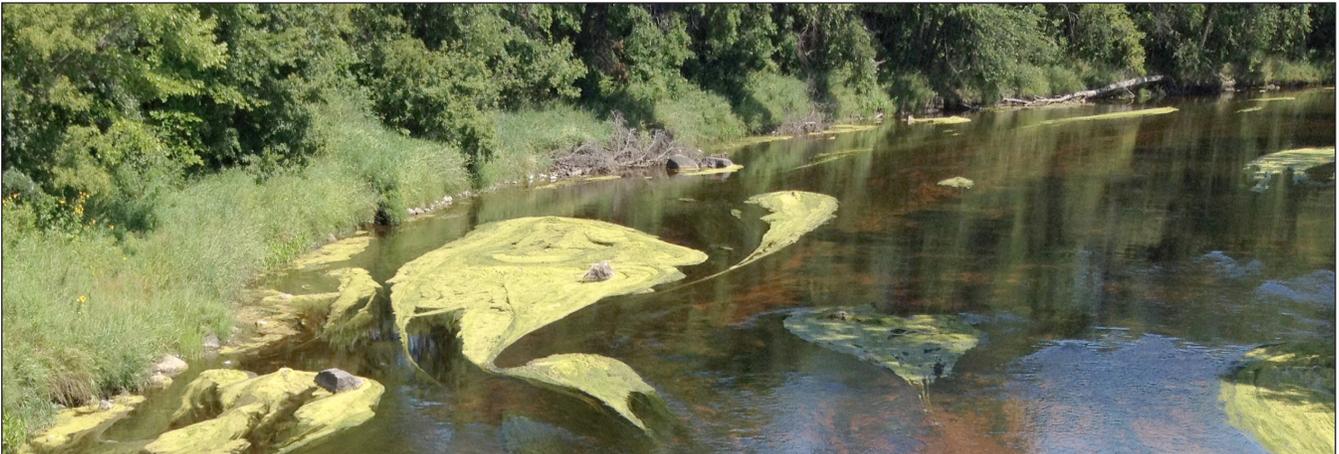
*Filamentous algae growth on 6/25/2015. Continuous DO data from this site recorded excessive DO flux, likely caused by extensive algae growth during the day followed by decomposition at night, which uses up available oxygen.*
