May 2021

Upper/Lower Red Lake Watershed Restoration and Protection Strategy Report

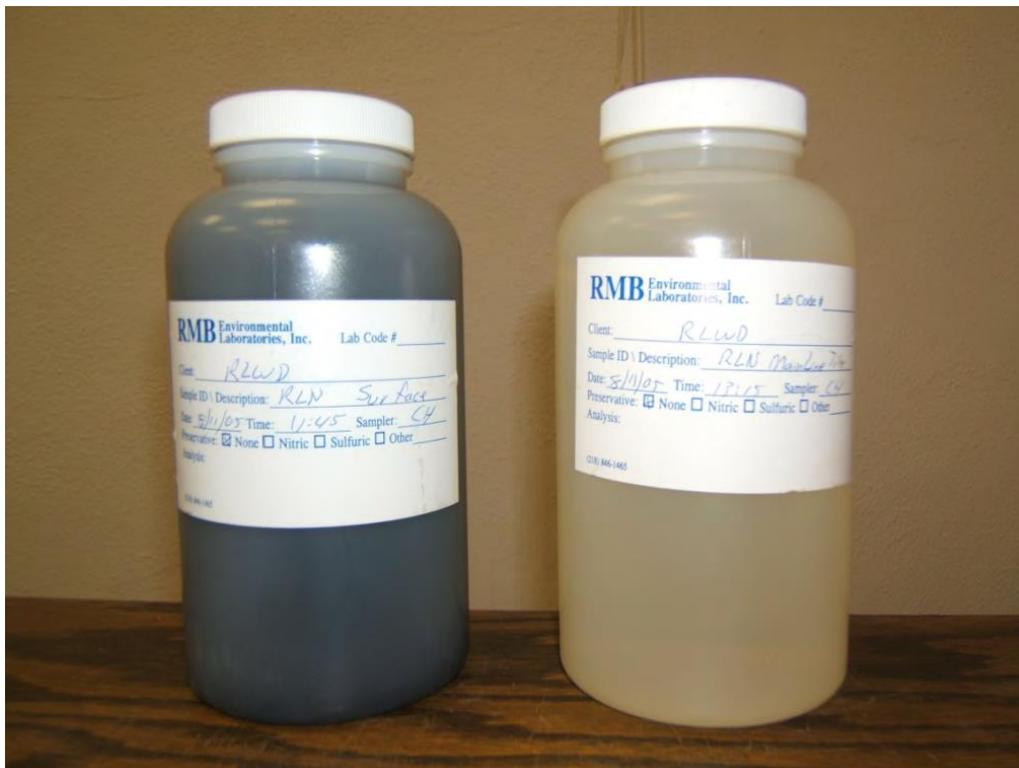
Figure 31. Comparison of surface drained wild rice paddy sample (left) and main line tile drained sample (right). Photo credit: Hanson 2009.
