Otter Tail River Watershed

Watershed approach

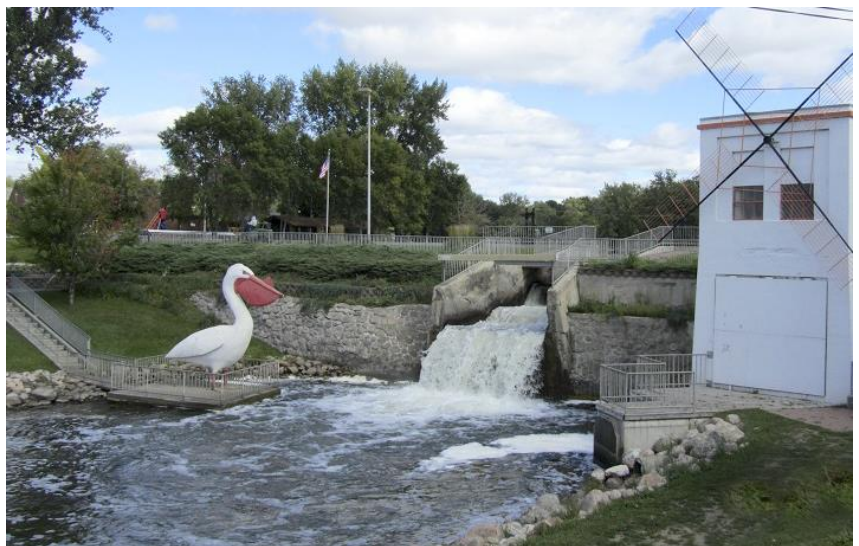
- To improve upstream mobility among aquatic communities, some existing dams and culverts can be modified to allow passage. A dam between Muskrat and Sallie lakes was among the first to be modified in the OTRW and serves as an example to what these projects can look like. Three other dam projects on Fish, Lizzie and Prairie lakes together reconnected 20 miles of the Pelican River. Other dams and culverts will likely be removed or replaced, including the dam located in Pelican Rapids. The existing park and well-known “World’s Largest Pelican,” Pelican Pete, will be preserved and enhanced.
