Marsh River Watershed

Watershed approach

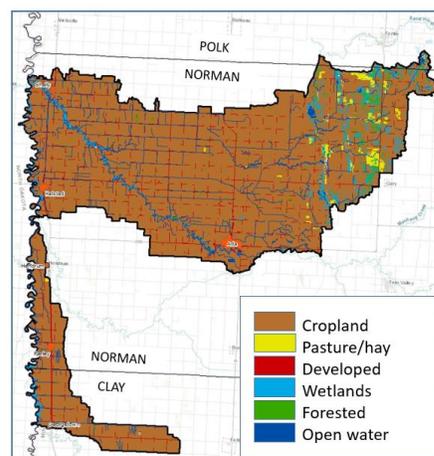
Land use in the Marsh River Watershed

- Size: 361.7 square miles Counties: Norman (91% of the watershed), Clay (8%), Polk (1%)
- Ecoregion: Lake Agassiz Plain
- Major tributaries: Marsh River, County Ditch 11, Spring Creek
- Towns: Halstad, Ada, Hendrum, Perley, and Shelly
- Land cover: Cropland (88.2%), pasture and hay (0.7%), developed (3.8%), wetlands (5.7%), forested (1%), open water (0.6%).
- The 8-digit hydrologic unit code (HUC): 09020107

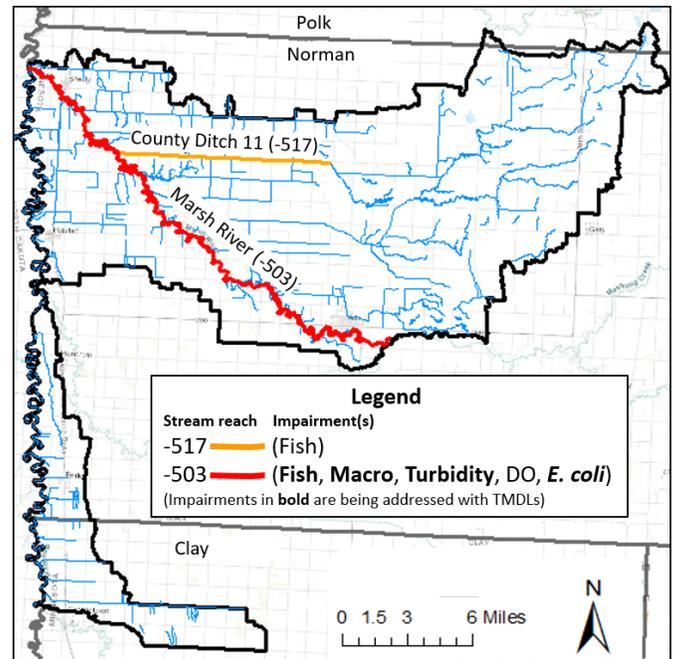
Map of impairments in the Marsh River Watershed

Excluding the mainstem of the Red River, the Marsh River Watershed (MRW) contains 16 stream reaches that have been assigned a number for assessment purposes. Of those, six have been assessed for aquatic life use (i.e., can they support fish and aquatic insect communities) and one for aquatic recreation use (i.e., is it safe for human contact such as swimming). The Marsh River (reach -503) is impaired for aquatic life use (as indicated by poor fish and aquatic insect communities, high turbidity, and low dissolved oxygen [DO]) and aquatic recreation use (as indicated by high levels of *E. coli* organisms). County Ditch 11 (reach -517) is designated as impaired for aquatic life use due to low fish [index of biotic integrity](#) (FIBI) scores. The remaining stream reaches were not able to be assessed due to insufficient data or inability to collect data.

Two TMDL studies were developed in one report to address four impairments in the Marsh River (reach -503). The total suspended solids (TSS) TMDL addresses the aquatic life use impairment caused by high turbidity and calculates reductions needed to achieve water quality standards for TSS. The TSS TMDL also addresses the impairments identified by poor biological communities in reach -503 when combined with other restoration efforts that are needed to address other stressors. The *E. coli* TMDL addresses the aquatic recreation use impairment caused by high *E. coli* in the Marsh River (reach -503).

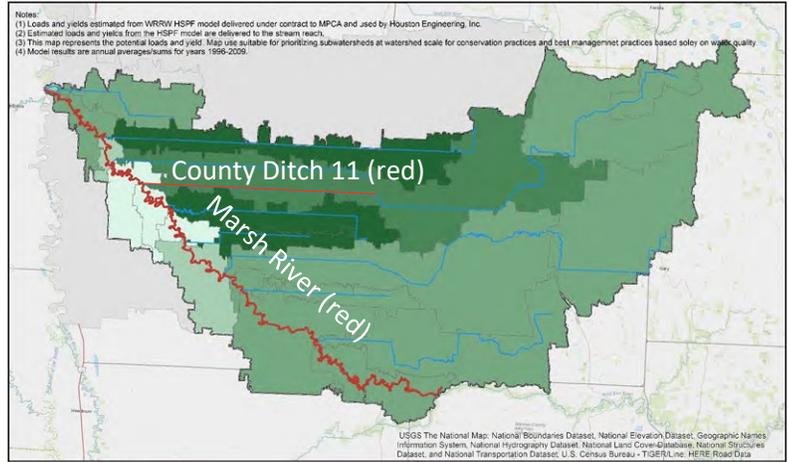
- The MRW WRAPS Report includes numerous maps local water managers can use to identify areas within the watershed where implementing BMPs would likely have the greatest impact in reducing various types of pollutants. For example, darker areas in the **map at right** indicate where BMPs to decrease sediment loading to the Marsh River would have the greatest impact to address excessive turbidity and loss of habitat.

Photo shows sediment-laden County Ditch 11 entering the Marsh River. County Ditch 11 (which is in a high priority area for sediment-reducing BMPs) also appears in the map near the top of this page.
