Blue Earth River Watershed

Watershed approach

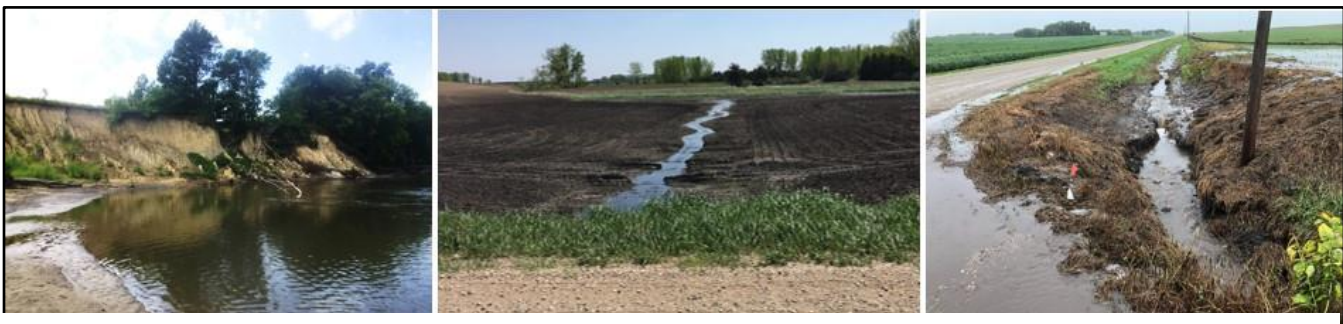
Many impairments in the Blue Earth River Watershed can be linked to excessive levels of sediment and nitrates, which can be deposited in surface waters via runoff from the landscape as well as in-stream erosion. Examples include, above left: streambank erosion resulting from high flows; above center: concentrated overland flow and, above right: ditch and ravine contributions.

Conditions affecting habitat include stream/landscape alterations that include the straightening of streams and extensive ditching that can increase sedimentation. In addition, high flows associated with spring runoff and summer storms, and extended periods of low flows can negatively affect habitat. The impacts of higher intensity storms and more severe droughts are amplifying these conditions.
