St. Louis River Watershed Stressor Identification Report

A study of local stressors causing degraded fish and aquatic macroinvertebrate communities in the St. Louis River Watershed

Minnesota Pollution Control Agency

December 2016

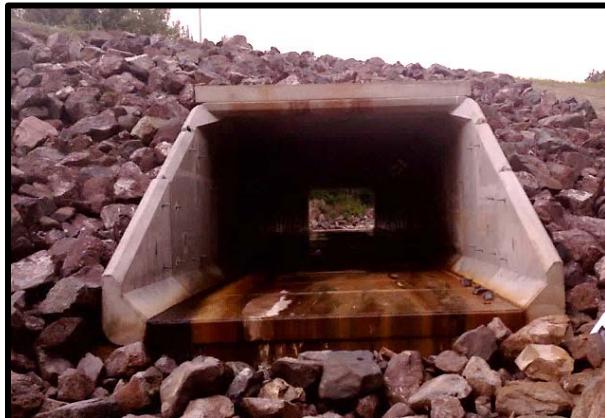
Figure 22a. Perched culvert on Kingsbury Creek at US Hwy 2 crossing, acting as a barrier to fish movement.

Kingsbury Creek, located in a rural/urban environment, also had crossings distributed throughout the entire watershed with a higher density on the main stem than contributing tributaries. The stream segment between Proctor and Duluth had a lower intensity of crossings than the stream miles in the highly developed urban settings. A total of 27 crossings were identified in the impaired AUID, including 13 culverts. One of those culverts was undersized and six were oversized resulting in 46% success rate in correct culvert sizing. An example of a perched culvert on Kingsbury Creek was found at the US Highway 2 crossing. A photograph taken during summer base flow (Figure 22a.) shows little to no flow and inadequate stream depth for fish passage through the culvert during dry periods. This site had a high stream slope which can pose challenges in placement design. Based on bankfull width estimates produced in the CASLRWIS report, the culvert was sized correctly.

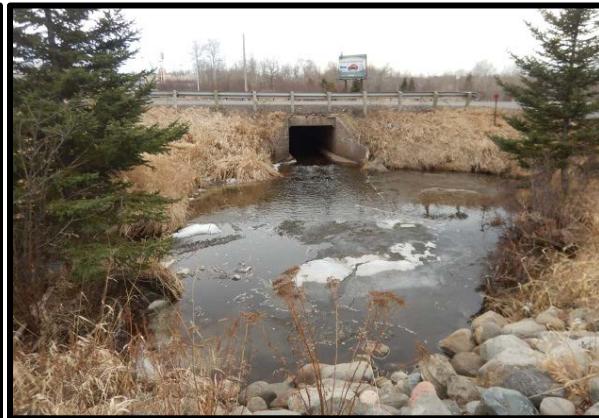
Figure 22b. Culvert on Miller Creek at US Hwy 53 crossing during snowmelt. The culvert becomes perched and acts as barrier to fish passage during the low flow season. The plunge pool downstream is an indication of an undersized culvert.

Miller Creek which was located in an urban environment entirely, from its headwaters to the mouth, had a high crossing density throughout most of the watershed. A 1.5-mile stretch of riparian corridor was established in the vicinity of Lake Superior College, between Anderson Road and Trinity Road, where no road crossings were observed on the main stem and very few were found on the contributing tributaries. The lower 0.6-miles of stream length flowed primarily underground through a culvert system, with a few stream fragments exposed above ground. A total of 36 crossings were identified in the impaired AUID, including 22 culverts. Six of those culverts were undersized, seven were oversized, and 2 undefined resulting in 35% rate in correct culvert sizing. An example of an undersized culvert on Miller Creek is shown below in Figure 22b. The same culvert was also perched during base flow conditions.

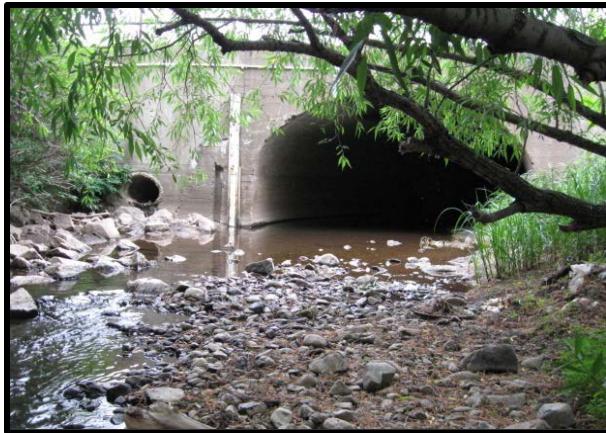
Figure 22c. Miller Creek outflows from an underground culvert that daylights at 26th Avenue West in Duluth, MN. This culvert is not perched, but is representative of the habitat loss present in the urbanized setting.

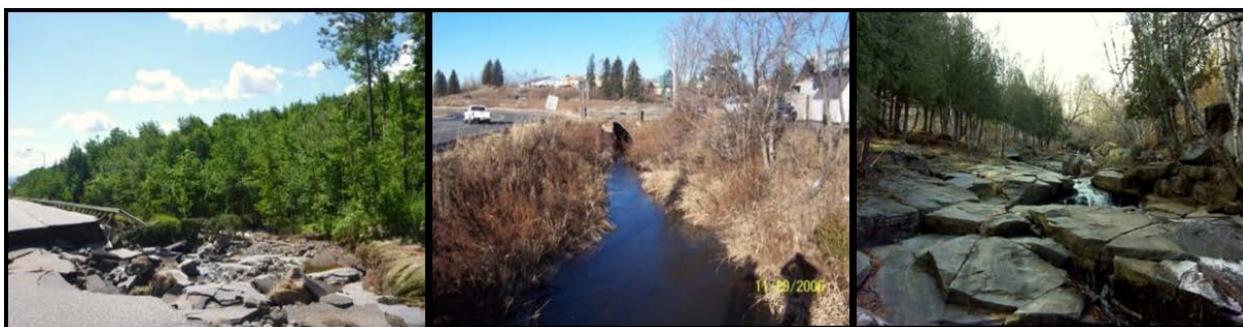
Figure 29: Representative reaches of impaired coldwater streams in the Duluth Urban Coldwater Watershed zone. (Left) Reach of Kingsbury Creek showing high gradient / bedrock geology nature of these streams. (Center) Impacts of 2012 flood Kingsbury Creek. (Right) Channelized portion of Miller Creek in high-density commercial area.

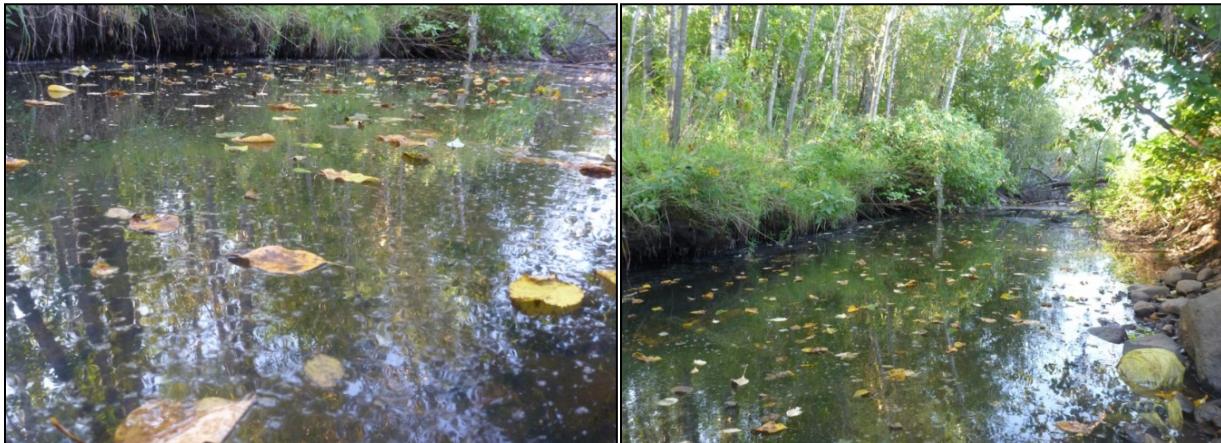
Figure 35: Stagnant water with surface film observed at Kingsbury Creek station 95LS036. This reach has been channelized and lacks channel features (esp. riffles) that provide habitat reaeration of water.

period, often for extended periods of time (20 – 42 hours) (Figure 37). Stream conditions during the continuous measurement were also symptomatic of a stream that may not support adequate DO concentrations for coldwater fish. Flows were stagnant, water temperatures were relatively warm ($> 20^{\circ}$ C), and a “scum layer” was observed on the surface of the water, perhaps due to nutrient enrichment (Figure 35). Diurnal DO flux was elevated (> 4 mg/L) during this monitoring period, likely due to the presence of algae and stagnant water. This reach of Kingsbury Creek has been channelized and lacks riffle features, which also limit DO inputs from reaeration.

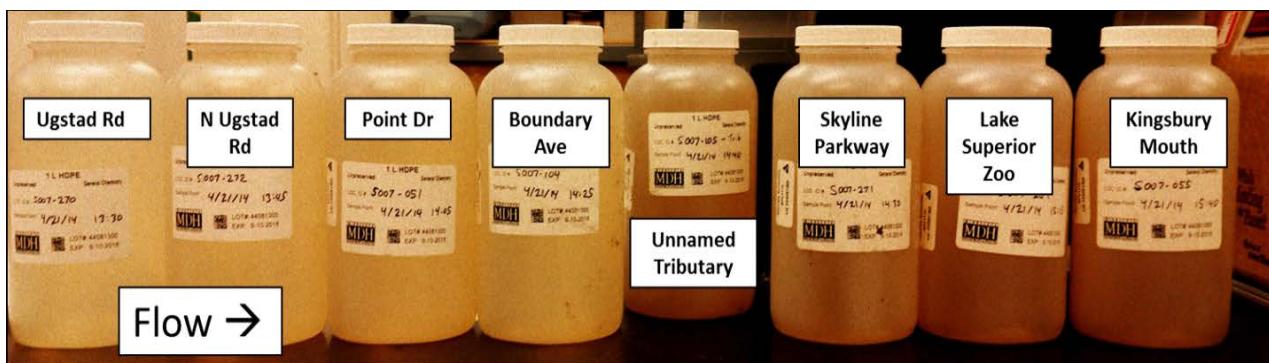
Figure 41: TSS sample bottles from the April 2014 snowmelt event

The results from a longitudinal sampling of a snowmelt event in April 2014 are shown in Figure 42. The results show a relatively large increase between S007-272 (North Ugstad Road) and S007-051 (Point Drive). The data also reveal significant sediment loading from a small tributary (pictured in Figure 45, upper left) entering Kingsbury Creek just upstream of Interstate 35. A six-fold increase in TSS, 53 mg/l to 320 mg/L, was observed between Boundary Avenue (S007-104) and Skyline Parkway (S007-271). It is no coincidence that the tributary mentioned above drains into Kingsbury Creek between these two sampling points. The tributary itself had a TSS concentration of 160 mg/L, suggesting that a significant amount of sediment is also being introduced from the main stem Kingsbury Creek segment between Boundary Avenue and Skyline Parkway. Figure 41 shows the sample bottles from this sampling effort, and is illustrative of how the water clarity changed from the headwaters to the mouth.

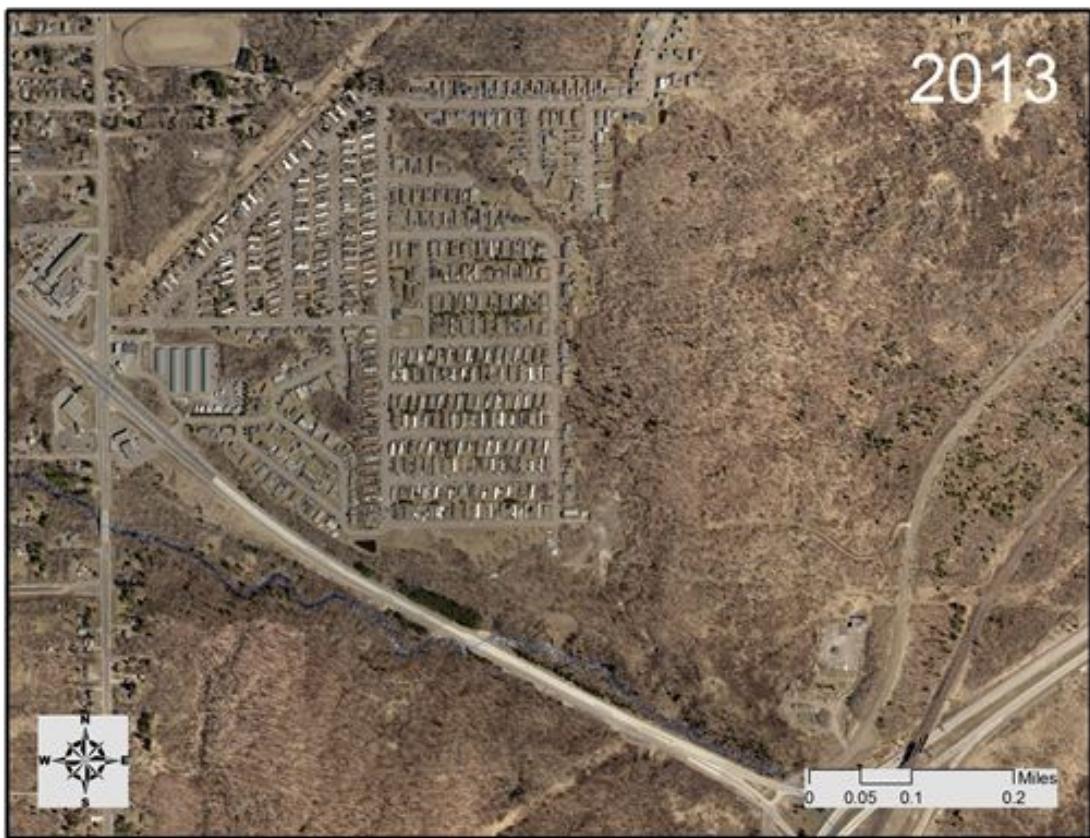
Figure 44: A dramatic example of development in the Kingsbury Creek Watershed

Channel instability is common in heavily urbanized watersheds (Booth 1990). Increased impervious surfaces cause augmented peak flows, and without grade control, stream channel incision is often the end result. Figure 44 shows an example of the increase in development and impervious surface in the Kingsbury Creek Watershed over the last half-century. The area displayed in the aerial photos in this Figure drains into an unnamed tributary that delivers high sediment loads to Kingsbury Creek during snowmelt and rain events.

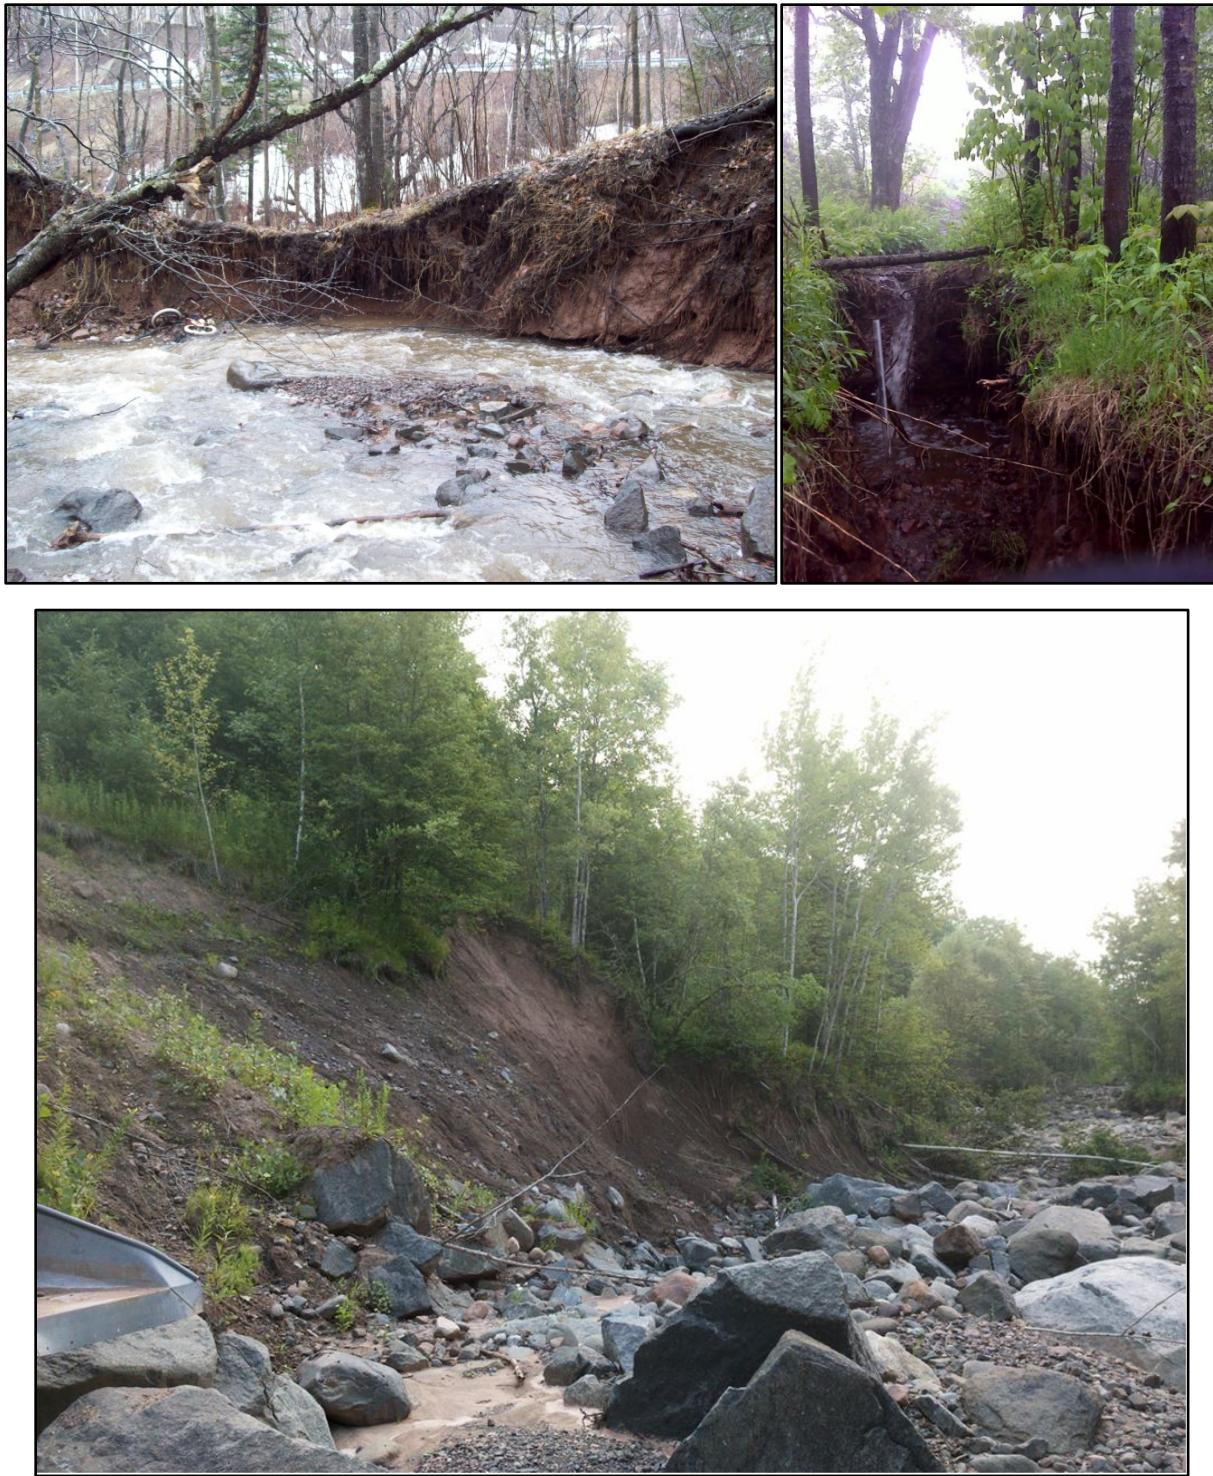
Figure 45: Severely eroding bank on the unnamed tributary to Kingsbury Creek (upper left); a ~1.0 meter headcut on the unnamed tributary to Kingsbury Creek (upper right); and major bluff erosion site downstream of HWY 2 (lower)

Areas of channel instability and bank erosion were observed mostly in the aforementioned tributary and in Kingsbury Creek between Interstate 35 and Boundary Avenue in Proctor. This is the transitional area between the low gradient headwaters and the bedrock-controlled cascading reaches in the lower part of the watershed. This area alternates between “B” type channels, which are mostly stable, and “C” type channels, which often show signs of lateral instability in the form of bank erosion (see Figure 45). C-type channels are less efficient at transporting sediment than B channels because they are generally flatter and are not as entrenched. Thus, in incised rivers with excess sediment supply, it is predicted that the C channels will be the reaches where aggradation and lateral instability will occur. This has been an

There are also areas that are contributing sediment as a result of vertical instability. A large headcut was observed in the Kingsbury tributary (Figure 45), just downstream of the trailer park. The reach immediately downstream of this headcut is likely contributing a significant amount of suspended sediment as channel evolution progresses.

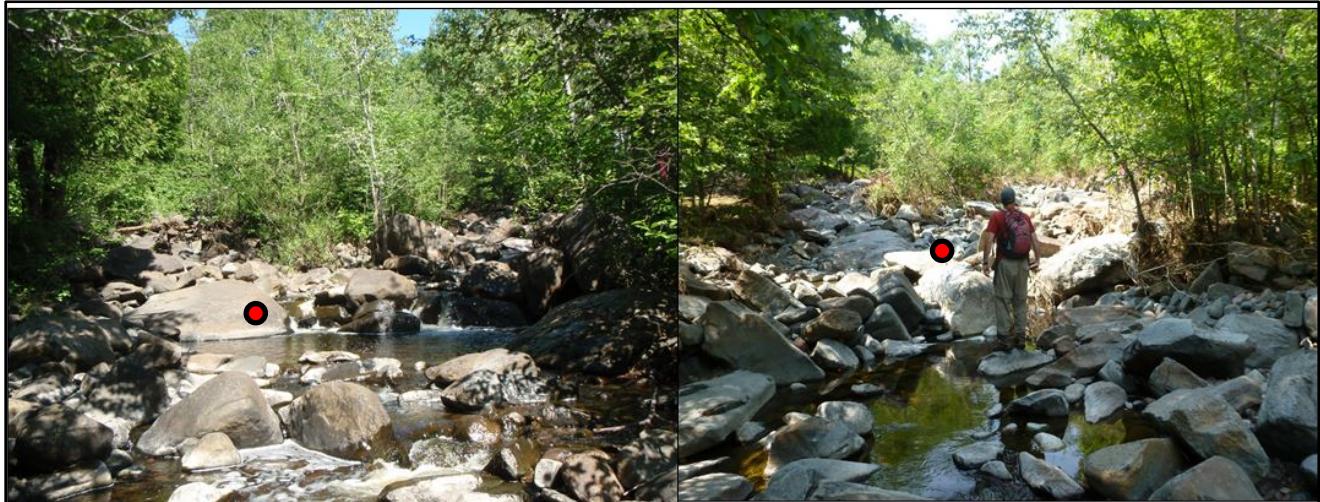
Figure 47: The photo on the left shows a deep pool where several Brook Trout were sampled on 6/13/12. The photo on right, taken about a month later, shows the extent of pool filling from the 2012 flood. (The red dot is marking the same rock in each photo).

Over the course of a 24-hour period on June 19-20th, the Duluth area received around 10 inches of rainfall. This precipitation event resulted in damaging floods in many of the watersheds in and around the Duluth metropolitan area, which drastically changed stream channel and floodplain conditions in many of these streams. In the Kingsbury Creek Watershed, many pools were filled with cobbles and boulders that were carried downstream as bedload during this extreme high flow event (Figure 47). The following link includes footage of Kingsbury Creek during this flood event

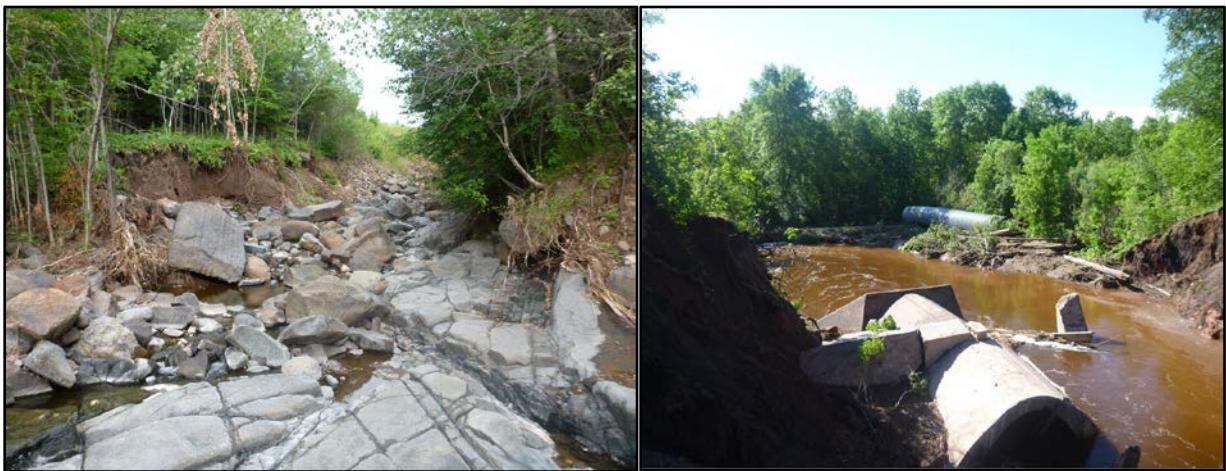
Figure 48: Streambank and infrastructure damage along Kingsbury Creek caused by extreme flood event in June 2012.

The 2012 flooding caused significant streambank and bluff erosion in the Kingsbury Creek Watershed, and also caused damage to infrastructure along the stream corridor (Figure 48). Many of the impacted

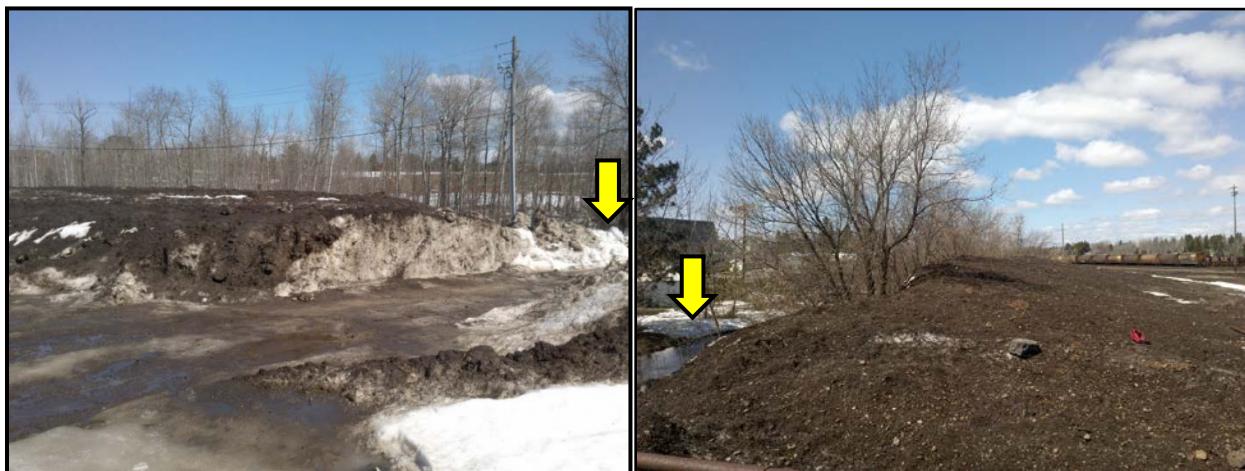
Figure 54: Large piles of snow laden with road salt and grit adjacent to Kingsbury Creek (4/21/14). Yellow arrows indicate location of creek.

The sources and pathways of chloride within the Kingsbury Creek Watershed are believed to be very similar to Miller Creek. See Section 5.2.2 to learn more about these sources. Specific “hot spots” for chloride in Kingsbury Creek likely include the city of Proctor, the U.S. Highway 2 and I-35 highway corridors in the middle reaches of the watershed, and the Grand Avenue crossing near the mouth of the creek. Synoptic monitoring at these locations and additional sites within the watershed is recommended to better understand chloride inputs to Kingsbury Creek.

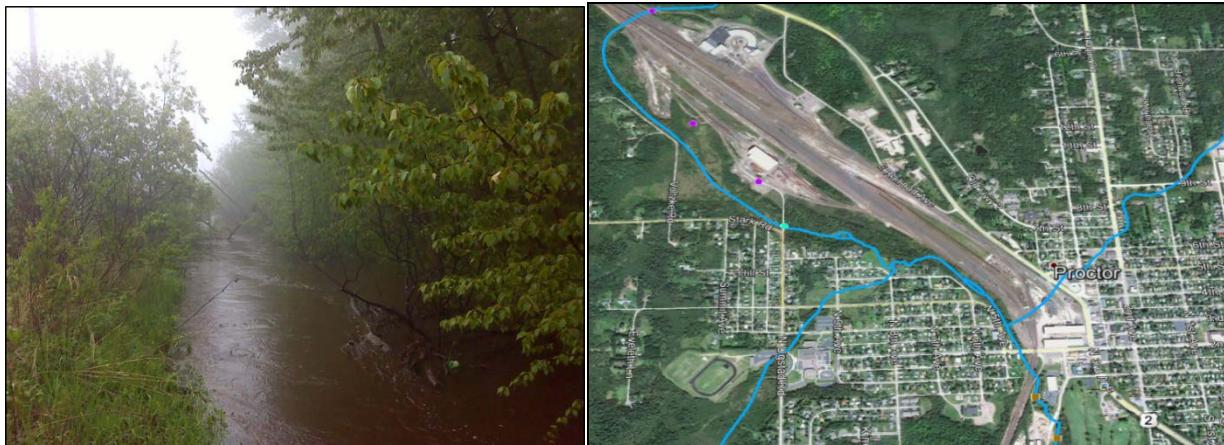
Figure 65: Photo of high-flow sampling conditions that produced a dissolved lead result above the CS (left) and an aerial photo of Kingsbury Creek winding through the city of Proctor, Minnesota (right)

Only two of the four lead samples had corresponding water hardness data, and the dissolved lead portions of these results are displayed in Table 29. One of the four samples exceeded the CS for lead toxicity (dissolved lead conc. = 3.18 µg/L; hardness = 55 mg/L) (Table 29). This particular sample was collected at biological monitoring station 95LS036 on 5/24/2012 following the aforementioned 3-inch rain event. Although water hardness data are not available to calculate dissolved lead concentrations for the samples collected on April 18, 2012, the dissolved portion of the lead results from that date are expected to be below the CS. Water hardness would have needed to be in the range of 30 mg/L for these samples to exceed the CS, which is unlikely during a snowmelt event given the high chloride concentrations typically observed in this stream (see Figure 53).

The elevated lead concentrations observed during the May 2012 rain event may have been due to the flushing of wetlands and stormwater ponds on and around the DM & IR rail yard site. On the other hand, there is no way to discount the potential contribution of other sources of metals upstream of this site (city of Proctor, gas stations, road runoff). Based on the limited data available, it appears that any violations of the water quality standard for lead are relatively minor (only CS was exceeded) and are driven by high flow events that mobilize contaminants from various sources in the watershed. The baseflow sampling completed during winter low flow resulted in dissolved lead concentration of 1.00 µg/L and a water hardness value of 230 mg/L. This sample was well below the chronic water quality standard for lead.

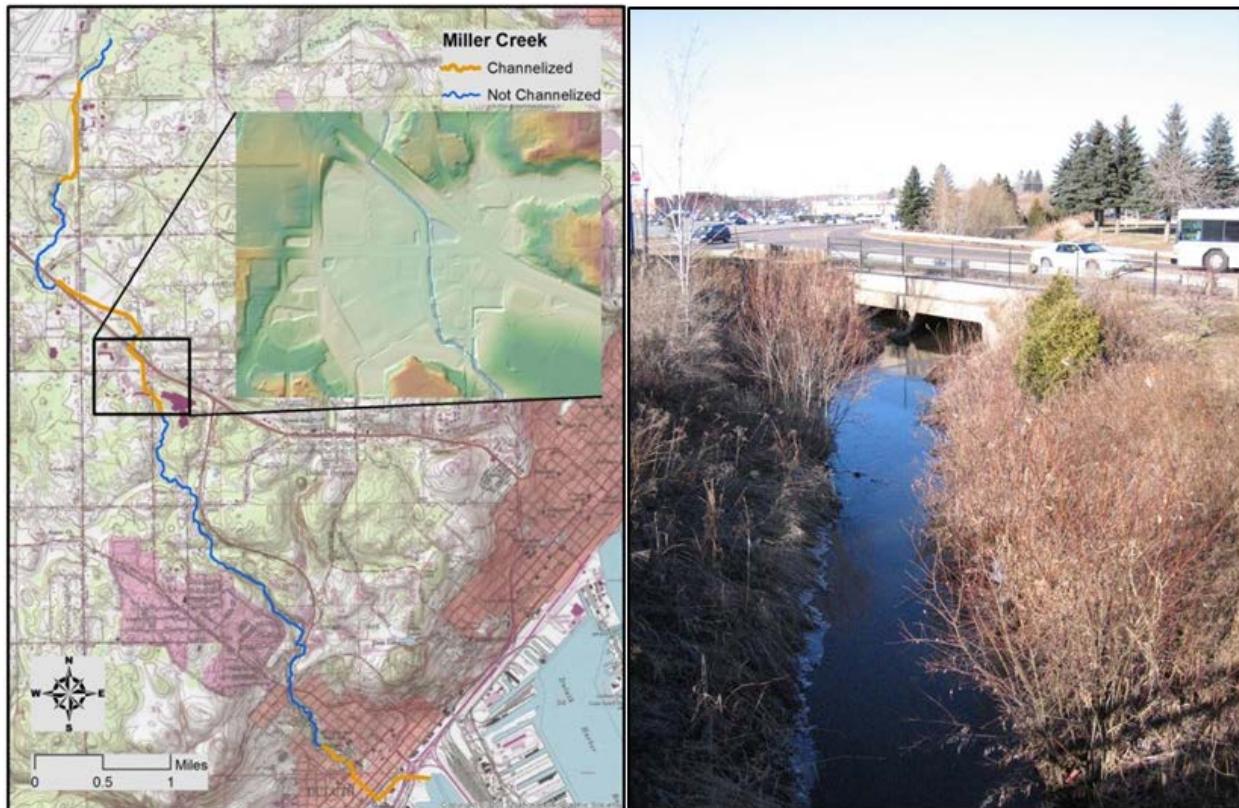
Figure 71: Map showing the channelized and straightened reaches of Miller Creek

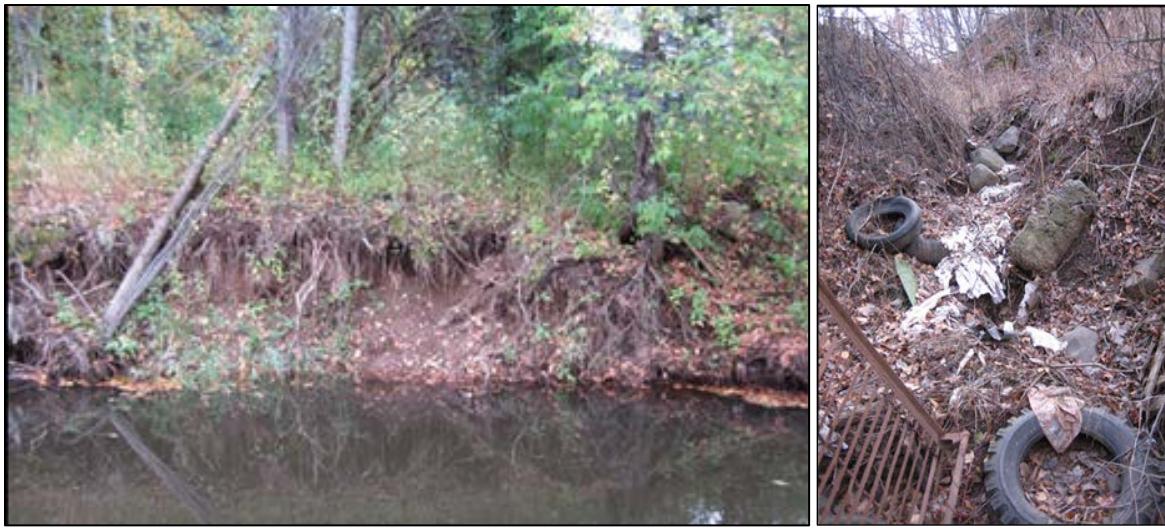
Figure 72: Bank and gully erosion in the Miller Creek Watershed

Areas of channel instability and bank erosion are minimal in the Miller Creek Watershed. A few unstable gullies and some localized bank sloughing were observed during a reconnaissance hike on the stream (Figure 72); therefore, it cannot be written off as a possible pathway. A much more significant pathway for suspended solids in the Miller Creek Watershed is urban stormwater runoff.

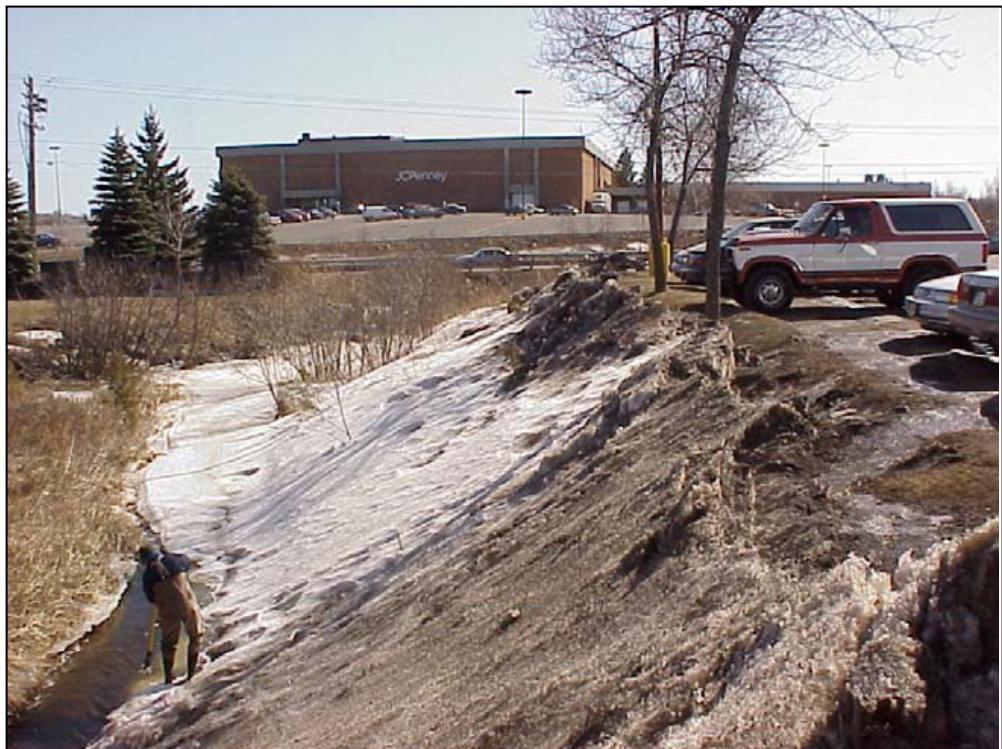
Figure 78: Large snowbank from a shopping center parking lot adjacent to Miler Creek. These snowbanks can contain significant amounts of road deicing salts and grit (sand/sediment). *Photo Credit:* Tom Estabrooks, MPCA- Duluth.

Groundwater is another delivery pathway for chloride to enter streams and rivers. Contaminated runoff from impervious surfaces can flow from the pavement into unlined ditches or ponds and infiltrate surrounding soil. In addition, road salt applied during snowstorms is generally plowed off the roadway and paved shoulder (Figure 78). When the resulting snowbanks melt, the meltwater, together with the dissolved salt, can migrate through soil and infiltrate into the water table. A study of groundwater influence on stream chemistry in Massachusetts confirmed that chloride originating from highway-deicing application persisted throughout the year as a source of contamination in groundwater, interflow, and surface water even during warmer months (Granato et al. 1995).

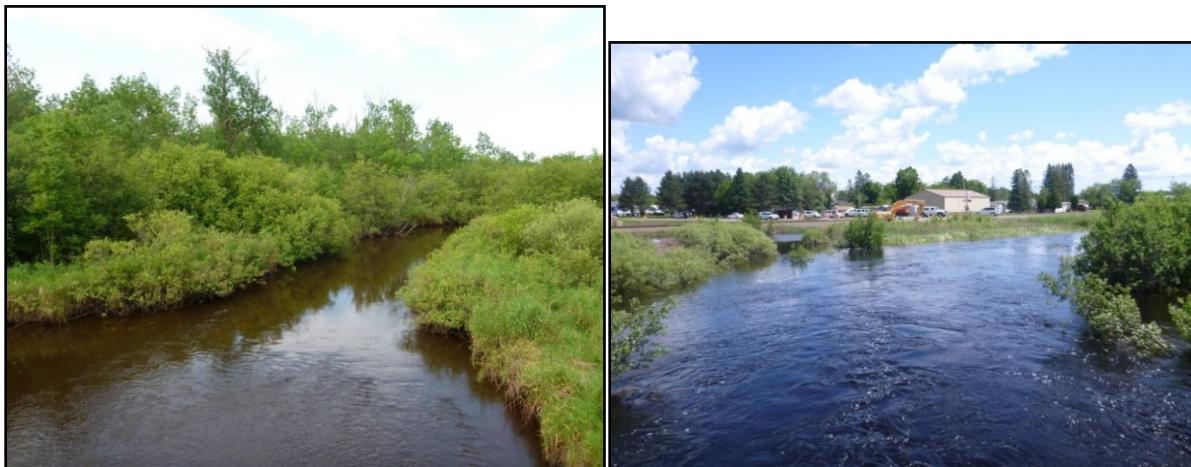
Figure 86: Looking upstream at Otter Creek monitoring station 09LS005 during low flow in September 2012 (left), and downstream during a high flow event in June 2012 (right).

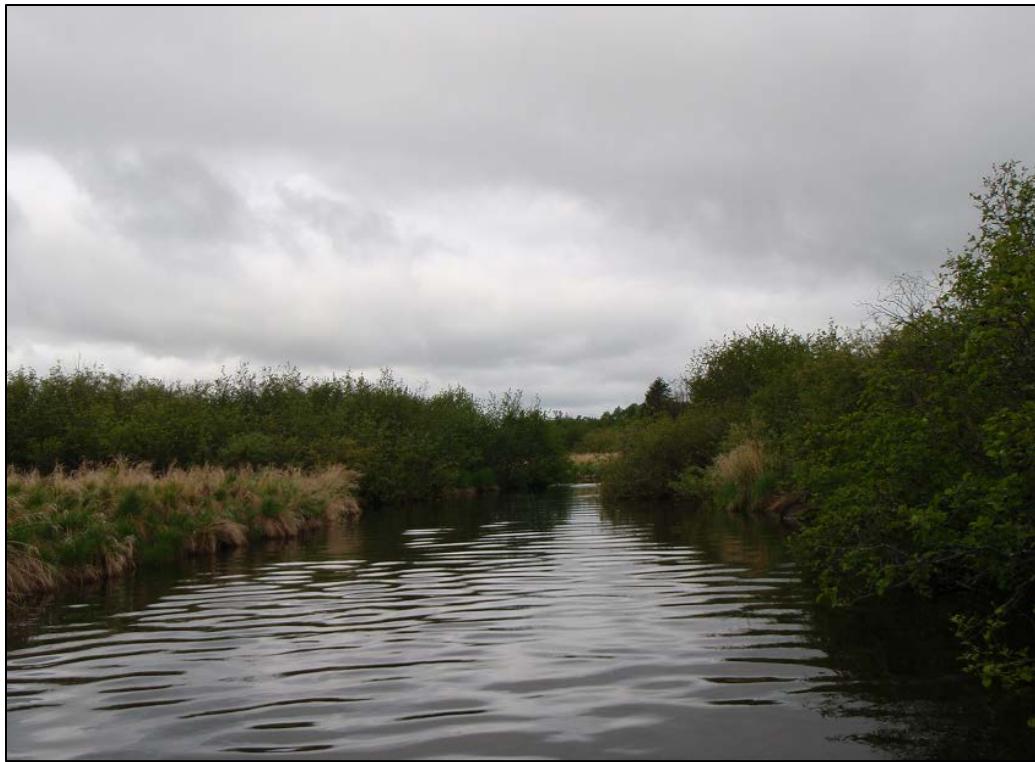
Figure 92: Otter Creek station 09LS005 is low gradient and lacks shallow, fast-water riffle and glide habitats

The original sampling reach on Otter Creek (09LS005) is low gradient and lacks shallow, fast-water habitats such as riffles and glides. Riffles and glides are often productive microhabitats with diverse and abundant macroinvertebrate assemblages. Compared to other class 8 MIBI stations in the SLRW, 09LS005 is dominated by “run” and “pool” habitats and had one of the lowest percentages of riffle habitat in the entire watershed for streams of this MIBI class (Figure 92). The lack of riffle and glide habitats within this sampling reach are one of several natural background factors that are likely factoring into the low MIBI scores observed.

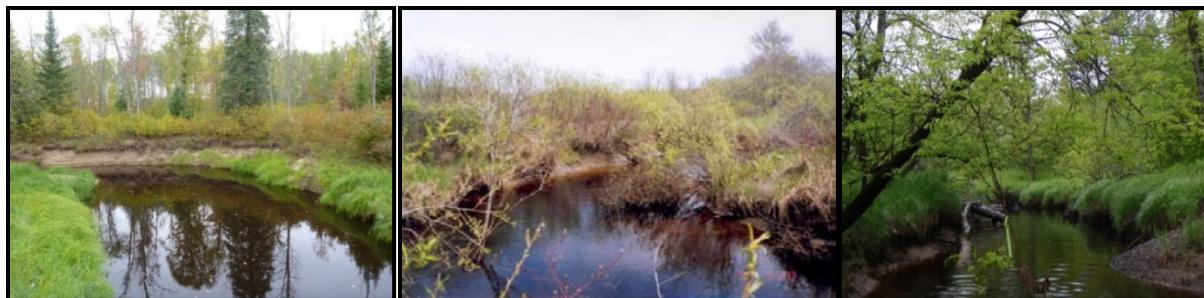
Figure 95: Some representative stream reaches from the Meadowlands Floodwood Peat Bog (MF-PB) Watershed zone. Pictured are Stony Creek (left), Vaara Creek (center), and Sand Creek (right). All of these streams are impaired for biological measures.

The Meadowlands Floodwood Peat Bog (MF-PB) Watershed zone exhibits one of the highest impairment rates of any region in the SLRW. The impaired streams in this region many similarities in terms of the symptoms of impairment and potential stressors. For the most part, streams of this watershed zone are very low gradient, and are lacking coarse substrates and riffle-run habitats. With the exception of the impaired reach on the main stem of the St. Louis River, all of the impairments are found on small tributary streams draining a network of ditches within the expansive Meadowlands Sax-Zim peat bog. All of these streams are severely tea-stained in color and low in alkalinity, which is a natural background condition that may be limiting the diversity and abundance of aquatic life.

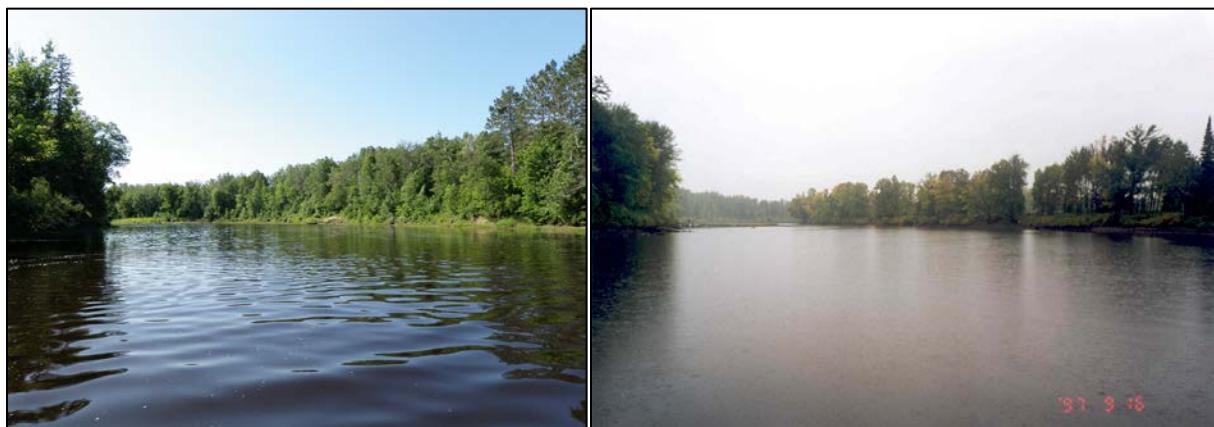
Figure 97: Photos from station 97LS090 taken in 2009 (left) and 1997 (right). Note the extremely wide channel with very few defined stream features (riffles, glides) and stagnant flow conditions.

Low MIBI scores and similar impairment symptoms in the biota are observed for a 20-mile stretch of the St. Louis River, including areas downstream of the impaired reach. Stream gradient is fairly low throughout this entire reach, and many of these stations with poor MIBI scores share similar habitat limitations. Compared to St. Louis River monitoring stations upstream and downstream, sites in the vicinity of the impaired reach generally have poorer substrate conditions, less in-stream cover, and morphological attributes that are not conducive to quality habitat (Figure 98).

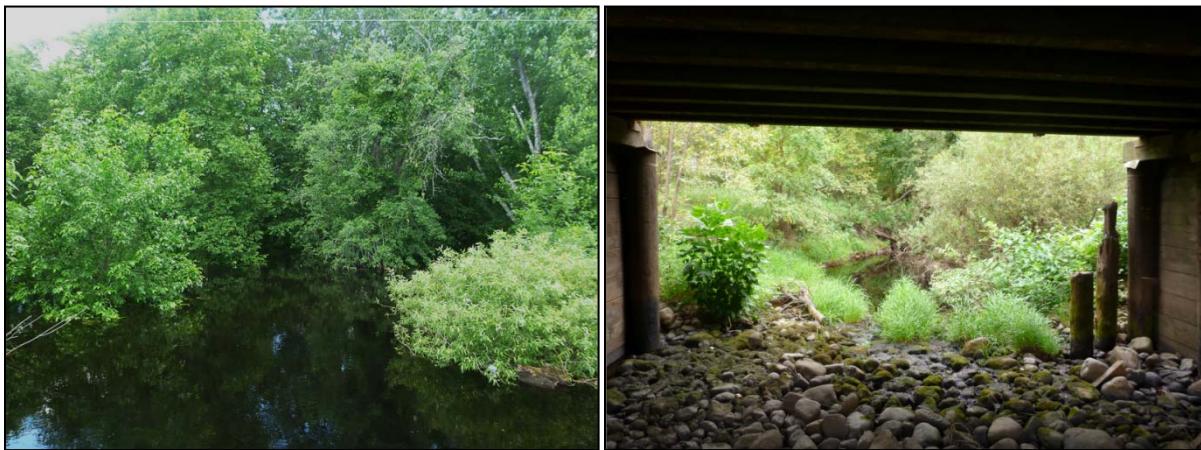
Figure 104: Skunk Creek at flood stage after major precipitation event in June 2012 (left). At the same station 3 months later, water levels were extremely low, resulting in water surface elevations the below bridge crossing (right).

Low DO concentrations were identified as a candidate cause for fish and MIBI impairments in Skunk Creek. Instantaneous measurements collected between 2009 and 2013 indicate that DO concentrations occasionally fall below the 5 mg/L water quality standard applied to warmwater streams. Approximately 28% of DO readings collected at the lone biological monitoring station (09LS031) were below the DO standard (Figure 105). The lowest concentration observed in Skunk Creek (2.41 mg/L) occurred in September of 2012 during an extended dry period when streamflow was stagnant and impounded by a bridge crossing that was above the water surface elevation (Figure 104). Less than three months earlier, a historic flood (estimated as a 500-year flood in some areas of the SLRW) hit the watershed, causing Skunk Creek to spill out onto its floodplain for several weeks (Figure 104). Due to all of the wetlands and bogs in the watershed that were flushed out during this precipitation event, DO concentrations were fairly low (4.54 mg/L) despite the extremely elevated flow conditions.

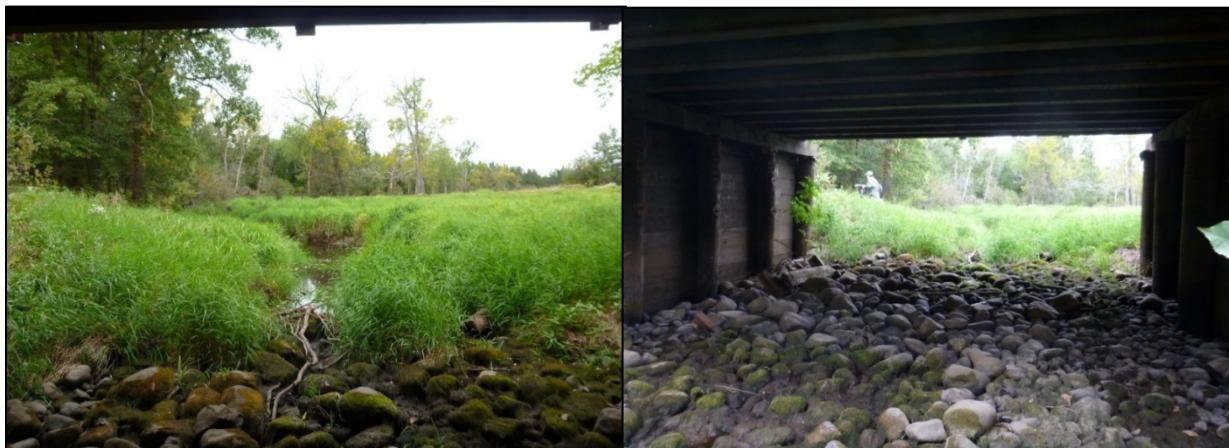
Figure 112 (Left): Looking upstream from CR 196 bridge. The cobbles added during bridge construction were set at too high of an elevation. Water flows subsurface through cobbles, and the improper crest elevation of the cobbles is creating a flat water surface upstream. (Right): The coarse cobble substrate and lack of water underneath the CR 196 bridge.

migration of the channel incision. Unfortunately, this means that at base flow the water flows subsurface in the vicinity of the County Road 196 bridge. So, in addition to providing grade control, the cobbles also create a barrier for fish and other aquatic life (see lack of water in Figure 112). Due to the high crest elevation of the cobbles, the water surface profile upstream of the bridge is artificially high and flat during low flows, which is likely eliminating shallow, fast-water habitats (riffles/glides) and create more slack water habitats that dominate this reach (runs/pools).

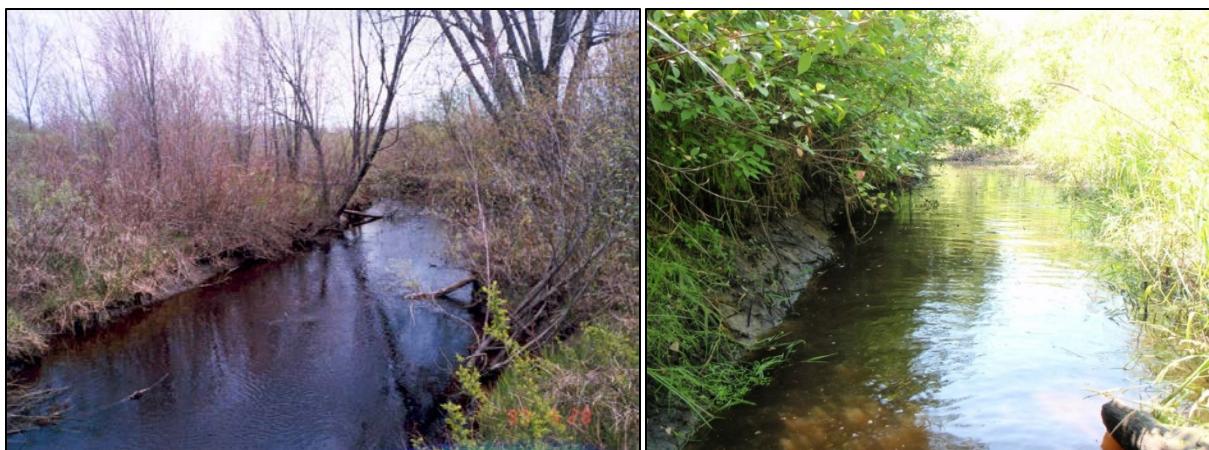
Figure 117: Low gradient conditions at Vaara Creek biological monitoring station. Note the lack of riffle/glide features

The PSI scores for Vaara Creek are typical of an incised channel, with characteristics such as bank erosion and loose bottom sediments leading to poor habitat conditions. Vaara Creek station 97LS034 scored a 90 on the PSI, which corresponds to a rating of “moderately unstable” for the potential E5 stream type (Figure 118). The channel instability in this reach of Vaara Creek may be due in part to seasonal flow variability. The wide channel and steep, high banks observed in this reach are indicative of stream with highly fluctuating flow conditions. Site visits to this reach have confirmed these conditions, as spring snowmelt conditions fill much of the stream channel and wetted width (width from waters edge to waters edge) during summer baseflow conditions is much narrower than the physical channel width (Figure 117).

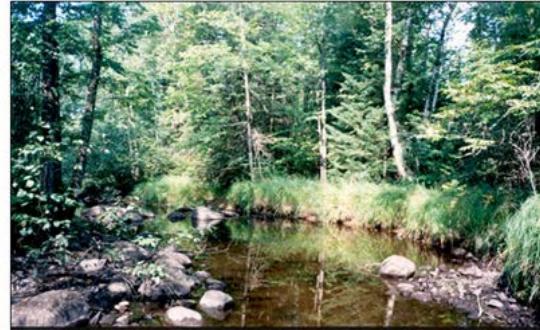
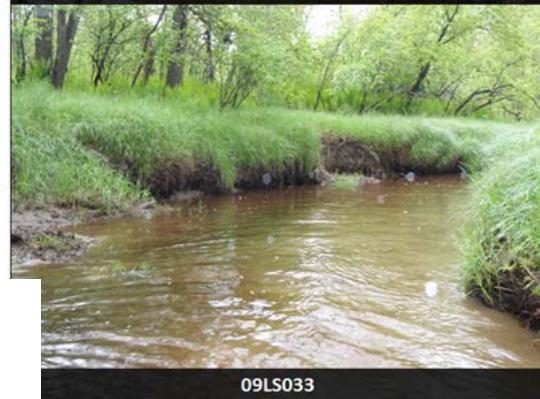
Figure 121: Comparison of fish species/abundance observed at the two biological monitoring stations on Sand Creek.

Station 98LS047		Station 09LS033	
Shared Species / Count			
Burbot	1	Burbot	3
Creek Chub	1	Creek Chub	11
Johnny Darter	34	Johnny Darter	11
Mottled Sculpin	50	Mottled Sculpin	6
Trout-Perch	4	Trout-Perch	7
White Sucker	4	White Sucker	4
Species unique to Station / Count			
Central Mudminnow	13	Bigmouth Shiner	10
Longnose Dace	63	Common Shiner	2
Walleye	1	Fathead Minnow	4
Northern Pike	1	Northern Redbelly Dace	2
		Golden Shiner	5

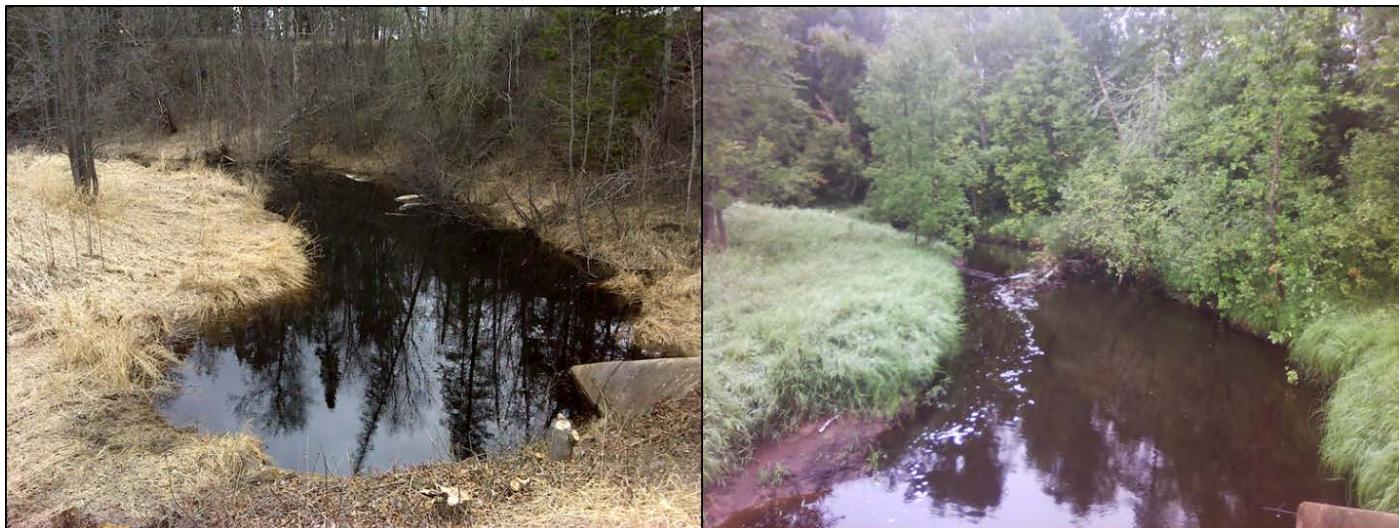
Figure 126: Sand Creek station S006-551 looking upstream during high flow conditions (left) and low flow conditions (right). Note tannin stained water in both photos.

In contrast to many streams in Northeastern Minnesota, Sand Creek appears to have clearer water during snowmelt than during baseflow (Figure 125). There is no discernible seasonal trend in TSS due to a lack of dated TSS samples (n=2). This may be caused by the relative increase in bog stained surface water during periods of low flow. During rain events and snowmelt, there may be more runoff from surficial sources which may actually increase transparency of the water in Sand Creek. Additional sampling, especially during snowmelt and during rain events, is recommended to make sure that this apparent trend is not merely attributed to a lack of sufficient data.

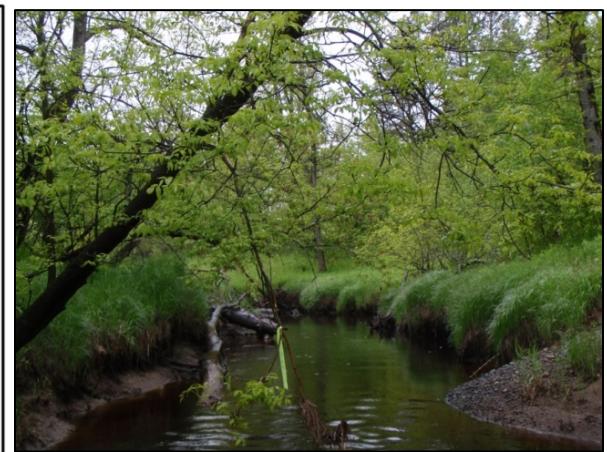
(Above): Erosion on both banks and leaning trees are a sign of channel incision in Sand Creek

Areas of channel instability and bank erosion were observed at the 09LS033 biological monitoring station (see Figure 127) and other road crossings in the watershed. Channel instability in the Sand Creek Watershed is likely a consequence of increased peak flows as a result of efficient landscape drainage (ditching). Many reaches in Sand Creek show erosion on both sides of the river as well as trees falling into the channel. These are dead giveaways for incision and support the hypothesis that ditching in the watershed increased water slopes and peak flows and led to channel degradation.

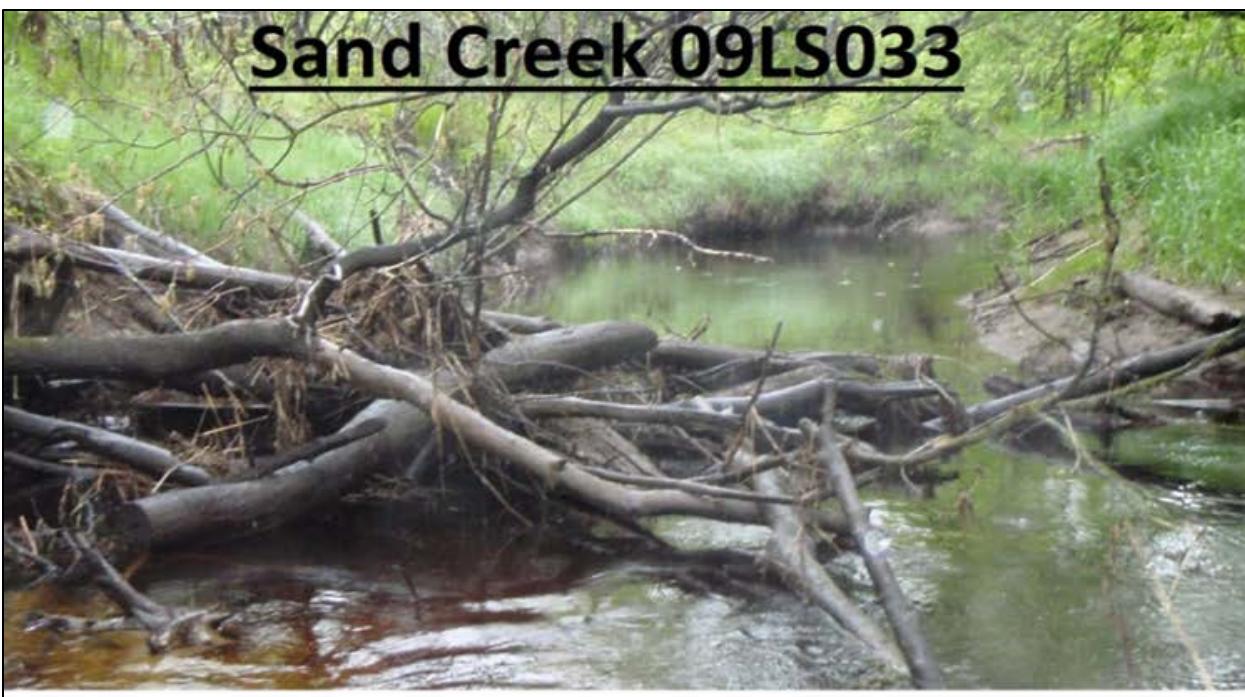
Worksheet 3-10. Pfankuch (1975) channel stability rating procedure, as modified by Rosgen (1996, 2001c, 2006b).

Stream: Sand Creek		Location: 09LS033				Valley Type: VIII				Observers:				Date:								
Location	Key	Category	Excellent		Good		Fair		Poor													
			Description	Rating	Description	Rating	Description	Rating	Description	Rating	Description	Rating	Description	Rating								
Upper Banks	1	Landform slope	Bank slope gradient <30%.	2	Bank slope gradient 30-40%.	4	Bank slope gradient 40-60%.	6	Bank slope gradient > 60%.	8												
	2	Mass erosion	No evidence of past or future mass erosion.	3	Inrequent. Mostly healed over. Low future potential.	6	Frequent or large, causing sediment nearly yearlong.	9	Frequent or large, causing sediment nearly yearlong OR imminent danger of same.	12												
	3	Debris jams potential	Essentially absent from immediate channel area.	2	Present, but mostly small twigs and limbs.	4	Moderate to heavy amounts, mostly larger sizes.	6	Moderate to heavy amounts, predominantly larger sizes.	8

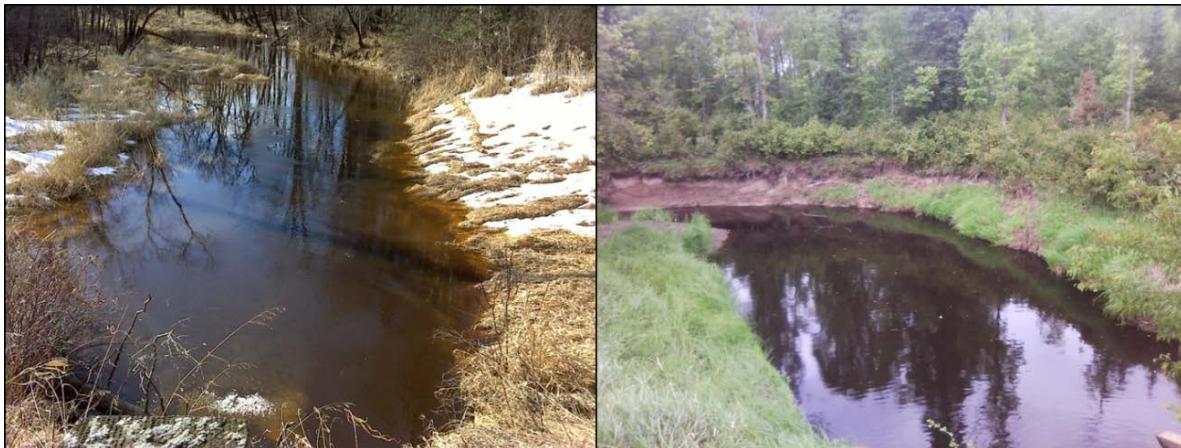
Figure 141: Stony Creek showing muddiness during snowmelt (left) and its tannin-stained appearance at low flow (right)

Stony Creek is opaque in appearance throughout the year. During rains and snowmelt its waters are muddy and during low flows the water is heavily tannin-stained. There is no discernible seasonal trend in TSS due to the low number of dated TSS samples.
