St. Louis River Watershed Stressor Identification Report

A study of local stressors causing degraded fish and aquatic macroinvertebrate communities in the St. Louis River Watershed

Minnesota Pollution Control Agency

December 2016

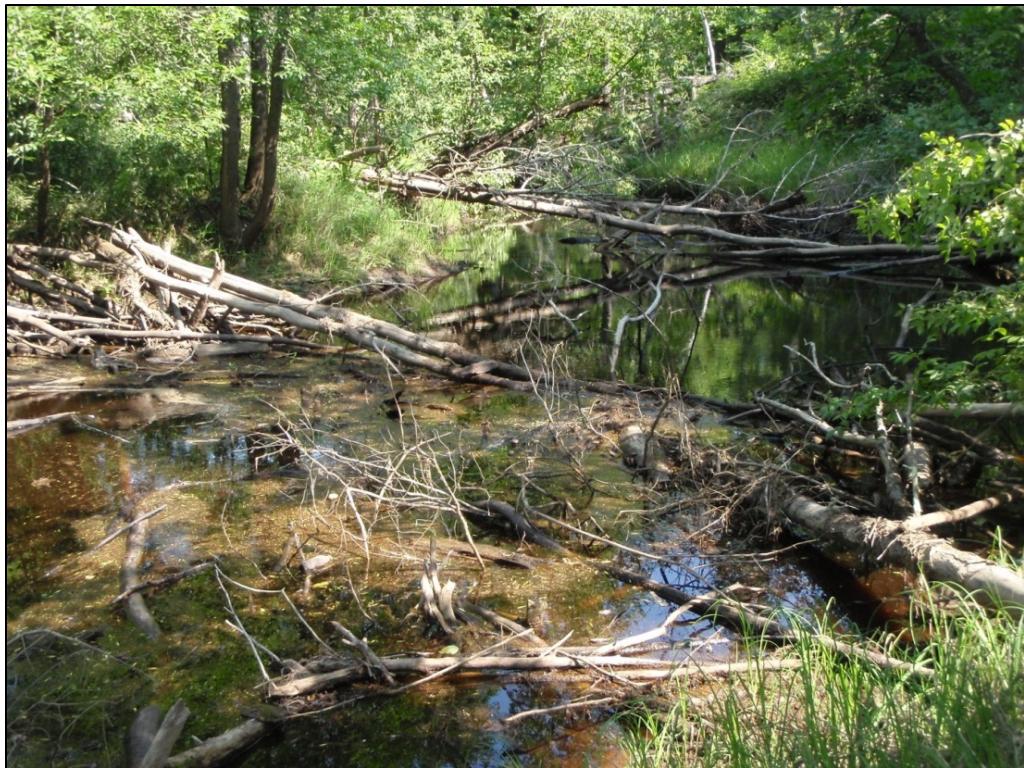
Figure 145: Leaning trees and massive debris jams are a sign of channel instability in Stony Creek

Areas of debris jams and other indications of channel instability were observed at the 09LS036 biological monitoring station (Figure 145). Channel instability in the Stony Creek Watershed is likely a consequence of increased peak flows as a result of efficient landscape drainage (ditching). Another possible pathway for channel instability may have been a local base level drop in the St. Louis River that caused a headcut to migrate up through the Stony Creek Watershed. More research is needed to determine whether historic landscape alterations (mass logging, ditching, development, etc.) in the SLRW caused peak flows in the St. Louis River to increase. If so, was incision of the St. Louis River a response to these alterations? The lacustrine sediments of the Glacial Lake Upham basin would probably not have been very resistant to downcutting forces. If the main stem St. Louis River incised in the recent past, it would have caused headcuts to migrate up every tributary that fed into the downcut reaches of the river. There is some evidence of this, especially in the part of the St. Louis that flows through the Glacial Lake Upham basin (Figure 146), which shows an incised tributary that feeds into the St. Louis River just upstream of Floodwood, Minnesota. Many of the tributaries in this area show evidence of downcutting, with high degrees of incision, V-notch valleys, and sediment deltas at their mouths.

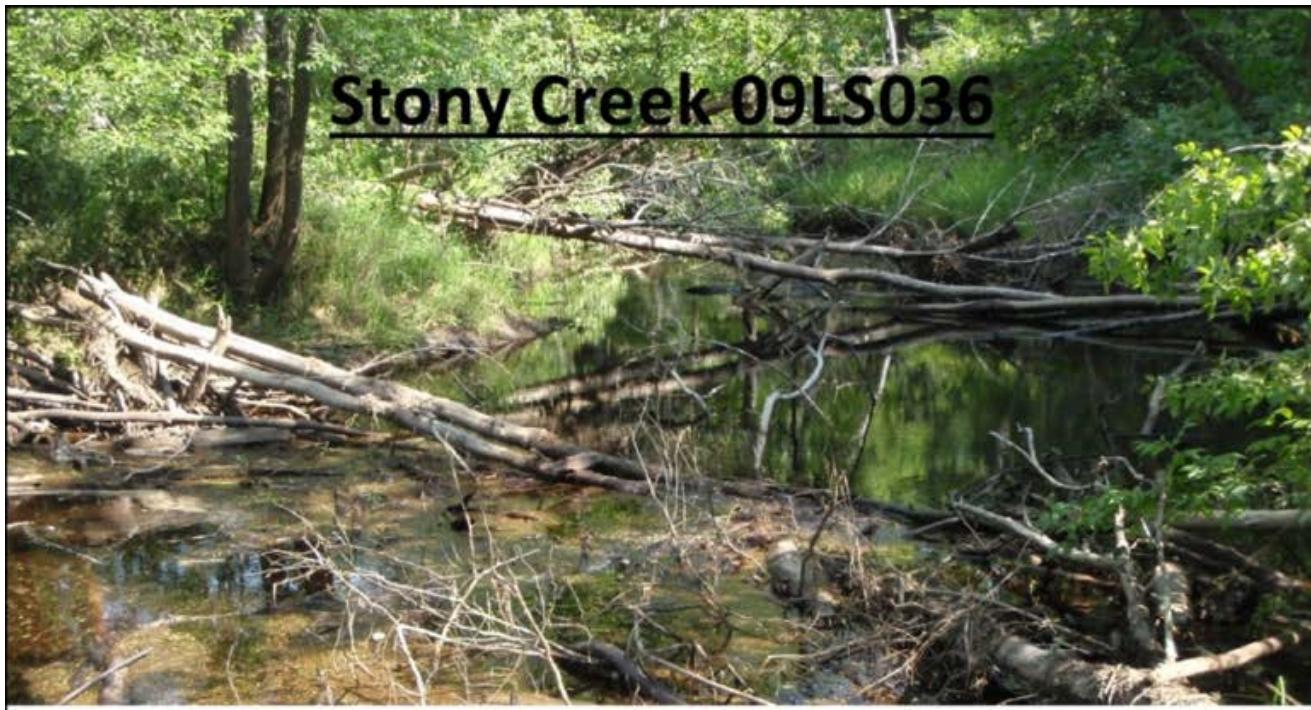
Worksheet 3-10. Pfankuch (1975) channel stability rating procedure, as modified by Rosgen (1996, 2001c, 2006b).

Loca- tion	Key	Category	Excellent		Good		Fair		Poor		Date:										
			Description	Rating	Description	Rating	Description	Rating	Description	Rating											
Upper Banks	1	Landform slope	Bank slope gradient <30%.	2	Bank slope gradient 30-40%.	4	Bank slope gradient 40-60%.	6	Bank slope gradient > 60%.	8											
	2	Mass erosion	No evidence of past or future mass erosion.	3	Inrequent. Mostly healed over. Low future potential.	6	Frequent or large, causing sediment nearly yearlong.	9	Frequent or large, causing sediment nearly yearlong OR imminent danger of same.	12											
	3	Debris jam potential	Essentially absent from immediate channel area.	2	Present, but mostly small twigs and limbs.	4	Moderate to heavy amounts, mostly larger sizes.	6	Moderate to heavy amounts, predominantly larger sizes.	8											
	4	Vegetative bank protection	> 90% plant density. Vigor and variety suggest a deep, dense soil-binding root mass.	3	70-90% density. Fewer species or less vigor suggest less dense or less root mass.	6	> 50% density plus fewer species and less vigor indicating poor, discontinuous and shallow root mass.	9	> 50% density plus fewer species and less vigor indicating poor, discontinuous and shallow root mass.	12

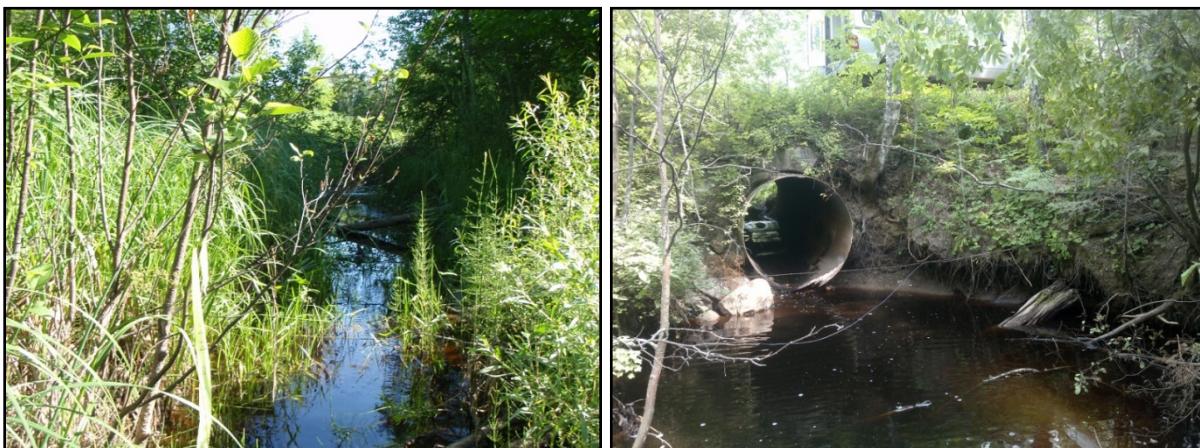
Figure 162: Photos of Unnamed tributary to St. Louis River at County Road 52. Note low flow conditions and possible barrier to fish passage (right).

The lone biological monitoring station (09LS035) located on this impaired unnamed tributary to the St. Louis River has a drainage area of only 4.83 square miles. Even under pristine watershed conditions, a stream of this size which lacks a substantial groundwater component may be prone to periods of low flow during seasonal drought conditions. This particular stream is especially vulnerable given that over 85% of the stream miles in its watershed have been channelized. Essentially 100% of the stream miles upstream of the biological monitoring site have been channelized, as most of the stream length that was left in a natural form is downstream of the impaired biological monitoring station. Several site visits were conducted along the impaired reach in 2011, 2012, 2013, and 2014, and at no point has flow been intermittent. During the mid-summer and fall months, water levels do recede to the point where flows become stagnant, and improperly set and/or old road culverts become barriers to fish passage. The crossing located at St. Louis County Road 52 is one of these low flow barriers (Figure 162).

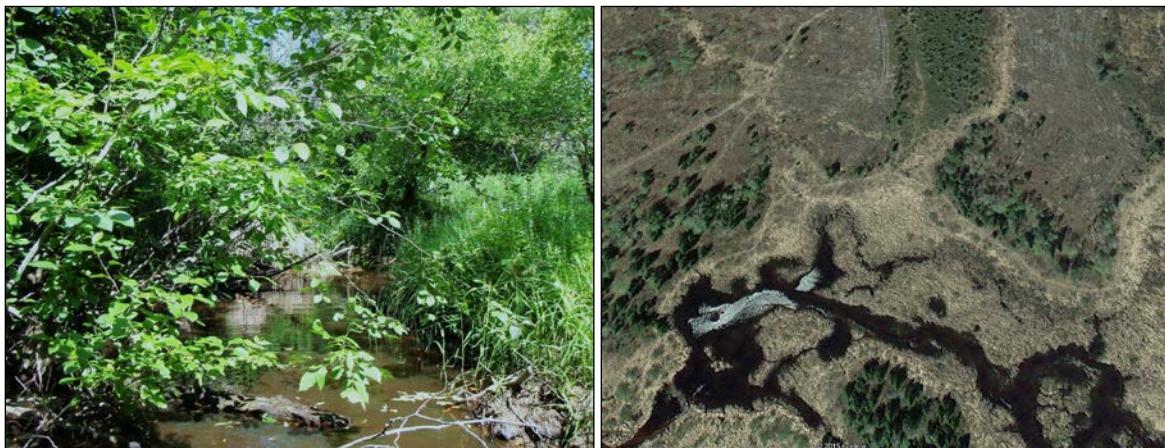
Figure 169: (left) Long grasses and deciduous tree canopies dominate the riparian corridor for Little Swan Creek. (Right) Beaver dams and logging in the headwaters of Little Swan Creek

riparian corridor is rather healthy as well, with moderate amounts of larger trees and long grasses to provide shade for most of the length of the stream (see Figure 169). However, large-scale logging activities are common in the upper part of the watershed (Figure 169), and the underlying geology of the watershed may be unfavorable to groundwater recharge. Additional study would be required to ascertain the impact of ground water recharge (or lack thereof) on the thermal regime of Little Swan Creek.

Another potential source of temperature loading is beaver activity. Using LiDAR profiles and high-resolution aerial photos, six beaver dams were counted on 7.2 miles of Little Swan Creek (0.8 dams/mile). One especially large, approximately 1 meter-high dam in the upper reaches has created a half-mile long impoundment (Figure 169). It is likely that the beaver activity on Little Swan Creek is having a negative impact on stream temperature and making the stream much more susceptible to the ambient atmospheric conditions.

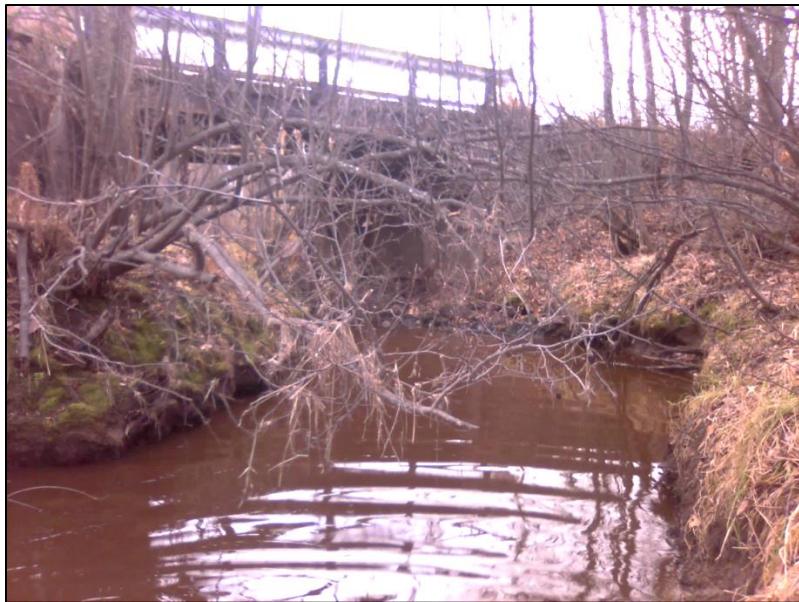
Figure 178: Erosion on both banks and leaning trees are a sign of channel incision in Little Swan Creek

Areas of channel instability and bank erosion were observed at the 09LS062 biological monitoring station (Figure 178) and other road crossings in the watershed. Channel instability in the Little Swan Creek Watershed is likely a consequence of increased peak flows as a result of road ditches or land cover change (forests converted to agriculture), or the result of a local base level drop in East Swan River which caused a headcut to advance up into the Little Swan Creek Watershed. Many reaches in Little Swan Creek show erosion on both sides of the river and vegetation falling into the channel – both are manifestations of channel incision.

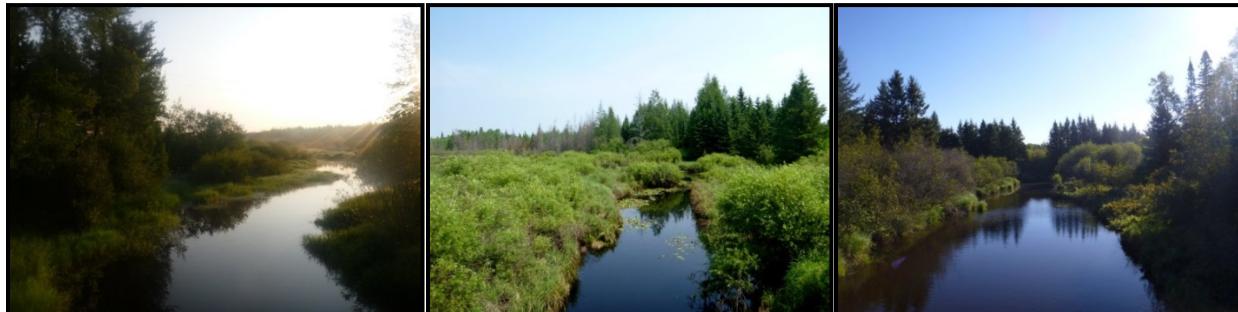
Figure 183: Examples of impaired streams in the Makinen Lakes Watershed zone. Paleface Creek (left), Water Hen Creek (middle), and Water Hen River (right).

Impaired streams in this watershed zone include Water Hen Creek, Water Hen River, and Paleface Creek. All of these streams are low gradient and feature predominantly glide-pool habitats. This watershed zone contains numerous lakes and wetlands, and most of the streams within it are connected to these features. Generally, the lakes of area are in relatively good condition. However, several of the lakes that are hydrologically connected to the impaired streams are impacted by elevated phosphorous concentrations. The outlet of Dinham Lake, which is impaired for excess phosphorous, enters Paleface Creek just upstream from the impaired reach of that stream and nutrient-impaired Long Lake serves as the headwaters of Water Hen River.

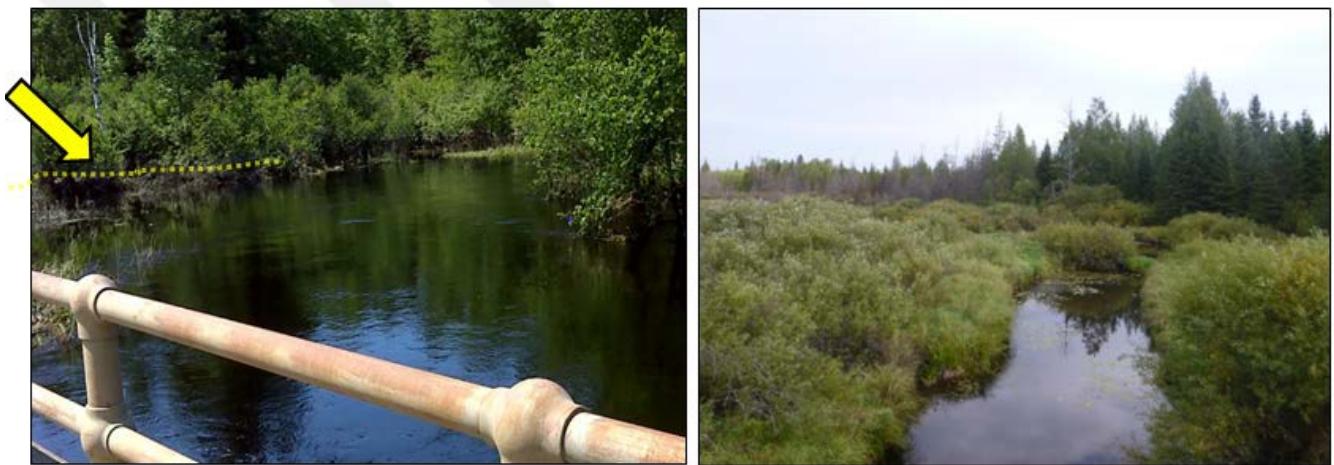
Figure 187: The June 2012 DO profile was conducted during high flows on the falling limb of the hydrograph after the 2012 flood event (left). An additional DO profile was conducted during low flows during September 2012 (right).

The DO concentrations were monitored continuously for a period of several days at the two biological monitoring stations. These continuous DO profiles were collected in June of 2012 immediately after a major rain event dropped 3-6 inches of rain in the Water Hen Creek Watershed, and again in September of 2012 during low flow conditions. Both of the profiles from the June 2012 high flow event show low DO concentrations and minimal DO flux (Figure 187). The September 2012 profile from monitoring station S007-045 is drastically different, as DO concentrations were much higher, and diurnal DO flux exceeded 9.0 mg/L. Diurnal fluctuation in DO concentrations of more than 4 mg/L can negatively impact aquatic macroinvertebrate communities (Heiskary et al 2013).

Despite elevated TP concentrations, DO flux in Water Hen Creek is typically low (0.5 – 2 mg/L), with the exception of the September 2012 DO profile from upper Water Hen Creek (see Figure 187). The tannin stained water of this stream may limit sunlight penetration and reduce primary productivity. Low DO flux in streams with wetland dominated watersheds and tannin stained water is a common observation in the SLRW.

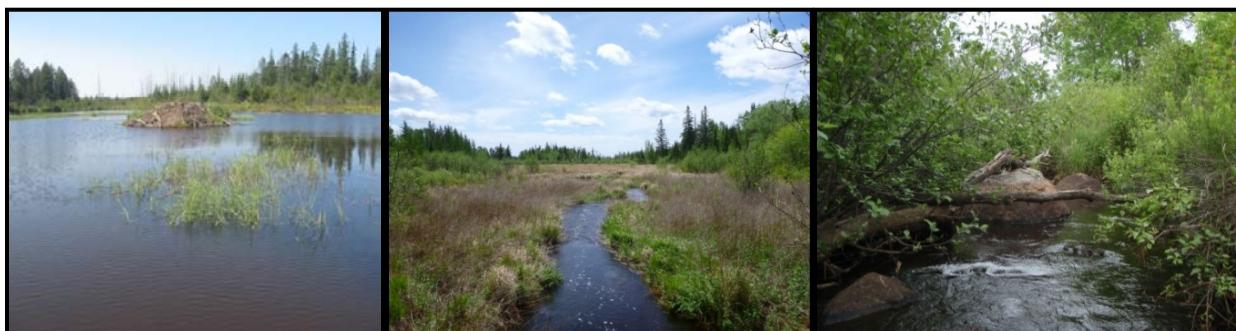
Figure 199: Photos from Wyman Creek showing beaver impoundments and diversity of channel types.

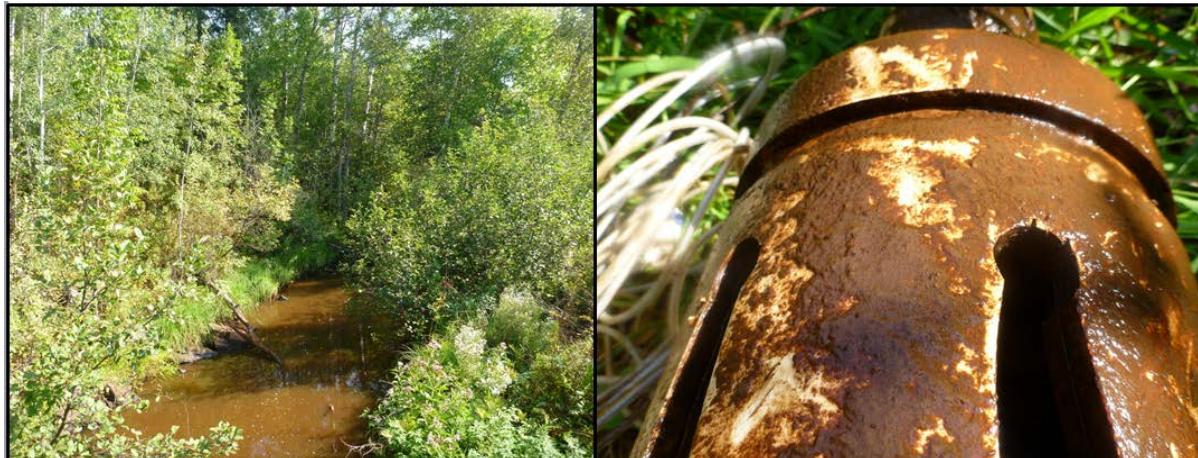
Figure 202: Iron precipitate observed at Wyman Creek biological monitoring station 81LS008 on 9/12/2012. The photo on right shows accumulation of precipitate on a barrel that was deployed in the stream for one week.

wide range of land-uses. Iron precipitates have been routinely observed in Wyman Creek during low flow conditions (Figure 202 and 203).

Iron precipitates have been observed throughout Wyman Creek and in many tributary streams. Water colors darken when this rust-colored orange precipitate forms (Figure 202). The darker appearance of the water under these conditions is likely to soak up more solar heat, particularly where these precipitates form in stagnant, impounded areas behind beaver dams. In addition, there are at least 18 different types of bacteria are classified as “iron bacteria,” which are long, thread-like organisms that “feed” on iron and secrete slime as a bi-product. Unlike most bacteria, which feed on organic matter, iron bacteria fulfill their energy requirements by oxidizing ferrous iron (Fe^{2+}) into ferric iron (Fe^{3+}). Ferric iron (Fe^{3+}) is insoluble and precipitates out of the water as a rust colored deposit. The effect of these iron forming bacteria on DO concentrations is not known, but it is possible that oxygen is consumed as iron bacteria form in this stream.

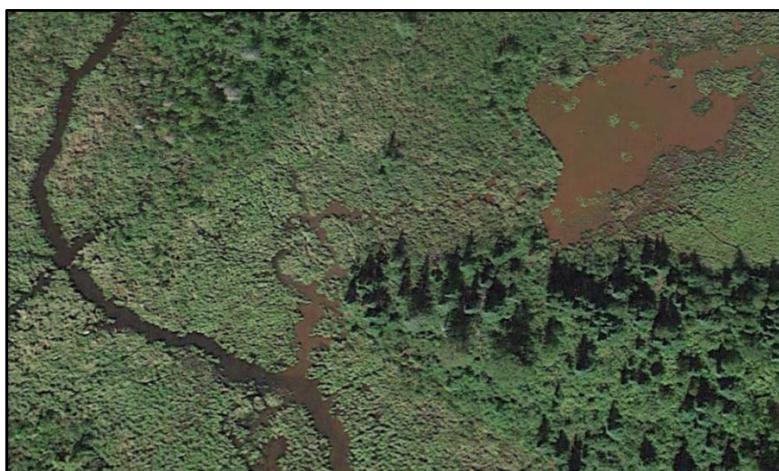
Figure 203: Iron precipitate (Fe^{3+}) rust colored water on upper right) forming in tributary stream to Wyman Creek. This particular stream has no upstream mining impacts, which is evidence that natural conditions in the watershed are favorable for the formation of Fe^{3+} .

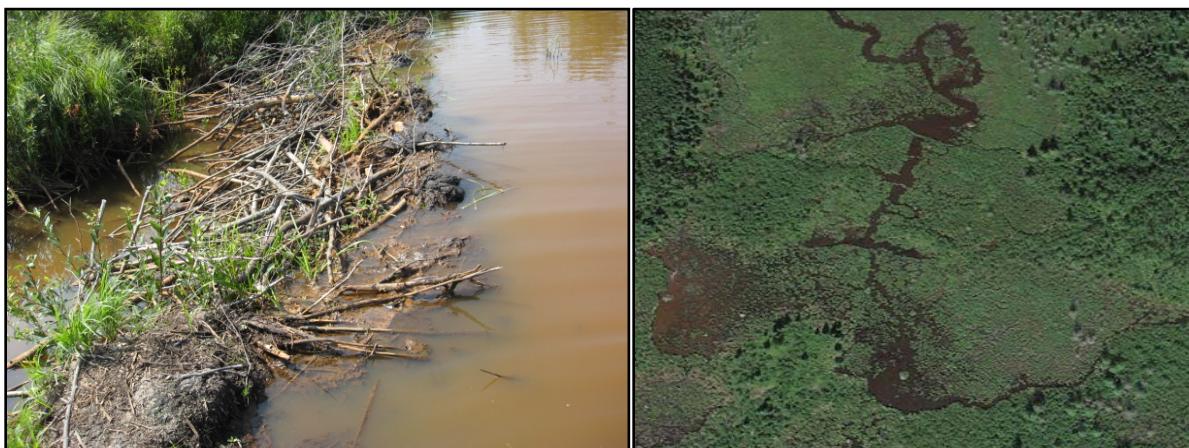
Figure 208: An example of a large beaver dam and the turbid water typical throughout Wyman Creek.

The Wyman Creek Watershed contains several possible sources of temperature loading, with two prominent potential sources being mine pits and beaver dams. Both impede water flow and increase the surface area available for the stream to absorb solar energy. Beaver dams have the added effect of flooding and killing riparian forests so that even when the beaver dams breach, the shading that used to be provided by the canopy trees is removed. The silt, clay and other organic matter deposited behind beaver dams is also easily re-suspended by wildlife, darkening the water and aiding in heat absorption (Figure 208). The absence of Brook Trout in the most recent fisheries surveys may be in part due to an increase in beaver activity. Historic photos of the watershed indicate a large increase in beaver activity in the last ~25 years. Current beaver dam density is 3.4 dams per mile, while in 1991; the density was 1.6 dams per mile (counted from Google Earth historic imagery).

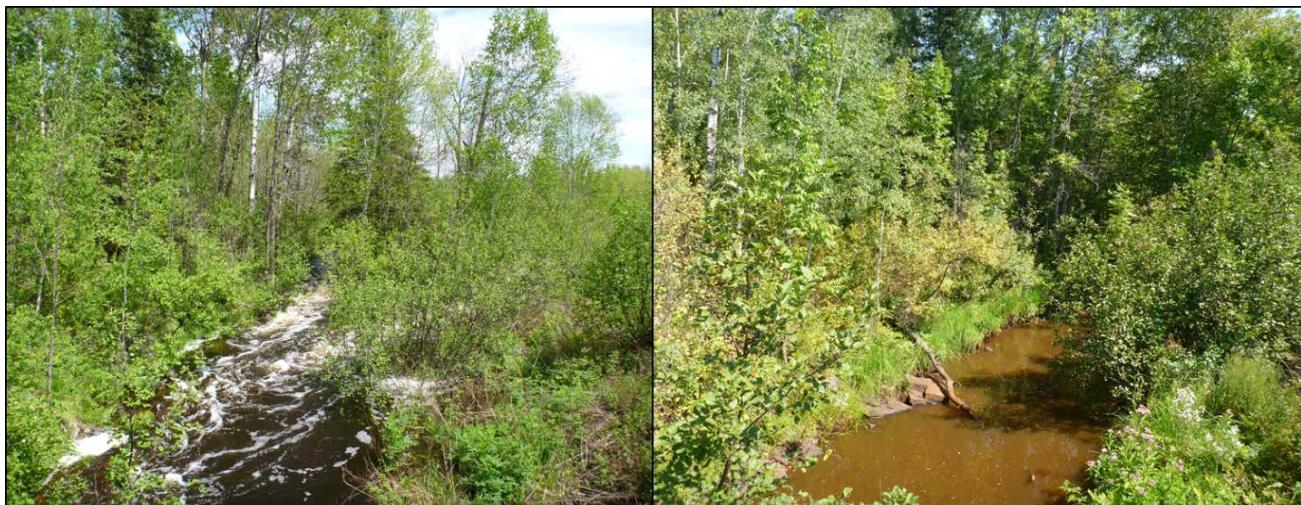
Figure 217: Wyman Creek after a May 2012 rain event (left) and during August 2012 at low flow, showing iron precipitate (right)

Visual observations suggest that there is some seasonal variation in the amount of TSS in Wyman Creek. During snowmelt and heavy rain events the stream runs stained yet relatively clear, but during summer and fall low flows the stream appears turbid. This suggests that bank erosion and overland flow are not significant sources of suspended solids in this watershed. During low flows, iron precipitate is frequently observed and the stream appears turbid. This hypothesis is supported by the limited TSS and Secchi Tube data for Wyman Creek. It seems that there is a slight rise in suspended solids during snowmelt, but the maximum amount of suspended solids (and minimum transparency) in Wyman Creek does not occur until August. It should be noted that this is based on a small sample size (n=6) and more sampling is recommended to expand on these observations.

Iron precipitate has frequently been observed in the lower reaches of Wyman Creek during low flow periods in the summer and fall (see Figure 217). The water chemistry and hydrological processes involved with the formation of iron precipitate are discussed in detail in [Section 3.1.11](#). Elevated TSS concentrations and lower transparency values were observed during several late summer and early fall visits when iron precipitates were present.

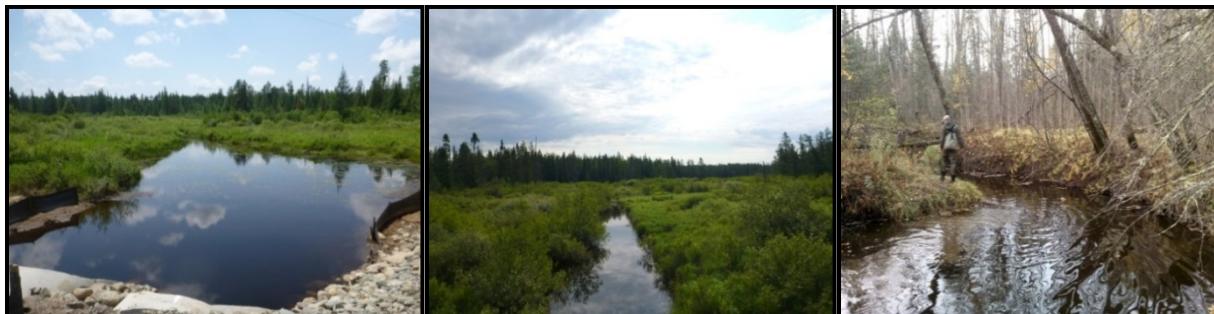
Figure 223: Typical stream reaches of the three impaired streams in this watershed zone. Spring Mine Creek (left), Embarrass River (middle), Ely Creek (right)

Impaired streams of this watershed zone include Spring Mine Creek, Ely Creek, and the headwaters reach of the Embarrass River. These impaired segments of these streams share similar natural background qualities in that they are relatively low in gradient, moderately sinuous, and have broad floodplains with wetland qualities. Beaver dams are common features in all three of these streams, and these impoundments appear to have a significant effect on channel pattern, in-stream habitat, and water surface slope. Physical habitat conditions in these streams are somewhat limited due to the lack of riffle-run features and an abundance of fine substrates. Mining activity in this watershed zone introduces the potential for point-source pollution as a stressor, particularly in the case of Spring Mine Creek, which originates from a mine pit high atop Giants Ridge.

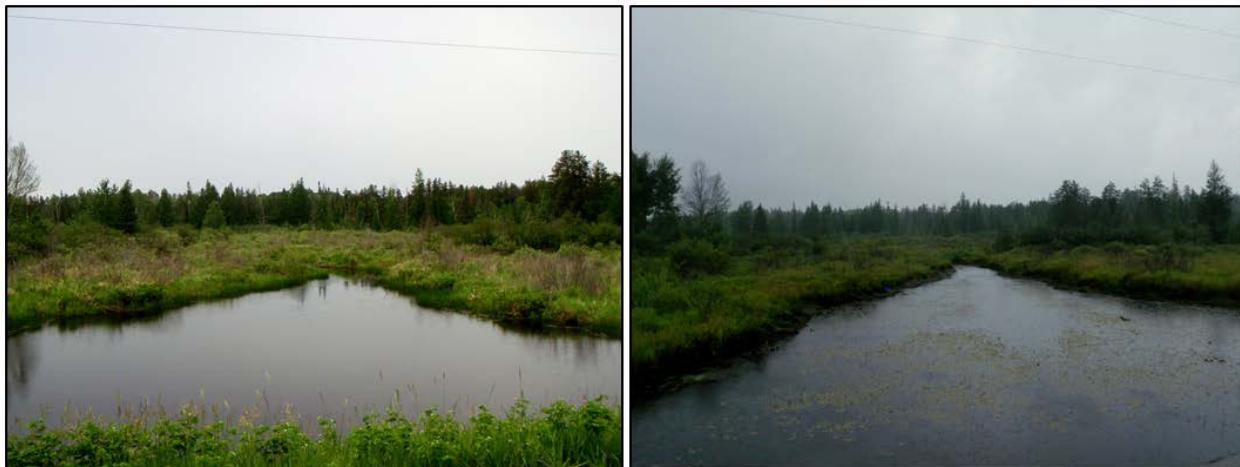
Figure 228: Photos of station 09LS101 looking upstream. Photo on the left was taken in June of 2009, and the photo on the right was taken in August 2009. Note the increase in floating leaf and emergent vegetation in the August 2009 photo.

The DO regime of Spring Mine Creek is likely influenced seasonally by the presence of submergent, emergent, and floating leaf aquatic vegetation. During site visits to station 09LS101, aquatic vegetation was generally present but somewhat sparse in the spring and early summer months. By August and September, a significant portion of the channel was typically covered by these vegetation types (Figure 228). As the amount of aquatic vegetation increases, DO flux generally increases as well due to photosynthesis and respiration process within the plant community. The elevated DO flux observed in Spring Mine Creek in August of 2011 may be linked to the increase in vegetation observed within the stream channel.

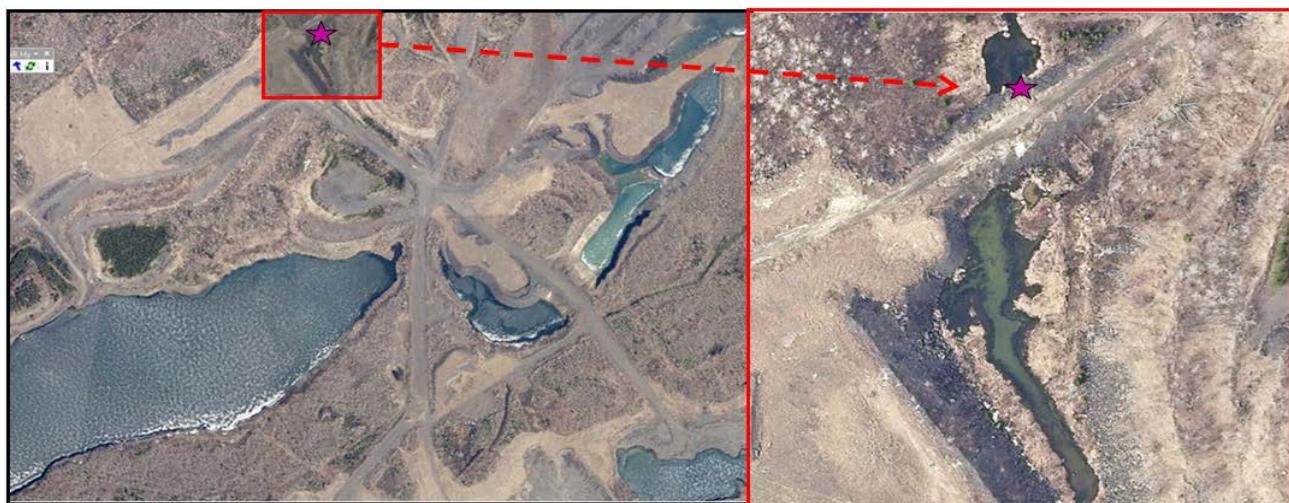
★ Point of continuous discharge to Spring Mine Creek

Figure 241: The headwaters of Spring Mine Creek are formed by a continuous discharge from a series of abandoned mine pits.

Monitoring data available per the requirements of NPDES permit MN0042536-SD-33 provide documentation of the quantity and quality of water being discharged to Spring Mine Creek at its headwaters. The location of this monitoring site (shown in Figure 241) is several hundred feet

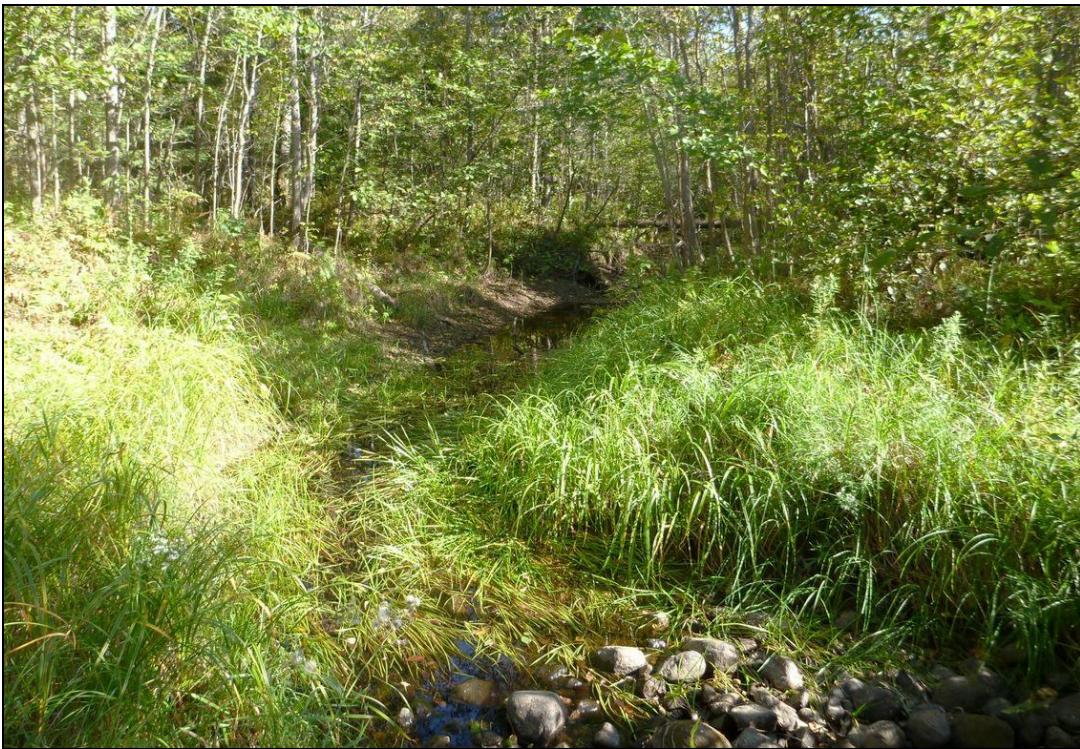
Figure 248: Low flow conditions at station S005-749 on September 13, 2012 (looking upstream). Continuous DO measurements revealed significantly lower DO concentration during this dry period.

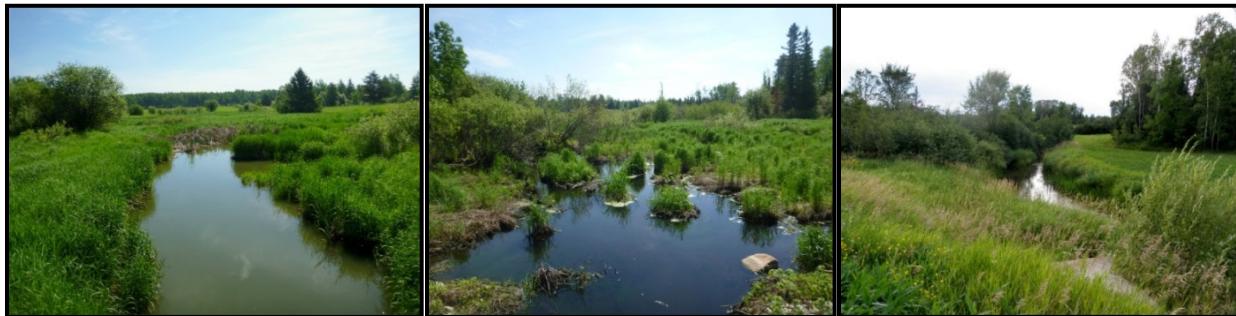
Figure 256: Photos from impaired stream segments in this watershed zone. Manganika Creek (left), Upper Elbow Creek (middle), and lower Elbow Creek (right).

Biological impairment listings within the Virginia Mesabi Range (VIR) Watershed zone include two segments of Elbow Creek and the outlet stream of Manganika Lake (Manganika Creek), which is a very short tributary to the East Two River. The watersheds of these two streams have been dramatically altered due to mining land-uses. While Elbow Creek still remains a free-flowing stream has retained most of its original length, much of the stream is channelized and routed around a series of mine pits and waste rock stockpiles. It flows through nutrient-impaired Elbow Lake at its mid-point before joining the St. Louis River near the town of Forbes. Elbow Creek has historically received dewatering flow from abandoned mine pits, and is currently the receiving water for the city of Eveleth's WWTP effluent.

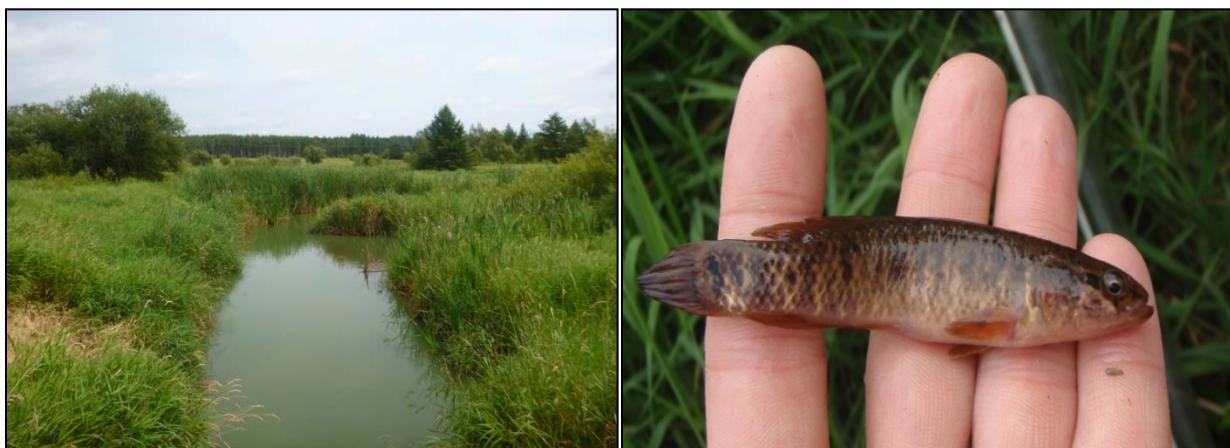
Figure 258: Significant algae blooms originating in Manganika Lake cause oxygen depletion and increased suspended solids in Manganika Creek (left photo). Central Mudminnow (*Umbra limi*), which can survive in anoxic conditions in streams and lakes, were the most abundant fish species at station 09LS078 (right photo).

Anderson, MPCA, personal communication). The photo in Figure 258 provides an example of an algae bloom in this system. The DO regime of Manganika Creek is heavily influenced by the biological and chemical processes taking place in Manganika Lake just upstream.

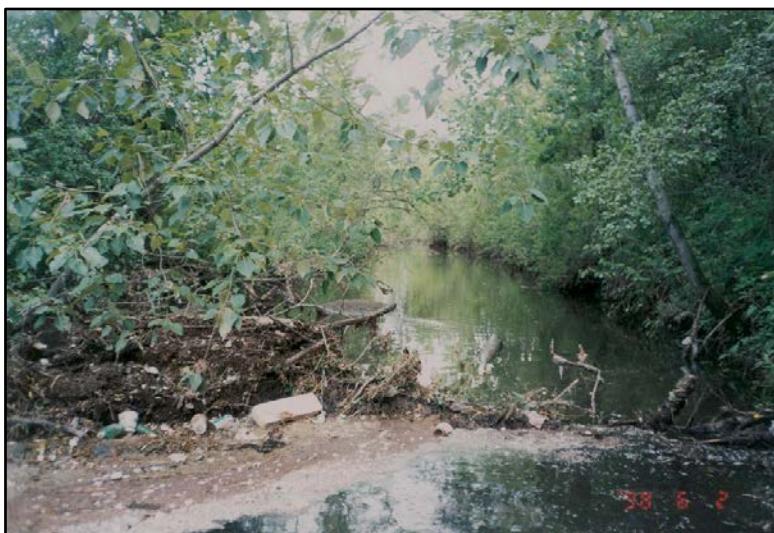
Figure 262: Photo of biological monitoring station 98LS015, located above Manganika Lake. This stream is channelized through this reach, and flows are stagnant and DO conditions are very marginal. All of the fish observed at this monitoring station were highly tolerant of low DO concentrations.

Central Mudminnow and Brook Stickleback were the only two fish species observed at the station upstream of Manganika Lake (98LS015). Both of these species are highly tolerant of low DO conditions. Fish community DO TIV results from this station were even lower than those observed at station 09LS078. Overall, the fish community of Manganika Creek both above and below the lake is symptomatic of a system that is stressed due to low DO concentrations.

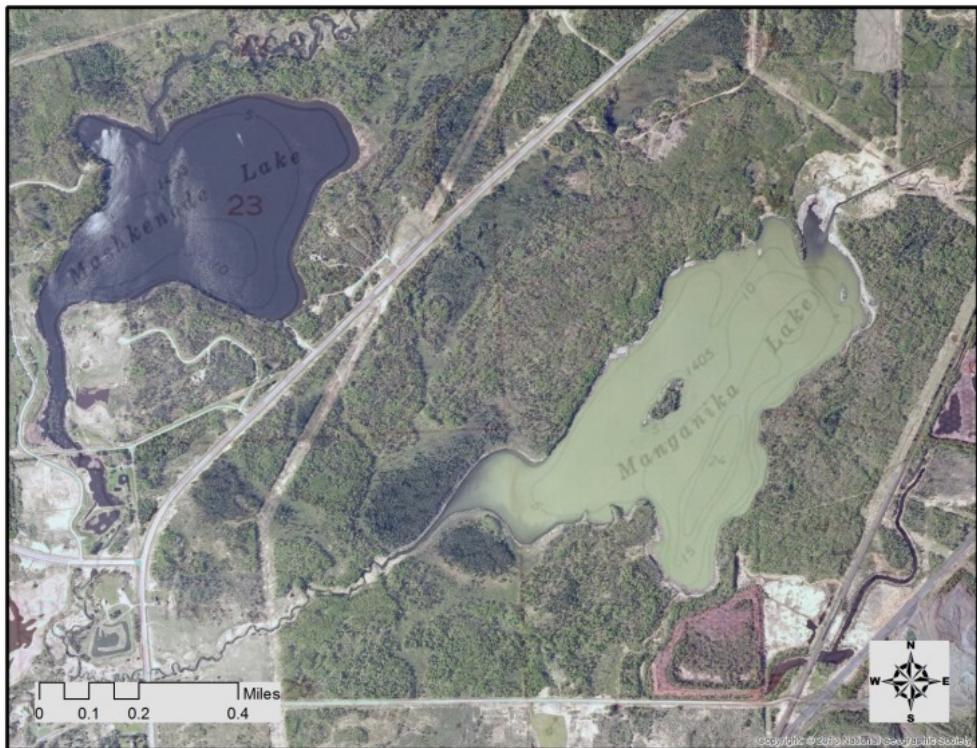
Figure 270: Algal bloom on Manganika Lake

The impaired reach originates from Manganika Lake, which is highly eutrophic and listed as impaired for high nutrient concentrations. Significant algal blooms are common in Manganika Lake throughout much of the year (see Figure 270), and the impaired reach of Manganika Creek closely mirrors the condition of its source. The majority of the TSS in Manganika Creek are volatile solids (algae) flowing out of Manganika Lake. Very little suspended sediment has been observed within the impaired reach, and there are no visible signs of streambank instability or other sediment sources downstream of the lake.

The lack of a precise mechanism for TSS to negatively affect macroinvertebrates weakens the case for this candidate stressor. The elevated TSS concentrations observed in Manganika Creek are driven by volatile solids (algae blooms) as opposed to suspended inorganic particles (sand/silt). The major pathways for TSS to harm to invertebrates are through abrasion, clogging of filtering mechanisms, and habitat degradation from suspended sediments settling out on the stream bottom. As a result, it is difficult to directly link the poor MIBI scores to the elevated TSS concentrations in this stream. There are obvious connections between the algae blooms, elevated TSS concentrations, and poor DO conditions that impact both fish and macroinvertebrate populations.

Water chemistry and biological data provide adequate evidence to diagnose elevated TSS and turbidity as a stressor to aquatic life in Manganika Creek. Efforts to improve the conditions of Manganika Lake will have the added benefit of providing better water quality for the fish and macroinvertebrate populations in this impaired stream.

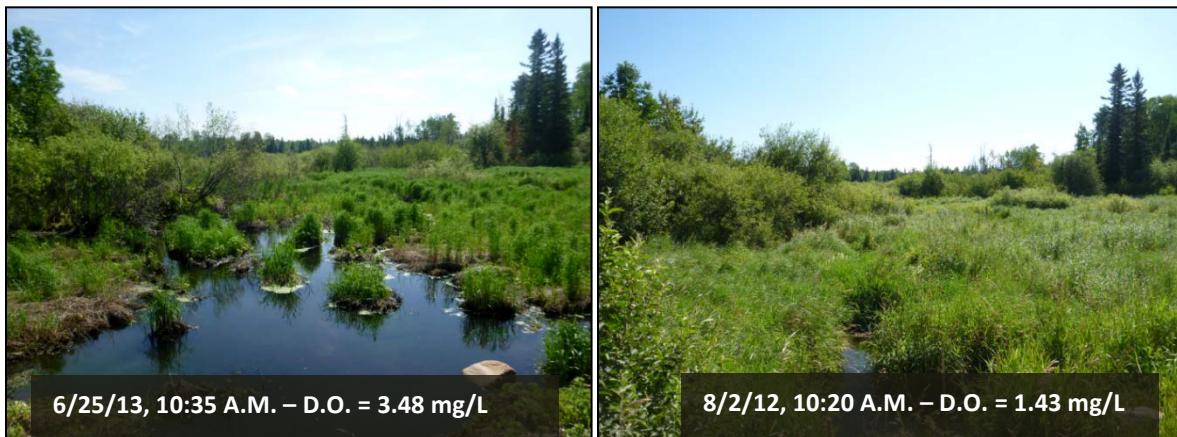
Figure 280: Photos of biological station 09LS082 showing low flow conditions and wetland dominated riparian corridor

The fish impairment on Elbow Creek is limited to a reach upstream of Elbow Lake (pictured in Figure 280). Fish survey results from this reach show an assemblage dominated by Brook Stickleback, Northern Redbelly Dace, Central Mudminnow, and Fathead Minnow. These species are commonly found in streams with wetland qualities and are all at least somewhat tolerant of low DO conditions. The Fathead Minnow is considered a “pioneer species,” which means they are highly adaptable to streams that are

Wetlands are a prominent feature of the riparian corridor of Elbow Creek upstream of impaired biological monitoring station 09LS082. Although riparian wetlands are beneficial for stream health in many ways (maintaining channel stability, filtering sediment and pollutants from runoff, streamflow regulation), they can also deliver oxygen depleted, nutrient rich water to nearby streams (Bourdagh, 2013). Beaver dams in amongst these wetland dominated areas have the potential to further lower DO concentrations by reducing or eliminating streamflow and reducing capacity to transport organic sediment. Numerous beaver dams were observed upstream of station 09LS082, including a large dam that currently creates an impoundment with an area of approximately 12 acres (Figure 281). The presence of beaver dams and riparian wetlands are likely contributing to the low DO concentrations observed at station 09LS082.

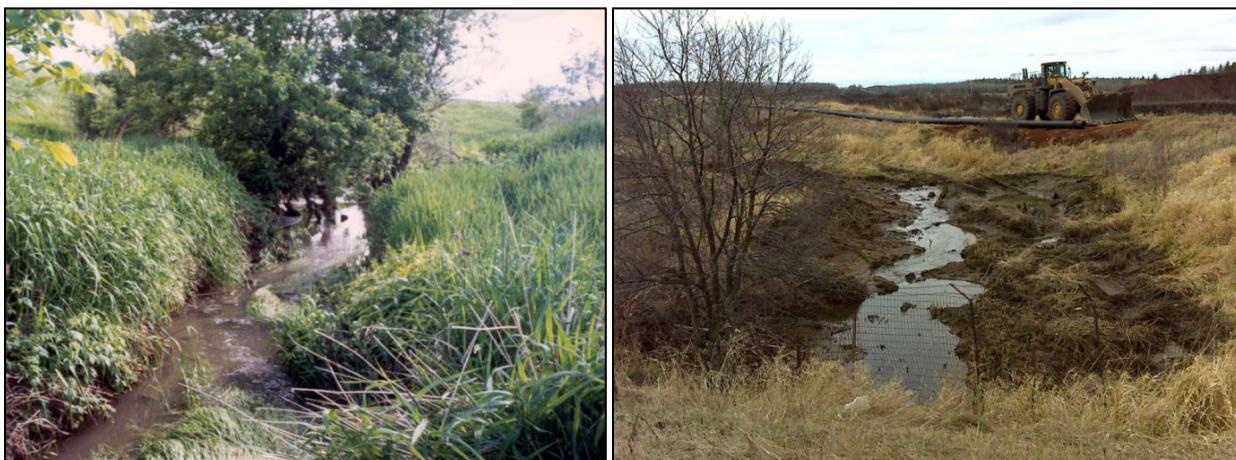
Figure 298: Elbow Creek just downstream of the Eveleth WWTP outfall, looking upstream from CR 101 (left) and downstream of CR 101 (right).

The Eveleth WWTP currently discharges to Elbow Creek via an NPDES permit which requires regular effluent monitoring for various parameters, including flow and nitrate nitrogen. Data for these parameters are only available for the 2013 and 2014 calendar years. The monitoring results show an average effluent discharge from the WWTP of roughly 0.4 million gallons per day (mgd), which equates to about 0.6 cubic feet per second (cfs) of continuous discharge entering Elbow Creek. Calendar month maximum discharges are roughly 0.9 cfs on average, and have been recorded as high as 1.5 cfs (May 2014). Sampling for nitrate + nitrite (nitrate) is reported as a “calendar month average” in the data report from the WWTP. Data are only available for April and September for both 2013 and 2014. The results for the April sampling range from 4.8 to 5.0 mg/L, while the September results are significantly higher, ranging from 9.3 to 15.0 mg/L.

These results confirm that WWTP effluent is the primary driver of elevated nitrate levels in the upper reaches of Elbow Creek. Although the overall volume of effluent is rather small, nitrate concentrations in the effluent are elevated enough to be a concern for the protection of sensitive aquatic biota. Streamflow data are not available for this reach, and therefore the percentage of baseflow that can be attributed to WWTP effluent cannot be accurately calculated. The drainage area of station 98LS016 is less than 2 square miles and baseflow is estimated to be 1-2 cfs based on visual estimates made during site visits. Based on the elevated nitrate levels and the low flow conditions observed in this reach, it can be concluded that effluent from the WWTP has a significant impact on the quantity and quality of water in the headwaters of Elbow Creek.

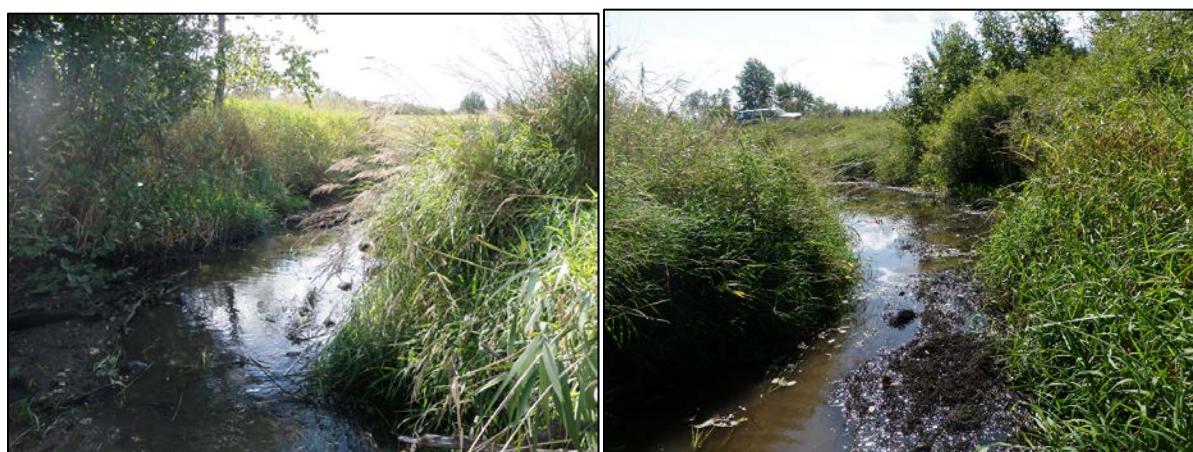
Figure 305: Wide, shallow riffle at 09LS081 (left) and low gradient, stagnant conditions near the culvert at HWY 16 within station 09LS081

The MSHA scores for the “channel stability” metric also provide some evidence of habitat degradation at station 09LS081. The 2011 assessment categorized the stream channel as moderately unstable due to some areas of minor bank erosion. Areas of the stream channel also appear to be incising (downcutting) and widening based on photographs collected within the biological monitoring reach. Figure 305 shows

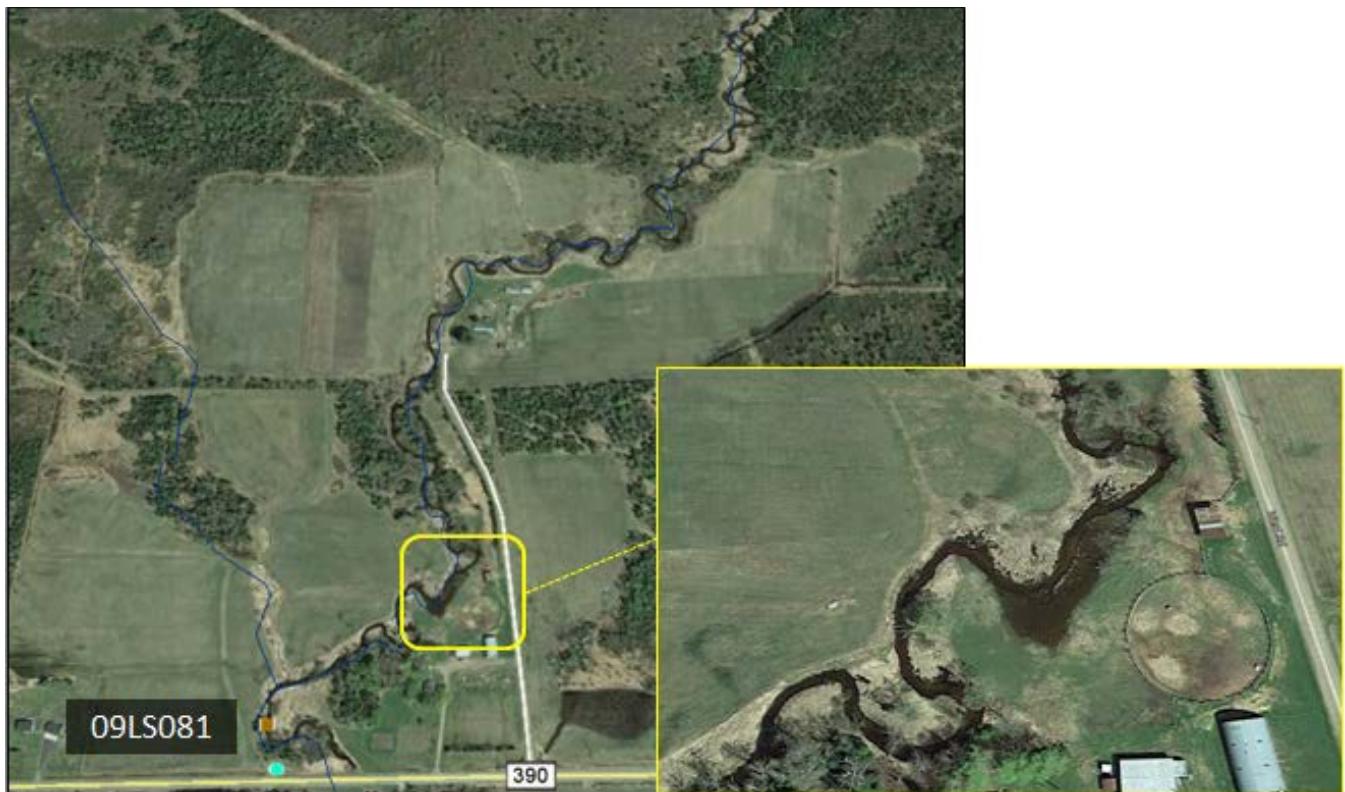
Figure 306: Aerial photo of landscape around station 09LS081. Hay/pasture lands border this monitoring station and along the stream corridor for approximately $\frac{1}{2}$ mile upstream. Riparian buffer conditions are fairly poor along the biological monitoring reach (inset photo on right).

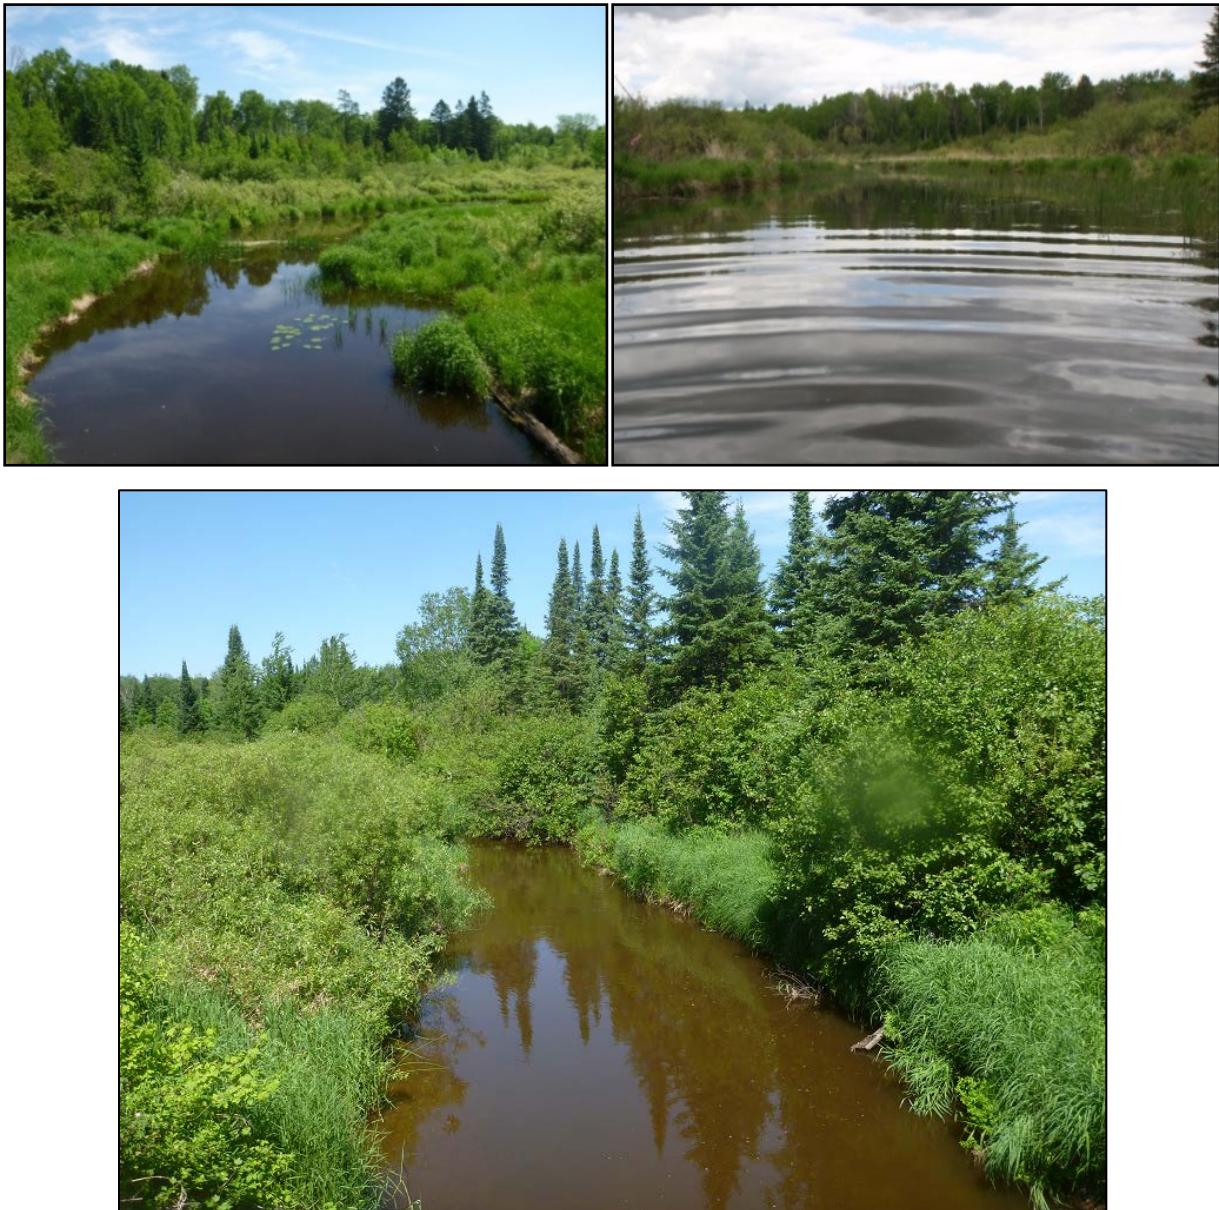
Figure 308: Photos of impaired stream reaches in the West Two McQuade Moraines Watershed zone. West Two River (upper left and upper right) and Unnamed Tributary to McQuade Lake (a.k.a. "Kinney Creek") (below)

This watershed zone includes two impaired streams, the West Two River below West Two Reservoir, and a tributary to McQuade Lake (Kinney Creek). West Two Reservoir was created in 1964 by U.S. Steel Company and is now listed as impaired for elevated nutrient concentrations. The impoundment is currently permitted to release a minimum of 3 cubic feet per second (cfs) of streamflow into the impaired reach of the West Two River. Headwaters streams in both of these watersheds have been removed or reduced due to the presence of mining land-use. The loss of these headwaters streams, as well as current mine-pit dewatering and impounded reservoirs, has altered the hydrological regime of these streams from their natural state.
