St. Louis River Watershed Stressor Identification Report

A study of local stressors causing degraded fish and aquatic macroinvertebrate communities in the St. Louis River Watershed

Minnesota Pollution Control Agency

December 2016

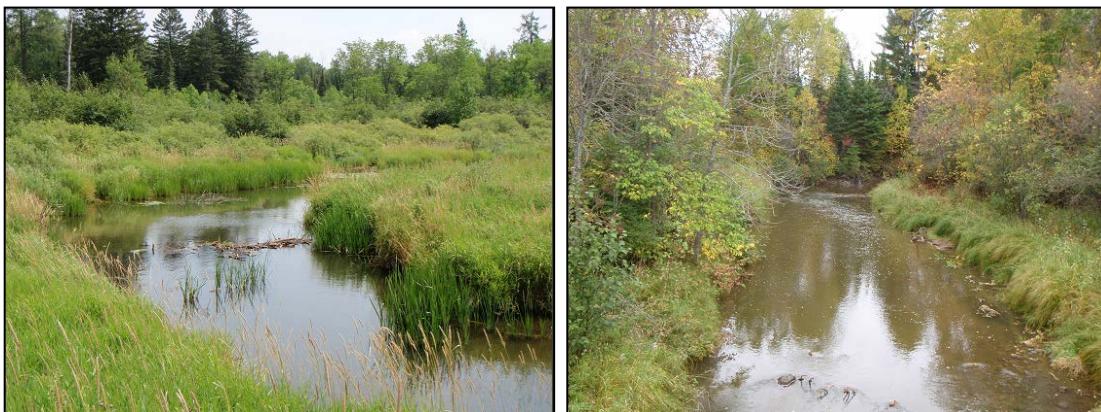
Continuous monitoring equipment was deployed at two biological monitoring stations, 09LS075 and 09LS073, during low flow conditions in 2012 and 2013. Based on the resulting DO profiles, it is clear that the DO regime at these two monitoring stations is drastically different in terms of both minimum DO concentrations and DO flux (Figure 312, 313). Just downstream from West Two Reservoir at station 09LS075, maximum DO flux observed during continuous monitoring ranged from 7.5 to 11 mg/L, and minimum DO concentrations dropped below the 5 mg/L water quality standard on a daily basis. Approximately 11 miles downstream at station 09LS073, maximum DO flux observed was less than 2 mg/L, and the DO minimums were all well above the water quality standard. A comparison of DO flux between the two monitoring stations is shown in Figure 311. Proximity to the eutrophic West Two Reservoir, higher water temperatures, and abundance of aquatic macrophytes are all factors that are likely resulting in higher DO flux at station 09LS075.

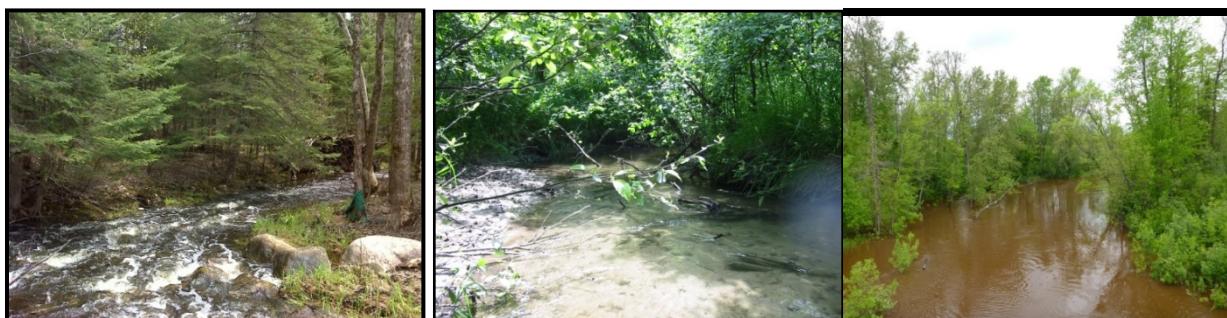
Figure 334: Photos of impaired stream sections in the Swan River - Hibbing Watershed zone. East Swan Creek (left and middle), Swan River (right)

Impaired streams within this watershed zone include East Swan Creek, a designated trout stream south of the city of Hibbing, and a main stem reach of the Swan River, just above its confluence with the St. Louis River. Portions of this watershed zone have been highly modified due to urban development and mining activities. Many of the streams in this region of the SLRW receive effluent from municipal WWTP and abandoned iron ore mining pits. Urban impacts, such as an increase in impervious surfaces, stream channelization, and pollutants from road runoff also need to be considered as potential stressors in this watershed zone. Elevated turbidity and TSS concentrations are also known problems in several streams in this region. These potential stressors will be covered in detail in the analysis and discussion of these impaired streams.

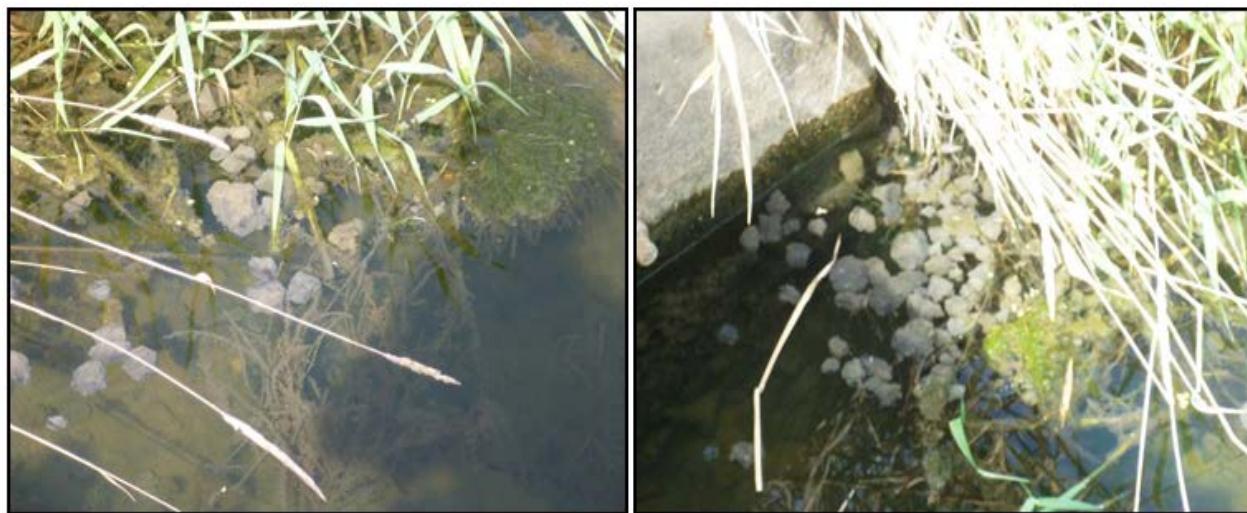
Figure 347: Signs of untreated wastewater in East Swan Creek observed at CR 16 (Town Line Rd.) in August of 2012

In February of 2014, several samples were collected in a longitudinal pattern along East Swan Creek to identify potential sources and pathways of nitrate within the watershed. Four stations were sampled in the lower half of the watershed where elevated nitrate concentrations had been previously observed. Two of these stations, S007-951 and S007-599 were specifically chosen to bracket the location where effluent from the Hibbing WWTP enters East Swan Creek (see map in Figure 349). The results of the longitudinal sampling clearly show that effluent from the WWTP is the primary source of nitrate entering East Swan Creek. Results from the stations above and below the WWTP outfall show an increase from < 0.05 mg/L above the discharge point to 13 mg/L immediately downstream of the discharge. Approximately 2.5 miles downstream from the WWTP discharge at station S000-589, nitrate concentrations were even higher (18 mg/L). Additional sources of nitrate between the WWTP and this station are unknown. The increase in nitrate concentrations between these two stations may be the result of in-stream nitrification processes. At station S000-598, 3.3 miles downstream of the WWTP discharge, nitrate concentrations decreased slightly to 12 mg/L.

During extreme low flow conditions, effluent discharge from the WWTP accounts for a large portion of the flow in East Swan Creek. Upstream of the WWTP, flows are generally <1 cubic feet per second (cfs) during baseflow periods, which was the case during the February 2014 longitudinal sampling event and other visits to East Swan Creek in late summer or early fall months. Based on permitting reports from the Hibbing WWTP, average discharge rates to East Swan Creek are in the range of 4-5 cfs for most of the year. In wet periods, such as spring snowmelt or large rain events, discharge to the creek can

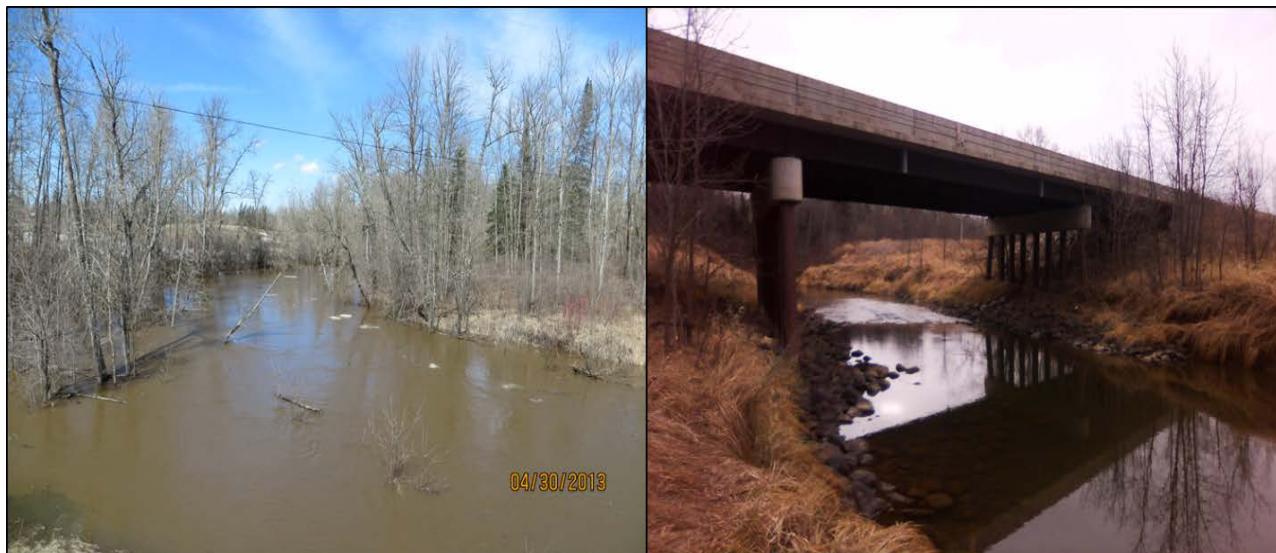
Figure 353: Turbid conditions (high TSS) in Swan River during snowmelt (left) and its clear appearance at low flow (right)

Elevated TSS concentrations in the Swan River are directly and positively related to discharge. Snowmelt runoff and large rain events result in extremely turbid conditions, but during low flow periods, the Swan River is fairly clear and tannin stained (Figure 353). A plot of all Swan River TSS results by month shows a distinct trend of higher TSS values from April to June, when stream flows tend to be higher as a result of snowmelt events and spring rains that fall on saturated ground (Figure 356 and 357). From July to October TSS in the Swan River maintain consistently low levels and regularly meet the draft 15 mg/L warmwater standard.

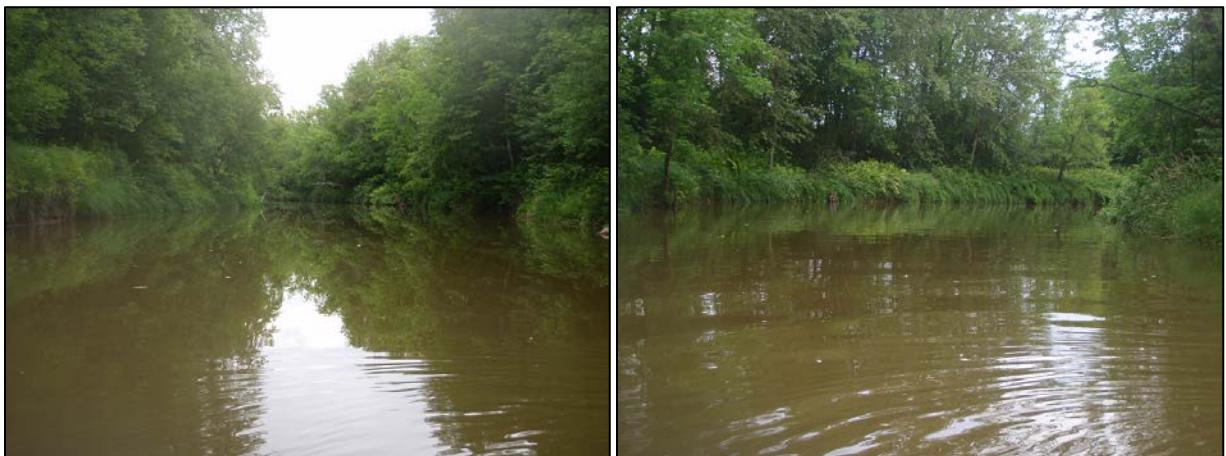
Figure 361: Photos from station 09LS061 on the Swan River. Note the lack of cover for fish and the lack of riffle and glide features.

Stream habitat conditions in the Swan River were evaluated using the MSHA semi-quantitative protocols developed by the MPCA's biological monitoring unit (source). MSHA results from a 2009 assessment of the Swan River at station 09LS061 resulted in score of 62.2 out of 100, which corresponds to a "fair" narrative score. The surrounding land use, riparian zone, and substrate of the stream are in fairly good shape and did not significantly affect the overall habitat score, combining for 35.2 out of a possible 47 points. The cover elements in the channel are somewhat limited and produced lower scores than high quality reference streams (Figure 362). Specific cover types that were lacking include undercut banks, boulders, rootwads, large woody cover, and aquatic vegetation. Scores were also relatively low in the channel morphology category, with poor channel stability, channel development, and velocity ratings.

The PSI was also used to evaluate physical habitat and stream channel stability in the Swan River. The PSI scores for station 09LS061 portray a marginally more unstable channel than the MSHA assessment results. The overall PSI score of 92 corresponds to a stability rating of "moderately unstable" for the potential C5 stream type. Characteristics such as bank erosion, pool filling, and loose bottom sediments were common at this site, and are typical of a slightly incised channel. It is possible that the consequences of channel instability are causing habitat degradation in the Swan River. For more information on channel instability in the Swan River Watershed, see Appendix X (Swan River geomorphic study).

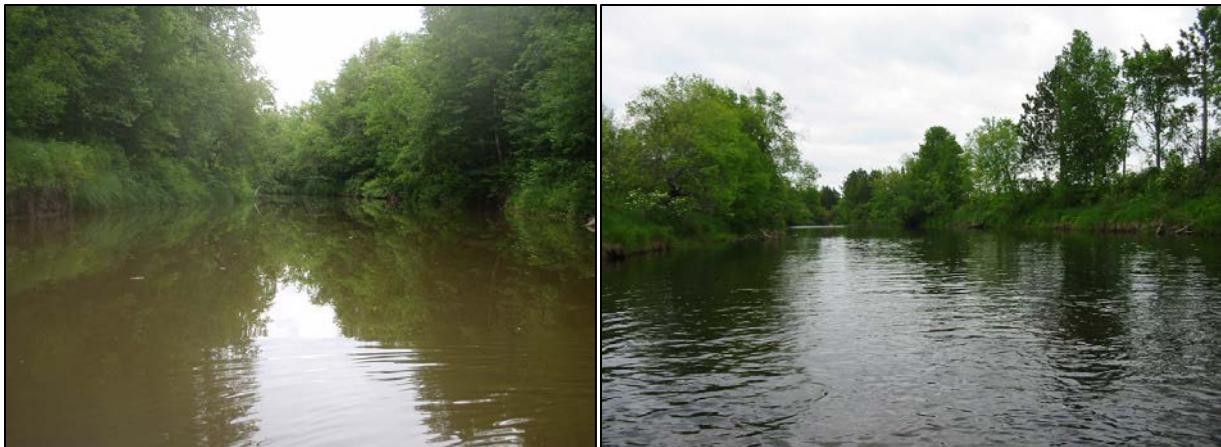
Figure 363: Station 09LS061 on the impaired reach of the Swan River (left) compared to station 09LS051 on the Whiteface River, which had exceptional FIBI scores. Note similar habitat features but poorer WQ conditions in the impaired reach of the Swan River on left.

However, there are some streams in the region with good to excellent FIBI scores that possess very similar physical habitat conditions to the lower Swan River. Station 09LS051 on the Whiteface River (shown in Figure 363), which is close in proximity to the Swan River and has a similar morphological setting, produced FIBI results well above the UCL of the standard despite having a slightly poorer overall MSHA result and comparable metric scores related to channel morphology and fish cover. According to the MSHA results, substrate conditions were somewhat more favorable at the Whiteface River station, and water chemistry results show no indication of the TSS and turbidity issues that plague the Swan River system. Overall conditions are likely more favorable in the Whiteface River, but in terms of physical habitat, there are quite a few similarities to the lower Swan River.

We recommend including physical habitat as a stressor in the lower Swan River. Water quality conditions in the Swan River (esp. elevated TSS concentrations) may be a higher priority stressor with more direct effects on the biota, but the physical habitat conditions within the impaired reach are also contributing to low IBI scores.
