## Stressor Identification Update

# Nemadji River Watershed

Lake Superior Basin, Cycle 2

July 2026

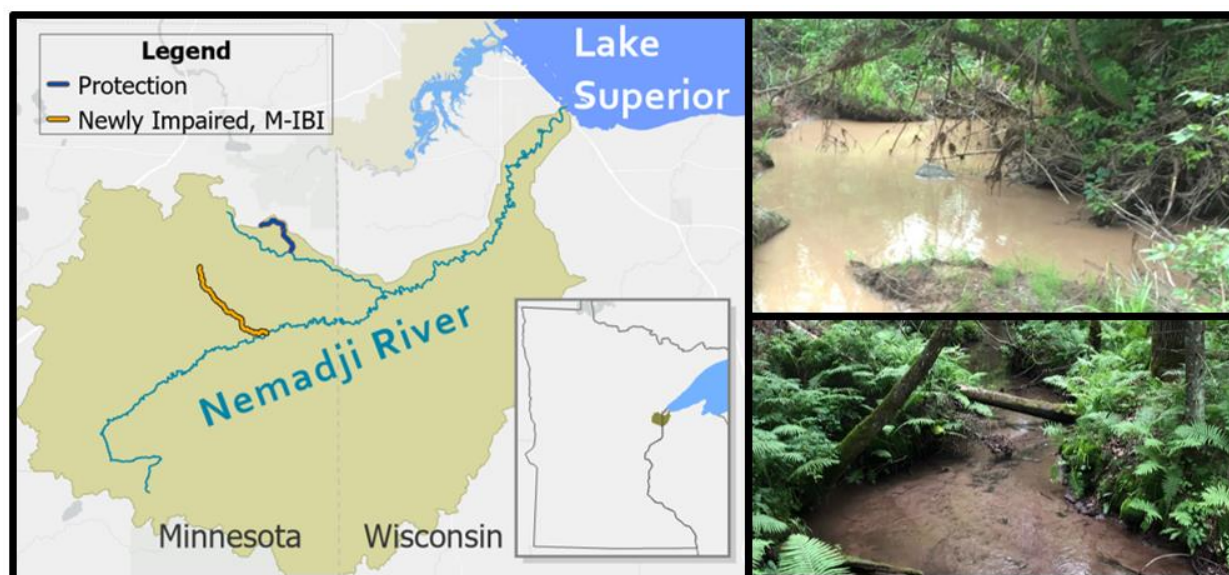
**Figure 1. Map of Nemadji River Watershed (left) identifies SID focus streams based on protection and new impaired waters designations. Deer Creek (top right) has a new impairment designation for macroinvertebrates and Military Creek (bottom right) is highlighted for protection of high-quality waters.**

Accordingly, SID and protection-based monitoring in the Nemadji River Watershed (Figure 1) focused on a few select subwatersheds. Focus subwatersheds were chosen based on the results of assessment-level water chemistry and biological monitoring completed between 2014 and 2023. The primary focus watershed, Deer Creek, was selected because the macroinvertebrate community did not meet criteria set for a healthy Northern Coldwater stream. The other focus watershed, Military Creek (a tributary to Clear Creek) was selected based on the need to protect high-quality water bodies.

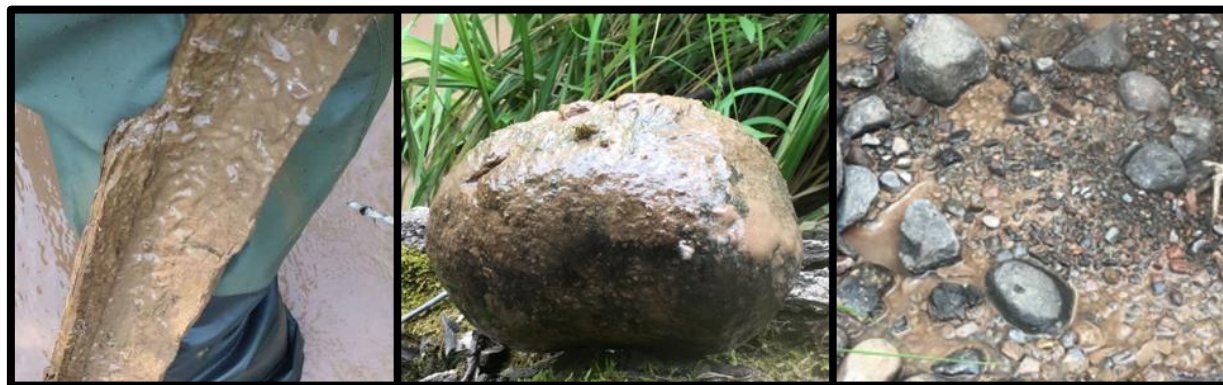
**Figure 3. Degraded habitat includes wood covered in silt and void of macroinvertebrates (left), sediment-biofilm covering rocks (center), and embedded gravel (right).**

**The MPCA biologists noted degraded macroinvertebrate habitat in the 2022 and 2023 visits.** During Cycle 2 visits, rock and wood habitats were largely covered in a slimy biofilm and silt/clay mixture; and had few to no macroinvertebrates on the surfaces (Figure 3). The interstitial spaces between gravel in stream riffles were filled with silty clay sediment, and the stream water was a muddy brown color. While Deer Creek is most-often muddy in color, the amount of sediment on surfaces increased between cycles.

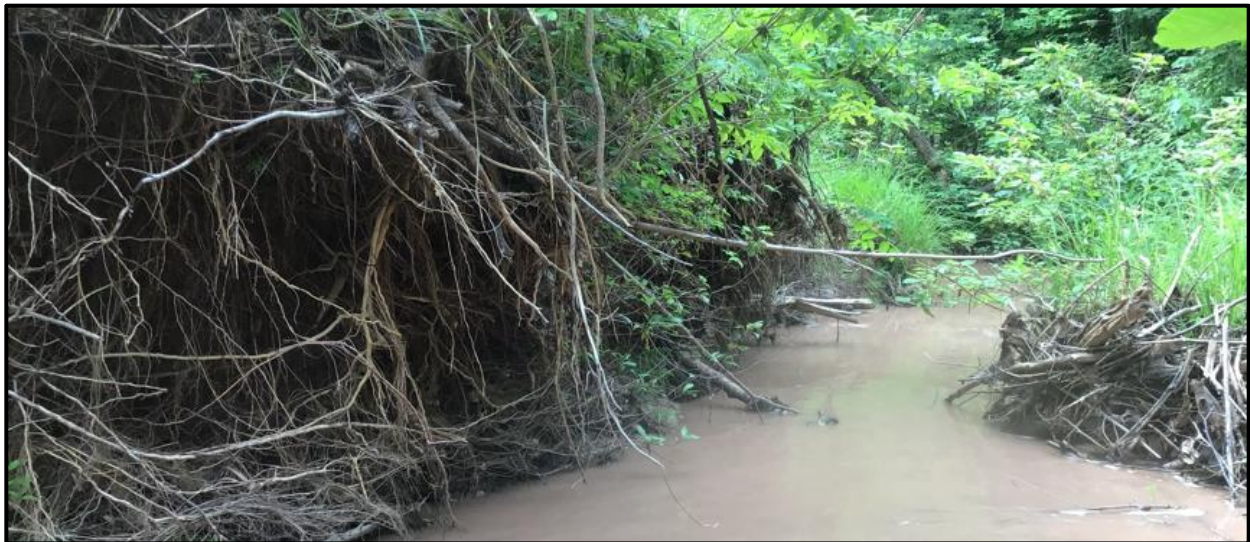
**Figure 4. Steep, high, and severely eroded streambanks along Deer Creek.**

**High levels of channel incision and limited floodplain access are documented in the watershed.** Deer Creek and its tributaries are cutting down deeper into the landscape. Channels show distinct reduction in sinuosity and width depth ratio and increased steepened slopes compared to historic conditions. During high flows, the water further erodes the incised channel banks as the high-velocity water is unable to spill out onto the landscape. Evidence of this within the biological reach includes steep, high, and severely eroded streambanks (Figure 4).

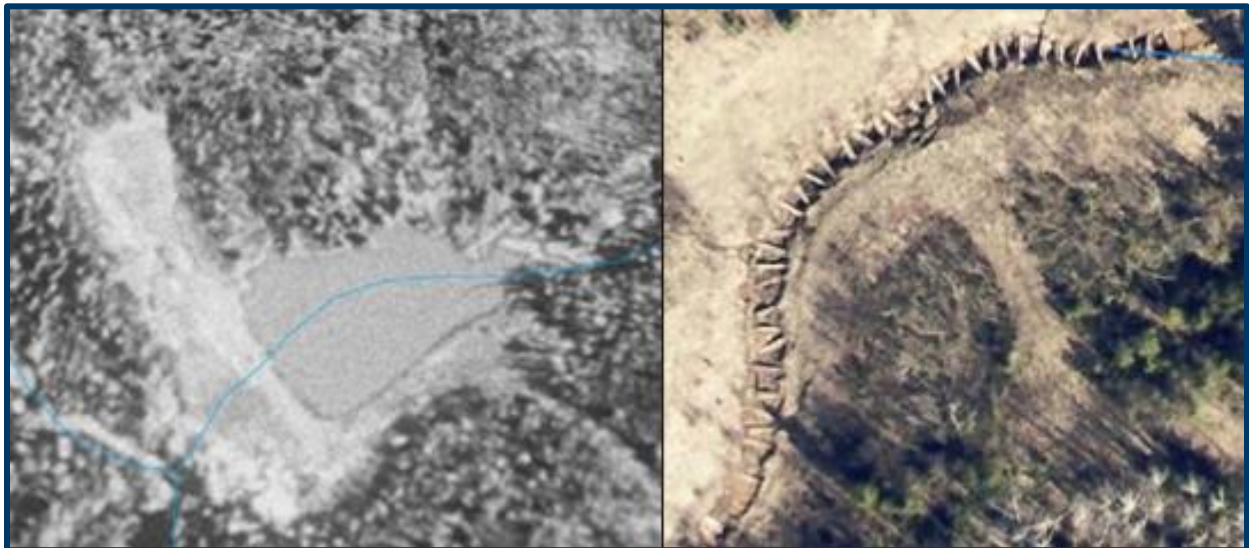
**Figure 5. The failure of a 1970's dam (left) released 9000 tons of sediment to Deer Creek and a head-cut in the post-dam, restored channel (right) actively erodes sediment.**

**Three of four 1970s red clay dams were assessed and found to be releasing sediment through failed pipes and berm breaches.** The largest contributor of sediment of the four dams is the most downstream structure built on a tributary to Deer Creek one-quarter-mile upstream of 11LS064. The dam initially breached sometime in the mid-2000s, releasing an estimated 9000 tons of sediment into Deer Creek. After the failure, the tributary cut through an embankment likely initiated by a 2012 flood event, causing further damage to the site. The 24-foot-tall nearly vertical slopes continued to slough off during heavy rains (BWSR, 2017), increasing the need for a resolution.

In 2016, the 500-foot-long stream reach was restored through the breached dam area. The design included floodplain grading, bank stabilization, logs placed as grade control structures, and riparian plantings. By 2019, a head-cut was reportedly migrating upstream through the project site, eroding away soil as the channel incised several feet below the restoration's grade control structures (Figure 5). Design limitations, a 2018 extreme flood event, and lack of upstream gravel bed load to lock in grade controls were critical contributing factors. Recent 2025 site inspections confirm that the head-cut continues to migrate upstream through the project site and the channel is completely disconnected from the floodplain. Local watershed planners are actively seeking out funding and resources to implement repairs and stop the source of erosion. In March 2026, a feasibility study outlined repair options. It stated that if left unaddressed, migration will continue upstream beyond the project site and into the natural channel expanding the zone of instability and sediment release.

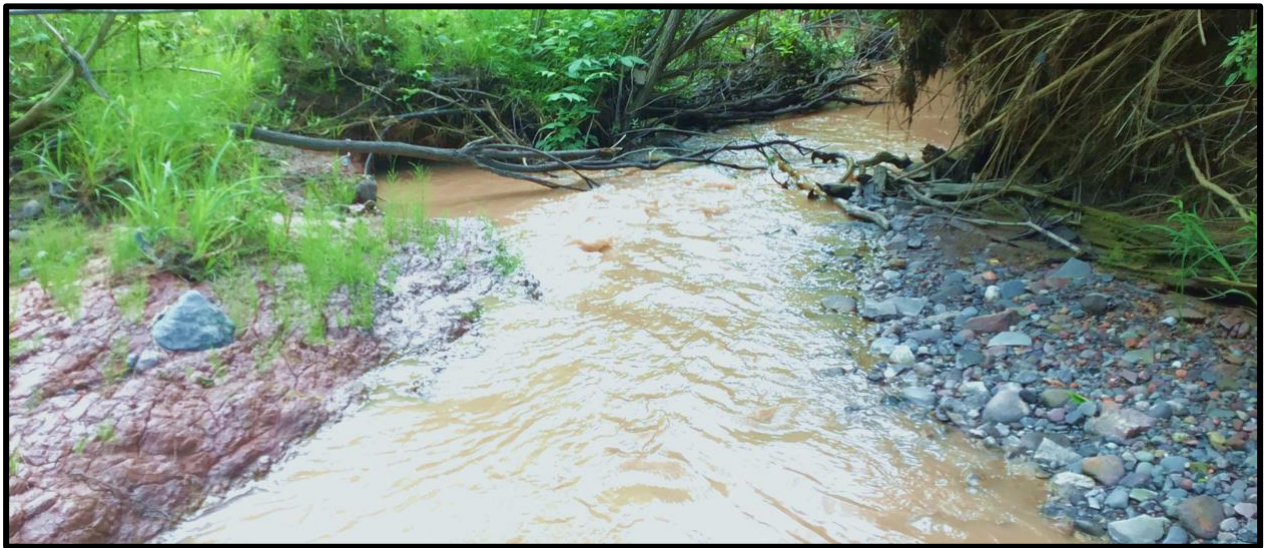
**Figure 8. Evidence of high flow effects on Deer Creek includes observations of clay bed scour (left side of image) and smooth gravel and cobble (right side of image).**

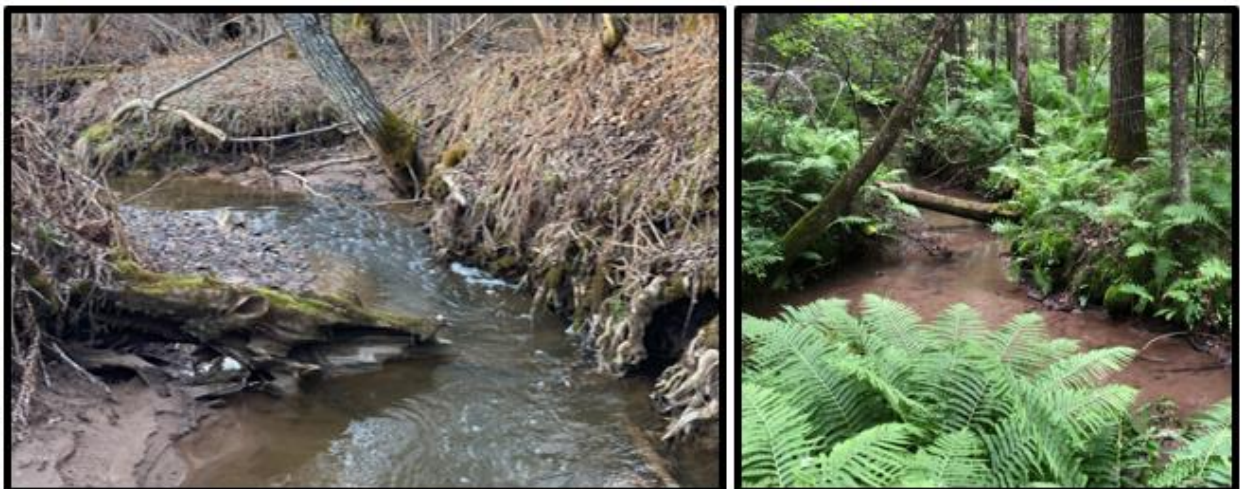
**Figure 13. Military Creek habitat includes a good riffle/pool habitat (left) and a wide to extensive riparian buffer (right).**

Stream bed materials included silt, clay, sand, gravel, and cobble materials. Despite cobble being on the smaller side of its range and the absence of large boulders, these habitats were productive in housing macroinvertebrates (Figure 14). Wood was also abundant and productive. Although some streambank erosion was noted at meander bends in the channel, there was low siltation of sediment on surfaces and only light embeddedness of gravel and cobble by finer sand and silt. Fish cover was moderate to extensive and consisted of undercut banks, large wood, rootwads, overhanging vegetation, and deep pools.

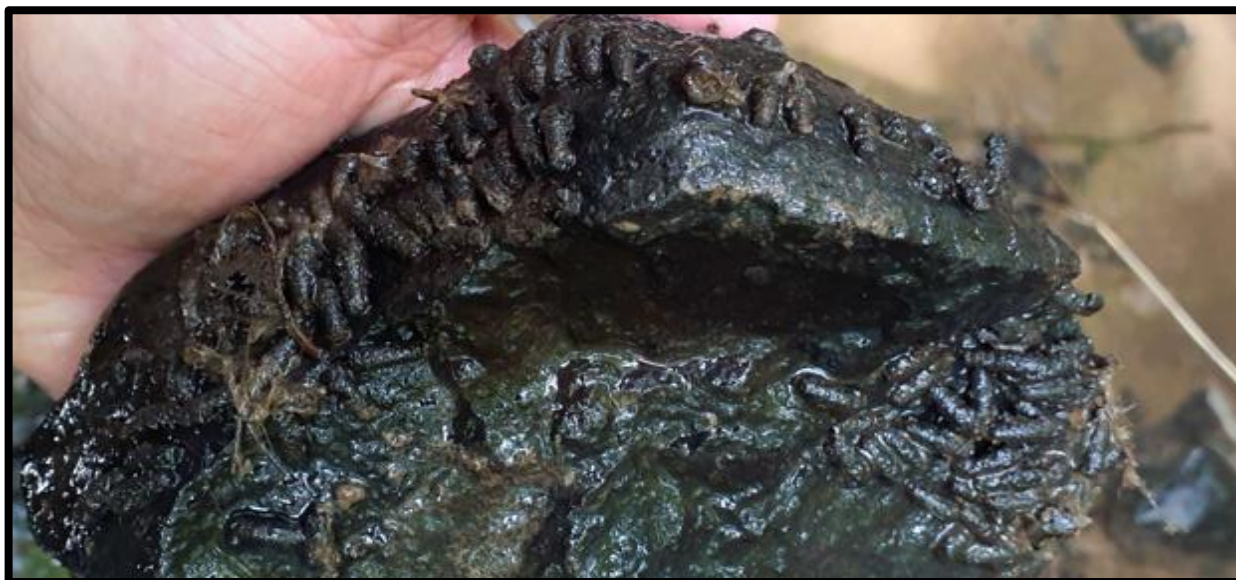
Figure 14. Cobble housing a high number of macroinvertebrates including the caddisfly *Hesperophylax designatus*.

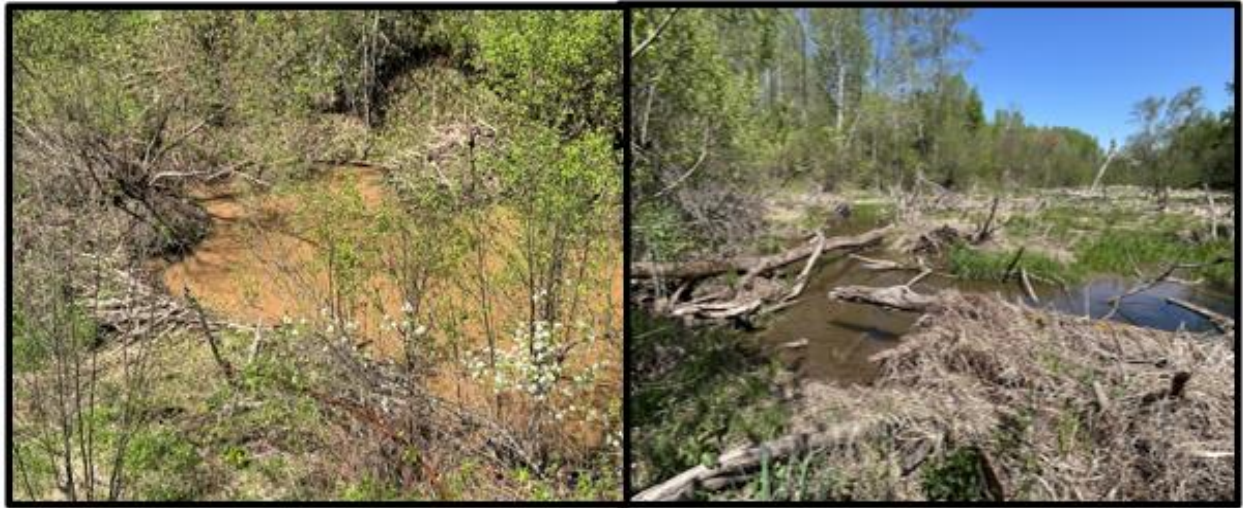
**Figure 15. Beaver dam effects on Military Creek between State trail (left) and Cemetery Road (right) crossings.**

**State Trail** (Figure 15) – A major dam was located tens of feet downstream of the culvert outlet forming a large pool of muddy water with higher water levels than previously observed at the culvert outlet. Water clarity improved just downstream, in the vicinity of groundwater springs that discharge to Military Creek. The beaver dam is likely a complete barrier to fish passage; however, the channel upstream of the crossing is undefined and only flows ephemerally, therefore the distance of stream miles being impeded is negligible under most flow conditions.

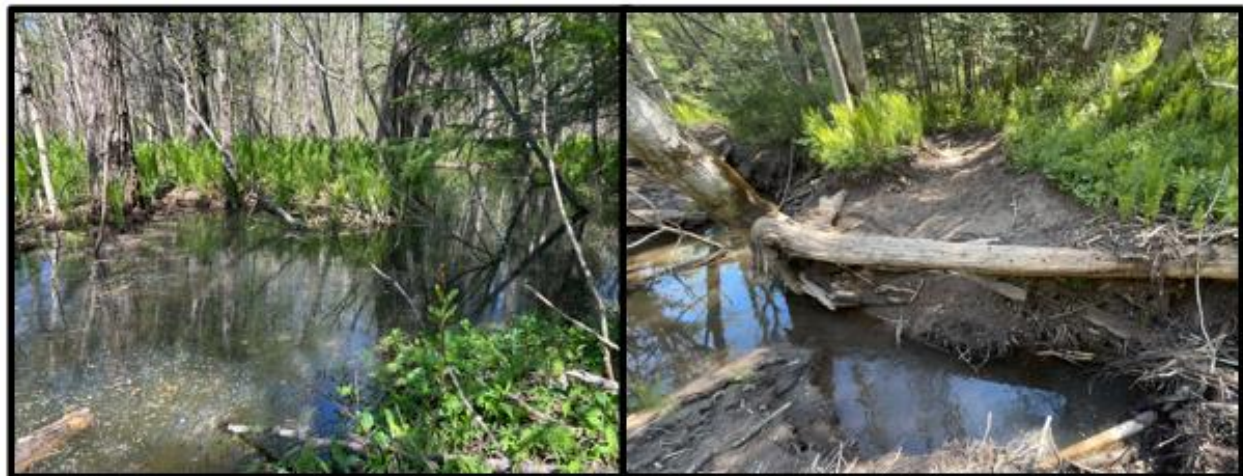
**Figure 16. Beaver dam effects on Military Creek at the CSAH4 crossing include flooding upstream (left) and a disturbed channel downstream (right).**

Beaver activity in the watershed has been observed over the study period but was most pronounced in 2025 and 2026 (Figure 15 and Figure 16). Dams were initially observed upstream of the Cemetery Road crossing in 2020 and then extended to the State trail and CSAH4 crossings in 2026. While beaver dams can be beneficial by reducing peak flows, storing water, and retaining sediment in some watersheds, they can also have negative effects. These include impeding upstream movement of adult trout and downstream movement of juvenile trout, altering sediment transport and water temperature regimes (creating conditions unsuitable to support trout), and loss of suitable spawning gravels. Effects observed within the watershed in May 2026 included:

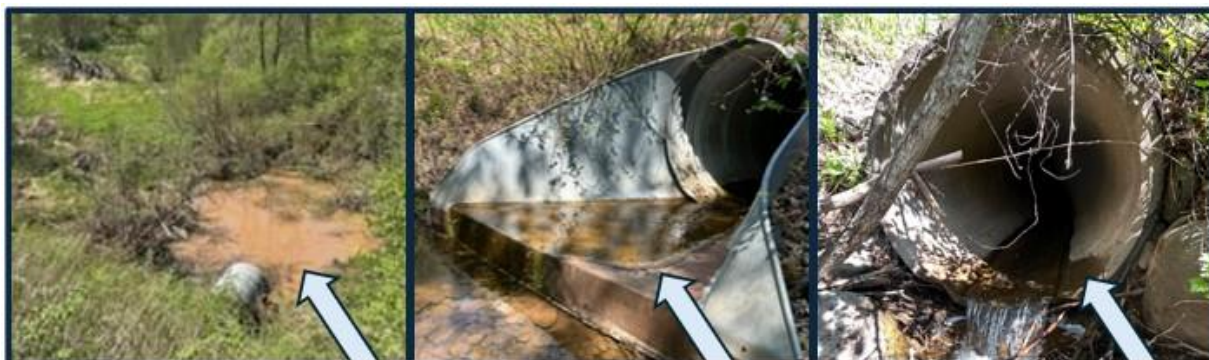
**Figure 17. Culvert assessment variables and prioritization for replacement for three crossings on Military Creek.**

highest priority culvert for replacement based on a greater distance (0.9 miles) of high-quality upstream habitat that removal would reconnect. Currently, both culverts are perched at the outlet, are undersized in diameter, and provide too shallow depth (0.1 feet) during baseflow conditions.

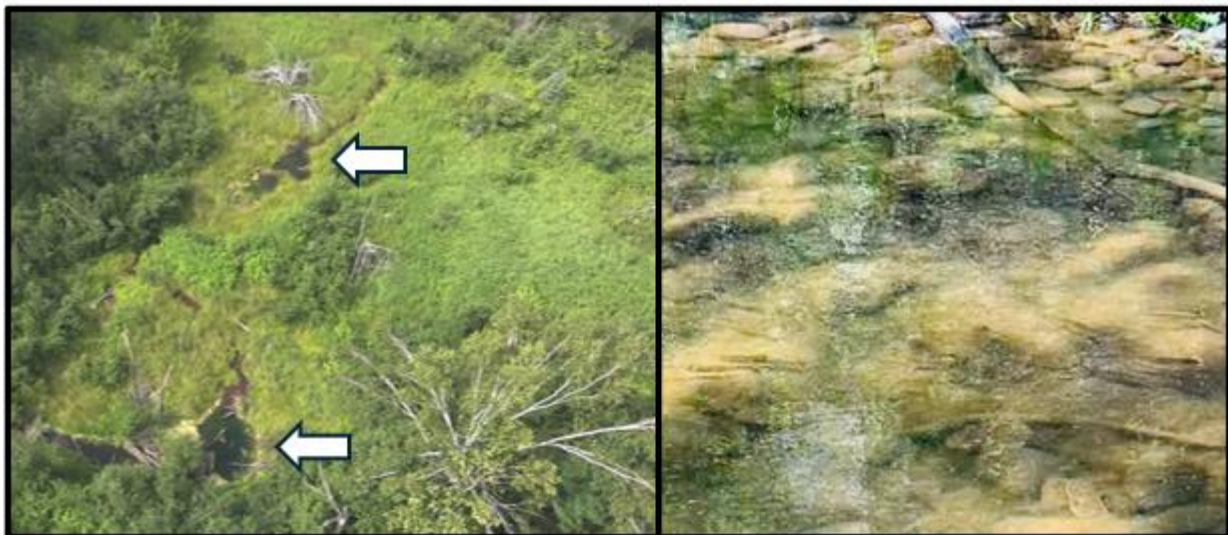
**Figure 19. Springs initiate downstream of the State trail (left) providing cold spring-fed water (left). Horizontal lines in left image are juvenile and age one trout in a pool near the Cemetery Road crossing.**
