# Mississippi River-Grand Rapids Watershed Stressor Identification Report

## Streams section

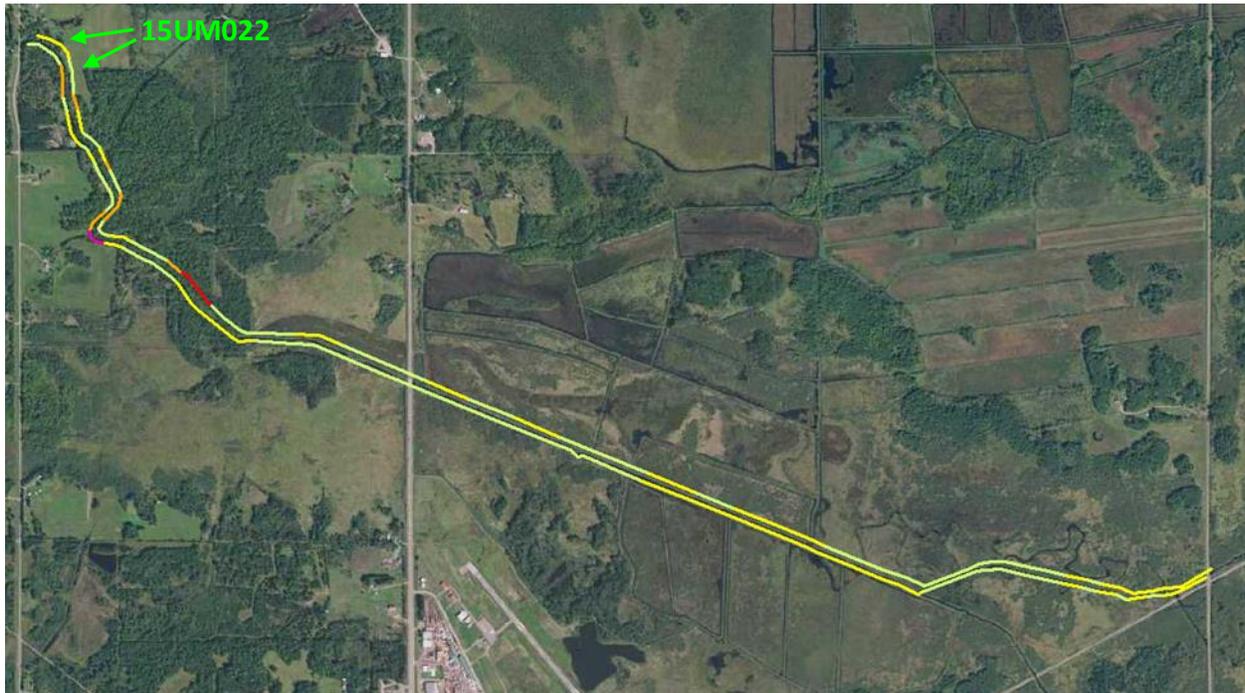
**Figure 16. BANCS categorizations of streambank sections upstream of 15UM022. Colors represent categories of estimated sediment input from a given stream bank section. Erosion increases as colors move from green to yellow to orange to red to pink.**

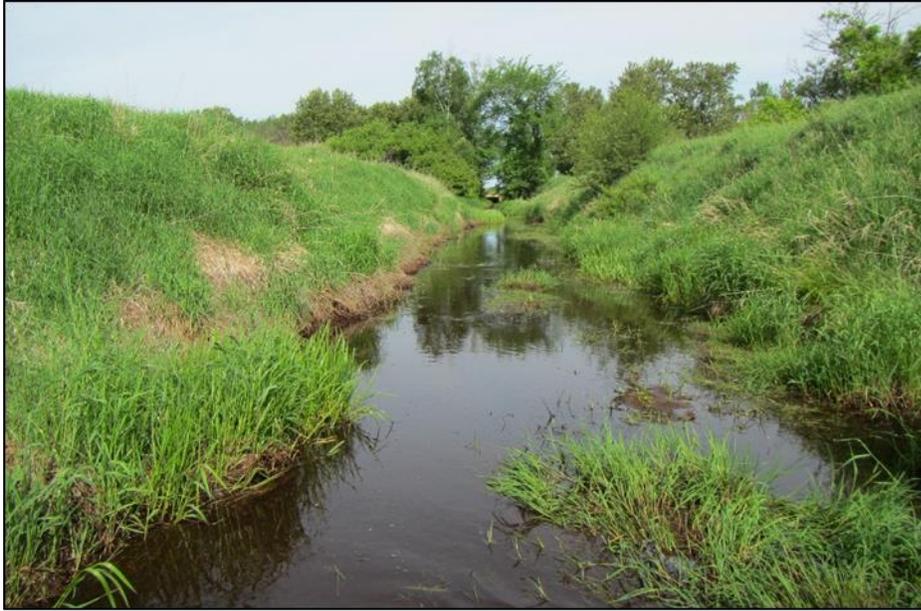
**Photo 1. The constructed ditch that forms AUID-518 in the biological sample reach, a trapezoidal channel with high banks.**

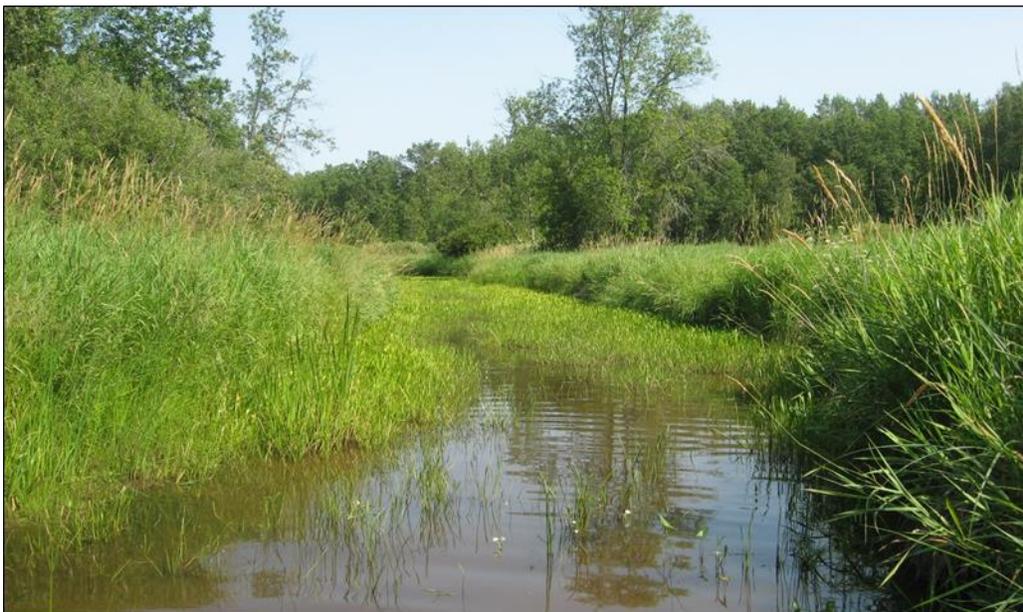
**Photo 2. AUID-519 functions more like a wetland than a stream during some of the summer, as shown by the extensive emergent vegetation growth.**

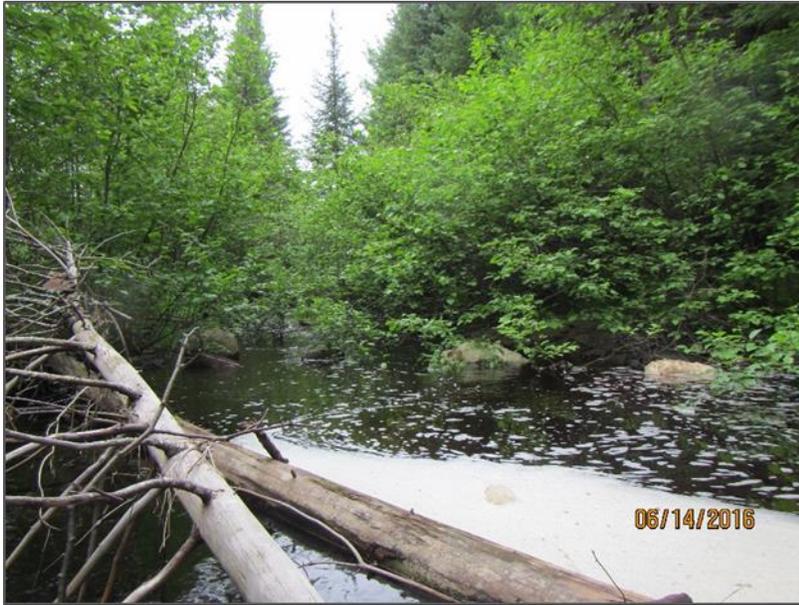
**Photo 3. DOC foam on the stream surface is evidence of turbulent flow; an explanation for the high % saturation of DO sometimes found in AUID-722.**

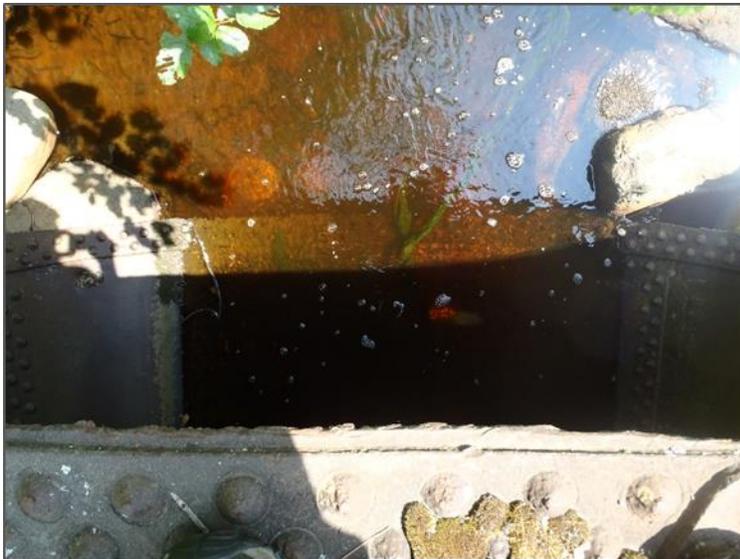
**Photo 4. Upstream invert of culvert at the cabin access road along the east side of Bray Lake.**

The author walked the stream channel from the culvert on 56A down to the mouth of the creek at Bray Lake to look for any other potential barriers, and none were found. There does not appear to be any beaver activity between 56A upstream to 15UM056 via aerial photography review (probably related to the higher gradient in this part of the stream). There is one riparian meadow in this part of the creek, though aerial photos from 1991 to 2015 do not show beaver activity there. The only beaver activity was in the creek’s headwaters area upstream of CSAH-56. Migration barriers do not explain the lack of fish at 15UM056.

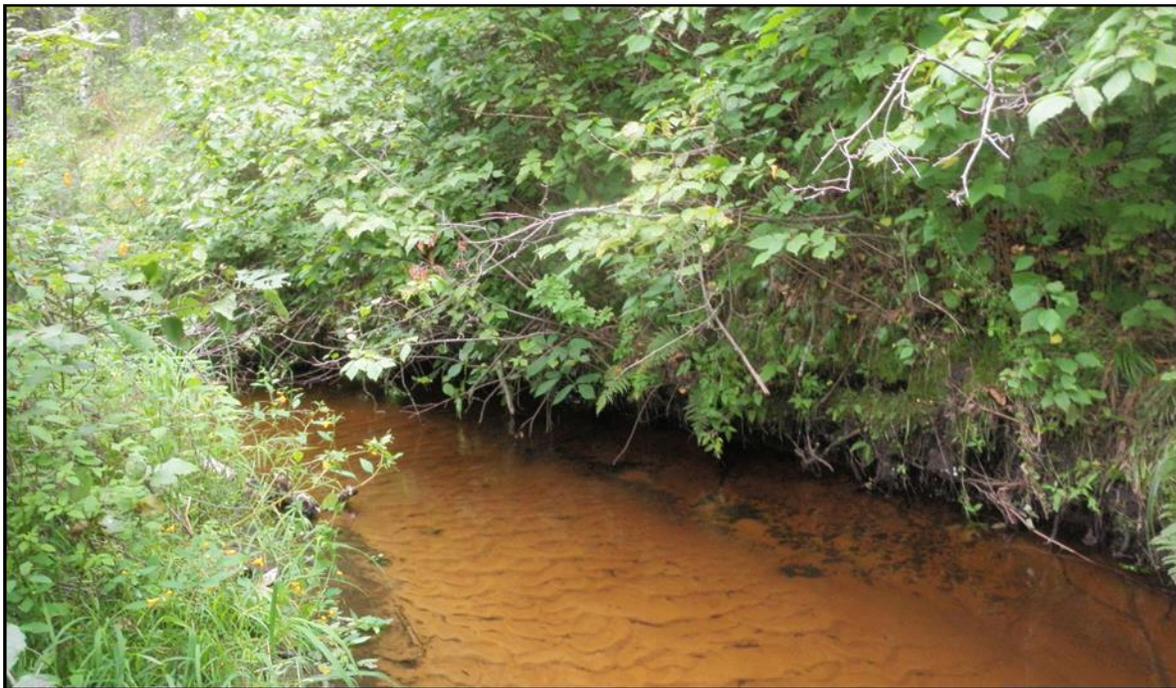
**Photo 5. Example of the sand-dominated, mobile streambed with very little protective cover for either fish or macroinvertebrates.**

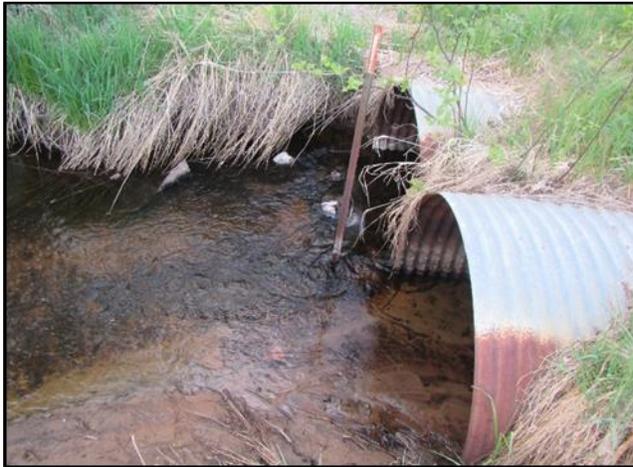
**Photo 6. Downstream end of culverts on Bluebird Drive showing that they are set at a good elevation, and are not causing downstream scour, suggesting that in-culvert velocity is not prohibitive of fish migration.**

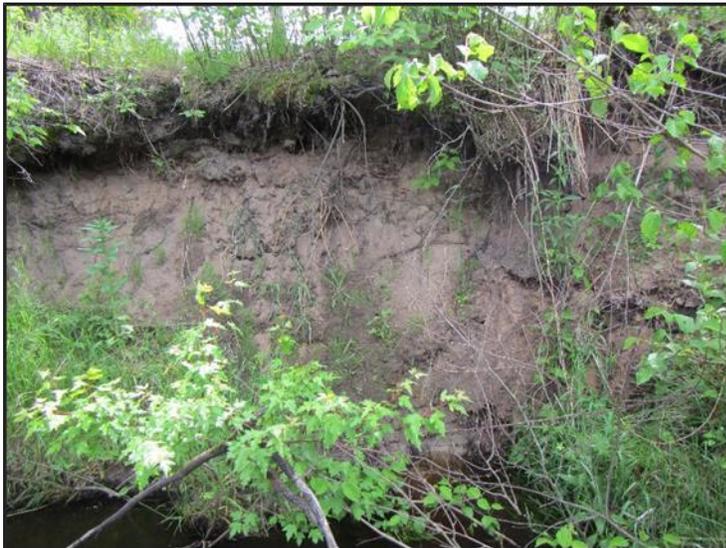
**Photo 7. Bank erosion at a location along the biological sample reach which is near the road. The soil is mostly sand, which has little cohesiveness to resist being eroded by the streamflow.**

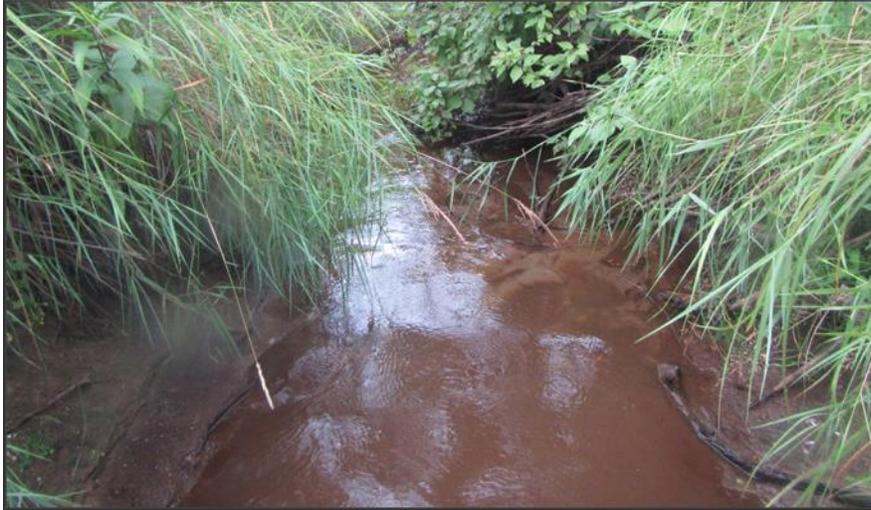
The poorest-scoring subcategory scores, based on a percentage of each category's possible score, were "Substrate" and "Channel Morphology". There was no coarse substrate, only sand and clay (though these are the substrates expected here due to the soil and surficial geology). Within the Channel Morphology subcategory, the Channel Development and Channel Stability components were the most influential in dragging down the score. The water depth is very shallow at times ([Photo 8](#)), probably a result of the channel being constructed larger than the original channel (see the following geomorphology section). As is common with ditches, it appears that this one is lacking a diverse set of microhabitats that support a diverse biological community, though the habitat model used for determining TALU classification suggests that habitat alone likely does not fully explain the biological impairment.

**Photo 8. Section of stream that is only 1-2 inches deep, with a barren, sand bottom.**

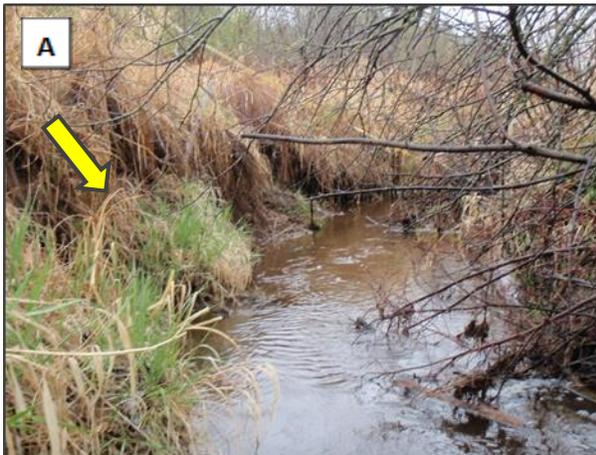
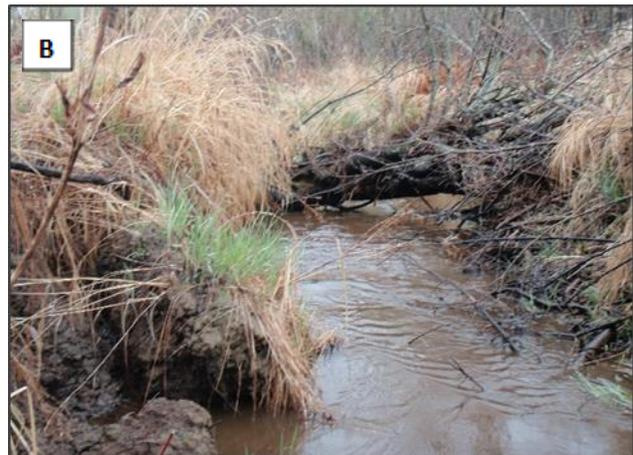
Photo 9. A and B. Bank instability is evident in the mass wasting seen along the reach. Photo A shows chunks of sod and soil that have dropped down into the channel on the left side. Photo B also shows a large chunk of bank that is gone in the left-front corner of the photo, leaving raw exposed soil that will erode further.

Ditching has reduced habitat quality by the elimination of sinuosity, and altering the patterns of hydrology. These contribute to channel instability and the follow-on habitat issues such as less stable substrate, and a general loss of microhabitats. There may be lower base flow volumes due to headwaters ditching (less upstream water storage that slowly feeds the stream). DO may be a problem too per fish community data and late-afternoon measurements not much over 5 mg/L. Low DO does not appear to be related to eutrophication based on a lack of any notable algae presence, and extremely low nitrate levels. It is most likely to be caused by enhanced drainage of the peatland soils, which are relatively anoxic in summer.

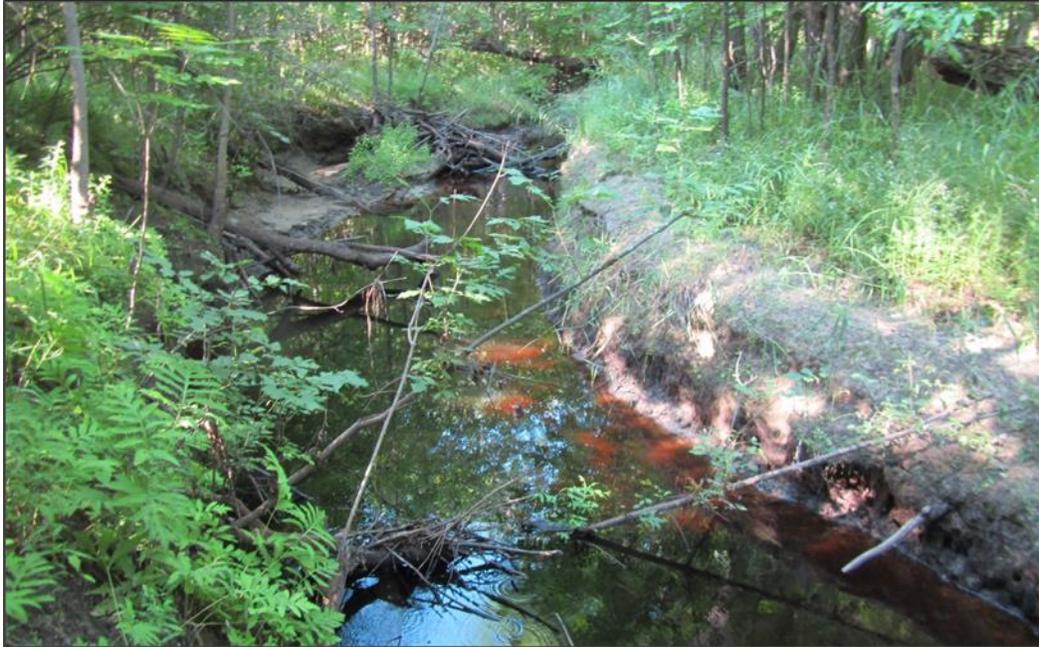
**Photo 10. Channel damage was found in the reach sampled for biology. Raw banks were prevalent. The channel has incised within the original floodplain, such that some of the higher flows are now retained in the channel, which results in excess erosion from the banks and streambed.**

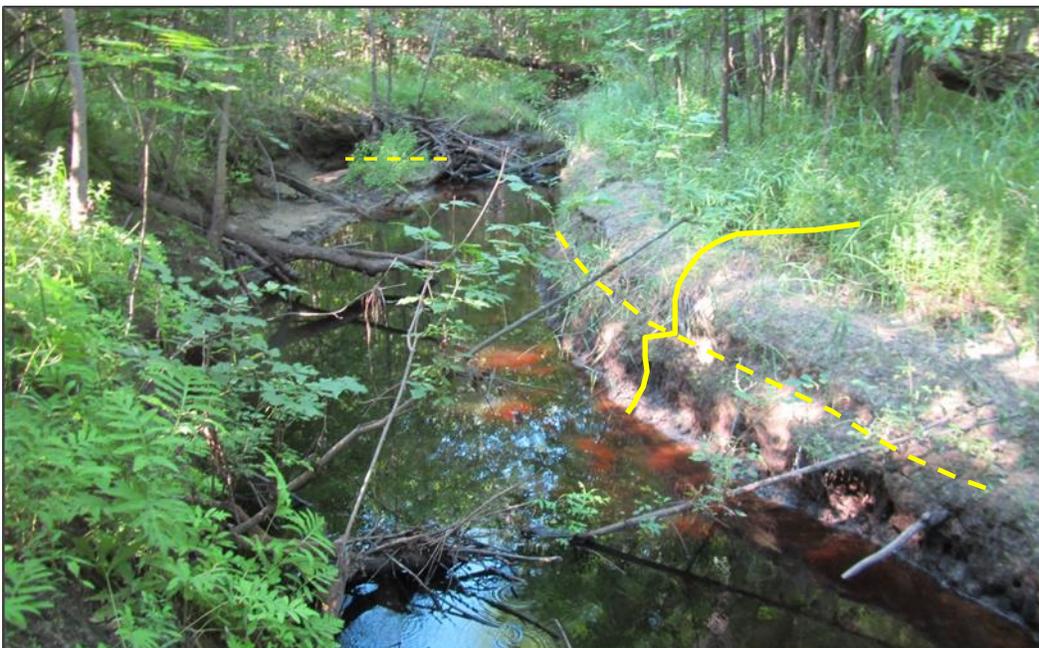
**Photo 11. Bankfull marks show channel incision. In the foreground at right, there is a small terrace about half way up the bank (dotted yellow line). The solid yellow line shows the profile of the bank up onto the floodplain. The dotted line in the background is at the top of a mound of sand piled upstream of a logjam (seen closer in [Photo 10](#)). The elevations depicted by the dotted lines are approximate bankfull elevations under current conditions.**

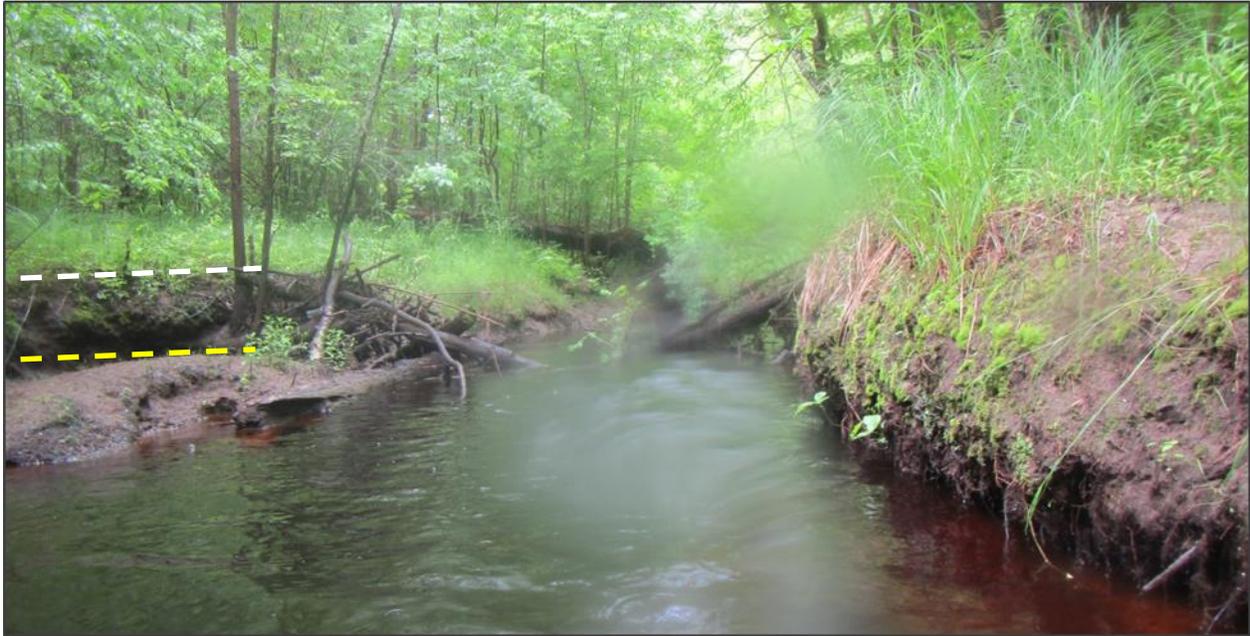
**Photo 12. Another indicator of the bankfull elevation (yellow dotted line) is the sand piled on the left side of the channel. A healthy stream's bankfull height is at the elevation of the floodplain (while dotted line). The new bankfull elevation is much lower than the pre-settlement floodplain elevation.**

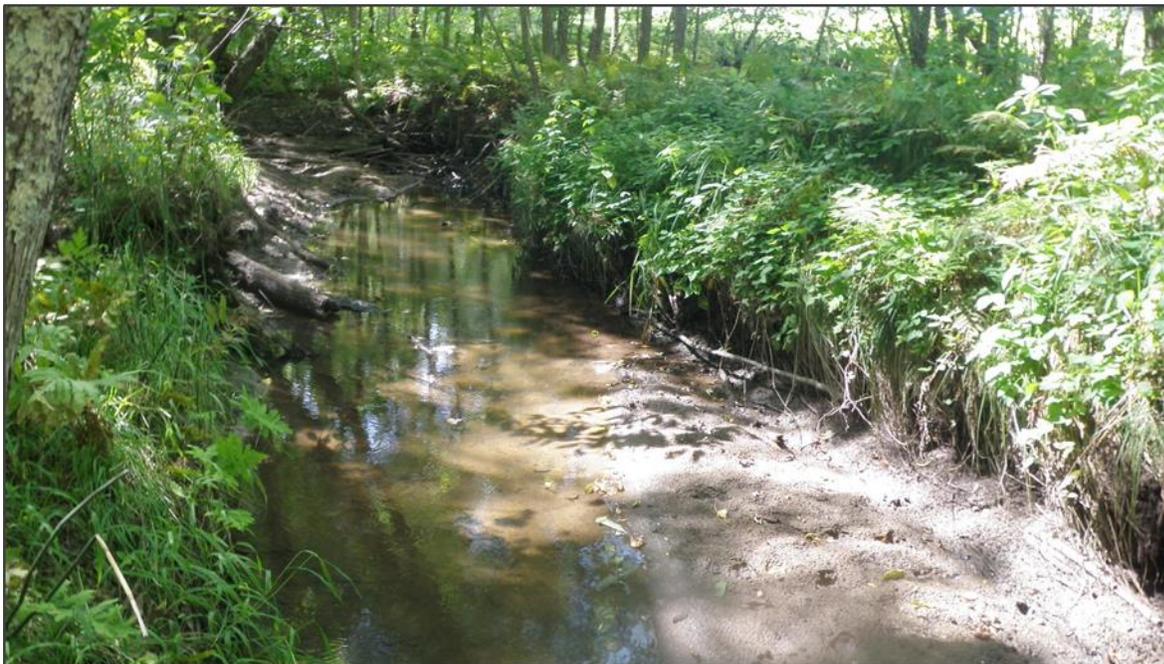
**Photo 14.** Sandy sediment deposition at 15UM091 forming a bar/new floodplain at the front-right side of the photo.

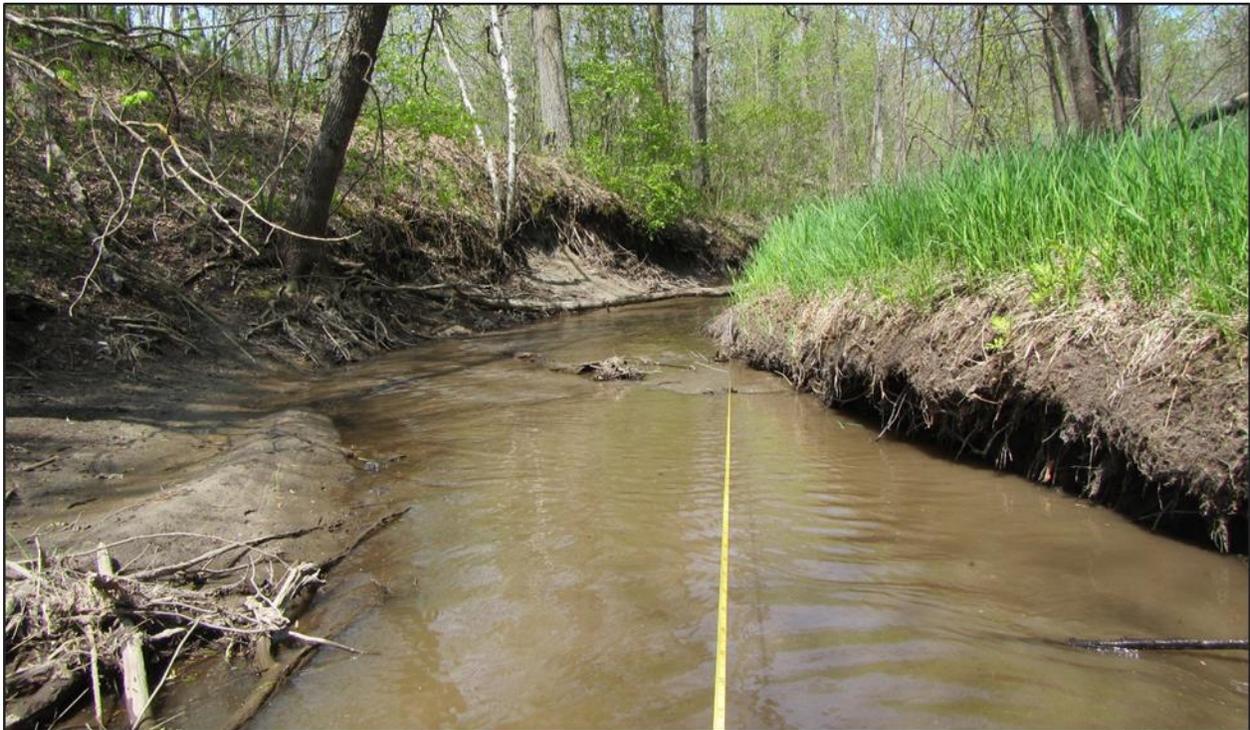
**Photo 15. 16UM151 - Extensive bank erosion on both sides of the channel and excess sediment deposition on the left side of the photo.**

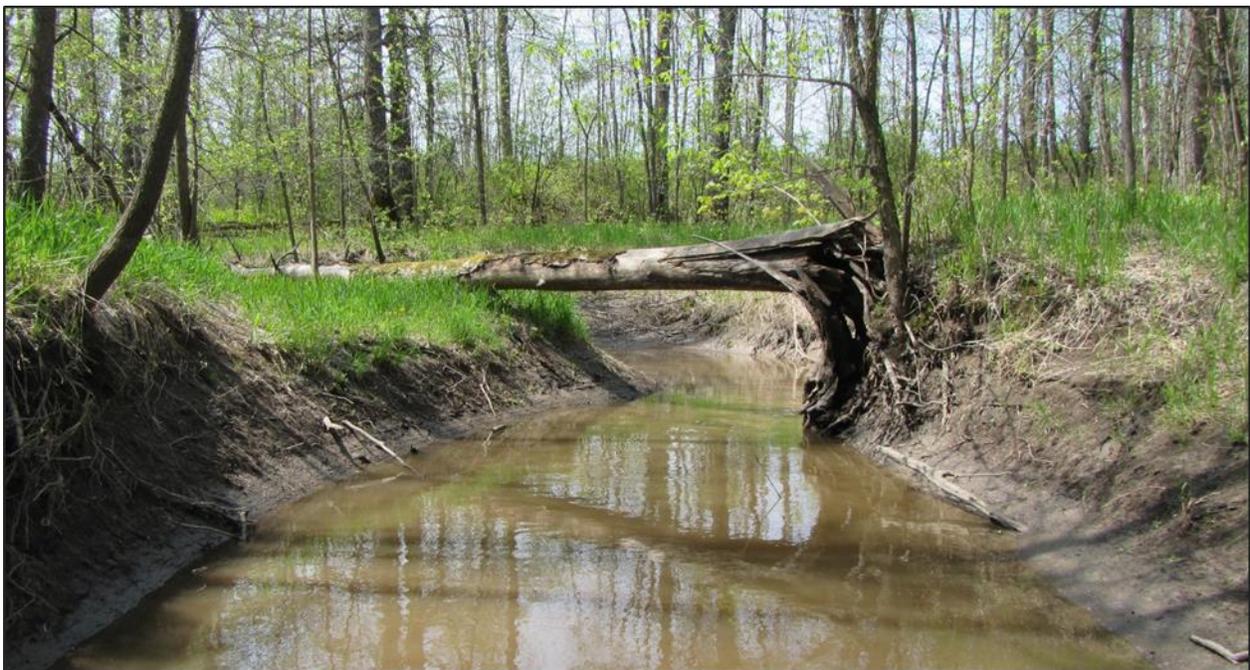
**Photo 16. 16UM151 - The channel is incised, with steep high banks on both sides of the channel, preventing high flows from spilling out onto the floodplain to dissipate energy.**

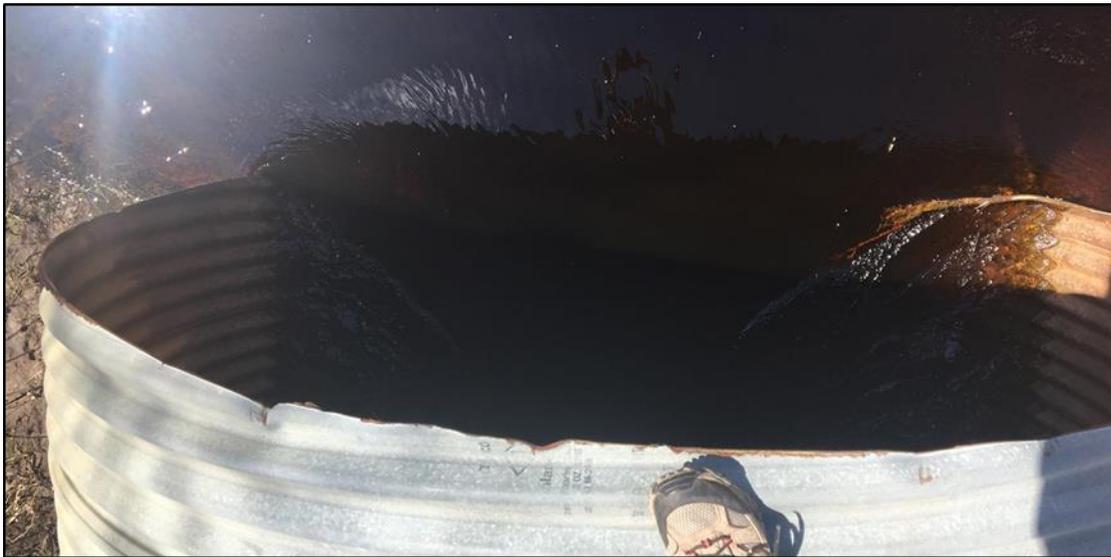
Photo 18. Upstream end of culvert on 334<sup>th</sup> Place is set too high, impounding water upstream and creating a sudden increase in velocity as water enters the culvert.

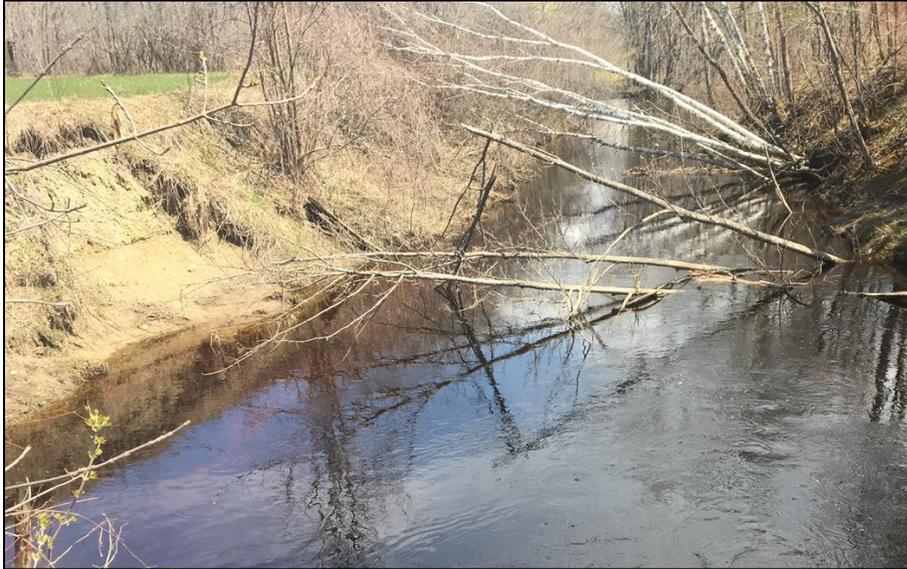
In general, the channel along CSAH-3 was quite stable for a ditch. There was a bit of sinuosity forming, with narrow floodplain benches within the ditch banks. Such features improve biological habitat in ditches. Bank sloughing was occurring in a few locations, most notably in association with the two problematic culverts noted above ([Photo 19](#)).

**Photo 19. Bank failure/erosion associated with the culvert on 334<sup>th</sup> Place.**

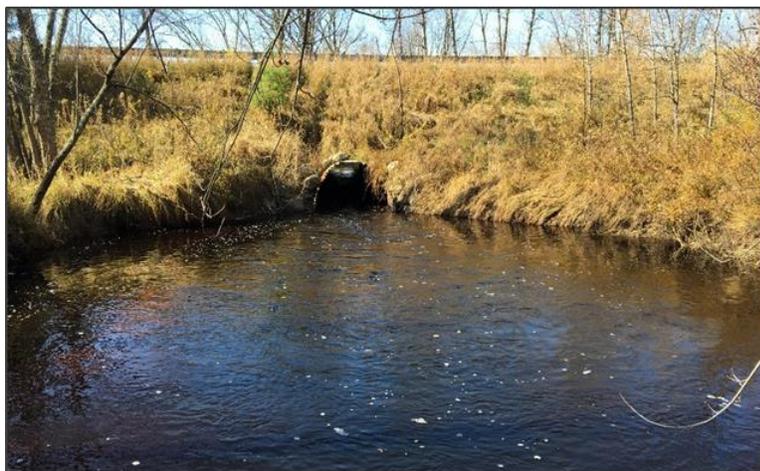
The culvert at the CR-10 crossing was assessed by DNR for fish passability. The culvert is undersized relative to the channel width, and flow velocity was quite fast within the culvert. A large scour pool below the culvert is additional evidence of fast moving water exiting culvert ([Photo 20](#)). In addition to the culvert being undersized, it has a higher gradient than the stream, exacerbating the effects of the constriction and increasing velocity in the culvert. This culvert is a migration barrier to smaller fish species, and at higher flow volumes, most species are probably prohibited from making it through the culvert.

**Photo 20. View of the CSAH-10 culvert from downstream, at the downstream end of the scour pool.**

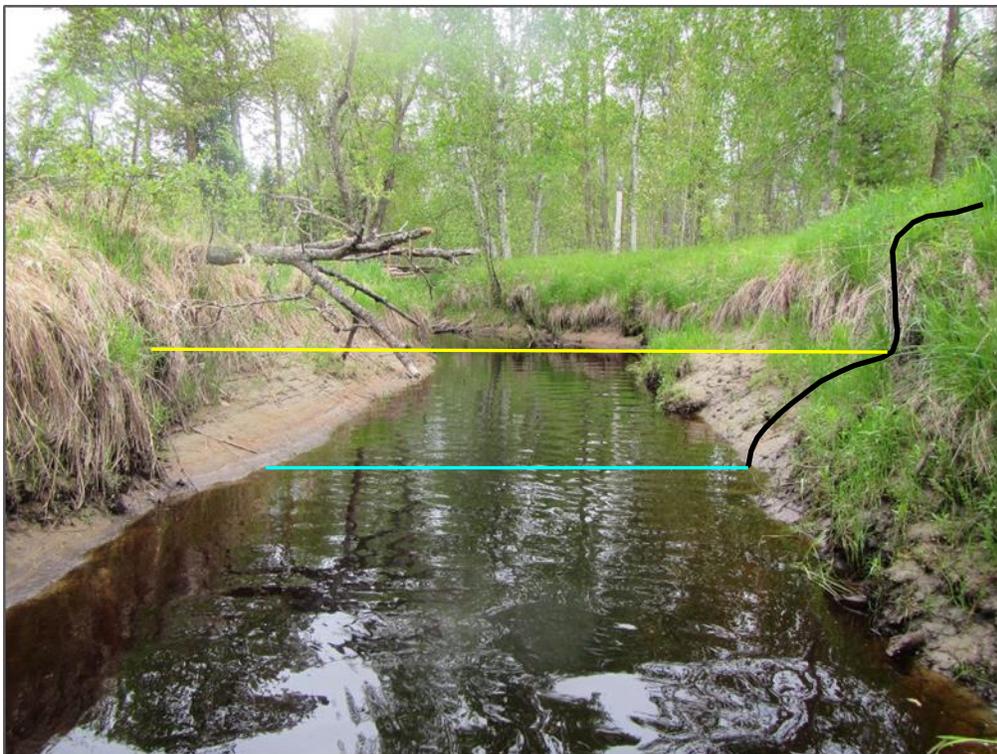
The DNR staff did a thorough assessment of channel conditions in the AUID, a short ways downstream from the biological monitoring site, just east of CSAH-10, where the channel has not been altered by excavation/re-routing.

**Photo 21. A depositional feature on the right side of the stream shows the bankfull elevation (yellow line) is substantially lower than the height of the stream banks and original floodplain elevation (arrow).**

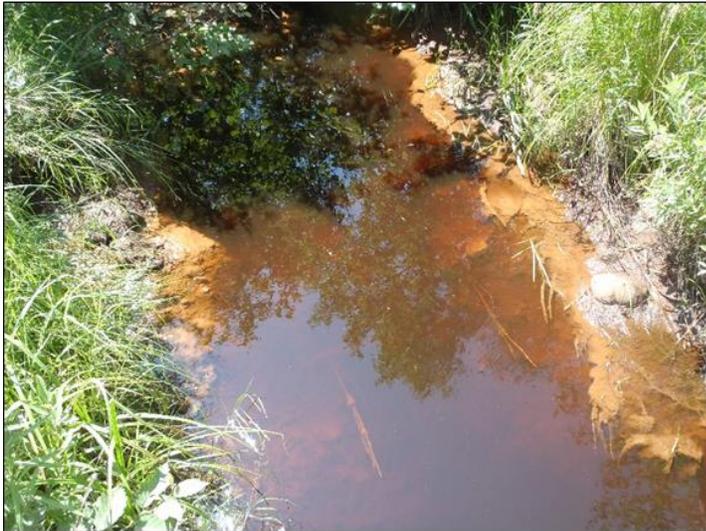
Photo 22. Musselshell Creek at S009-505 on August 6, 2018 showing the iron floc covering all stream surfaces.
