Mississippi River Brainerd Watershed Stressor Identification Report

A study of local stressors limiting the biotic communities in the Mississippi River
Brainerd Watershed

Document number: wq-ws5-07010104a

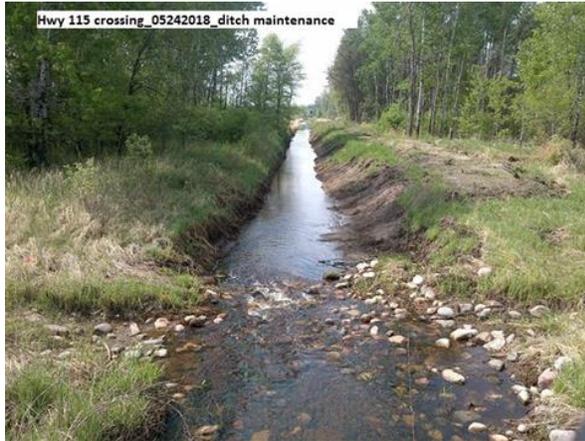
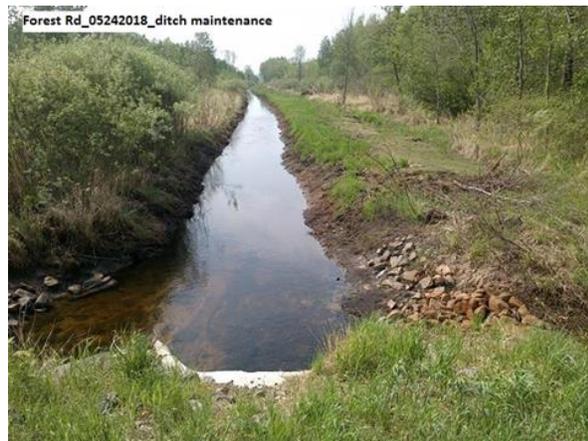
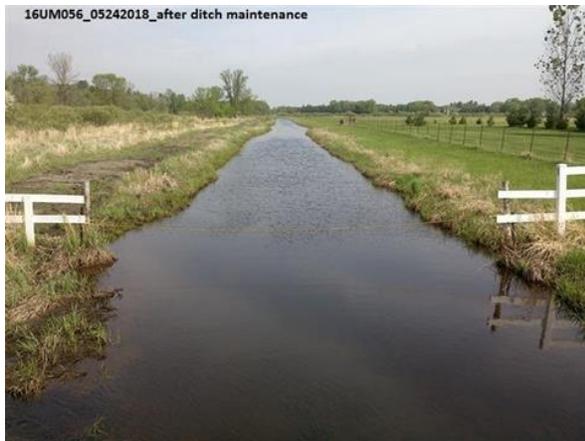
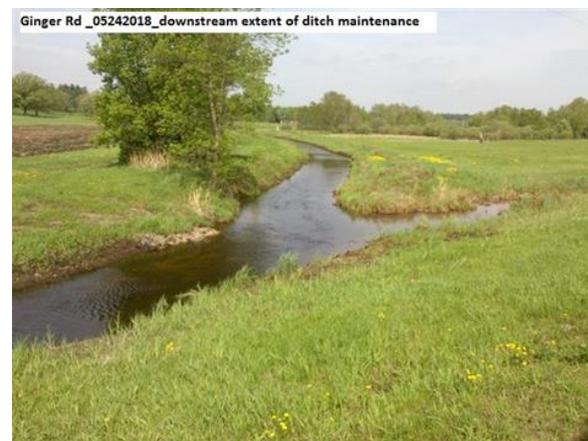
The current condition of the stream is ditched; however, the channel does not appear to have been maintained, as the banks were heavily vegetated and stable during biological sampling in 2016. However, in the winter of 2018, the entire channel was maintained between Hwy 115 and downstream of the sampling location. Below is photo documentation of the ditch maintenance that occurred on Unnamed Ditch in the winter of 2018. The photos are taken in a downstream direction. It can be noted that the channel width is narrower in the two upstream photos. Channel width and water depth are significantly different at the sampling location.

During sampling in 2016, the ditch had not been maintained very recently. Overall, it appears that not much has changed in the shape of the channel. The depth is slightly deeper and any accumulated fine sediment has been removed. By mid-summer in 2018, the channel was vegetated and appeared stable.

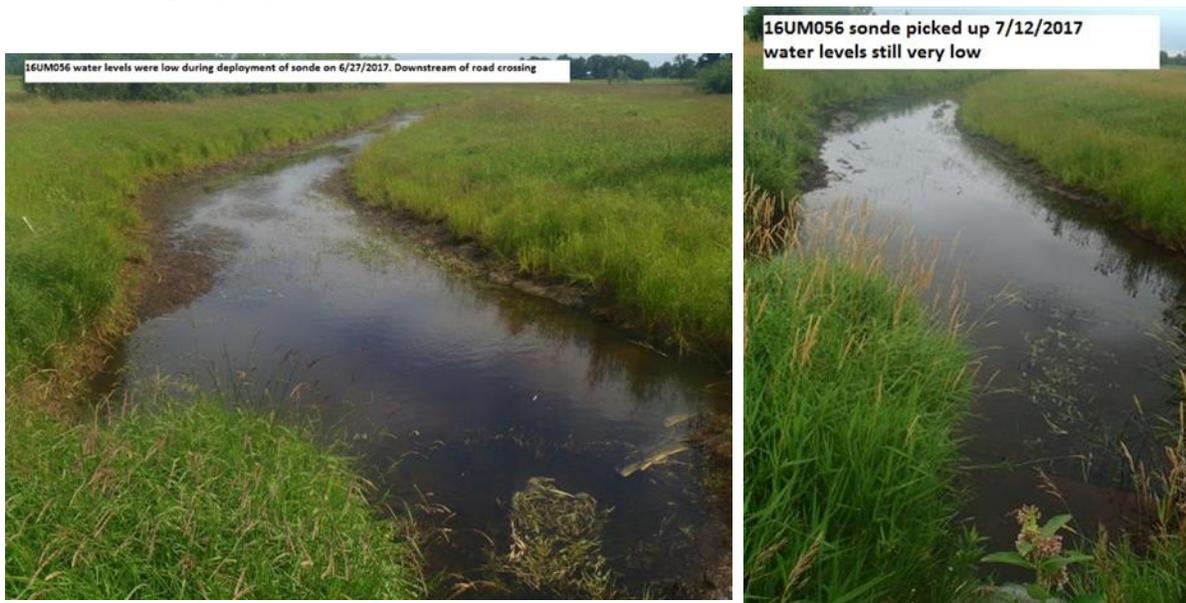
Photo 1: YSI sonde deployment conditions. Photo on left was taken on 6/27/2017 during the initial deployment. Stream flow was very low. Photo on the right was during sonde retrieval on 7/12/2017. Stream flow was also very low during this time. There was some rainfall that occurred during this period, which slightly increased stream discharge by July 12.

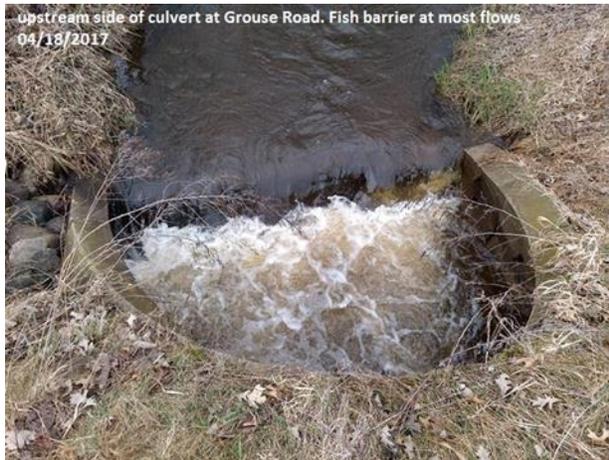
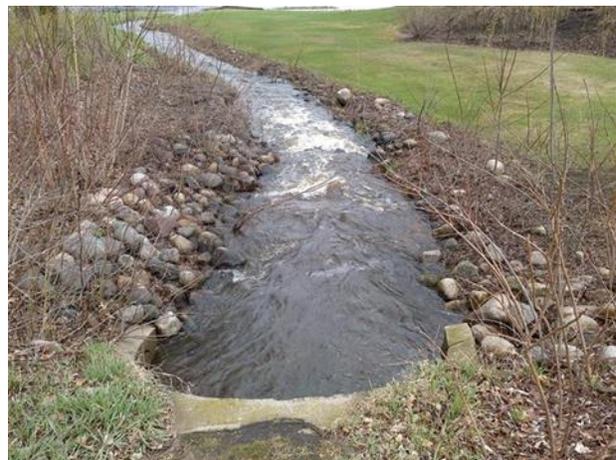
Photo 2: Photos taken on 4/18/2017. Left photo: culvert inlet with drop. Right photo: high velocity stream flow on downstream side of crossing.

In addition to low DO, longitudinal connectivity appears to be a likely stressor. The road crossing located at Grouse Road has a three-foot drop (Photo 2) from the upstream to downstream side of the culvert, and the stream velocities are fast enough on the downstream side to partially impede fish migration during certain flow periods. Lack of longitudinal connectivity is a stressor to the fish community due to this road crossing. A highly variable flow regime has been documented in this ditch during field visits from 2016-2018. On September, 13, 2018 there was virtually no flowing water in the channel as seen in photo 3. This site inspection helps show that the stream can and often does get down to very low flow conditions. These annual drops in stream flow will have a negative effect on both fish and macroinvertebrate communities. The nature of the altered stream flow patterns due to channelization and a lack of upstream storage is causing stress to the stream biology.

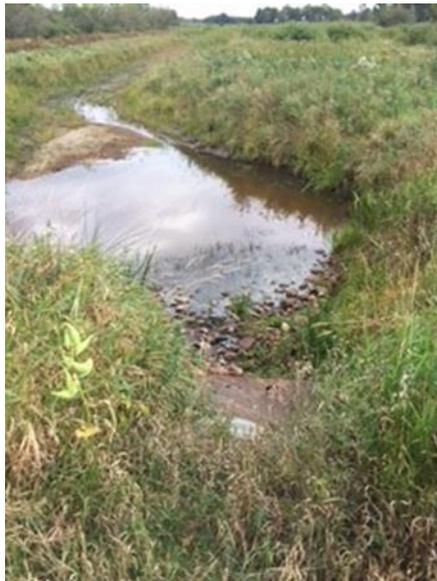
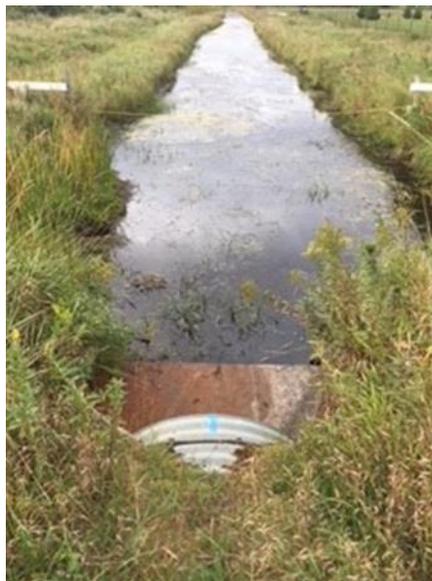
Photo 3: Photos taken on 9/13/2018. Stream flow is at 0 during this site visit. Photo on the left is viewing downstream of road crossing. Photo on the right is the upstream side of the road crossing.

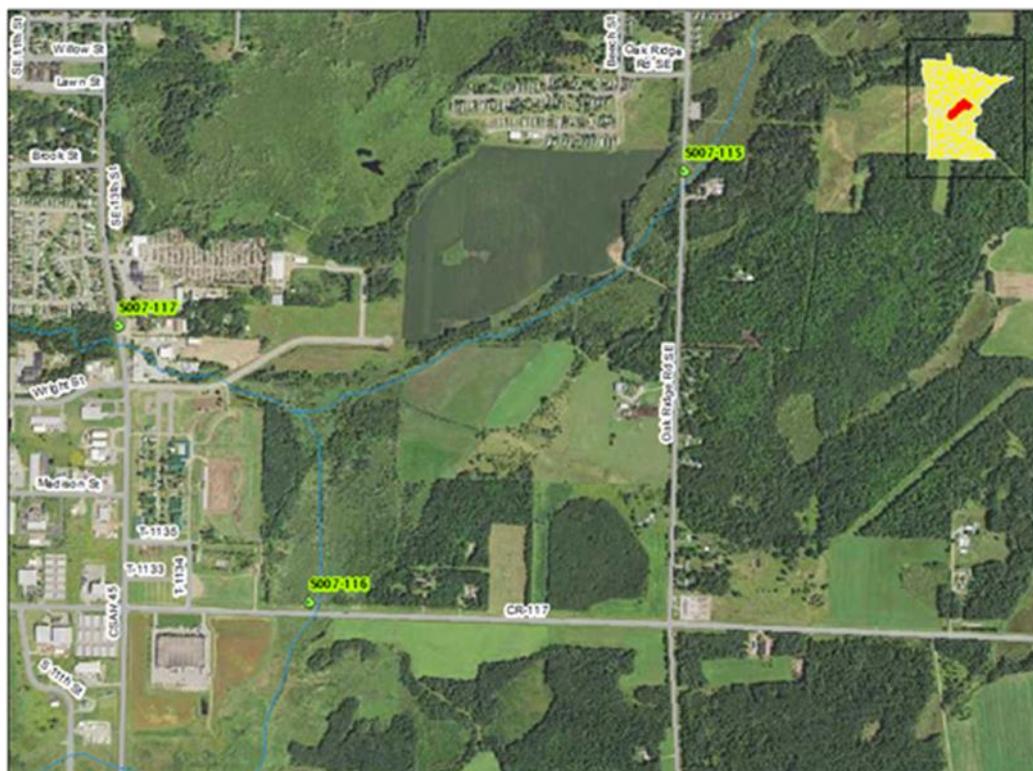
Little Buffalo Creek (00UM015) sampling location map for upstream sites

Figure 20: Sampling locations upstream of city of Brainerd on Little Buffalo Creek. Sites were sampled three times on simultaneous dates to determine impacts of various sections on water quality. Site S007-117 collects additional storm water from nearby industrial activities and street drainage. Direction of flow is northeast to southwest.

A limited number of water chemistry samples were also collected upstream of S006-602, at site S007-117, which crosses at SE 13th St. just north of the Crow Wing County fairgrounds (Figure 20). This site collects storm water runoff from various industrial parking areas and the fairgrounds. Further upstream of S007-117, two additional locations were also sampled concurrently (Table 14). Site S007-116 is located upstream, at the CR117 crossing, and site S007-115 is located at the Oak Ridge Rd. SE crossing. These two sites represent two split reaches that combine to form Little Buffalo Creek, just east of the Crow Wing County fairgrounds.

All three of these sampling sites experienced elevated TP concentrations, as did the downstream sampling location on 7th St. in Brainerd. TSS concentrations appear to be highest at the S007-117 station, which is also influenced by storm water drainage. This site collects storm water from the north and northeast, and also from the south. This storm water flows through residential areas and industrial parking areas that have gravel and are storage areas for semi-trucks, tractors, and junk automobiles (Figure 20).

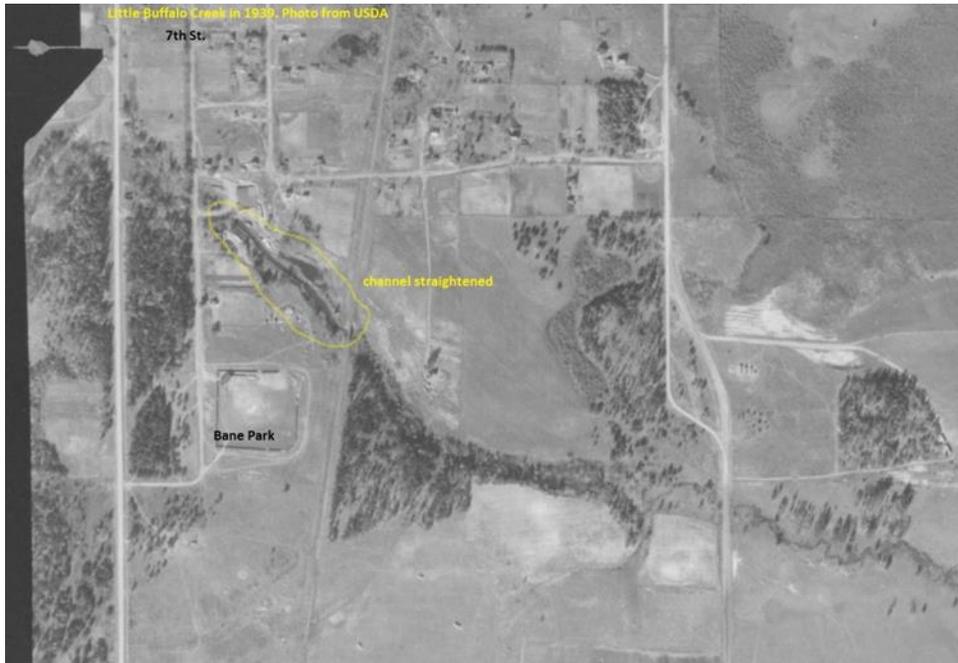
Figure 26: 1939 aerial image of Little Buffalo Creek in Brainerd, Minnesota. Note the yellow highlighted section where stream channel was straightened.

Review of 1939 aerial imagery confirms that this section of Little Buffalo has been altered for an extended period of time. Figure 26 shows the 1939 aerial image and has highlighted the area of Little Buffalo Creek that was straightened upstream of South 7th St. This area has been exporting sediment to the downstream portion for at least the last 80 years.

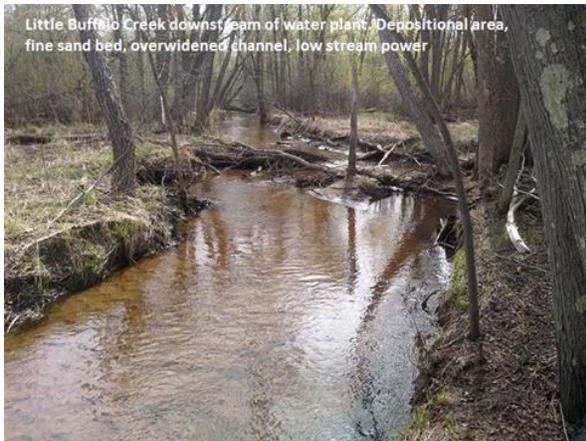
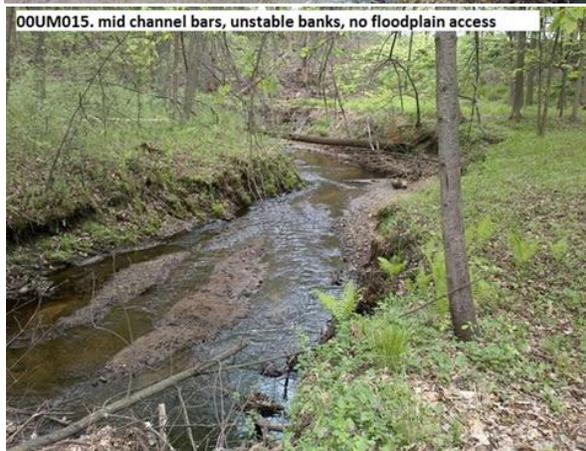
Photo 4: Photographs documenting various stream conditions along Little Buffalo Creek. Areas above the depositional zone are actively eroding, while the deposition zone is constantly being supplied with new sand being exported downstream.

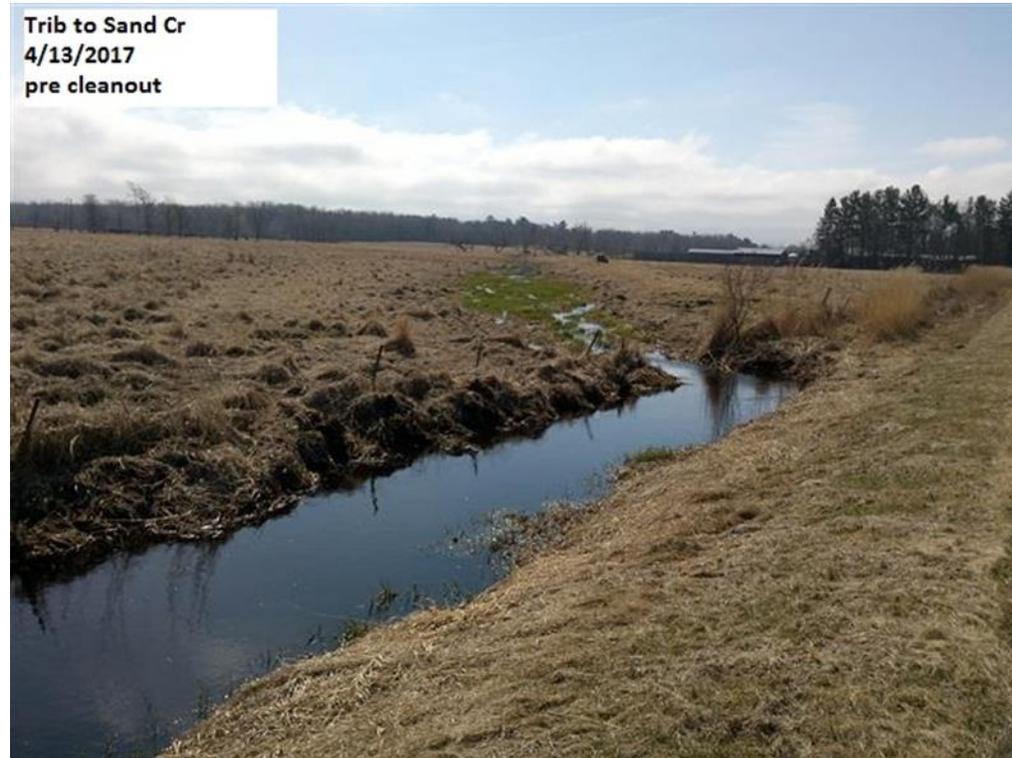
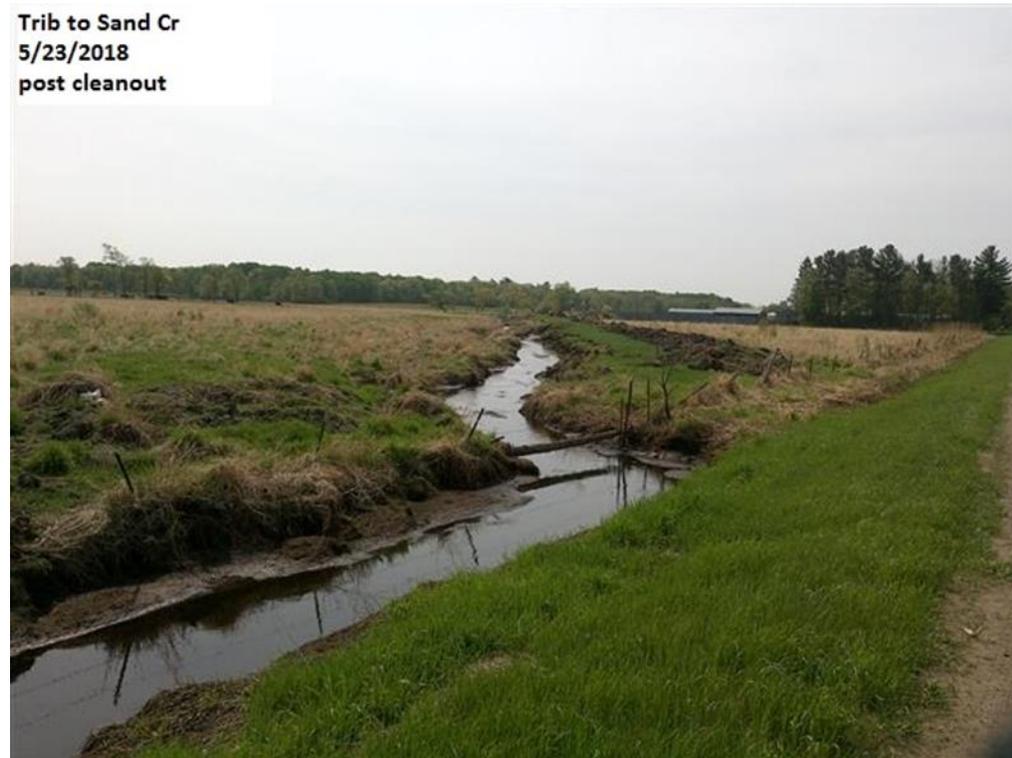
Photo 5: Pre and post ditch maintenance photos of sampling location 16UM042 on tributary to Sand Creek.

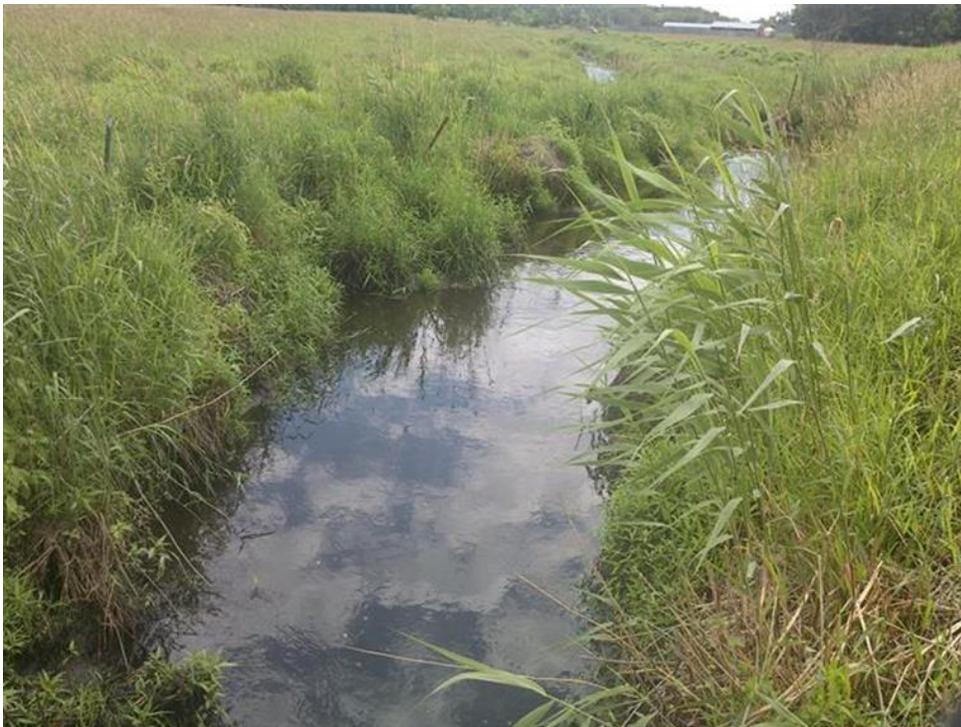
Photo 6: The photo was above taken on July 2, 2018 on the upstream side of CR159. The sonde was located on the upstream edge of the culvert at the road crossing.

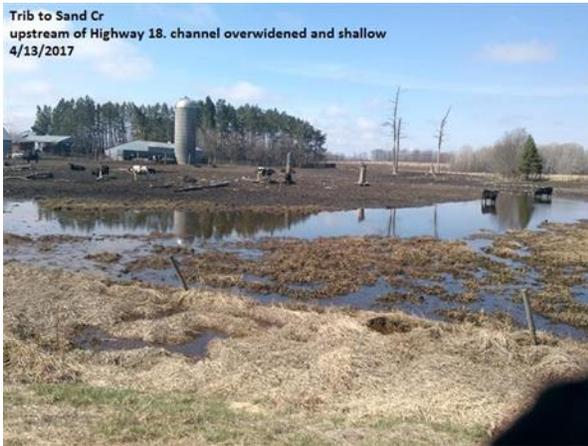
Trib to Sand Cr
upstream of Highway 18. channel overwidened and shallow
4/13/2017

Elevated phosphorus, and possibly suspended sediment, concentrations are being imported from a cattle operation located approximately 1.5 miles upstream of 16UM042. The area upstream is devoid of all vegetation and the channel is trampled to the point of a lack of stream channel. This area was visited many times during 2017 and 2018 to document any changes to the site's management. The photos below show the condition of the cattle yard in spring of 2017 and again spring of 2018. The channel at this location is very shallow and over widened. Cattle have direct access to the stream.

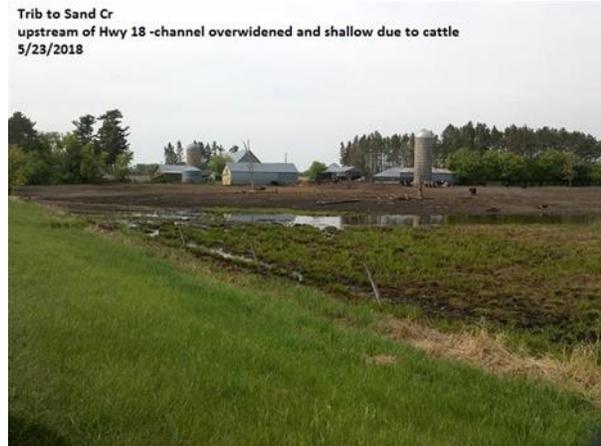
Trib to Sand Cr
upstream of Hwy 18 -channel overwidened and shallow due to cattle
5/23/2018

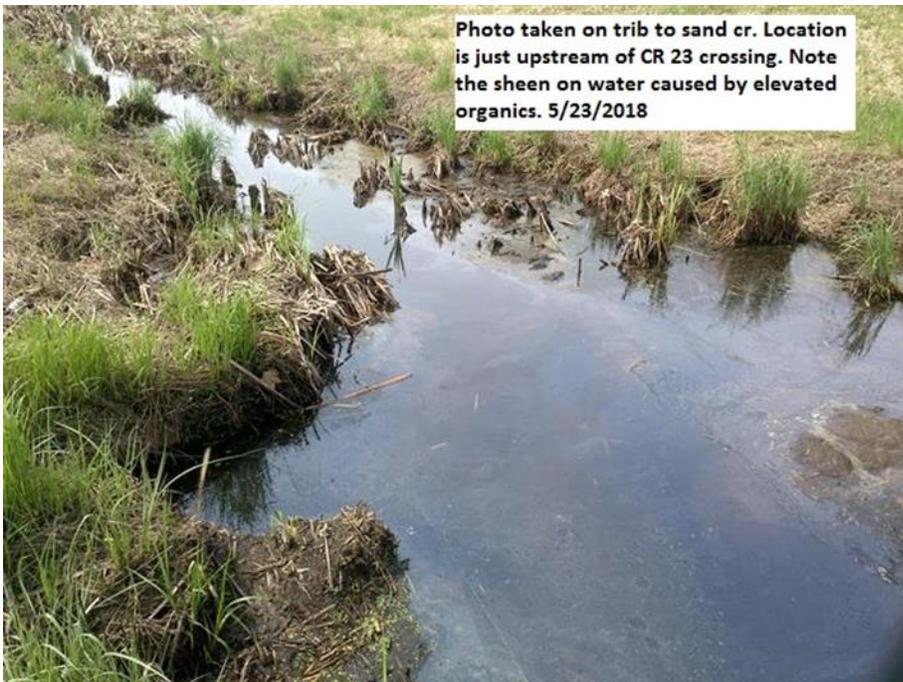
Photo taken on trib to sand cr. Location is just upstream of CR 23 crossing. Note the sheen on water caused by elevated organics. 5/23/2018

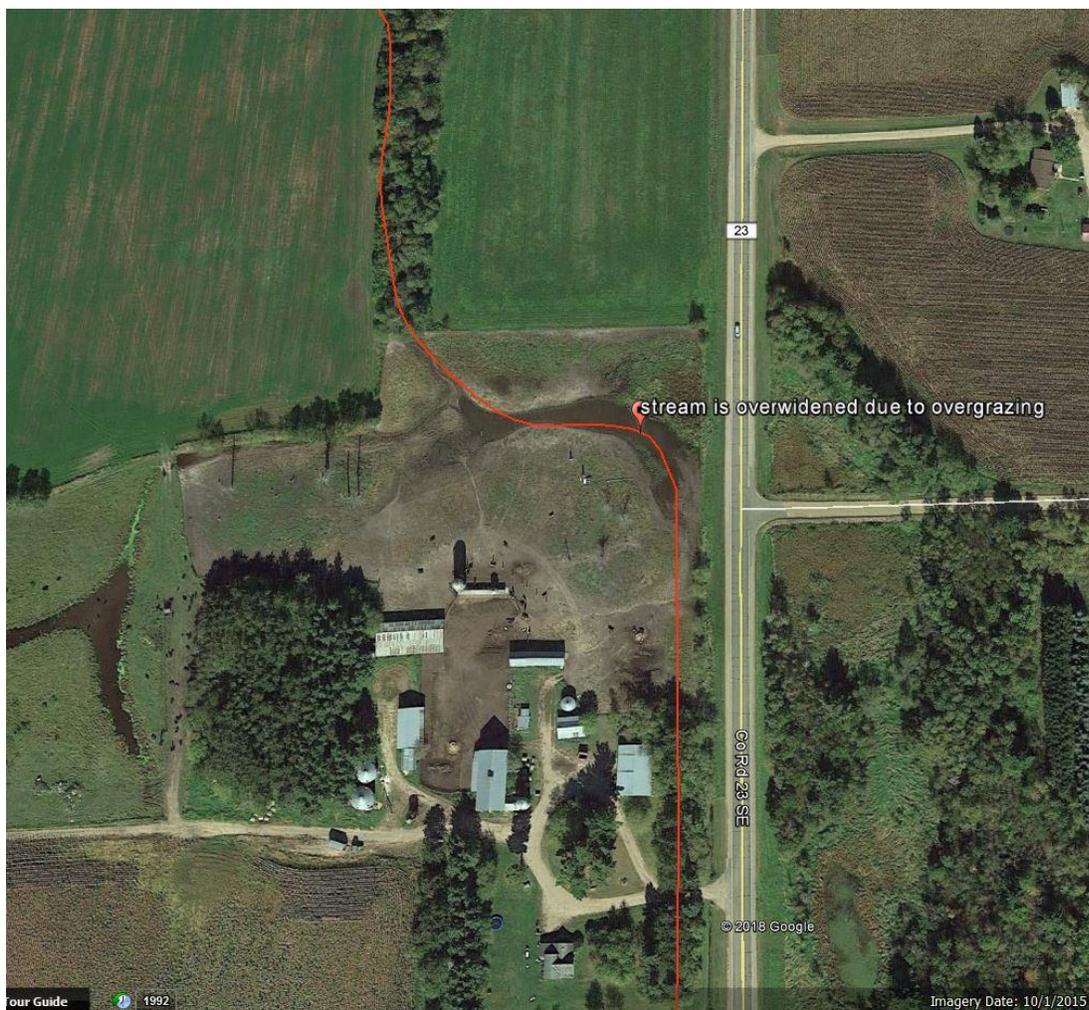
However, based on site visits, the pasture located on the west side of CR 23, approximately 0.5 miles south of the intersection of Highway 18, appears to be the largest single contributor of nutrients and bacteria. This particular farm has enough cattle to have eliminated all vegetation and entirely eroded the stream channel. There is no stream bank or confined area for the stream to stay contained in on this property. All of the manure will drain directly into the stream during rain events, as there is no vegetation throughout the growing season at this site. Review of aerial photography suggests that this site became overgrazed starting in 2011. Pre-2011 aerials show some vegetation along stream corridor, reviewing the 2013 aerial and newer shows no vegetation and the stream channel is disappearing (photo below is from June 2015).

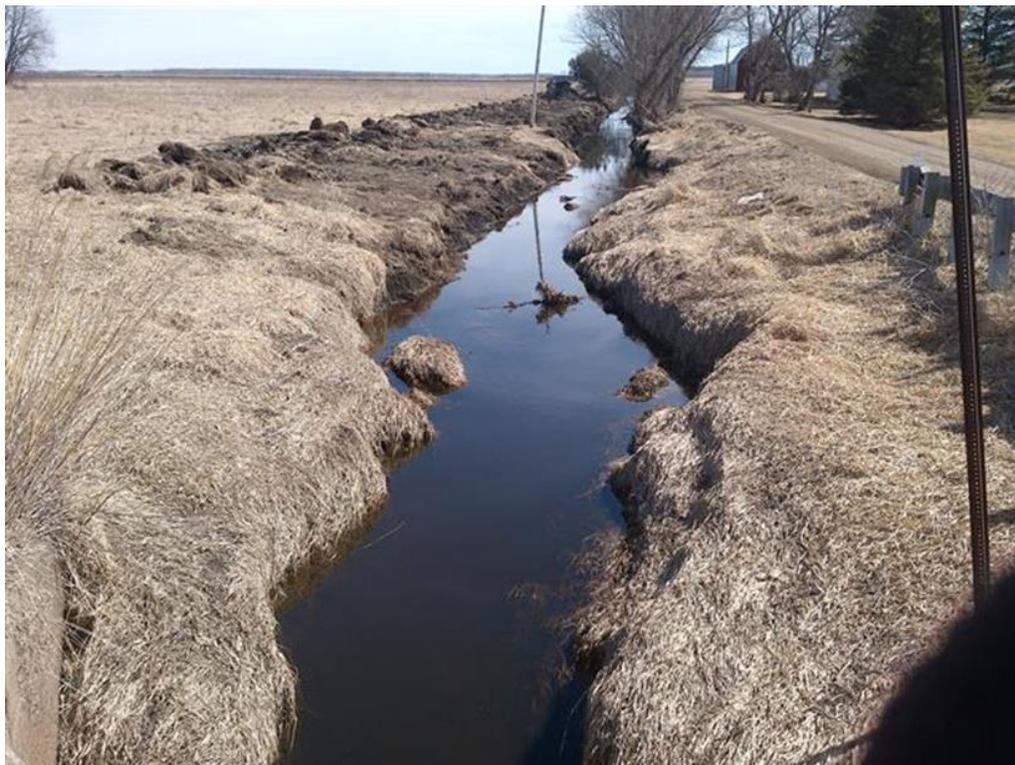
Photo 7: Maintenance of private ditch entering Sisabagamah Creek just upstream of Highway 169. Note spoil piles and no erosion control measures at site.

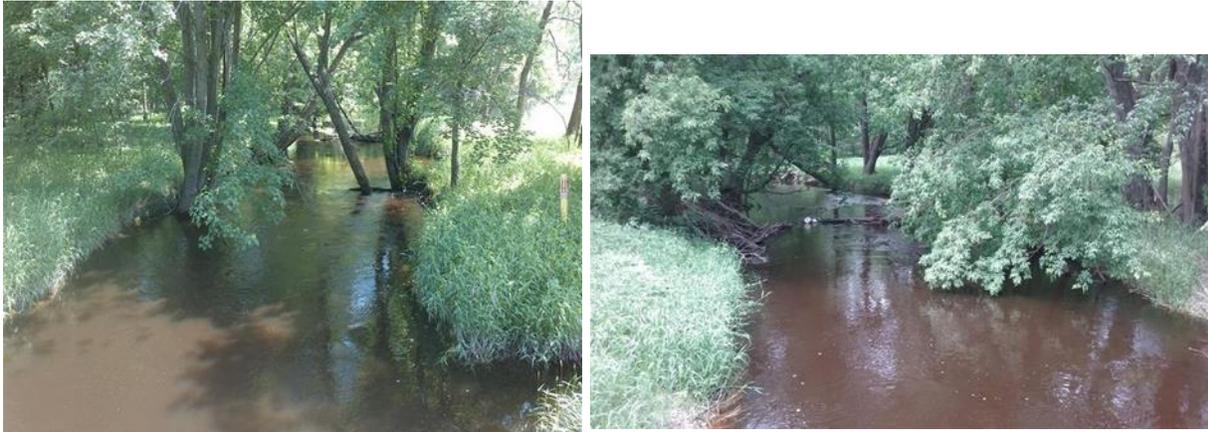
Photo 8: High flow event from 6/18/2018 on the left and the receding flow from 6/21/2018 on the right. Both photos show milky looking water with suspended sediment being transported downstream.

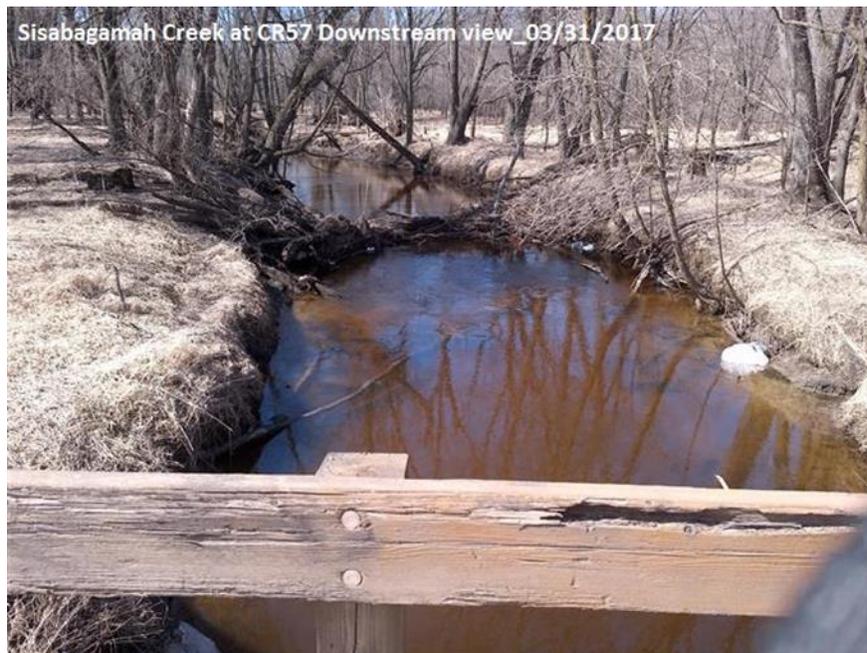
Photo 9: Low flow period on Sisabagamah Creek. Showing sand substrate and wide stream channel.

The sampling location for macroinvertebrates is downstream of CR54. Photo 9 below was taken on 3/31/2017 looking downstream at the sampling location. We can see from the photo that the stream channel is over widened and the substrate is dominated by sand. This sand substrate has been filling pools and creating an embeddedness issue throughout this lower reach. As stream banks erode, trees are falling into the channel creating logjams and depositing more sand and fine sediment in the channel.

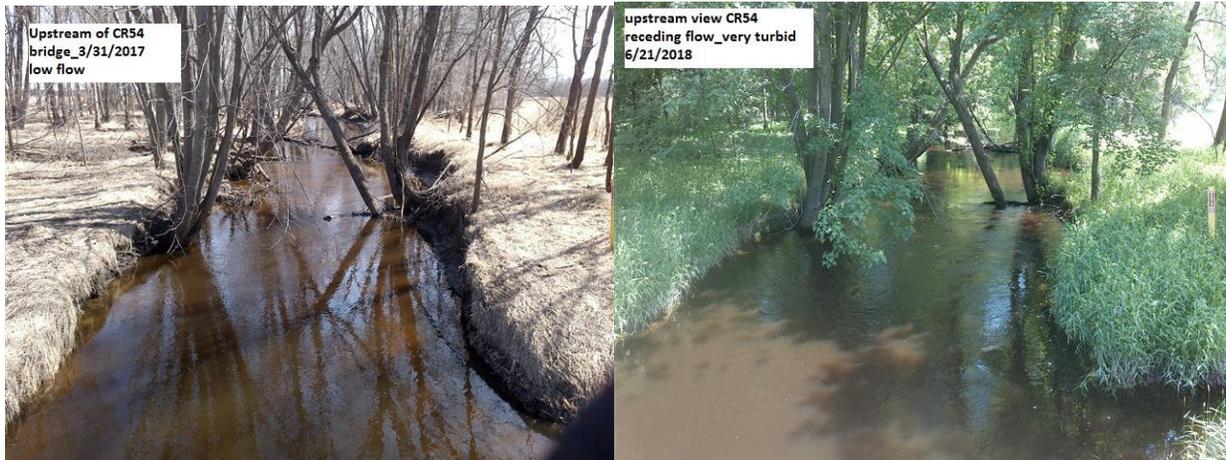
Photographs at the CR54 road crossing show the impacts of sediment export at various times of the year with differing flow regimes. At low flow conditions in spring of 2017, there was very little sediment in the water. This coincided with little snow melt and before any spring rains occurred. On June 21, 2018, the stream was very turbid following a significant (2-4 inch) rainfall. Much of this fine sediment is being introduced to the stream from the ditch network just north of the U.S. Highway 169 crossing. Sampling on the same date at 16UM046, which is upstream of U.S. Highway 169, showed that there was no turbidity and the Secchi tube reading was 100 cm, which is the maximum.

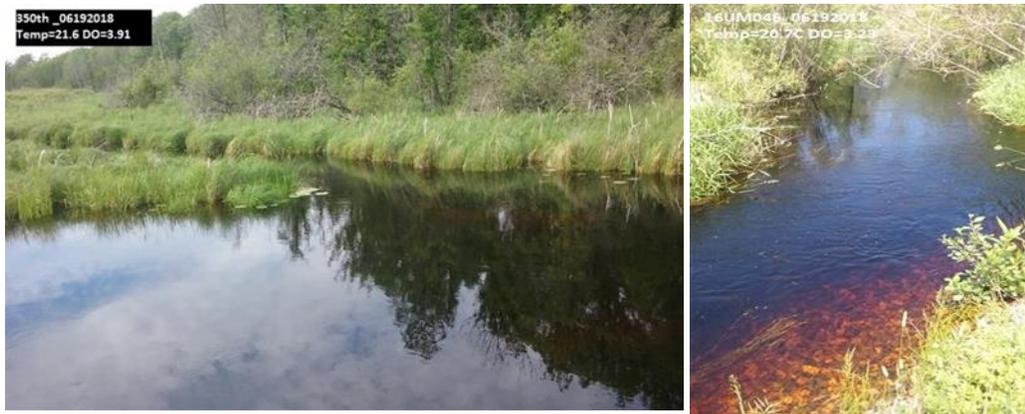
Photo 10: Sisabagamah Creek flow conditions during the June 19, 2018 water quality sampling events. Flow was high (40 cfs).

The photos below document the conditions during the various DO sampling events in 2018. DO concentrations were below the 5 mg/L standard during all sampling visits in the summer of 2018. The top photos (Photo 10) were taken on 6/19/2018 following a significant 2-4 inch rain event that increased stream flow dramatically. The theory with the low DO this year is that the wetland riparian fringe flooded and as water receded the SOD and/or BOD that was washed into the stream corridor was stripping the DO from the stream. Limited reaeration occurs in this reach as the gradient is very flat and there are no riffles. During the August 28, 2018 site visits, (Photo 11) stream flow was once again very low in this section of Sisabagamah creek. Stream flow at S013-493 was 0.5 cfs on this date and stream flow at the 350th street crossing was 0.2 cfs. The DO concentrations were recorded as 2.9 and 1.63 mg/L respectively at the two locations.

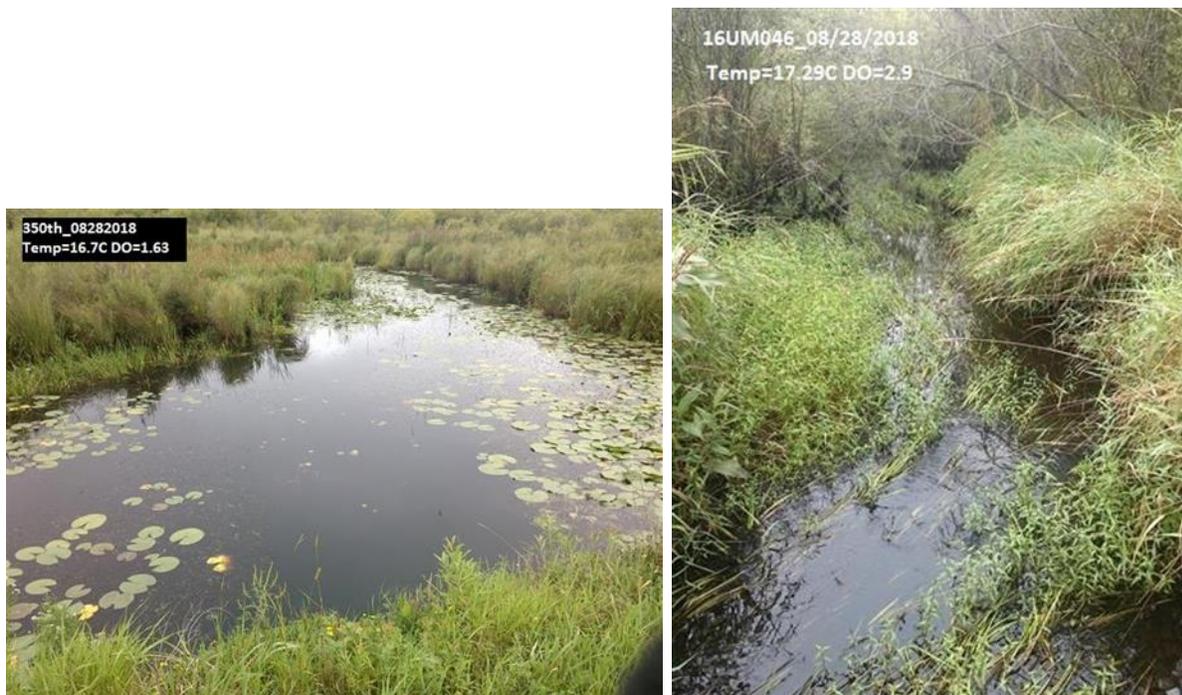
Photo 11: Sisabagamah creek flow conditions during the August 28, 2018 water quality-sampling event. Flow was 0.5 cfs.

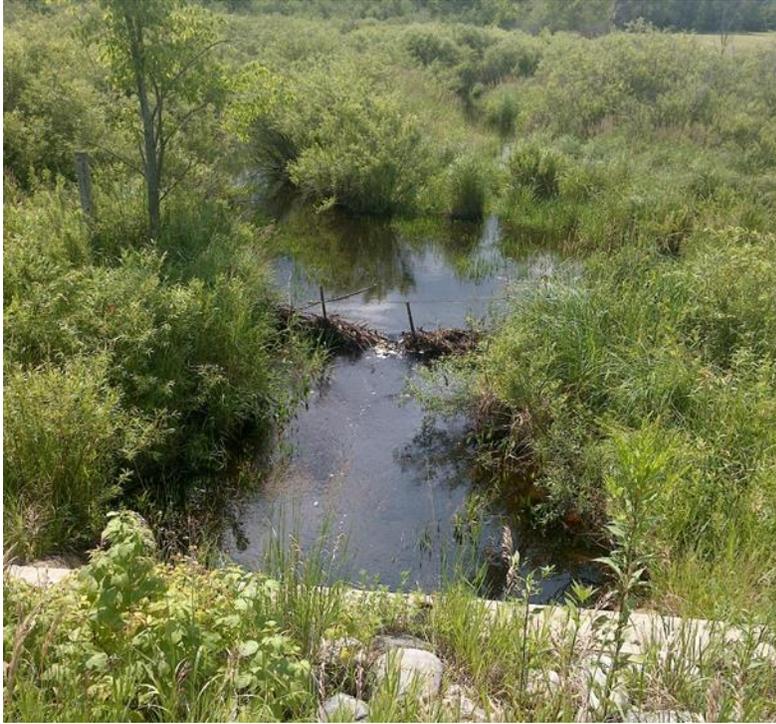
Photo 13: Beaver dams located on upstream side of Highway 47 road crossing. July 10, 2017.

During field visits in 2017 and 2018 it was documented that a large beaver dam was located just downstream of the private driveway crossing downstream of Hwy 47. This beaver dam posed a 1.5-foot drop during a survey conducted on April 27, 2018. Photo 13 shows the condition of the beaver dam during this elevation survey.

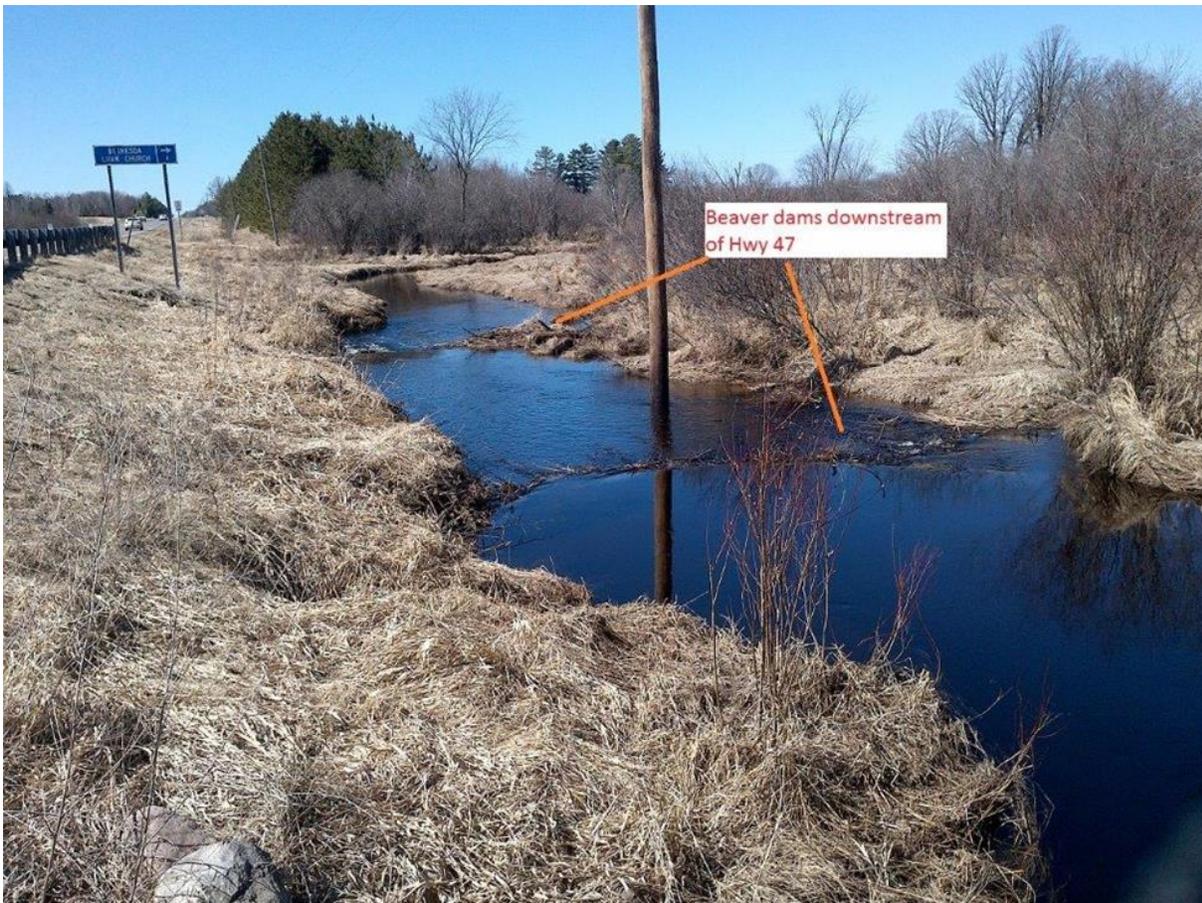
Photo 14: Beaver dams located on Sisabagamah Creek just downstream of the confluence of Rabbit Creek and Sisabagamah creek on the downstream side of Highway 47.

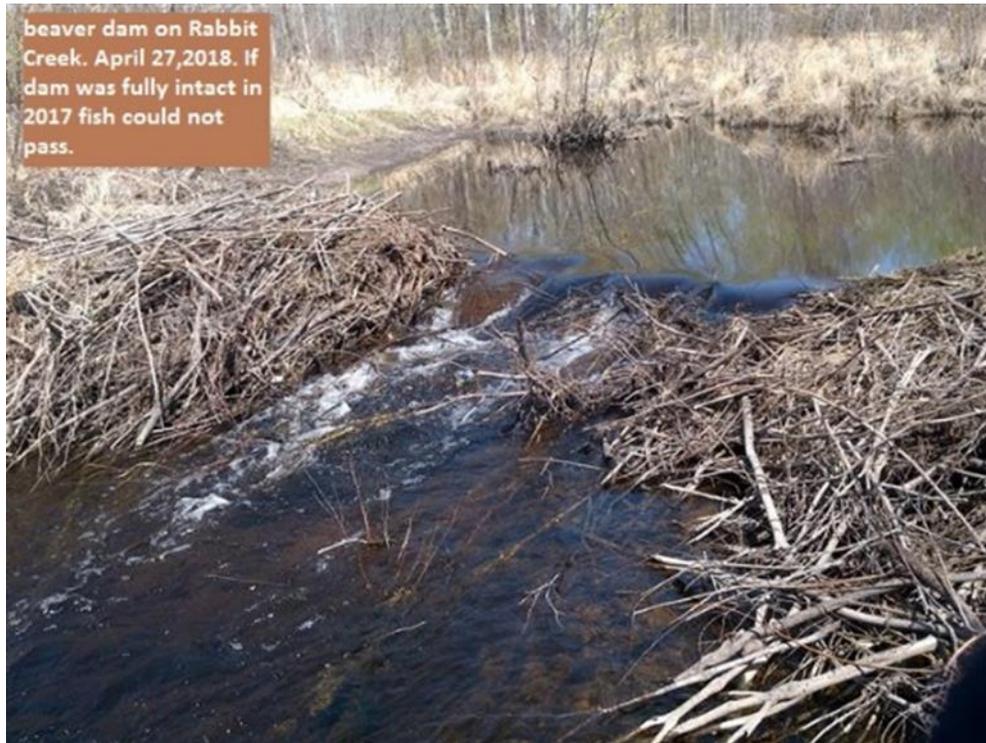
Photo 15: Large beaver dam located approximately 400 feet downstream of private driveway on Rabbit Creek. This beaver dam is backing up water and has the potential to block fish passage. Location is also downstream of site 16UM032.

Of note, the fish community in Rabbit Creek seems to be more stressed than the macroinvertebrates. The fish IBI scored 7.7 points below the threshold of impairment, while the macroinvertebrates scored 8.2 points above the threshold. It is believed that the downstream beaver dam is causing the greatest impact on the fish community. However, during periods of heavy rainfall, the DO concentrations will drop below the 5 mg/L level and will also affect the biological diversity of both fish and macroinvertebrates. This low DO is caused by naturally occurring wetland complexes located upstream of the sampling area.

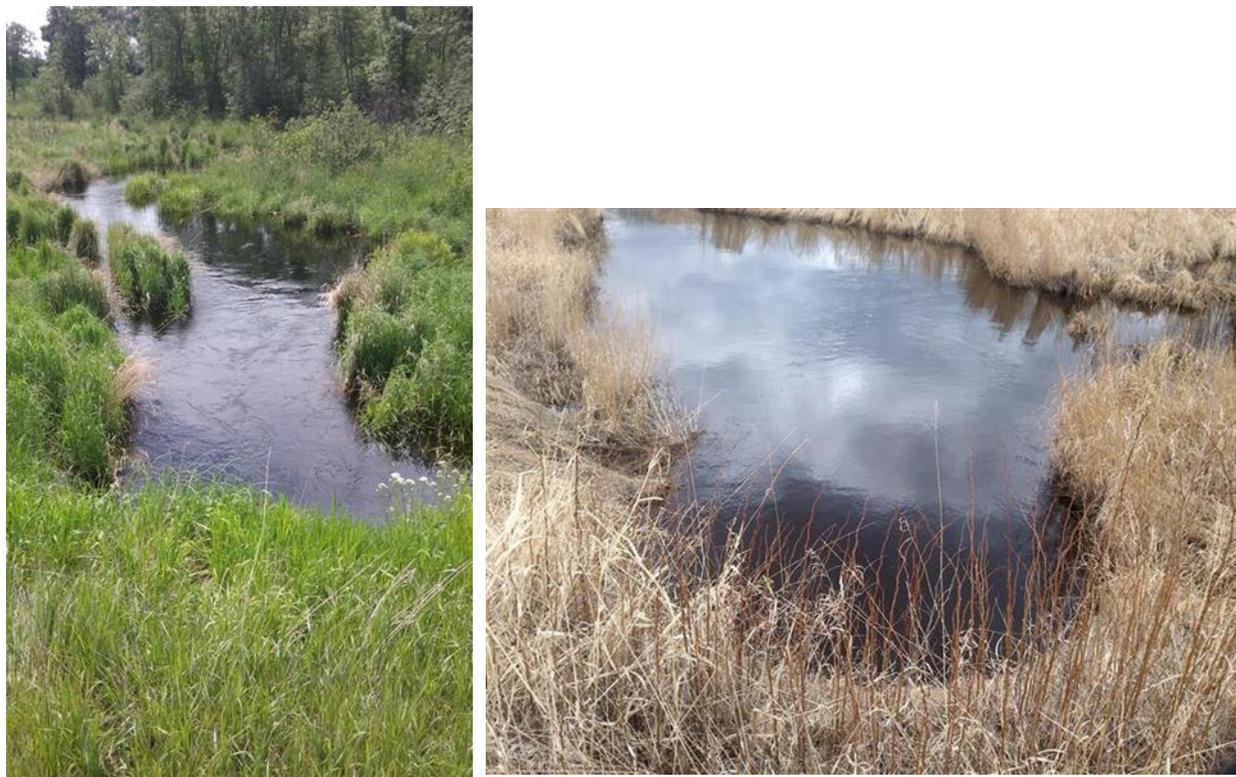
Photo 16: Rabbit Creek site visit photos. Photo on the left is upstream side Hwy 47 on June 19, 2018, the photo on the right is upstream side Hwy 47 on April 27, 2018. Both are high flow events.

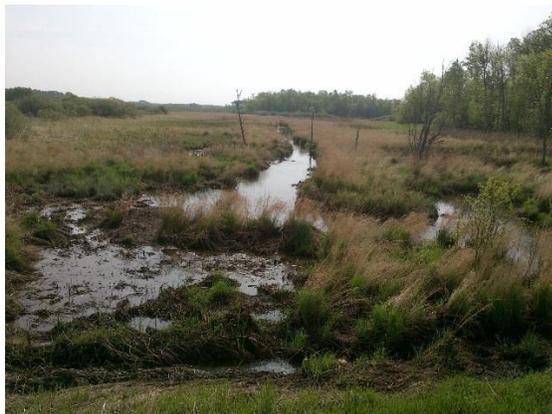
The following picture was taken on May 24, 2018 at the site on Dove Road, 16UM011/S013-472. This photo is looking upstream and shows the condition of the wetland riparian area along the reach.

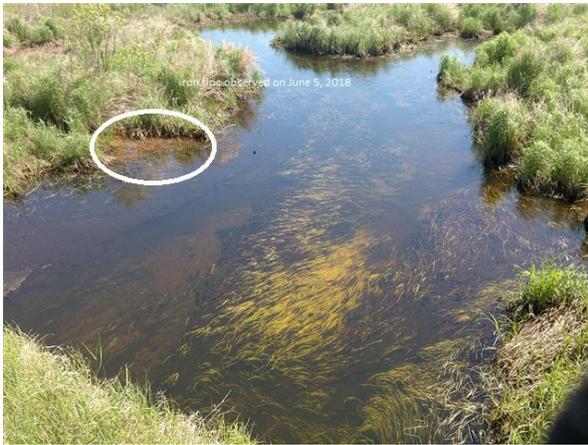
June 5, 2018 photo

Field visits during data collection throughout 2018 verify that low DO is probably the main stressor in AUID 682. Nutrient levels are elevated but do not appear to be the driving force behind the low DO conditions. Daily DO flux for the short deployment was around 3 mg/L but the deployment only lasted for 3 days so the record is short and it is not clear if eutrophication is a main driver of the low DO. The upstream AUID, which does not have the same wetland influence in the riparian, has a DO flux of around 1mg/L. This site has very similar water chemistry concentrations but does not respond like the downstream site that has a higher percentage of wetland acres draining through it. There is a substantial amount of submerged plant growth in the stream as can be seen in the pictures below. In addition, the pictures show some low DO ground water input, evidenced by the iron precipitate in the photo.

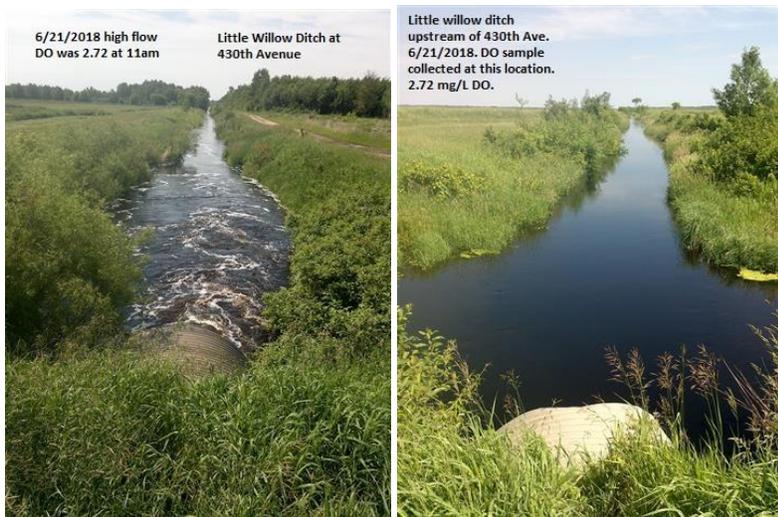
The photograph displayed here shows the high stream flow and turbulent stream velocity exiting the culvert at 430th Ave along with the upstream side of culvert where DO readings were collected.

Lack of habitat is also a problem in this AUID. This entire AUID is channelized and has the sole purpose of supplying water to the neighboring wild rice paddies. Sampling was conducted downstream of 430th Avenue and this crossing is influenced by an undersized culvert. Water has very high velocity as it leaves the culvert and causing a redistribution of sediment locally. At the sampling site further downstream, the culvert is no longer influencing the substrate, however the substrate in the sampling reach is sand and clay with some minor silt, and detritus along the edges. There are no pools, no channel depth variability, and no rock or gravel riffles. The only available habitat for macroinvertebrates was very small woody debris in the form of twigs (mobile during high flows) undercut banks, overhanging vegetation, and submerged macrophytes. If the water levels drop substantially during the pumping season much of the overhanging vegetation and undercut bank habitat would become dry and not available for macroinvertebrates to utilize.
