April 2025

# Redeye River Watershed Stressor Identification Report Update 2025

A study of local stressors limiting the biotic communities in the Redeye River Watershed.

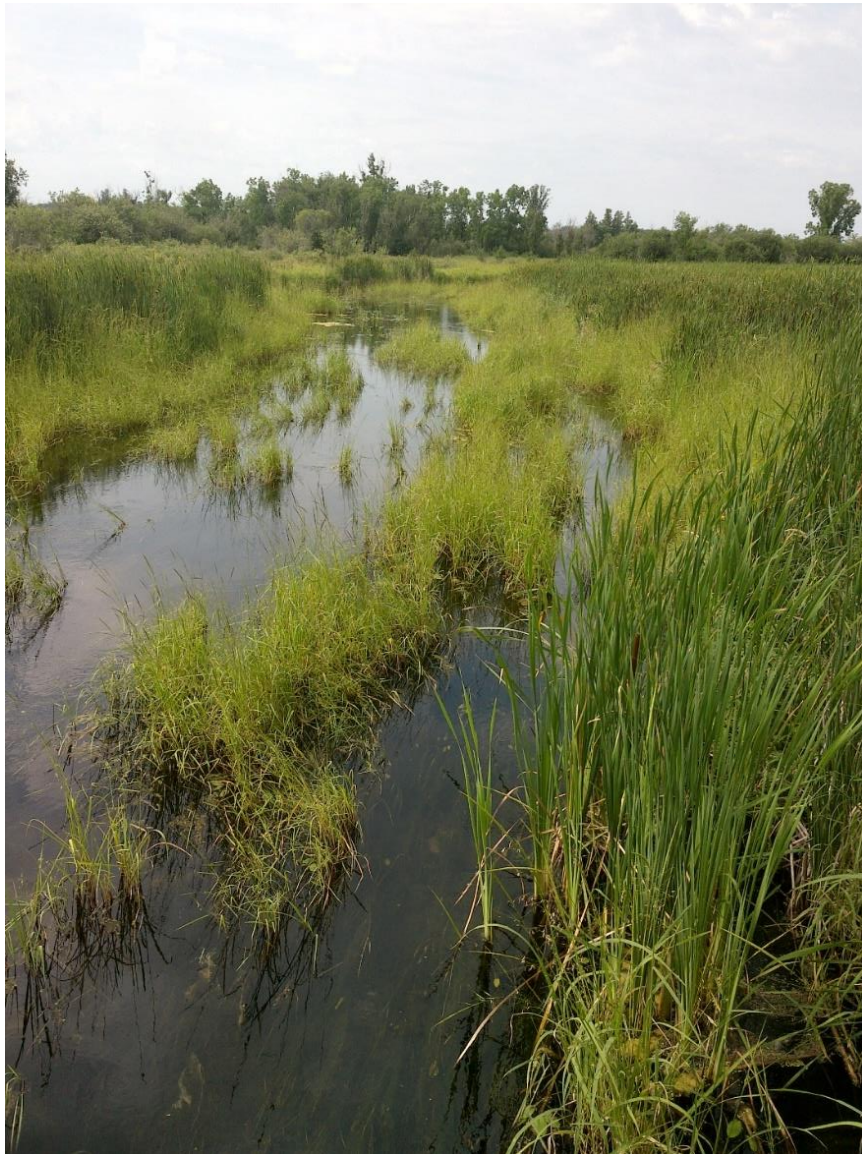
Dissolved oxygen (DO) samples exceeded the state 5 mg/L standard 52.4% of the samples. This reach of the Leaf River has extensive submerged and emergent aquatic plant growth. Wild rice grows extensively in this upper portion of the Leaf River as can be seen from the below photo taken on August 1, 2023.

**Figure 4: Leaf River wetland conditions, showing low gradient and wild rice growth in channel.**

The extensive plant growth causes low DO concentrations during the evening hours as plant and periphyton growth respire. During the fall as the plant and periphyton start to die off the DO concentrations can stay below the standard during the entire 24 hour cycle. Fish were sampled on 9/28/2011, which is late in the summer season and was quite possibly after the wild rice started to decompose and DO levels were abnormally low in that reach. The 6/22/2022 fish sample would have occurred early enough in the growing season of the wild rice that the channel would have had above state standard levels of DO. Since fish are mobile it is anticipated that the fish would probably have moved outside of the area of low DO influence during these periods in the fall.

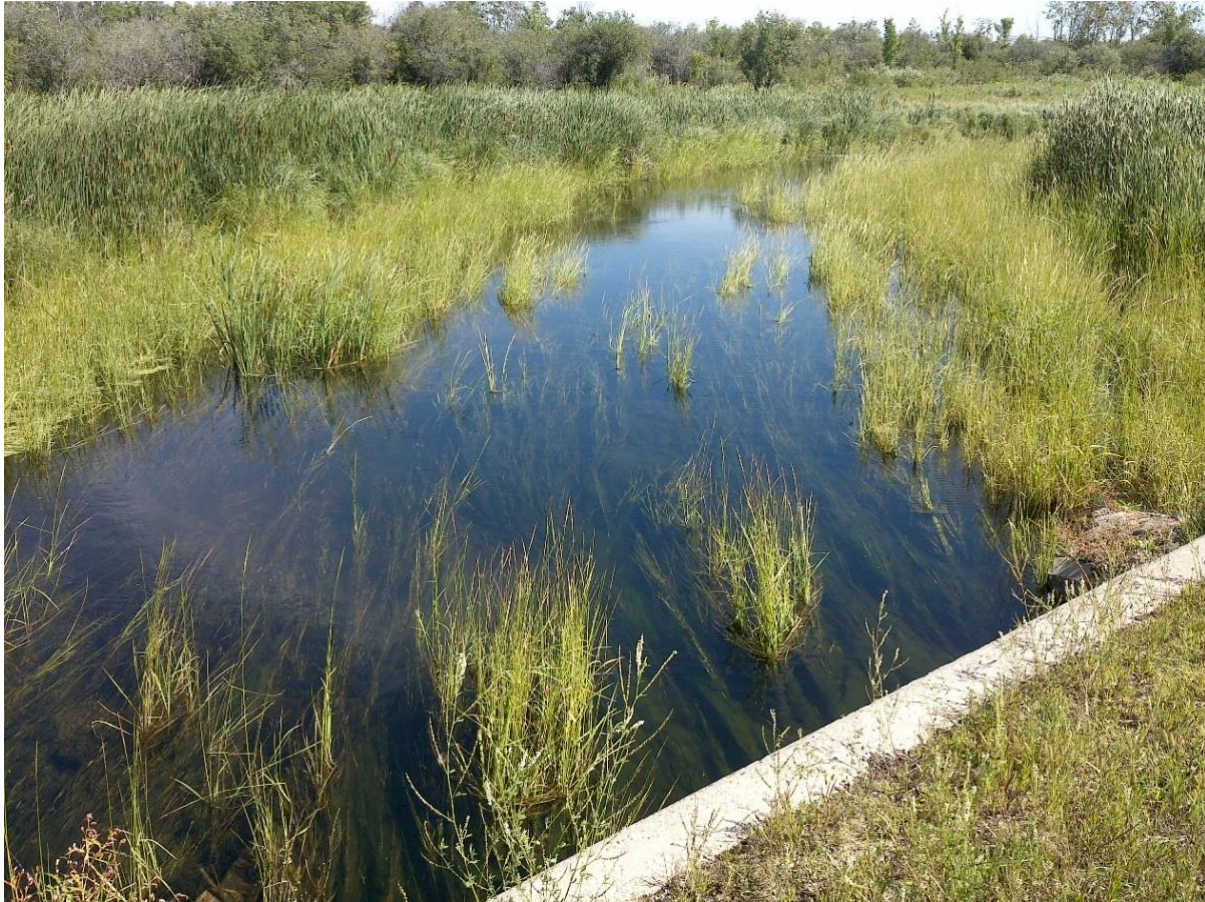
Over time, there have been many changes on the landscape that have changed the natural hydrology and geomorphology of Leaf River, and the entire subwatershed. The most significant historical changes to the landscape have been land conversion from mature forests to hay/pasture/crop land and woody wetlands and the channelization of the natural streams and wetlands. Leaf River has been straightened along the entire length of the AUID. Historically, Leaf River was comprised of multiple wetlands and small stream channels. The channel was altered to drain the landscape, starting from the Southwest and ending downstream of Highway 71. Prior to channelization the reach of stream was 16.06 miles long. Following the channelization project, the stream length is 11.86 miles. This equates to a loss of 4.2 miles of channel. This will affect the slope and the length of travel time that it takes water to flow through the stream reach. This channel alteration accelerates stream flow, resulting in higher flows during precipitation events, which achieves the agricultural land use drainage goals, but causes instability. Water leaves the landscape quickly, resulting in periods of higher flow than what would have naturally occurred. As the landscape drains, water that was once held in the upstream wetlands is flushed downstream, carrying low DO water throughout the reach. Then, as these flows quickly drain, the flow regime quickly transitions to slow moving discharge from East Leaf Lake, reaching low conditions

starting early in the late summer (Figure 8). Although 2023 was a dry summer, Leaf River maintained flow throughout the summer, a result from the large snowpack from the winter and the volume of water passing through the Leaf Lake chain of lakes. This reach is very low gradient and has very slow stream velocities for large portions of the summer and fall.

**Figure 8: Leaf River at S012-039 on August 15, 2023.**

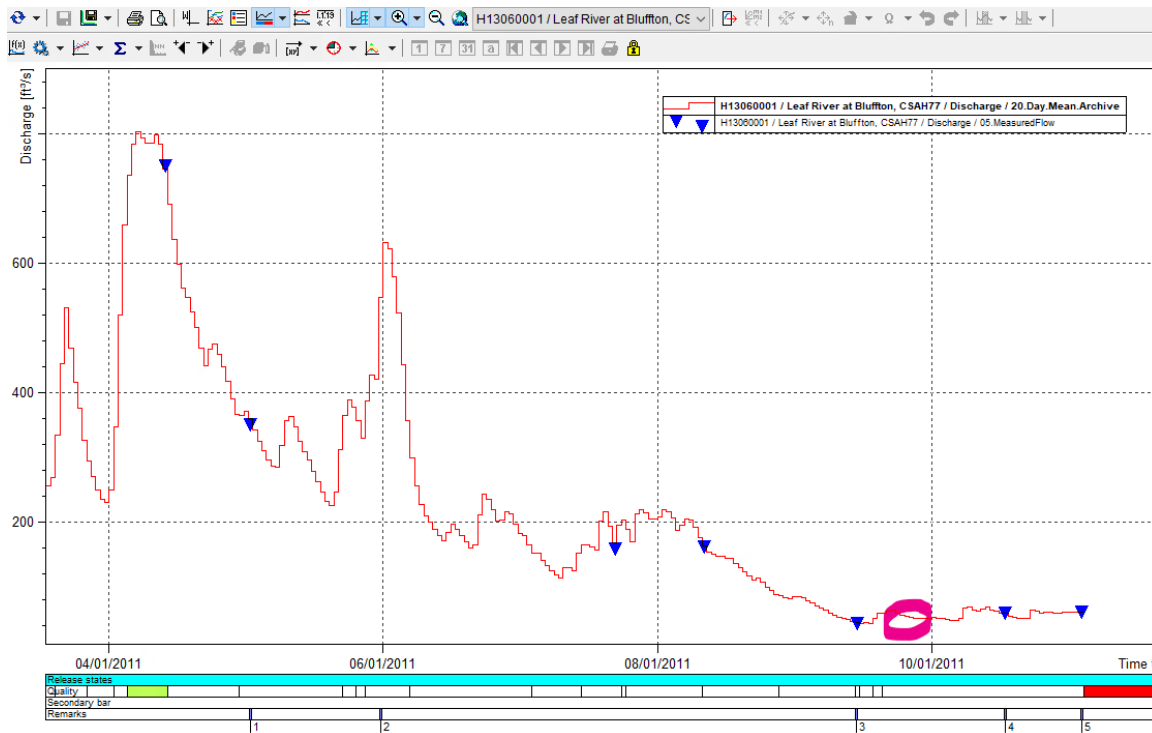
Figure 10: Flow conditions during the 9/28/2011 fish sampling event. FBI score was 32.2 during this visit represented by the red circle on the graph.

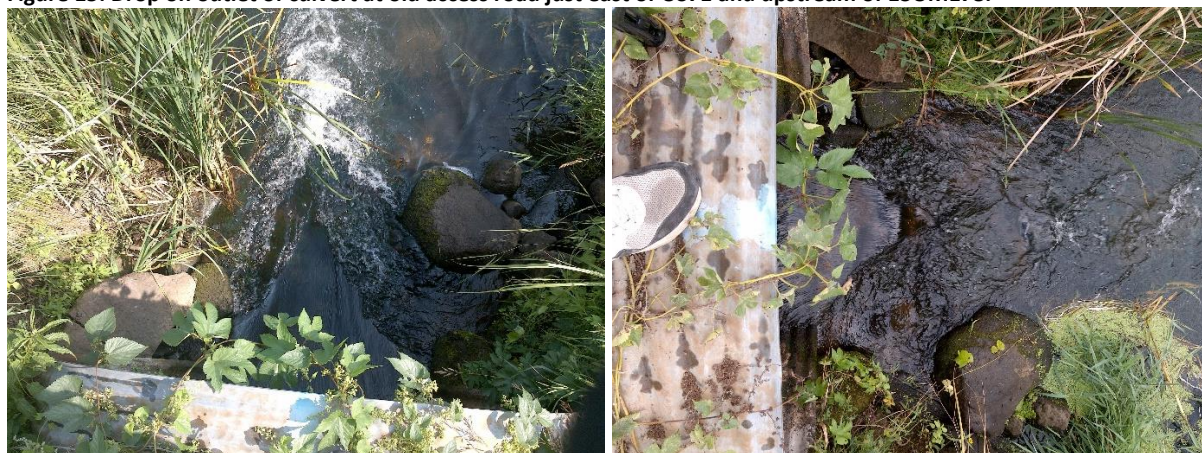
There is one connectivity barrier between 13UM177 and 13UM178. This barrier is located on an old path that accesses the stream off of US71 just upstream of 13UM178. This culvert is mainly a barrier during certain flow regimes where the velocity inhibits free passage of many smaller fish species as can be seen in Figure 15 below.

Figure 15: Drop on outlet of culvert at old access road just east of US71 and upstream of 13UM178.

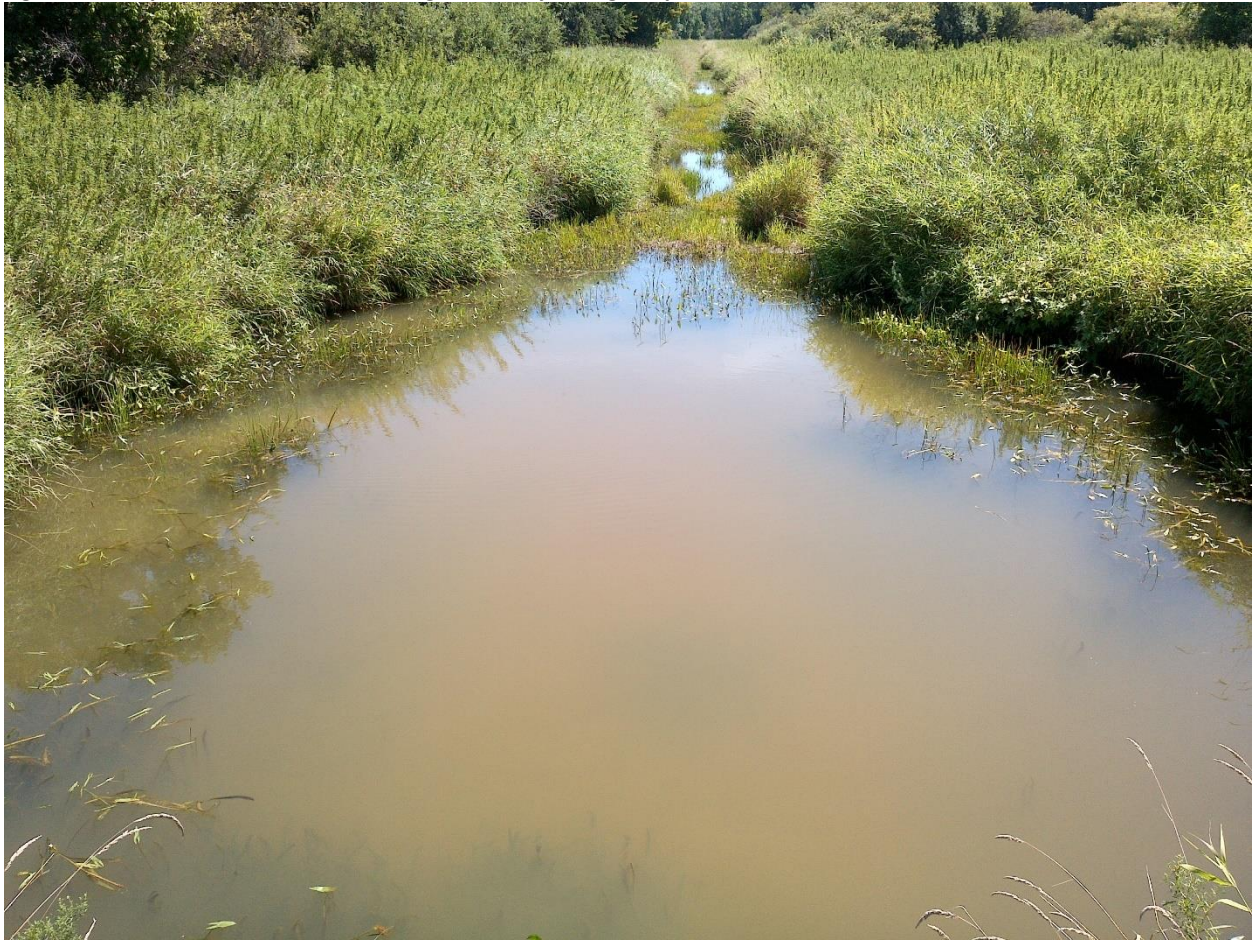
If DO is below 5 mg/L for extended periods of time, biological communities can be severely impacted. DO was collected 14 times in 2011 and 2023 (Table 5). The average DO concentration was 7.83 mg/L. Of the DO concentrations collected, 21% were below the 5 mg/L standard for 2B waters. The low DO readings occurred during the mid to late summer months when water levels were below normal during the very dry summer of 2023. Much of central Minnesota was in a moderate to severe drought in 2023.

**Figure 17: The photo below shows standing water only during a September 19, 2023, site visit.**

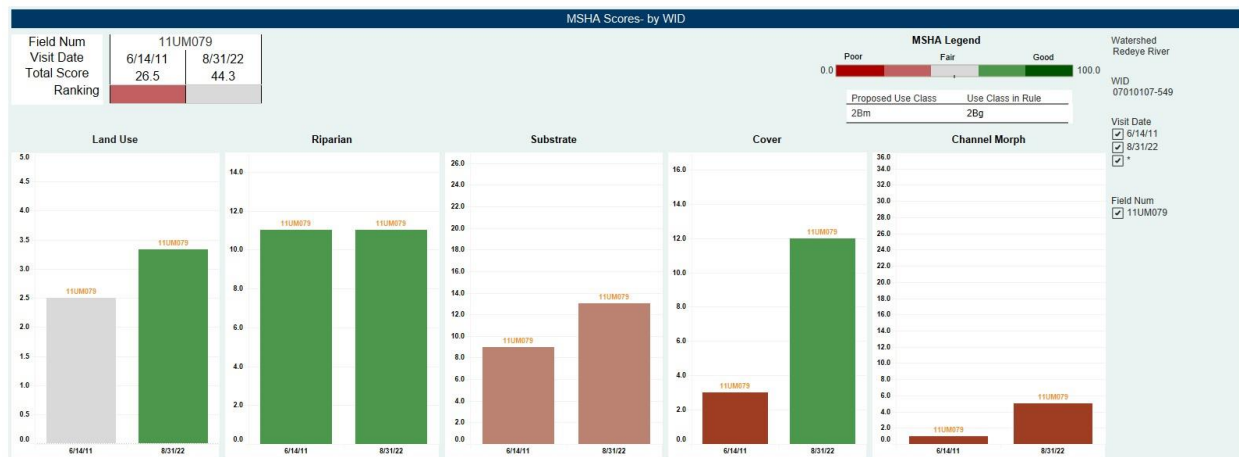
Habitat was classified as poor-fair on CD13, through the MSHA evaluation at the two fish sample sites (Figure 18).

**Figure 18: MSHA habitat scores for CD13.**

Although the MSHA score was poor-fair overall, substrate and channel morphology scored particularly low as noted in Figure 18. Substrate was the first low scoring component of the MSHA score, as indicated by the dominance of sand and silt. Healthy fish communities need coarse substrate in order to build nests and spawn. Excessive fine sediment also affects juvenile fishes, as the sediment is stirred into the water column creating TSS, it can easily tear sensitive juvenile fish gills. Similarly, many sensitive macroinvertebrates also have specialized gills that are used to breathe DO. Excessive fine sediments can damage these gills, similar to juvenile fishes, making the creek inhabitable for sensitive species.

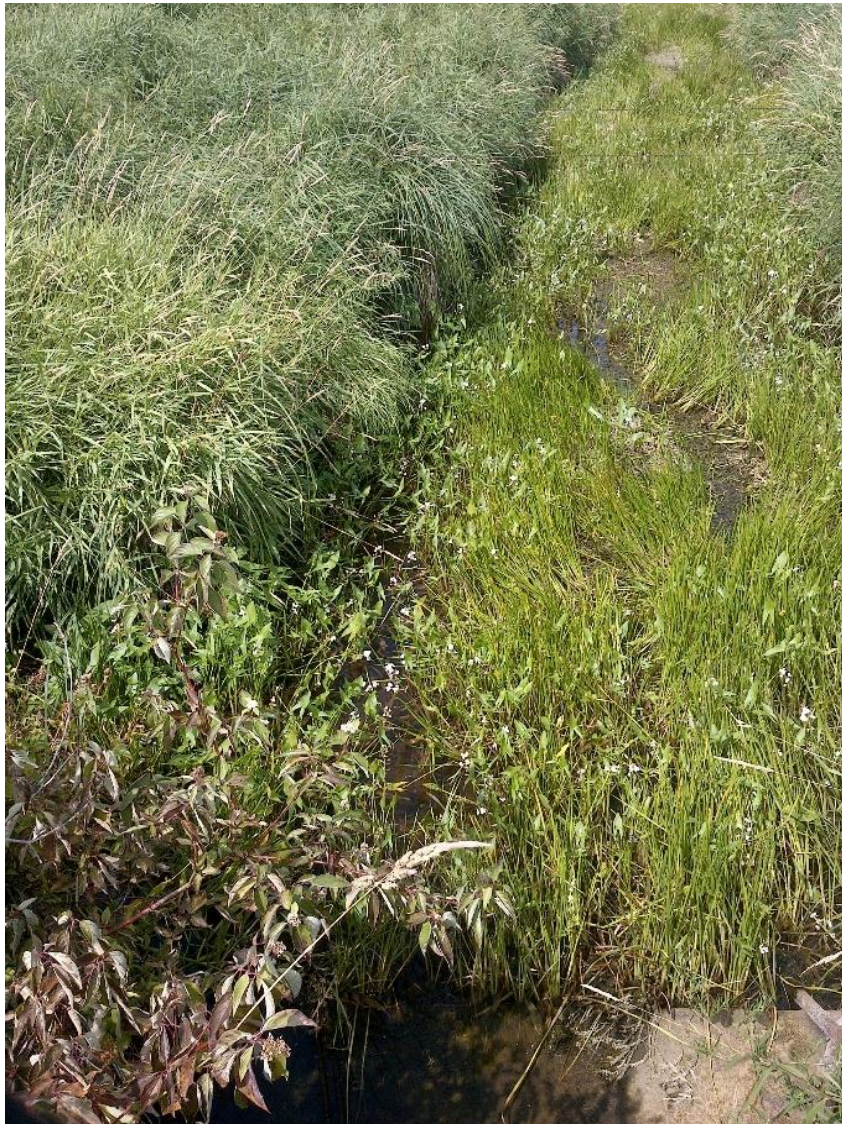
As the channel was altered to drain the landscape, a new channel was cut through mixed forest and woody wetlands, creating a direct connection to Wing River. This channel alteration accelerates stream flow, resulting in higher flows during precipitation events which achieves the agricultural land use drainage goals, but causes instability. Water leaves the landscape quickly, resulting in periods of higher flow than what would have naturally occurred. As the landscape drains, water that was once held in the upstream wetlands is flushed downstream, carrying low DO water throughout the reach. Then, as these flows quickly drain, the flow regime quickly transitions to intermittent, reaching stagnant conditions starting mid- late in the summer (Figure 19, Figure 20). Although 2023 was a dry summer, CD13 was already mostly dry by late July. The water that was present in the channel was very shallow groundwater seeping into the channel.

**Figure 19: CD13 on August 1, 2023. Channel was nearly dry and not connected either upstream or downstream of the road crossing.**

Therefore, due to the altered hydrology and geomorphology of CD13 causing the channel to dry up, it is considered to be the primary stressor within CD13.

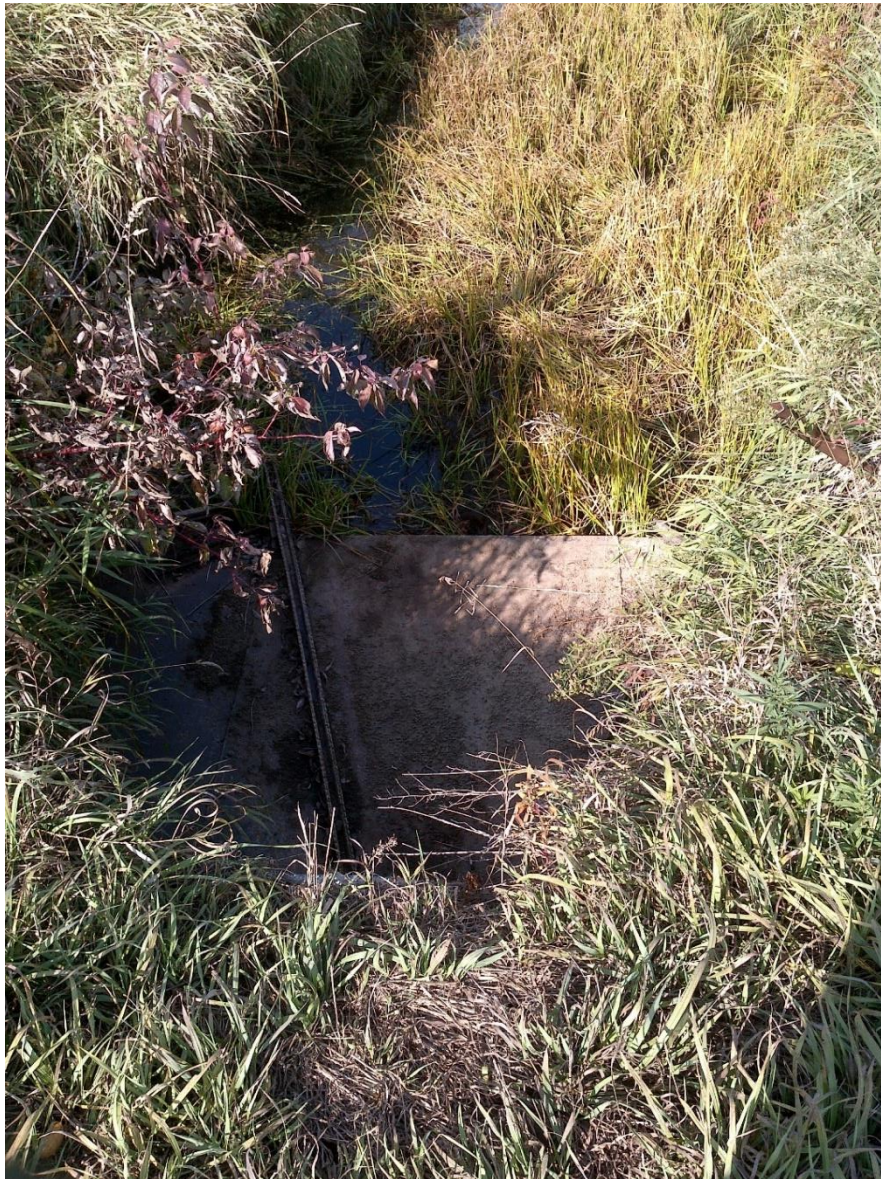
**Figure 20: CD13 on 9/19/23, showing a dry channel.**

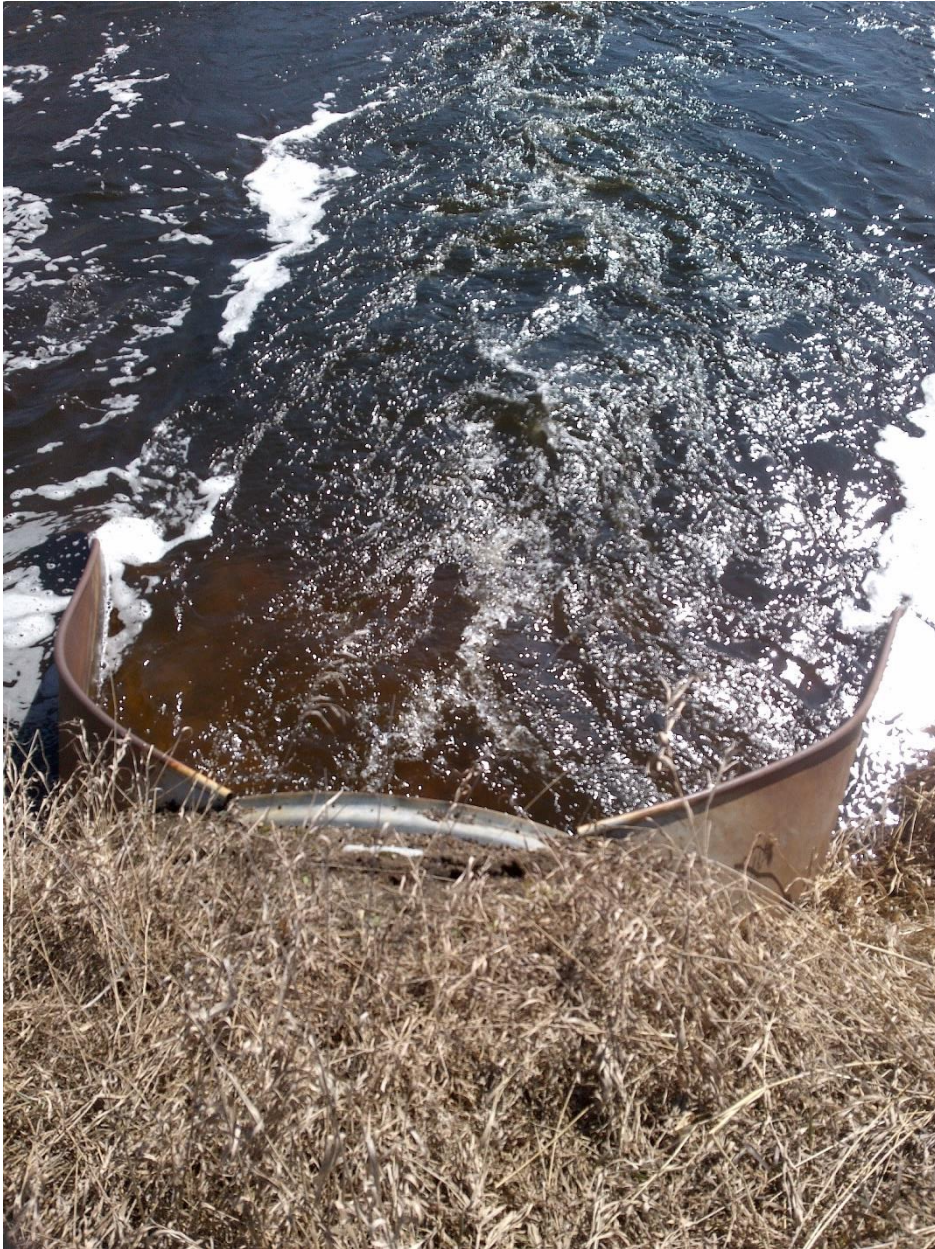
The culvert crossing by 11UM079 off 106th Street. does appear to be a fish barrier. The culvert on 106<sup>th</sup> Street has very high velocities during high flows and very shallow water levels during low flows as seen in Figure 21 and Figure 22 below. This culvert is a barrier to fish movement during certain flow regimes.

Figure 21: CD13 on 4/25/2023, showing high velocity leaving culvert.

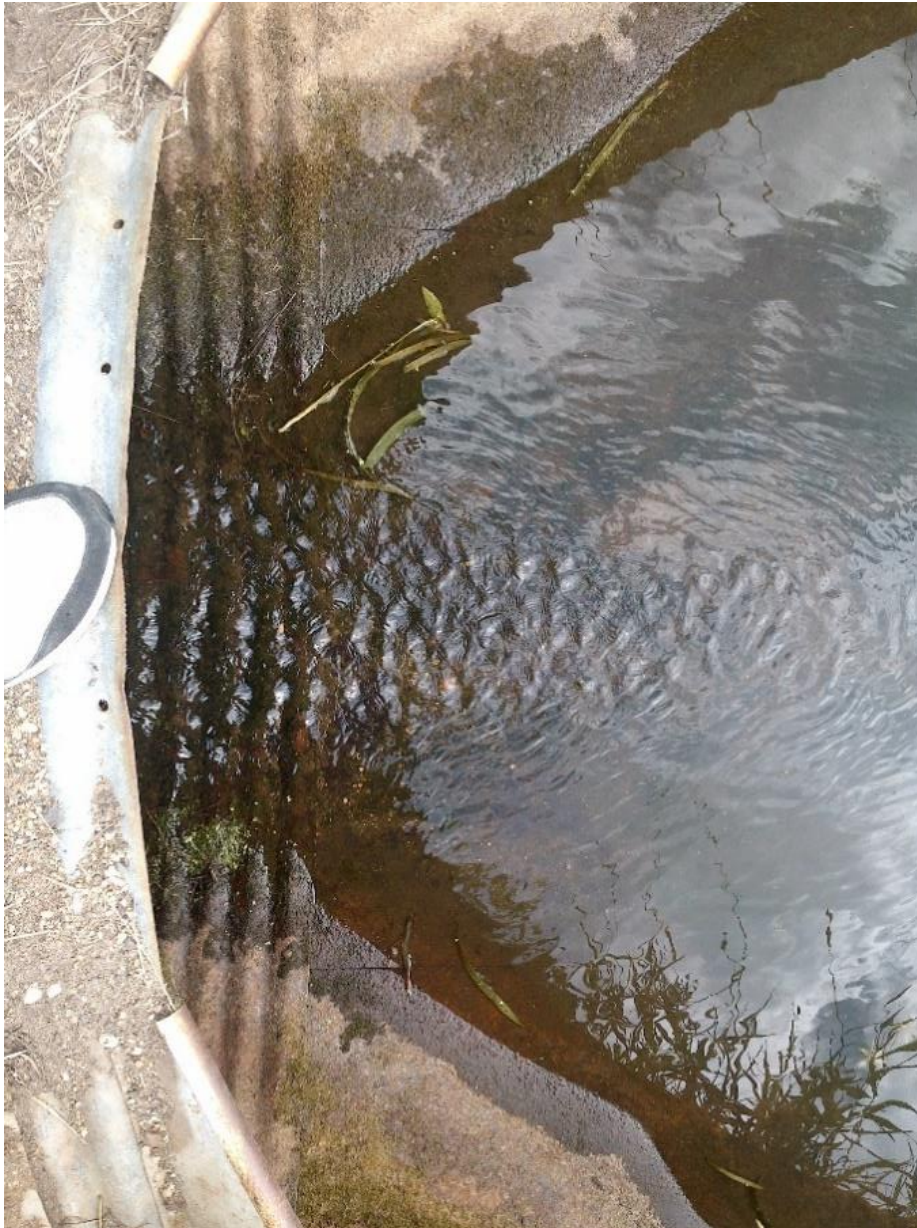
Figure 22: CD13 on 7/28/2023, showing very low water levels leaving culvert.

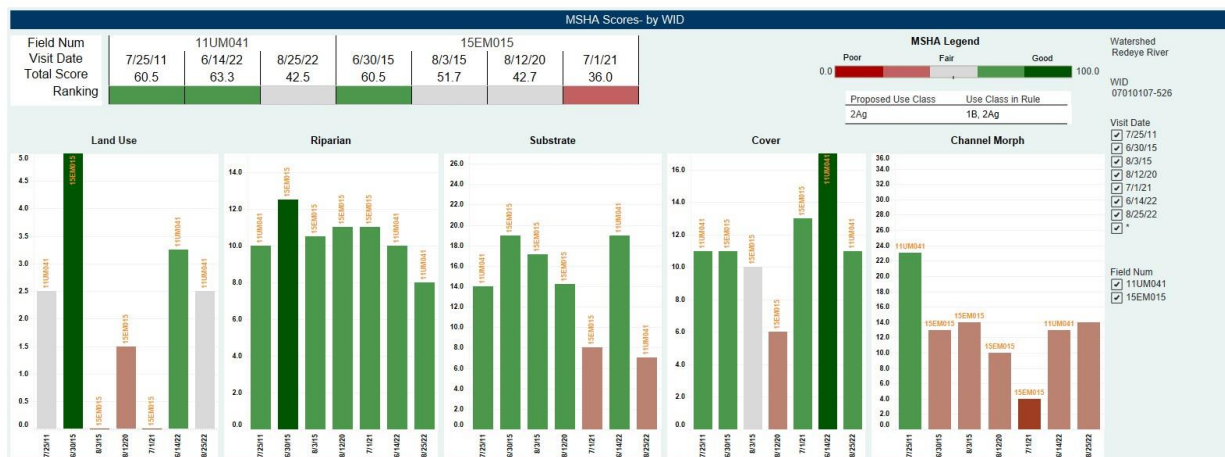
Habitat was classified as poor-good on Hay Creek, through the MSHA evaluation at the two fish sample sites (Figure 23).

**Figure 23. MSHA habitat scores for Hay Creek.**

Although the MSHA score was poor-good overall, land use and channel morphology scored particularly low as noted in Figure 17. Land use scores low because the monitoring sites are located in agricultural area. The immediate land use is row crop or pasture. There are also a high number of center pivot irrigation systems located along the channel. The withdrawal of near surface groundwater can have an impact on stream flow, which in turn can have an impact on the channel morphology. This lower flow regime can cause fine sediment to settle in the channel as the flows are minimized during periods of less precipitation. Substrate scored poorly in 2021 and 2022 at both sampling locations. Healthy fish
