Long Prairie River Watershed Stressor Identification Report

Minnesota Pollution Control Agency

August 2014

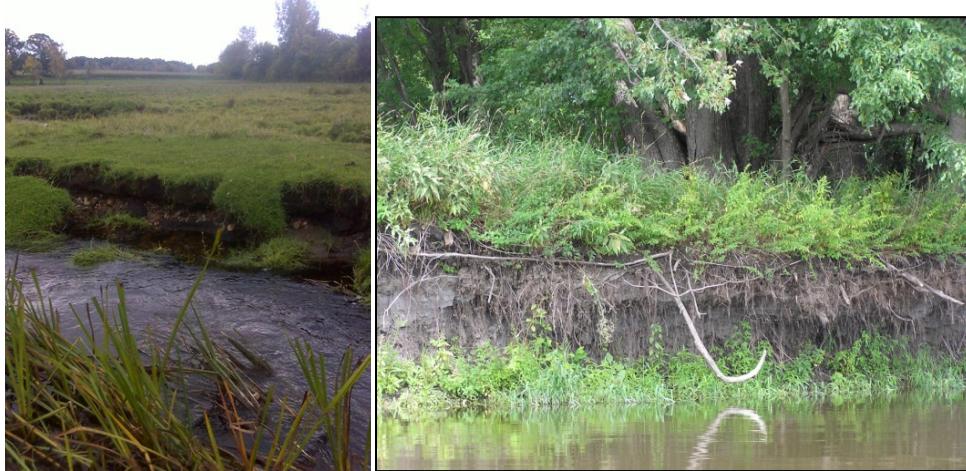
Figure 7: Examples of bank erosion from various land cover types in the LP Watershed

Figure 7 shows examples of bank erosion observed in the LP Watershed. Bank erosion occurred within urban/developed areas, along the edges of cultivated cropland, and even heavily-wooded riparian corridors. This suggests that there are multiple land uses and erosional processes contributing to increased sediment inputs and sediment-related stressors to aquatic life. Buffers of inadequate width to protect streambank integrity and aquatic habitat were observed in the LP Watershed. The causes and potential sources for increases in turbidity in the LP Watershed are modeled at [EPA's CADDIS Sediments webpage](#).

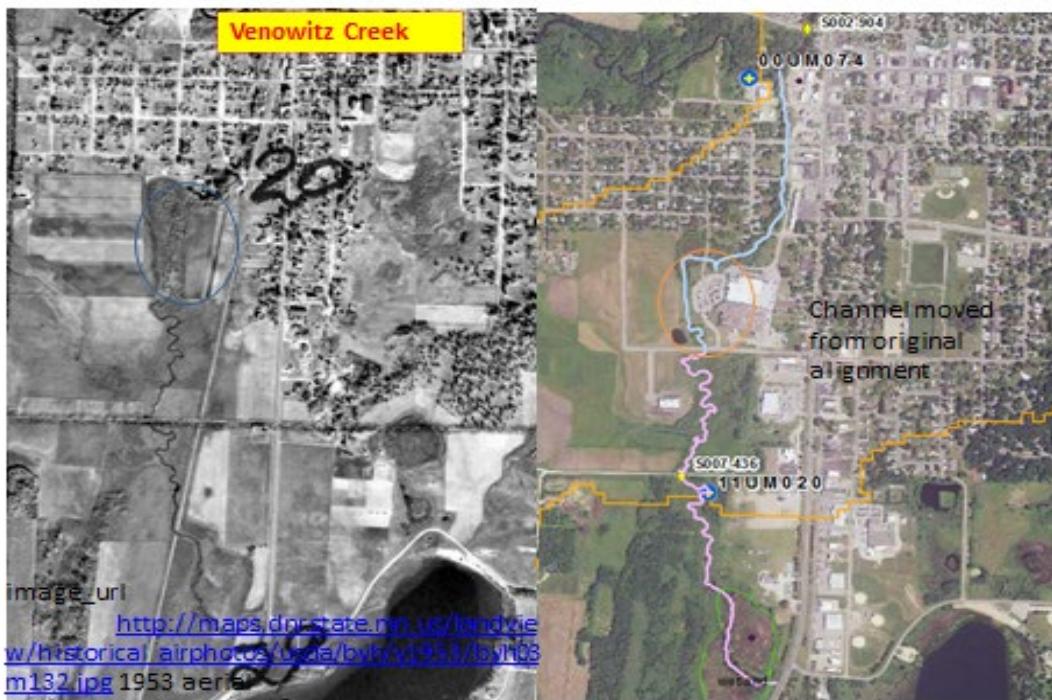
Figure 14: Alignment changes in stream channel in Venowitz Creek from 1953 to present

Another land-use component that may be negatively impacting ecological health is the intensity of developed land in this watershed. Potential stressors related to this land-use are increased nutrient concentrations and increased stream bank instability due to impervious runoff and lack of riparian vegetation in sections of the stream. Once the vegetation along the banks is removed or altered, it leaves the banks of the stream channel susceptible to erosion and mass failure. The increased chance of stormwater runoff causing a peak event in the stream flow can cause stream bank instability. Changes in stream channel alignment are also common practices in developed watersheds. Figure 14 below shows the realignment of a section of channel in Venewitz Creek.

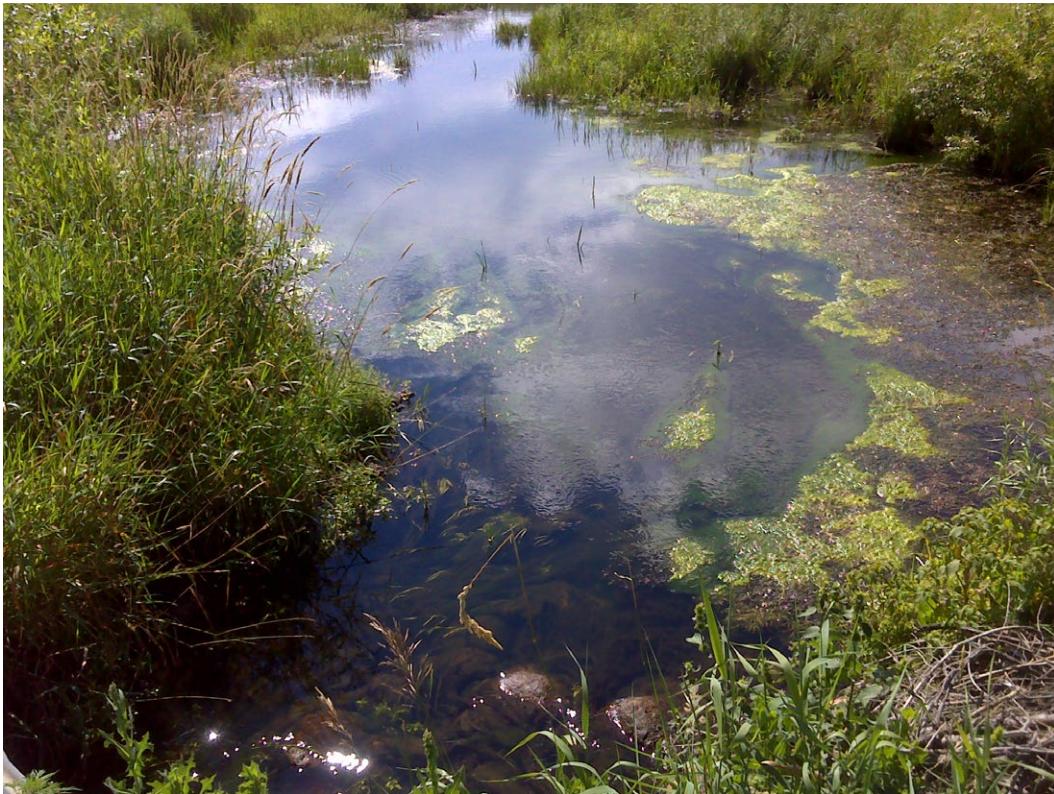
Figure 16: Photo of submerged aquatic plant growth at biological site 11UM020 (August 2013)

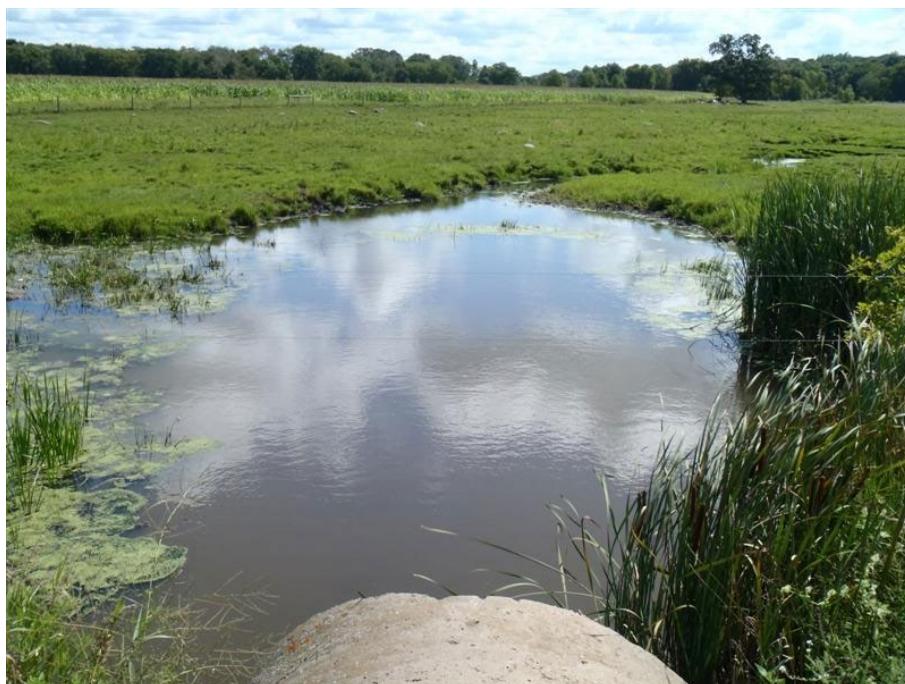
Figure 25: Algae growth in Harris Creek at sampling site S007-438 (August, 2013)

Chlorophyll-a concentration are commonly used to measure algal productivity in surface water, and have been shown to correlate with maximum DO concentrations and DO flux in non-wadable rivers (Heiskary et al., 2010). Field visits at EQuIS monitoring site S007-438 revealed significant submerged plant and algal growth (Figure 25). There is no chlorophyll-a data for this site. The amount of attached periphyton growth in the channel suggests that elevated nutrients are causing elevated in-stream plant growth.

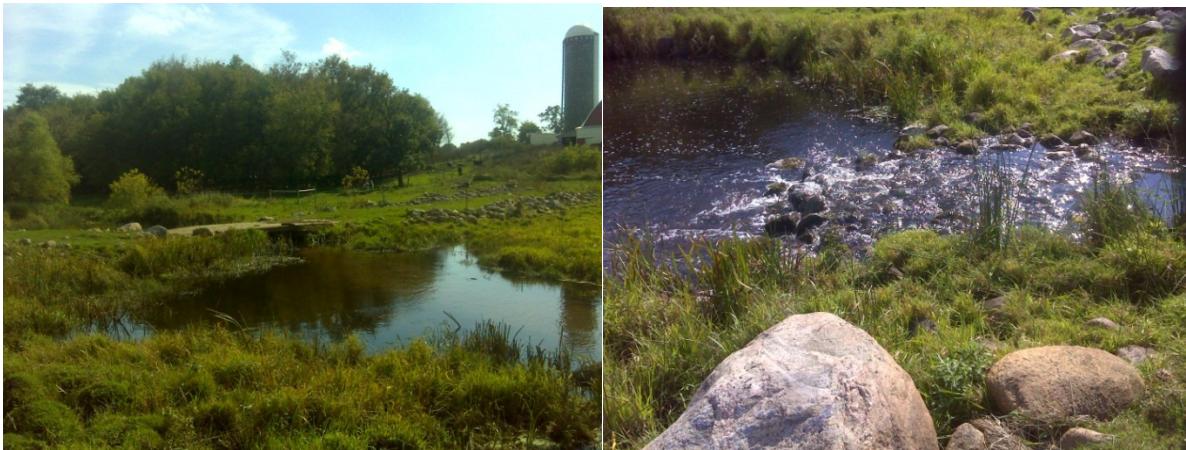
Figure 29: Photo of field crossing located downstream of 11UM013. Crossing is not causing fish passage problem; however, is causing a flattening of the stream channel slope which is causing some pool filling and aggradation.

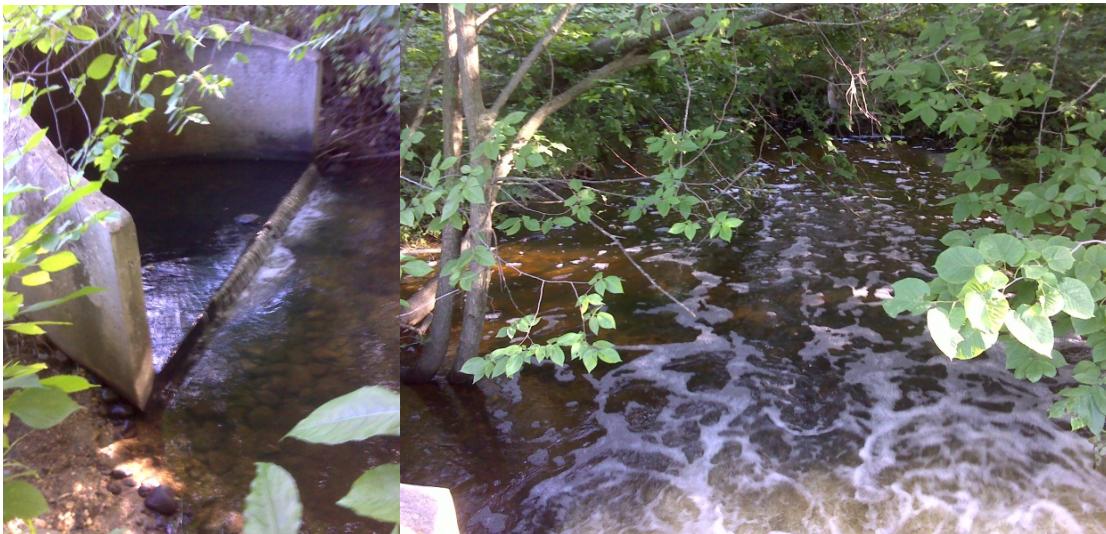
Figure 37: Unnamed Creek culvert outlet on County Road 14 on July 2, 2013, and July 18, 2013 after heavy rainfall.

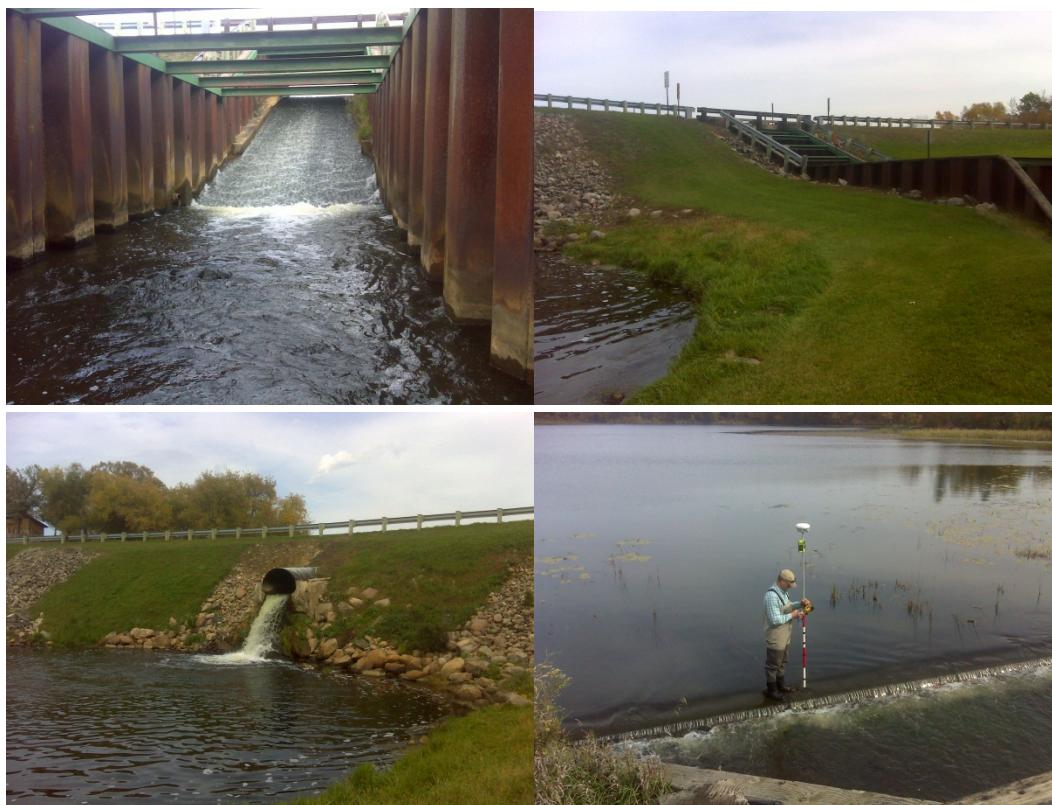
Figure 44: Photos of the dam separating the two sampling sites on Spruce Creek. The dam is acting as a fish barrier and changing the slope of the upstream channel (making the slope flatter).
