Long Prairie River Watershed Stressor Identification Report Update 2025

A study of local stressors limiting the biotic communities in the Long Prairie River Watershed.

Document number: wq-ws5-07010108c

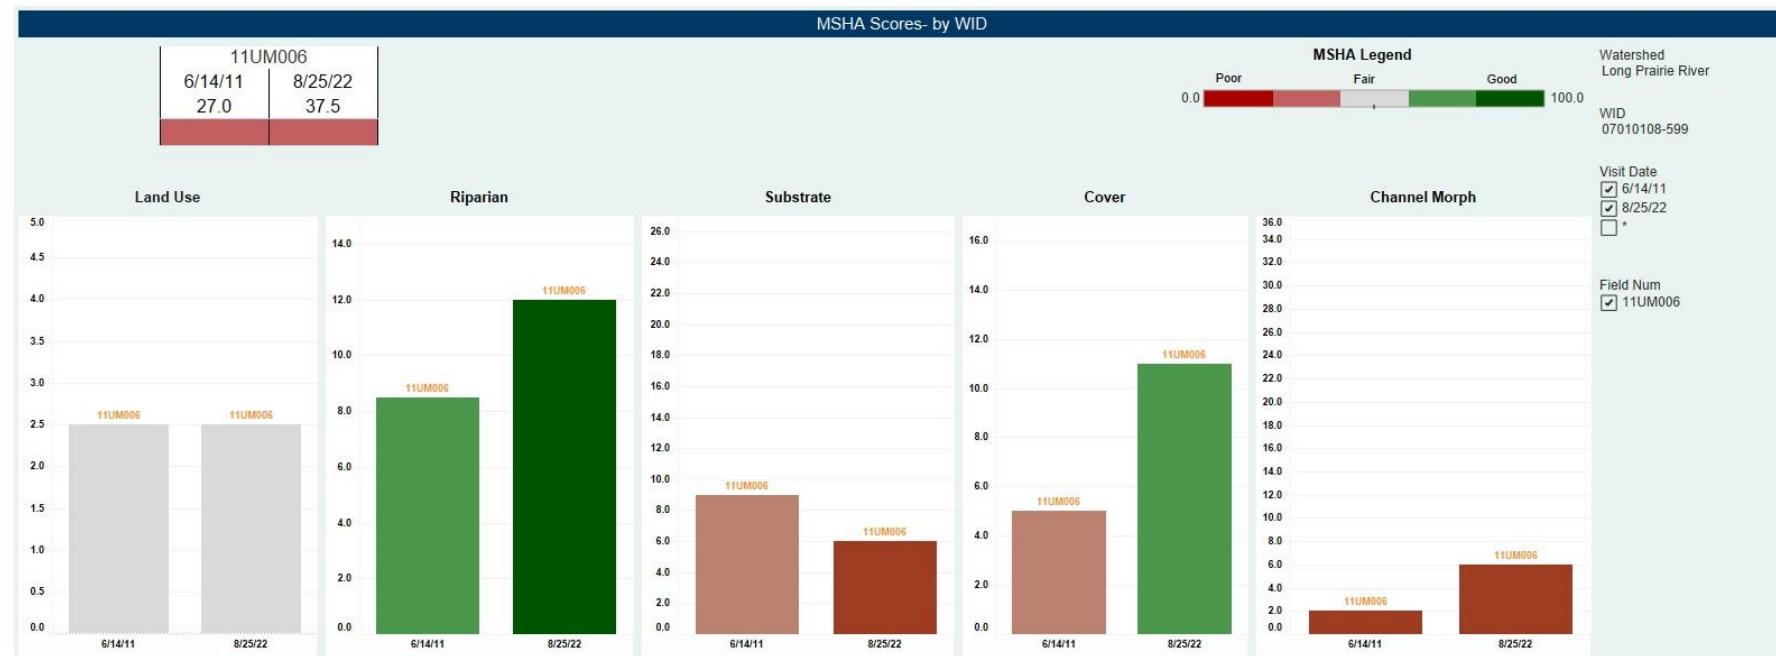
Figure 3: MSHA Habitat scores for Unnamed Creek

Habitat was classified as fair/poor on Unnamed Creek, through the Minnesota Stream Habitat Assessment (MSHA) evaluations during the fish and macroinvertebrate samples (Figure 3). This section of stream has been historically ditched and flows through a large woody wetland, perfect habitat for beaver activity. Stream substrate was dominated by sand, silt and some clay during the 2011 and 2022 site visit.

In general, the MSHA evaluations score poor on Unnamed Creek; however, there is a stark difference in the habitat availability between the two visits from the biological monitoring station (11UM006) shown in Figure 3. The most significant differences between the two visits can be seen in the cover and channel morphology categories. The substrate at 11UM006 was dominated by sand and silt, with the presence of clay also noted. Healthy fish communities need coarse substrate to build nests and spawn. Excessive fine sediment also affects juvenile fishes, as the sediment is stirred into the water column creating TSS, it can easily tear sensitive juvenile fish gills. Similarly, many sensitive macroinvertebrates also have specialized gills that are used to breathe DO. Excessive fine sediments can damage these gills, similar to juvenile fishes, making the creek inhabitable for sensitive species. In addition to the differences in substrate between the two biological monitoring stations, channel morphology also changed between the two stations. The channel morphology score at 11UM006 indicated that the channel development was poor (no pools, slow velocity runs, and no riffles **Lack of habitat is a stressor** to the aquatic life in 11UM006 due to poor channel morphology and substrate.

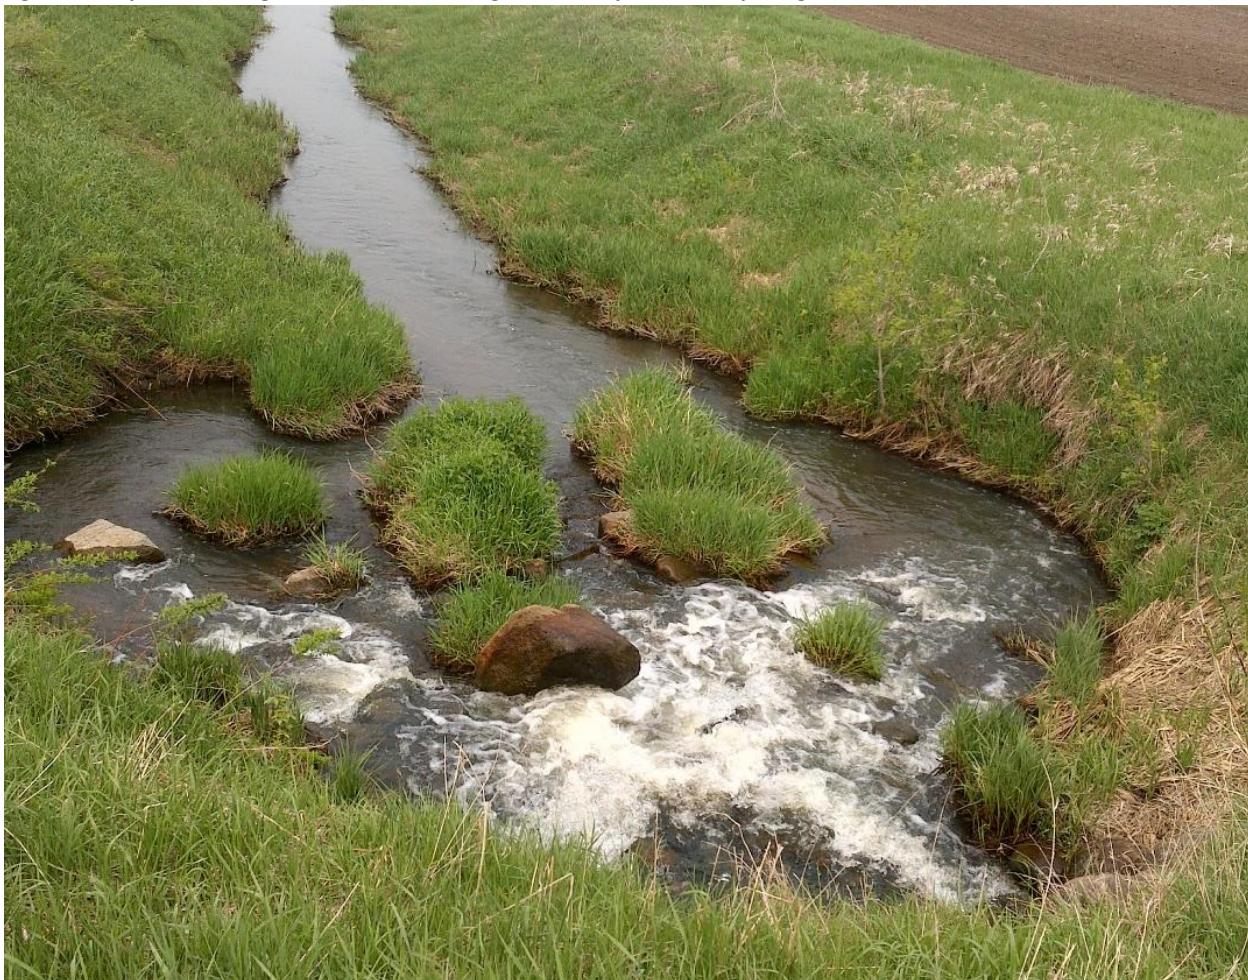
Figure 5: May 17, 2023; high flow at CR18 crossing. Velocities prevent fish passage.

The culvert crossing by 11UM006 off CR18 is a fish barrier. The drop structure associated with this crossing is a barrier at all flow regimes as can be seen in the photos below. Sampling site 11UM006 is on the upstream side of the culvert. This culvert is **considered the main stressor** at the sampling location for fish as it poses a barrier to fish movement within the stream at almost all flow regimes.

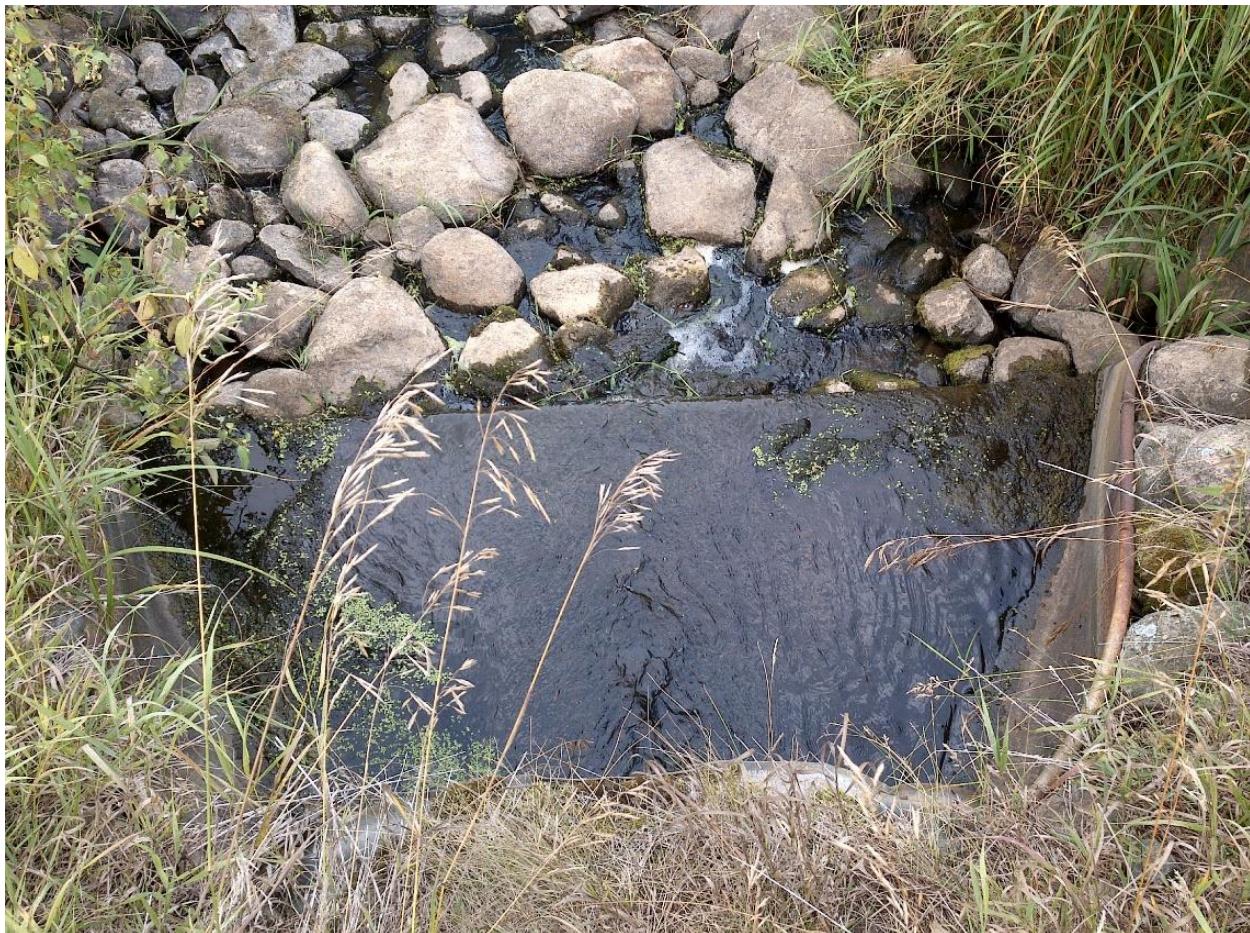
Figure 6: August 1, 2023; low flow at CR18 crossing. Drop structure at outlet and minimal water in culvert prevent fish passage.

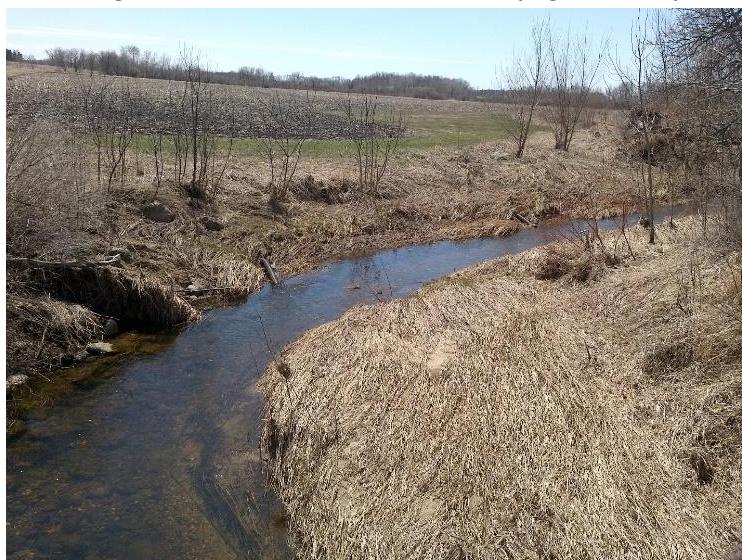
Figure 8: Unnamed Creek biological monitoring site 11UM012 and Equis site S012-009. Photo taken 5/03/2023 when stream was flowing. Stream is channelized and has row crop agriculture adjacent to both sides of the channel.

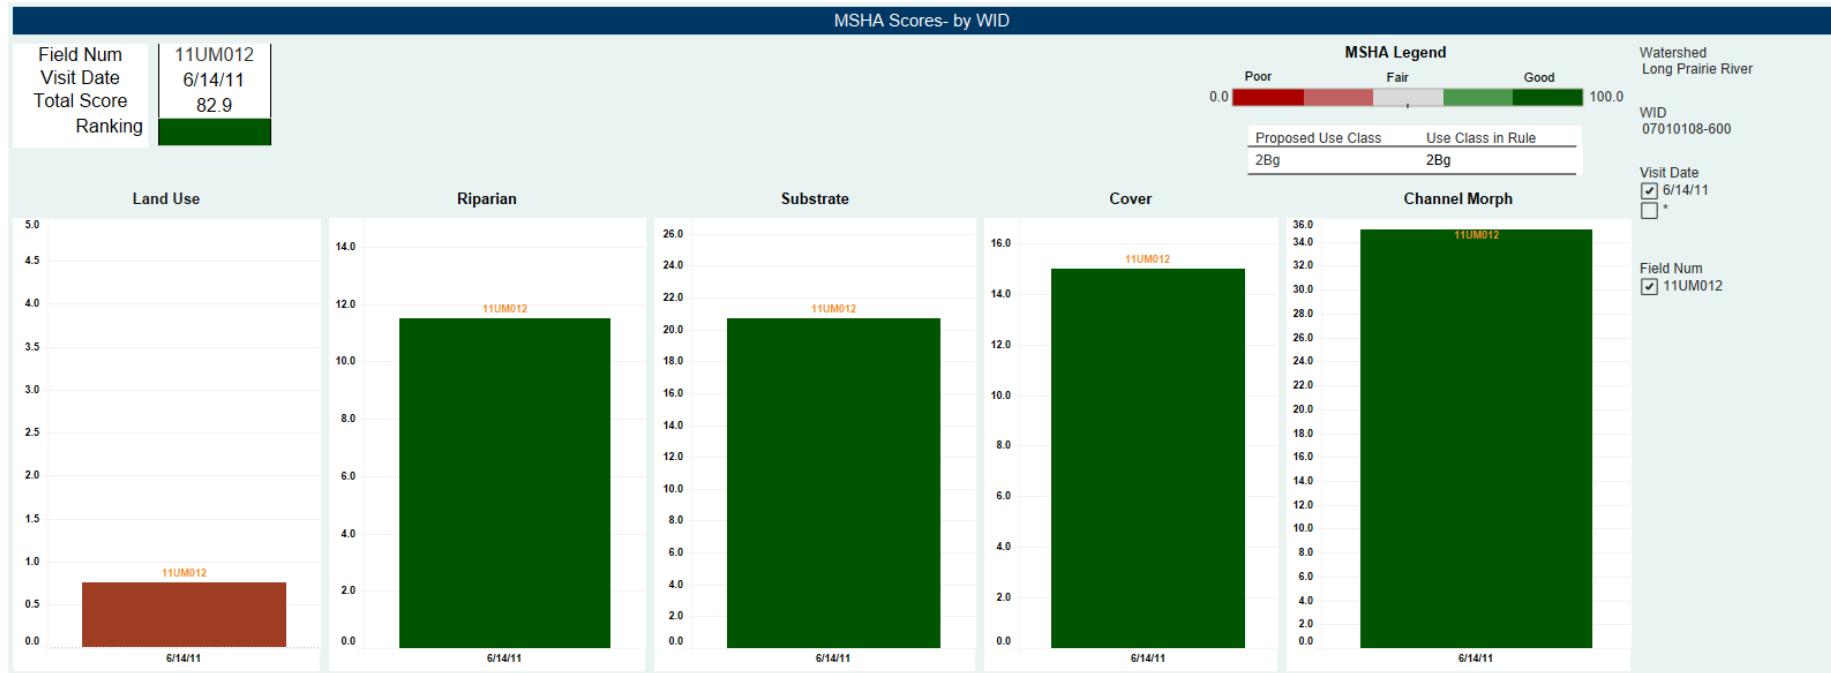
Figure 9: MSHA habitat scores for Unnamed Creek.

Habitat was classified as fair on Unnamed Creek, through the MSHA evaluations during the fish and macroinvertebrate samples (Figure 9).

There was one habitat assessment conducted at 11UM012 on June 14, 2011, during the fish visit. This site scores good in riparian cover, substrate, cover and channel morphology. There are active cattle pastures downstream of 284th St near water quality station S012-009. The downstream portion of the reach shows signs of active bank erosion from cattle. Figure 10 shows the active pasture on the downstream side of road.

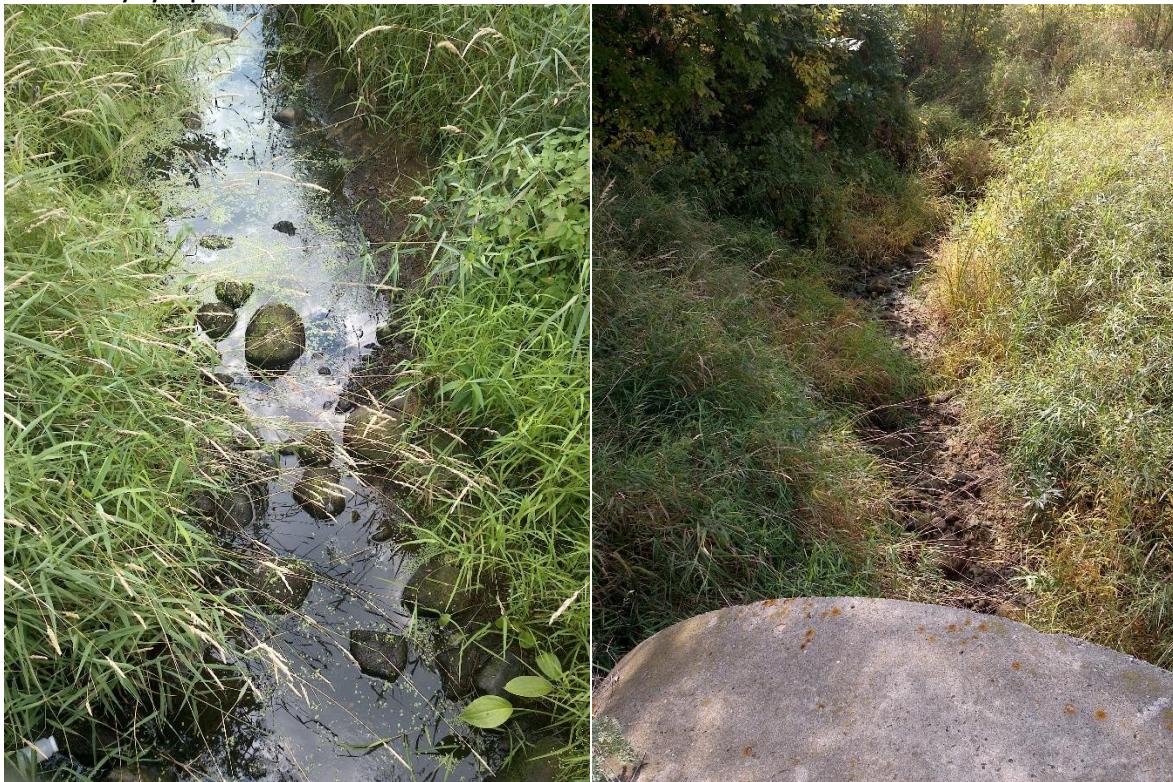
Figure 11: Unnamed Creek at S012-009 on 8/1/2023. Most of the July through September of 2023 streamflow was less than 0.5 cfs or dry by September of 2023.

and small stream channels. It appears that the upper reaches of the ditch were cut through wetlands to drain wetlands and convert the land for agricultural purposes with minimal success. This channel alteration accelerates stream flow, resulting in higher flows during precipitation events, which achieves the agricultural land drainage goals, but causes channel instability. Water leaves the landscape quickly, resulting in periods of higher flow than what would have naturally occurred. As the landscape drains, water that was once held in the upstream wetlands is flushed downstream. Then, as these flows quickly drain, the flow regime quickly transitions to intermittent, reaching stagnant conditions starting during periods of low precipitation (Figure 11). **Channelization and the corresponding flow alteration are stressors to the biological community.**

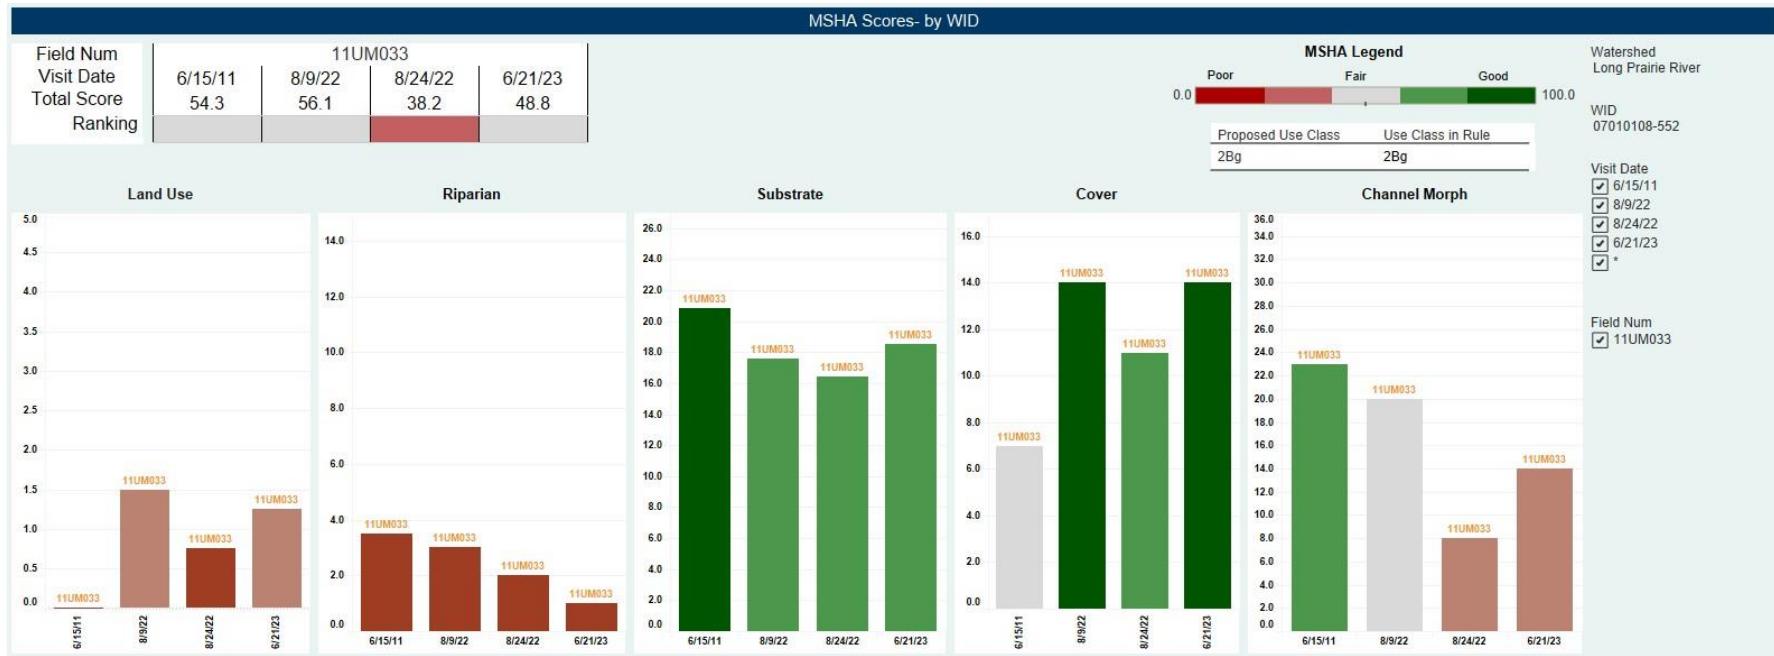
Figure 13: MSHA habitat scores for CD11.

Habitat was classified as fair on CD11, through the MSHA evaluation at the fish sample (Figure 13).

Although the MSHA score was fair overall, land use, riparian and channel morphology scored particularly low as noted in Figure 13. Land use scored low because the sampling location is located within a cattle pasture bordered by extensive row crop agriculture.

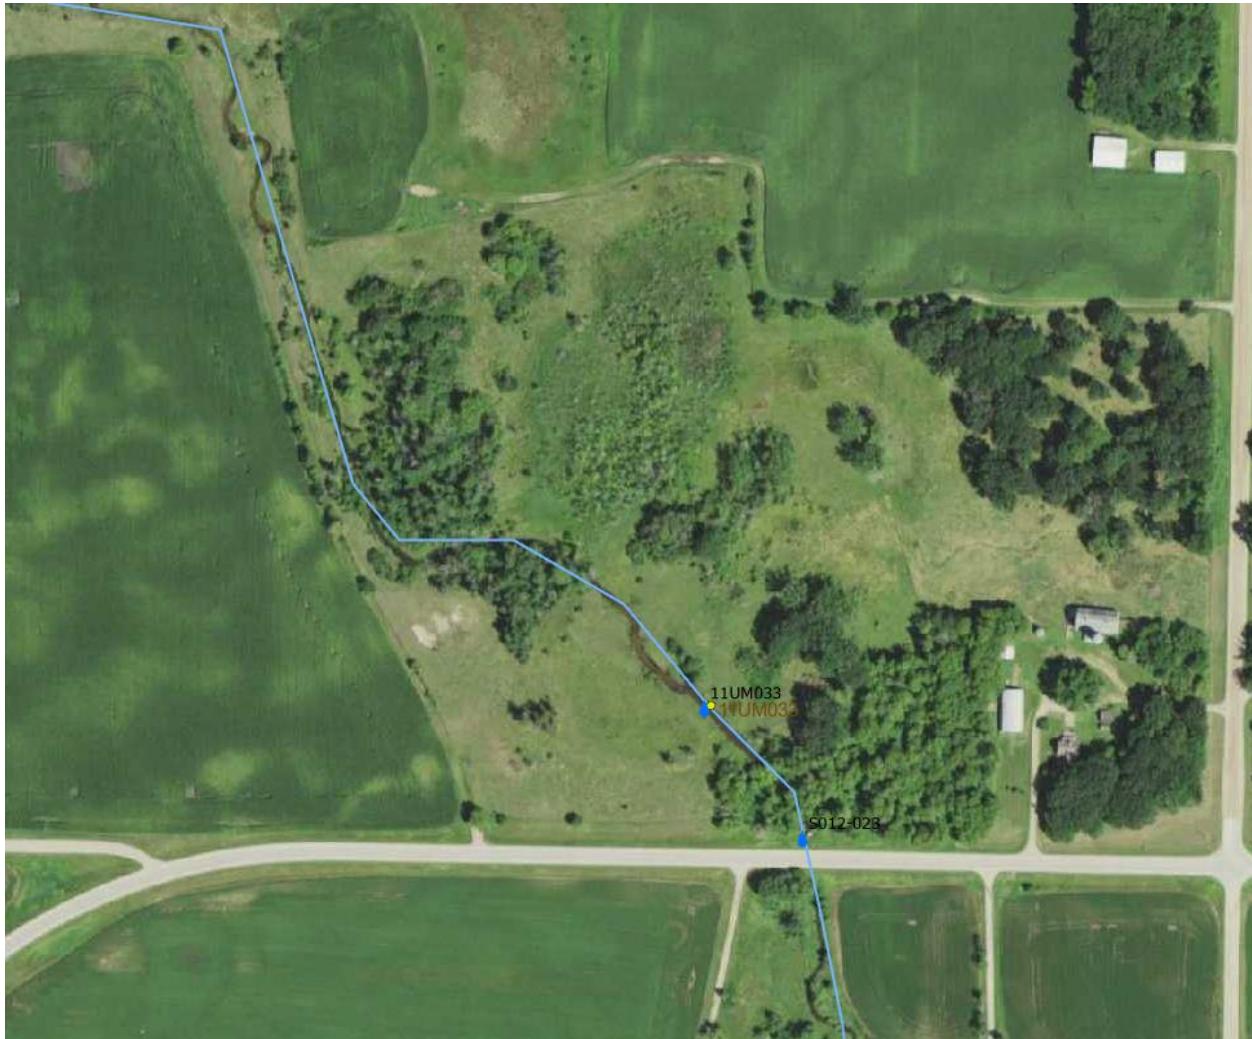
Figure 14: Sampling station 11UM033 is located within an active cattle pasture.

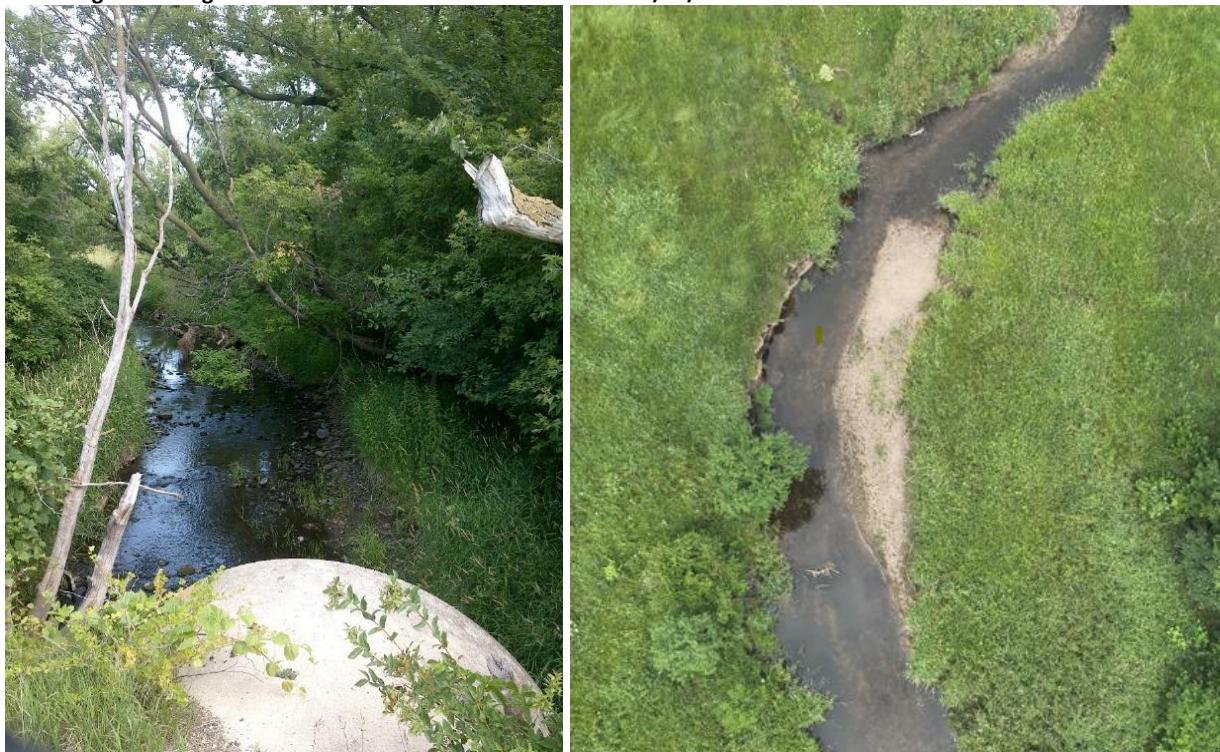
Figure 15: CD11 on July 11, 2023. Water levels are very low and fish could not move through the reach at these water levels. Drone flight showing sandbar and sediment accumulation from 6/27/2023.

Drone imagery captured in 2023 (Figure 15) showed sandbars located upstream of the road crossing. It is possible that this excess sediment would have historically settled out within the wetlands that made up most of the riparian pre-settlement, but due to the channelization, the sediment is flushed downstream during precipitation events. Therefore, due to the altered hydrology and geomorphology of CD11 causing the channel to get very low, it is a **secondary stressor**.

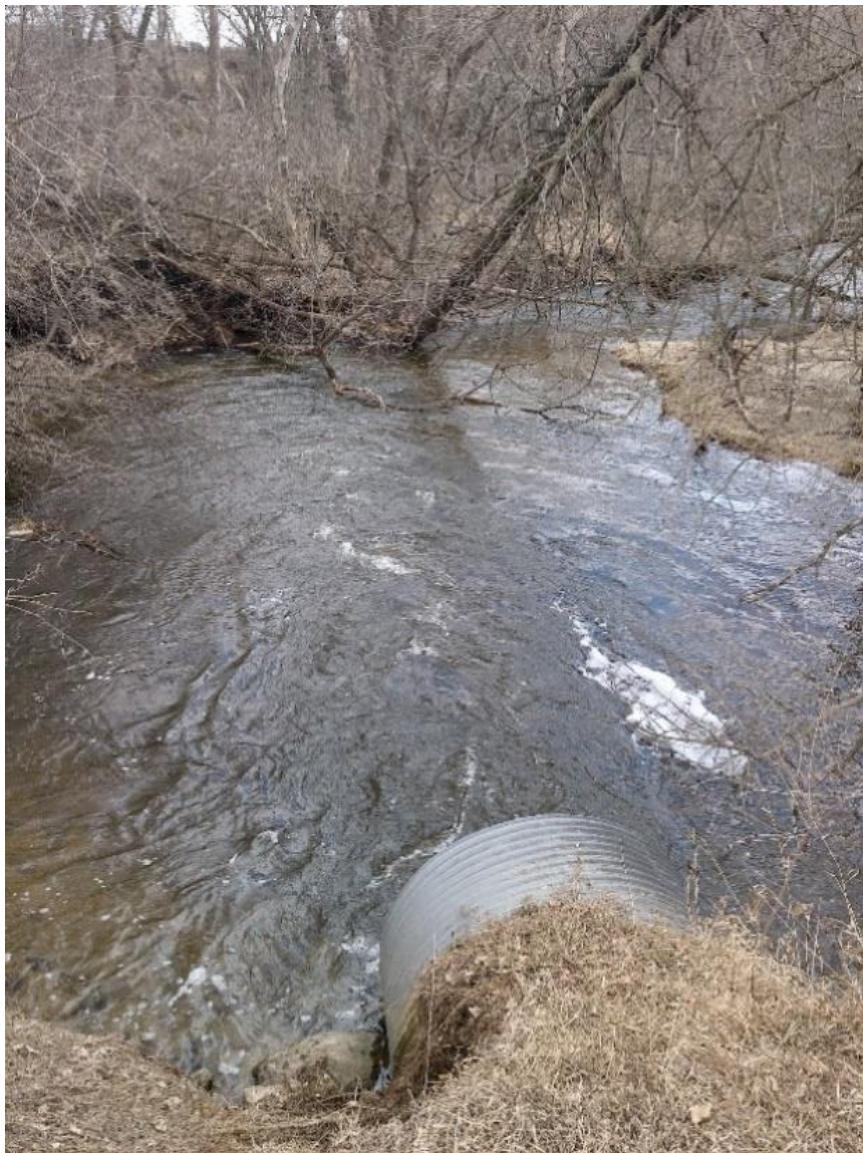
Figure 16: high spring flow velocity barrier in culvert. Water goes through corrugated metal culvert like a fire hose. Photo from 4/25/2023.

The culvert crossing downstream of 11UM033 off Dittberners Creek Road NW does appear to be a fish barrier at certain stream stages. During high flows the velocity coming out of this culvert is very fast, preventing fish passage for most fish species. During low flow events there is not enough water in the culvert to allow for fish passage. Fish passage is only feasible during the right flow regimes as seen in Figure 16. This culvert **appears to be a barrier** to fish movement.
