Mississippi River-Twin Cities

Stressor Identification Update

April 2024

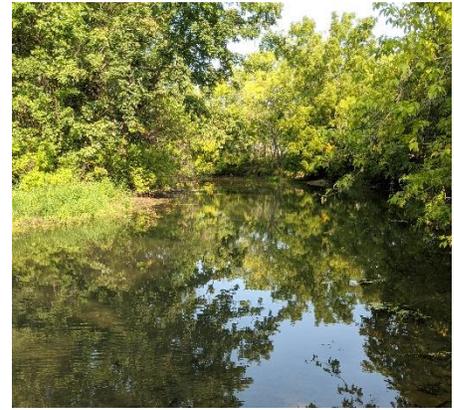
Figure 1: Bassett Creek at site S015-084.

The Mississippi River-Twin Cities Watershed has many opportunities for recreation such as fishing, canoeing, and hiking. Water quality monitoring, identifying impairments, and completing SID work (Figure 1) helps guide where to implement restoration best management practices (BMPs) and where to protect healthy streams that will help to preserve them for future generations. This SID update focuses on streams, while the Minnesota Department Nature Resources (DNR) will produce a SID document focused on lake SID work for this watershed.

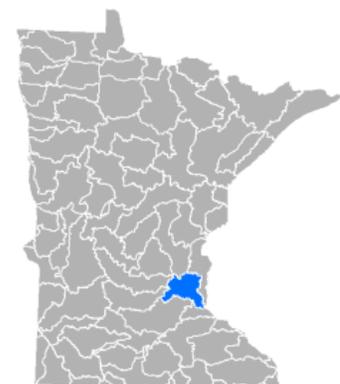
Figure 2: Mississippi River-Twin Cities Watershed

The Mississippi River-Twin Cities Watershed (Figure 2) faces issues related to altered hydrology and connectivity throughout. Much of this can be attributed to the various flow control structures and barriers that can stop fish migration and limit the consistent flow the stream needs to support aquatic life.

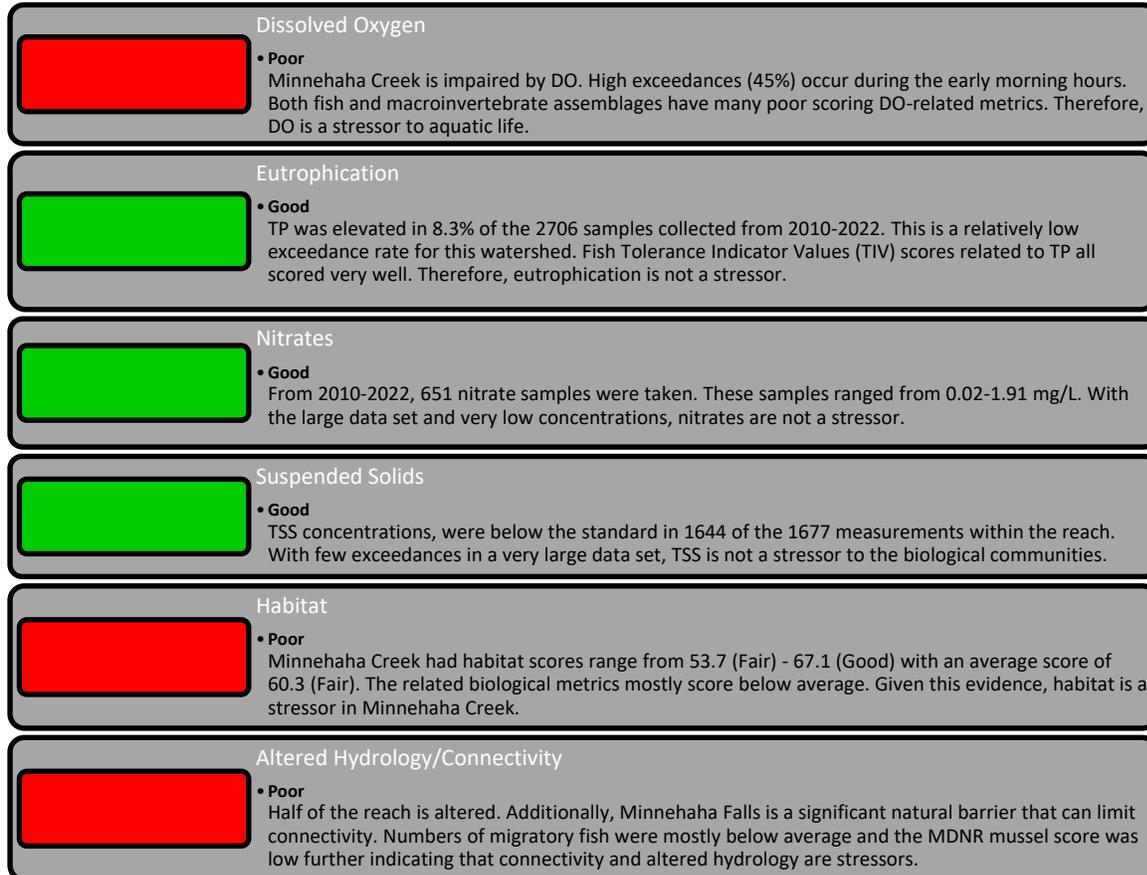
SID monitoring in the Minnehaha Creek (-539) did not occur during C1. The goal of C2 SID work was to get additional information on DO, eutrophication, nitrates, connectivity, habitat, and stream transparency. C2 SID work focused on and identified DO, habitat, and flow connectivity/alteration as stressors (Figure 4).

Figure 4: Biological stressor determinations for Minnehaha Creek. Red boxes indicate poor conditions; therefore, a stressor to aquatic life. Green boxes indicate good conditions and not a stressor to aquatic life.

Additional biological and water chemistry data has identified additional focus areas for DO, habitat, and altered hydrology/connectivity stress in Minnehaha Creek. Prioritization of future work should consider these stressor impacts at various locations in the Minnehaha Creek Subwatershed.

DO issues are present in Minnehaha Creek. DO concentrations tend to drop to harmful levels during the early morning hours, mostly in the upper half of the stream reach, which negatively impacts aquatic life.

Habitat scores were better in the upstream portion of the reach. Factors limiting the habitat were the developed land use, and channel morphology (fair channel development, sometimes limited depth variability). Habitat improvement projects could help further develop and provide more diversity to the biotic communities in this reach.

Altered hydrology and connectivity are also significant issues along Minnehaha Creek. The large natural barrier of Minnehaha Falls prevents fish migration from the Mississippi River. Also, the flow

management along this reach can cause areas to dry up and prevent fish movement, especially during dry years or periods of low rainfall.

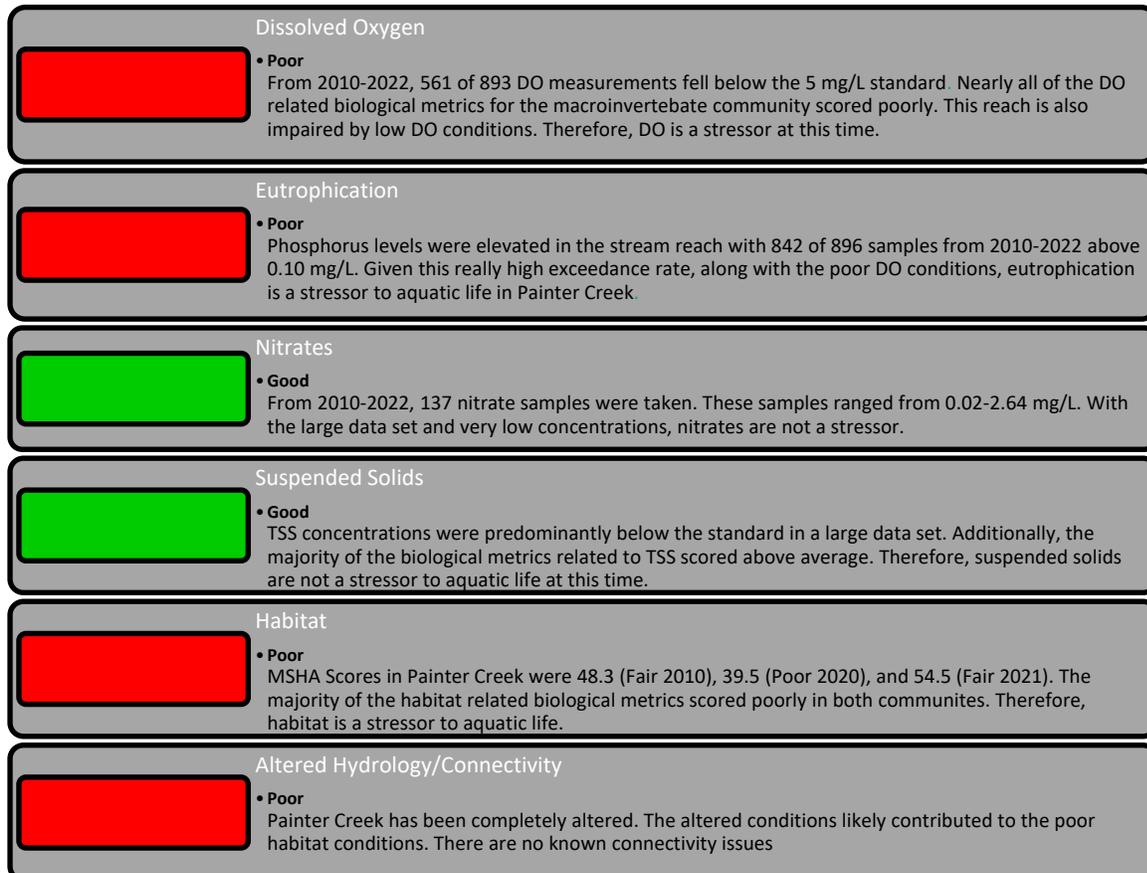
SID work was not completed in Painter Creek during C1 SID. The goal of C2 SID work was to get additional information. In this reach, DO, eutrophication, habitat, and altered hydrology were identified as stressors (Figure 6).

Figure 6: Biological stressor determinations for Painter Creek. Red boxes indicate poor conditions and therefore, a stressor to aquatic life. Green boxes indicate good conditions and not a stressor to aquatic life.

Additional water chemistry information taken in 2022 in Painter Creek identified additional focus areas for DO and eutrophication, while habitat and altered hydrology issues were also found to be stressors to aquatic life. Prioritization of future work should consider these stressor impacts at various locations in the Crystal Bay-Lake Minnetonka Subwatershed.

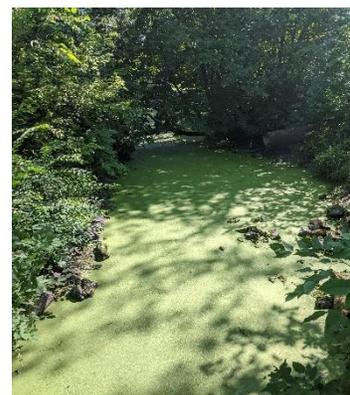
Painter Creek has issues related to eutrophication and DO. Elevated levels of phosphorus can lead to eutrophic conditions (Figure 7) and oxygen depletion. DO levels frequently fell below the standard, while also reaching high levels, which is common in eutrophic streams. Phosphorus levels were often elevated throughout this reach. The amount of wetland areas may be a contributing factor.

Figure 7: Eutrophic conditions at S002-573 on Painter Creek.

Wetlands in the upper portions of this reach and further upstream can both be a source for excess phosphorus and low DO conditions. Furthermore, these low-lying areas reduce flow and the ability to push silt through a stream system resulting in siltation and degraded habitat conditions.

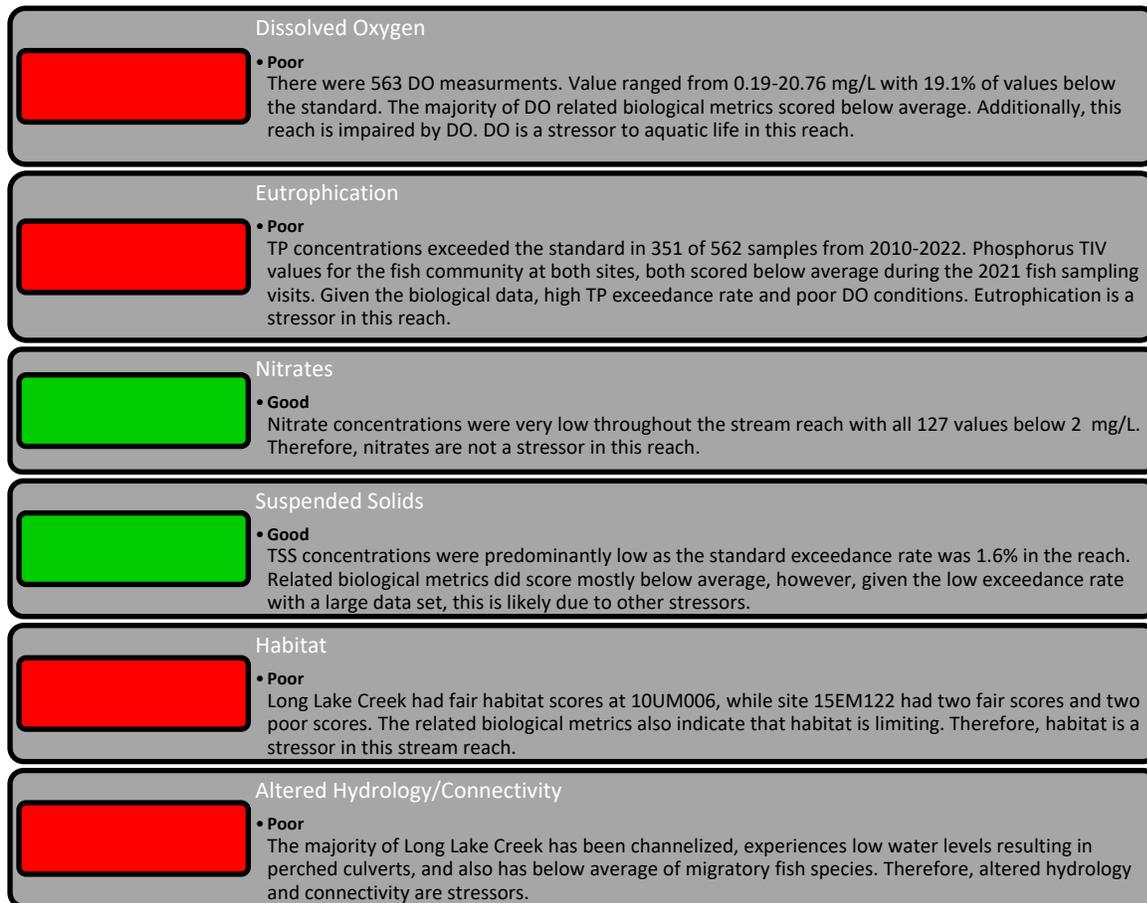
SID work was not completed in Long Lake Creek (-712) during C1 SID. The goal of C2 SID work was to gather and analyze the biological and chemical data to determine the likely cause of stress to the impaired macroinvertebrate community. Based on the information collected and analyzed, it was determined that DO, eutrophication, habitat, as well as altered hydrology and connectivity, are the stressors to biology in Long Lake Creek (Figure 9).

Figure 9: Biological stressor determinations for Long Lake Creek. Red boxes indicate poor conditions; therefore, a stressor to aquatic life. Green boxes indicate good conditions and not a stressor to aquatic life.

Additional analysis of the biological, water chemistry, and general stream conditions in Long Lake Creek identified additional focus areas for DO, eutrophication, habitat and altered hydrology/connectivity issues. Prioritization of future work should consider these stressor impacts at various locations in the Lower Lake Minnetonka Subwatershed.

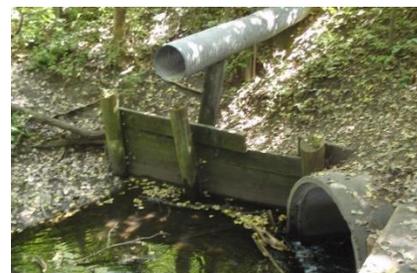
Altered Hydrology is a significant stressor to aquatic life in Long Lake Creek. The prior channelization of this reach has changed the overall flow conditions, often resulting in low flow conditions. These low flow conditions result in perched culverts (Figure 10) further limiting the proper movement of fish communities.

Figure 10: Perched culvert on Long Lake Creek.

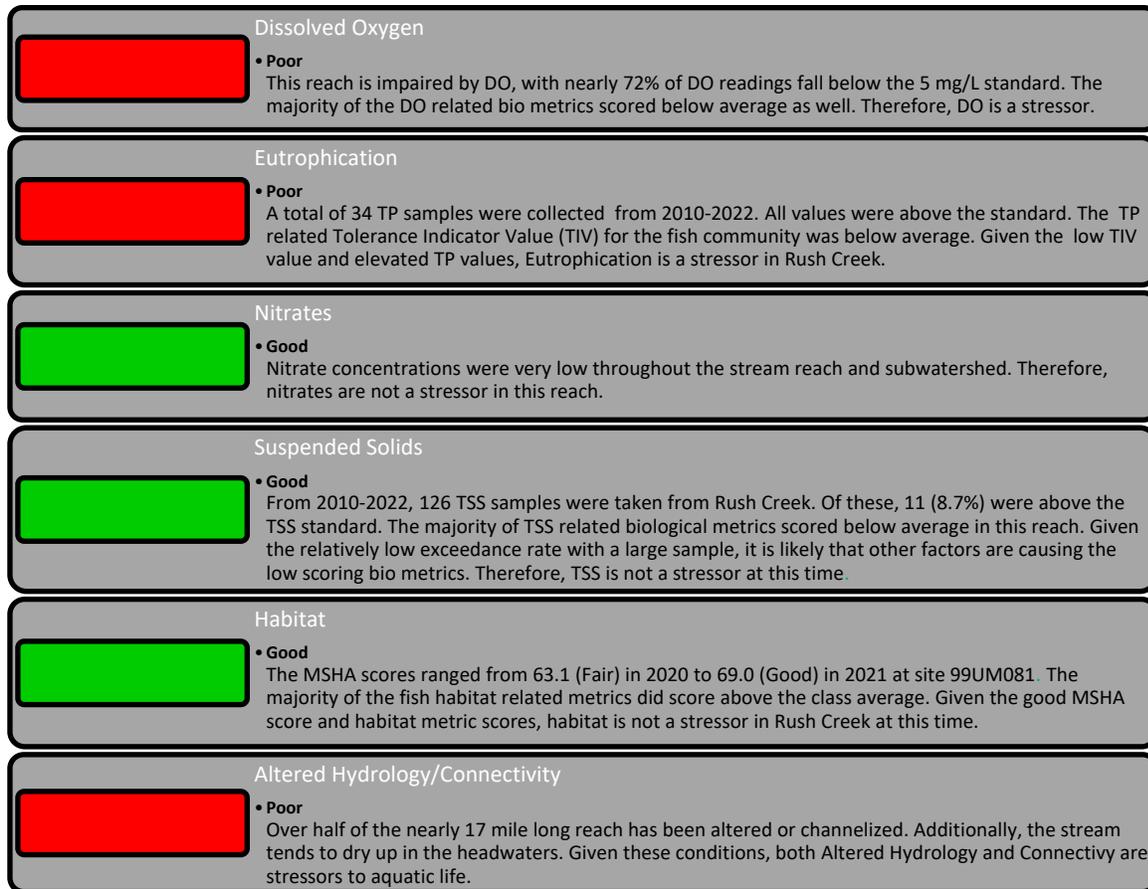
SID work was completed in Rush Creek during C1 SID. This effort determined that DO, eutrophication, and suspended solids were stressors to aquatic life. The goal of C2 SID work was to gather and analyze the biological and chemical data to confirm these stressors as well as evaluate other potential stressors to the impaired fish and macroinvertebrate communities. The latest SID work found DO and eutrophication to still be stressors as well as altered hydrology and connectivity. Suspended solids are not a stressor at this time. For further details of the stressors, see Figure 12.

Figure 12: Biological stressor determinations for Rush Creek. Red boxes indicate poor conditions; therefore, a stressor to aquatic life. Green boxes indicate good conditions and not a stressor to aquatic life.

Additional analysis of the biological, water chemistry, and general stream conditions in Rush Creek has determined that Rush Creek is still negatively impacted by the excess amount of nutrients in the stream system. These eutrophic conditions also negatively impact DO concentrations. Altered hydrology and connectivity were also found to be stressors to aquatic life. Habitat conditions in this reach were good and not limiting the biotic communities.

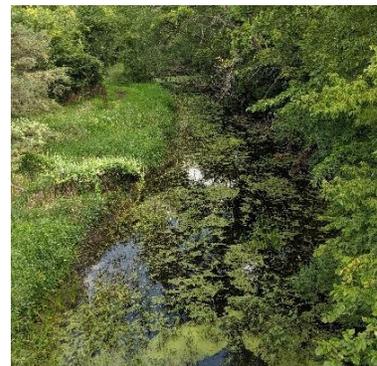
All phosphorus samples were above the standard, while chlorophyll-a samples exceeded the standard 17.1% of the time. These high concentrations are leading to eutrophic conditions (Figure 13) in this reach. The presence of wetlands along this reach may also be contributing to these conditions. Increasing stream riparian areas could be a potential solution to limiting nutrients entering the stream system.

Figure 13: Eutrophic conditions at S004-539, downstream of Territorial Road.

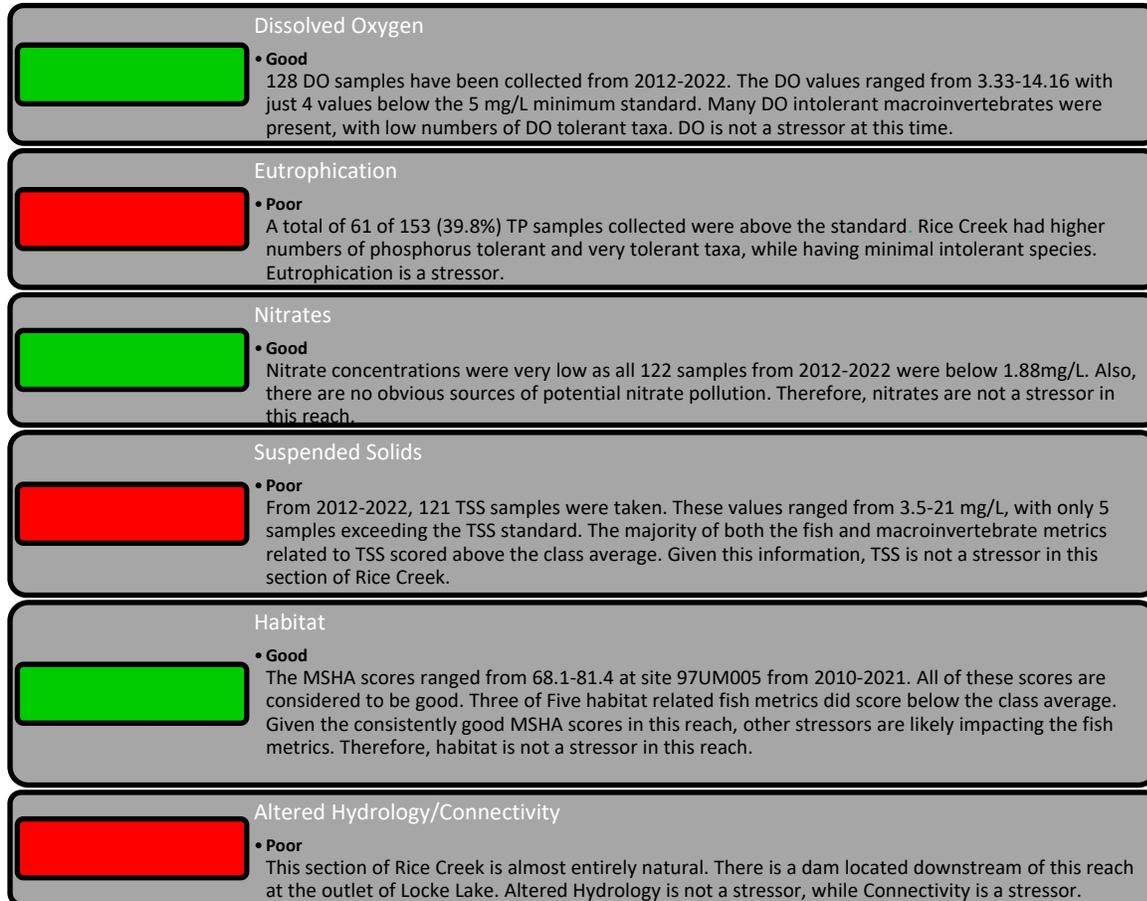
SID work was not completed in Rice Creek during C1 SID. The goal of C2 SID work was to gather and analyze the biological and chemical data to determine the likely cause of stress to the impaired fish and macroinvertebrate communities. Eutrophication and connectivity were the identified as stressors in this reach. DO levels were at acceptable levels, nitrate concentrations were very low, and the habitat in this reach was deemed suitable for aquatic life. See Figure 15 for more details regarding the stressor decisions in this reach.

Figure 15: Biological stressor determinations for Rice Creek. Red boxes indicate poor conditions; therefore, a stressor to aquatic life. Green boxes indicate good conditions and not a stressor to aquatic life.

Additional analysis of the biological, water chemistry, and general stream conditions in Rice Creek has pointed to the importance of connectivity. Barriers that limit fish migration can change fish community dynamics upstream of the barrier. Eutrophication and connectivity stressors were present along this reach.

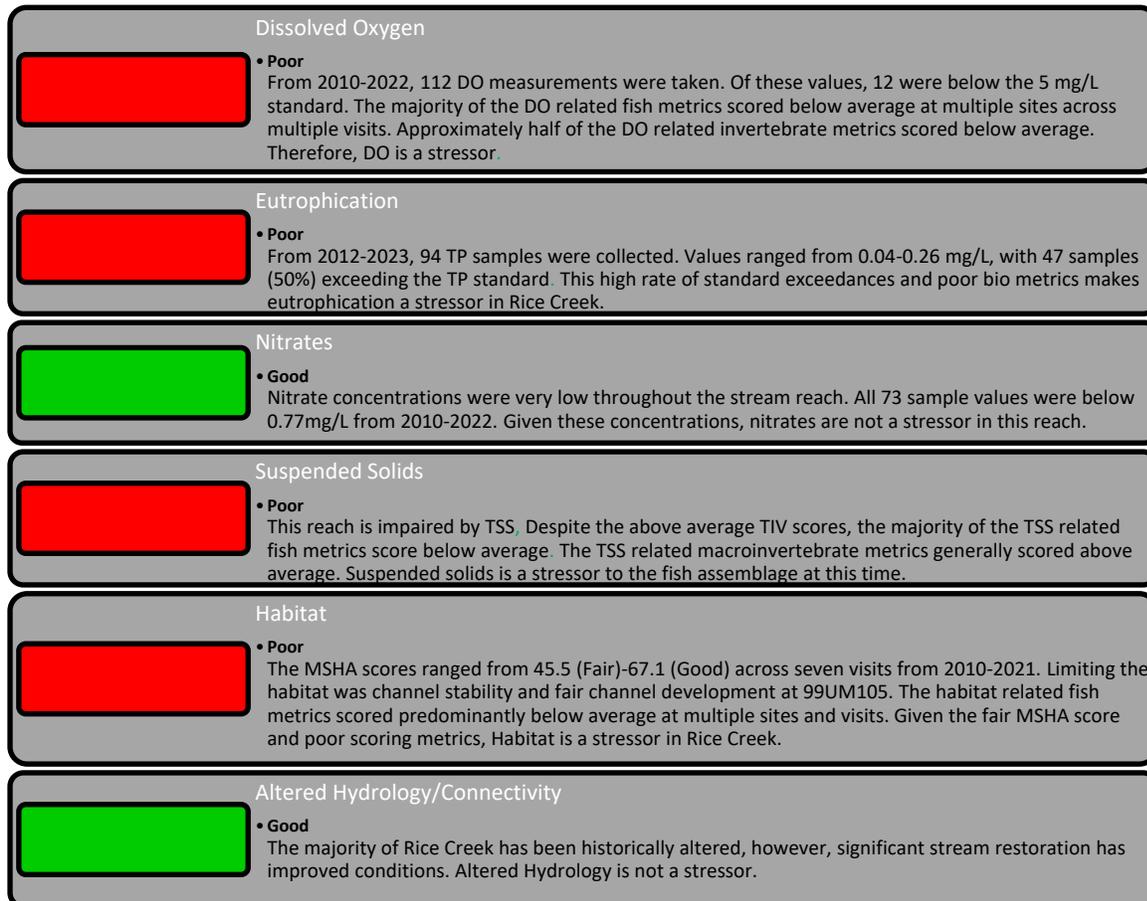
SID work was not completed in Rice Creek (-583) during C1 SID. The goal of C2 SID work was to gather and analyze the biological and chemical data to determine the likely cause of stress to the impaired fish and macroinvertebrate communities. DO, eutrophication, suspended solids, and habitat were the identified stressors. Nitrate concentrations are very low in this stream reach and there are no nearby connectivity issues. See Figure 17 for more details regarding stressors in Rice Creek (-583).

Figure 17: Biological stressor determinations for Rice Creek. Red boxes indicate poor conditions; therefore, a stressor to aquatic life. Green boxes indicate good conditions and not a stressor to aquatic life.

Additional analysis of the biological, water chemistry, and general stream conditions in Rice Creek showed that eutrophication and DO were significant issues in this reach. Suspended solids and habitat were also determined to be stressors.

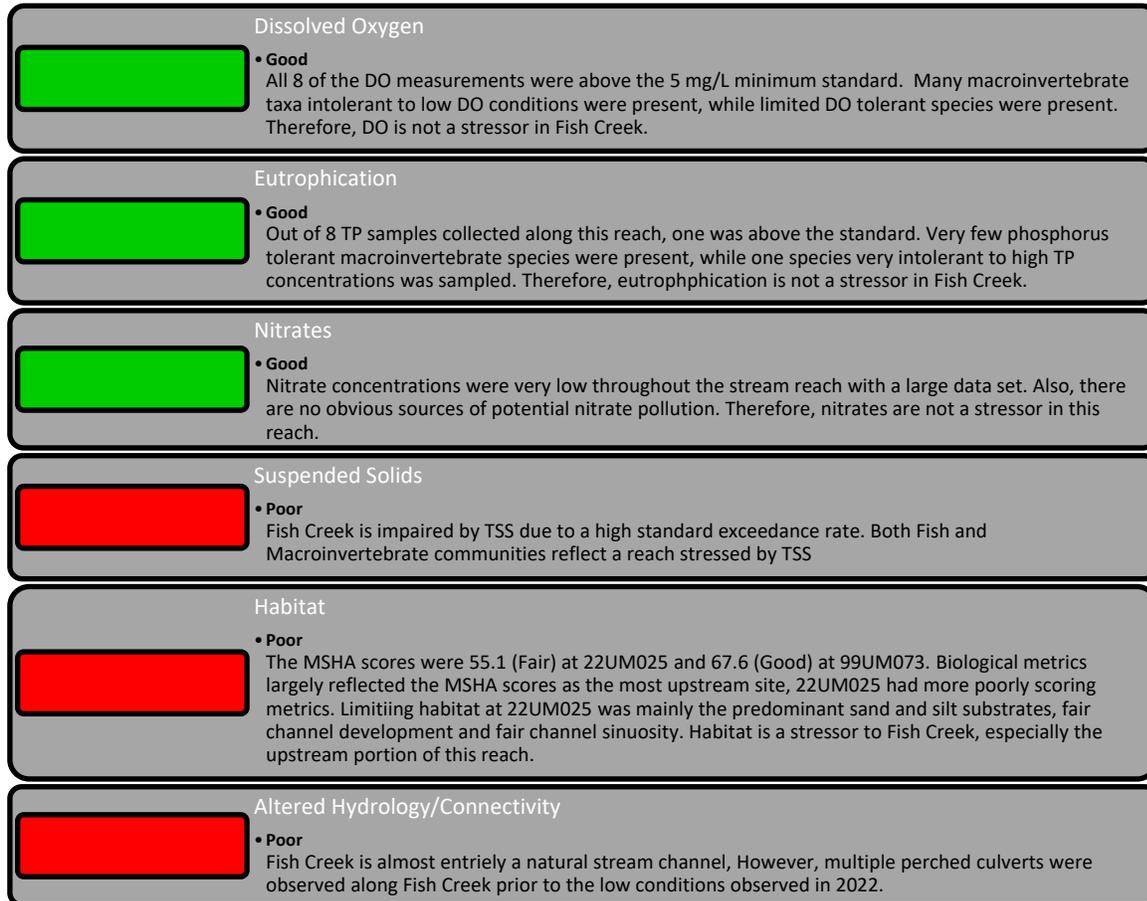
SID work was not completed in Fish Creek during C1 SID. The goal of C2 SID work was to gather and analyze the biological and chemical data to determine the likely cause of stress to the impaired macroinvertebrate community. Suspended solids, habitat and altered hydrology/connectivity were the identified stressors. See Figure 19 for more information regarding stressors in Fish Creek.

Figure 19: Biological stressor determinations for Fish Creek. Red boxes indicate poor conditions; therefore, a stressor to aquatic life. Green boxes indicate good conditions and not a stressor to aquatic life.

Additional analysis of the biological, water chemistry, and general stream conditions in Fish Creek has pointed to the importance of connectivity. Barriers that limit fish migration can change fish community dynamics upstream of the barrier. Additionally, habitat and suspended solids were also determined to be stressors to aquatic life in this reach.

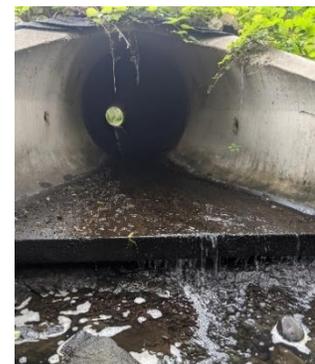
Connectivity is a stressor in Fish Creek. Multiple perched culverts were observed along Fish Creek preventing the upstream migration of fish species (Figure 20). Correcting culvert elevations would improve conditions.

Figure 20: Perched culvert along Fish Creek.

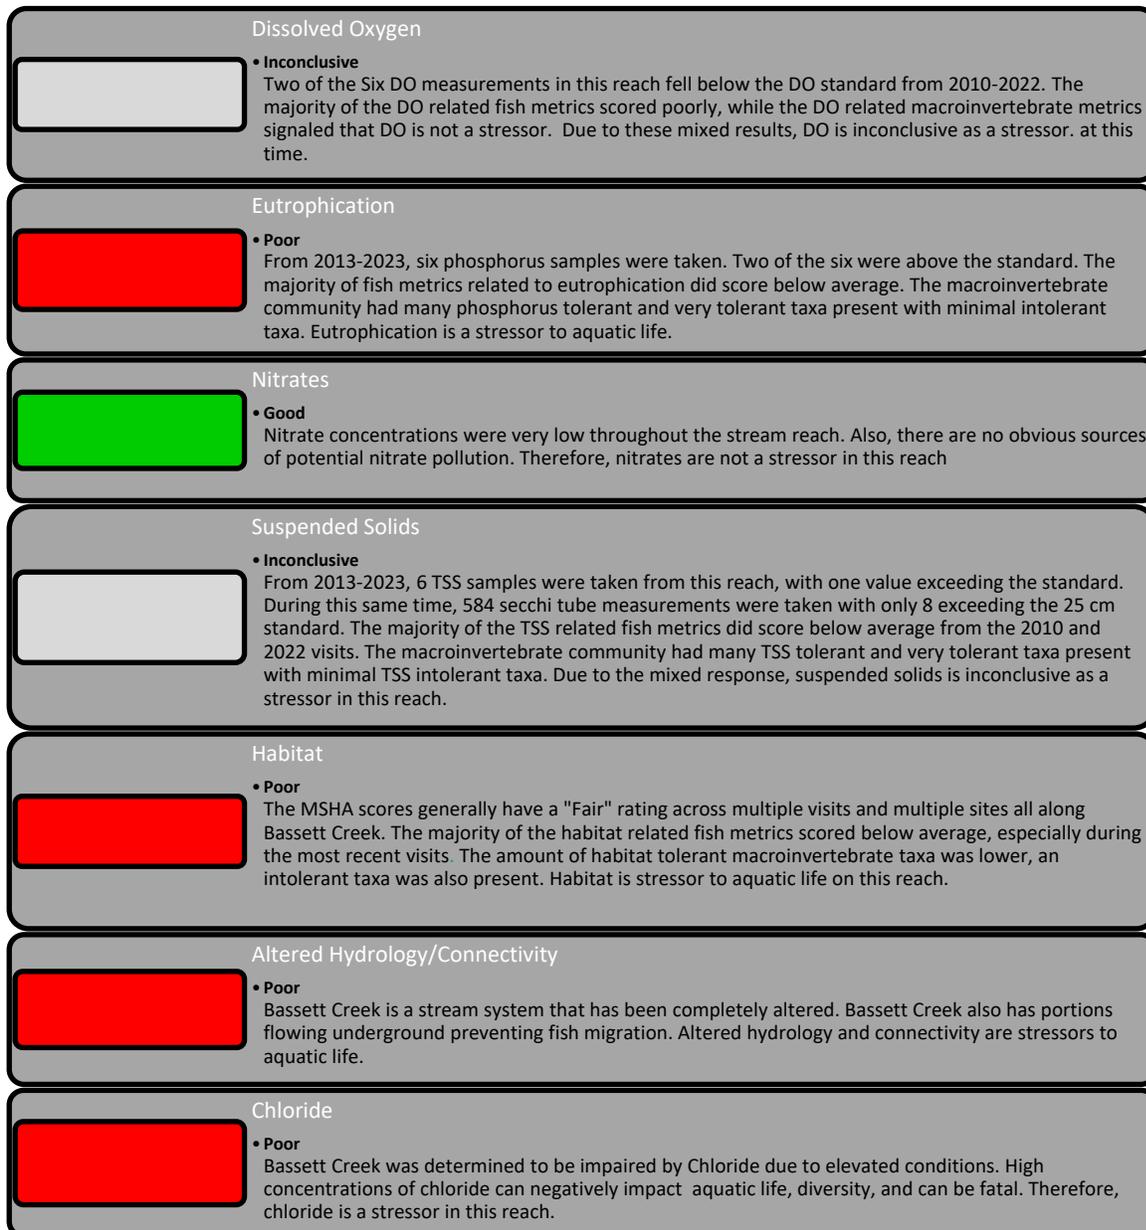
SID work was not completed in Bassett Creek during C1 SID. The goal of C2 SID work was to gather and analyze the biological and chemical data to determine the likely cause of stress to the impaired fish and macroinvertebrate communities. Eutrophication, habitat, altered hydrology/connectivity and chloride were the identified stressors, while suspended solids and DO were inconclusive. More DO and suspended solids data is needed to determine if it is having a negative impact on aquatic life (Figure 22).

Figure 22: Biological stressor determinations for Bassett Creek. Red boxes indicate poor conditions; therefore, a stressor to aquatic life. Green boxes indicate good conditions and not a stressor to aquatic life. Grey boxes indicate that the parameter is inconclusive as a stressor.

Additional analysis of the biological, water chemistry, and general stream conditions in Bassett Creek has pointed to the importance of connectivity. Barriers that limit fish migration can change fish community dynamics upstream of the barrier. Eutrophication, habitat, and chloride issues were also present along this reach. Additional transparency and DO data are needed to more accurately determine if these candidate causes are stressors in Bassett Creek.

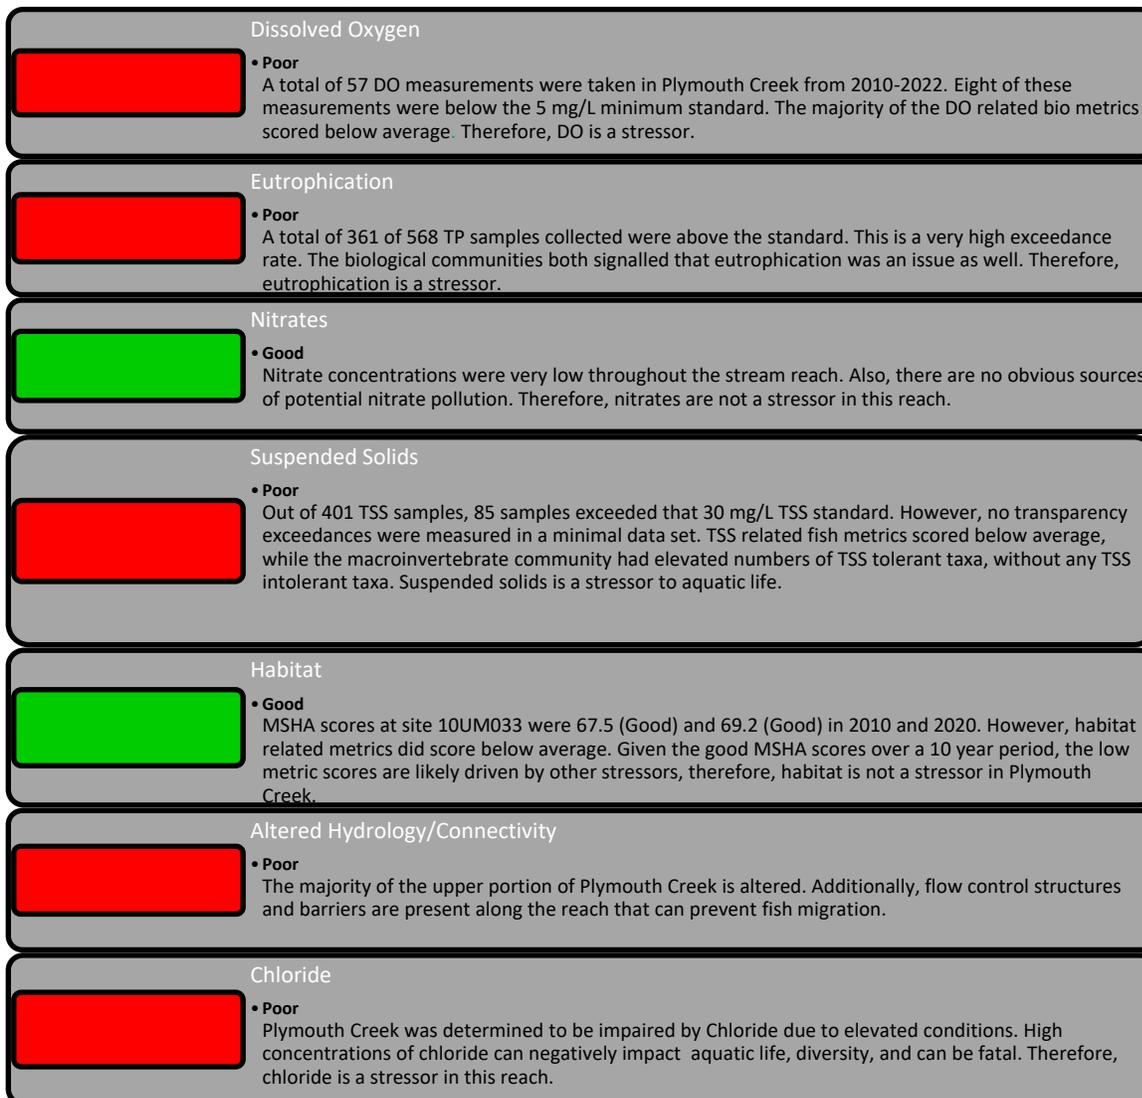
SID work was not completed in Plymouth Creek during C1 SID. The goal of C2 SID work was to gather and analyze the biological and chemical data to determine the likely cause of stress to the impaired fish and macroinvertebrate communities. DO, eutrophication, suspended solids, altered hydrology/connectivity, and chloride were the identified stressors. Nitrate levels were low on this reach and in the watershed, and the habitat scores were generally good at the biological site on this reach. See Figure 24 for more details related to the stressors of this reach.

Figure 24: Biological stressor determinations for Plymouth Creek. Red boxes indicate poor conditions; therefore, a stressor to aquatic life. Green boxes indicate good conditions and not a stressor to aquatic life.

Additional analysis of the biological, water chemistry, and general stream conditions in Plymouth Creek has pointed to the importance of connectivity and altered hydrology. This stressor can also contribute to other stressors as well. Additionally, eutrophication, DO, suspended solids, and chloride issues were also present in this reach.

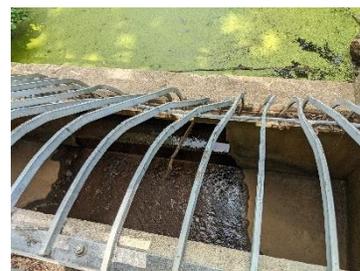
Barriers that limit fish migration can change fish community dynamics upstream of the barrier. Numerous barriers and flow control structures are present, for various reasons, however, fish migration and flow conditions are still heavily impacted. (Figure 25)

Figure 25: Flow Control Structure on Plymouth Creek.
