# Hawk Creek Watershed

## Stressor Identification Update

May 2026

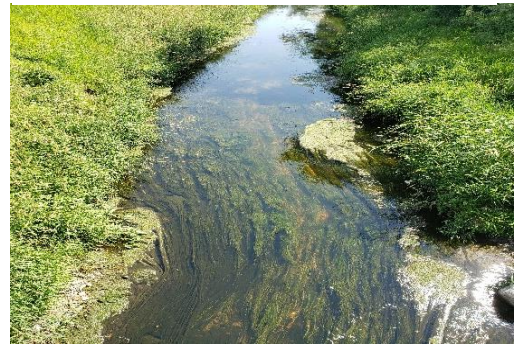
Figure 10. Algal growth at 03MN007 (6/29/03).

Thick algae growth was found in Hawk Creek, upstream of the two impaired reaches (Figure 10). While eutrophication determined inconclusive as a stressor to Hawk Creek (-568, -587), elevated phosphorus (a high value of 1.65 mg/L) and elevated pH (a high value of 10.18) were prevalent on both reaches. Chl-*a* (44%) and biochemical oxygen demand (BOD; 38%) were also elevated on the lower reach. Reducing nutrient inputs to the creek would be beneficial.

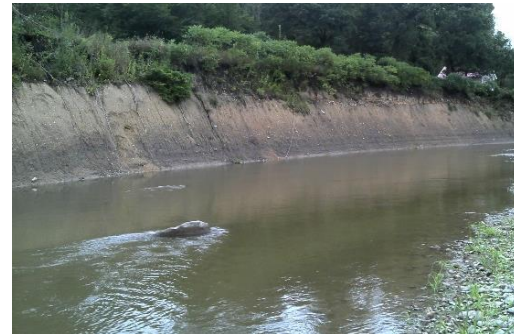
Figure 11. Erosion at 15MN204 (8/19/15).

Severe bank erosion was recorded at site 15MN204 in 2015 (Figure 11). Riprap was added to the banks (Figure 12), but erosion will continue until the creek has access to its floodplain. The DNR did a geomorphology study at site 15MN204 and found the site to be entrenched and "...the channel is notably wide relative to its depth... The high W/D ratio makes the channel inefficient at transporting bedload, resulting in multiple areas of sand and gravel depositional bars" (DNR 2025).

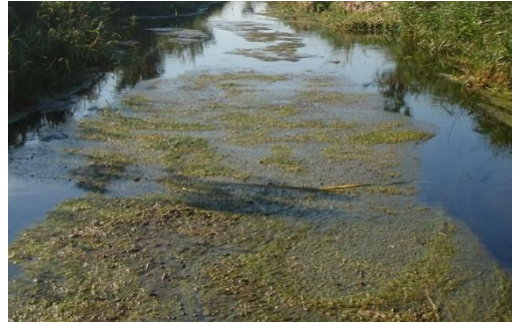
Figure 15. Algae growth at 10MN137 (7/8/10).

Excessive algal growth was observed at CD 37 and JD 2 (Figure 15 and Figure 16). Omnivorous fish, which increase with eutrophication increased from 3% in C1 to 47% in C2 at site 10MN103 on JD 2 (-730).

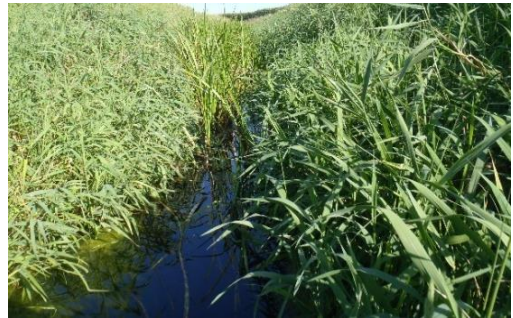
Figure 17. Vegetation filled channel at 10MN102 (7/19/10).

The habitat scores were rated poor at all three sites. The scores were lowered due to a lack of: channel development, depth variability, different substrate types, coarse substrates, and velocity types. JD 2 and the unnamed ditch were lacking any pools or riffles. The habitat scores decreased from C1 to C2 on JD 2. The unnamed ditch on reach -731 had choking vegetation through the reach (Figure 17).

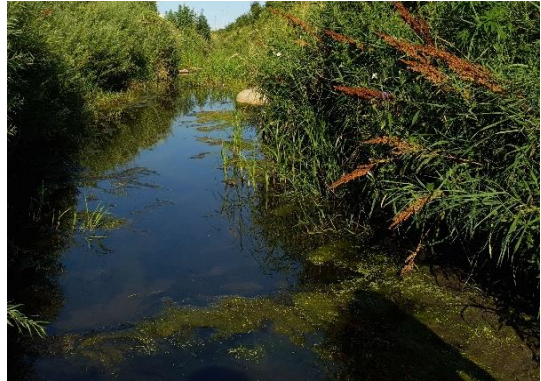
Figure 21. Algae on the tributary at 10MN138 (8/1/22).

Excess phosphorus concentrations can lead to eutrophic conditions (Figure 21 and Figure 22). Both reaches in this subwatershed showed elevated phosphorus concentrations. Eutrophication can also limit the amount of DO available, with both reaches showing low levels of DO and poor scoring biological metrics related to DO. Improving the riparian buffer and limiting phosphorus loading to the stream will likely lead to much improved conditions regarding eutrophication and DO.

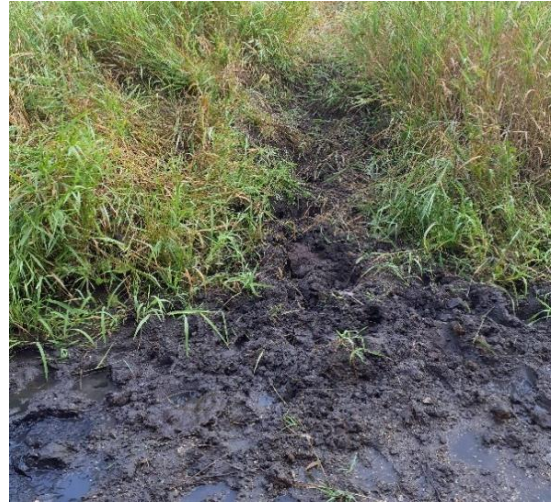
Figure 25. Cattle trampling at site 10MN116 (8/18/21).

The fish community at site 10MN116 on CD 36A was supporting of aquatic life in both C1 and C2. Macroinvertebrates were not collected in C1 but indicated impairment based on sampling in C2. The biological monitoring site is located within a fenced cattle pasture (Figure 25).

The erosion and excess sedimentation in the stream bed are impacted by riparian and upstream land uses. Cattle trampling in the adjacent pasture, and upstream channelization are both contributing to the lack of habitat in the reach. The channel is natural through the reach and has sinuosity and a wooded riparian area. Limiting the cattle access would help improve conditions at this tributary to the Minnesota River.

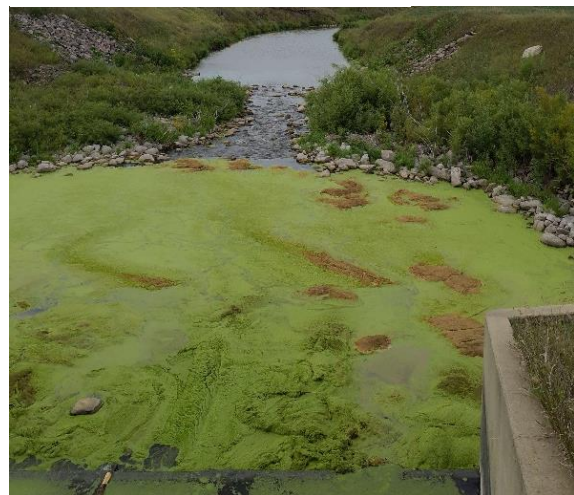
Figure 31. Algae at 10MN016 (8/11/21).

Phosphorus values were limited on the impaired reaches, but upstream reaches on Chetomba Creek have more data, with 67% of values over the standard. Longitudinal phosphorus sampling in 2023 at four locations showed values decreasing from upstream to downstream. One chl-*a* sample (2.46 ug/L) was taken just upstream of site 10MN016, and was well below the standard of 40. Thick algae was observed in August of 2021 (Figure 31). Phosphorus reduction in the watershed would be helpful to reduce algae.

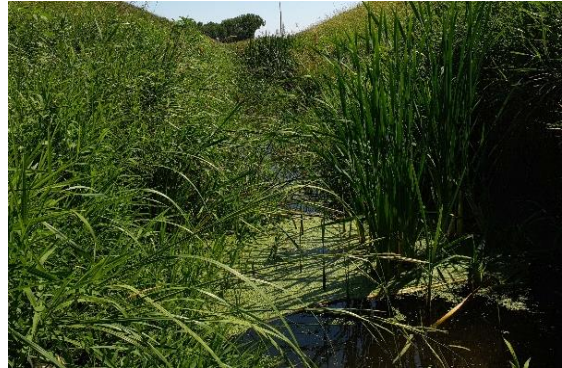
Figure 33. Cattails in channel at 91MN016 (8/1/22).

Low DO values were collected on all the ditches that are tributaries to Chetomba Creek in 2010 including CD 8 (2.18 mg/L), JD 8 (0.17 mg/L), and CD 18 (Figure 33) (0.690 mg/L). CD 18 and CD 31 had increases in low DO tolerant macroinvertebrate taxa from C1 to C2. CD 31 had both low and elevated DO values, an indication of possible eutrophication issues.

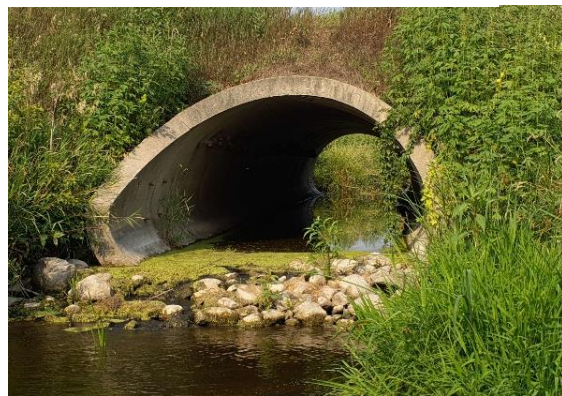
Figure 35. Perched culvert at 10MN083 (8/2/21).

Connectivity is a stressor in CD 31, which has a perched culvert and rock dam, and is preventing the upstream migration of fish species upstream especially during low flow conditions (35).

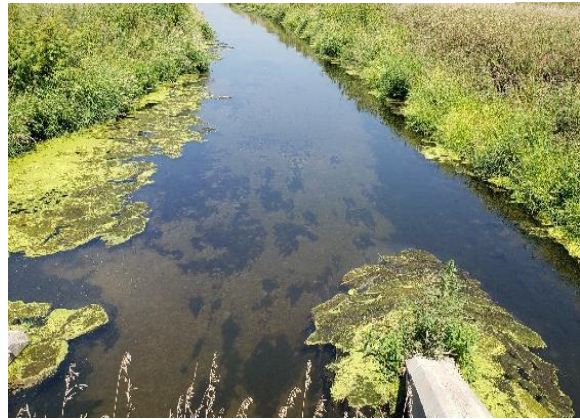
Figure 38. Algal growth at site 10MN115 (8/23/23).

Phosphorus values were high, with 67% of values over the standard. Longitudinal phosphorus sampling in 2022 at three locations (S004-687, S000-484, and S000-404) along the East Fork Beaver Creek showed values increasing from upstream to downstream. All three longitudinal phosphorus values were over the standard (increasing from 0.170 mg/L in the headwaters to 0.270 mg/L near the mouth) . Phosphorus values were slightly higher in East Fork Beaver Creek than in West Fork Beaver Creek. Daily DO flux data from August 2024 showed all 7 days above the standard, with a maximum value of 11 mg/L. Eutrophication is likely driving low DO values, algal growth (Figure 38) and elevated daily DO flux.

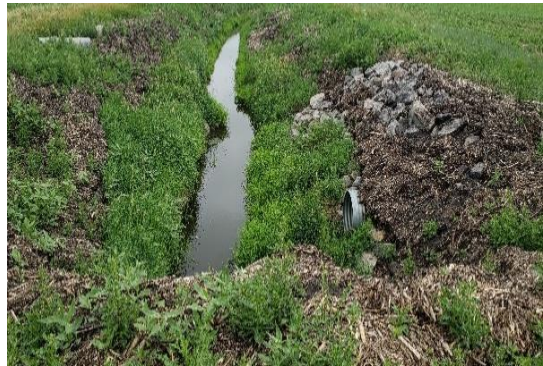
Figure 42. Site 10MN107 (7/6/22).

Site 10MN107 was sampled once in 2010 and the high percentages of legless and burrower macroinvertebrates correspond with the amount of fine substrates observed during sampling. Central stonerollers were the most prevalent fish collected at site 10MN033 in 2022, corresponding with an increase in coarse substrates. High flows are moving through the system as evidenced by the debris (Figure 42) and the creek doesn't have access to its floodplain, which is causing erosion and eroding banks (Figure 43).

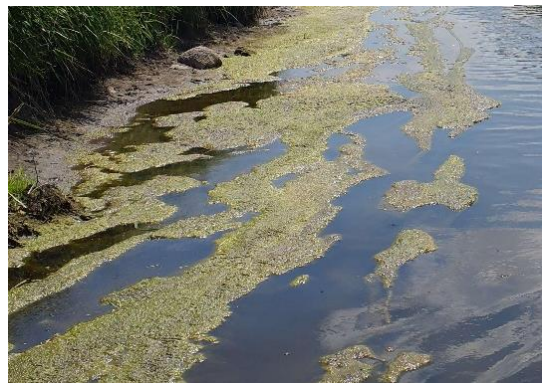
Figure 44. Algae at site 10MN033 (6/27/22).

Total phosphorus values exceeded the standard at a high rate, and elevated DO values up to 25 mg/L were collected. Thick algae was also observed (Figure 44). The EPT percentage decreased from 25.2% in C1 to 7.5% in C2 at site 10MN033. DO flux and chl-*a* values were not elevated, but it would be helpful to get further DO flux at an upstream location where the elevated DO values were collected, to eliminate eutrophication as a stressor. Limiting phosphorus loading to the stream would be beneficial.

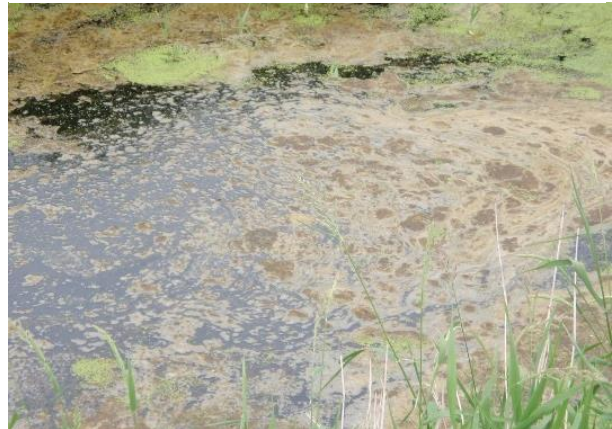
Figure 46. Scum at 03MN017 (6/7/10).

Two low DO values below 1 mg/L (0.220 in 2015 and 0.880 mg/L in 2010) were collected on CD 37, and the ditch was listed on the Impaired Waters List for DO in 2020. The low DO values were collected both upstream and downstream of the Southern Minnesota Beet Sugar Coop discharge. No fish were collected at downstream station 03MN017 in 2010 (Figure 46).

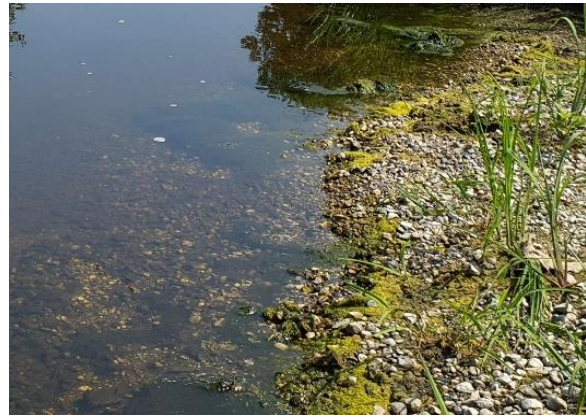
Figure 50. Filamentous algae at 10MN021 (8/2/22).

Biological and water chemistry information throughout Sacred Heart Creek identified nitrate and TSS as stressors with potential stress coming from eutrophication (Figure 50).

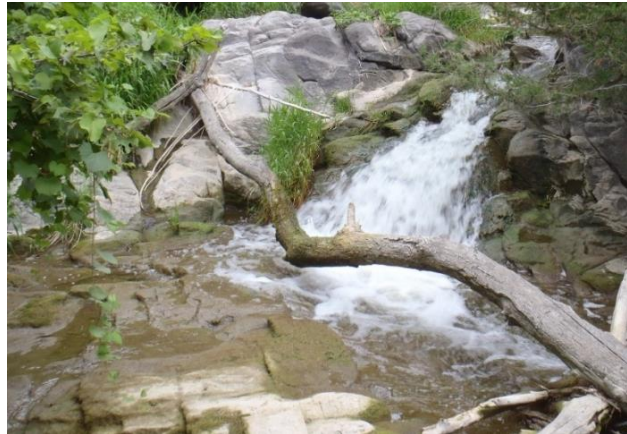
Figure 56. Timms Creek at 10MN077 (7/21/10).

The three creeks are direct tributaries to the Minnesota River. The bedrock geology and high gradient of Timms Creek makes for unique features like large riffles and small cascades (Figure 56).
