# Chippewa River Watershed Biotic Stressor Identification Report

Minnesota Pollution Control Agency

November 2015

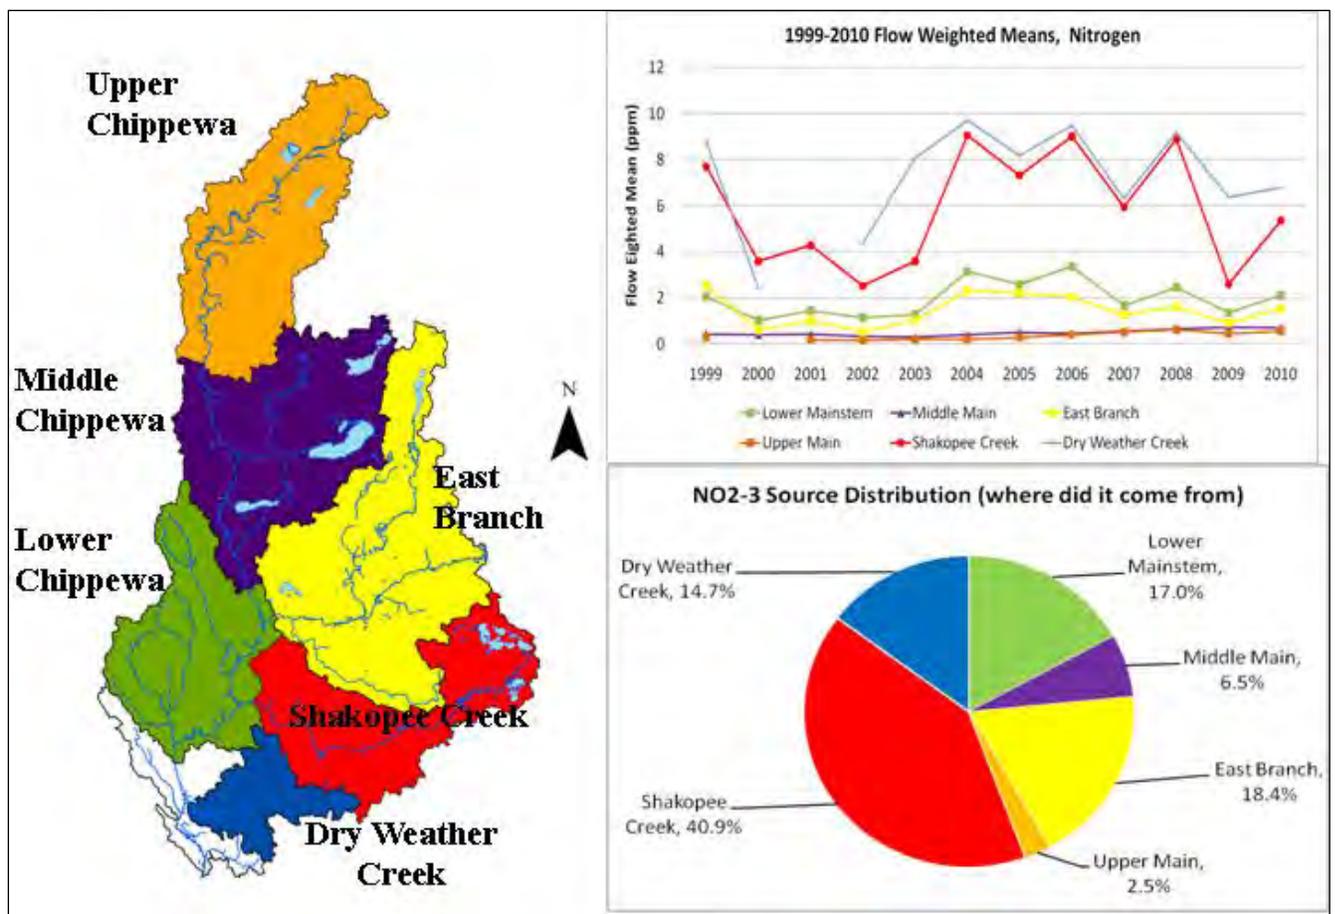
Calculations of the Chippewa River's nitrate plus nitrite-nitrogen loads indicate a variation of levels between sites and regions (see Chippewa River Watershed Monitoring and Assessment Report for more information). In general NO<sub>2</sub>-3 levels increase from north to south and upstream to downstream in the Chippewa watershed (see Figure 1-2). Areas where row cropping is dominant tend to have the highest NO<sub>2</sub>-3 levels but there are exceptions to this trend (Cottonwood Creek).

Figure 1-4 Nitrogen monitoring results (from Chippewa River Watershed Monitoring Summary 2009-2010).

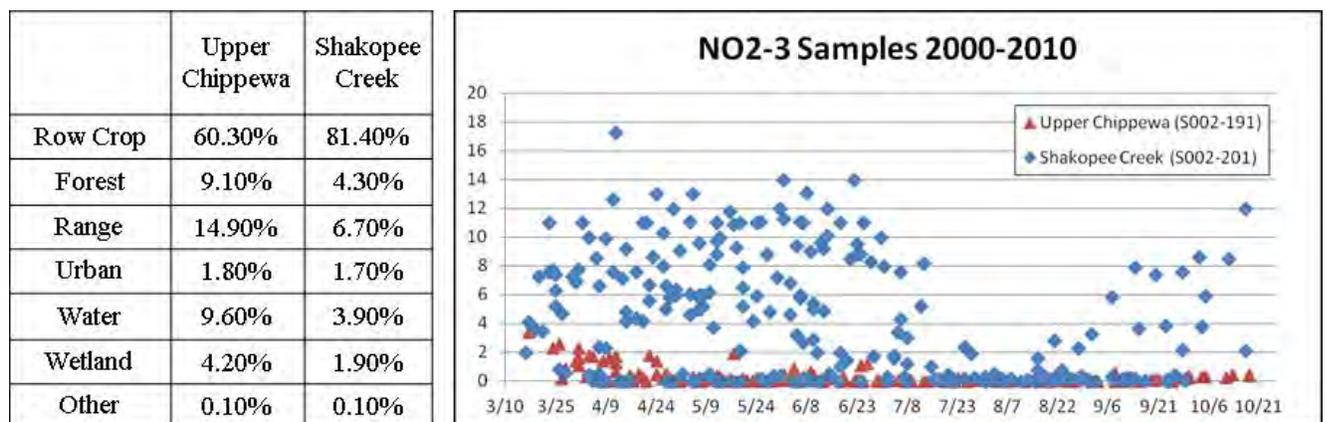
Point measurements provide a useful picture of NO<sub>2</sub>-3 in the watershed. NO<sub>2</sub>-3 tends to leak out of watersheds with less perennial land uses in the Chippewa watershed. An example of this can be seen in Figure 1-3. The chart documents point measurements of NO<sub>2</sub>-3 in two sub-watershed of the Chippewa River Shakopee Creek and the Upper Chippewa. In Shakopee Creek NO<sub>2</sub>-3 levels are high starting during the spring melt period and generally drop in July when the row crops mature. NO<sub>2</sub>-3 levels rise again in late August when the row crops stop growing.

Figure 1-5 Land uses and NO<sub>2</sub>-3 point measurements for Upper Chippewa and Shakopee Creek 2000-10.

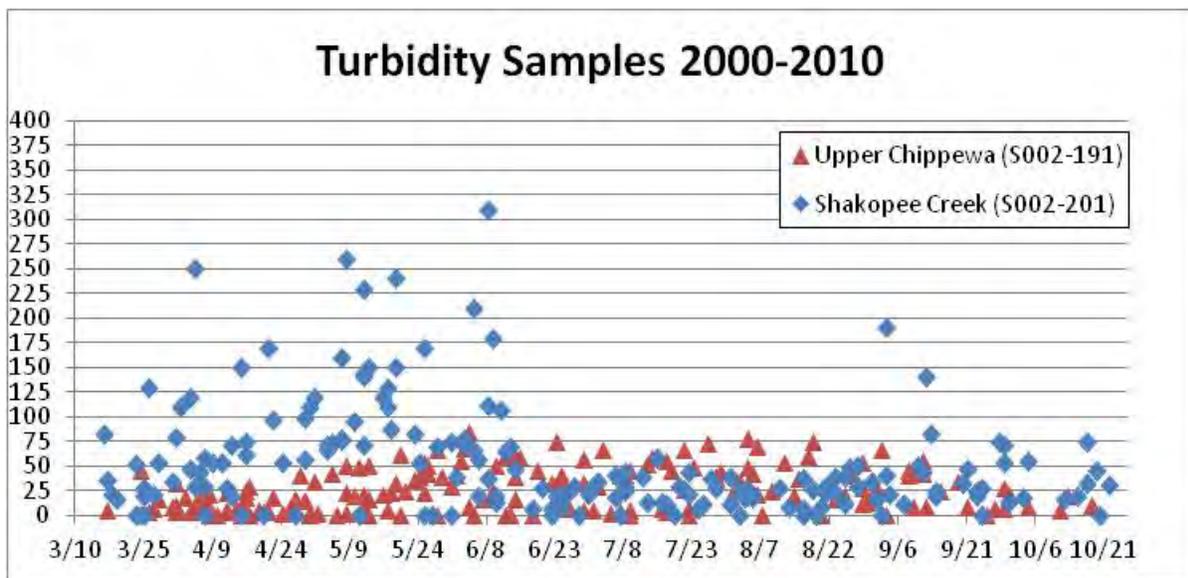
In the Chippewa, in areas where row cropping is more prevalent, there is a trend toward higher turbidity during the spring months when there is little canopy cover. In the Northern part of the Chippewa, where row cropping makes up a smaller portion of the overall land use, the turbidity profile is different. Turbidity tends to rise into June, July and August and then come down in September. This may be due to high levels of nutrients and warm water temperatures creating the ideal conditions for algal growth in the stream channel and connected lakes. High turbidity for long periods of time including during low flow periods is alarming. The consistently high turbidity levels seen throughout the watershed suggest that aquatic habitat and recreational enjoyment on the Chippewa is seriously degraded. (Figure 1-12).

Figure 1-12 Turbidity point measurements for Upper Chippewa and Shakopee Creek 2000-10.

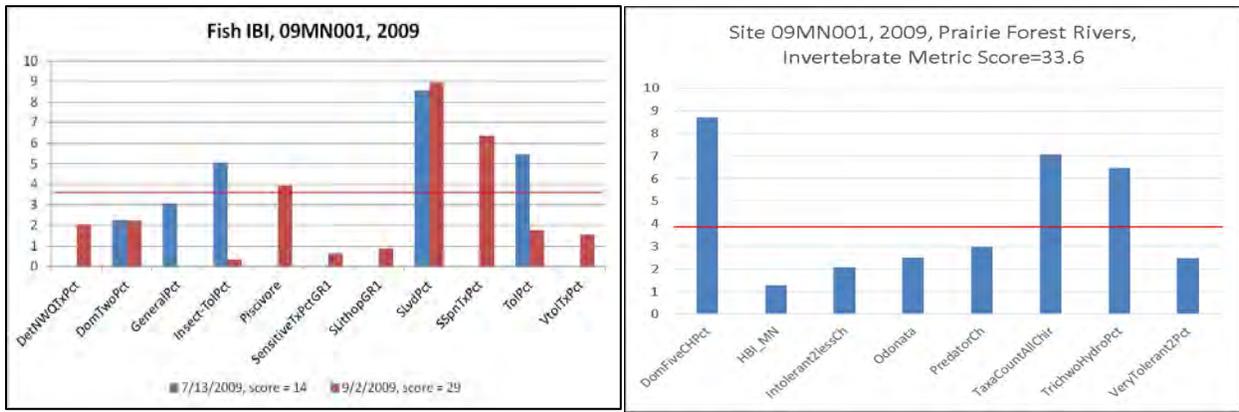
Invertebrates were sampled once in August 2009 and reported 51 genera. This site scored well for the number of Trichoptera taxa present, and total taxa richness, and was not overly dominated by the dominant five taxa (DomFiveCHPct) in the sample (Figure 502-2).

Figure 502-2 Fish and Invertebrate metric scores belonging to site 09MN001. The red line indicates the average metric score needed for the score to be at the threshold.

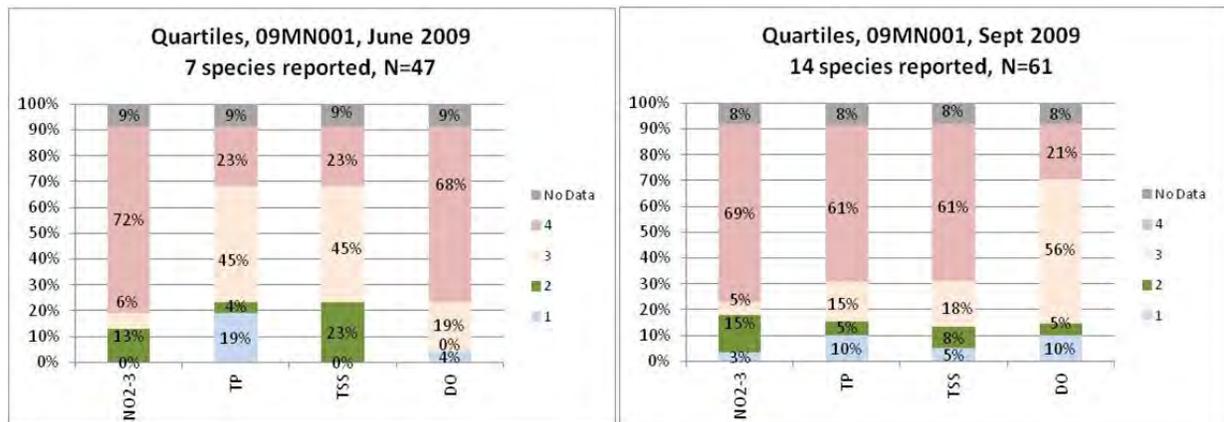
A survey of fish species tolerance levels to NO<sub>2</sub>-3, TP, TSS and DO revealed a high number of pollution tolerant individuals (Meador and Carlisle, 2006). These results suggest that low DO, turbidity, high phosphorous and high nitrogen are all possible stressors.

Figure 502-3 Fish quartile values for NO<sub>2</sub>-3, TP, TSS and DO.

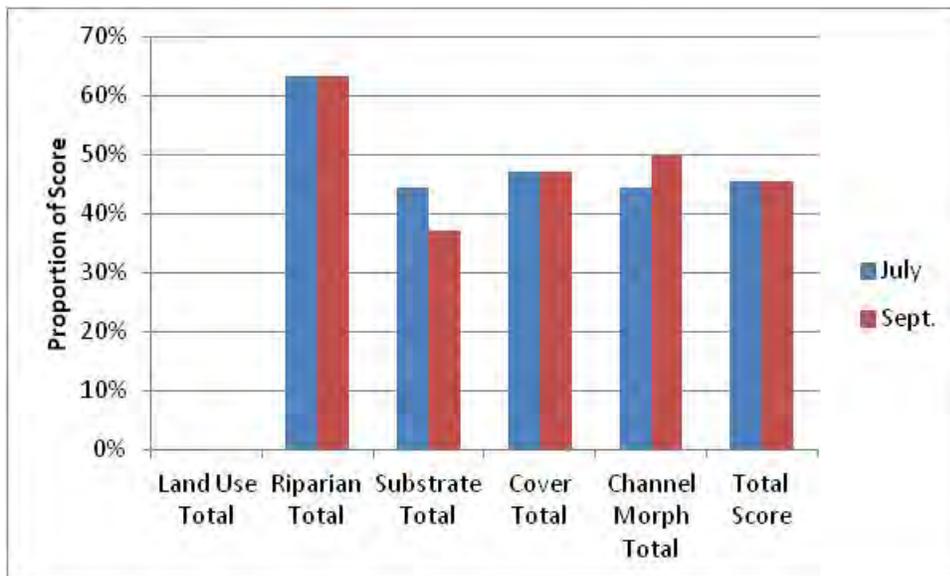
Both of the 2009 MSHA's scored riparian conditions well. Substrate, cover and channel morph all pulled the overall score down. (Figure 502-9)

Figure 502-9 MSHA scores by category for 09MN001

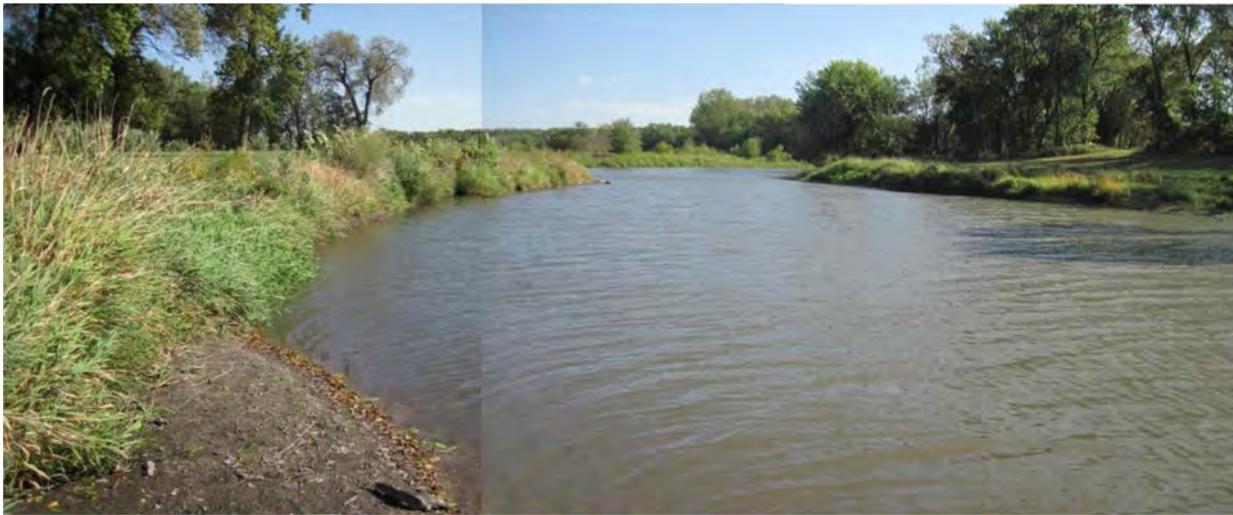
The SVAP survey conducted in 9-2012 noted a number of negative factors for aquatic habitat. In general, the river is entrenched and suffers from poor channel condition and obvious hydrologic alteration. The banks are somewhat unstable. The water appearance was poor and there were multiple signs of nutrient enrichment. The presence of two dams immediately downstream of the reach creates serious barriers to fish movement. The survey team observed a moderate number of habitat types for fish but only two of eight types of invertebrate habitats. The condition of pools at the site was excellent.

Figure 502-10 Looking upstream toward 09MN001.

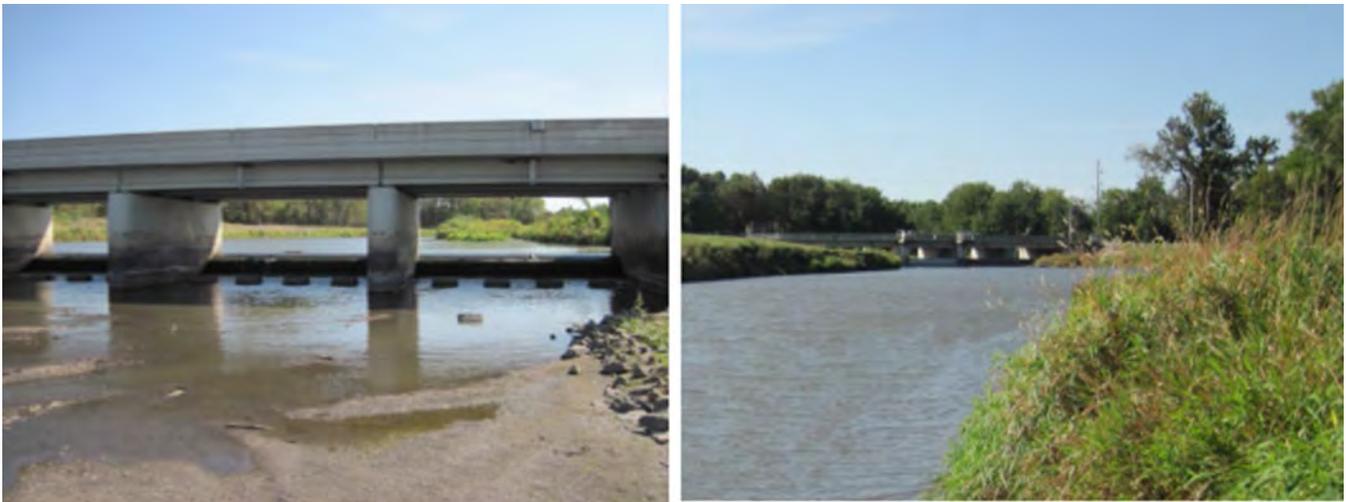
Figure 502-11 The two dams downstream of 09MN001.

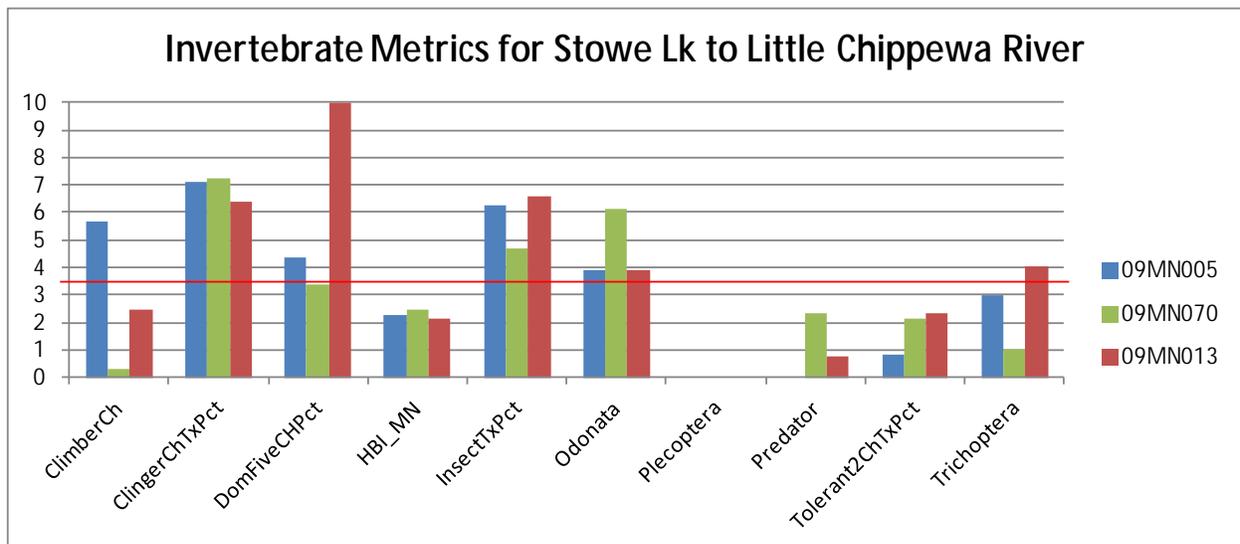
The relatively low values for the Predator metric (taxa richness of predators), indicate that trophic complexity supported by this reach is poor. Less disturbed sites support a greater diversity of prey items and a variety of habitats in which to find them.

Figure 503-2 Invertebrate metric scores belonging to the Chippewa River, Stowe Lake to Little Chippewa River AUID: 07020005-503. Red line indicates the average metric score (3.6) needed for IBI score to be at the threshold.

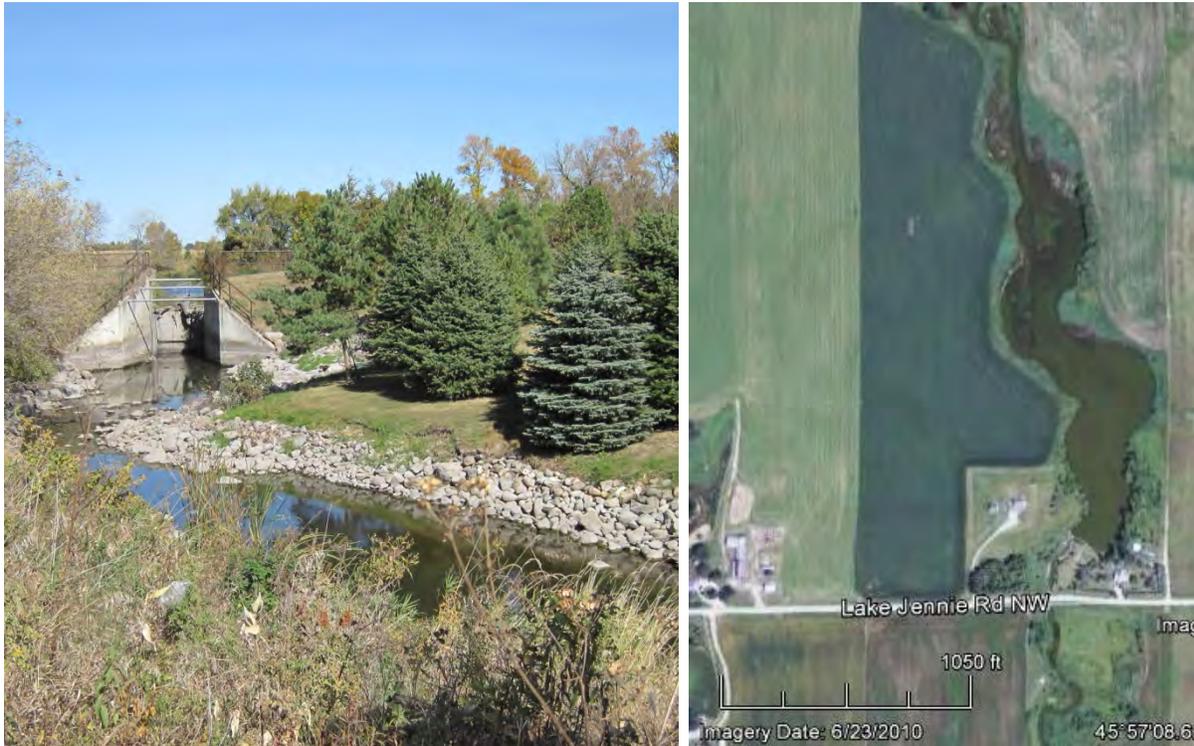
Dissolved oxygen levels can be affected by impoundments by collecting nutrients and organic materials leading less to availability and by serving as areas for algae blooms. In the AUID 07020005-503 watershed, there is one constructed impoundments and eight known natural impoundment. Figure 503-3 shows photos of one of the constructed impoundments, where the creek is held back by a 6-8 foot impoundment wall. The upstream impoundment conditions are difficult to discern from the road.

Figure 503-3 Impoundment on Upper Chippewa River, 9/26/ 2012 and aerial view 6/23/2010.

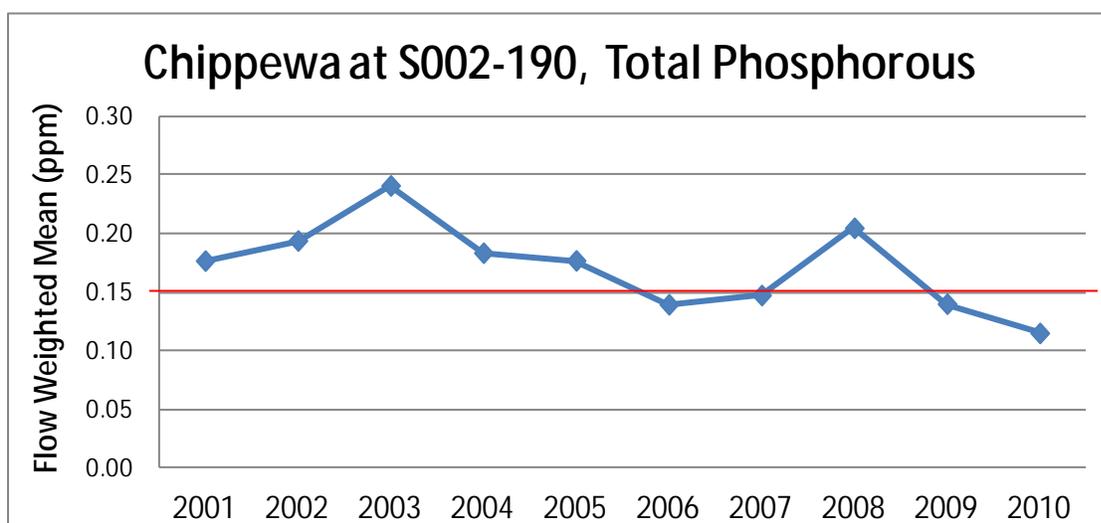
Total phosphorus concentrations in AUID 07020005-503 are often above the Minnesota draft standard (0.15ppm). The flow weighted mean phosphorus levels from 2001 through 2010 were above the proposed standard and ecoregion expectations six out of the past ten years (Figure 503-4). Of the three sites monitored for phosphorus in this reach all of them reported levels above the draft standard at some point (09MN005 - 10% (N=10), S002-190 - 60% (N=106), 09MN013 - 40% (N=10)).

Figure 503-4 Flow Weighted Mean for Total Phosphorous at site S002-190

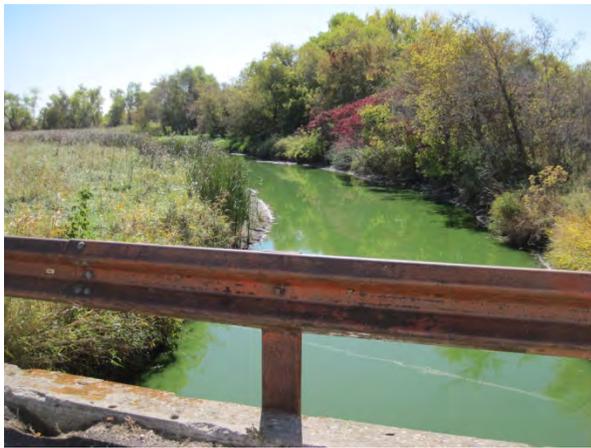
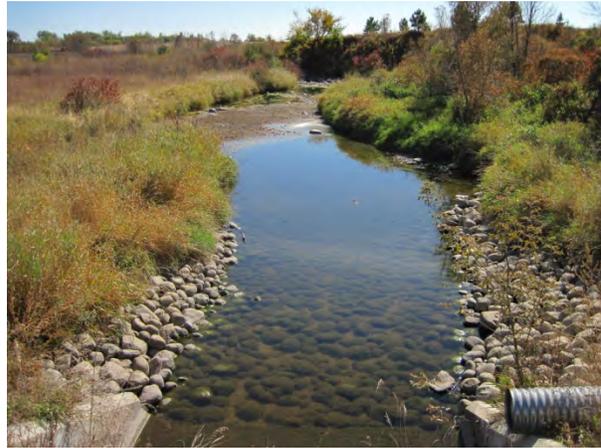
Figure 503-5 Photos from the Upper Chippewa taken on 9/26/2012 showing algae saturated water algae covered substrates.

Stream Visual Assessments conducted in October of 2012 by CRWP staff provide a useful perspective. At the time of the survey the three sites 09MN005, 09MN070 and 09MN013 presented bright green water and channel substrates covered with algae (Figure 503-5). Since algae are often related to high phosphorus concentrations it seems reasonable that these sites experience high phosphorous.

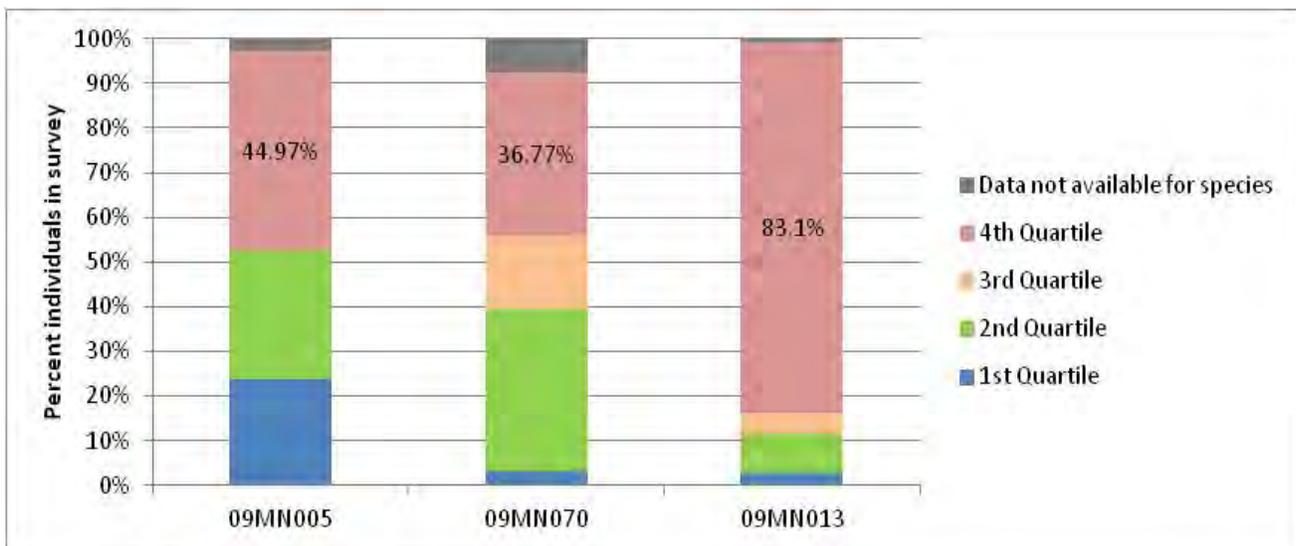
In 2009 and 2010, the fish samples in the Upper Chippewa were comprised of varied portions of nitrogen tolerant individuals (fourth Quartile) at each of the sites (Figure 503-10). At the Upstream site (09MN005) 44.97% of the sample was made up of nitrogen tolerant species, 36.77% at 09MN070 and then 83.1% at 09MN013. These fluctuating levels of Nitrogen tolerance and the drop-off of nitrogen intolerant species suggests that nitrogen may be more of an issue in the lower portion than it is in the upper portion of the reach.

Figure 503-10 Percent fish individuals by biological site in the Upper Chippewa River, for each quartile based nitrate tolerance indicator values (Meador and Carlisle, 2007).

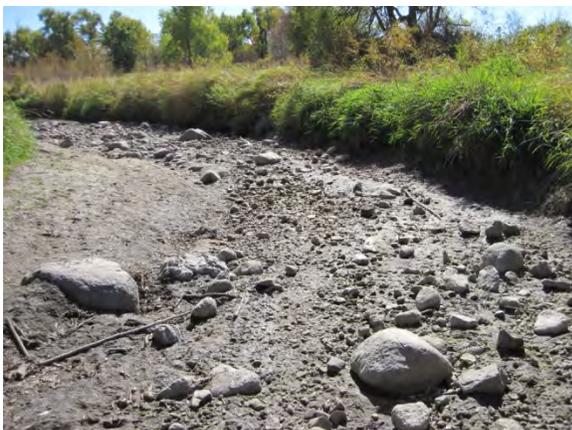
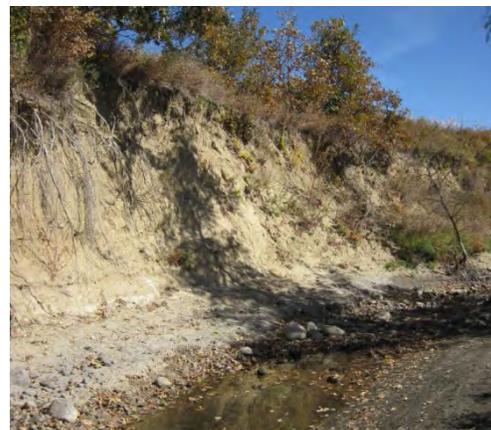
Figure 503-11 Station 09MN005 9/26/2012 (extreme drought, channel dewatered).

Station 09MN005 is the most upstream biological monitoring site on the Upper Chippewa. The contributing drainage area is approximately 149 square miles. The Chippewa River at station 09MN005 is classified as a C3 stream type, characterized by a gravel bed, low entrenchment ratio with good connectivity to the flood plain, moderate to low width depth ratio, moderate sinuosity, and low slope. The reach is protected from down-cutting by riffles with boulders and subpavement materials that are resistant to degradation. There is a dam 3.25 miles upstream from this site. In addition, the reach has a 1,500 foot straightened section about 2,000 foot upstream of the monitoring site. The dam and straightened portion of the creek are likely reasons for severe erosion on the outside of bends and the prevalence of undercut banks. The hydraulically controlling culvert, riffles and stable stream bed in this reach help resist down cutting. This leaves the stream banks as the weakest link in adjusting to the sediment free flows coming over the upstream dam and down the increased slope of the straightened section.

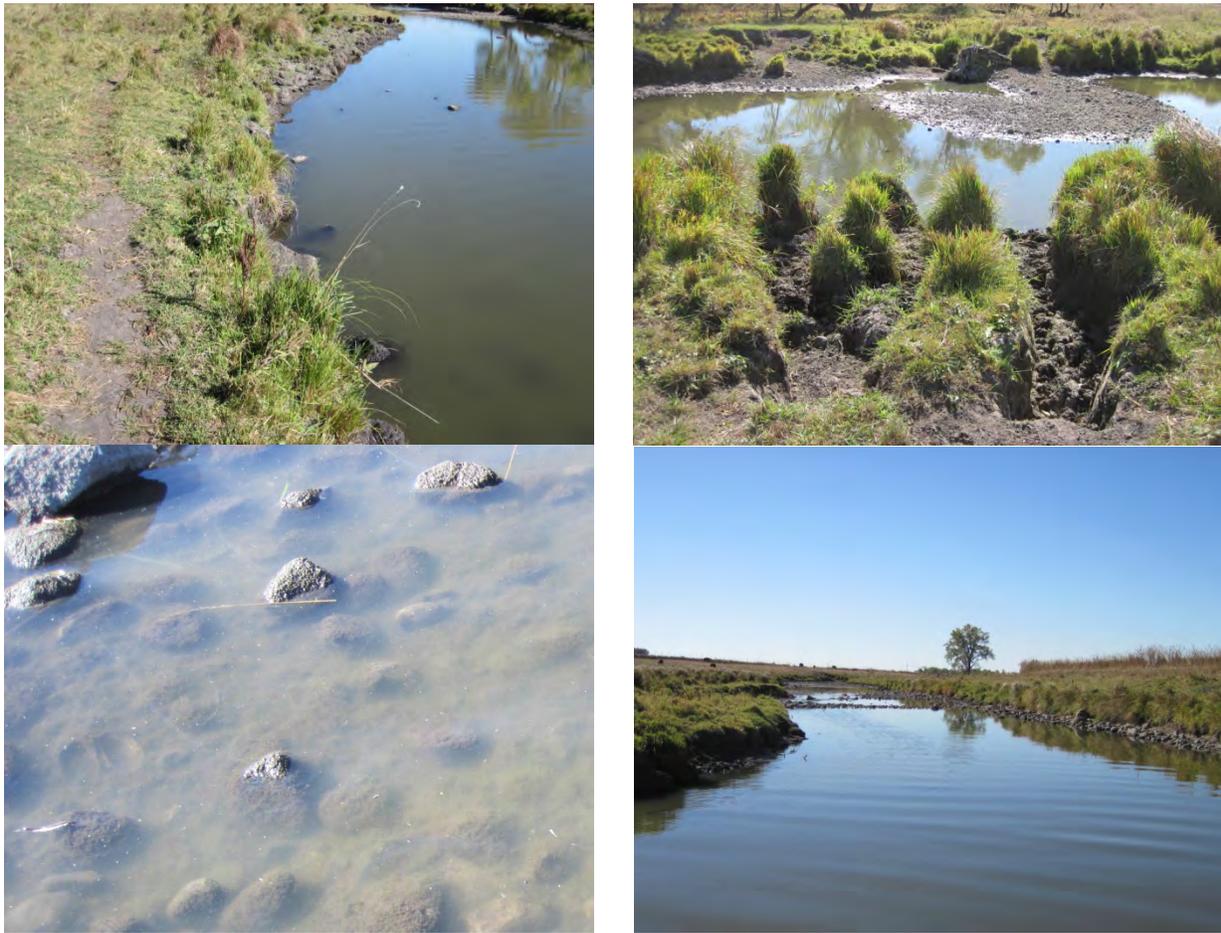
Between the continuously grazed pasture and the adjacent row crop fields little of value was left for the function of the riparian zone. The land use adjacent to this site does not provide "natural riparian zone" benefits (as defined by NWCC Technical Note 99-1, Stream Visual Assessment Protocol, December 1998) for invertebrates, fish nor natural stream function.

Figure 503-13 Station 09MN070 9/26/2012, livestock impact and algae in water column and on substrate.

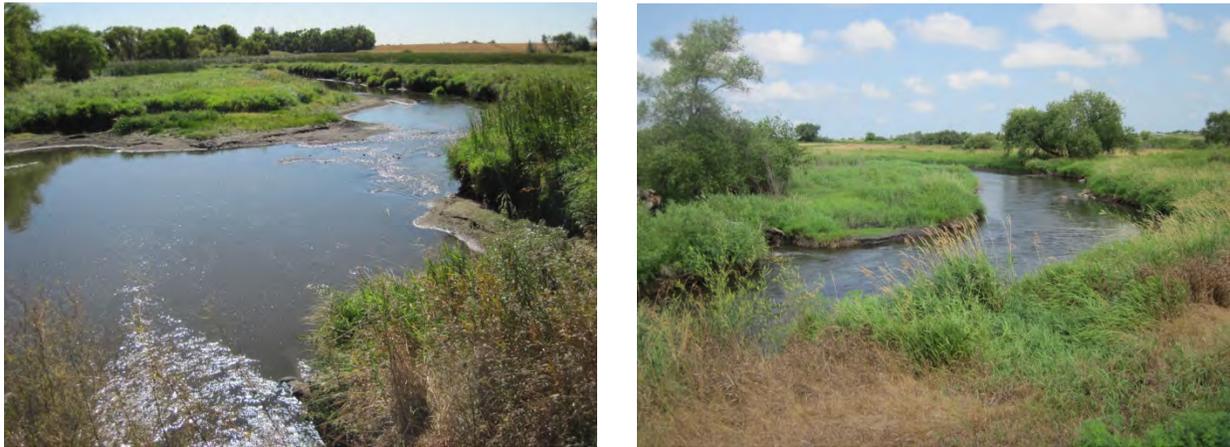
Figure 503-15 Photos of site S002-190, looking downstream and upstream.

While this site is fairly stable and well protected by perennial vegetation the geomorphology of this site is negatively impacted by the road and culverts. This brought down the scores for channel condition and hydrologic alteration. The road acts as a dike to the river during high flows and prevents access to the flood plain on one side. Even so, since the flood plain is so large this impact is minimal. The culverts restrict flow and focus the rivers power into the river channel during high flows. This has had the impact of creating a scour pool downstream of the culverts. In addition, the stream banks downstream of the culvert are noticeably worse than those upstream of the road.

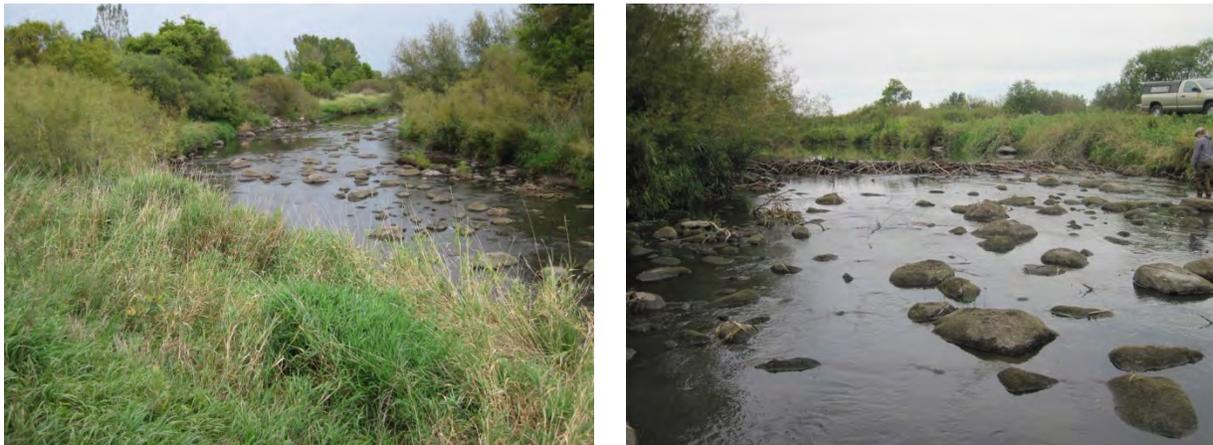
**Figure 503-17 Site 09MN013 looking downstream and upstream.**

The SVAP gave 09MN013 an overall score of Good. Invertebrate habitat scored 10 out of 10 points. Invertebrate habitat types documented were: overhanging vegetation (draped in water), boulders, cobble, coarse gravel, fine woody debris, root wads and undercut banks. Clearly this site has excellent habitat characteristics for invertebrates. The only factors that were negative for this were water quality based. Scores for water appearance and nutrient enrichment were poor due to the documented pervasively bad turbidity levels and the high nutrient issues.

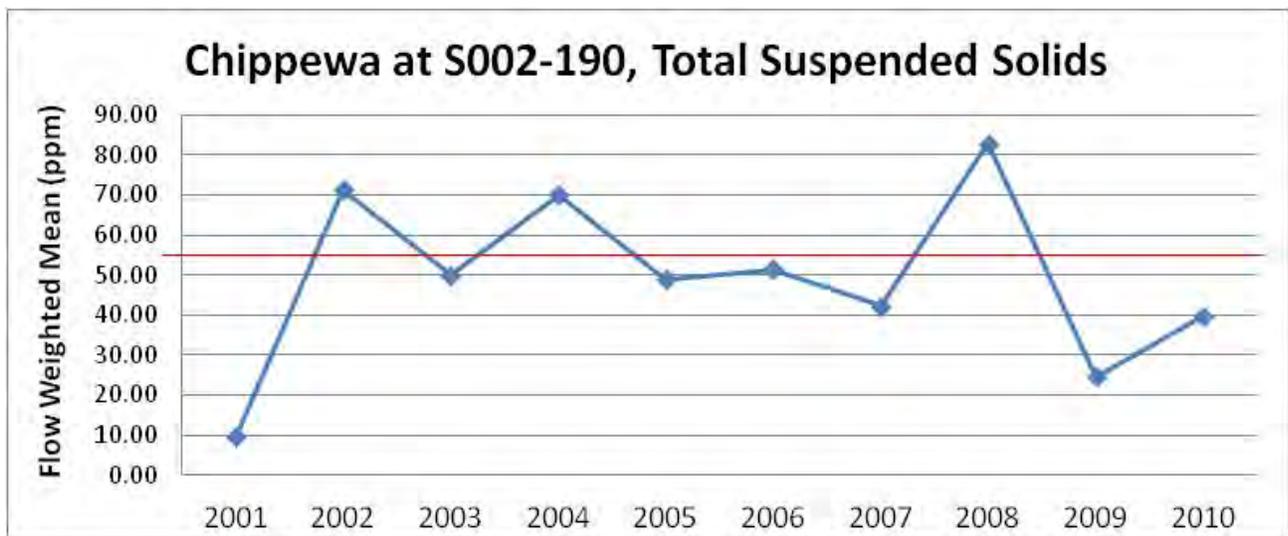
Turbidity concentrations in AUID 07020005-503 are often above the Minnesota standard (25 NTU). In AUID 07020005-503 site S002-190 was the only site where turbidity was directly measured. At site S002-190 from 2007 through 2012 101 turbidity measurements were made, 45% of them exceeded the standard. At site 09MN005 11% of 19 transparency measurements taken over 2009 and 2010 exceeded the standard. At site 09MN013 85% of the 55 transparency measurements taken between 2006 and 2010 exceeded the standard.

Figure 503-18 Flow Weighted Means for S002-190, 2001-2010.

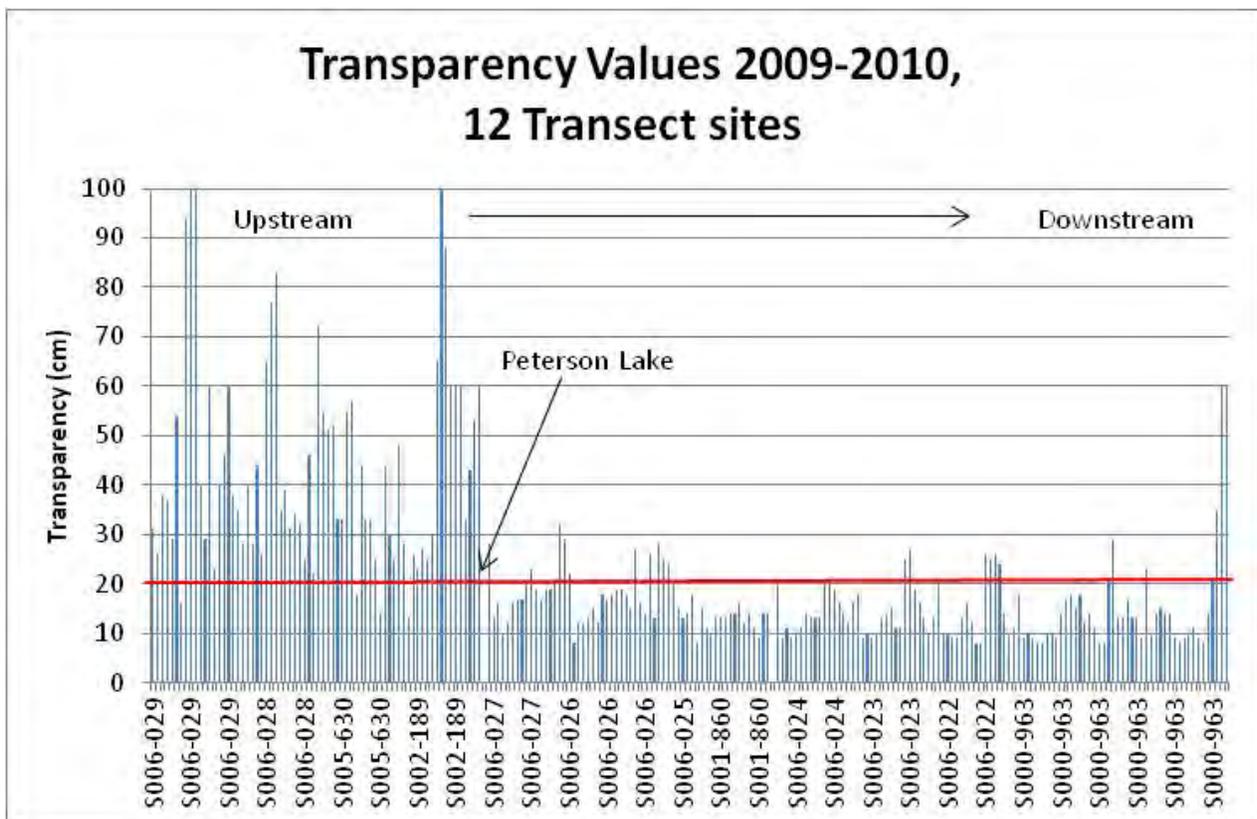
Review of the transparency data from the transect sites from 2009 and 2010 reveals an interesting pattern. Overall the 12 sites were monitored for transparency 19 times each over this two year period and overall they exceeded the standard 58% of the time. When the sites are broken out we see that the first four sites upstream of Peterson Lake exceeded the standard 6% of the time. The next eight sites downstream of Peterson Lake exceeded the standard 80% of the time. Turbidity is a significant issue from Peterson Lake downstream till the end of the reach. Upstream of Peterson Lake, in-stream turbidity appears to not be an issue.

Figure 503-19 Transparency results showing the drop in transparency as the water moves downstream (note the red line, values below 20 cm are considered in exceedance of the standard).

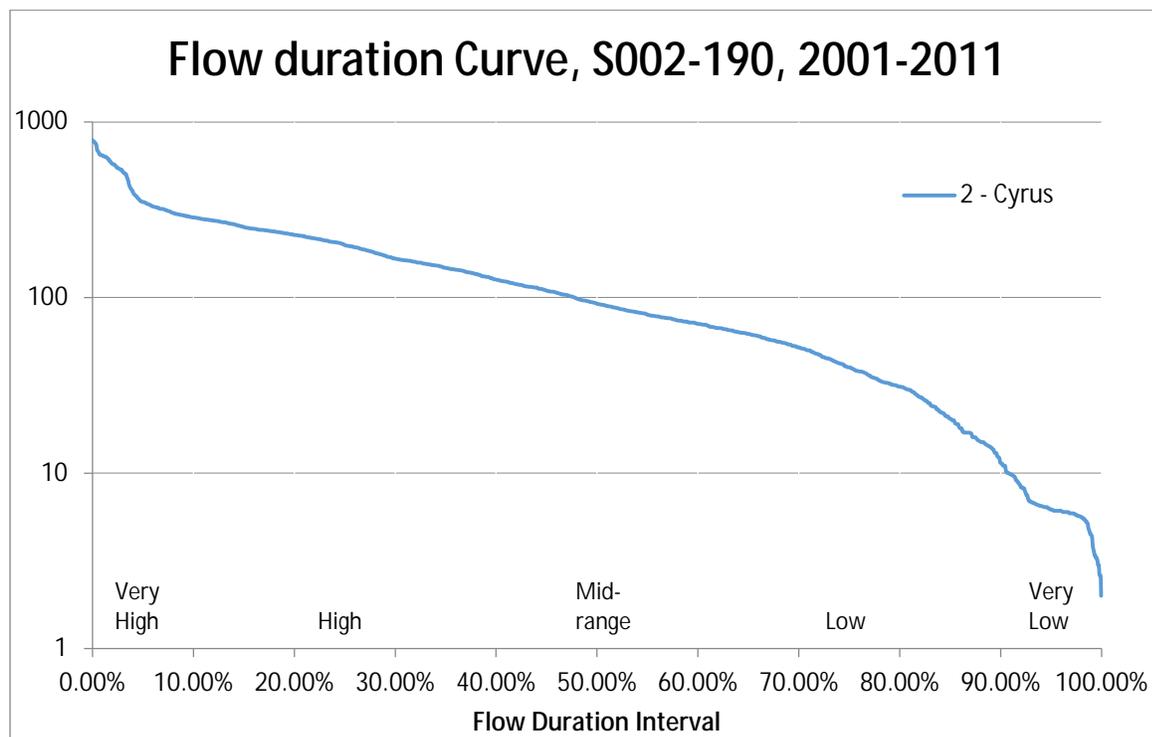
There is physical evidence to support listing altered hydrology as a candidate cause in the upper portion of the reach. Surveys at site 09MN005 noted channel erosion, scouring and dry stream conditions. These are all evidence of flow alteration. The presence of a dam and channelized section of stream immediately upstream of site 09MN005 are likely contributing factors to these observed conditions. In the case of 09MN070 the channel erosion appeared to be the result of extensive over grazing and the resulting destruction of the riparian corridor. Surveys at 09N013 did not find physical evidence indicative of flow alteration. Further evidence against flow alteration as a candidate cause in the lower region of the reach comes from bank pins placed at site S002-190. They have not documented high rates of bank erosion.

Figure 503-20 Flow duration curves for S002-190.

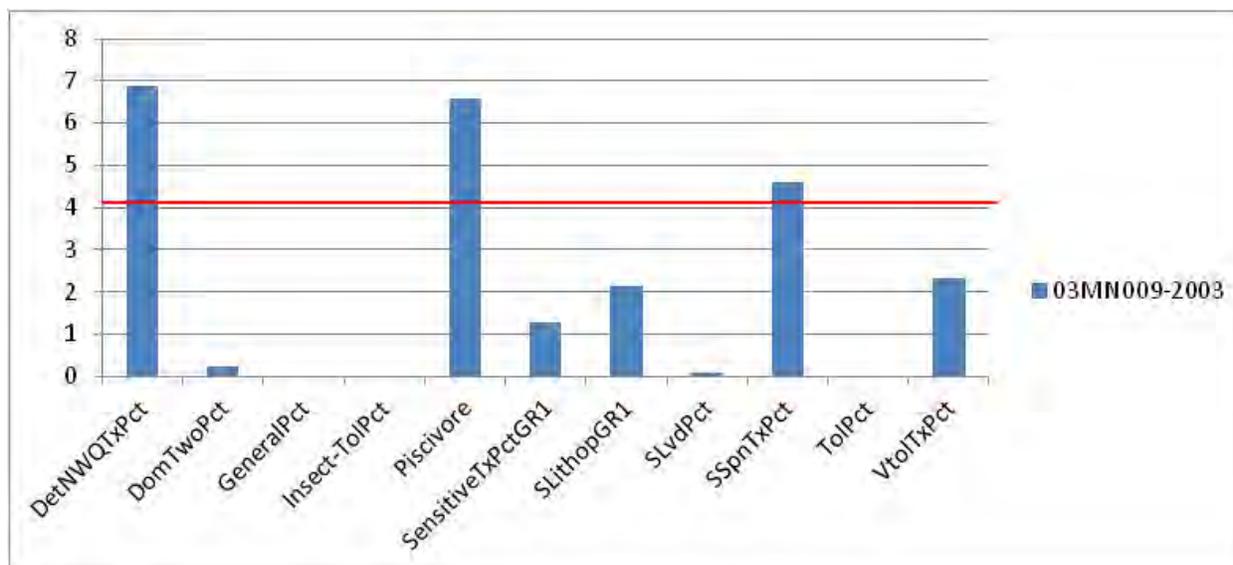
indicate potential issues with disturbance, water born pollution and a lack of adequate aquatic habitat (Figure 505-2). Sevenhundred twenty-four fish were caught representing 23 different species.

Figure 505-2 Fish metric scores belonging to site 03MN009 from the Chippewa River, Outlet Creek to East Branch Chippewa River AUID: 07020005-505. Red line indicates the average metric score (4.18) needed for IBI score to be at the threshold.

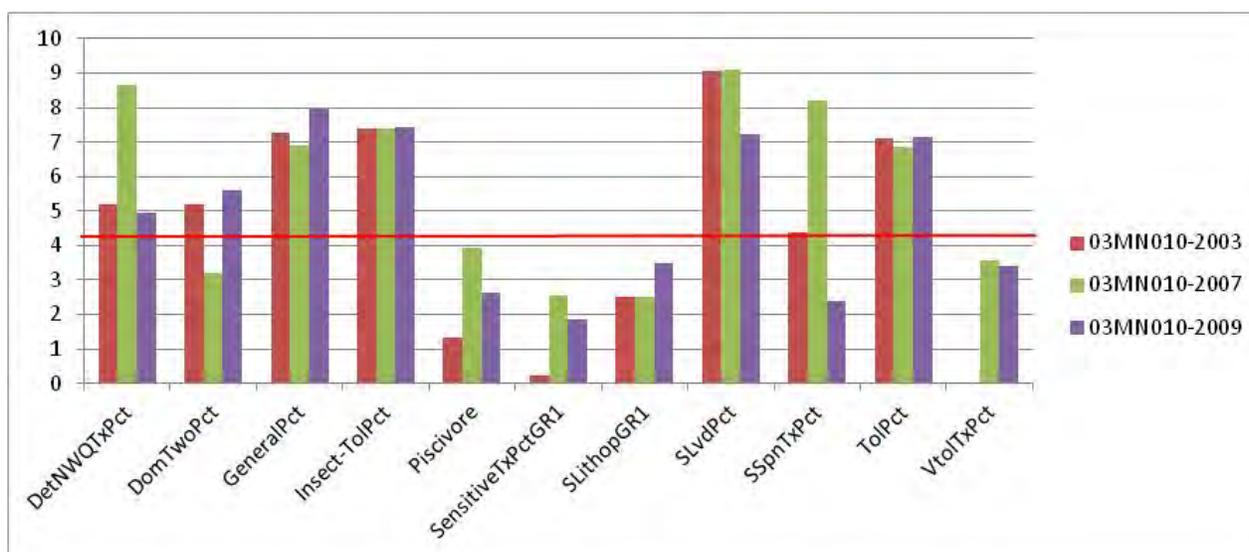
At the downstream channelized site 03MN010 in all three years sampled there were a lack of piscivorous species and simple lithophilic spawners (Figure 505-3). In addition the relative abundance of taxa that are sensitive was low while tolerant taxa made up the majority of the samples. Overall this site had fewer numbers of fish (average per sample 124) but represented more species, thirty species were noted.

Figure 505-3 Fish metric scores belonging to non-assessable site 03MN010 (2003, 2007, 2009) from the Chippewa River, Outlet Creek to East Branch Chippewa River AUID: 07020005-505. Red line indicates the average metric score (4.18) needed for IBI score to be at the threshold.

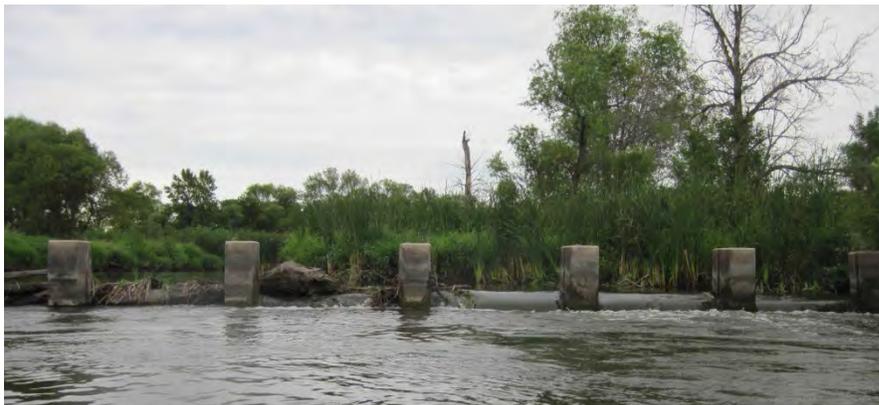
[Figure 505-4 Impoundment on Upper Chippewa River, August 14, 2012.](#)

Dissolved oxygen levels can be affected by impoundments by collecting nutrients and organic materials leading less to availability and by serving as areas for algae blooms. In the AUID 07020005-505 watershed there is one constructed impoundment. Figure 505-4 shows a photo of the constructed impoundments, where the creek is held back by a low head impoundment wall.

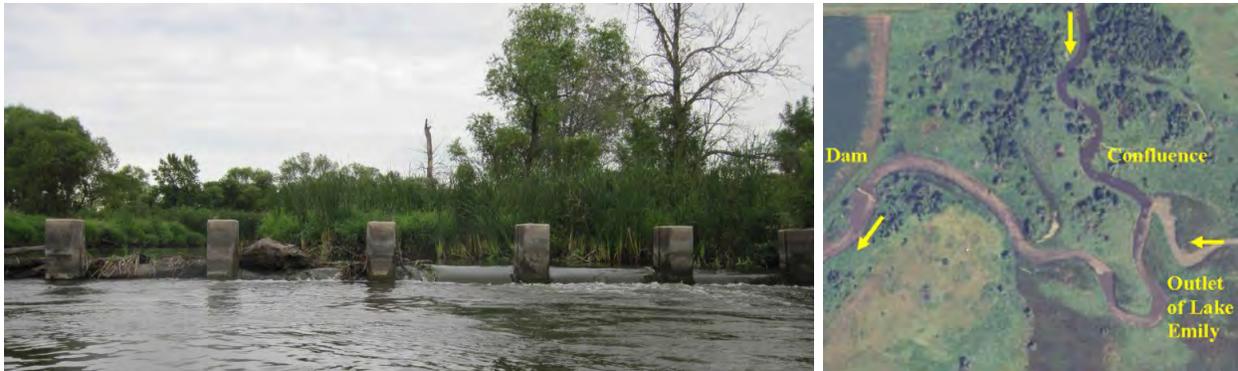
Figure 505-9 Impoundment on Upper Chippewa River, 8/14/ 2012 and aerial view 6/23/2010, note the water color difference at the confluence of Lake Emily Outlet and the Chippewa River.

In the AUID 07020005-505 watershed there is one constructed impoundment. Figure 505-9 shows a photo of the constructed impoundments, where the creek is held back by a low head impoundment wall.

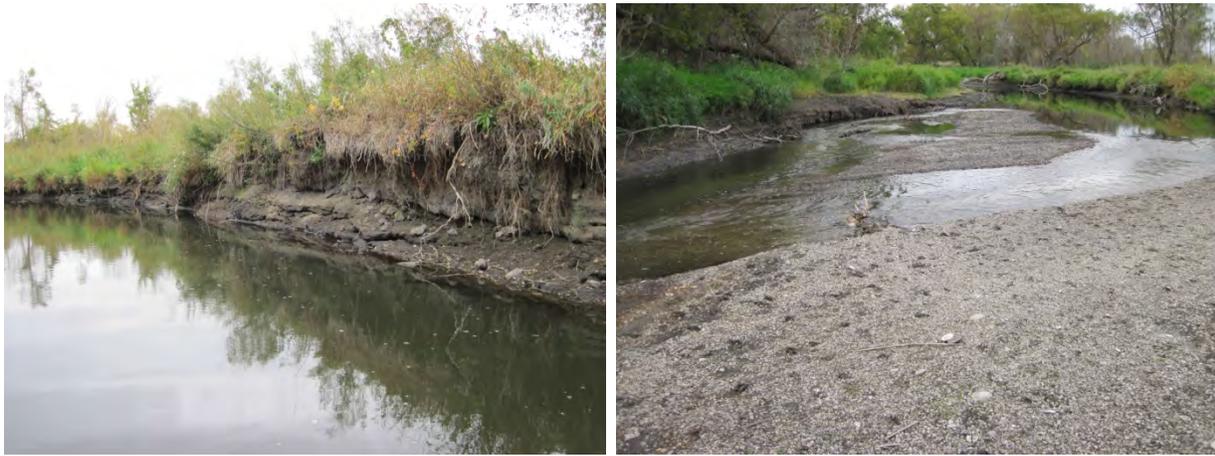
Figure 505-11 Photos of site 03MN009, note unstable banks and sandy substrate.

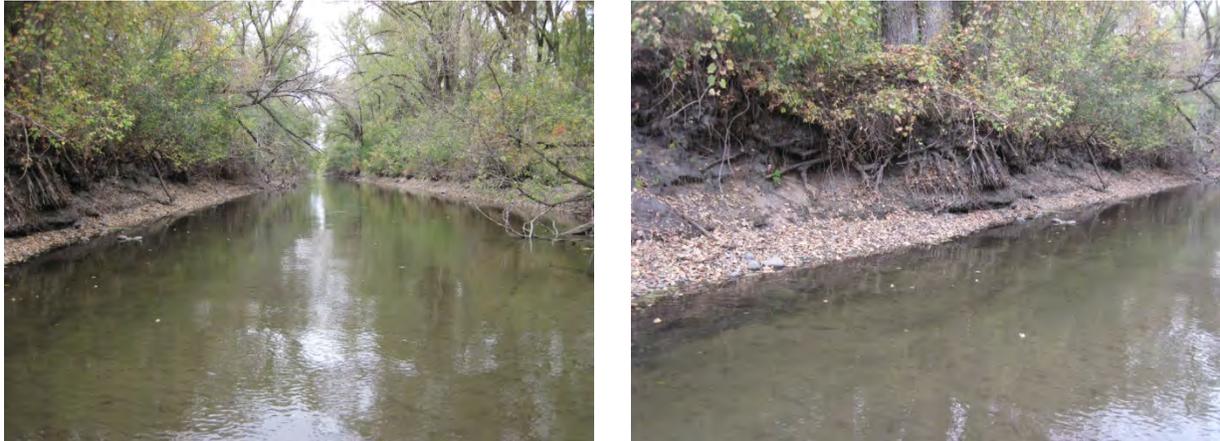
Figure 505-13 Station 03MN010 September 18, 2012, entrenched ditch with significant bank erosion.

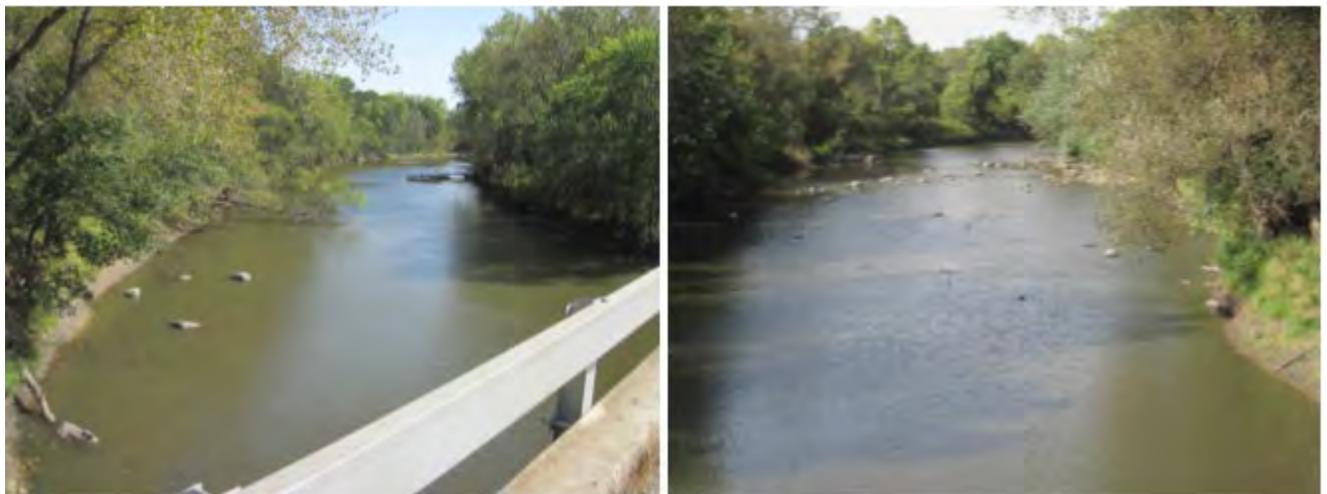
Figure 507-10 Station 09MN063

The SVAP surveys conducted in 9-2012 noted a number of negative factors for aquatic habitat. In general, the river is entrenched and suffers from poor channel conditions and obvious hydrologic alteration. The banks are unstable. The water is turbid and there are multiple signs of nutrient enrichment. Both sites have the elements for good habitat.

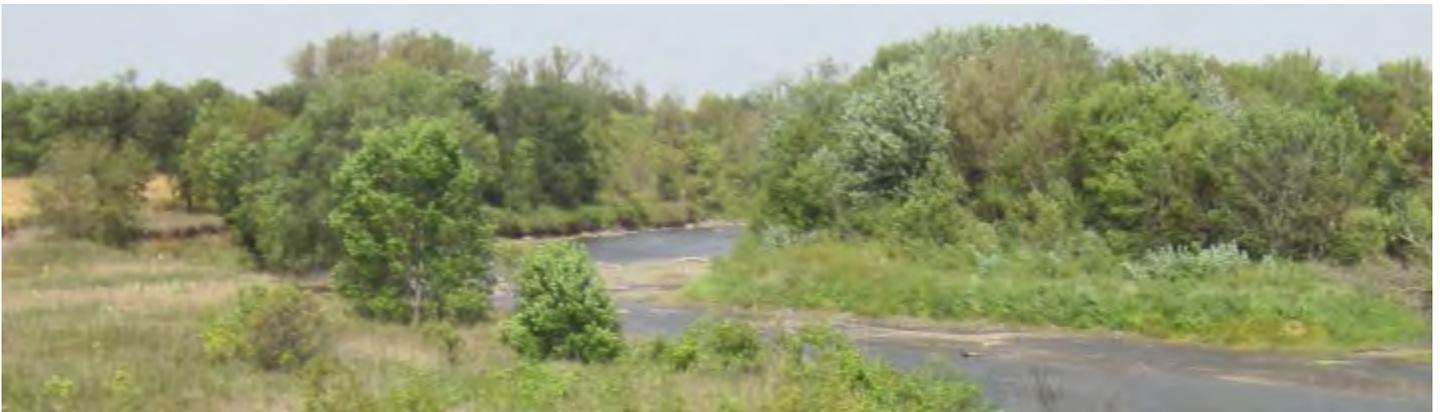
Figure 508-10 Station 09MN064

The SVAP survey conducted in 9-2012 noted a number of negative factors and positive factors. In general, the river is entrenched and suffers from hydrologic alteration. The banks are unstable. The water appearance was poor and there were obvious signs of nutrient enrichment. On the positive side there are no dams in the reach. The survey team observed a good number of habitat types for fish and an excellent diversity of habitat types for invertebrates and the condition of pools at the site was excellent.
