# Chippewa River Watershed Biotic Stressor Identification Report

Minnesota Pollution Control Agency

November 2015

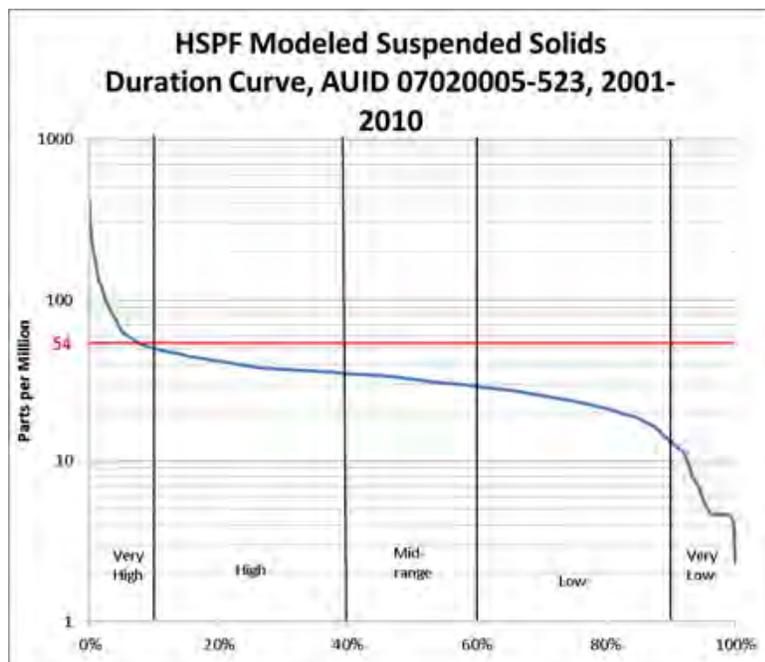
HSPF modeling of TSS projects levels in exceedance of the 54ppm surrogate standard 16% of the time (Figure 523-8).

Figure 523-8: HSPF TSS modeling projections.

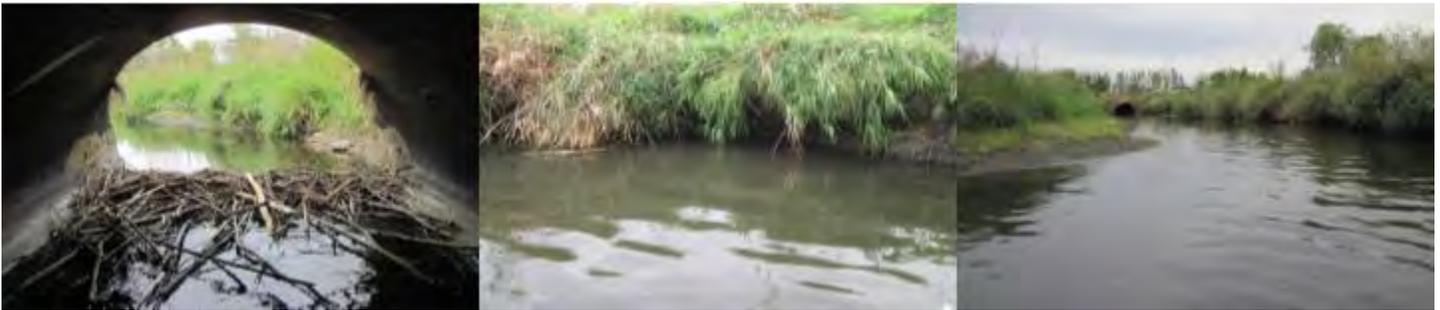
Figure 523-9 Station 09MN065 (Note beaver dam and undercut banks).

The SVAP surveys conducted in 9-2012 gave 09MN065 an overall assessment score of Good and 09MN077 an overall assessment score of Fair. They observed a good number of habitat types for invertebrates and slightly less for fish species. Channel condition and hydrologic stability were Fair with lateral erosion evident. There was bank erosion evident and a beaver dam in the culvert at site 09MN065. At sight 09MN077 thick mats of floating algae were noted. They are likely the result of excessive nutrients.

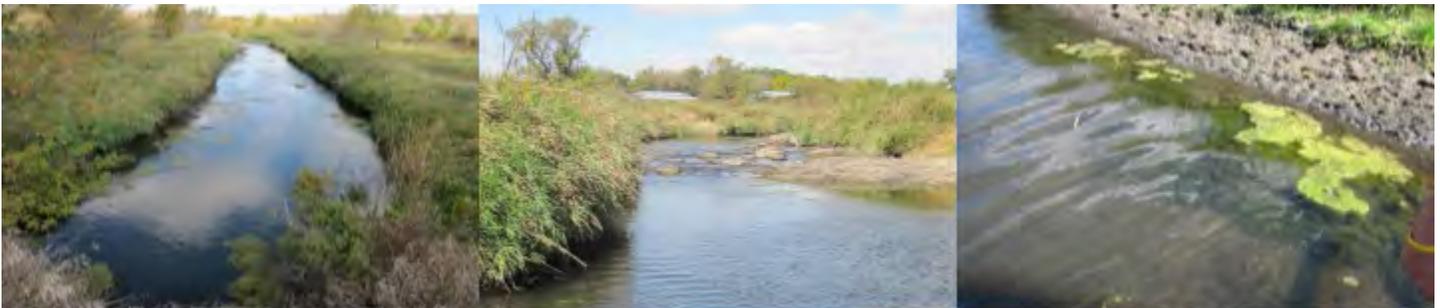
Figure 523-10 Station 09MN077, Note thick mats of floating algae.

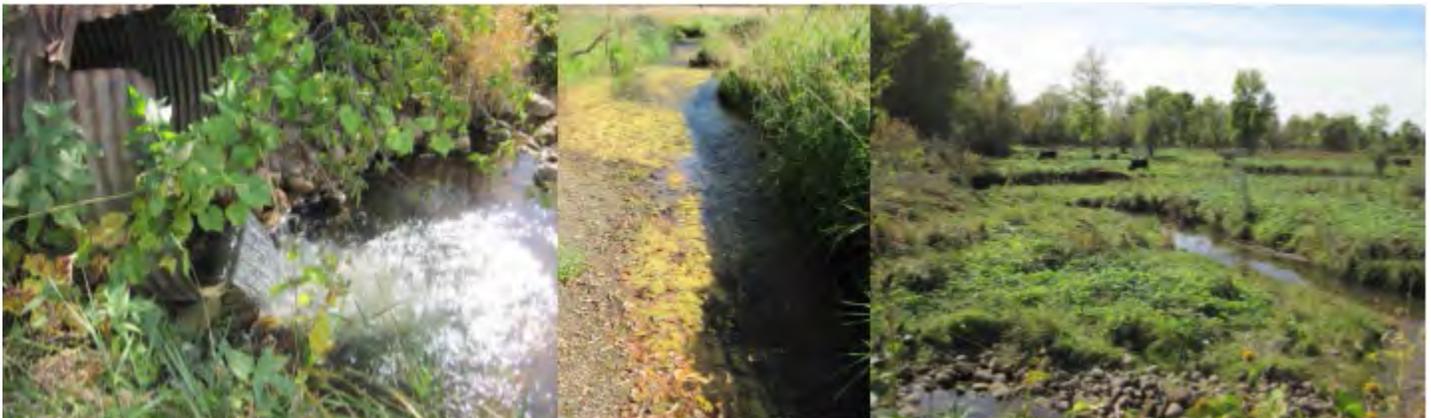
Figure 551-9 Station 09MN065 (Note perched culvert, algal mats and livestock grazing in riparian zone).

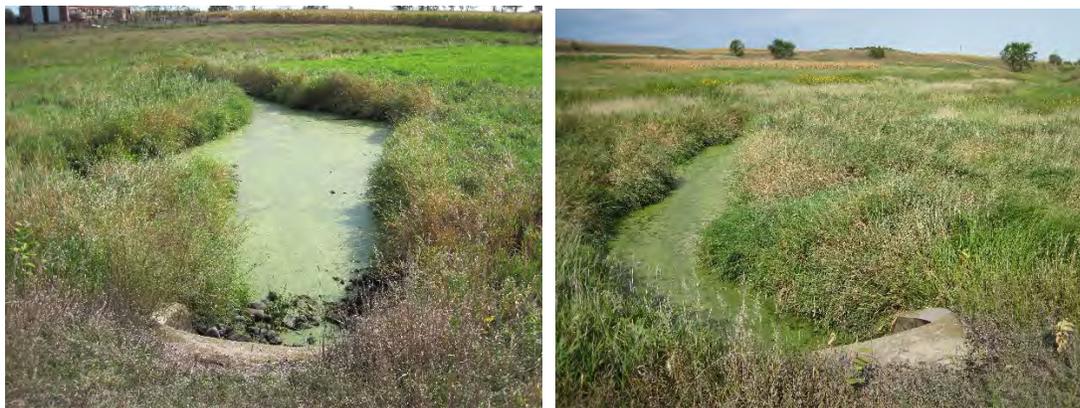
Figure 584-9 Station 09MN002 9-2012 extreme low flow

Habitat is not a stressor at site 09MN002 in AUID 07020005-584. Several site visits give this location a fair assessment.

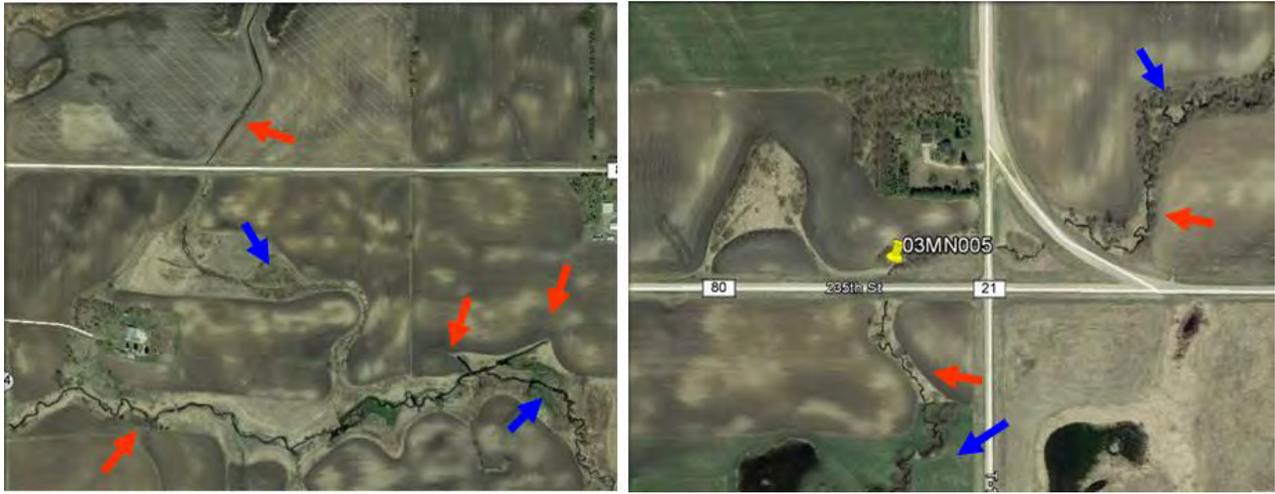
Figure 623-6 Example of good buffers (blue) and inadequate buffers (red) between cropland and water (2012).

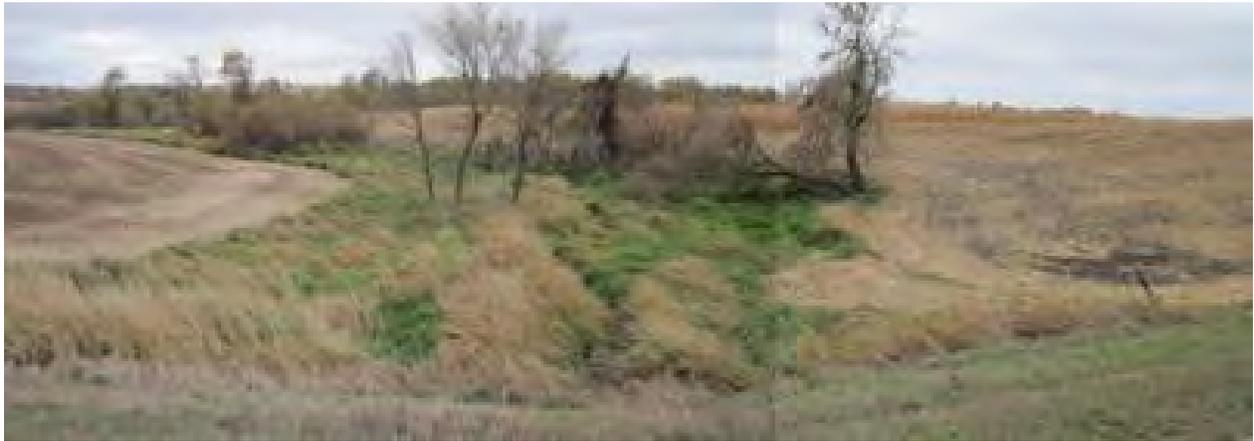
Figure 623-9 Station 03MN005 upstream.

Fish populations and habitat were sampled in the summer of 2003. In 2012 the site was visited again and a SVAP survey was completed. During the 2012 site visit the channel was observed to be completely dry, a condition that has been noted at this site in the late summer five out of the last seven years it has been monitored for transparency. This site is clearly an ephemeral stream that should not be assessed in the same manner as a stream with a perennial source of water.

Site 03MN005 has fair habitat as scored by the MSHA in 2003. The site scored poorly in the category of surrounding land use, the riparian zone was listed as narrow and the instream zone was not very diverse and much of the rock habitat was severely embedded. Channel morphology and instream cover types were somewhat better and brought the overall score up enough to give the site a score of fair. The survey noted a good depth variability, no riffles, good sinuosity and fair channel development.

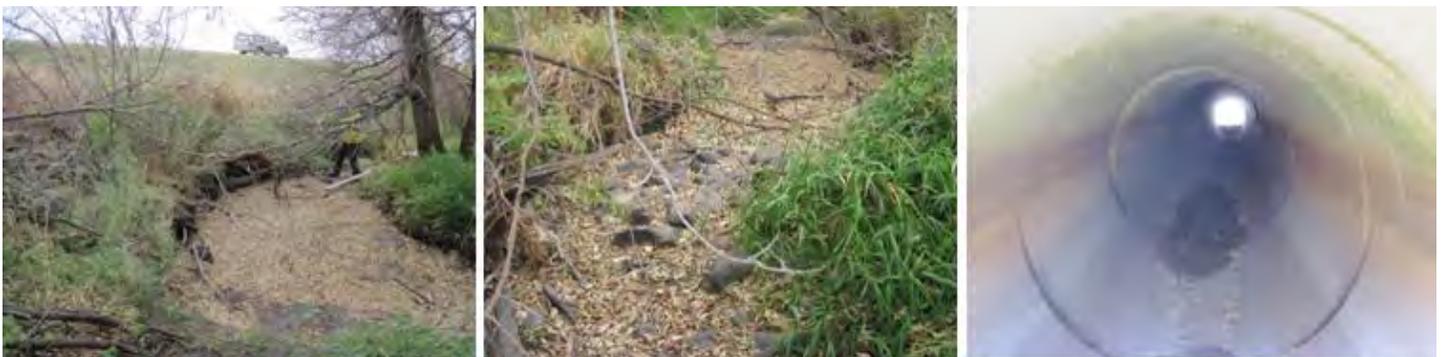
Figure 623-10 Station 03MN005 note dry channel and long dry culvert.

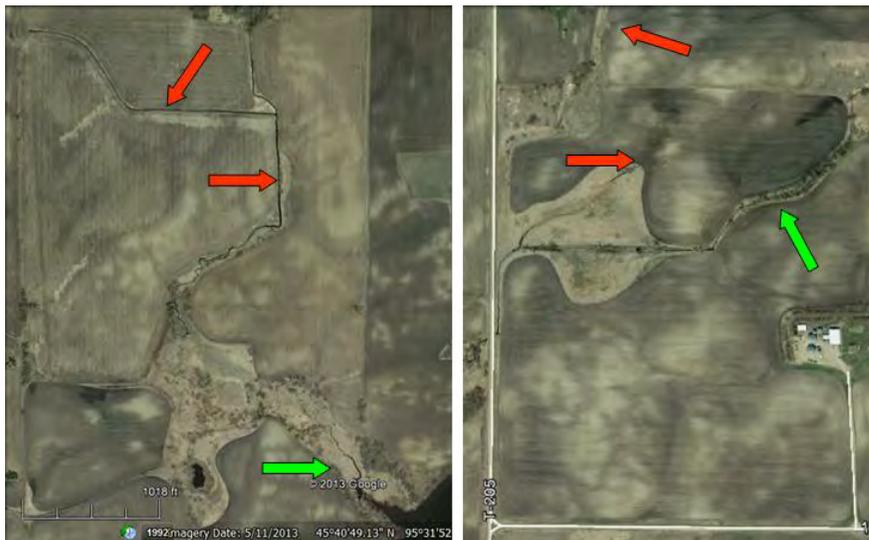
Figure 628-5 Example of good buffers (green) and lack of buffer (red arrows) between cropland and waterways along tributaries of Trapper's Run (2013).

The riparian buffers along the impaired reach are at least twice the width of the stream channel in most areas. A lack of buffers can be seen on the many tributary streams and ditches that feed into Trapper's Run and the upstream impaired lakes. These unbuffered tributaries may allow high amounts of nutrients and sediment from adjacent fields and mowed yards to enter the waterway (Figure 628-5).

The riparian buffers along the main channel of the reach are mostly good and serving their function as natural habitat. Riparian conditions are poor in upstream tributary areas (see Figure 628-5) where row cropping gets too close to the river. These impacted areas no longer serve a benefit as natural habitat. In some cases, when the physical conditions are right, the lack of protective vegetation the river could shift to unstable riparian conditions.

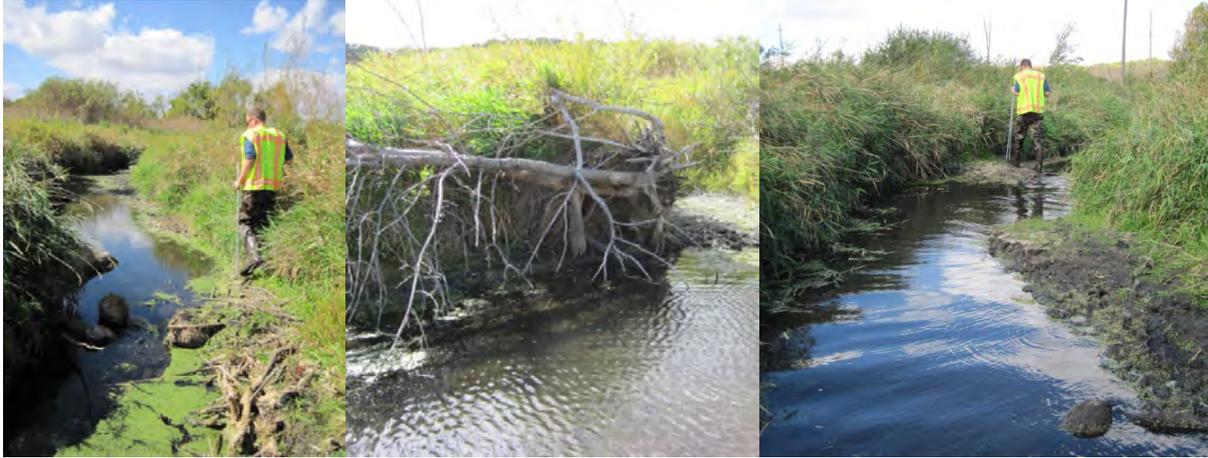
Figure 628-8: Station 09MN007 (Note soft soil stream bottom and bank erosion).

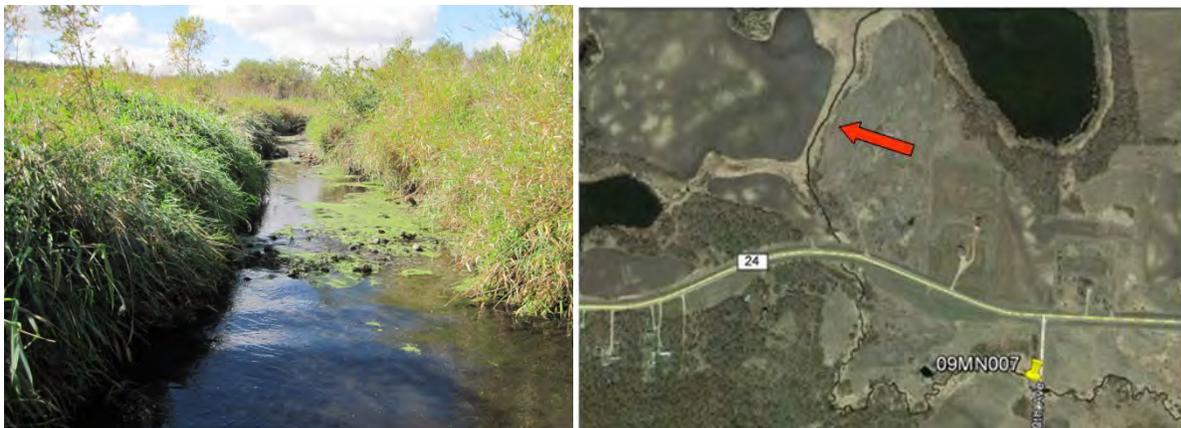
Figure 628-9 Channel Alteration

Channel alteration in distinct locations on the stream and in reaches contributing to the river have likely led to changes in the hydrological and geomorphological condition. This has led to changes in discharge patterns, changes in substrate, changes in sinuosity, and increases in erosion (see candidate cause: altered hydrology below).

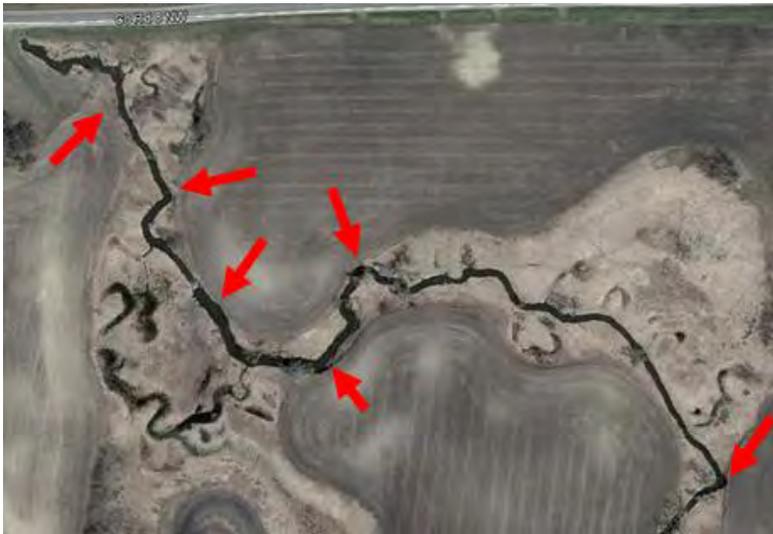
Figure 638-4 Example of lack of buffer between cropland and water along unnamed creek (2012).

The riparian buffers along AUID 07020005-638 are minimal to non-existent in many areas. Lack of buffers can allow high amounts of nutrients and sediment from adjacent fields and mowed yards to enter the adjacent stream.

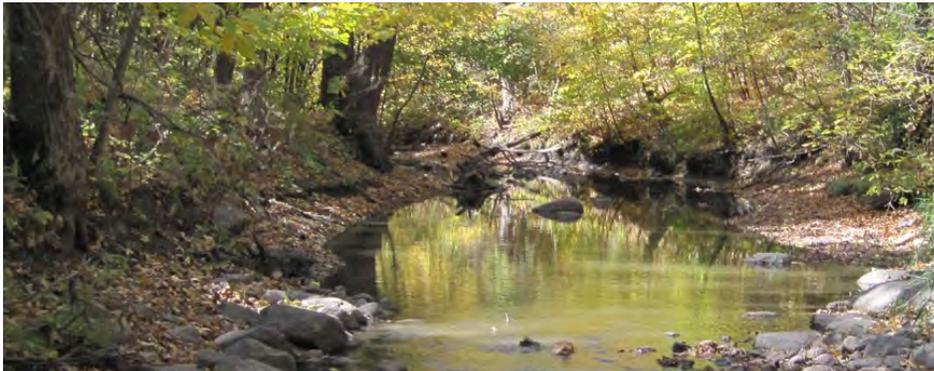
Site 09MN018 has fair habitat as scored by the MSHA during the fish survey visit in 2009. The site scored well in most of the categories. The site scored low to average in the channel morphology category suggesting that there are geomorphological issues. The survey noted a lack of depth variability, no riffles, limited sinuosity and inadequate channel development.

The SVAP survey conducted on September 26, 2012, observed a wide range of habitat types present including riffles. Despite the presence of good habitat components the overall assessment score was poor. The upstream ditching and a poorly placed culvert were causing downstream scouring issues. This in turn had led to heavy bank erosion. The rocks and stream bottom were coated with algae and the water itself was green indicating poor water quality.

Figure 638-8: Station 09MN018 (Note entrenched channel and bank erosion).

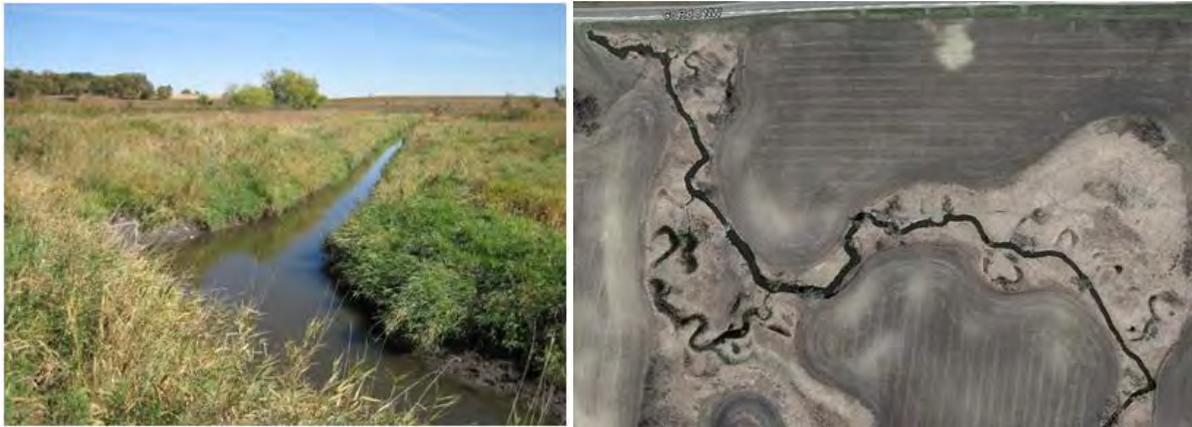
Channel alteration in distinct locations on the stream and in reaches contributing to the river have likely led to changes in the hydrological and geomorphological condition. This has led to changes in discharge patterns, changes in substrate, changes in sinuosity, and increases in erosion.

Figure 638-9: Upstream ditching and meander cutoffs

Channelization of reaches within AUID 07020005-638 are minimal. Hydrological changes appear to have impacted the geomorphological condition of the stream. It appears that the stream is in the process of cutting off meanders and decreasing its sinuosity. This has led to changes in erosion rates that have led to an increase in turbidity (Figure 638-9).

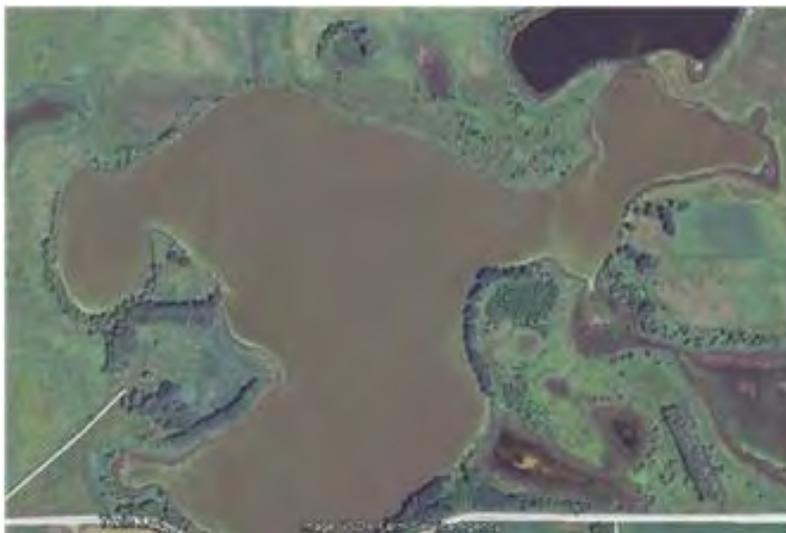
The unnamed lake immediately downstream of Lake Venus and the last lake body before the stream reach begins is prone to turbid water and algae blooms. This can be seen easily in USDA Farm Service Agency aerial photos (Figure 638-14).

Figure 638-14 Unnamed Lake at beginning of impaired reach, note green algae along the shoreline.

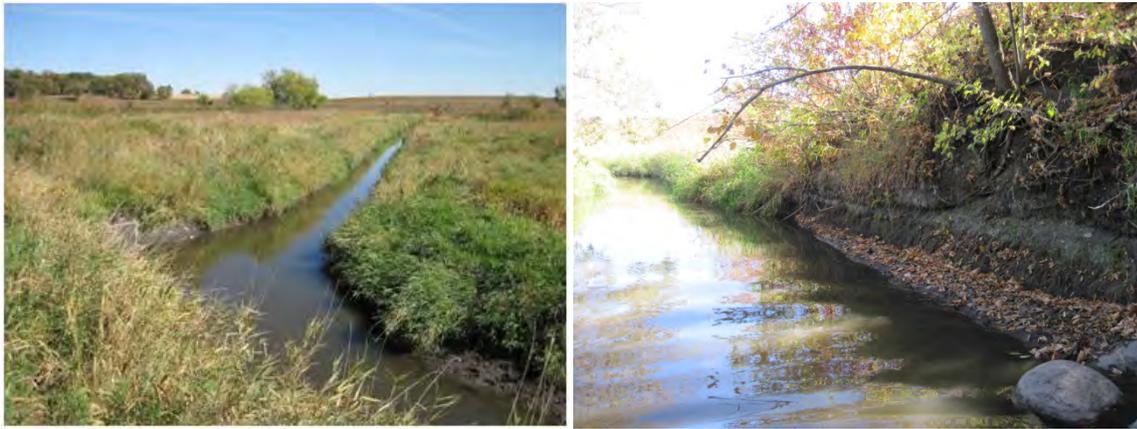
Figure 638-16 Upstream ditching

Bank erosion downstream of culvert

There is physical evidence to support listing flow alteration as a candidate cause directly upstream of the 09MN018 monitoring site. Surveys at site 09MN018 noted channel scour directly downstream of the upstream culvert. Scouring and dry stream conditions are also evidence of flow alteration. The presence of a channelized section of stream immediately upstream of site 09MN018 is likely a contributing factor to these conditions.

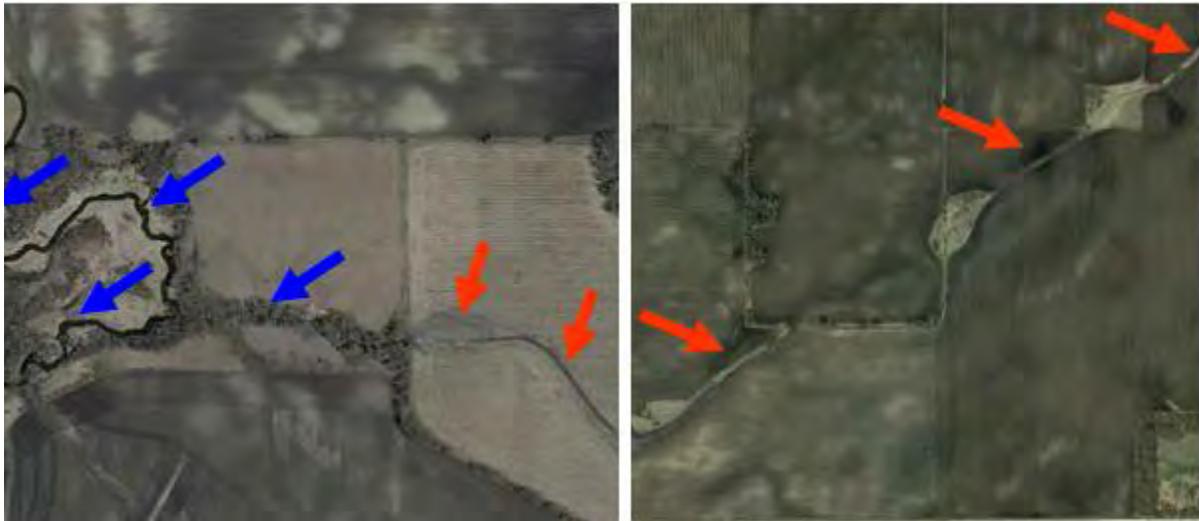
Figure 713-6 Example of good buffers (blue) and inadequate buffers (red) between cropland and water along the Little Chippewa River (2012)

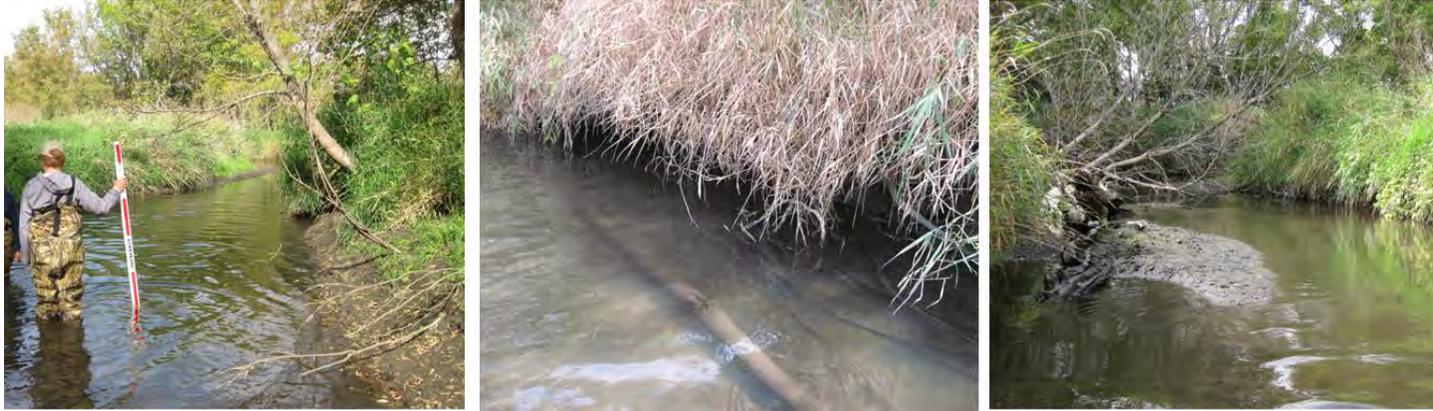
**Figure 713-10 Station 09MN004 upstream (Note undercut bank and fine bed substrate).**

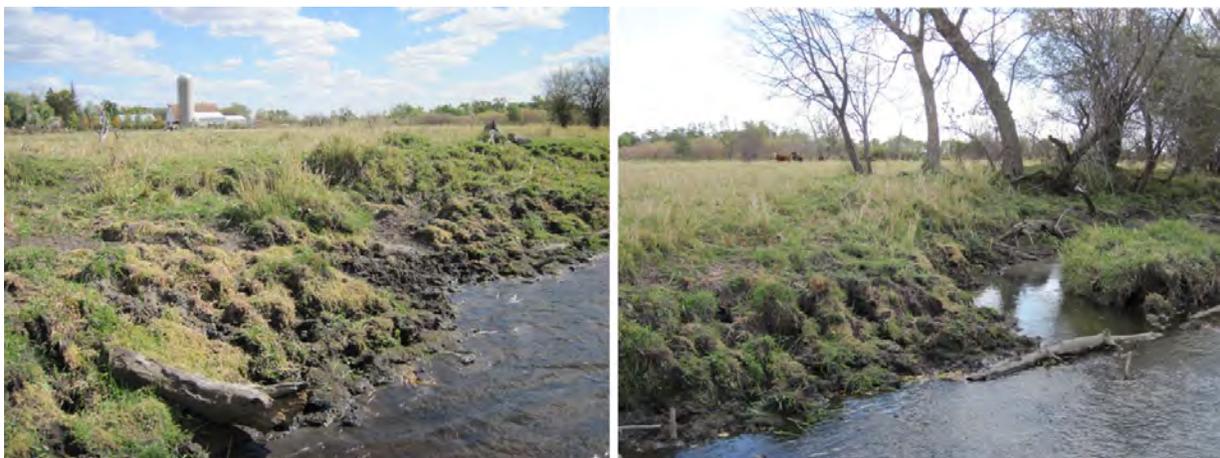
**Figure 713-11 Station 09MN004 downstream (Note overgrazed bank and bank erosion).**

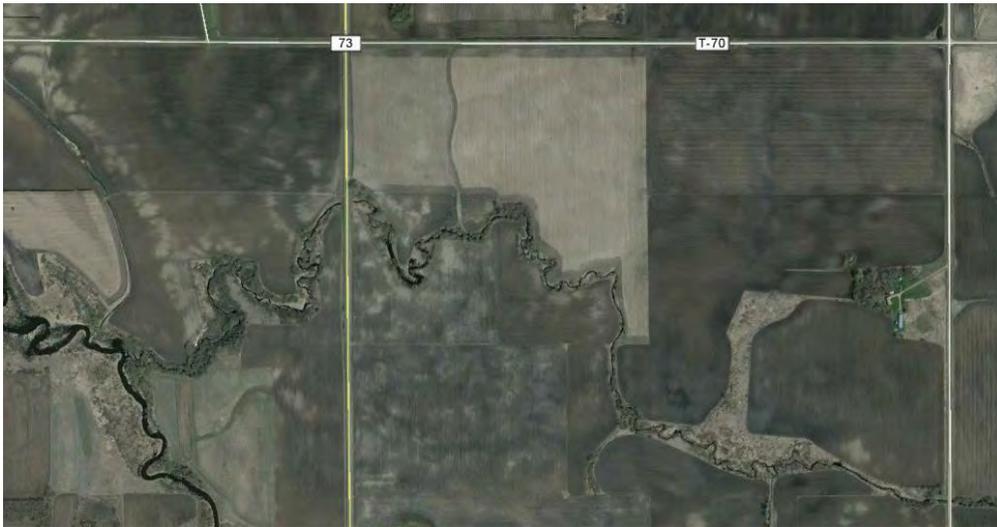
AUID 07020005-714 has good high flow characteristics. Surveys of the channel found that overall the higher flow hydrological condition of this reach appears to be in good shape as can be seen in the good meander patterns in Figure 714-9.

**Figure 714-9 Little Chippewa River healthy meander pattern**

AUID 07020005-714 has good high flow characteristics. Surveys of the channel found that overall the higher flow hydrological condition of this reach appears to be in good shape as can be seen in the good meander patterns in Figure 714-9.
