Summary

Chippewa River Watershed Biological Stressor Identification

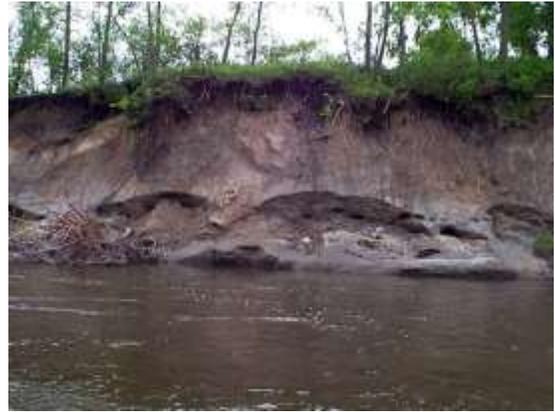
Bank sloughing a source of sediment

Much of the Chippewa River is impaired for turbidity. In 2009 and 2010 most of the Chippewa's load monitoring sites exceeded the standard. In 2009 and 2010 overall, 32% of the samples taken exceeded the standard for turbidity. In the Chippewa, in areas where row cropping is more prevalent, there is a trend toward higher turbidity during the spring months when there is little canopy cover. The consistently high turbidity levels seen throughout the watershed suggest that aquatic habitat and recreational enjoyment on the Chippewa is seriously degraded.
