October 2024

Le Sueur River Watershed Stressor Identification Update

A study of local stressors limiting the biotic communities in the Le Sueur River Watershed.

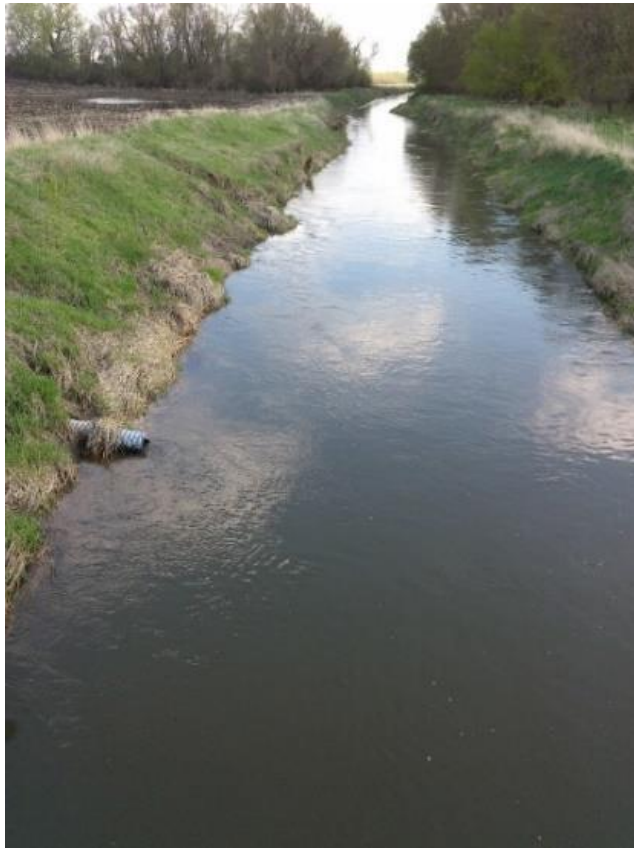
Figure 15. Example of a channelized stream in the Le Sueur River Watershed.

Ditching is defined as the digging of a trench to divert water where no channel previously existed. Channelization is the process of straightening a preexisting natural channel, highlighted in Figure 15. Drainage ditches and channelized streams are a common feature in the Le Sueur River Watershed. Channelization and/or ditching changes the physical structure of a stream but will also change the flow regime for a waterway. The result is often increased peak discharges and reduced baseflow (Blann et al. 2009). As water is diverted from the landscape and routed through manmade or altered channels, there is a loss of habitat features. The habitat features that are commonly affected include loss of pool depth, increased embeddedness of gravel and cobble in riffles, loss of floodplain connectivity, and loss of woody material in the channel. Additionally, high flows can scour organisms and substrate from streambeds, while low flows can reduce habitat

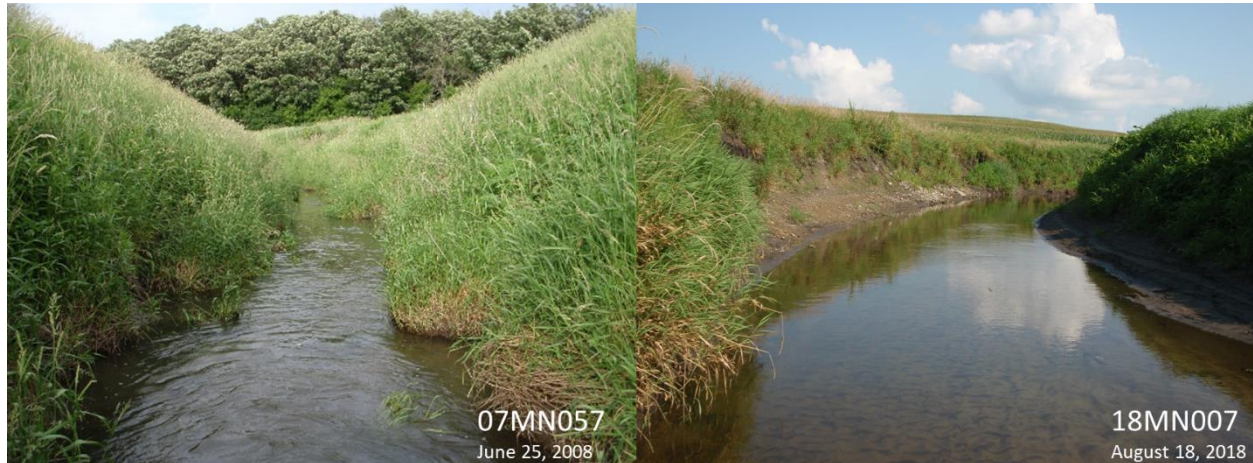
Figure 20. Biological monitoring stations on the headwaters of the Le Sueur River (WID-664).

The fish sample at station 07MN057 occurred in the summer of 2007 and 2008. Both samples scored above the threshold for a modified stream. Station 18MN007 was added as part of the 2018 Cycle 2 biological assessment on this stream. As shown in the community metric data (attached Appendix), over the course of the sampling events in 10 years, there was not an increase to the overall fish IBI score. However, there was a slight decline in the tolerant community. In Cycle 2 there were not any fish found with Deformities, Eroded fins, Lesions, and Tumors ([DELTS] black spots were noted in the Creek Chub community in Cycle 1). There was also an increase in lithophilic spawners that generally require specific habitat needs to thrive. Cycle 2 highlighted the emergence of pioneer species. This would likely be due to the ditch cleanout that occurred in 2017 (Figure 21). It is likely that if the ditch clean out had not occurred, the overall IBI could have increased. Macroinvertebrates were not found to be impaired in the original Cycle 1 assessment. The community was made up of both sensitive and tolerant taxa, yet all functional groups were found to be appropriately distributed throughout the system. Macroinvertebrates were not sampled in 2018 for Cycle 2.

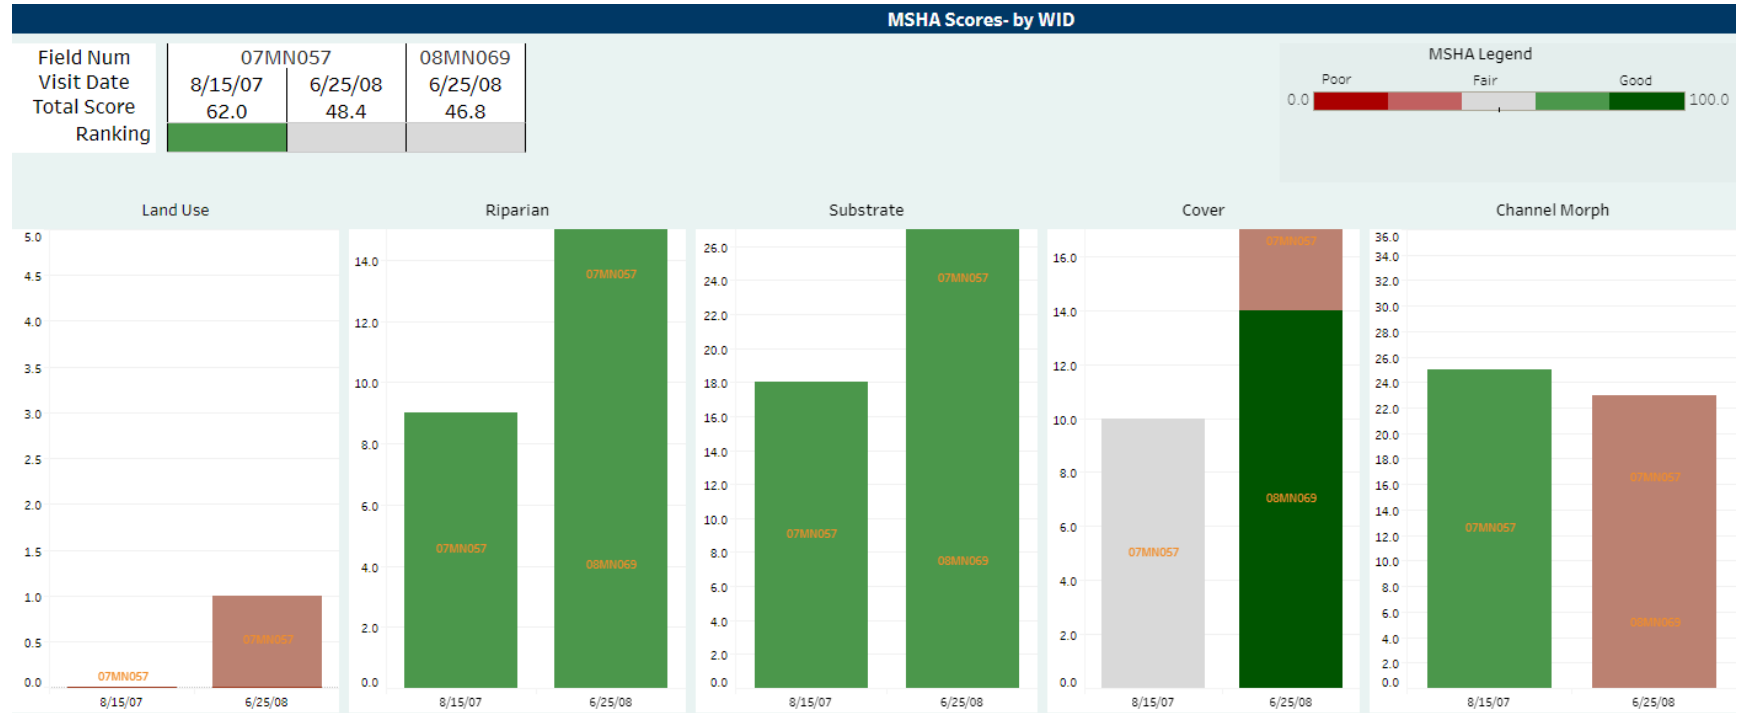
Figure 22. MSHA scores between WID -664 and -618.

In addition to similar biologic indicators, habitat is often one of the primary limiting factors to biology. Nearby land use, riparian zone, substrate, canopy cover, and channel morphology of streams are quantitatively assessed using MPCA Stream Habitat Assessment (MSHA) scoring. As shown in Figure 22, the habitat similarities and scores are similar between the stations at the passing WID of WID-664 and the historically impaired -618. Note that the new station of 18MN007 was omitted from the graph as recent clean out eliminated habitat that resulted in scores of nearly 0 across the entire set.

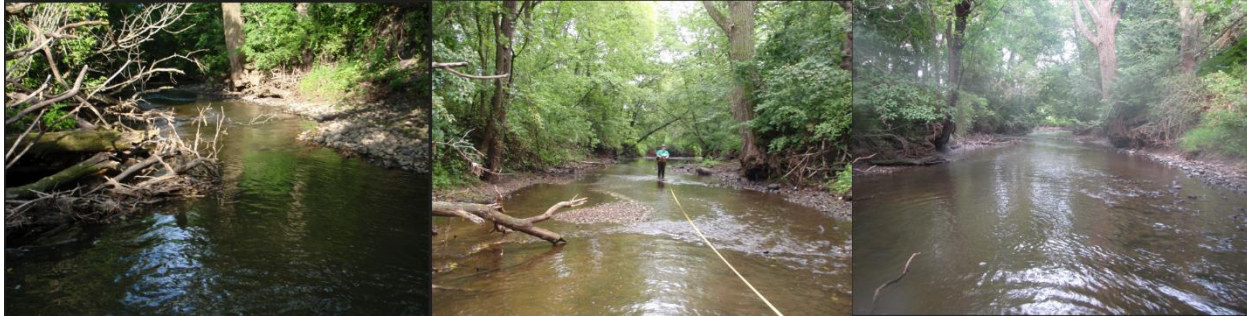
Figure 23. Monitoring conditions at 08MN055 during July 15, 2008 (left), August 19, 2010 (center), and July 18, 2018 (right).

Stations along WID -665 from upstream to downstream are identified as 08MN055, 10MN161, and 08MN029. The furthest upstream station of 08MN055 was the only station that was surveyed multiple times between Cycle 1 and Cycle 2 biological assessment. Nearly all fish communities in every monitoring year scored well below the expected threshold. Comparing the fish communities in 2008, 2010, and 2018, the overall dynamics that made up the fish sample did not change. Figure 23 shows the

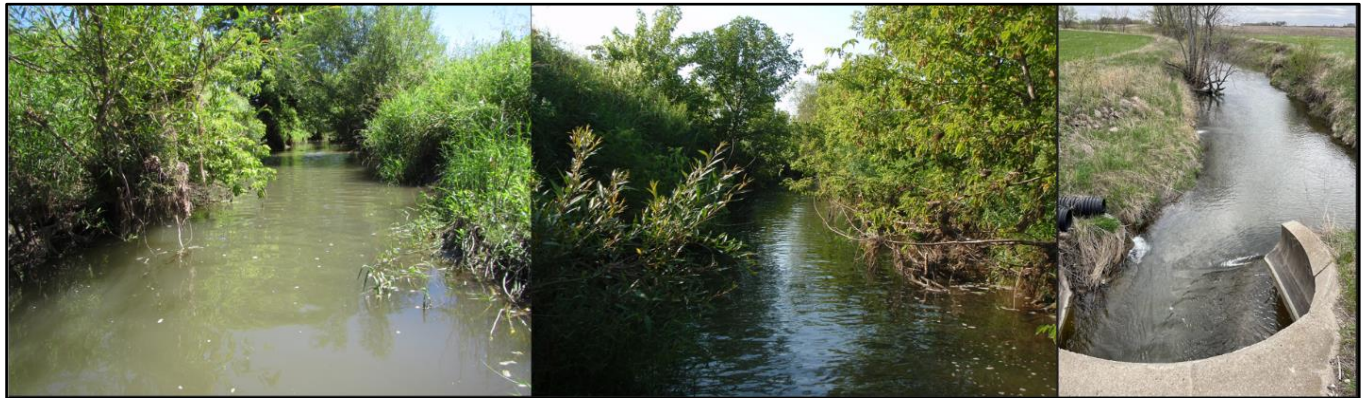
Figure 25. Monitoring conditions at 18MN002 during July 17, 2018 (left), August 6, 2018 (center), and May 10, 2023 (right).

This section of Boot Creek was a new sample location added in Cycle 2 (2018) at monitoring station 18MN002 (Figure 25). While the macroinvertebrate community scored a little above the threshold, the fish failed to meet the threshold. The fish community was made up of mostly tolerant, generalist species, that have short life spans. However, there was a single hog sucker (sensitive species) in the sample that was found to be over the age of three, in addition to a couple of mature golden redhorse.

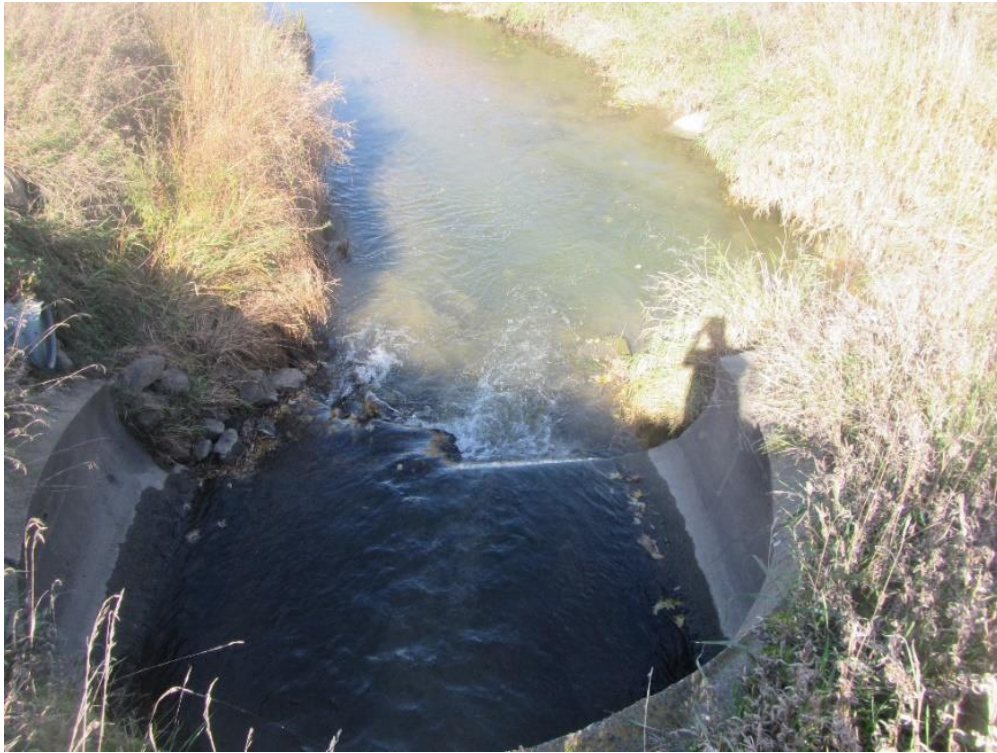
Figure 26. Perched culvert at WID -621 on Boot Creek on.

There is a direct barrier by way of a perched culvert within this WID (Figure 26). While there were some migratory species noted in the fish sample, during times of low flow this culvert will impact the ability for some to successfully complete their life cycle.

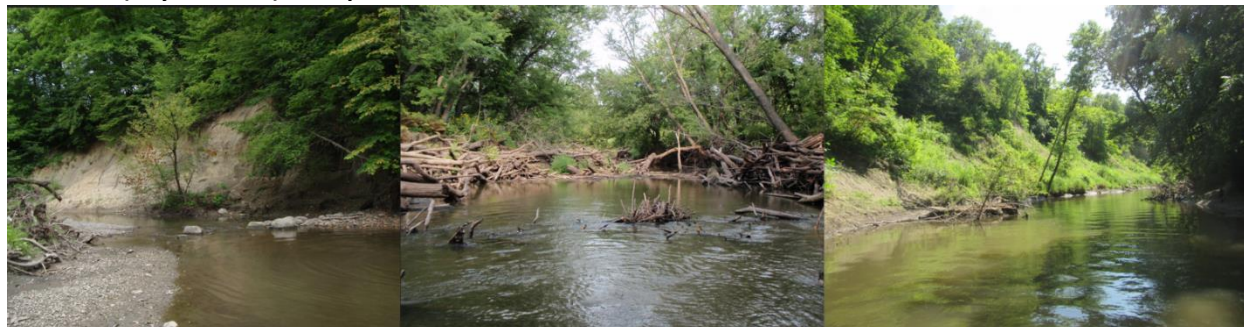
Figure 28. WID -620 at the time of monitoring at 08MN053 (August 13, 2008), 08MN048 (August 14, 2018), and 08MN053 (July 15, 2019) in respective order.

Fish and macroinvertebrates have been sampled multiple times throughout Cycle 1 and Cycle 2 on this WID. Macroinvertebrates remained consistent in their scores for support while the fish community is showing an improving trend. 08MN048 was sampled once in 2008 and in 2019. 08MN053 was sampled in 2008, 2010, and 2019. The upstream and downstream WIDs of this site both have current fish impairments. As Figure 28 below highlights, the stream’s channel is rated as having moderate to severe bank erosion. While this section of stream is supporting biology, it is important to highlight how vulnerable it is to degradation in the future.

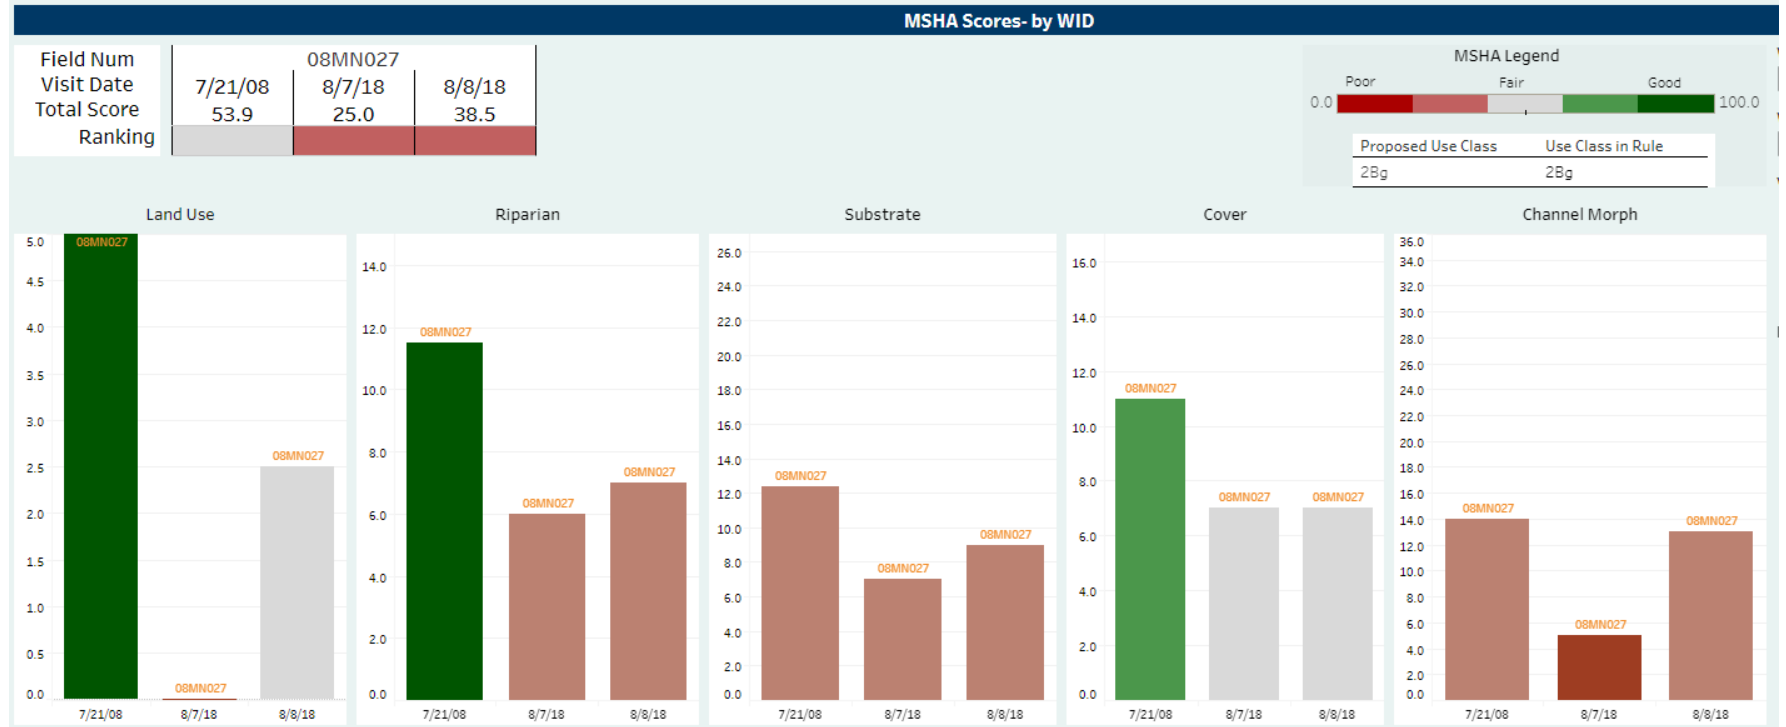
Figure 30. MSHA scores on WID -573 at station 08MN027.

There were three habitat surveys performed, with two of them occurring in 2018 and the other in 2008 (Figure 30). Habitat is noted as one area of concern, particularly impairments around the channel's morphology limitations. The fish community reflected benthic habitat displacement, as riffle dwellers and lithophilic spawners both were found in small numbers (less than half of what would be expected for this stream). The nearby land use of this stream is a combination of natural forest and prairie vegetation (found in the middle of the stream system) with other large sections both upstream and downstream of this WID surrounded by row crops. This has resulted in the upstream section of the stream being physically altered by way of channelization.

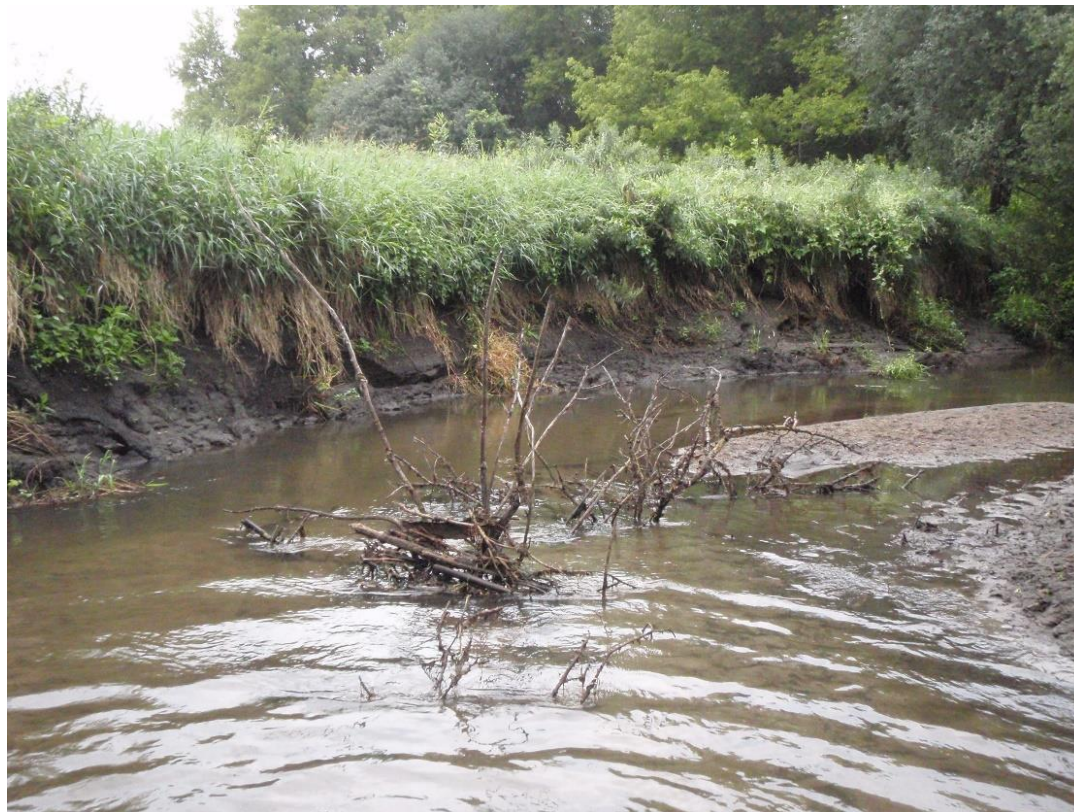
Figure 25. 08MN027 bank erosion and siltation of stream on August 7, 2018.

During the habitat survey there was documentation of mass erosion of stream banks, as well as heavy siltation of the stream bed. Riffle features seemed to decline in the last 10 years as this process progressed (Figure 25).

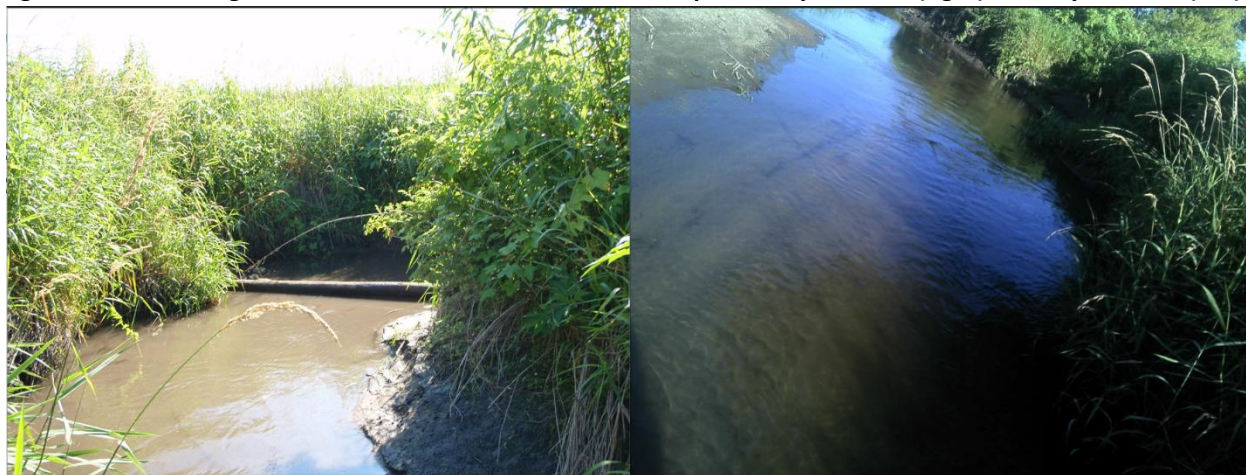
Figure 31. Monitoring station 08MN030 at the time of fish sample on July 22, 2008 (right) and July 15, 2018 (left).

County Ditch 35 (07020011-511) is of significance as it is one of the few streams within the Le Sueur River Watershed that significantly improved between Cycle 1 and Cycle 2 (Figure 31). The most recent 2018 fish survey showed an increase in sensitive species, more taxa diversity, and a decrease in both tolerant and generalist species. The macroinvertebrates also had an increase in overall diversity as well as more sensitive species that made up the population. This stream is particularly noteworthy as it is fully modified as a channelized ditch. It is not common to see biological improvements of this magnitude within a highly altered stream. The subwatershed of CD 35 displayed the highest amount of implemented best management practices to reduce water pollution between Cycle 1 and Cycle 2 monitoring ([Healthier Watersheds](#)).

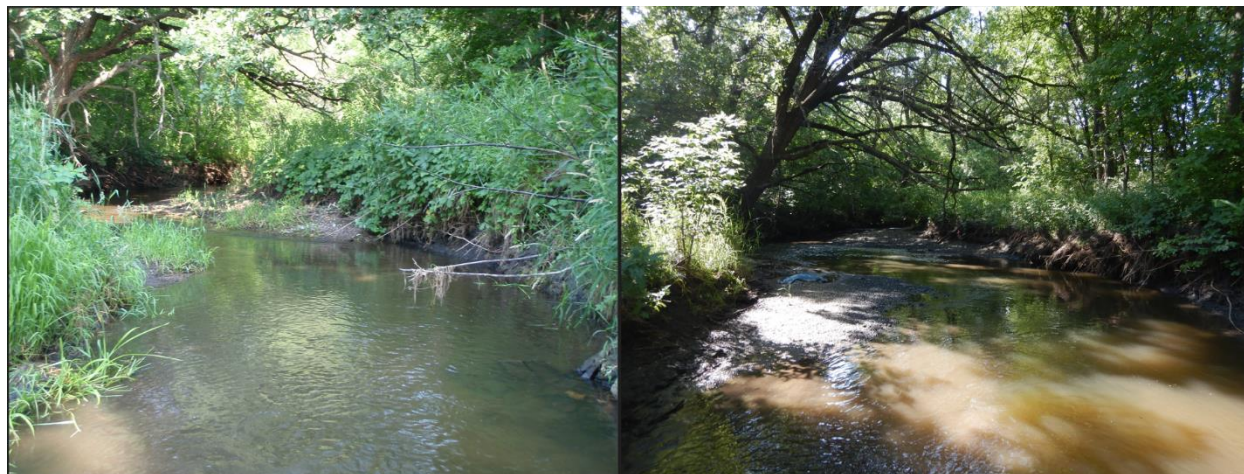
Figure 33. Station 08MN026 taken at the time of biological monitoring on July 2, 2008 (right) and July 30, 2018 (left). The 2019 sample conditions were not photographed.

Iosco Creek was sampled in both cycles at station 08MN026 (Figure 33). While the macroinvertebrate community was found to be in support, the fish community showed large variability throughout three separate samples. The station was originally sampled in 2008 and scored extremely low (12) for overall community IBI with the threshold being 55 (see Appendix). This first sample was made up of only 7 species, with 83 fathead minnows being the most abundant, followed by 5 white suckers. The stream was sampled again for Cycle 2 in 2018 after a period of high water. The IBI from this sample jumped up to 63.2, significantly above the general use threshold. However, a very different community of fish was collected. In this sample yellow perch and black crappie were both collected, while they were absent from the first sample. It is possible these fish moved into the stream from Lake Elysian as it is only a couple miles from the site. More tolerant species like fathead minnow and brook stickleback were noticeably missing. Because of the drastic change in IBI and persistent high water in 2018, the site was sampled again in 2019. The IBI from 2019 was zero. Only three species were collected, and included yellow perch, largemouth bass, and white sucker. Fewer than 25 fish were collected. With such drastic changes in IBI from the most recent samples it does not appear there is enough evidence to delist the stream, even with the high passing score from 2018. Additional biology sampling was requested to make a future determination.

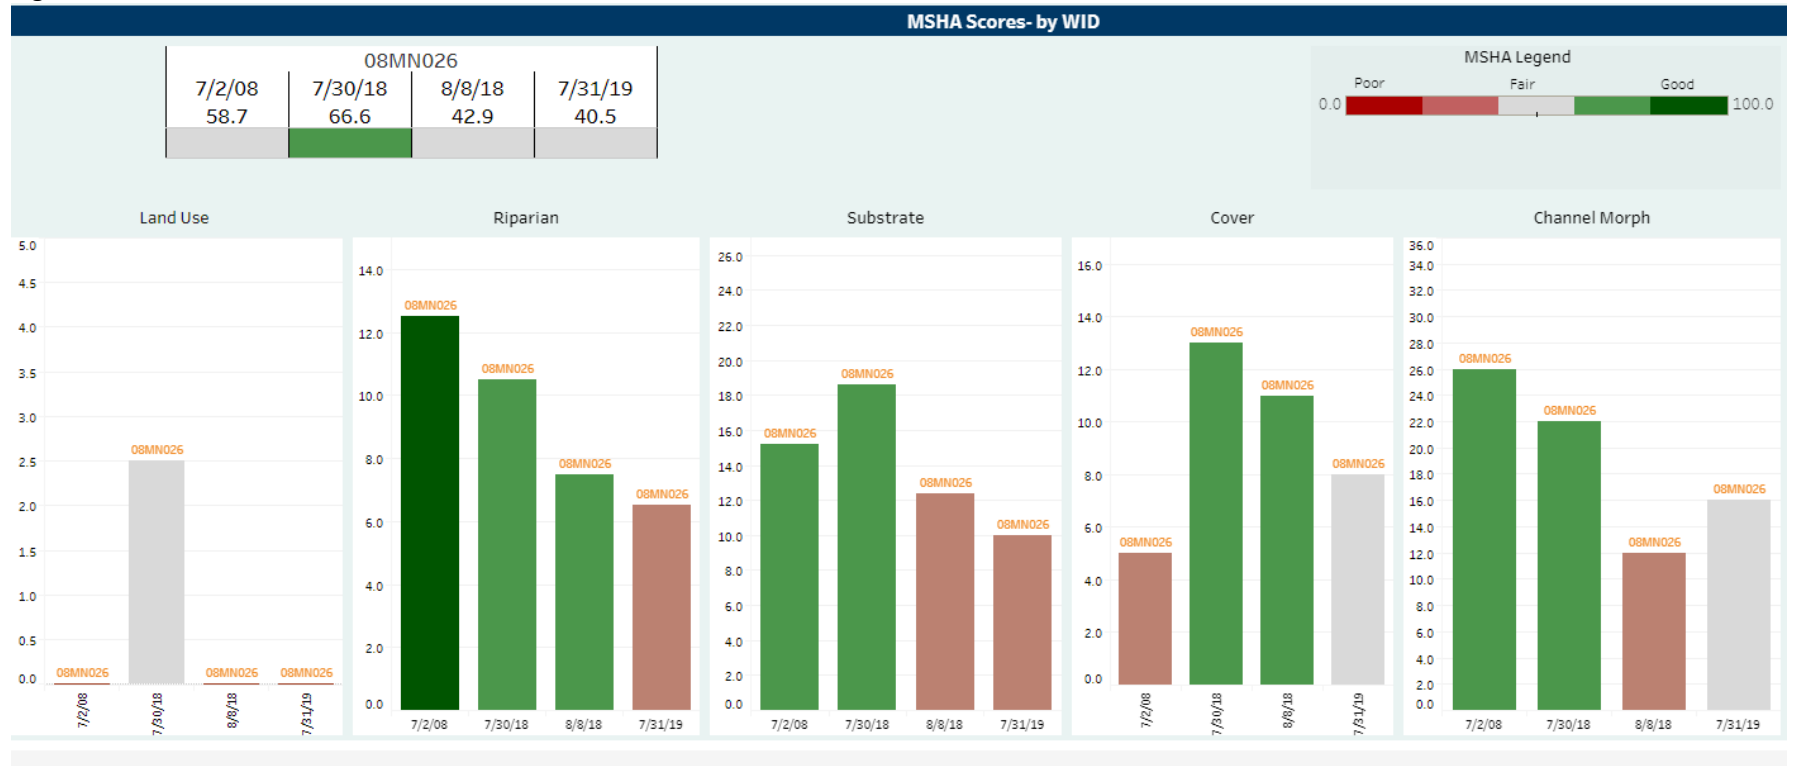
Figure 34. MSHA scores for losco Creek on WID -576.

While there is some level of uncertainty around Losco's fish impairment status, there is a clear trend of decreasing habitat, as shown in the MSHA scores in Figure 34.

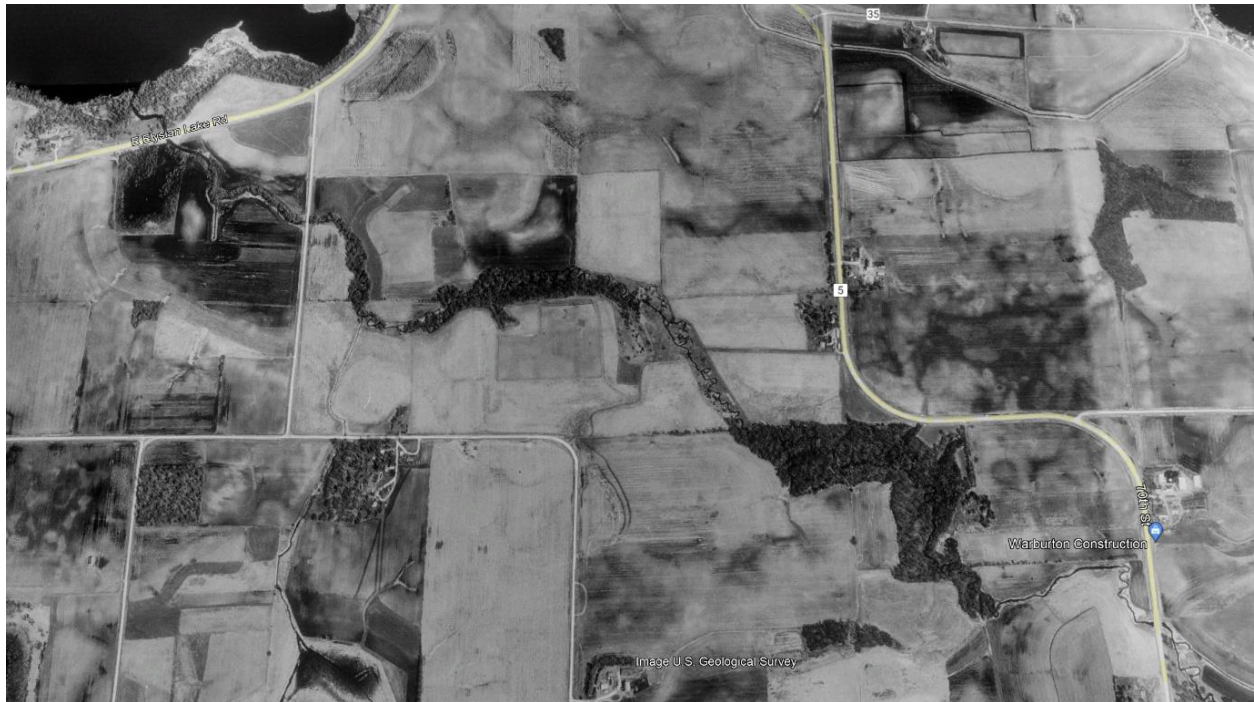
Figure 35. Historic aerial image highlighting poor vegetation and channel alterations in 1991.

Notes of new channels forming and widening were noted at the time of biological monitoring. There is also a clear change in the stream's sinuosity and riparian area when comparing historic aerial imagery to current conditions (Figure 35 and Figure 36). Analysis of the photos indicates that as the stream is finding its equilibrium there are dynamic changes occurring, particularly within the stream bed and near channel.

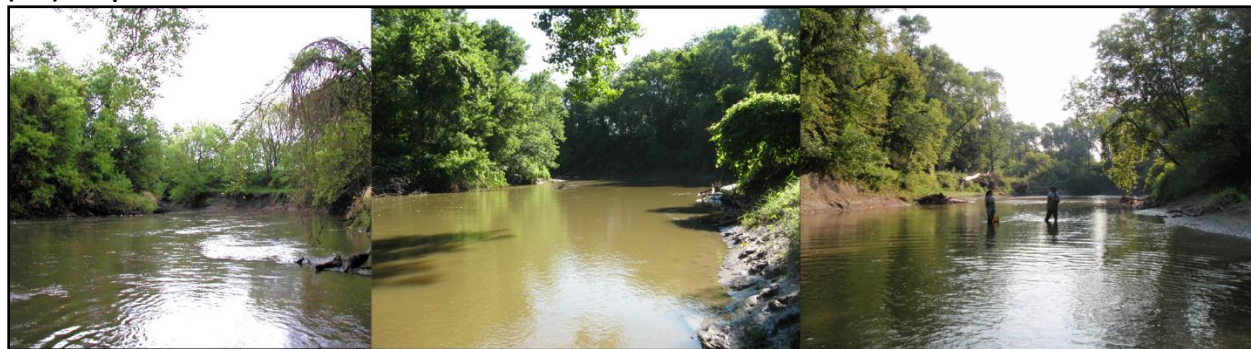
Figure 37. Biological station 03MN071 during July 28, 2003 (right), July 23, 2008 (middle), and August 14, 2018 (left) samples.

This section of the Le Sueur River (WID -507) has been sampled extensively for biology with sampling going back to 2003 at the downstream station of 03MN071 (Figure 37) identifying a fish impairment. In addition, WID -507 is a location for two pollutant load monitoring sites that allow for a better understanding of conventional parameters. Biology showed consistent scores throughout the sample periods, with all four samples of the macroinvertebrate community scoring above the impairment threshold. However, the fish community showed an impaired community in all samples across the years. Figure 38 highlights how consistent the fish population looked in each sample (see definitions in attached Appendix). There was a slight increase to detritivores, a decrease in piscivores, and lithophilic spawners decreased over time while serial spawners increased between 2003 and 2019.

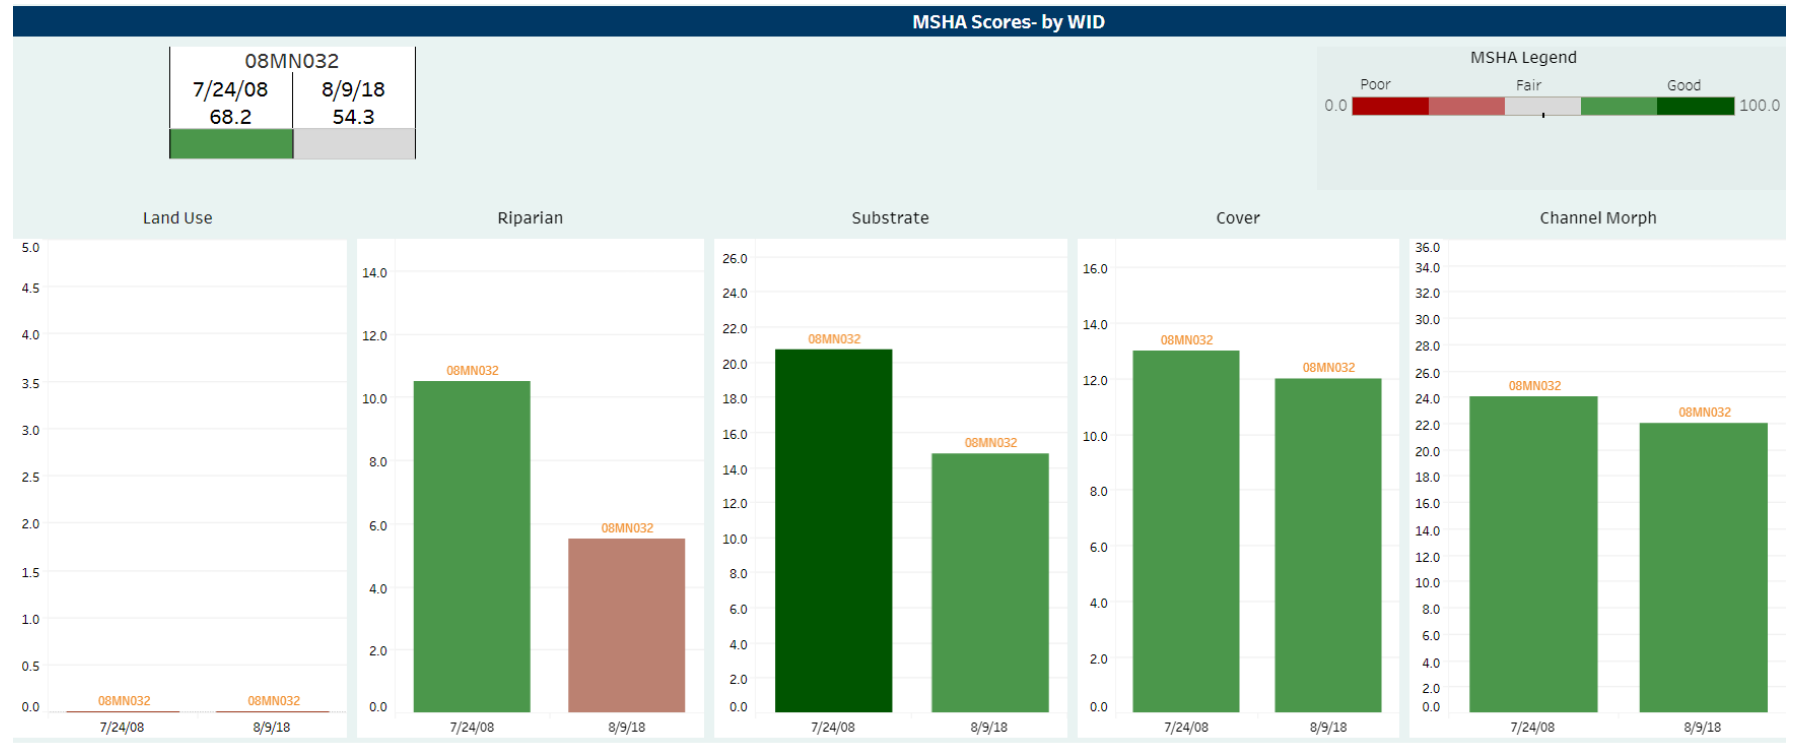
Figure 43. MSHA scored taken at the time of the biological sample on 08MN032 on WID -510.

Notes taken at the time of biological sampling indicated an erosive and changing stream. In addition, the habitat scores do show a slight decline between the two cycles (Figure 43). With erosion, TSS metrics will often indicate sediment displacement and can be used as a line of evidence of habitat stress. However, there is an increase of filter feeders that should be driven down from sediment rather than increase. TSS often will limit diversity as it impacts habitat types and substrate. While the overall score did slightly decrease, habitat was found to be diverse and adequate.

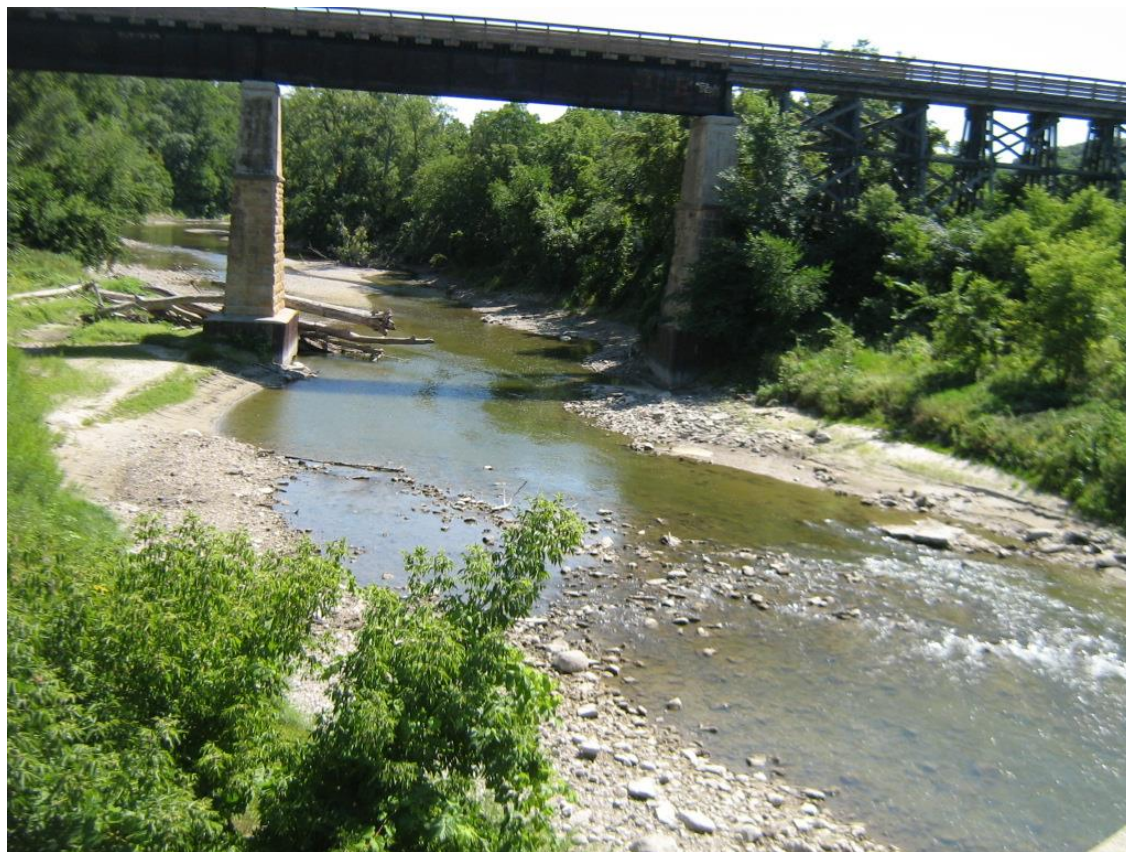
Figure 44. Conditions at biological station 08MN001 during Cycle 1 sampling August 7, 2008.

WID -501 is the outlet for the Le Sueur River Watershed as a whole, before it converges with the Blue Earth River and into the Minnesota River. In 2008 (Cycle 1), sampled macroinvertebrates were found to be in support for aquatic life while the fish community was impaired. SID from Cycle 1 determined eutrophication, nitrate, TSS, habitat, and altered hydrology to be limiting factors to fish, while DO was found not to be a stressor (MPCA 2014). As shown in Figure 44, flow was low at the time. Cycle 2 sampling found a similar macroinvertebrate community as compared to Cycle 1 and as before, was found to be passing. The fish community showed improvement in both diversity and overall IBI score. However, the status of the aquatic life impairment was determined to be inconclusive as additional monitoring was recommended to truly determine if this location merits delisting. While this WID is currently listed as inconclusive for an aquatic life impairment, upstream mitigation efforts for identified stressors will help improve this WID's overall community as well.

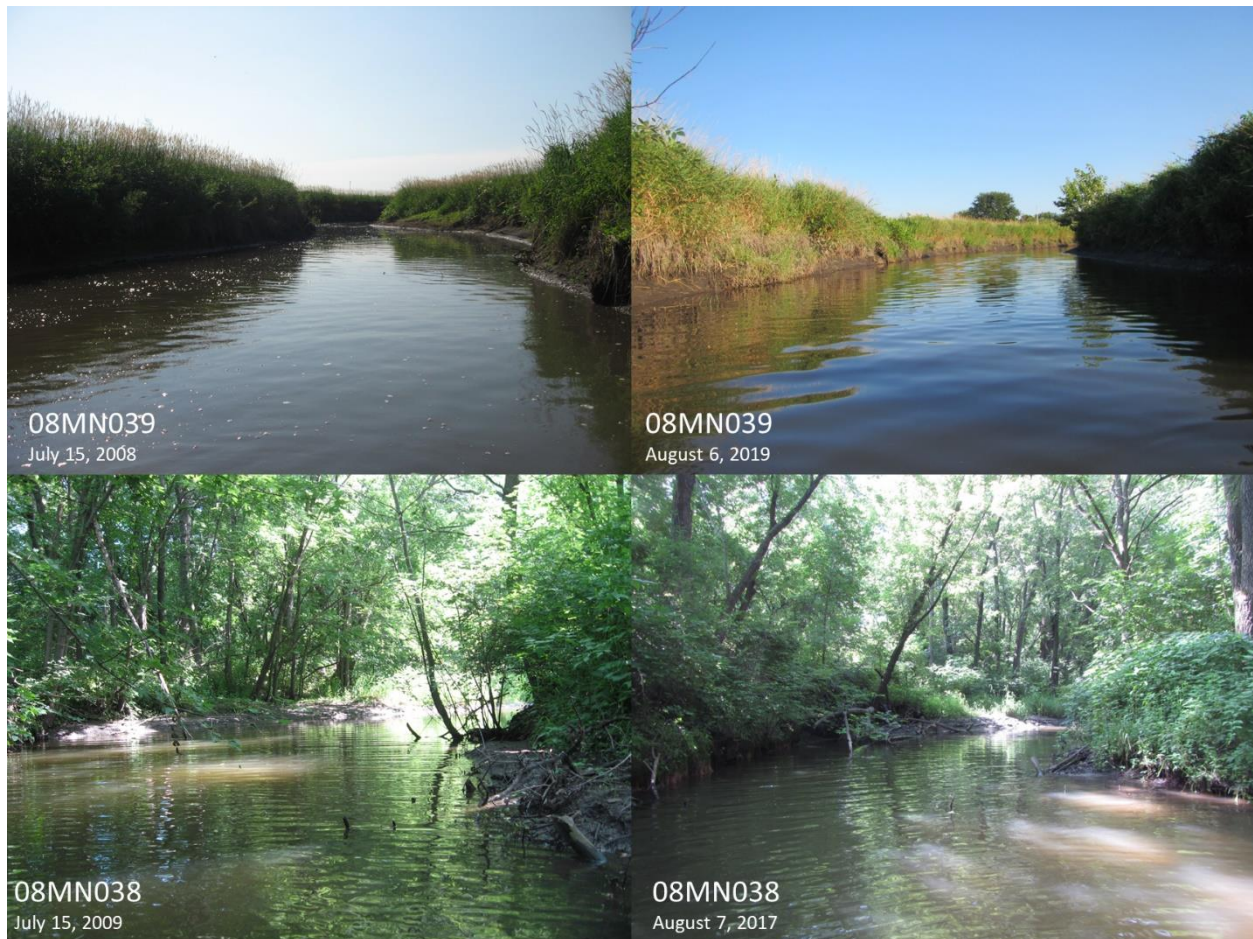
Figure 48. Taken at the time of biological monitoring, in order from upstream to downstream.

This stretch of the Little Cobb River, WID -524, has been assessed in multiple locations in both Cycle 1 and Cycle 2. The 08MN038 is the furthest upstream location with 08MN039 being the furthest downstream site on this nearly 16-mile length of stream. These locations can be seen in Figure 48, with clear changes in stream features from upstream to downstream. There is an artificial barrier between the two sites that could contribute to marginal species migration numbers (that will be discussed below). Trenton Lake is the headwaters for this ditch system. Looking at historical aerial imagery, this lake has frequent algal blooms in summer months (Figure 49). This lake was assessed in 2022 but data yielded insufficient findings for an impairment listing.

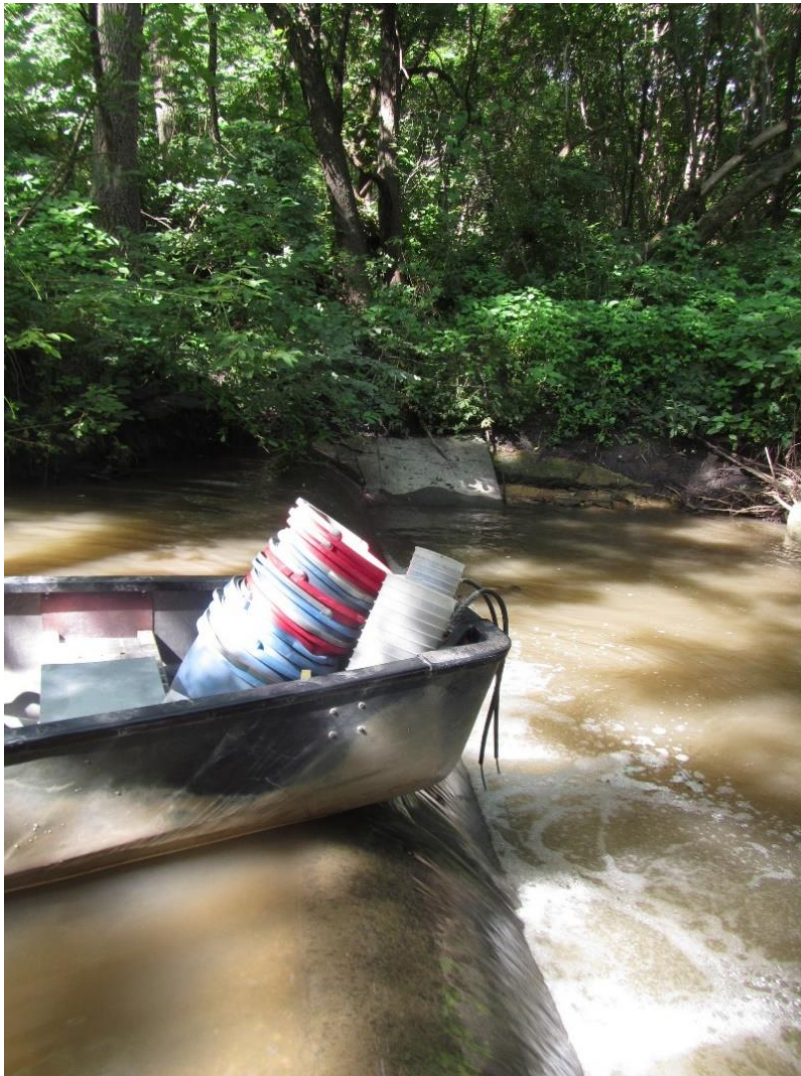
Figure 50. Fish barrier taken at the time of the July 18, 2018, fish sample.

Looking at tolerance values across all conventional parameters at WID -524, there are signals in nearly every fish and macroinvertebrate sample indicating broad impacts. As the fish and macroinvertebrates are primarily made up of generally tolerant species, there can be cross over indications when looking at the biological metrics alone. Some metrics did decline even further over time. Nitrate tolerance values within the fish community significantly declined in the last 10 years, more than any other metric category. Nitrate samples often fell within a high range. Nitrate is one of the primary stressors that is driven by altered hydrology from nearby agricultural practices. In addition, habitat scores (Figure 51) tend to show a decrease in quality over time. Particularly poor substrate diversity and channel instability are seen to displace riffle dwellers, lithophilic spawners, and benthic feeders within the fish community. Macroinvertebrates also did show a community made up of primarily high sediment tolerant taxa types. Habitat and TSS are both stressing the biology within this WID, with altered hydrology being the primary cause. The final stressor noted is connectivity for fish. While there are still some migratory species that are found upstream of the barrier, the overall count is low.

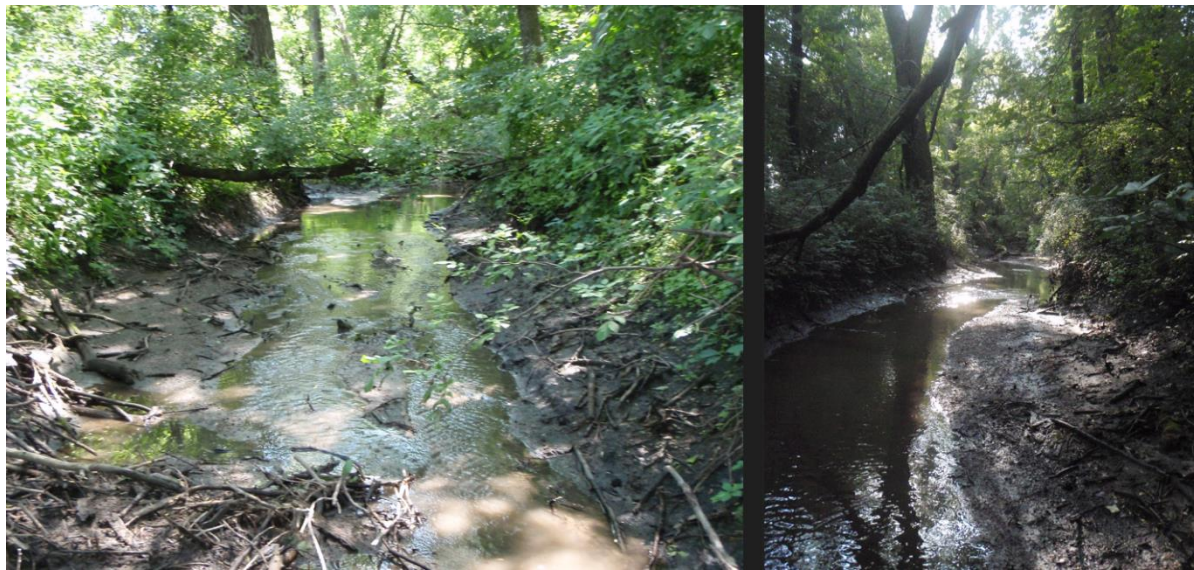
Figure 52. Conditions of County Ditch 20 taken at monitoring station 08MN062 on July 22, 2008 (left) and July 17, 2018 (right).

County Ditch 20 (WID -566) is a small order stream that is a headwater to the Little Cobb River. This section was sampled in both Cycle 1 and Cycle 2 (Figure 52) for macroinvertebrates and in Cycle 2 for fish assemblage. The macroinvertebrate community was found to be fully supporting of the standard and had many pollutant sensitive species within the sample, indicating adequate water quality and habitat needs are being met in both cycles. In contrast, the fish sample in 2018 collected a single fish (bigmouth shiner) resulting in an impairment listing.

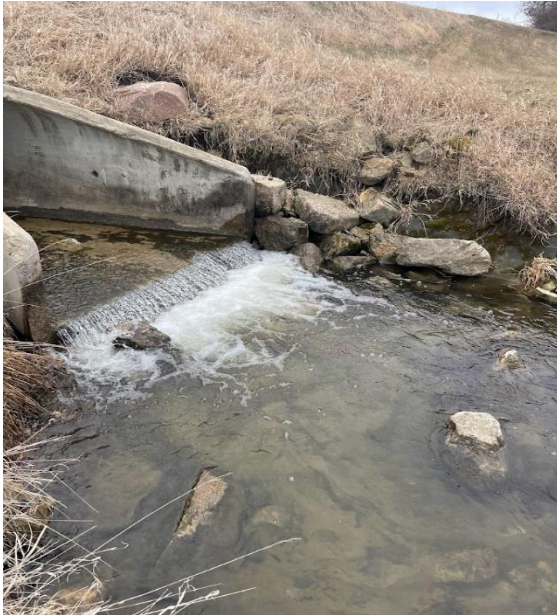
Figure 37. Perched culvert causing fish impairments at 08MN062.

With only a single fish being found during the stream survey, and with an optimal macroinvertebrate community to indicate good water quality, fish barriers were looked at. A perched culvert that could impede fish migration is located downstream of the monitoring location, as shown in Figure 37 below.

Other fish metrics were not able to be evaluated due to the single sample size. However, the macroinvertebrate community indicates a well-balanced community. It is feasible that if the barrier were corrected, the fish population would be thriving. There is some influence of altered hydrology that is noted in the slight incising of the stream that occurred between 2008 and 2018. This also is the driving force that has made the culvert lose its connectivity to the streambed.

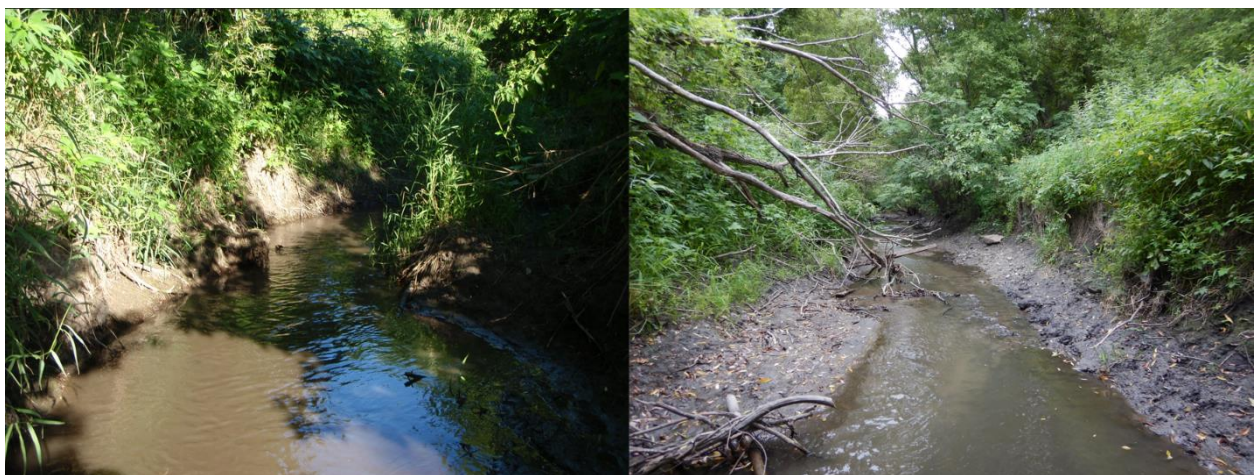
Figure 53. 08MN037 at the time of biological monitoring July 1, 2008 (left) and August 2, 2018 (right).

WID -613 on the Little Cobb River is on a headwater tributary that runs parallel to the headwater section of WID-524. This stream passed for macroinvertebrate assemblage yet failed for fish both in Cycle 1 and in Cycle 2 at station 08MN037 (Figure 53). Creek chubs made up most of the population in both samples.

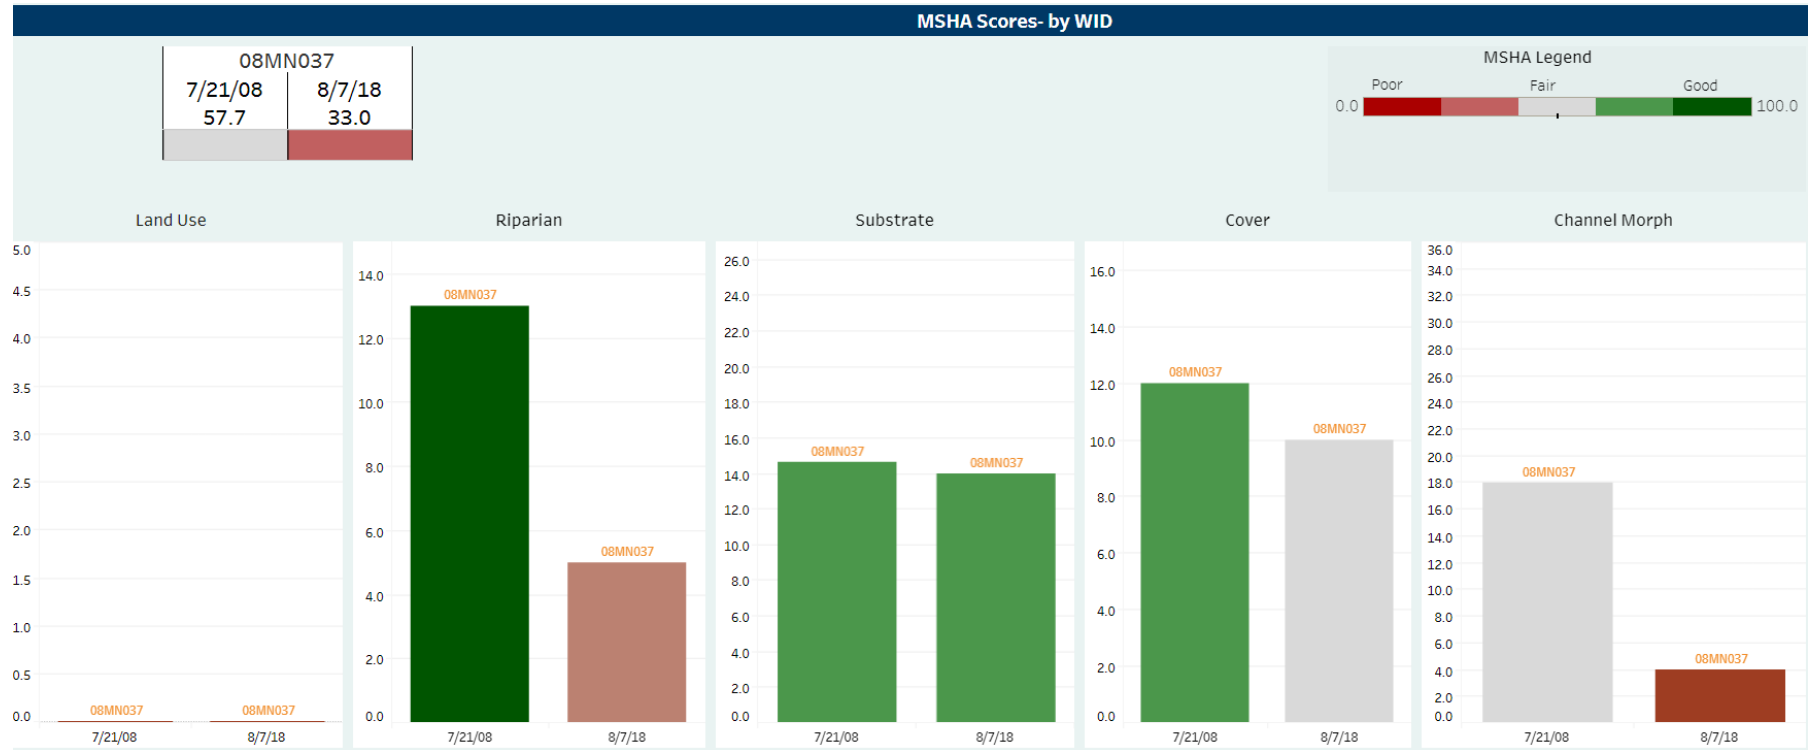
Figure 54. MSHA score on WID -613 within the Little Cobb River.

Habitat has significantly declined between Cycle 1 and Cycle 2 sampling, as shown within the MSHA scoring in Figure 54. Poor channel morphology and substrate are the limiting factors, with agricultural land use and channelization of the stream acting as the primary driver to habitat degradation.
