October 2024

Le Sueur River Watershed Stressor Identification Update

A study of local stressors limiting the biotic communities in the Le Sueur River Watershed.

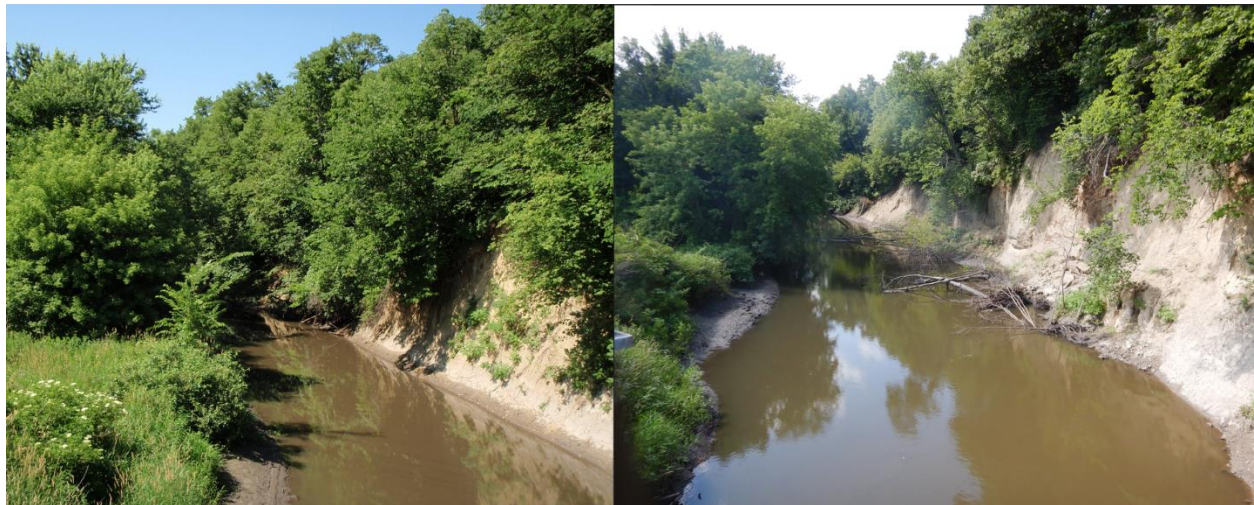
Figure 55. 08MN006 at the time of biological monitoring on July 09, 2008 (left) and August 07, 2019 (right).

WID-504 of the Little Cobb River has an existing fish impairment based on Cycle 1 sampling at station 08MN006. SID from Cycle 1 determined that DO, eutrophication, nitrate, TSS, and habitat were all stressors driven by altered hydrology. This location was sampled again in 2019 for Cycle 2 (Figure 55).

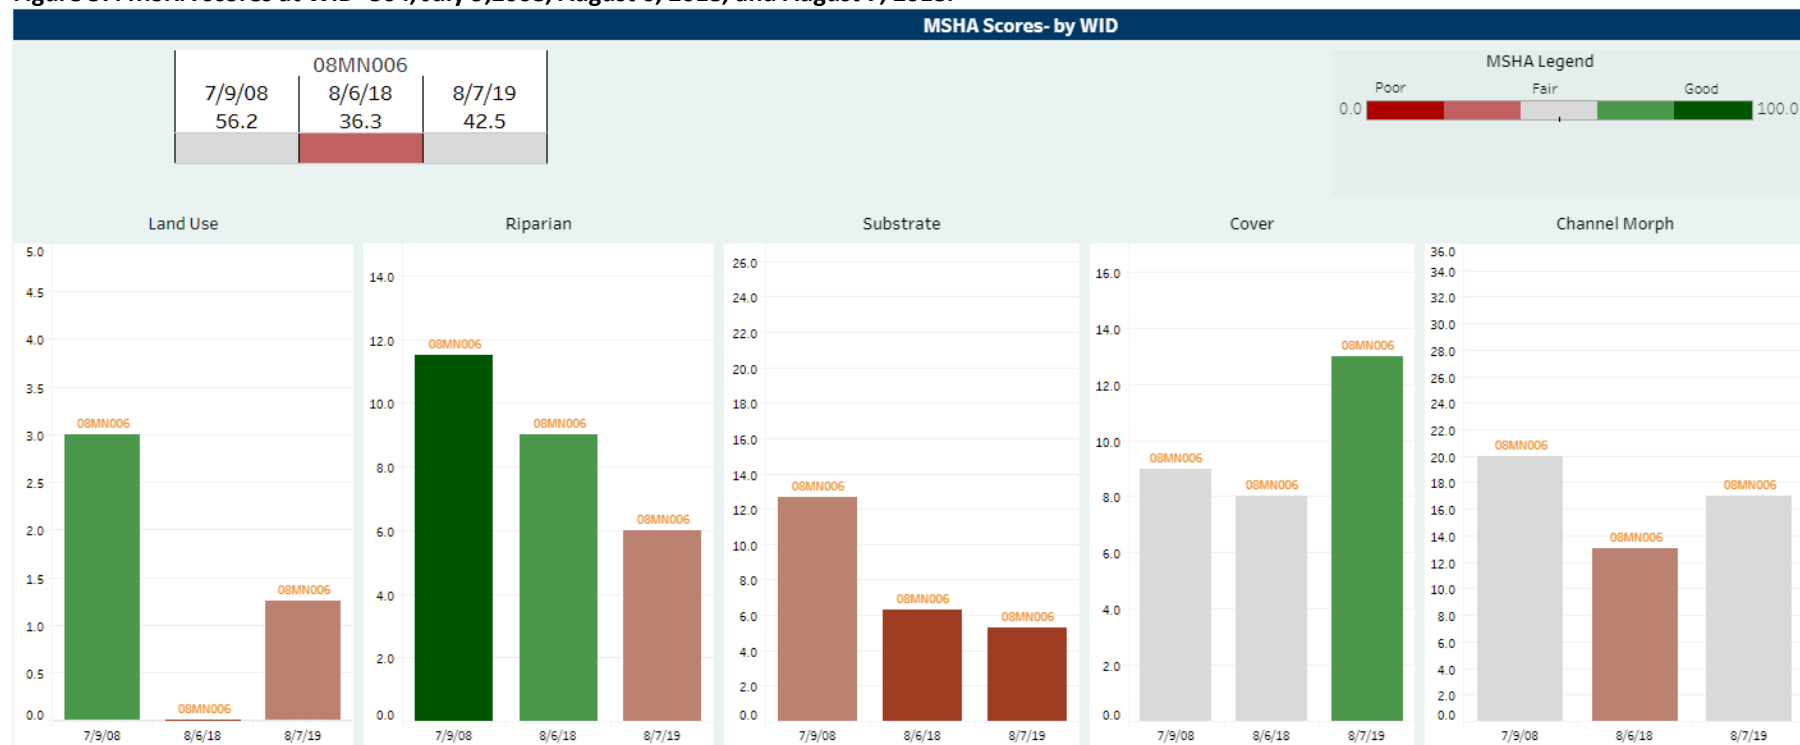
Figure 57. MSHA scores at WID -504, July 9,2008, August 6, 2018, and August 7, 2018.

Low DO is likely being driven by eutrophication, as suspended algae were noted within the stream, as well as sediment oxygen demand as the stream bed was heavily embedded. As highlighted in the MSHA scores (Figure 57) substrate was one of the lowest scoring aspects of the stream. Silt and muck were at times knee deep.

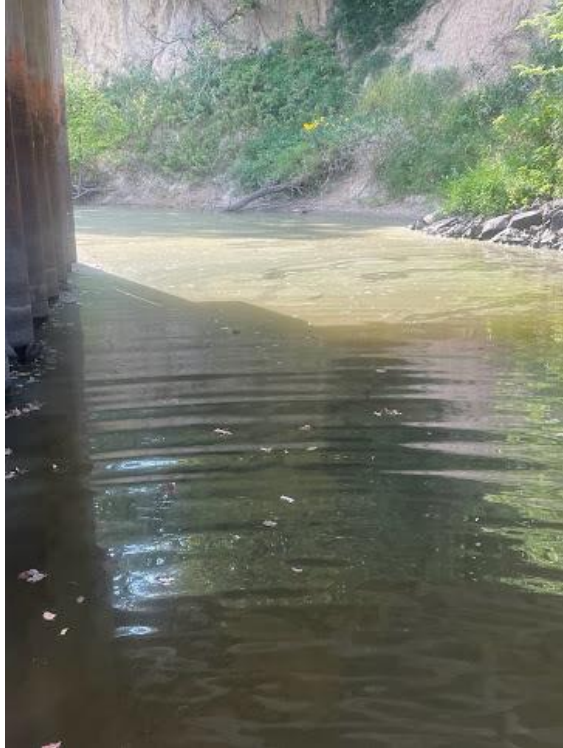
Figure 58. Stagnant conditions in the Little Cobb River shortly downstream of WID -504 on September 7, 2022.

This is an area of the Little Cobb River where deposition is occurring. Base flow and flow in general are of concern in this WID. Site inspections at this location noted conditions observed in Figure 58 below, where water was often stagnant and not flowing.

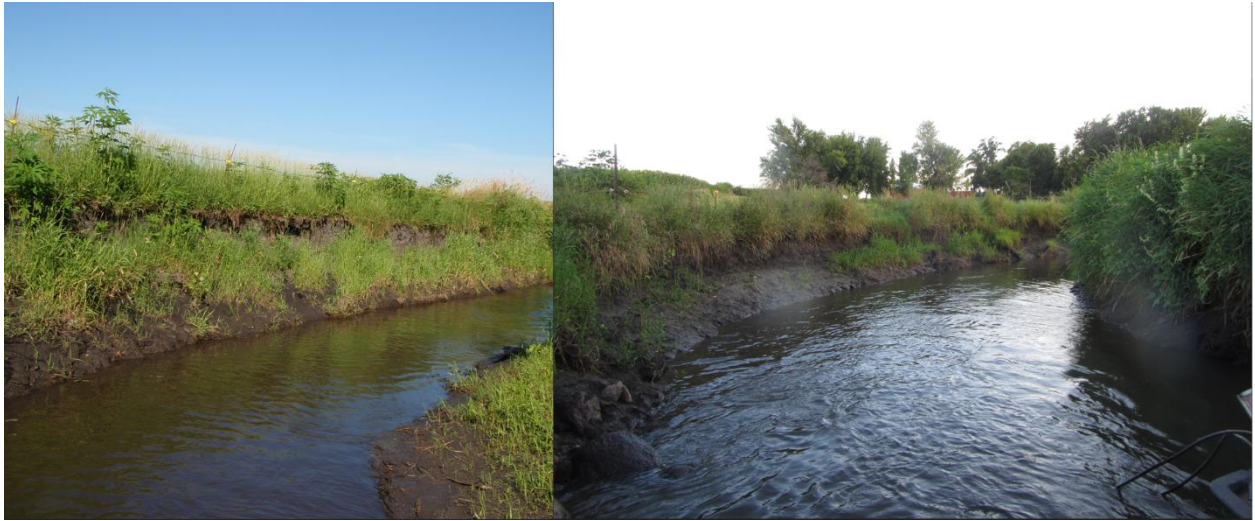
Figure 59. Conditions of WID -647 on Bull Run Creek, taken at the time of biological sampling on July 23, 2008 (right) and August 7, 2018 (left).

This section of Bull Run Creek (WID -647) has two stations (08MN040, 18MN010), each sampled once in 2018 (Figure 59). Station 08MN040 was also sampled in 2008 for Cycle 1 biological assessment. Biological sampling found that this section of Bull Run Creek does support the macroinvertebrate community, while the fish community was found to be impaired. The 2008 fish IBI scored 18.9 (well below the threshold of 35) resulting from only 13 species present and fathead minnows being the most abundant. The 2018 Cycle 2 sample scored 36.3, showing improvement. Eighteen species were found during the sample. Spotfin shiner, fathead minnow, and green sunfish were the most dominant species collected.

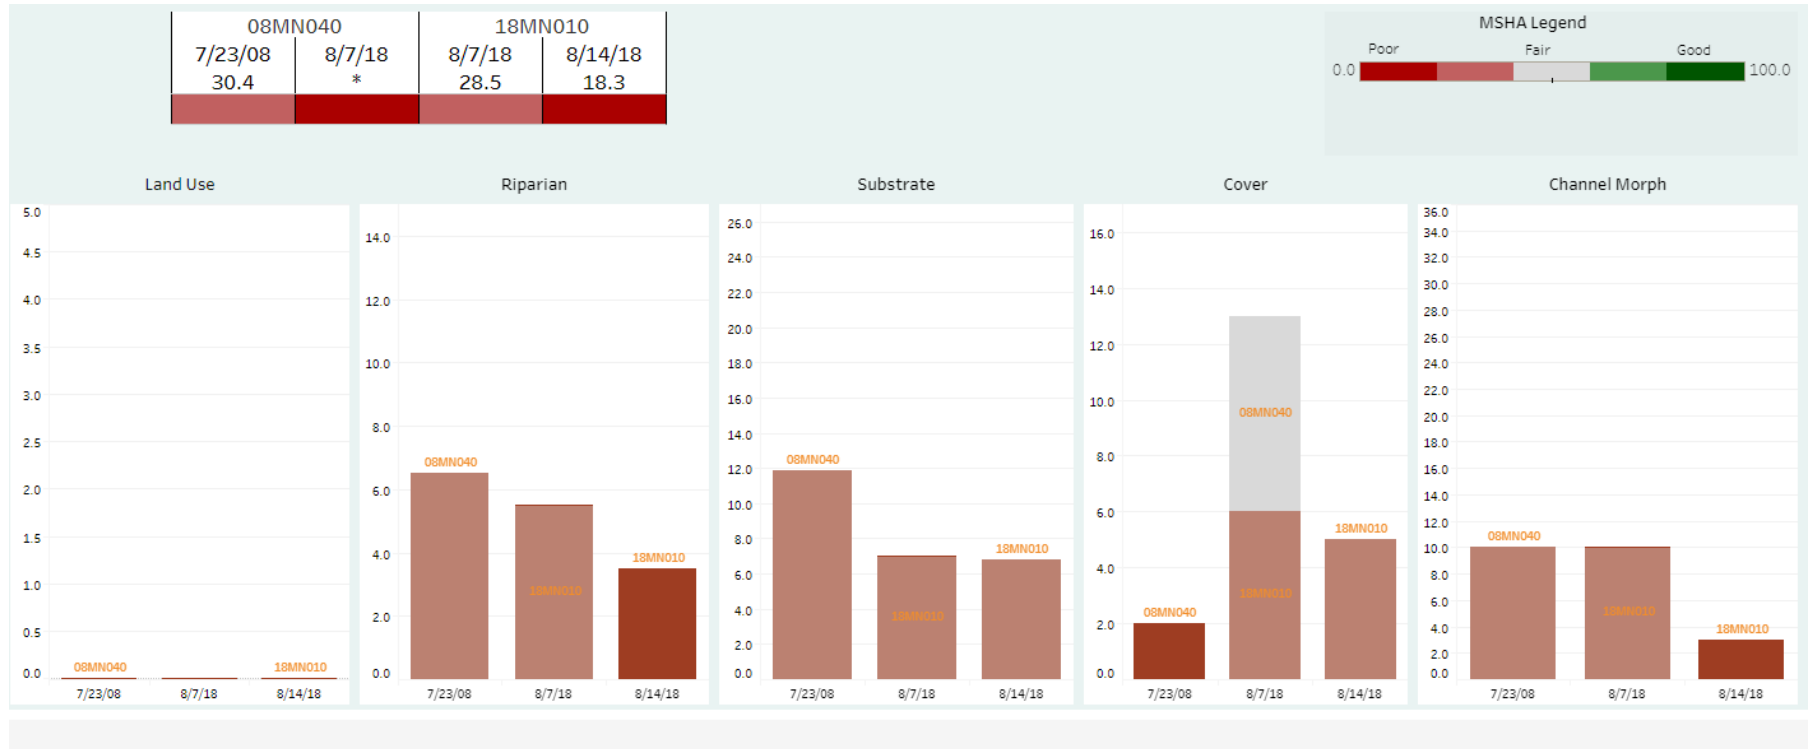
Figure 60. MSHA at Bull Run Creek on WID -647, July 23, 2008, August 7, 2018, and August 14, 2018.

Habitat and TSS are the leading stressors within Bull Run Creek. Figure 60 shows habitat displacement in nearly all scores aspects of the MSHA in every assessment.

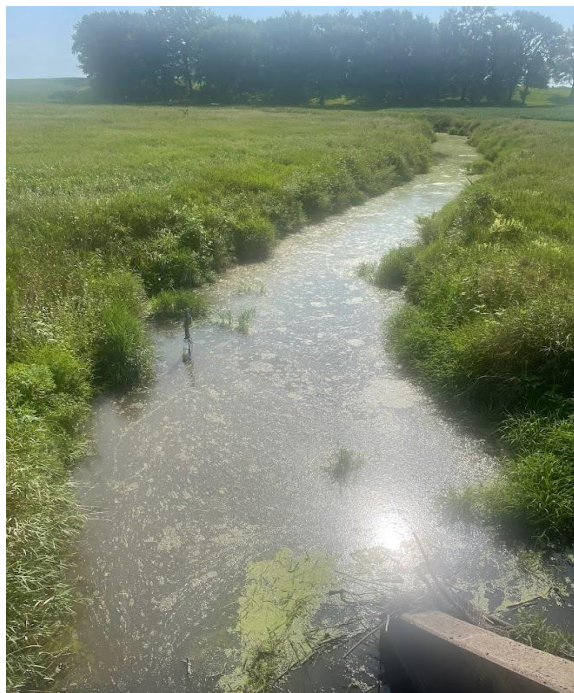
Figure 62. Bull Run Creek (WID -647) showing eutrophic conditions in algal growth.

There are also clear indications of eutrophication occurring (Figure 61 and Figure 62) leading to TSS driven by both algae as well as sediment. DO stress could be the result of both eutrophication as well as sediment-oxygen demand. Continuous data collected from August 12 through August 19, 2022, shows DO flux that would be consistent with eutrophication, with low DO occurring mostly at night. Connectivity is also found to be a stressor at times of low flow at one of the culverts in this WID, as this culvert is slightly perched. Most times of the year, this is passable yet was observed to be above the base waterline on a few site visits.

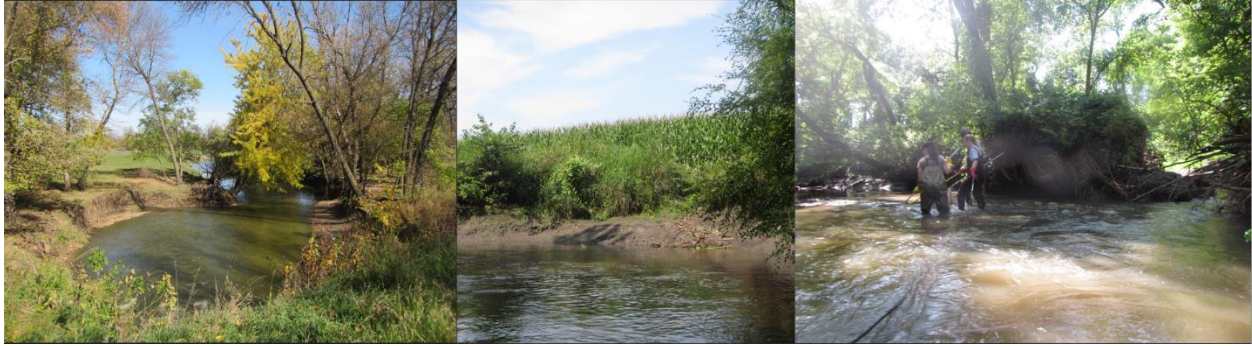
Figure 65. Upstream of WID – 568 capturing changes to stream and nearby land use. (Right shows erosion to pasture on the downside of culvert in 2017; middle highlights erosion up to the cornfield in 2018; left was captured at the time of the 2019 fish sample where the river formed a new channel).

This section of stream has a mix of natural features and channelized stretches. Most land use within the reach watershed is agriculture. Between tile drainage and physical alterations of the stream, there have been dynamic stream changes as shown in Figure 65. The stream channel has changed significantly within the last 10 years, leading to mass channel erosion and loss of land. So much so, that this section has created cut offs of the old stream's pathway and created a new one. There is a current turbidity impairment that also coincides with the high erosion rates. Fish and macroinvertebrates also show consistent TSS stress with a lack of intolerant species, and an overabundance of TSS tolerant species. Across all parameters, TSS metric values indicated a clear stressor to aquatic life. Chemistry assessment also shows that 20% of TSS samples exceeded 65 mg/L with the highest in the last 10 years being 87 mg/L.

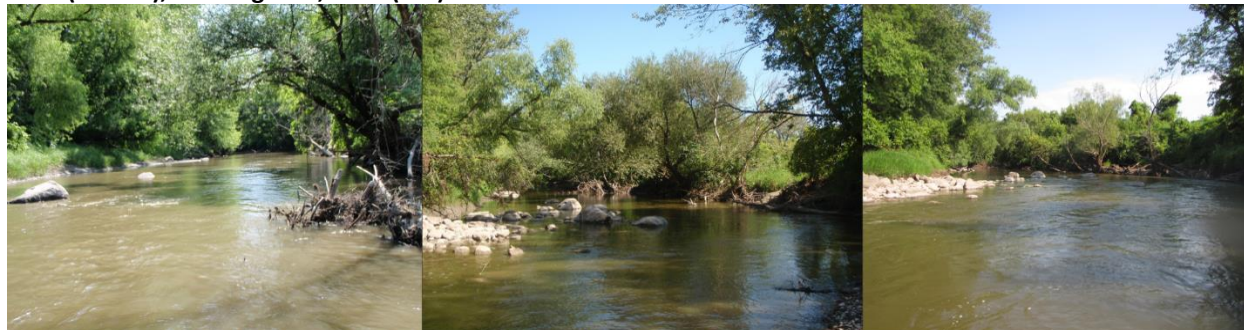
Figure 67. Conditions of Station 08MN005 at the time of biological monitoring on July 8, 2008 (right), August 24, 2010 (middle), and August 8, 2018 (left).

WID -566 on the Cobb River has one station (08MN005), sampled a total of three times, once in 2008, 2010, and 2018 (Figure 67). The 2018 sample scored just above the threshold at 50.1. Notable species collected in this sample were gar and large flathead. An additional fish collection in 2019 (nonreportable as a result of flows) sampled two shovelnose sturgeon and a short nose gar. While the newest score is above threshold, it did not meet statistically significant growth to place it out of fish impairment status. The macroinvertebrate samples throughout the years fall above and below the threshold, within the CI. Like the fish community, the macroinvertebrate community is not far off from reaching a supportive status.

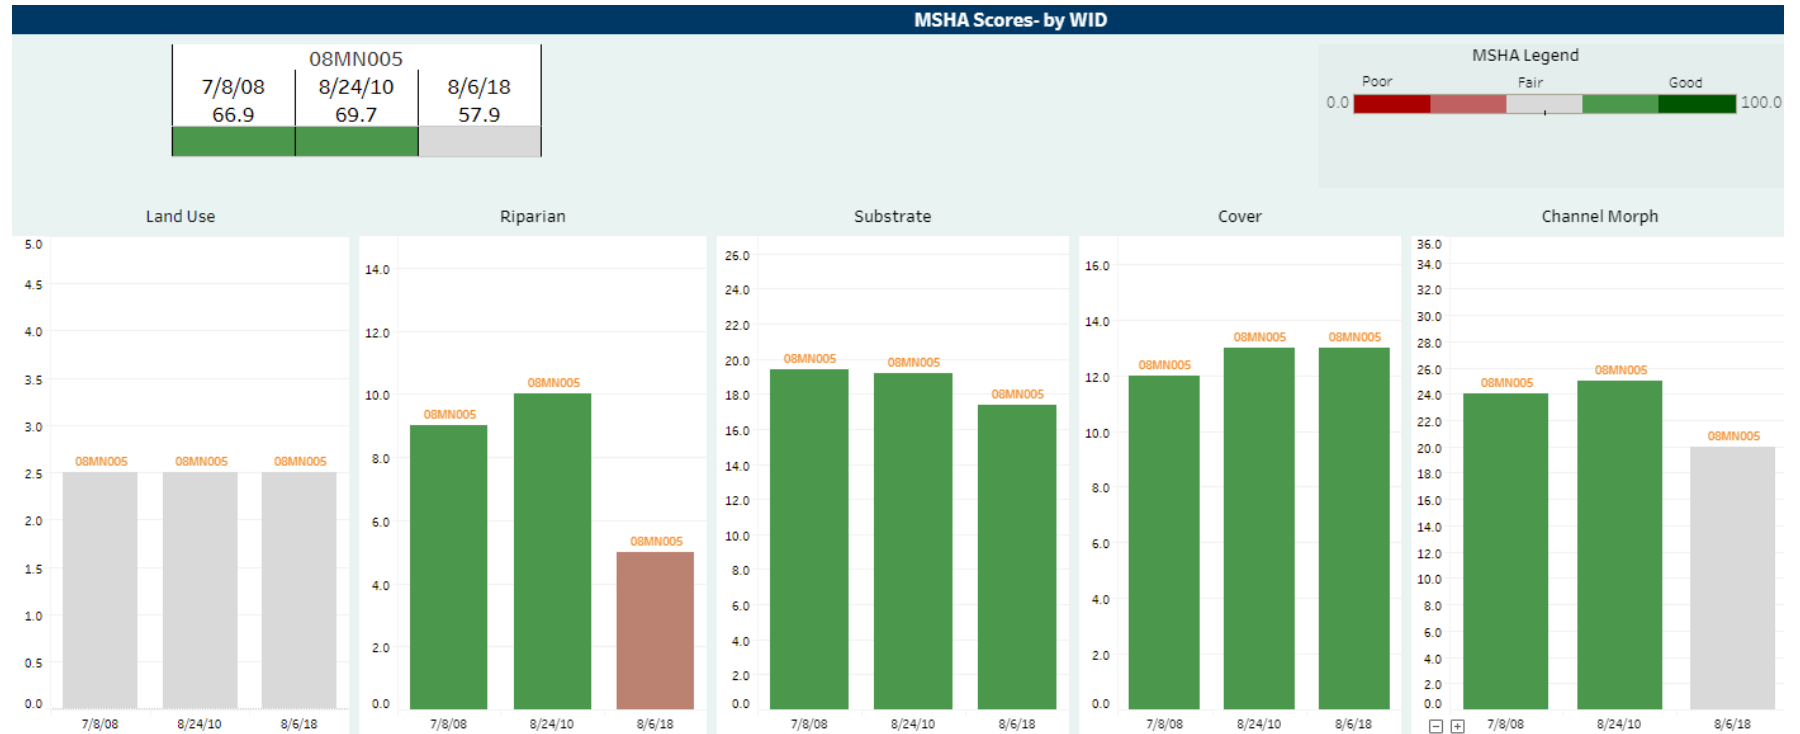
Figure 68. MSHA scores at -556 of the Cobb River, July 2008, August 2010, and August 2018.

listing for aquatic life use based on turbidity (2008) and nutrients (2016). Extensive phosphorus data indicates elevated concentrations across the years. Chl-*a* data indicates a significant response to elevated nutrients and highlight eutrophication. Robust TSS and STUBE datasets reveal poor conditions for aquatic life. This can be noted in the stream's poor riparian scores as well as morphology (Figure 68).

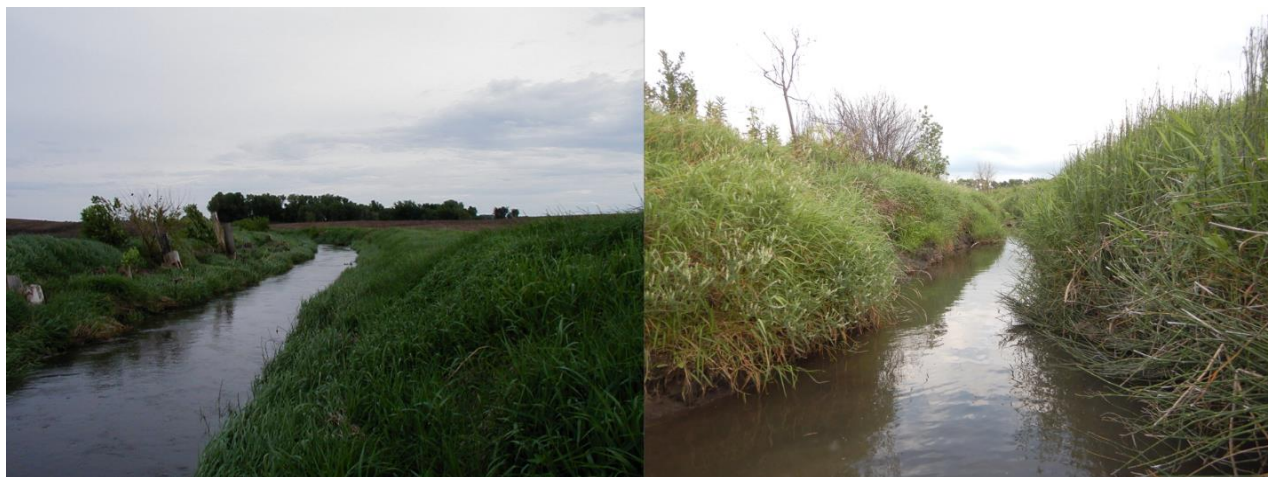
Figure 70. Monitoring conditions at 01MN030 on July 23, 2008, (right) and August 01, 2018 (left).

WID -541 has one station 01MN030 sampled in 2001 and 2018 (Figure 70). The designated use of WID -541 was previously changed to modified use, based on channelization and habitat characteristics. The WID was found to be in full support based on the modified use threshold for macroinvertebrates. The 2018 fish sample had a similar community as the previous Cycle 1 fish sample, aside from white suckers. In 2008 over 600 white suckers were collected, but in 2018 only 23 were collected. Regardless, there was sufficient diversity to determine this stream is not impaired for fish or macroinvertebrates.

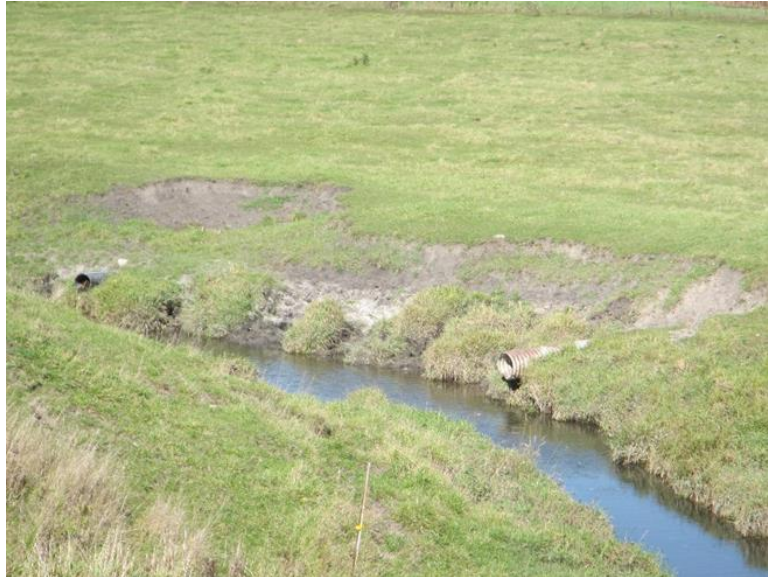
Figure 71. Erosion along Judicial Ditch 51 on October 19, 2017.

This WID is slightly different in highlighting it as passing, as there are clear indications of stream instability Figure 71 that can create dramatic changes to habitat. In addition, there are WIDs upstream and downstream with biological impairments that were found in Cycle 2 assessments. Correlations to nearby land use or BMPs would be helpful to further investigate in understanding what practices are keeping biology from falling below the threshold between two WIDs that are not supporting biology.

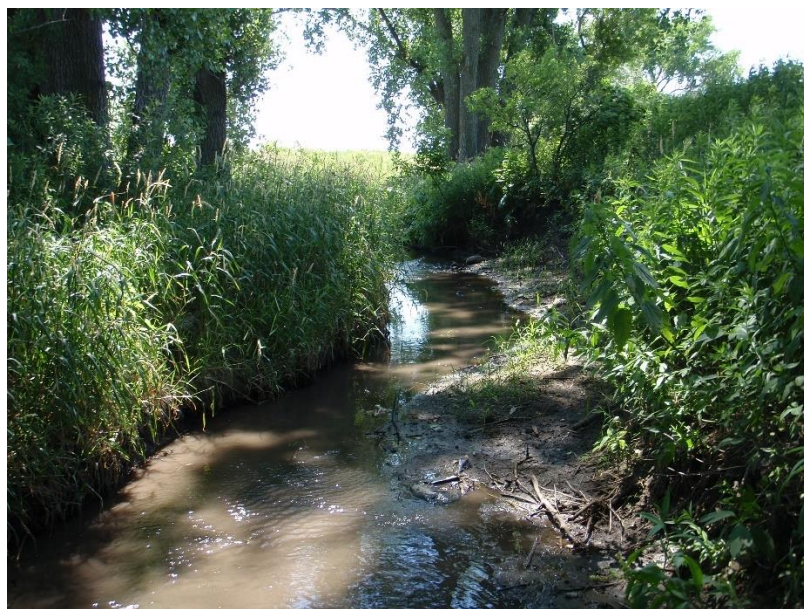
Figure 72. Monitoring conditions of 08MN068 taken July 16, 2008.

WID -615 is a small headwaters stream that flows into the mainstem of the Cobb River. While this branch was initially left out of Cycle 1 SID assessment, reevaluation of initial data found communities to be meeting the threshold developed for modified streams, for both fish and macroinvertebrates. This station was only sampled in 2008 at monitoring station 08MN068. While it is not often that both communities are found to be thriving in a channelized system, this section stands out as it has unique riparian vegetation that is allowing for slightly more habitat diversity (Figure 72).

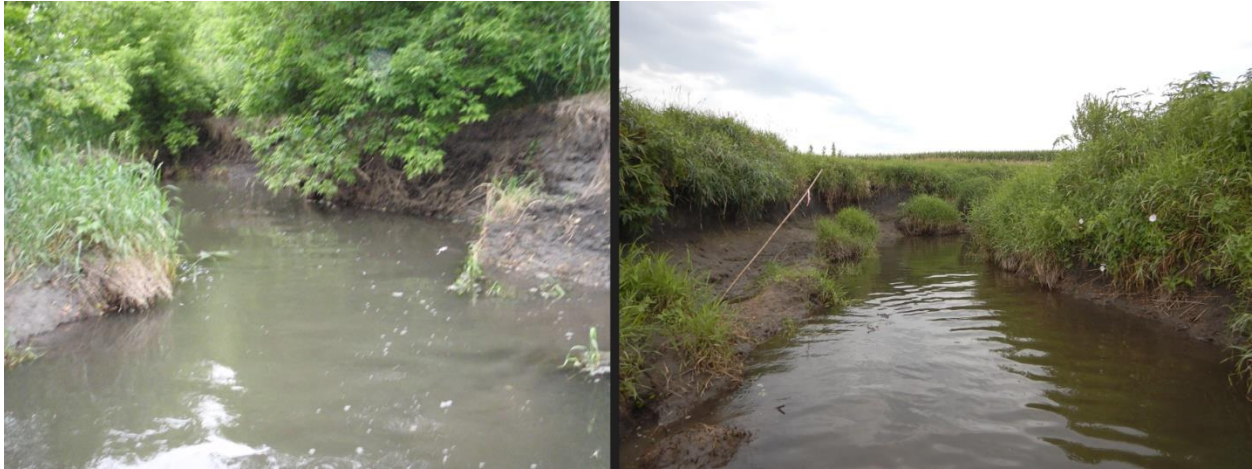
Figure 75. Conditions at the time of monitoring at 08MN015 on July 26, 2008 (right) and 18MN008 on August 01, 2018 (left).

This headwater prairie stream (WID -593) has two stations: 08MN015 in Cycle 1 sampled in 2008, and 18MN008 for Cycle 2 sampled in 2018 (Figure 75) This stream was designated as modified use based on channelization and habitat characteristics upstream from the confluence of Minnesota Lake.

Habitat is a clear stressor to biology within WID -593. As shown in Figure 75, both site visits show an extremely entrenched and ditched channel. While the MSHA score for substrate scored fair (Figure 76), this section of stream is primarily silt, sand, and clay. Primarily generalist and tolerant species made up both macroinvertebrate and fish samples, indicating a lack of specialized habitat. Altered hydrology is the driving force of the entrenched channel in this case.

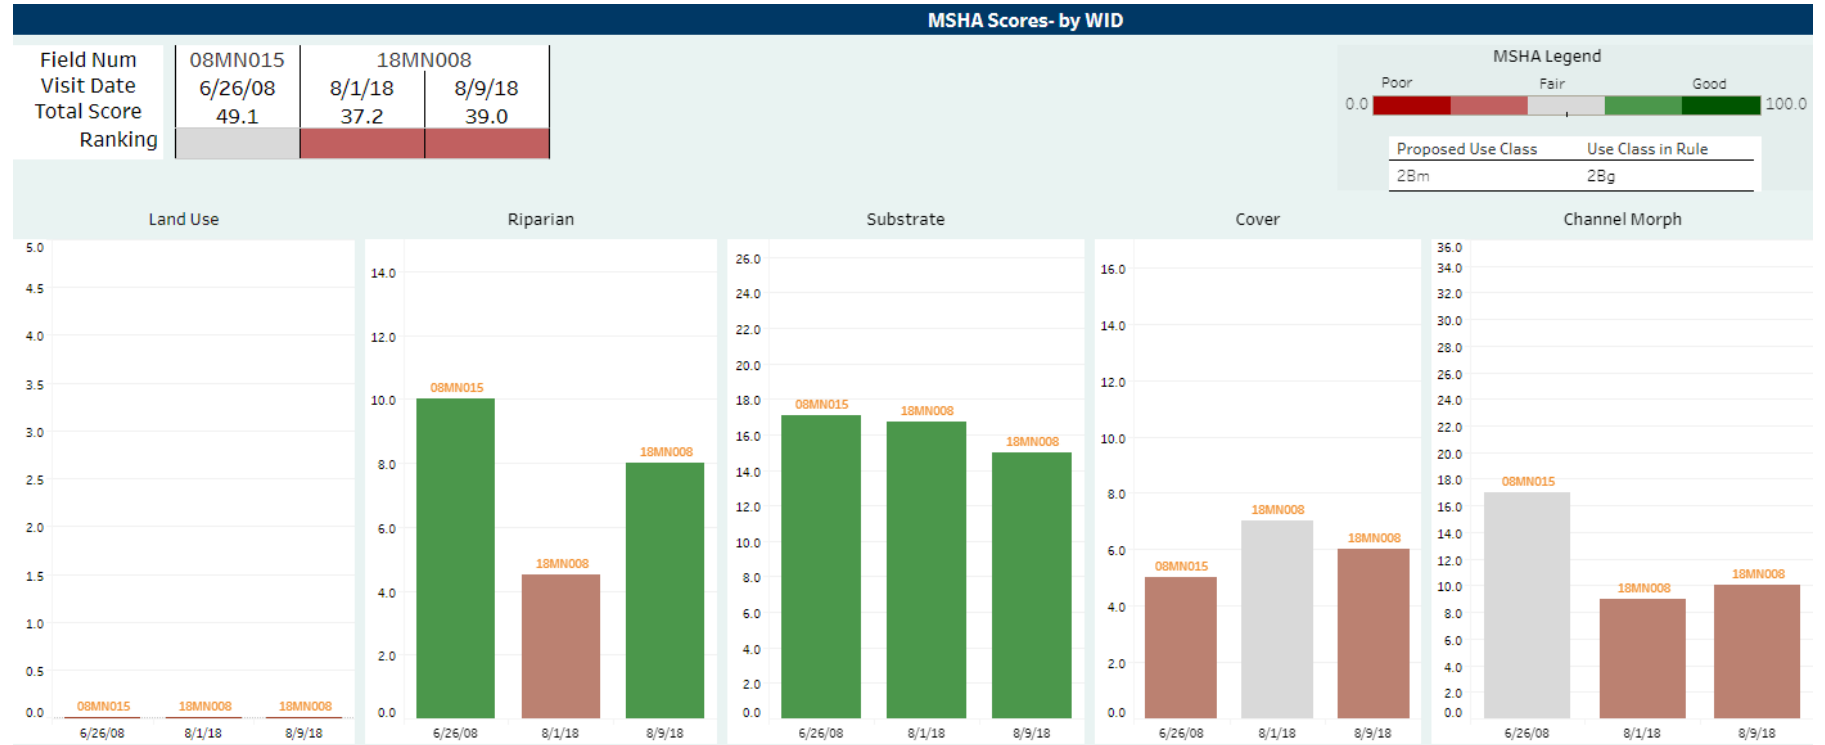
Figure 76. MSHA scores in County Ditch 85 in WID -593.

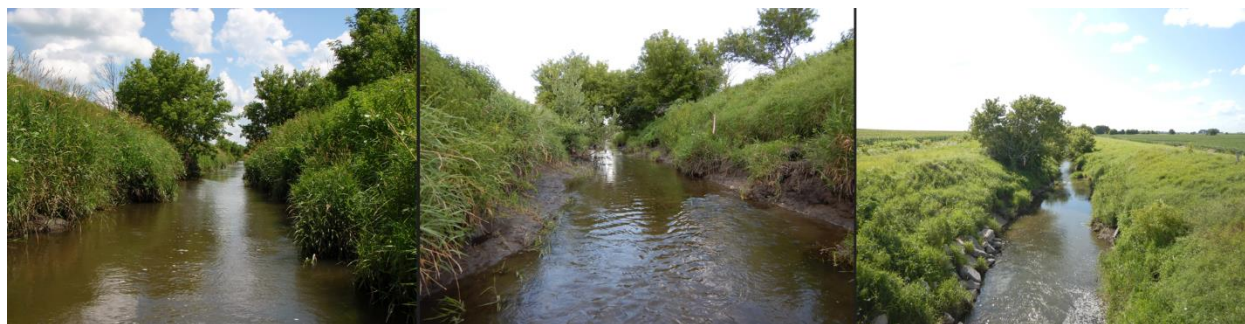
Figure 77. Conditions at the time of monitoring 07MN062 taken July 22, 2008 (right) and July 31, 2018 (middle and left).

County Ditch 3 (WID -550) is a small tributary upstream of the Maple River. This section is impaired for both fish and macroinvertebrates with a single monitoring station of 07MN062 (Figure 77). There was little change between the macroinvertebrate communities sampled in 2008 and 2018. The 2008 invert IBI scored 23.2, and the 2018 sample scored 25.1. The fish IBI from Cycle 1 (2008) was determined to be nonreportable due to high flow. The 2018 sample had higher numbers of fish and more species compared to the 2008 sample. However, the overall IBI score remained low. In addition to the biological impairment, this WID has limited chemistry assessment work, or additional samples taken.

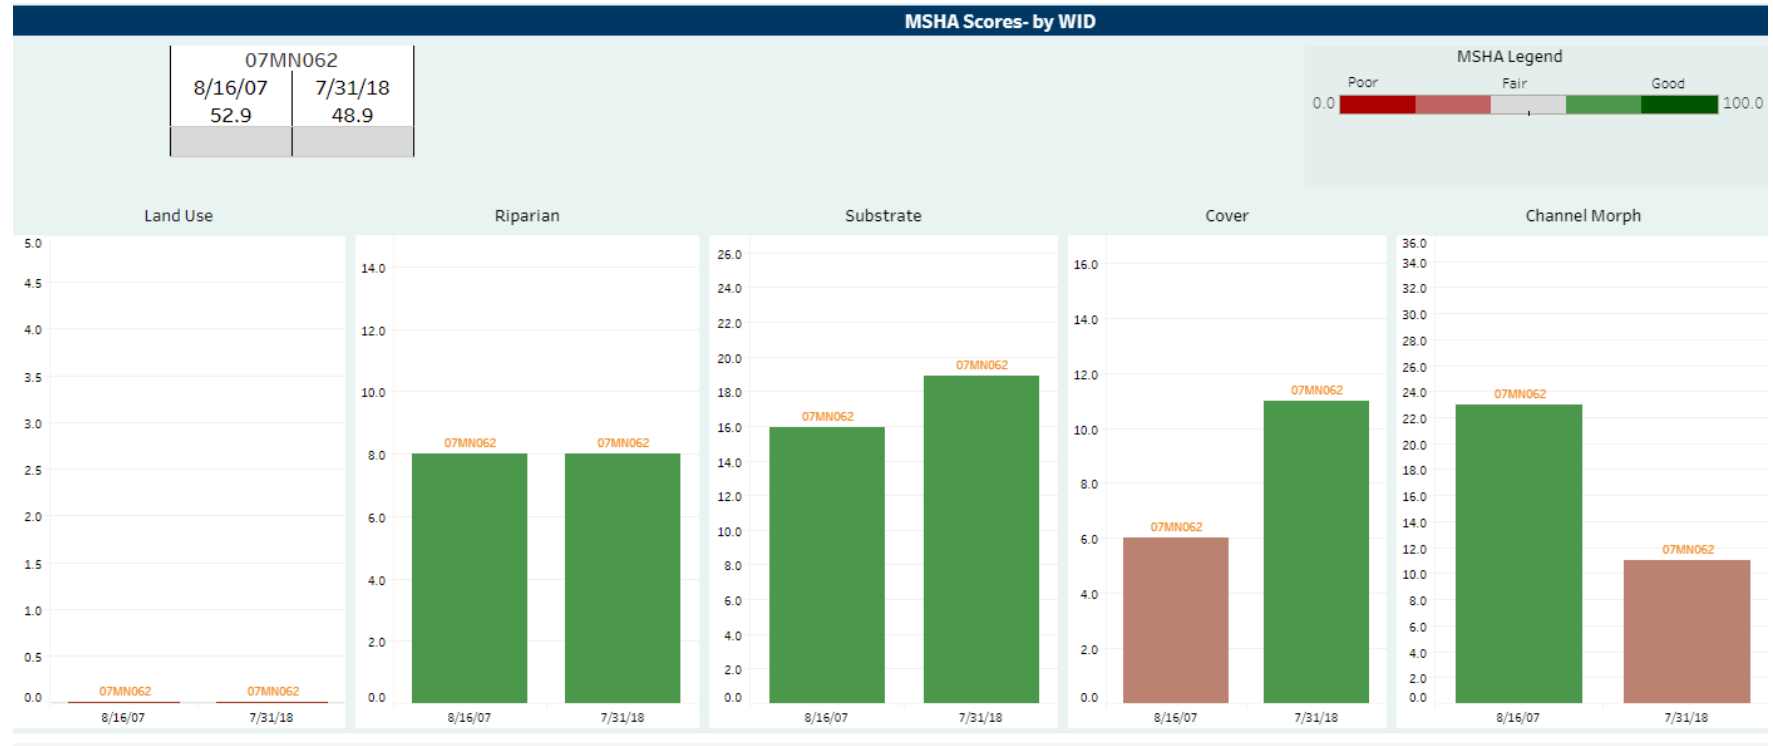
Physically, not a lot has changed within the channel of this WID. As shown in Figure 78 below, the greatest threats to the stream's habitat is land use as well as the riparian area's lack of cover and vegetation. This is a channelized stream.

Figure 78. MSHA score on County Ditch 3 at WID -550, August 2007 and July 2018.

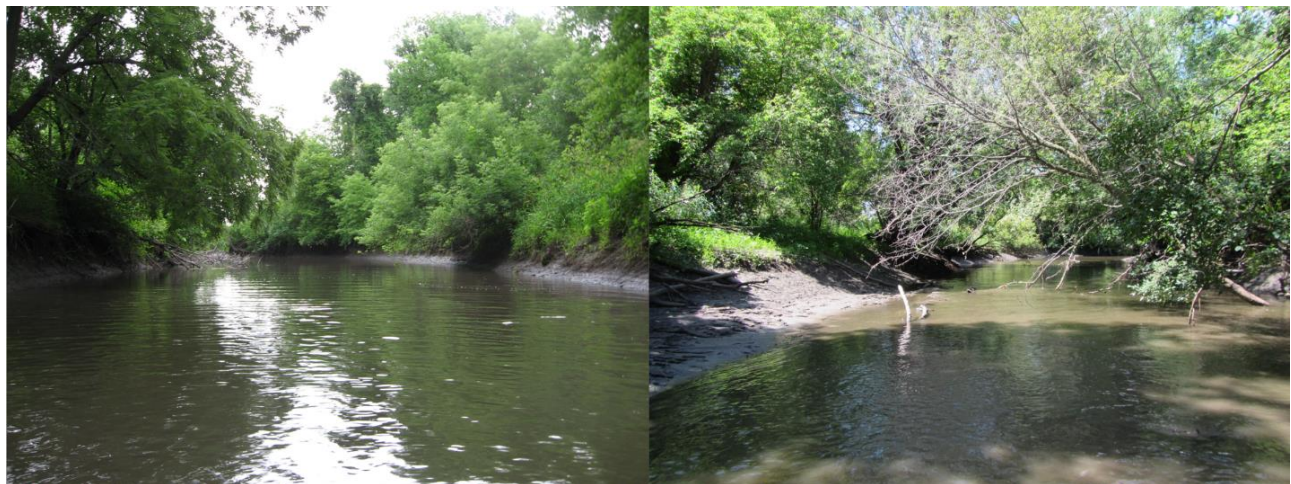
Figure 79. Conditions at the time of biological monitoring at 08MN023 on July 24, 2008 (left), and August 06, 2019 (right).

This is one of the longer assessed WIDs of the Maple River, located downstream of Minnesota Lake. The farthest upstream station is 08MN023 (Figure 79) where biology scored poorly in both Cycle 1 and Cycle 2, while the furthest downstream station of 08MN091 (Figure 80) showed less of an impairment, with macroinvertebrates scoring well above the threshold in later years. As shown below, the 2013 sample was taken when eutrophic conditions were present, where other years of 2022 and 2023 highlight why this stream is impaired by turbidity.

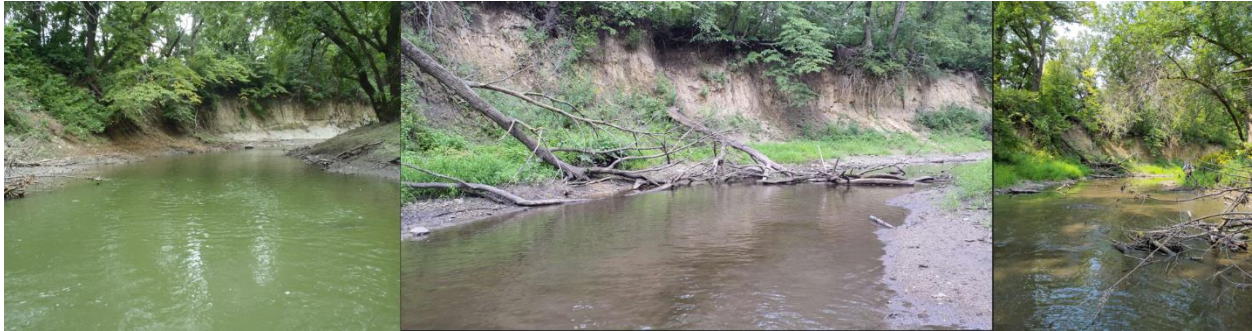
Figure 80. Conditions at the time of biological monitoring at 08MN091 August 21, 2013 (right), August 24, 2022 (middle), August 21, 2023 (left).

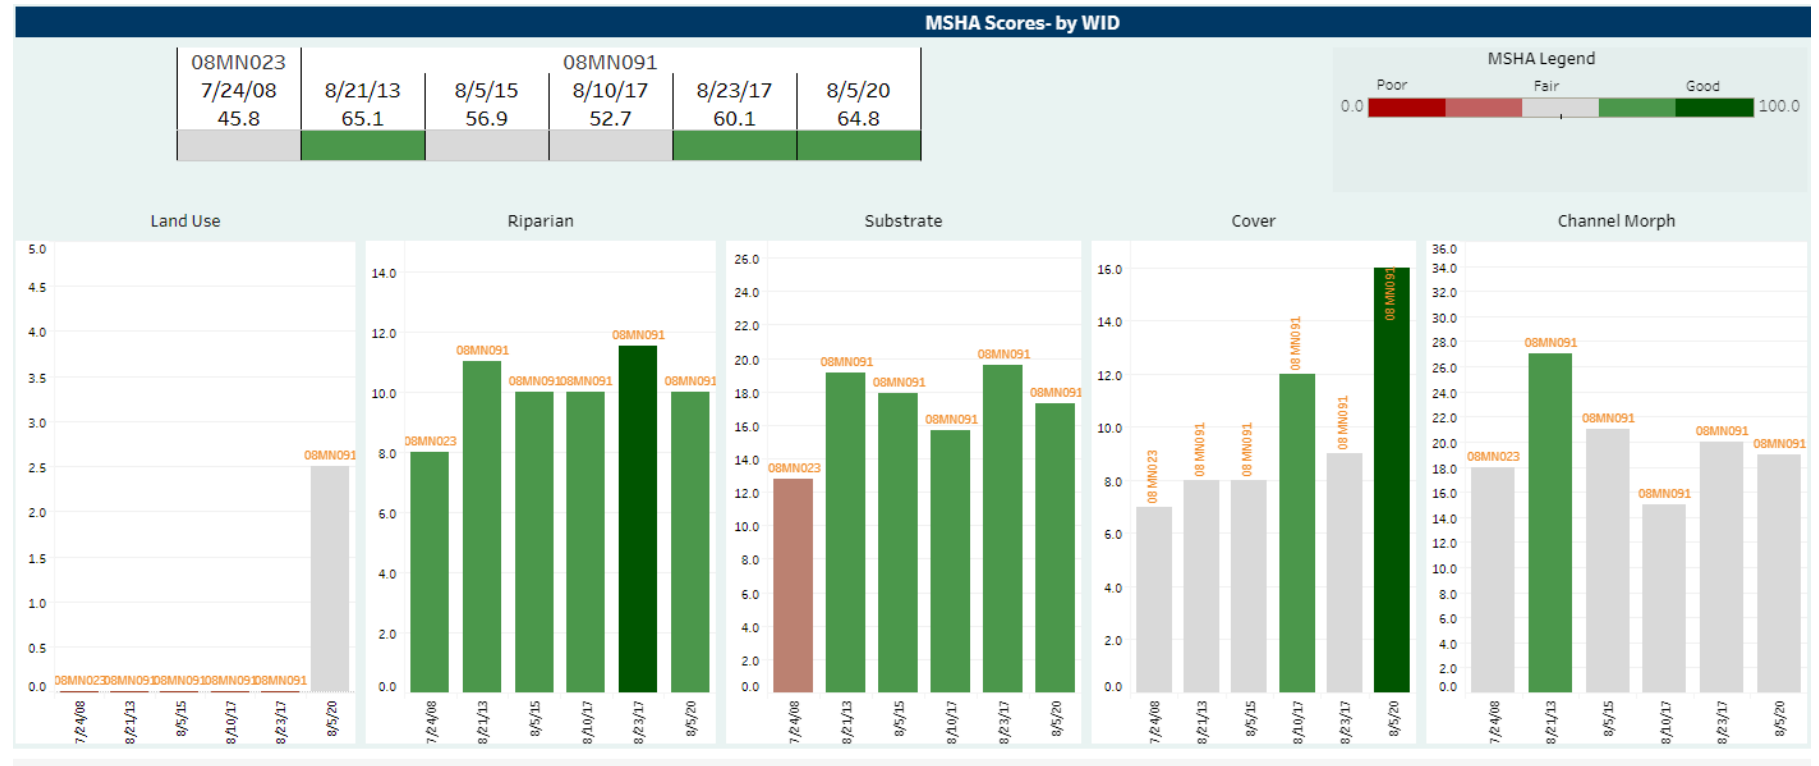
This section of the Maple River (WID -535) has a turbidity impairment, that is reflected in the data as well. Macroinvertebrates showed the strongest signal of being stressed by TSS. Often with a TSS stressor to biology, habitat is found to be degraded as well. As shown in Figure 81 below, overall scores show fair habitat. However, there were signals within the fish community of habitat displacement for benthic spawners and riffle dwellers. There was also a decrease of riffle dwellers at the upstream station. Macroinvertebrates also showed some imbalance in terms of functional feeding groups and expected habitat types. There is a lot of variability between location and time, yet the furthest upstream sections conclude that habitat is limiting biology within WID -535.

Figure 81. MSHA scores during multiple site visits within WID -535 of the Maple River.

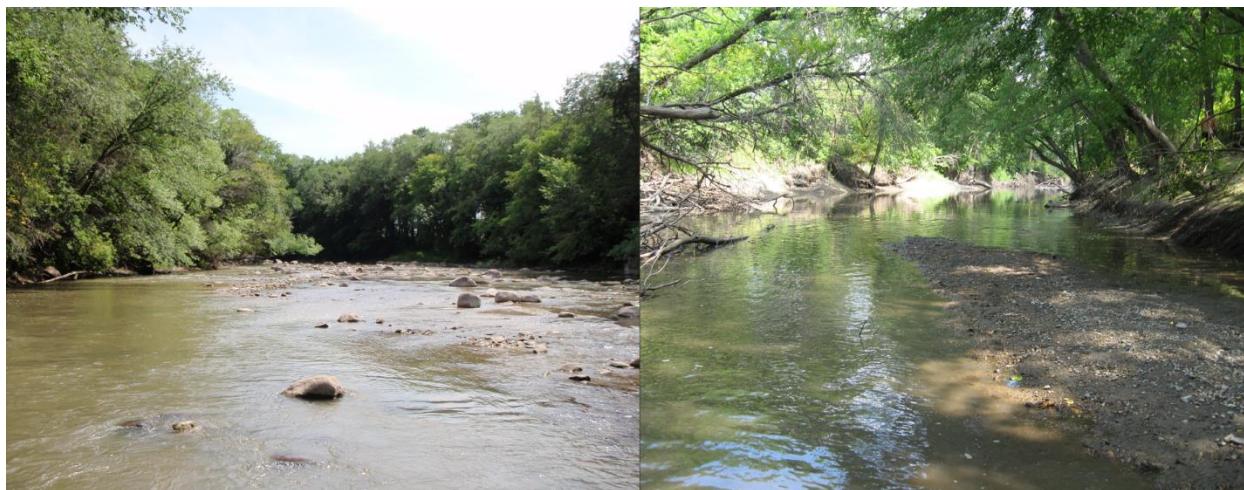
Figure 82. Monitoring station 08MN003 on July 30, 2008 (right) and 08MN019 on August 20, 2008 (left).

This WID (-534) of the Maple River has two stations (08MN003, 08MN019) sampled a total of three times, twice in 2008, and once in 2018. Data from current assessment (2018) suggests a nonimpaired conditions as data from 08MN003 scored significantly above the threshold. The invertebrate community is excellent, with three intolerant taxa present, and abundant clinger and Ephemeroptera, Plecoptera, Trichoptera (EPT) diversity.

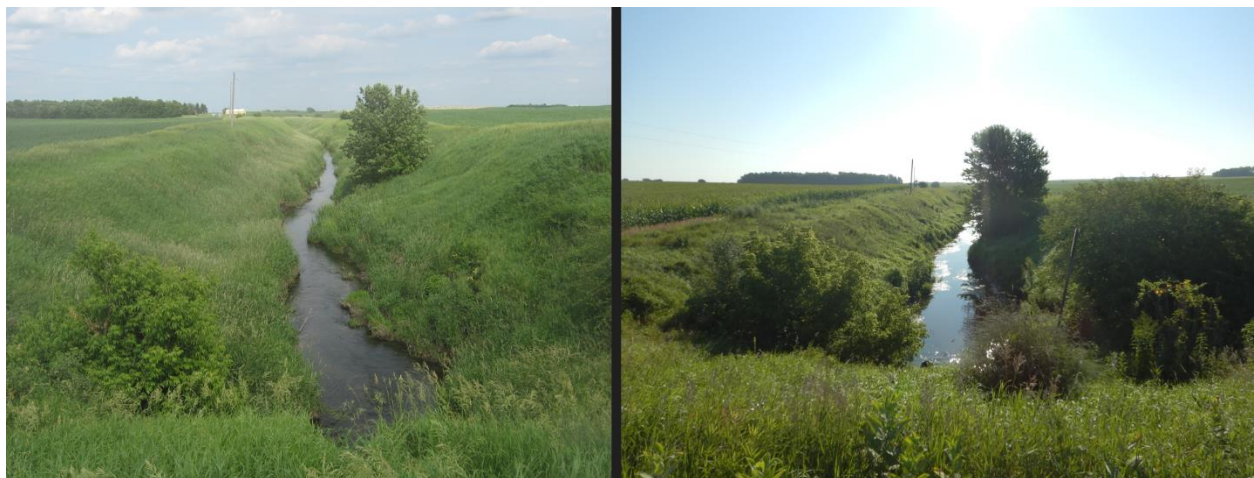
Figure 84. Monitoring station 08MN008 at the time of sample on June 25, 2008 (right) and July 31, 2018 (left).

Providence Creek (WID -650) is a modified use stream due to channelization and outlets into WID-534. This is one of the few sites that improved between Cycle 1 and Cycle 2 regarding the fish community. The previous fish impairment has been removed as the reach is now found to be in support. Station 08MN008 was sampled for Cycle 1 in 2008 and again for Cycle 2 in 2018 (Figure 84) that resulted in a current impairment for the macroinvertebrate community. While the reach is technically impaired for macroinvertebrates, the IBI values fell near the threshold. Nearly/barely streams like this stand out during assessment, as fewer practices are needed to result in a support of aquatic life.

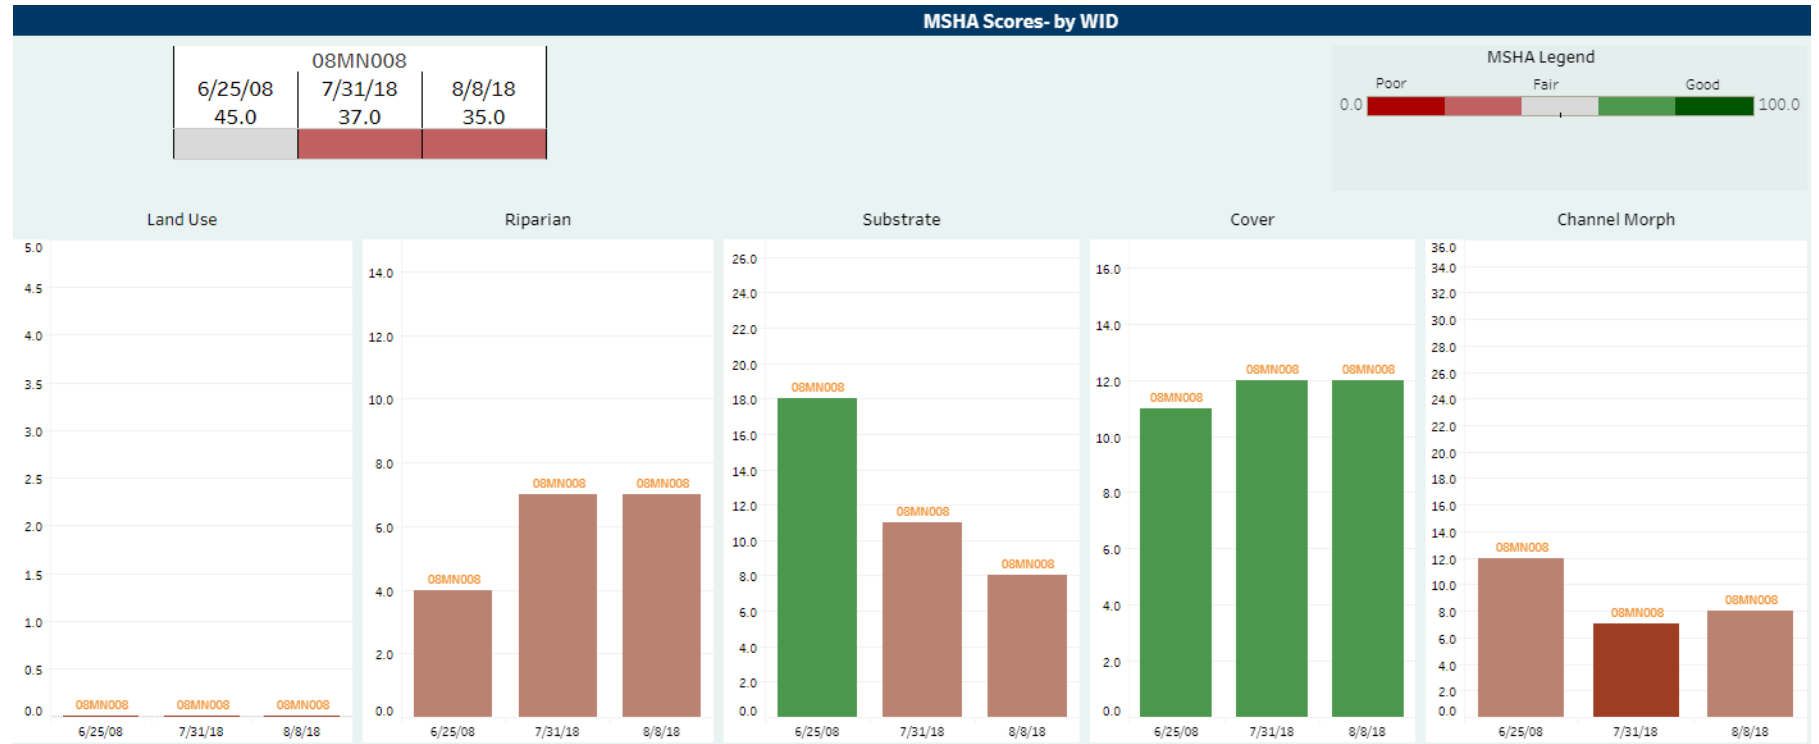
Habitat is one of the clear limitations to the macroinvertebrate community (Figure 86). While cover is rated as good, the primary source of habitat for macroinvertebrates was noted to be overhanging vegetation and aquatic macrophytes (algal mats). The substrate and overall stream stability is playing a limiting factor. This section is rated as being moderately embedded. As this stream has been altered by way of channelization for agriculture, altered hydrology is the primary driver to creating stream instability and poor habitat features.

Figure 86. MSHA scores within Providence Creek WID -650, June 2008, July 2018, and August 2018.

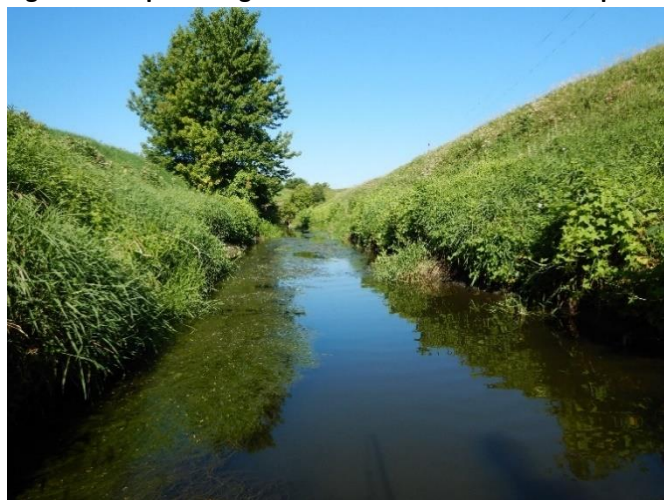
It is likely that WID -650 is eutrophic. Algae was noted in the 2018 sample (Figure 87). While chemistry samples are limited to what was collected at the time of the sample, there was one early morning reading of DO of 5.84mg/L and only 66% saturation. This would be indicative of a eutrophic stream coming out of a period of respiration. While phosphorus fell below 0.15 mg/L, nitrates were elevated at 12 mg/L. The macroinvertebrate metrics did indicate a lack of nitrate sensitive species within the sample, yet still had some nitrate sensitive taxon present. It is likely an effort to reduce nutrient inputs and stabilize the habitat would result in this impairment being delisted in time.

Figure 87. Aquatic vegetation at the time of 2018 sample at 08MN008.

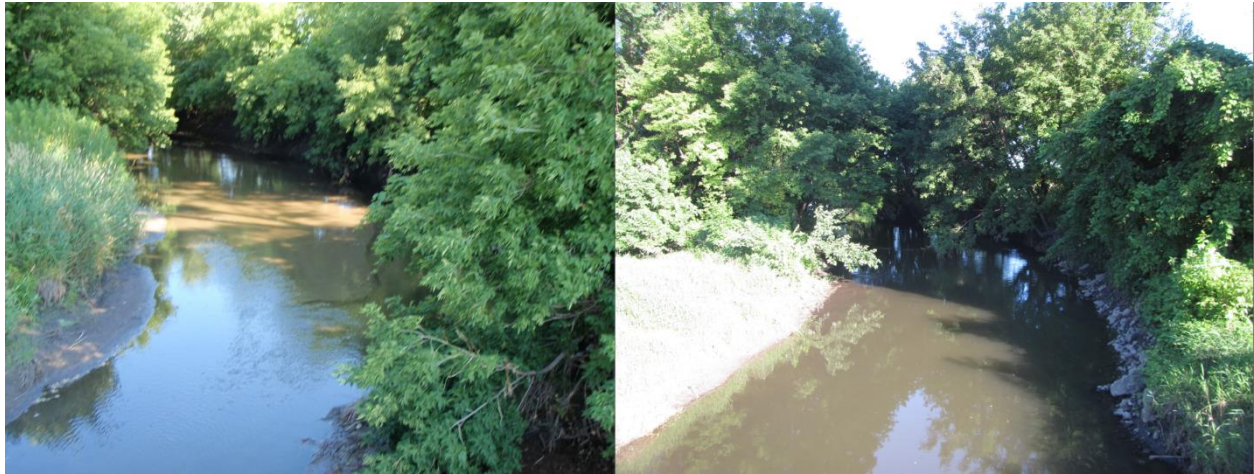
Figure 88. Monitoring conditions at 08MN002 on July 29, 2008 (right) and July 16, 2018 (left).

This section (WID -652) of County Ditch 7 is downstream of WID -591 that was found to be passing in Cycle 1. This is a modified stream due to channelization and is impaired for both fish and macroinvertebrates. One station (08MN002) was sampled in 2008 for Cycle 1 and 2018 for Cycle 2. In 2018, water levels were low and there was not adequate habitat to support collection of an invertebrate sample. It was determined that this was an unnatural condition, and the site was given an IBI score of 0. Despite a lack of data, this score looks very similar to what was found in 2008 (Figure 88), as this site received a score of 1.4. The fish sample from 2008 scored only 21.7, which is below the modified use threshold of 35. The 2018 score was similar at 22.5. Only 16 species were collected with fathead minnows being the most abundant (223 individuals), and common shiner was the next most abundant (85 individuals). As macroinvertebrates were sparse, metrics will not be of use for that community. In addition to the Aquatic Life impairment, WID -652 also has a turbidity impairment.
