October 2024

Le Sueur River Watershed Stressor Identification Update

A study of local stressors limiting the biotic communities in the Le Sueur River Watershed.

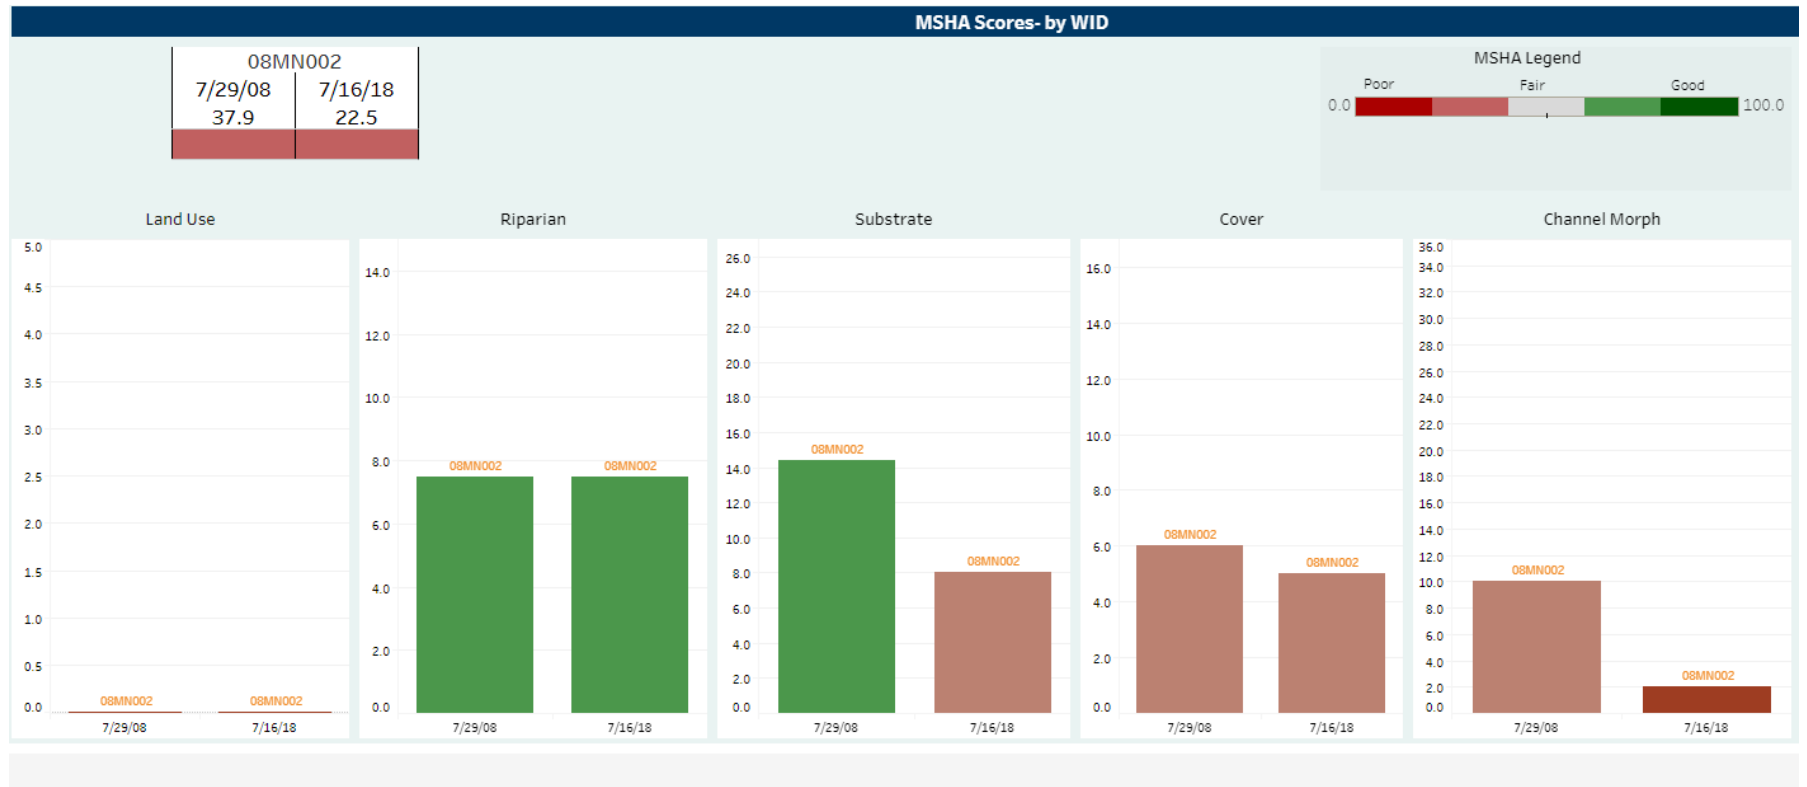
Habitat in WID -652 is the clearest limitation to biology, as it's altered conditions were the reason the second macroinvertebrate sample could not be conducted. The MSHA assessment (Figure 89) highlights the reach's poor habitat diversity and stream stability. The fish community was dominated by generally tolerant species that do not have specific habitat needs for their life cycle needs, noted in the lack of benthic insectivores, lithophilic spawners, and nest guarders. These are the same groups that would typically be displaced by TSS or turbidity. Nitrate was a parameter that was high at the time of sampling (12 mg/L). There were 13 additional samples collected for nitrates that often exceeded 10 mg/L with the highest reaching 15 mg/L. Fish metrics did indicate some nitrate displacement within the tolerance values. There was also a deformity within the 2018 sample that can be associated with high nitrate environments.

Figure 89. MSHA of County Ditch 7 on WID -652, July 2008 and July 2018.

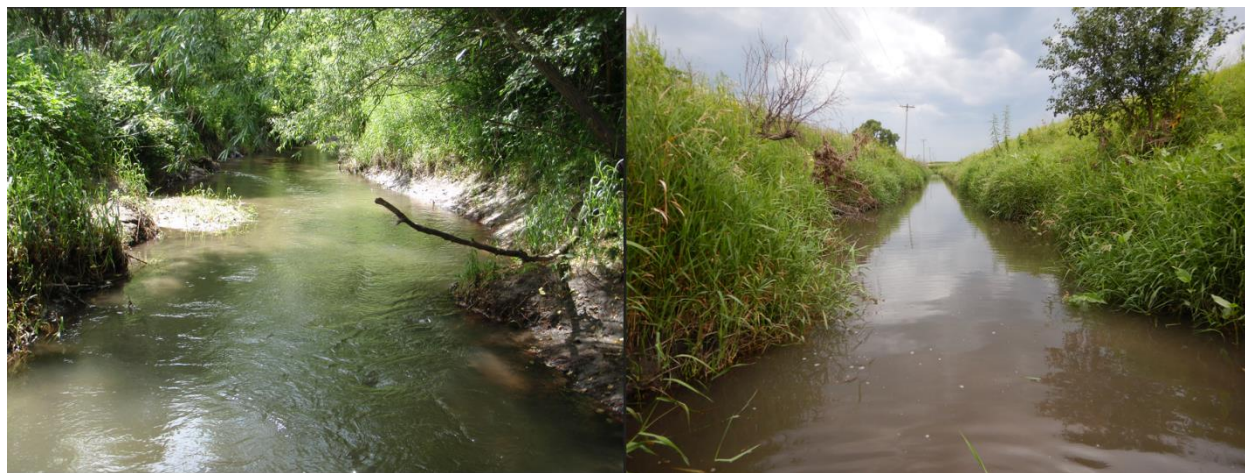
Figure 90. Conditions at the time of monitoring 08MN14 on June 25, 2008 (right) and 18MN009 on August 01, 2018.

This is the furthest upstream headwater tributary (WID -592) that leads to the Maple River, prior to the confluence of Minnesota Lake. This site has two stations: 08MN014 sampled in 2008 for Cycle 1, and 18MN009 in 2018 for Cycle 2 (Figure 90) Cycle 1 macroinvertebrates were found to be in support while the fish community was impaired. In Cycle 2, 18MN009 was a new site within WID -592. The biological sample at 18MN009 showed a greatly improved fish community. However, it was determined that the old station of 08MN014 should be sampled to ensure the delisting of the biological impairment within this WID. The status for the biological impairment is currently inconclusive for fish, therefore SID was not completed.

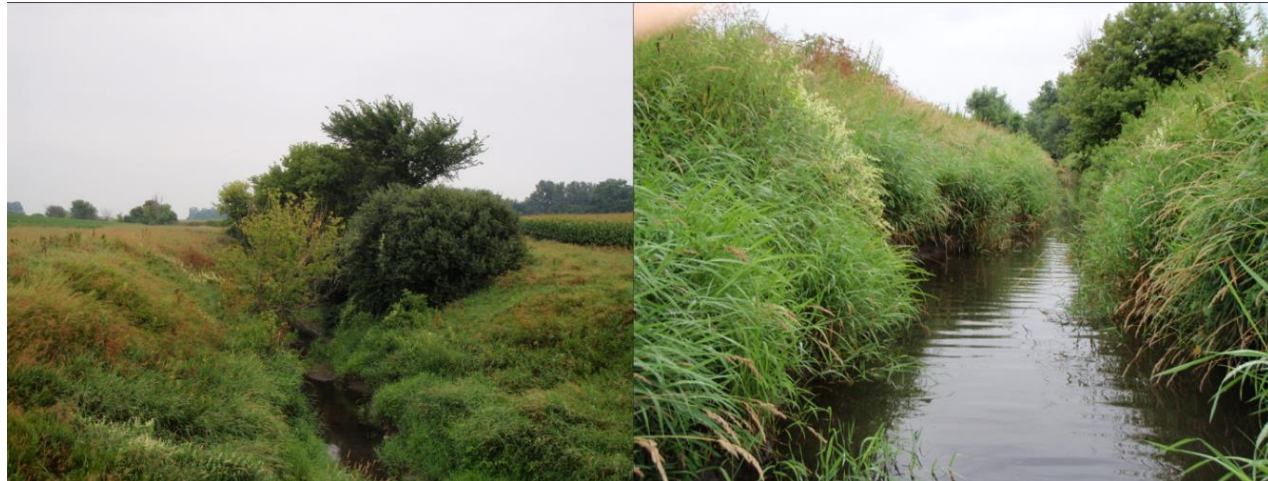
Figure 91. Conditions highlighting habitat in 08MN045 at the time of biological monitoring on August 12, 2008.

This stream (WID -590) was not assessed in Cycle 2. While there were other modified streams that passed during Cycle 1, this station stands out as the IBI score rose above most others. One invertebrate visit at one station (08MN045) was sampled in 2008 (Figure 91). This reach also has a proposed use class change to modified use, due to channelization and limited habitat. The sample scored above the modified use threshold, above the 90% confidence limit and was determined to be in full support of the modified

aquatic life use, based on the invertebrate assessment. In 2008, there were two fish visits on 08MN045 as part of Cycle 1 watershed monitoring. Both visits scored significantly above the modified use threshold and the upper CI. Additional habitat assessment and community composition determined that ecosystem function is largely maintained. There was not a second sample in Cycle 2, as this location clearly passed in Cycle 1. This stream is modified by way of channelization. However, there is enough diversity noted in the riparian area, vegetation, and meandering of the stream that is likely allowing species to thrive at this location.

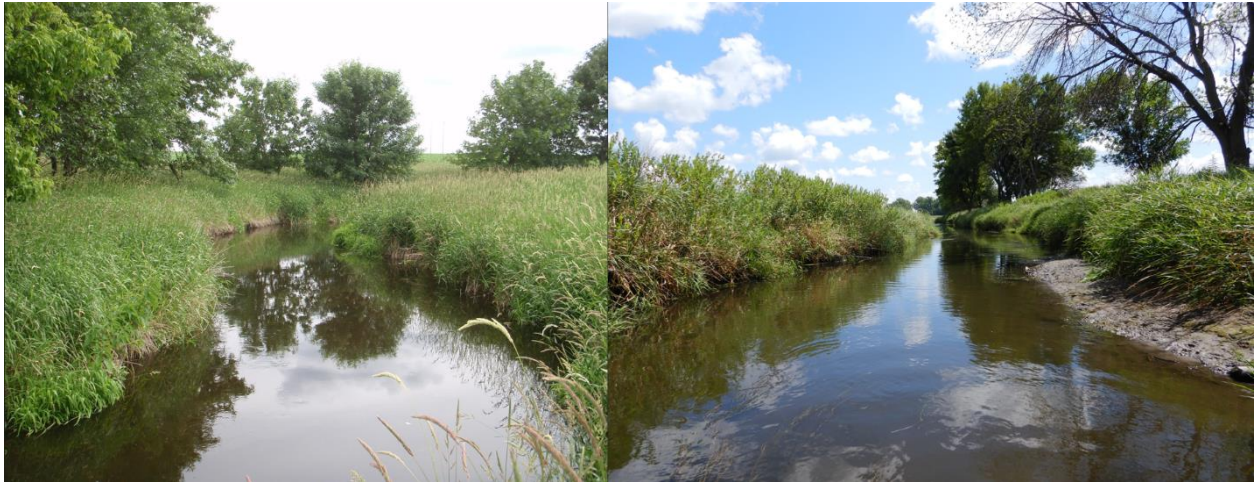
Figure 93. Monitoring conditions at 08MN009 on June 23, 2008 (right) and July 31, 2018 (left).

This tributary (WID -589) leads into the mainstem of Rice Creek from Rice Lake. There is one biological monitoring station 08MN009 (Figure 93) that was sampled once in 2008 for Cycle 1 and once in 2018 for the Cycle 2 watershed assessment. In both sample periods, macroinvertebrate samples highlighted a poor community made up completely of tolerant individuals, with very low diversity. The IBI score from the fish sample in 2008 was 34 out of 55. The 2018 sample scored a similarly at 36.7. The 2018 fish sample had less diversity than the 2008 sample with only six species.

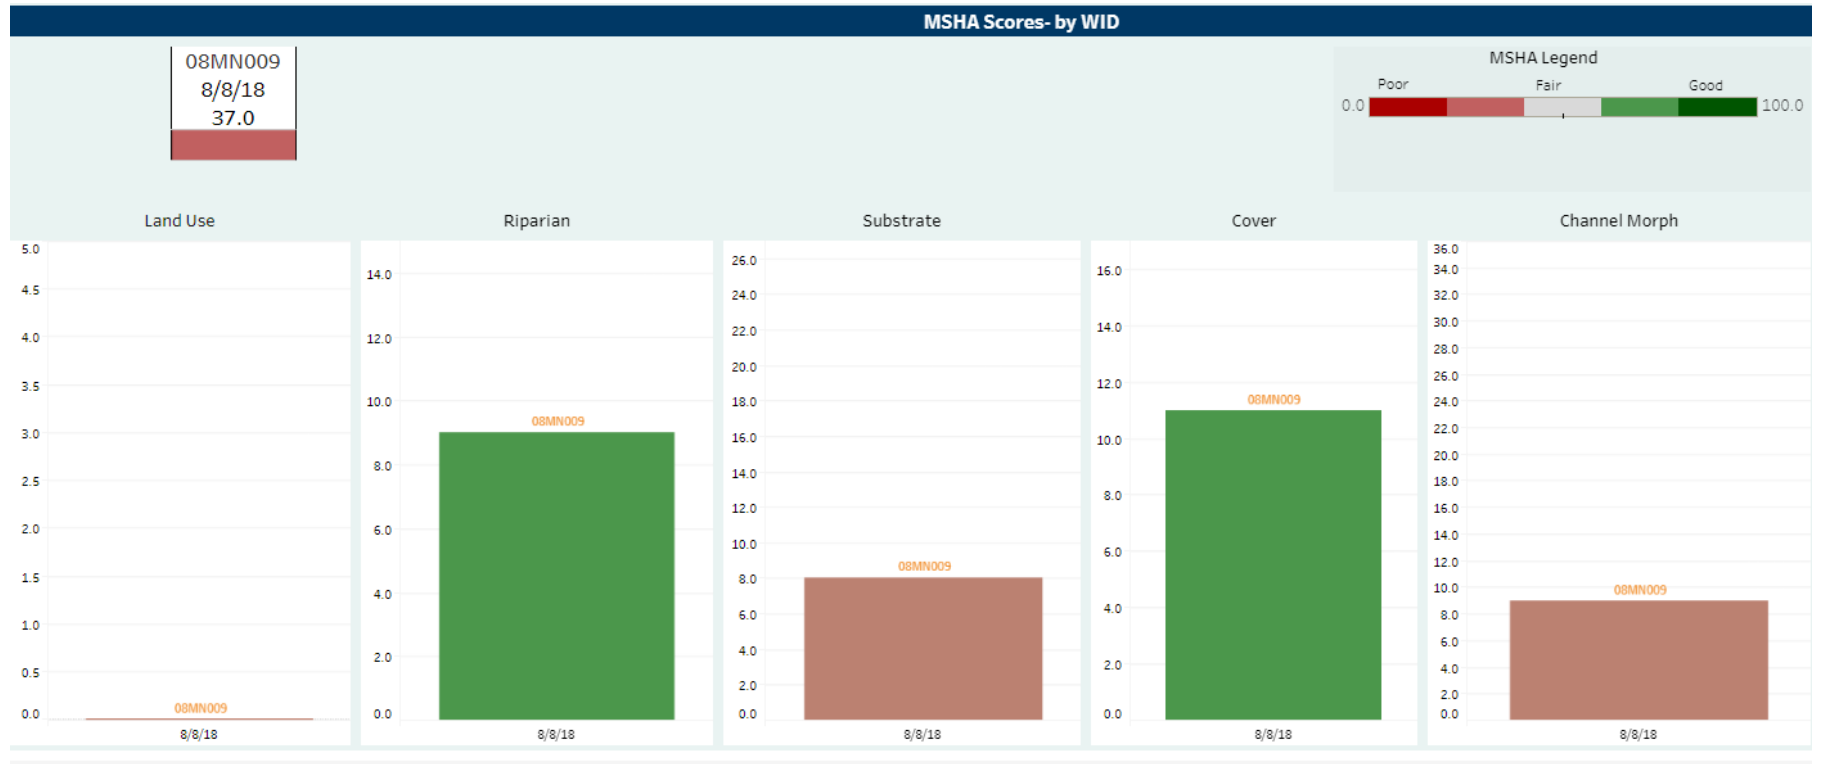
The macroinvertebrate community highlighted displacement in species sensitive to eutrophication, DO, and nitrate. In addition, water chemistry data was collected in 2010 at one downstream station. All collected DO data points fell below the standard of 5 mg/L with the lowest recorded at 0.74 mg/L at 7:48 am. In addition, phosphorus values were at times double the South River Nutrient Region standard (0.15 mg/L). Nitrate concentrations were also elevated falling just under 10 mg/L. While fish metrics were limited as there was a lack in species diversity to measure, habitat showed the largest impact when looking at tolerance scores. Figure 94 below highlights poor instream habitat. The available instream habitat was homogenous, with silt making up much of the stream bed substrate.

Figure 94. MSHA scores in WID -589 within Rice Creek, August 2018.

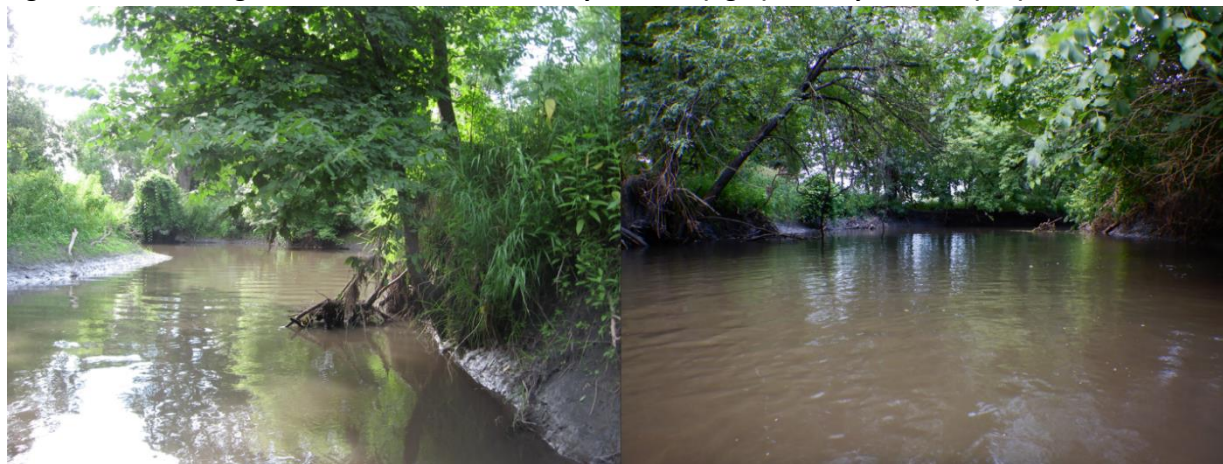
Figure 95. Monitoring conditions at 08MN004 on July 23, 2008 (right) and July 15, 2019 (left).

The mainstem of Rice Creek (WID -669) is one of the longest reaches within the Le Sueur River Watershed. There is a total of six monitoring stations (03MN067, 08MN004, 08MN010, 08MN076, 08MN086, 18MN001), sampled a total of seven times between 2003 and 2018. The only station visited twice was 08MN004, which was sampled in 2008 and 2018 (Figure 95). This station was previously assessed in 2012 and found to be nonsupporting for aquatic life. Current macroinvertebrate data appears somewhat improved, but still shows an overall impaired condition. 08MN004 is the only station that scored above the threshold in both cycle assessments. This site is also the furthest downstream station in the WID. All other stations scored below the threshold. Due to questionable data timed with varying flows at some stations at the time of fish sampling, the status of the fish community was inconclusive. While the status of the fish impairment cannot be listed as passing or failing, some of the fish data may still be used to evaluate or additionally support indications of stressors to the macroinvertebrate community. This stream does have an impairment for turbidity.

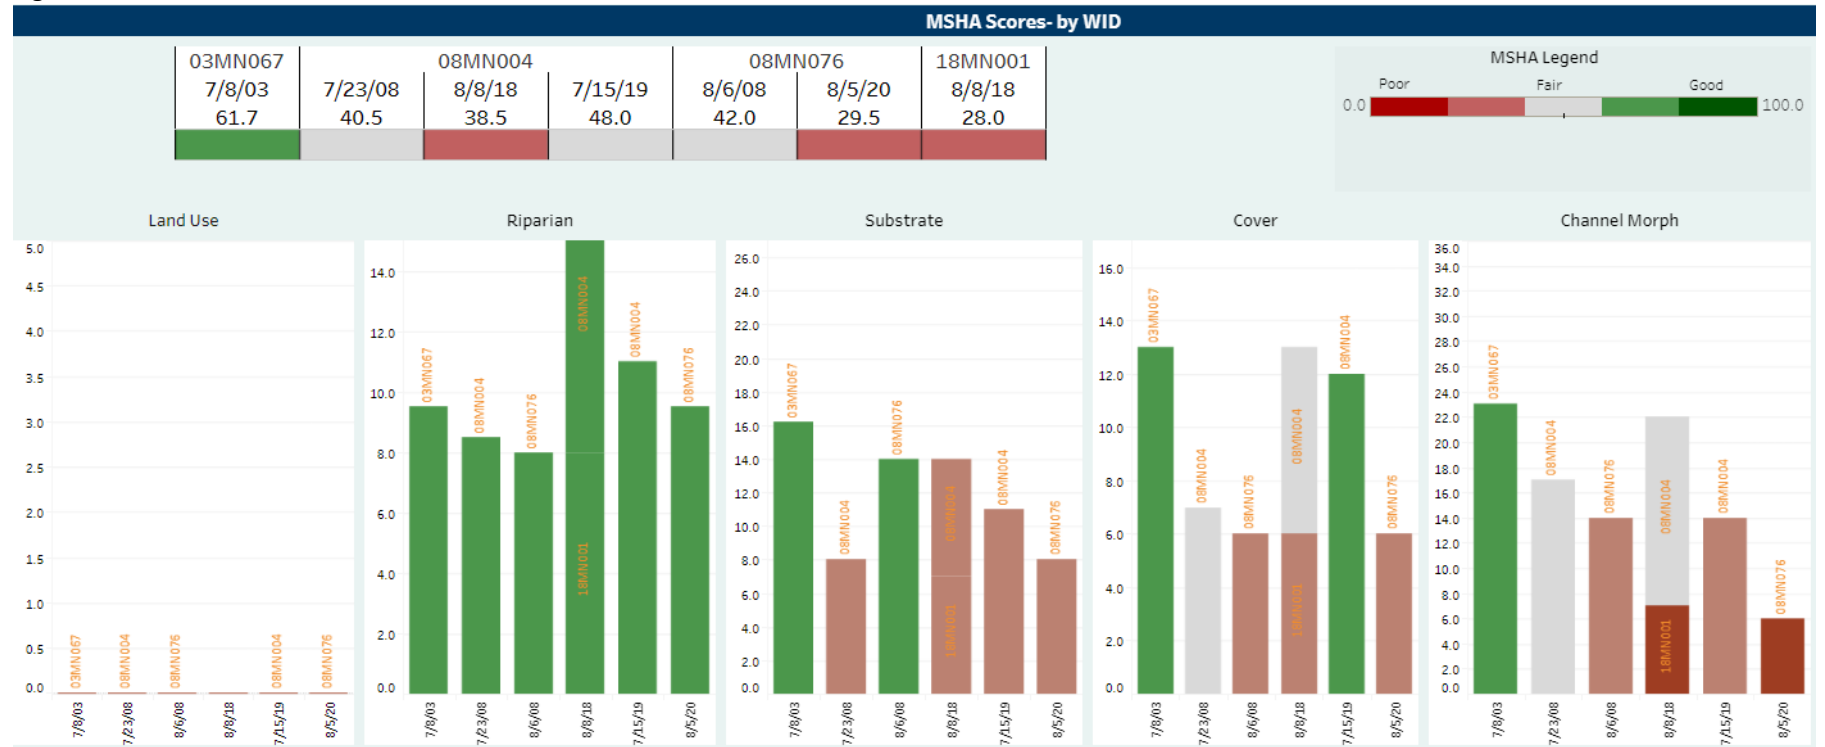
Habitat generally improves the further downstream monitoring sites are, apart from the penultimate station of 03MN067 that scored best for habitat availability. Overall, stations that were sampled multiple times scored consistently to what had been surveyed years prior (Figure 96). Channel stability and substrate seemed to have the poorest scores. This would be consistent with signals of TSS impacts and stream impairment for turbidity. Taxa tolerant and very tolerant to nitrate seemed to increase over the years and made up a large percentage of some of the macroinvertebrates sampled. TSS, habitat instability, and nitrate all are driven by altered hydrology as the headwater's contributing streams are all channelized and nearby land use is dominantly row crop fields.

Figure 96. MSHA scores from all sites across time on Rice Creek WID -669.
