April 2020

Upper St. Croix River Watershed Stressor Identification Report

Assessment of stress factors affecting aquatic biological communities of streams in the Upper St. Croix River Watershed.

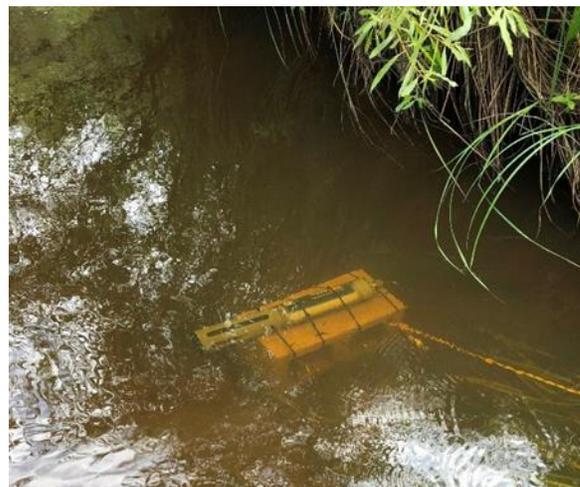
Image: Deployed continuous monitoring probe.

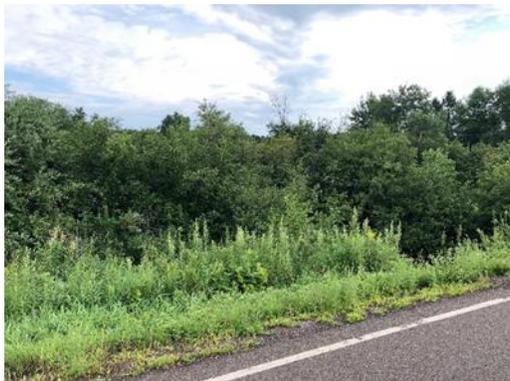
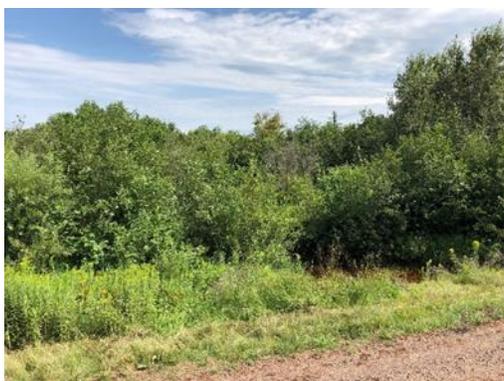
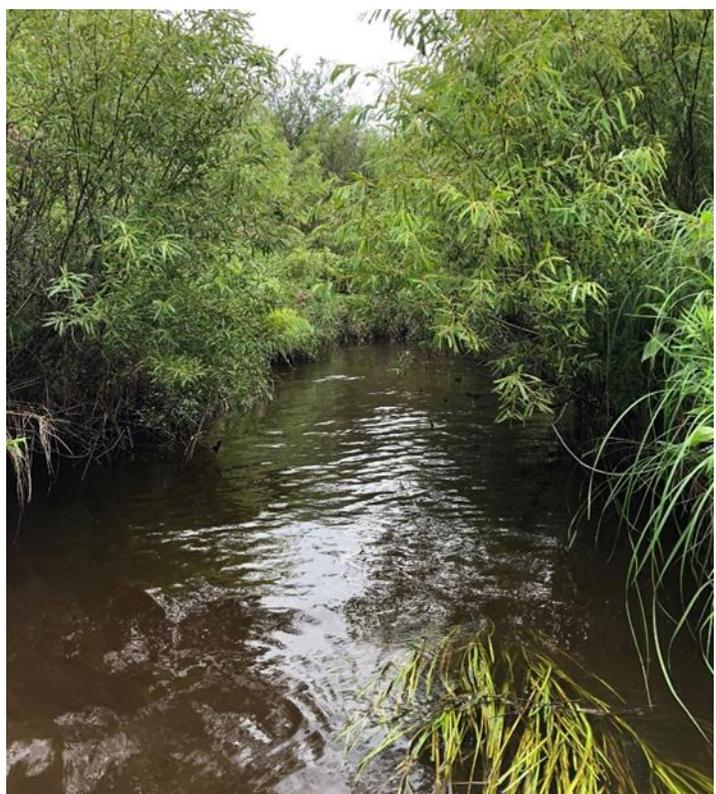
Images: Common wetland (shrub carr) community habitats along Hay, Sand, and Wolf Creeks assessed using RFQA sampling methodology.

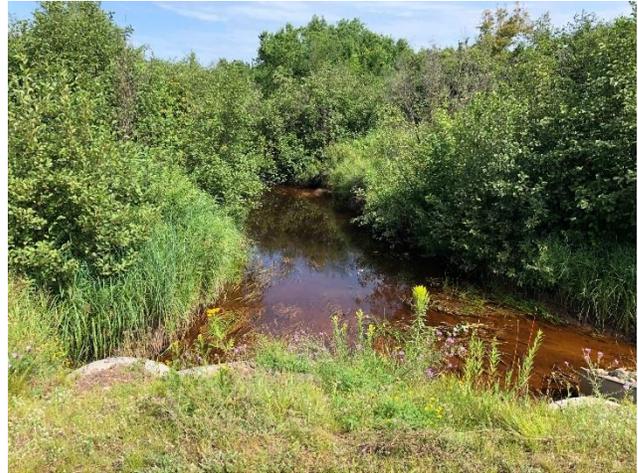
Figure 18. Biotic sampling stations, impaired stream reach and land cover class as determined by the NLCD 2011 within Wolf Creek subwatershed.

Impairment: Lower Sand Creek (Figure 18) is classified as a coldwater stream (2A designation) and was therefore assessed using coldwater IBIs to determine the health of the biotic (fish and macroinvertebrate) communities. The upstream section of Sand Creek (07030001-538) has not been sampled for biota and is classified as a warmwater reach (2B designation). Sand Creek Reach 604 was assessed as having non-support of general aquatic life based on the fish community.

Most of the land within the Sand Creek subwatershed is wetland or forested (Figure 18 and Table 28). The forest that persists is predominantly deciduous while wetlands include wooded, marsh, and bog types. Land cover types throughout the uplands are primarily forest with some hay/pasture lands. There is minimal cultivated crop agriculture or developed areas (~1% of watershed) within the Sand Creek watershed. Visual inspection using recent air photos of the cropland areas shown in Figure 18 suggests many of these areas are currently not in production. The reach upstream (07030001-538) of the impaired reach was straightened, as was the full length of the impaired reach, with further review provided in later sections.

There are three road/private crossings along the Sand Creek impaired reach and upstream of the impaired reach: Starch Road, Sand Creek Road, and one private road crossing (Figure 18). Two of these crossings (Starch Road and Sand Creek Road) were assessed for fish passage by the DNR as part of the 2017 culvert inventory report (DNR 2017). None of the assessed crossing were identified by the DNR as high priority connectivity barriers. Culverts at the Sand Creek Road do not appear to be undersized, but may have been in the past (Figure 24). There is a large scour pool on the downstream side of this road crossing. These pools have the potential to slow the flow of water, increase temperature, and lower dissolved oxygen. No notes or information was available regarding the private crossing near the headwaters of Sand Creek.
