April 2020

Kettle River Watershed Stressor Identification Report

Assessment of stress factors affecting aquatic biological communities and other aspects of streams and lakes

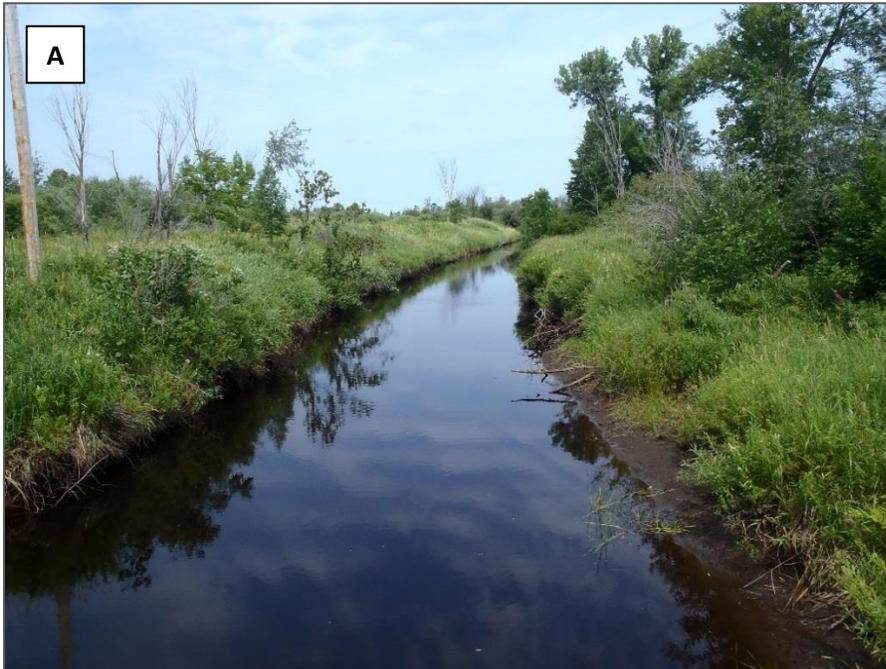
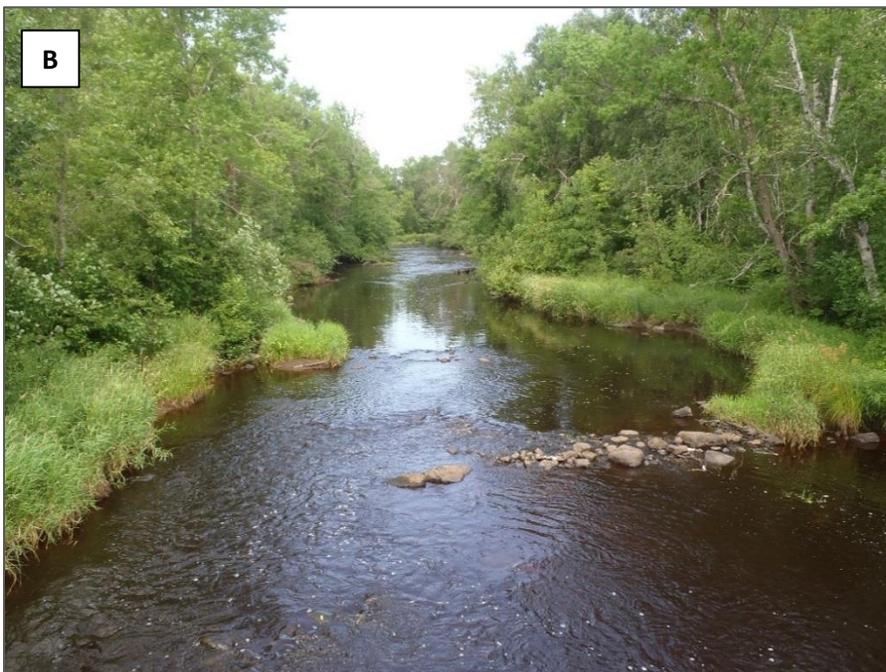
Photo 1. Habitat differences along AUID-511. Photo A is at the site (16SC043) with an impaired fish community, while photo B is about 4 miles farther downstream (at CR-156, 96SC085), where the biological communities were excellent at a previous sampling (1996); the fish scored far above the exceptional use threshold and the macroinvertebrates also scored beyond their exceptional use threshold here.

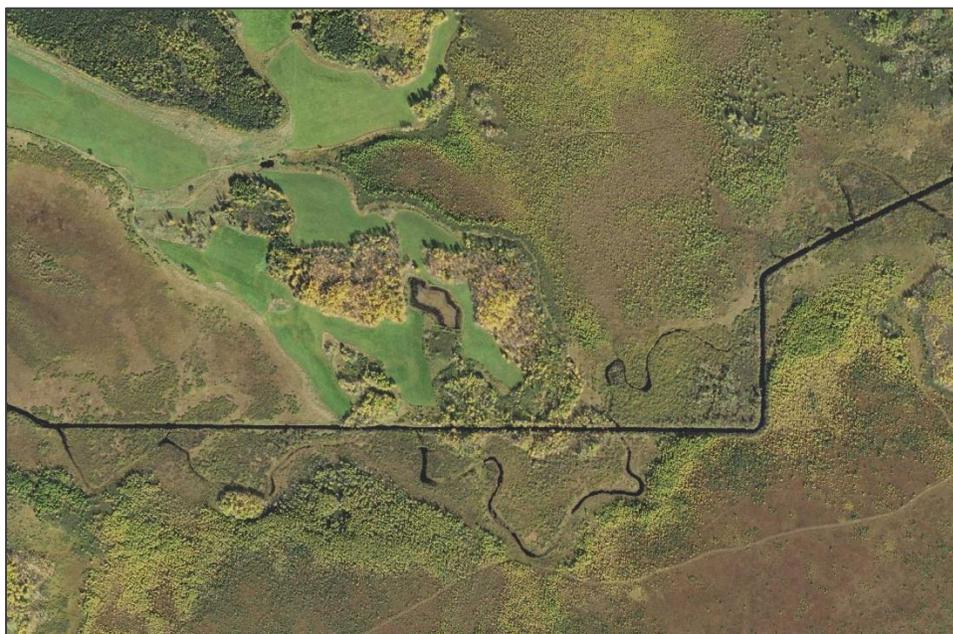
Figure 11. Example location where re-meandering could be accomplished to improve habitat and naturalize hydrology. This site is just west of Kettle Lake. The ditch spoil piles are still present and could be pushed back into the ditch to cause water to flow again in the original stream channel.

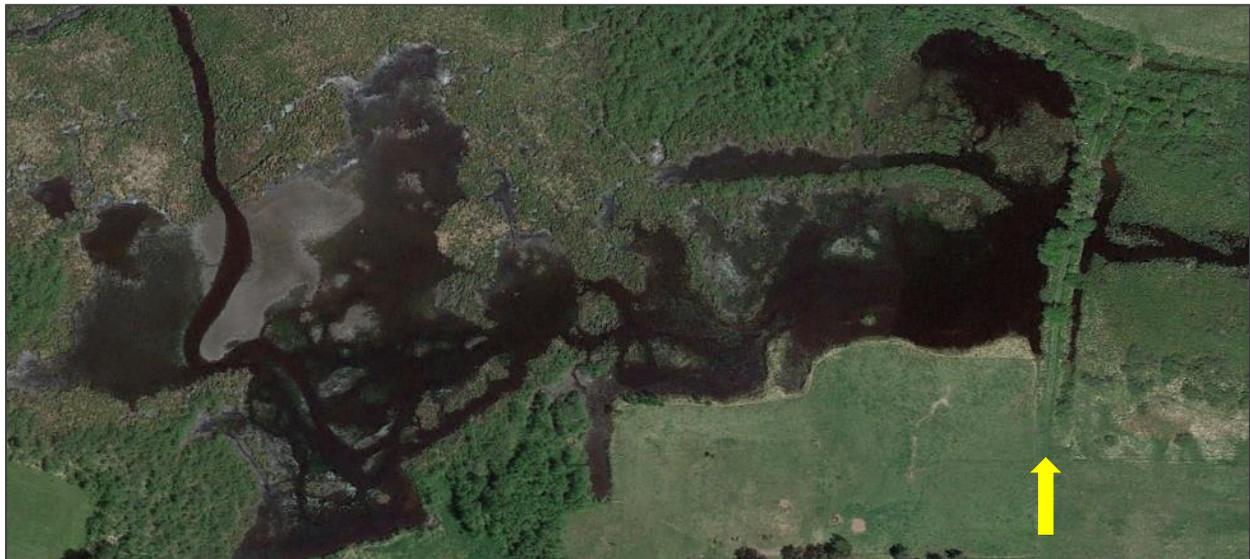
Figure 21. Impoundment caused by a private road crossing. Arrow points to the road.

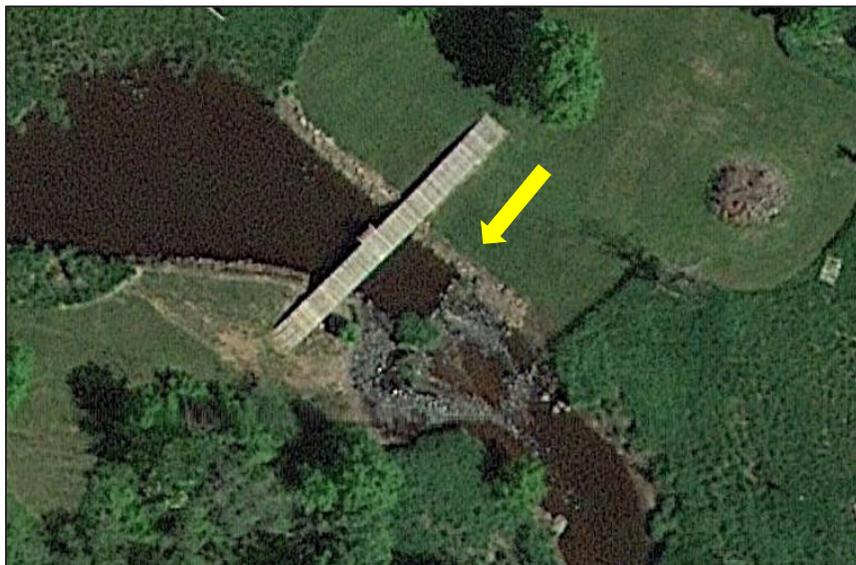
Figure 22. Possible stream modification that may be a barrier. This site is located about 0.35 miles upstream of CSAH-17.

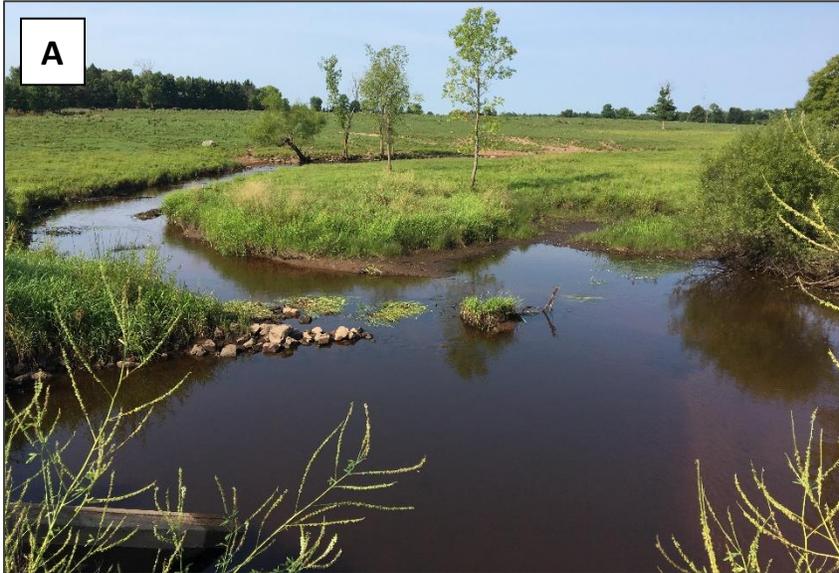
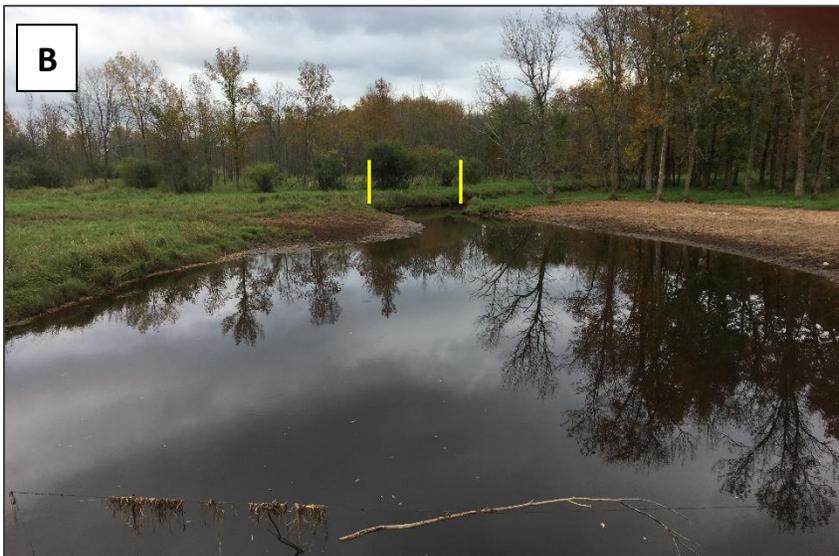
Photo 2. Example of local, over-widened areas. A. Upstream side of culverts on CSAH-17 (Fox Road) B. Downstream side of culverts on CSAH-17 (Fox Rd.). The yellow bars show the natural stream channel width. A heavily used cattle crossing exists here, and along with the current design of the culverts, factor into the creation of this large pool.

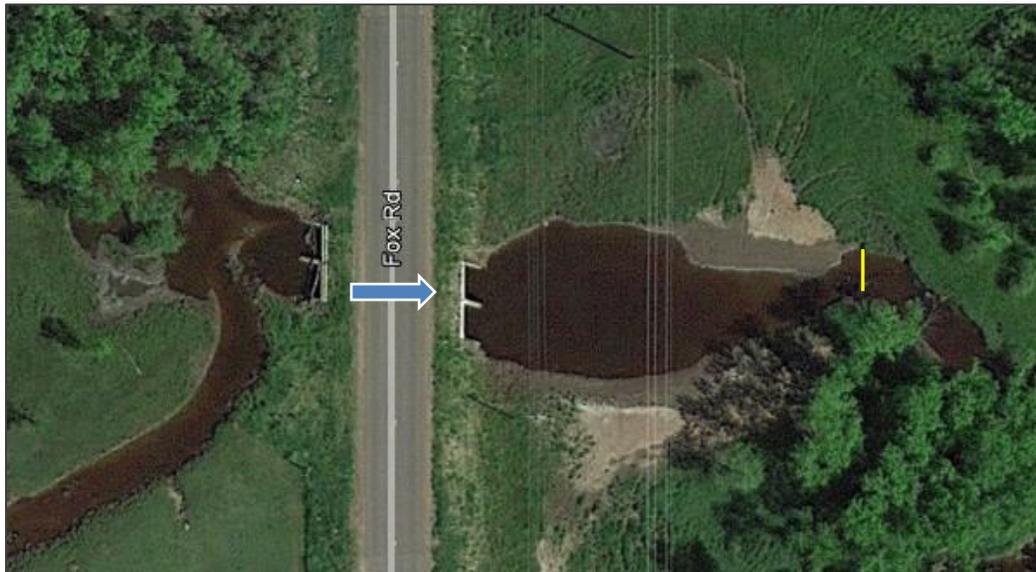
Figure 23. Aerial view of the pools shown in Photo 2. The yellow bar corresponds to the location of the width measurement shown in Photo 2(B). Arrow shows flow direction.

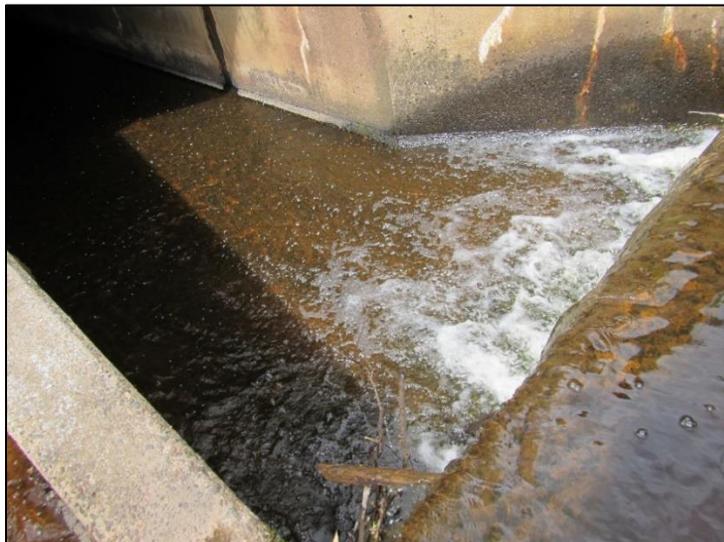
Photo 3. Cement drop structure at top of culvert that runs under I-35, a complete barrier to fish migration moving up from downstream.

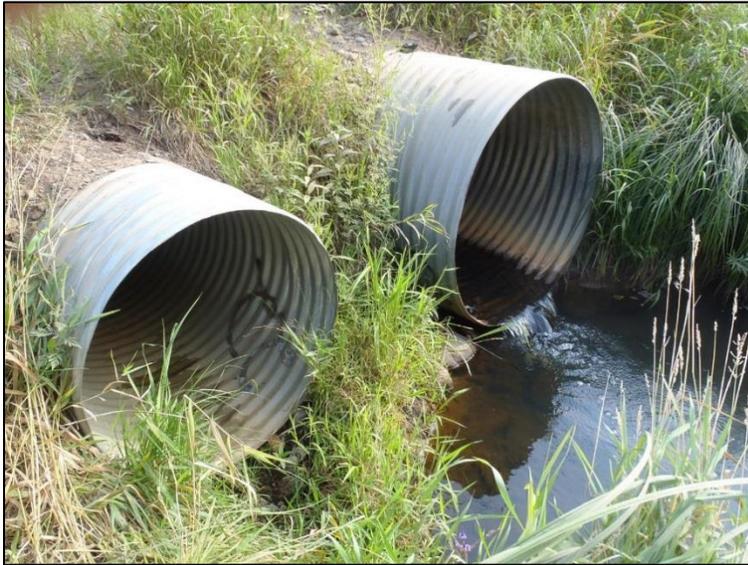
Photo 4. Perched culverts (downstream side) at Old Government Road on Spring Creek, just upstream of biological monitoring site 10SC001. Both culverts are several inches above the August 16, 2018 water level.

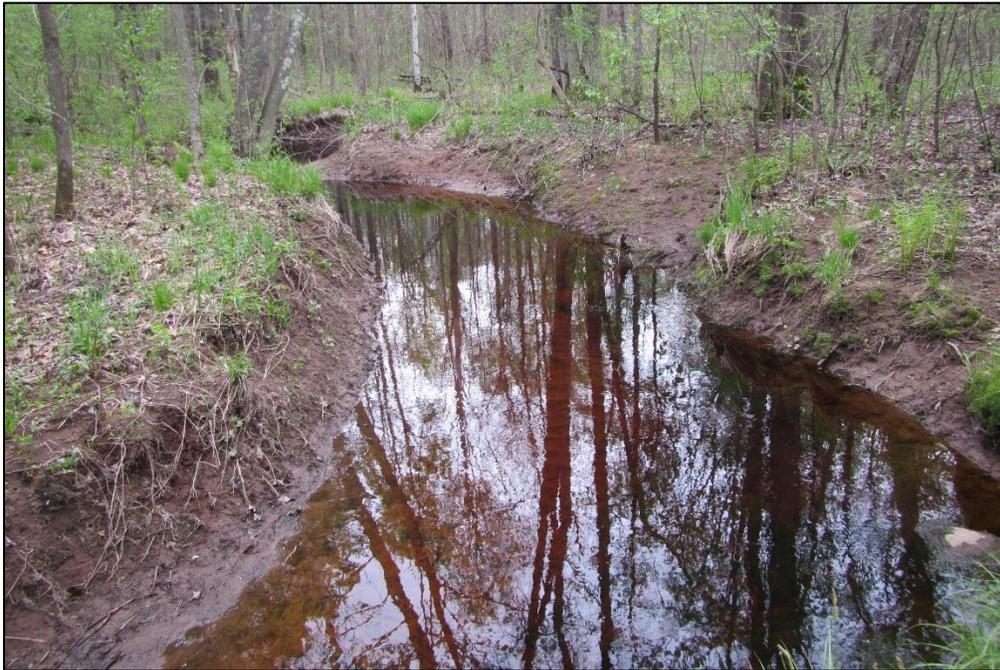
Signs are evident that the channel has and is experiencing instability due to altered hydrology and that damage to the physical channel has occurred (incision and overwidening). Photos taken during the biological monitoring visits show the channel having relatively high, raw vertical banks (Photo 5), and there appears to be significant movement of sand on the streambed (wavy dunes).

Photo 5. The AUID-617 channel within the biological sampling reach. The stream is in its natural channel here (i.e., not ditched). The channel shows signs of instability; raw banks, apparent incision, overwidening, and excessive bedded fine sediment.

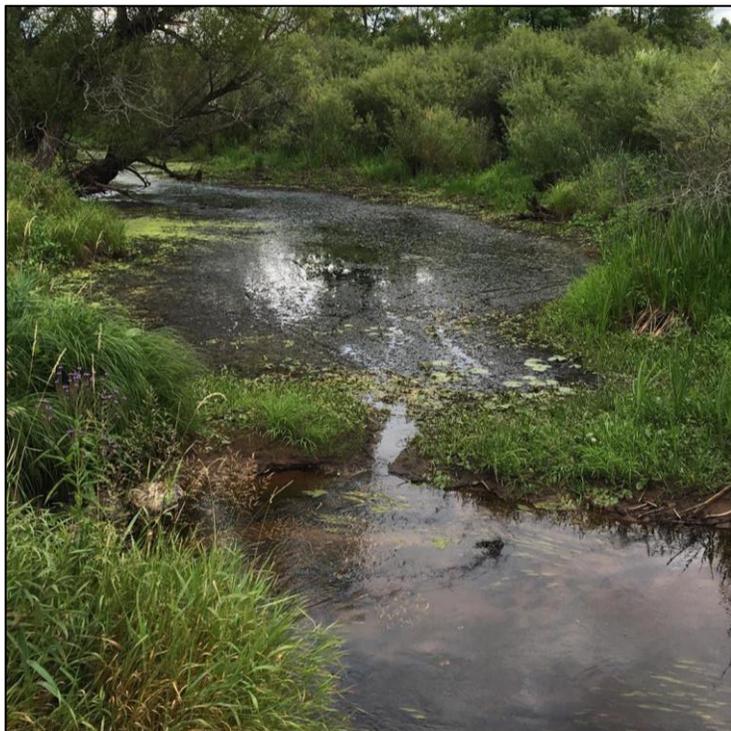
Riparian wetlands are likely playing a significant effect in the DO regime. During high water periods, these wetlands are draining water to the stream. Since wetlands are areas of significant plant decay, they often have low DO levels. When they are contributing significant water to the stream, the DO levels in the stream decrease. This likely explains why the DO is better at lower water levels (see Photo 6). From a combination of the flow patterns and DO concentrations from 2016 (Figure 39) and 2018 (Table 59 - site 5), a hypothesis might be that DO becomes temporarily low a few days after a mid-summer, large precipitation event.

Photo 6. This riparian wetland area (likely an oxbow) is contributing very little water to the river when flows are low. This wetland has been observed to be very connected to the stream at higher flow volumes. The yellow line is the edge of the stream channel and the arrow shows flow direction.

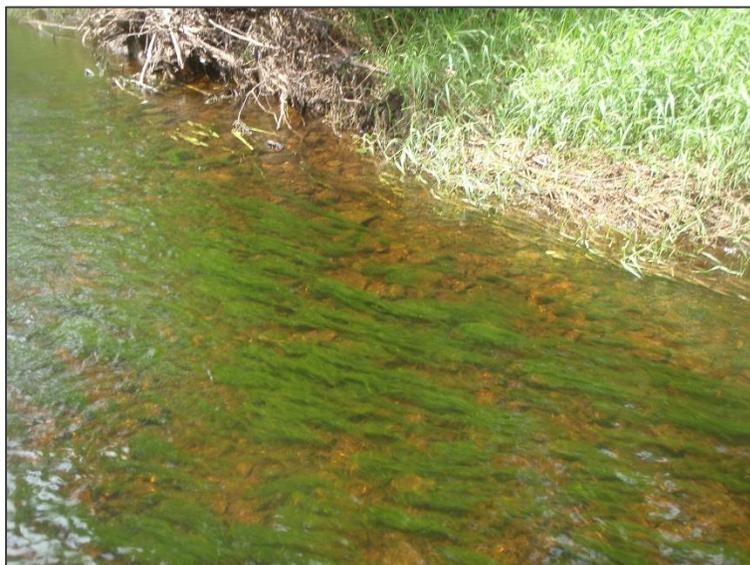
Both of the TP samples were at relatively healthy levels, though at a more heavily monitored site between the two biological sites, the average TP concentration is fairly close to the northern eutrophication standard (Table 61). The levels as measured should not be a significant problem or cause eutrophication, particularly since nitrate concentrations are extremely low. In 2016, fairly abundant filamentous algae were present (Photo 7). During SID work in 2018 and 2019, very little filamentous algae was observed during multiple visits to various locations on the two AUIDs discussed here. At the lower two sites visited for longitudinal monitoring (5 and 6 on Figure 38), on August 14, 2019, it appeared there was a thin layer of periphyton (algae or diatoms) growing on the sand substrate of the riverbed.

Photo 7. August 16, 2016 photo of algal growth taken at the biological site 16SC011.

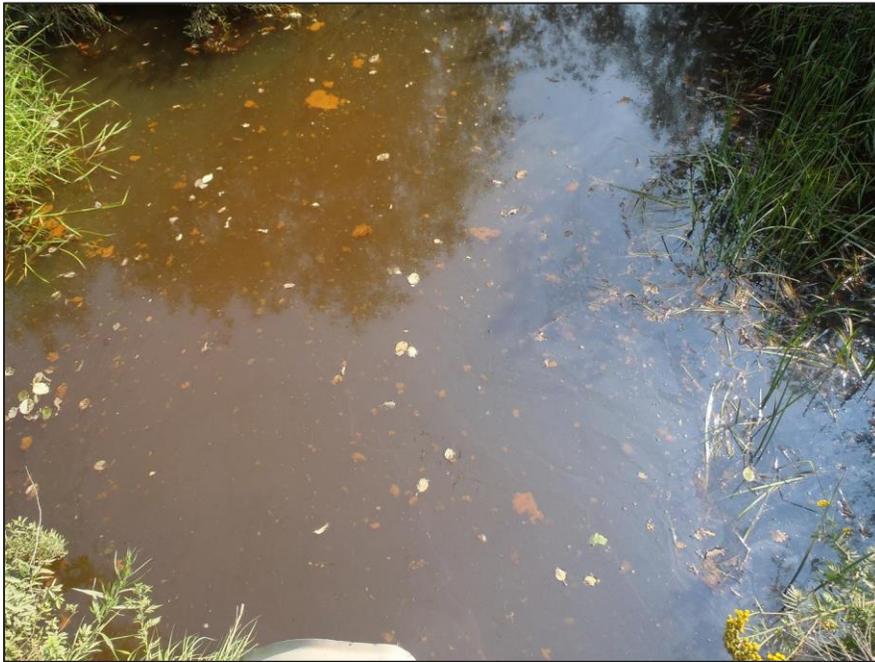
On two of the three dates sampled, the water was very clear (Table 75). The TSS concentrations on these two dates was very low, with most or all of it being organic particles. The August 4 observation was somewhat turbid. The water levels were much higher on this visit and flow was more turbulent based on review of biological sampling photos. No TSS was collected on August 4. A visit on August 23, 2018 found the water to be a fairly opaque orange color due to colloidal iron particles (Photo 8). This same situation has been found by the author in numerous streams fed by groundwater that interacts with organic riparian soils, and observed at this particular time of the summer. This opaque orange color was also observed at the adjacent headwater areas of the Willow and Little Willow Rivers in August 2018.

Photo 8. Larsen Creek, August 23, 2018. Water was a semi-opaque orange color with chunks of floating iron floc. An organic oil sheen can be seen on the water surface in the right half of the photo.

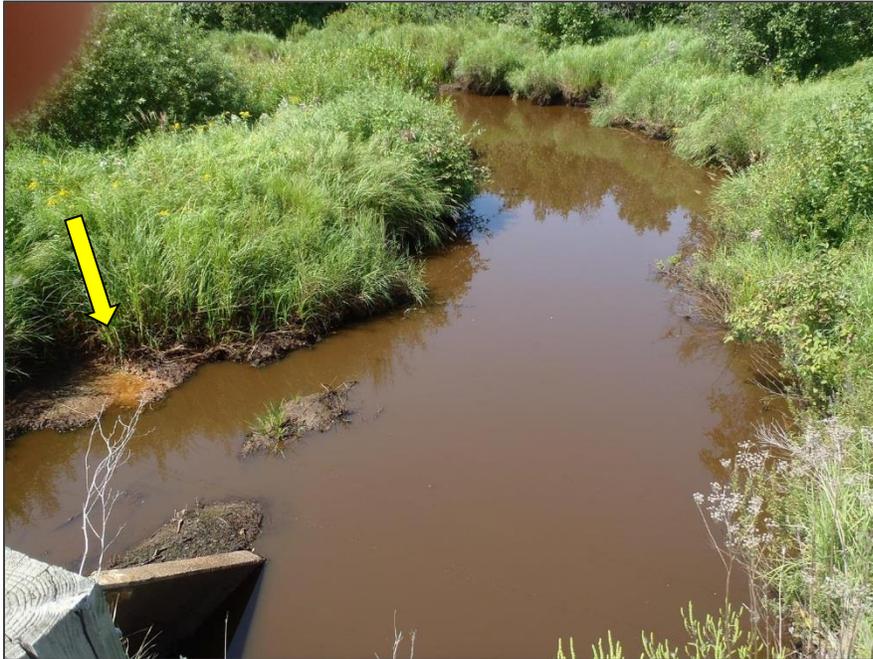
Reason: The author has found numerous locations across northern Minnesota where small streams are orange in color, and sampling has shown the reason to be very high iron content, with the source of the iron being from groundwater inputs to the stream. This same phenomenon was observed while doing fieldwork in the KRW in a few locations (Photo 9). It generally occurs where streams flow through peatlands, as is the case here. This is a natural condition that develops in summer, and might concern citizens thinking that there is something very wrong with the stream's water quality.

Photo 9. Little Willow River at State Highway 23 on August 16, 2018, showing the very turbid orange color of the water. The arrow points to a groundwater seep with iron floc.

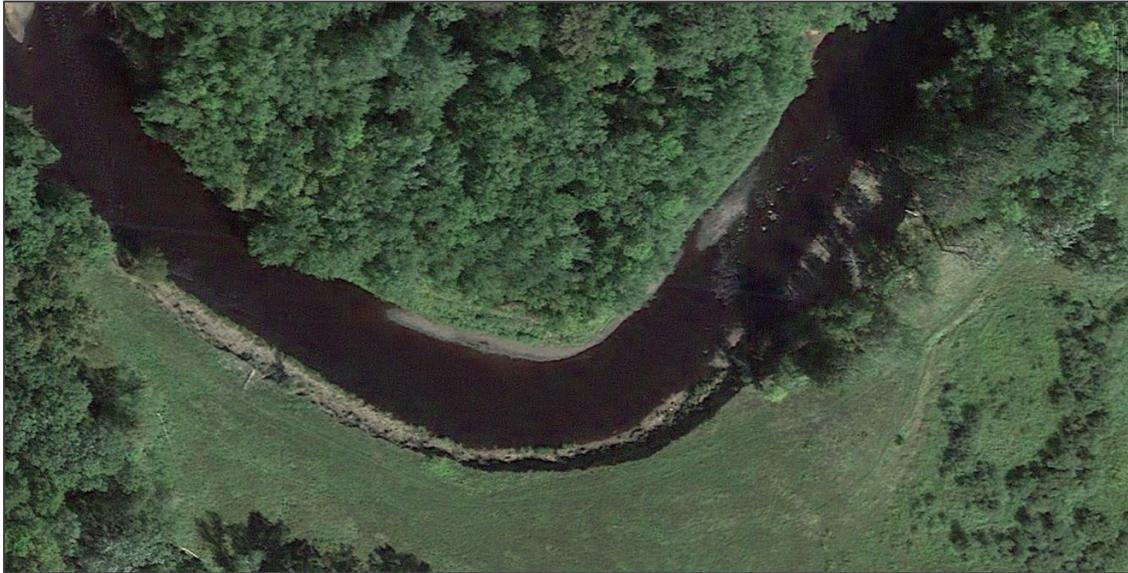
In areas where streams and rivers become larger, their shoreline areas become attractive for residential or recreational development, much like occurs on lakes. Property owners generally like to be able to see the river from their homes and thus alter the natural riparian vegetation significantly. This can make the riverbank much less resilient to erosion, as deeper root structure from woody plants is lost and often replaced with lawn grasses with very shallow root systems that do not protect and hold the bank soils well. Not all bank erosion situations can be blamed on this situation, but it is extremely common (Figure 41, 42, and 43). Keeping the riparian and bank vegetation in their natural, wooded state will prevent bank erosion (and loss of property) and the sediment input to the stream channel that harms aquatic habitat.

Figure 41. This location on the Kettle River shows erosion of a bank where woody vegetation has been removed for a pasture. The landowner here is losing property due to erosion of the unprotected bank.

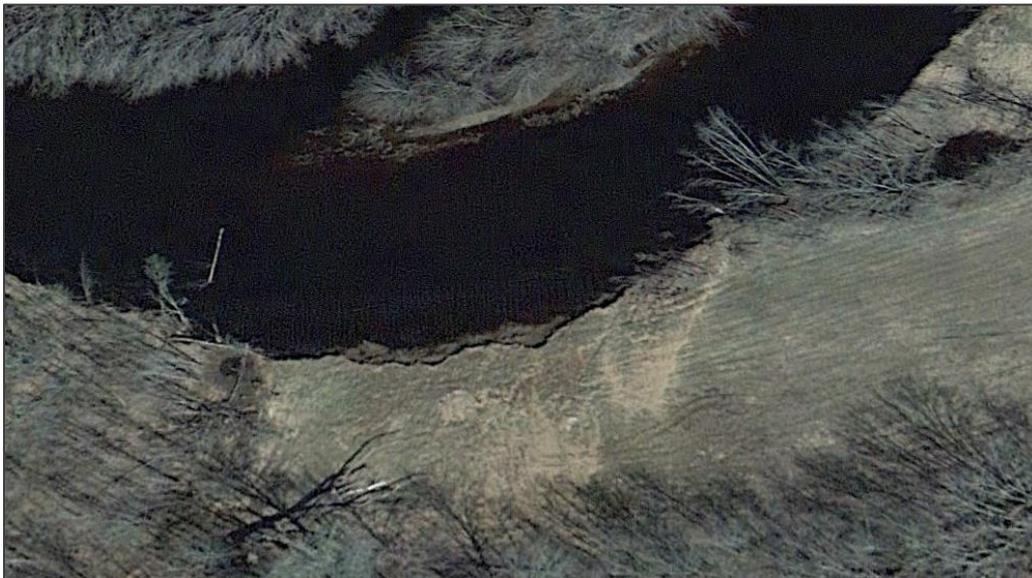
Figure 42. Local area of bank erosion where woody bank vegetation has been removed and replaced with grasses.

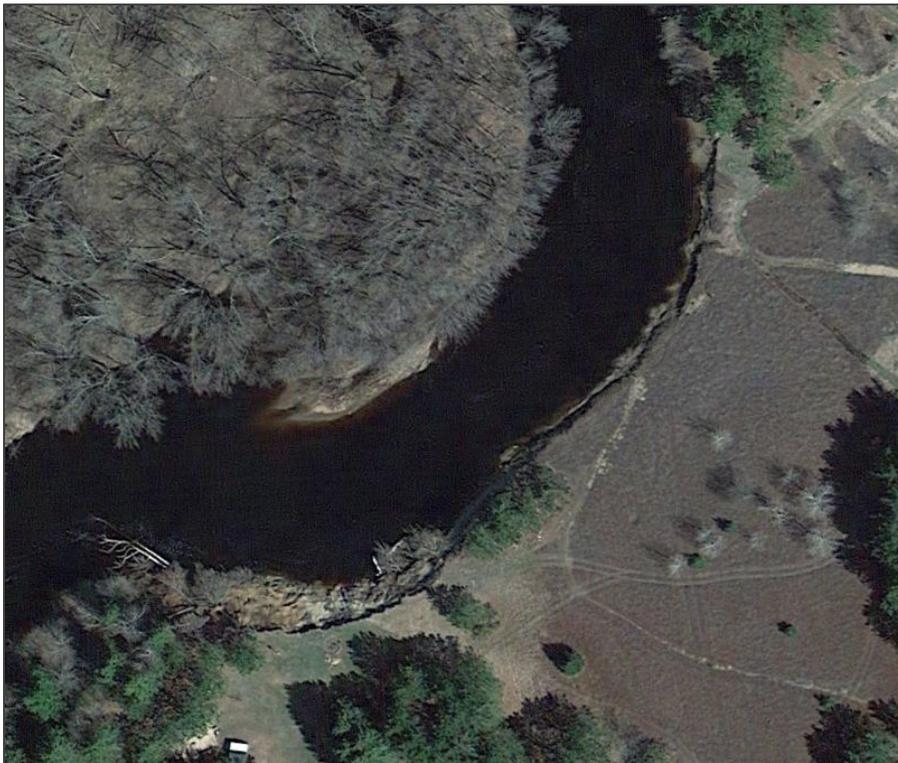
Figure 43. Bank erosion all along the outside bend where trees have been cleared and replaced with grasses, which have far less capability of providing erosion resistance to the riverbank.
