Mississippi River-LaCrescent Stressor Identification Report

A study of local stressors limiting the biotic communities in the Mississippi River –LaCrescent Watershed

Document number: wq-ws5-07040006a

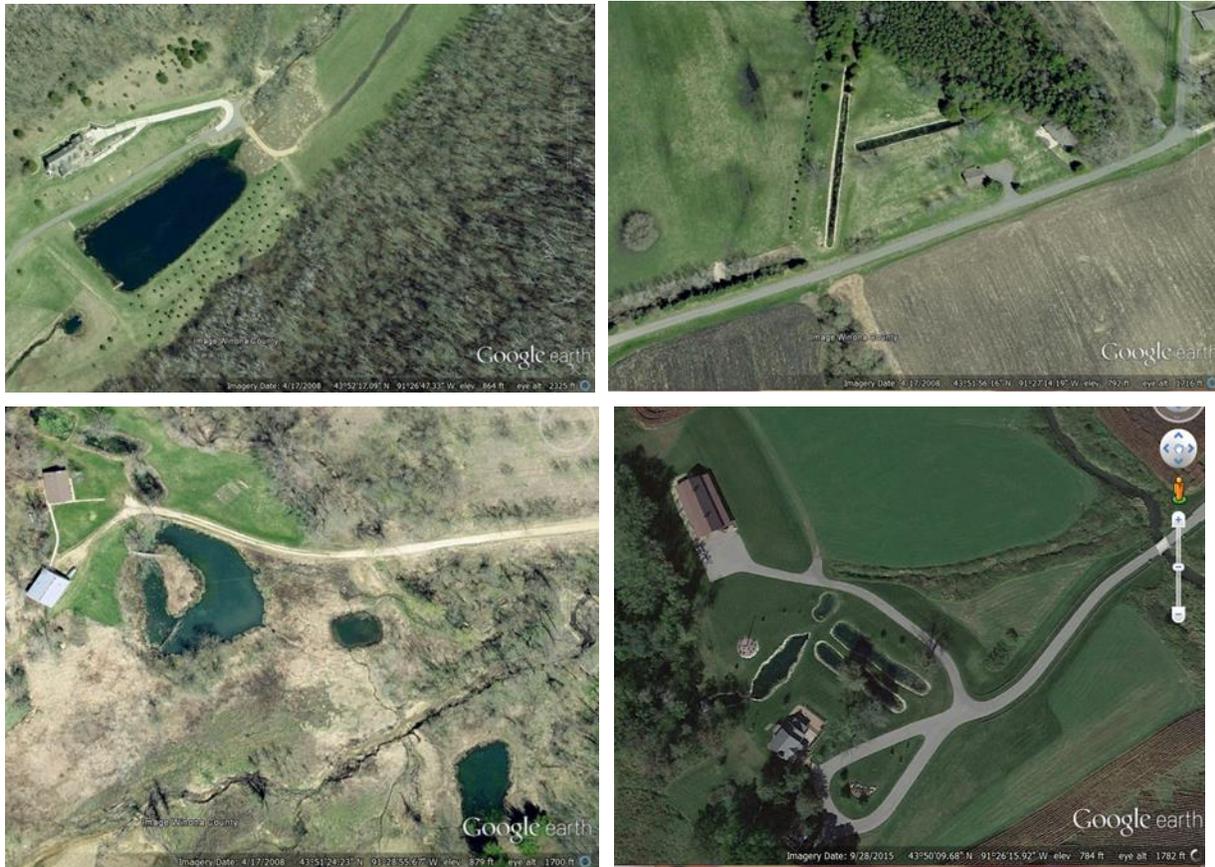
Figure 7. Aerial photos of spring/tributary ponds between 15LM041 (New Hartford) and 15LM040 (CR16). Google Earth (2008, 2015).

Downstream of 15LM040 there are some significant coldwater tributaries (Rose Valley, Burns Valley, and Lanes Valley) which likely provide some thermal buffering in the lower reaches before 15LM043. Temperature measured in those tributaries, compared to Pine Creek, are all considerably lower. Increased shading of the stream in the area downstream of 15LM040 is also a likely contributor to a less dramatic temperature increase in this section.

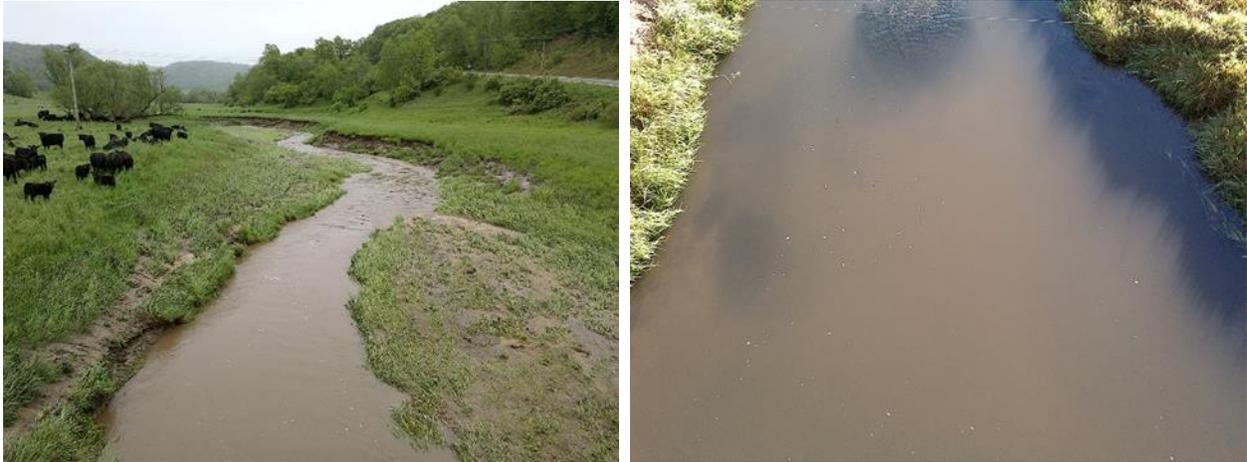
Figure 8. Monitoring station 15LM040 at CR16; May 18 2017 (left) and October 4,2017 (right) showing turbid water.

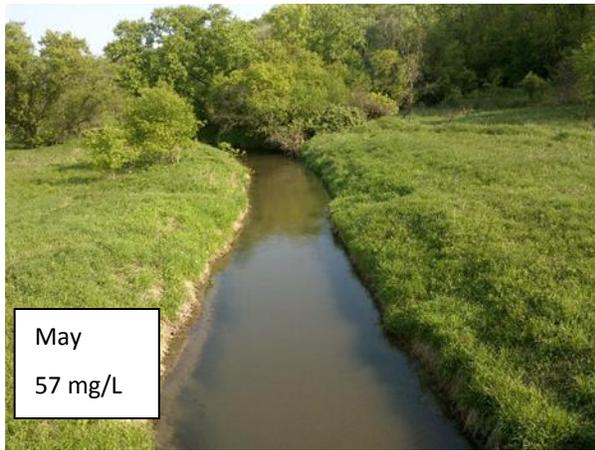
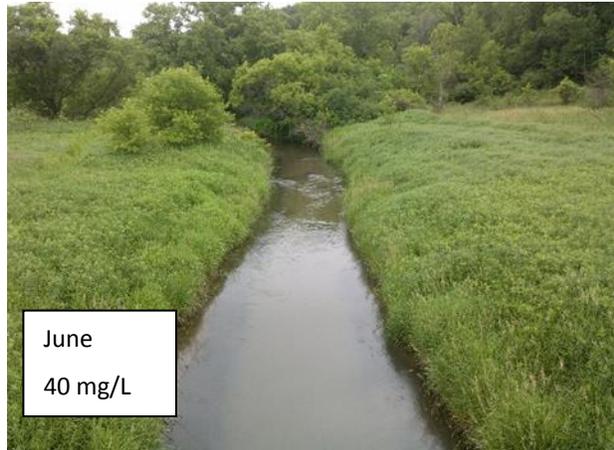
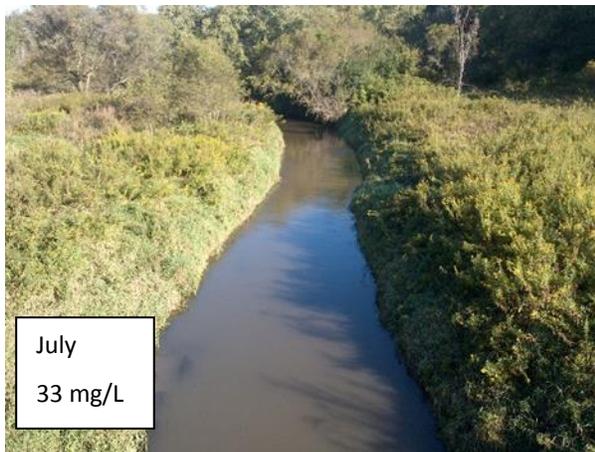
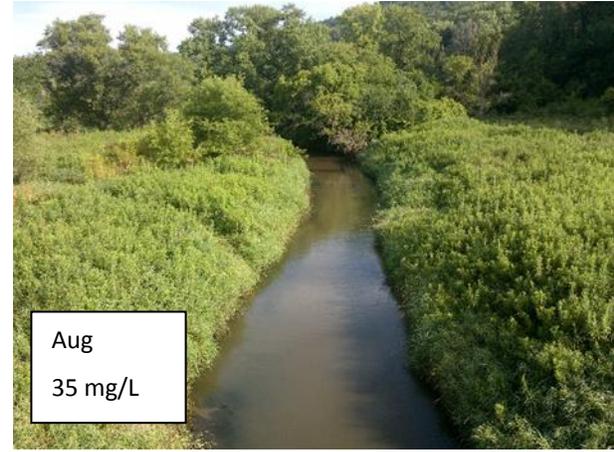
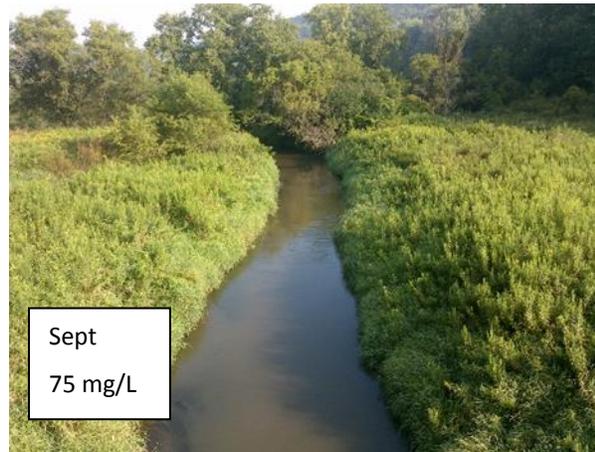
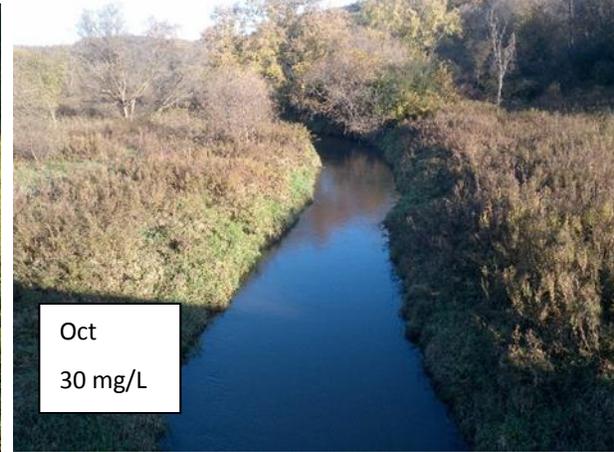
Figure 11. Photos from 15LM043 taken from May – Oct of 2016. All samples were scheduled (monthly) and all exceeded the TSS standard of 10 mg/L; demonstrating chronic turbid conditions.

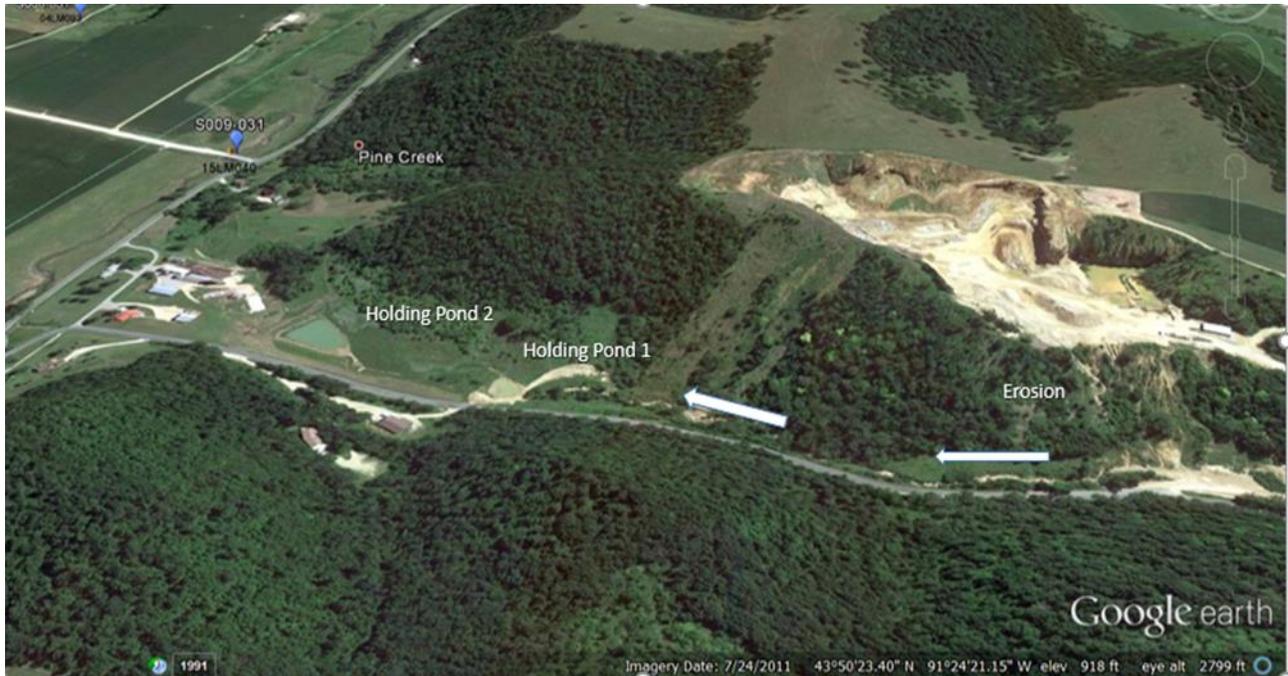
Figure 14. Google earth imagery of quarry location in Pine Creek.

During stressor identification, a large quarry was observed upstream of 15LM040; S009-031. ([Figure 14](#)). This quarry does have the potential to affect sedimentation in the stream, but at this time, there is not any evidence that sediment from the quarry is discharging to Pine Creek. Two holding ponds have been capturing overland runoff from the quarry. During multiple rain events in early 2017, the drainage areas were checked to ensure runoff from the quarry was not discharging to Pine Creek. It appeared that only during a very large storm event, would the second holding pond fill up and potentially release water. Until then the pond would allow solids to settle and release the clean water. As long as the ponds are maintained, they should continue to be effective.

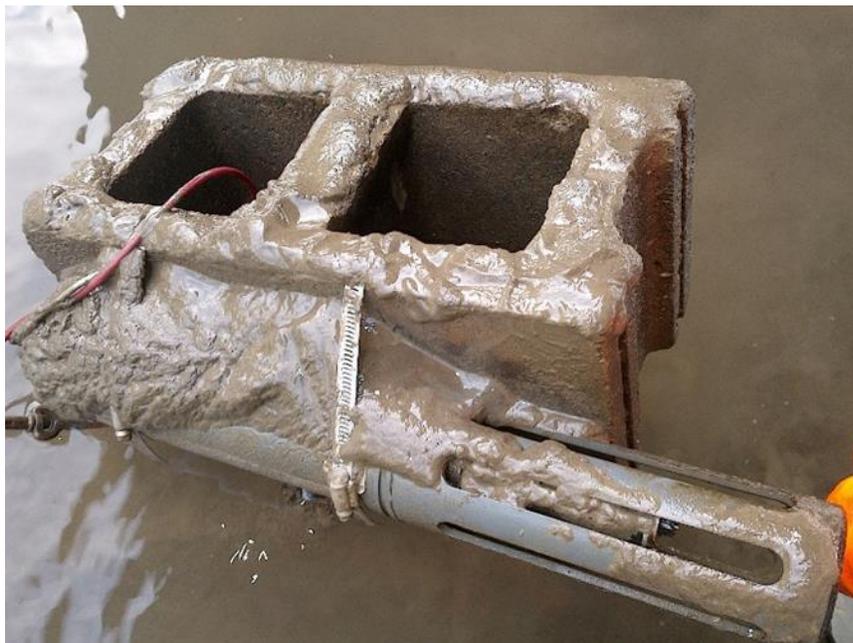
Figure 15. Sediment accumulation on sonde deployed at 15LM043 for two weeks at the end of August 2017.

Station 15LM043 had a sonde deployed in 2017 for two weeks at the end of August ([Figure 15](#)). There was very little rainfall documented during this time, yet during sonde retrieval, the sediment accumulation was dramatic. Most sites where sondes are deployed have nowhere near this much sediment accumulation during a two-week deployment. This demonstrates the amount of fine sediment moving through this system, some of which is being settled out at this monitoring location.

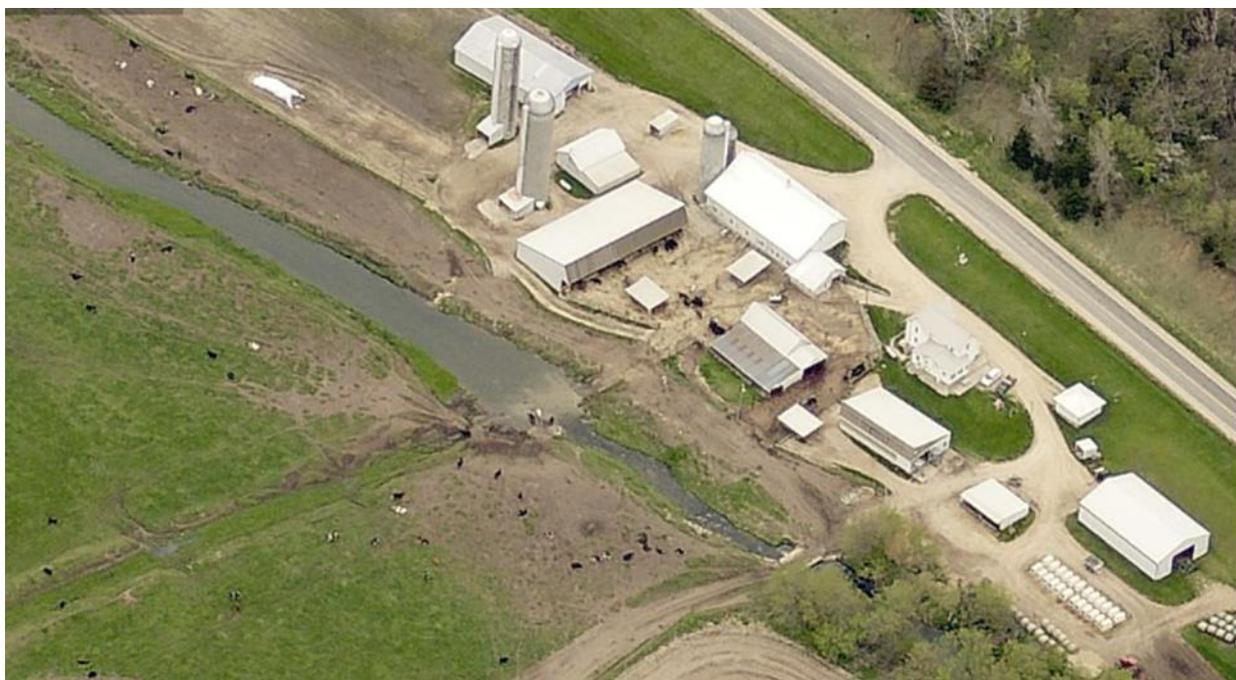
Figure 16. Aerial photo example of pasturing, stream channel changes and erosion/sedimentation impacts. Credit: Pictometry Houston County, 2017.

The sources of TSS to Pine Creek are likely bank erosion, poor pasturing practices, and other near channel sediment impacts ([Figure 16](#), [Figure 17](#), and [Figure 18](#)). Overall, the valleys in this watershed are very steep and have a loamy soil characteristic susceptible to erosion. Coupling these watershed features with steep stream slopes and excessive grazing (unvegetated pastures and unrestricted cattle access) favors turbid stream conditions. The biological, chemical, and physical evidence all overwhelmingly support that TSS is a stressor to Pine Creek.

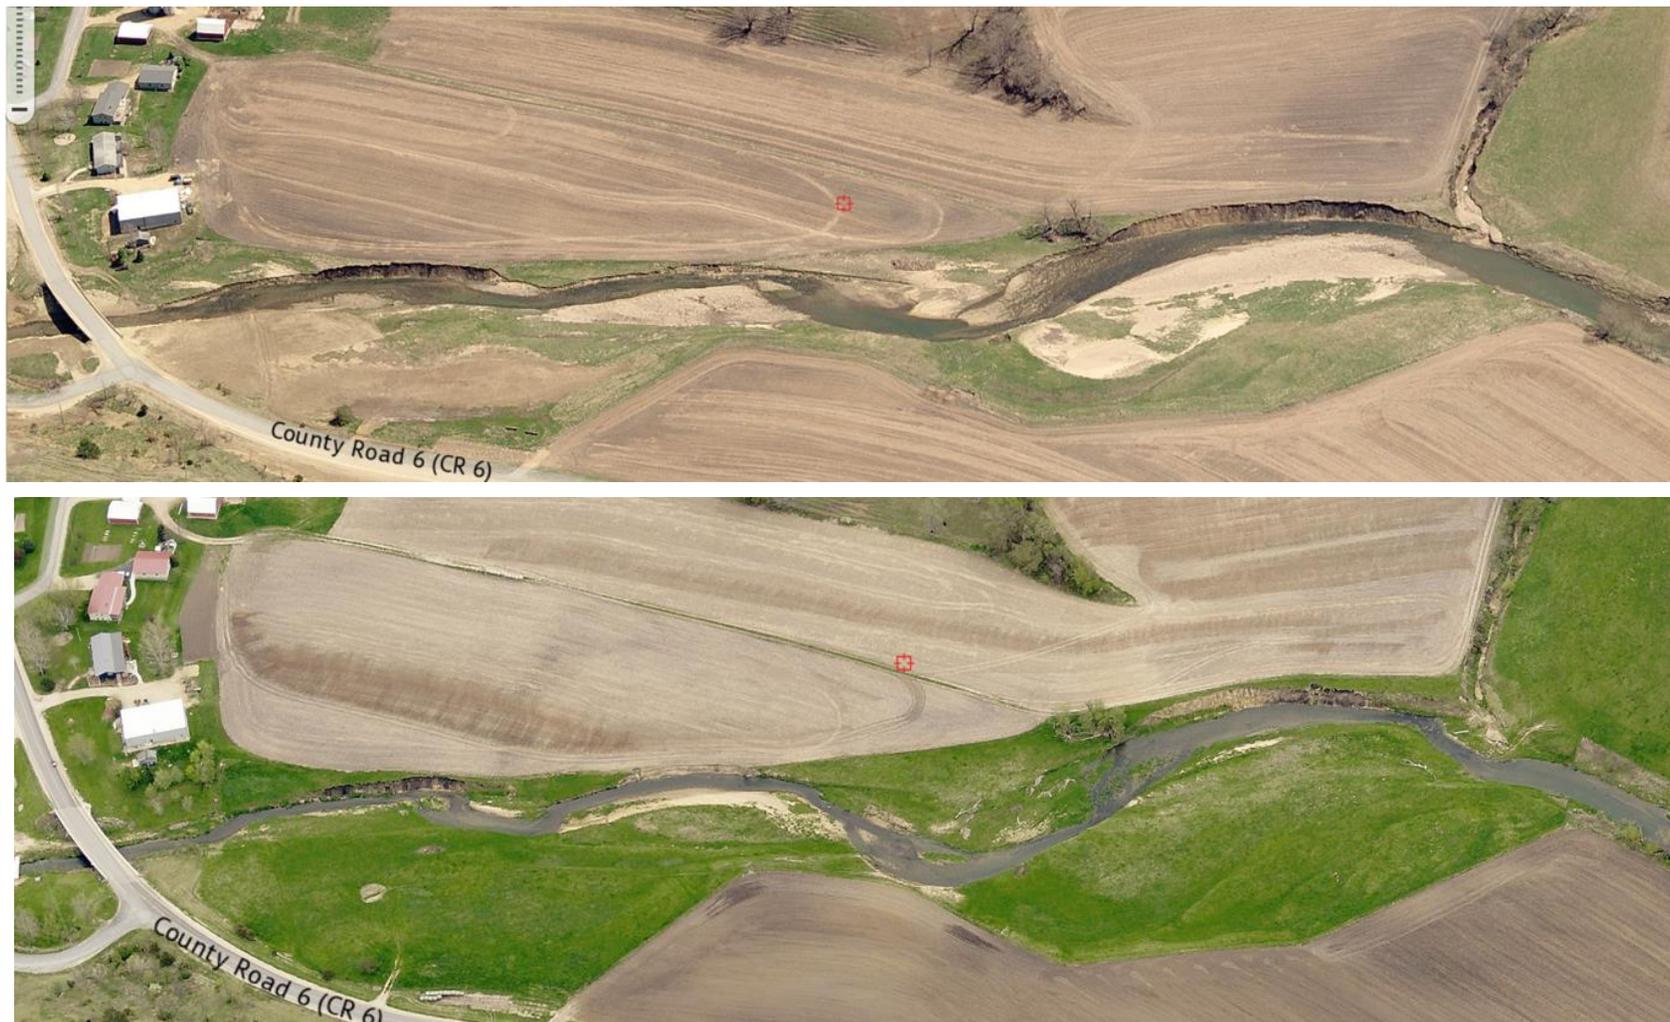
Figure 18. Images of bank erosion in the impaired reach (next road crossing upstream of 15LM040). The upstream photo is from 2008 and captures large changes to the stream channel from the 2007 flood. The bottom photo shows the current photo (2017), with areas of bank erosion still present. Note large ravine in upper right corner of photos that appears to be contributing a large amount of sediment to the stream. Image Credit: Pictometry Houston County, 2008 and 2017.

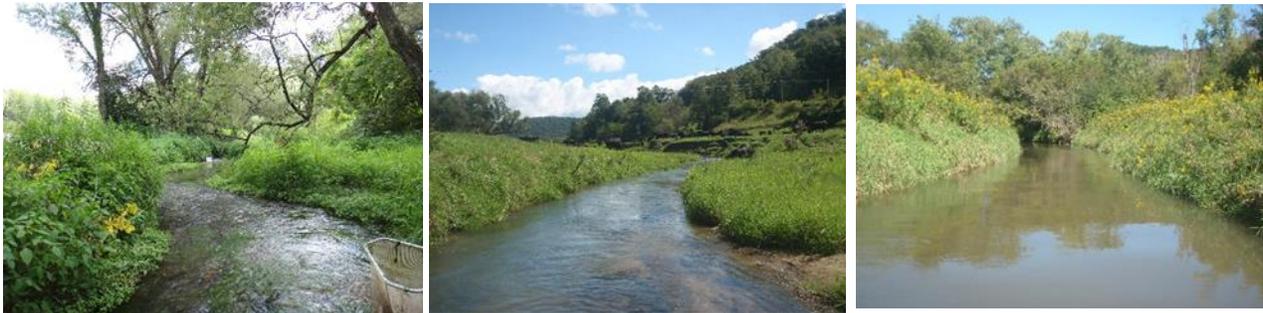
From Left to Right: 15LM041 (Good MSHA score: 65); 15LM040 (Fair/Poor MSHA Score: 44-48) and 15LM043 (Fair/Poor MSHA Score: 44-45).

When looking closer at more specific habitat characteristics, there are large discrepancies between the upstream and downstream sites (Table 11). Embeddedness, siltation, and bank erosion increase dramatically moving downstream. Additionally, shade and course substrate decreases. This agrees with other characteristics outlined in the TSS and temperature sections of the report, and further demonstrates how these characteristics are connected to potential habitat limitations. Photos taken at each location (Figure 21) demonstrate some of the differences moving downstream.

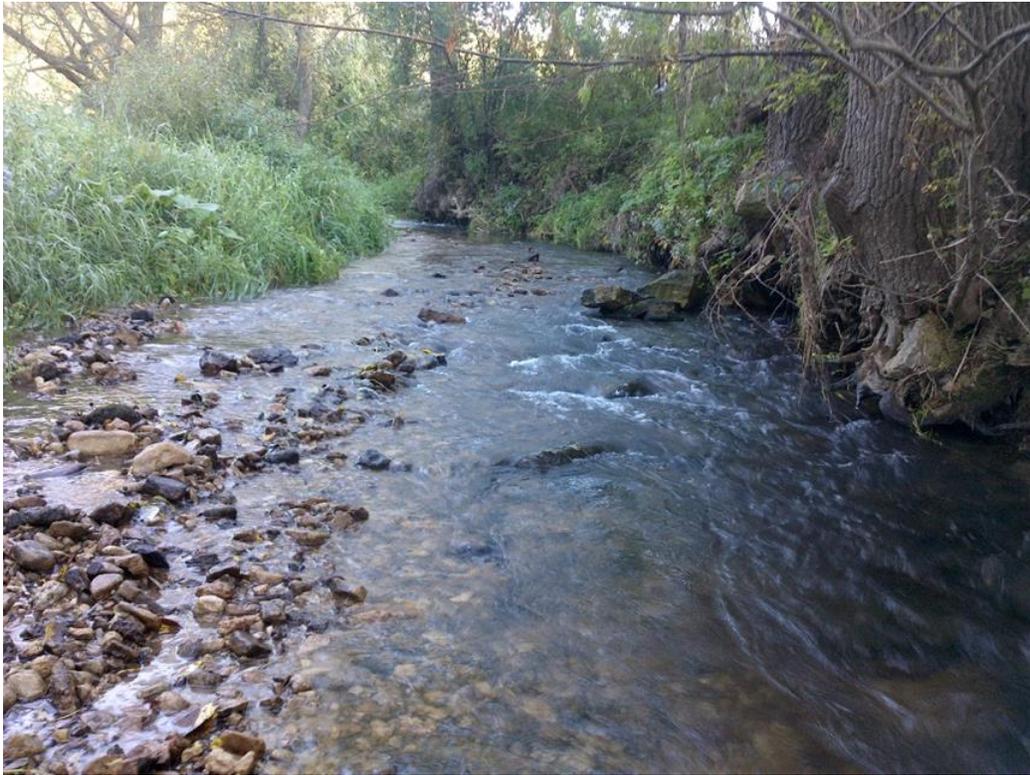
Figure 22. Station 15LM041 on September 14, 2016 showing good riffle habitat including coarse substrate and cover

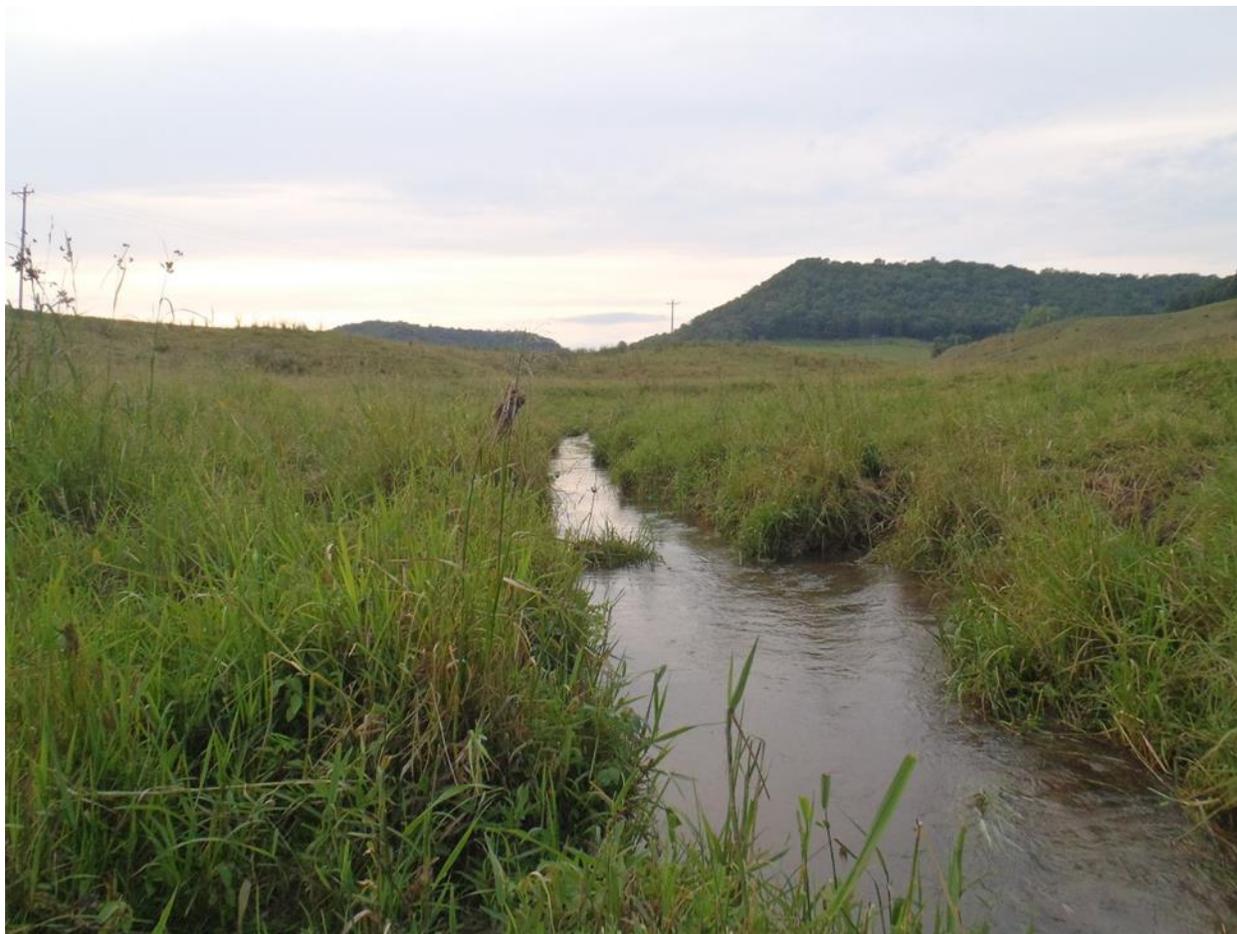
Figure 25. Rose Valley Creek 04LM093 in 2015.

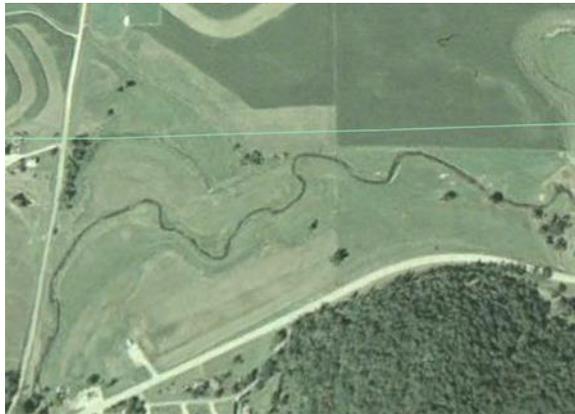
Figure 7. Widening and straightening as a result of a large flood event in 2007.
