# Stressor identification update

# Root River Watershed

March 2022

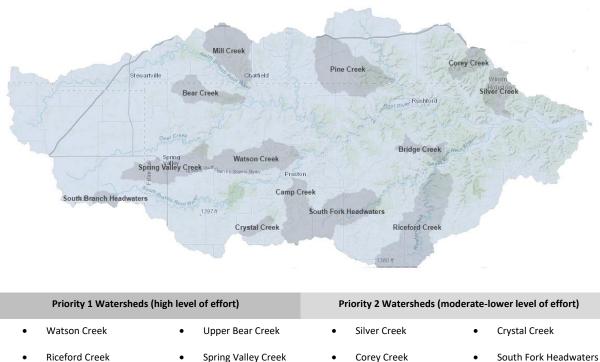
#### Figure 2. Map and list of stream studied in this report by priority.

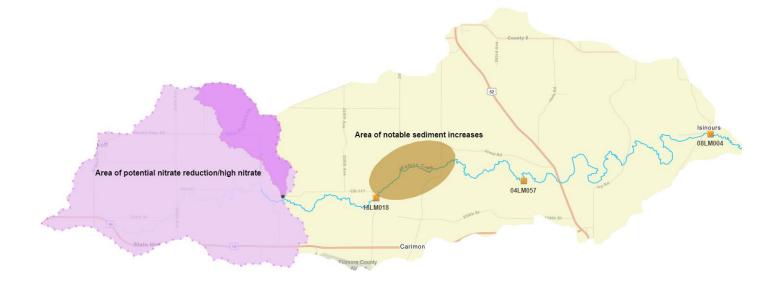
Figure 4. Map of the Watson Creek Watershed showing potential opportunities for nitrate and sediment reductions. Purple shaded areas include Stagecoach/Thunderhead spring watersheds (true springshed delineation not shown, but differs and includes a much larger area of consideration than shown). Brown shaded circle indicates the area between CR117 and CR11, where notable sediment increases and stream instability have been documented.

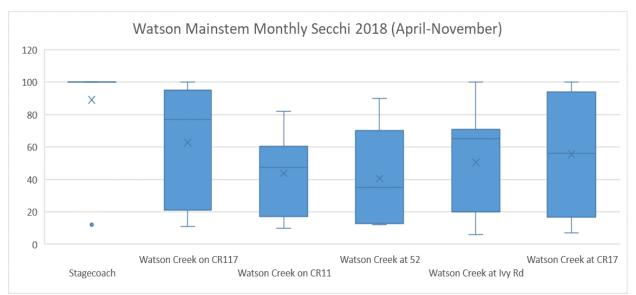
Figure 5. Monthly longitudinal secchi boxplots from Watson Creek showing the notable sediment increases (decreased transparency/secchi measurements) between CR117 and CR11 in 2018.

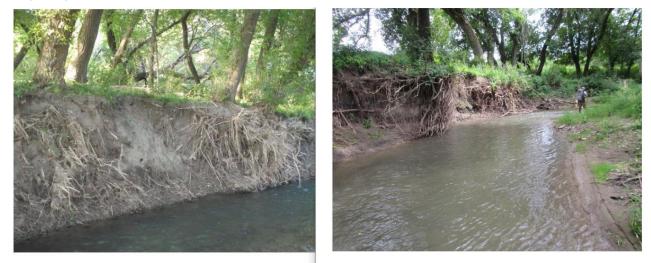
Figure 6. Photos of bank erosion near 18LM018, July 2018. (Downstream of CR117, the area of increasing sedimentation as noted in previous figures).

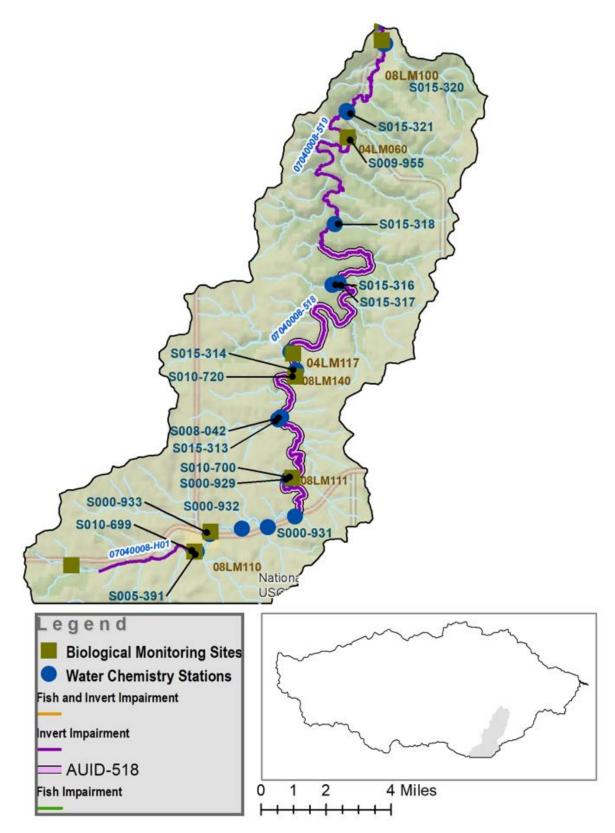
Figure 7. Map of the Riceford Creek Watershed showing biological monitoring and water chemistry stations. Riceford Creek (07040008-H01) farthest upstream and warmwater, is a new impairment for macroinvertebrates. The next section of stream moving downstream (07040008-518) is also impaired for macroinvertebrates and is coldwater. The farthest downstream section of stream (0704008-519) is warmwater and a proposed macroinvertebrate impairment correction.

During Cycle 1 SID (for -518 and -519) the stressors identified in Riceford Creek were habitat and nitrate. TSS and DO were considered inconclusive in the middle coldwater reach (518). Temperature and connectivity were ruled out as potential stressors throughout the stream. Cycle 2 SID work focused on understanding longitudinal differences in sediment, habitat, and nitrate throughout the stream to help determine potential pollutant sources and areas of highest impact of those stressors in the watershed. This included the addition of many water chemistry sampling stations (Figure 7).

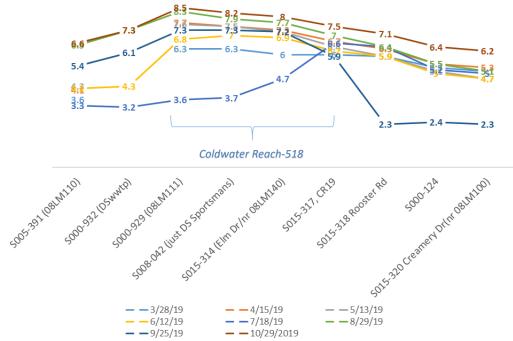
Figure 8. Nitrate results from longitudinal chemistry sampling in 2019. The sites are organized upstream to downstream (left to right). Nitrate was highest through the middle (coldwater) reaches; commonly 6-8 mg/L at baseflow (lower concentrations noted were storm event samples when dilution was occurring). The upper warmwater reach (2 sites farthest left) were slightly elevated; but concentrations increased when moving towards the coldwater reach-518, likely due to increased groundwater inputs. Then farther downstream concentrations showed decreases as well; likely related to the geology and changes in land use moving downstream

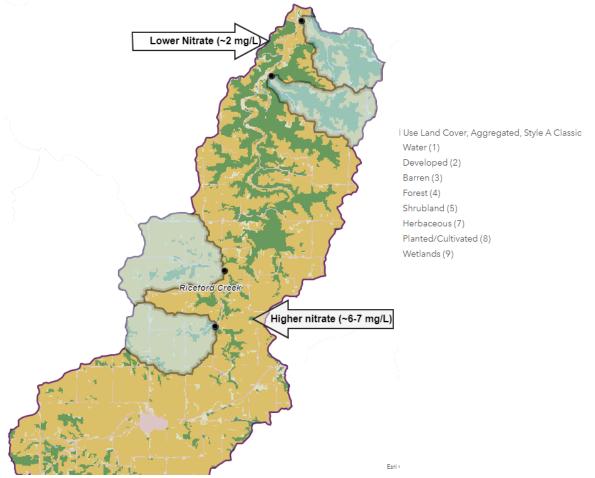
Figure 9. Tributary monitoring showing range of nitrate concentrations throughout the watershed. The middle sections of Riceford Creek (Coldwater reach-518) had the highest nitrate concentrations, including the tributaries in this map. Efforts to reduce nitrate may make the most impact in the middle to upper parts of the watershed as opposed to the lower end.

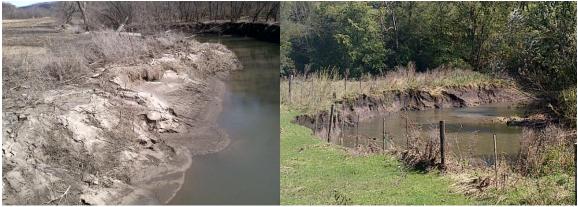
Figure 10. Areas of bank erosion and sedimentation in Riceford Creek.

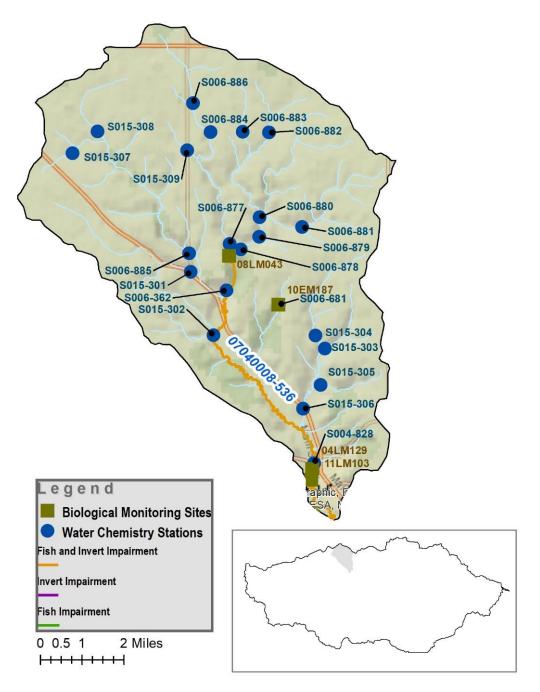
Figure 11. Map of the Mill Creek Watershed showing biological monitoring and water chemistry stations. Mill Creek (07040008-536) is impaired for fish and macroinvertebrates.

Mill Creek (07040008-536) biological data indicate both fish and macroinvertebrate impairment (Figure 11). The stream was deferred in Cycle 1 due to channelization of the stream channel at the sampling site. In 2011, an additional site was established nearby on a natural channel reach of Mill Creek near Chatfield. Multiple biological samples have been collected at the two sites from 2007 through 2018, and confirm impairment for both fish and macroinvertebrates. SID work began in 2019 with additional chemistry monitoring at multiple stations (Figure 11). The goal was to better understand sediment and nutrient sources and impacts throughout the watershed.

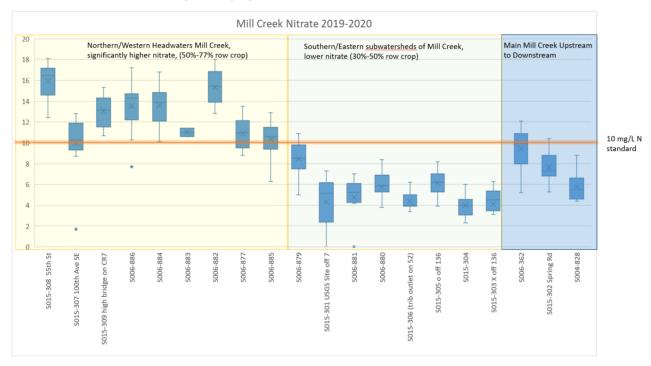
Figure 12. Nitrate sampling from multiple sites in Mill Creek from 2019 and 2020 (n=~15 samples/site), showing tributaries in the north and western areas with significantly higher concentrations relative to the southern and eastern subwatersheds.

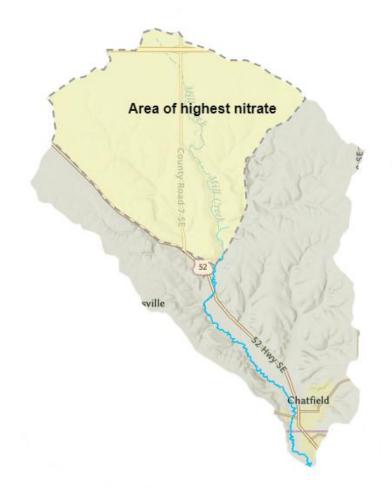
Figure 13. Map of Mill Creek Watershed showing the potential focus area of higher nitrate concentrations in the watershed based on nitrate sampling completed in 2019 and 2020.

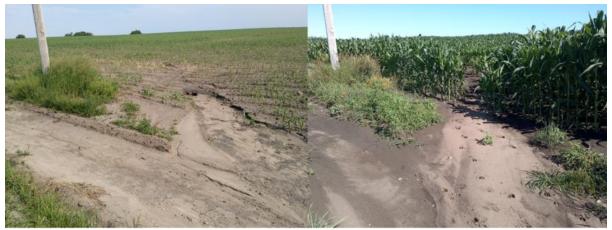
Figure 14. Headwater area erosion from a field June 2020 vs July 2020.

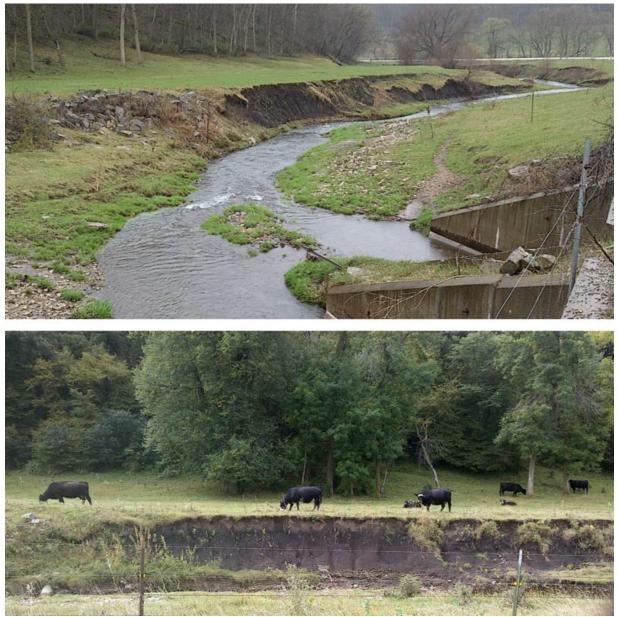
Figure 15. Some of the areas of severe bank erosion contributing sediment to the stream in the upper parts of Mill Creek.

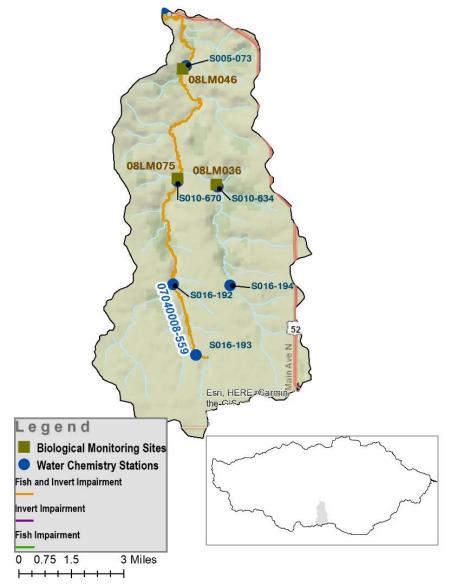
Figure 16. Map of the Camp Creek Watershed showing biological monitoring and water chemistry stations. Camp Creek (07040008-559) is impaired for fish and macroinvertebrates, and covers most of the length of the watershed.

Camp Creek (07040008-559) was listed in Cycle 1 for fish and macroinvertebrates (Figure 16). Both biological monitoring stations were sampled in 2008 and 2018. Fish still show impairment at both sites, with lower scores at the upstream station 08LM075. Site 08LM046, towards the mouth of the watershed, scored right at impairment threshold for fish in both 2008 and 2018, with mostly brown trout and white suckers present. The upstream site 08LM075 has a much different fish community present, with a larger mix of species and fewer trout. Site 08LM046 indicated a good macroinvertebrate community in 2008, but the score was lower in 2018. Conversely, 08LM075 scored poorly in 2008, but in 2018 was above the impairment threshold. Overall, the invertebrate community as a whole has not made a significant change despite changing scores, and remains stressed. Additional biological monitoring at these sites over time might help understand the variability in scores at these two sites.

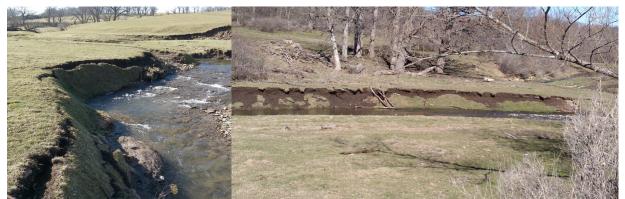
Figure 17. Areas of intense pasture/bank erosion failure near CR22, upstream of 08LM075.

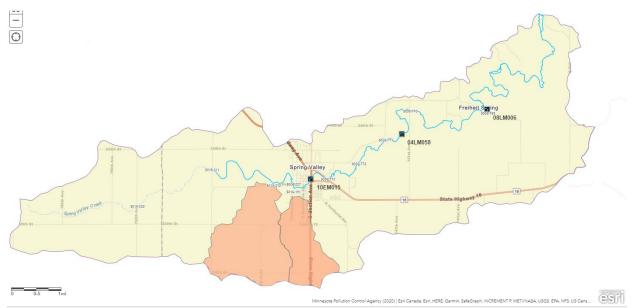
Figure 22. Map of Spring Valley Creek Watershed and two tributaries with high nitrate (>10 mg/L; shown in orange). The west tributary watershed (S015-312; left) also had lower transparency readings comparatively in 2019 as well.

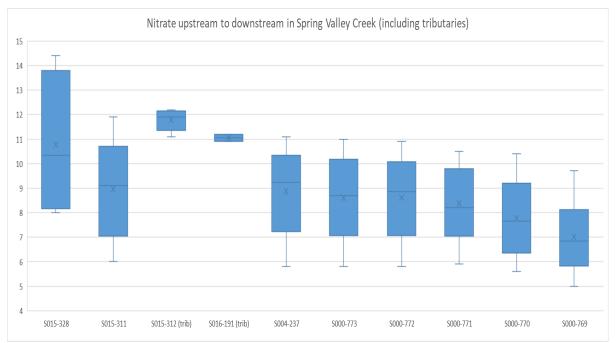
Figure 23. Boxplot comparison of nitrate concentrations in Spring Valley Creek in 2019. The two tributaries showed the highest concentrations, but nitrate is highest upstream (left) and decreases moving downstream (right). The Spring Valley WWTP discharge location is also noted, with sampling sites just upstream and downstream of the outfall location.

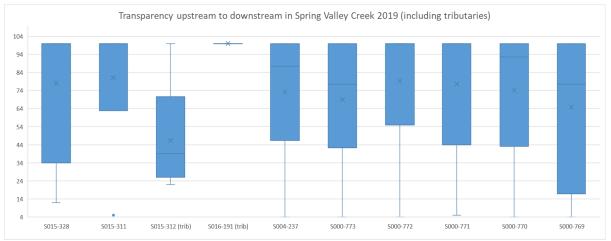
Figure 24. Transparency boxplot of sites in Spring Valley Creek from 2019. Tributary S015-312 had the worst transparency readings comparatively throughout the entire watershed.

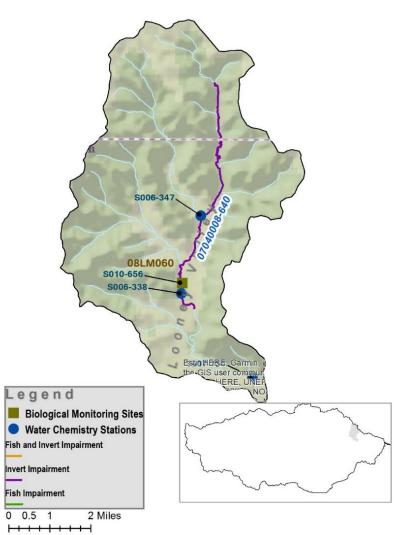
Figure 26. Map of the Silver Creek Watershed showing biological monitoring and water chemistry stations. Silver Creek (07040008-640) is impaired for macroinvertebrates (previously impaired for fish and delisted).

Silver Creek (640) was listed as impaired for fish and macroinvertebrates in Cycle 1 (Figure 26). Since then, additional data collected at 08LM060 has indicated the stream is recovering from the historic 2007 flood that severely affected the stream channel. The recovery has been more significant for fish, with a dramatic increase in fish scores and sensitive species (brook trout) present when comparing 2008 to 2019 data. After additional monitoring in Cycle 2, the fish IBI score increase was enough to remove it from the impaired waters list for fish. The macroinvertebrate community has improved slightly, but it is still considered impaired.

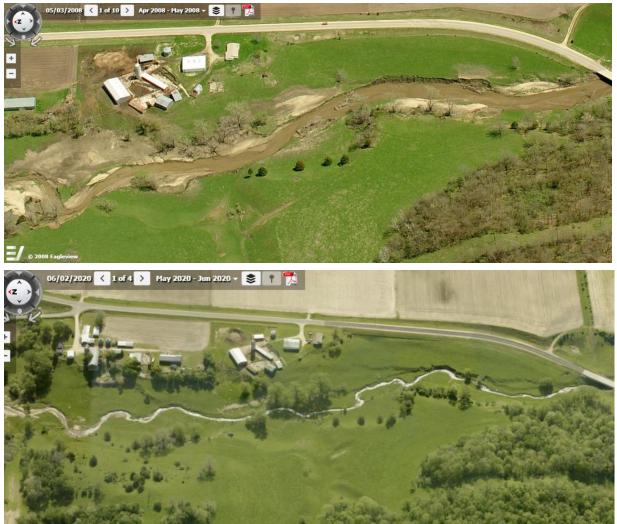
Figure 27. Aerial photos comparing the stream in 2008 (top) to 2020 (bottom). The stream channel has narrowed and healed from the flood of 2007 in this location, increasing available fish habitat and fish IBI scores.

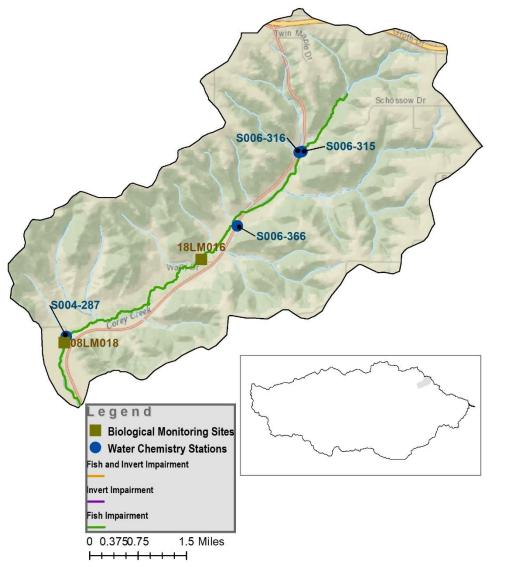
Figure 28. Map of the Corey Creek Watershed showing biological monitoring and water chemistry stations. Corey Creek (07040008-631) is impaired for fish.

Corey Creek (07040008-631) was listed in Cycle 1 as a fish impairment (Figure 28). With the most recent round of monitoring, one additional biological site was added upstream to better understand the entire stream system (18LM016). The addition of 18LM016 provided a sampling of a more representative condition of Corey Creek and shows that the fish community in Corey Creek is doing well, typical of a coldwater stream in southeast Minnesota. The old site, 08LM018-is at the "bottom" of the stream system and it is downstream of a perched culvert. This additional site and biological data help rule out other potential stressors and confirm the stream is healthy.

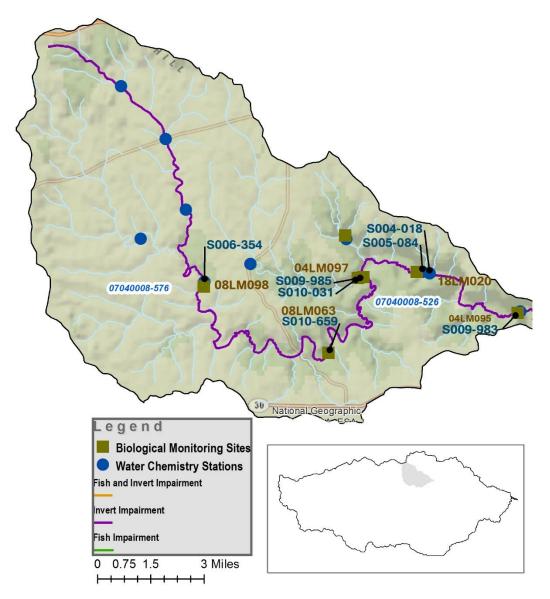
Figure 29. Map of the Pine Creek Watershed showing biological monitoring and water chemistry stations. Pine Creek (07040008-526) is impaired for macroinvertebrates.

Pine Creek (07040008-526) was listed in Cycle 1 for macroinvertebrates (Figure 29). With the more recent monitoring, one additional station was added (18LM020) to help better characterize the differences between sites throughout Pine Creek. This site was located in an area of new habitat improvement work, and in-between sites 04LM097 and 04LM095. The biological data collected at 18LM020 and the previously established stations indicate that while the fish and macroinvertebrate indicators vary somewhat given the significant length of the monitored stream reach, the overall aquatic health of the system is good and typical of a coldwater stream in southeast Minnesota and thus a macroinvertebrate delisting is proposed on the entire stream. This area could be prioritized for protection to ensure macroinvertebrates remain healthy.

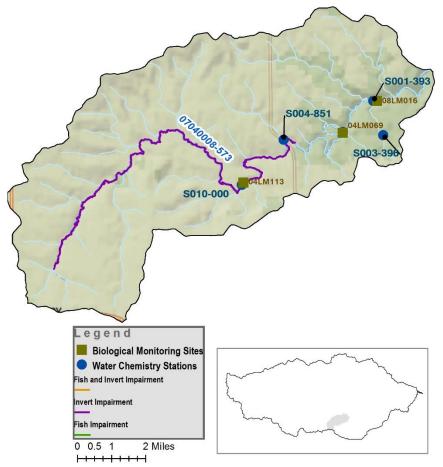
Figure 30. Map of the South Fork Headwaters Watershed showing biological monitoring and water chemistry stations. This stream (07040008-573) is impaired for macroinvertebrates.

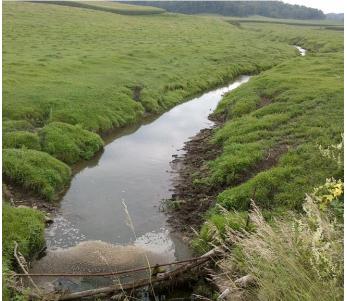
Figure 31. Photo looking upstream from biological monitoring station on 8/7/2018 during sonde deployment showing stagnant water and foam/scum. This was also observed in photos when sonde was picked up on 8/20/2018.

- Opportunities still exist to improve water quality in the headwater area of the South Fork Watershed (Figure 31). Feedlot improvements, practices that help reduce erosion and sedimentation in the stream channel, ensuring the stream is not excessively grazed, and has adequate buffers could help water quality. A study by Winona State Water Resources Center determined that this reach had high levels or organic fractions of sediment during baseflow conditions, which were likely tied to near stream agricultural land uses (Dogweiler 2010).

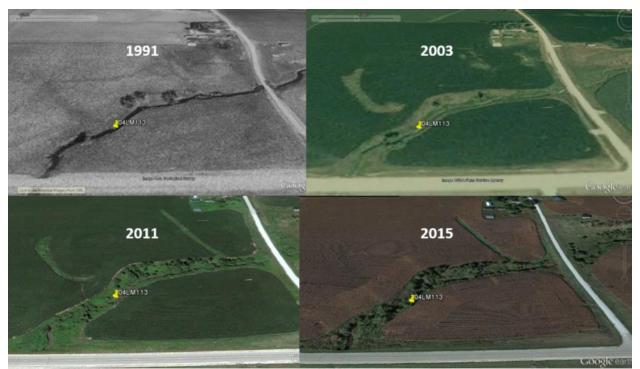
Figure 32. Aerial photo comparison showing positive changes in riparian corridor at the biological monitoring station (04LM113) from 1991 to 2015.

- Embeddedness and lack of riffle/woody debris are largest limiting factors related to habitat. Local land use was noted as large contributor to stress (Figure 32). Improvement in the riparian corridor may have helped increase the MIBI score in 2018, but more data over time would help understand if 2018 had other impacts (like more flow) that also helped boost that score. While macroinvertebrates seemingly improved, it's a little too early to say that this is due solely to the improved habitat.

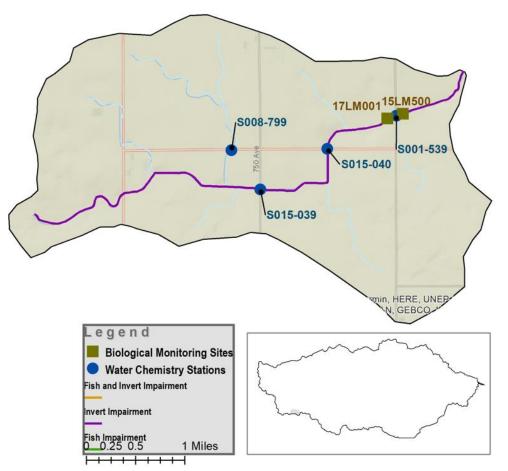
Figure 33. Map of the South Branch Headwaters Watershed showing biological monitoring and water chemistry stations. This stream (07040008-H18) is impaired for macroinvertebrates.

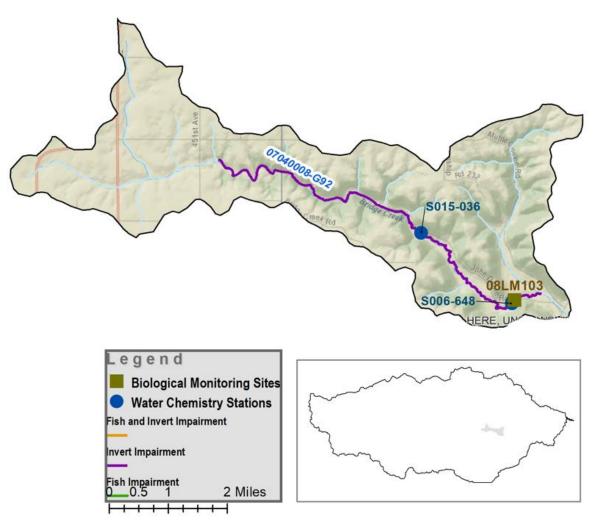
Figure 34. Map of the Bridge Creek Watershed showing biological monitoring and water chemistry stations. This stream (07040008-F54) is impaired for macroinvertebrates.

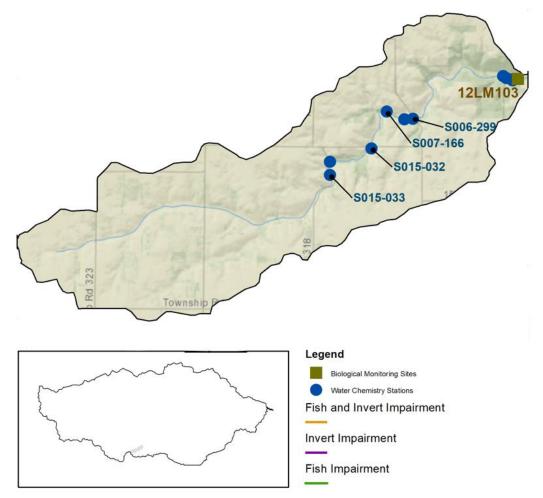
Figure 35. Map of the Crystal Creek Watershed showing biological monitoring and water chemistry stations. This stream (07040008-601) is not currently impaired for aquatic life.

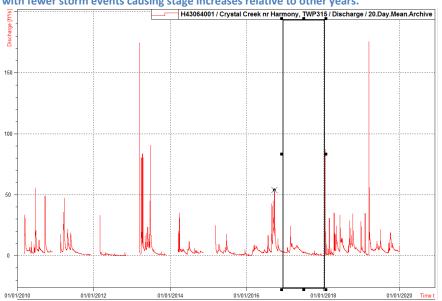
Figure 36. Stream flow/discharge data from Crystal Creek from 2010-2020. Black box outline indicates the water year 2017, with fewer storm events causing stage increases relative to other years.
