Otter Tail River Watershed Stressor Identification Report

Document number: wq-ws5-09020103a

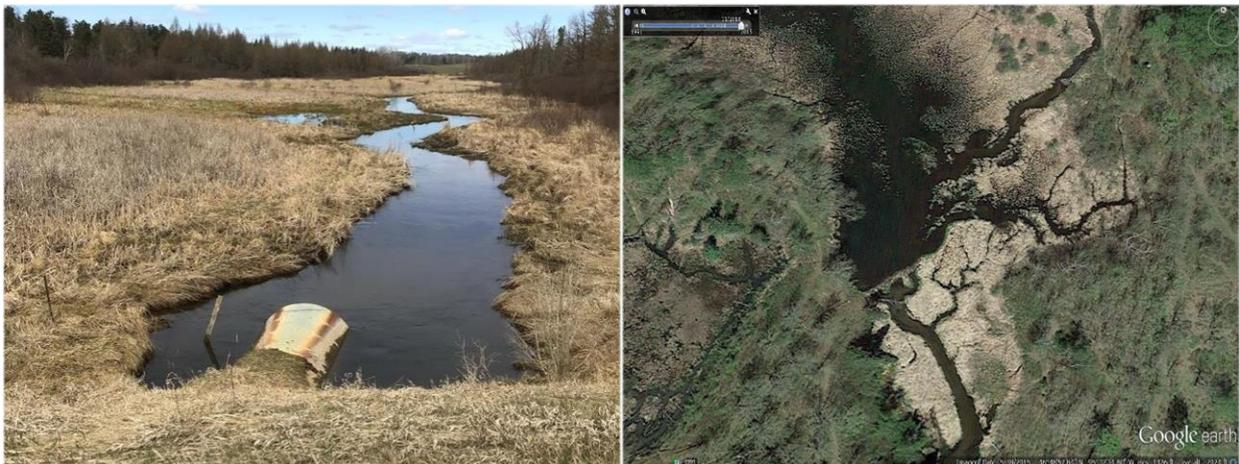
Figure 6. Images of connectivity-related issues associated with Toad River (526), including an undersized and damaged culvert at the CR 122 crossing (left) and a large beaver dam located upstream of the CR 122 crossing on May 18, 2015 (right), courtesy of Google Earth.

The evidence suggests that the F-IBI impairment associated with the Toad River (526) is attributed to a loss of longitudinal connectivity, insufficient physical habitat, and to a lesser extent, high suspended sediment. Several beaver dams were noted to be interfering with fish passage during reconnaissance. The impoundment of water caused by these dams can also alter sediment transport processes, thereby degrading physical habitat. Removal of beaver dams should be considered to restore connectivity along the reach. Additionally, the culvert at the CR 122 crossing is severely undersized and has partially collapsed. During moderate and high stage conditions, the flow velocity through the culvert is likely high enough to impede connectivity for many fish species. The installation of a properly sized culvert at this intersection is highly recommended. The physical habitat of the downstream portion of the reach is naturally limited by its surficial geology (undifferentiated outwash). As a result, the substrate in this segment is dominated by sand, with minimal cover present. Channel incision was also noted in a geomorphology assessment completed along the lower extent of the Toad River (526). Further investigation is needed to determine the cause(s) of this instability.

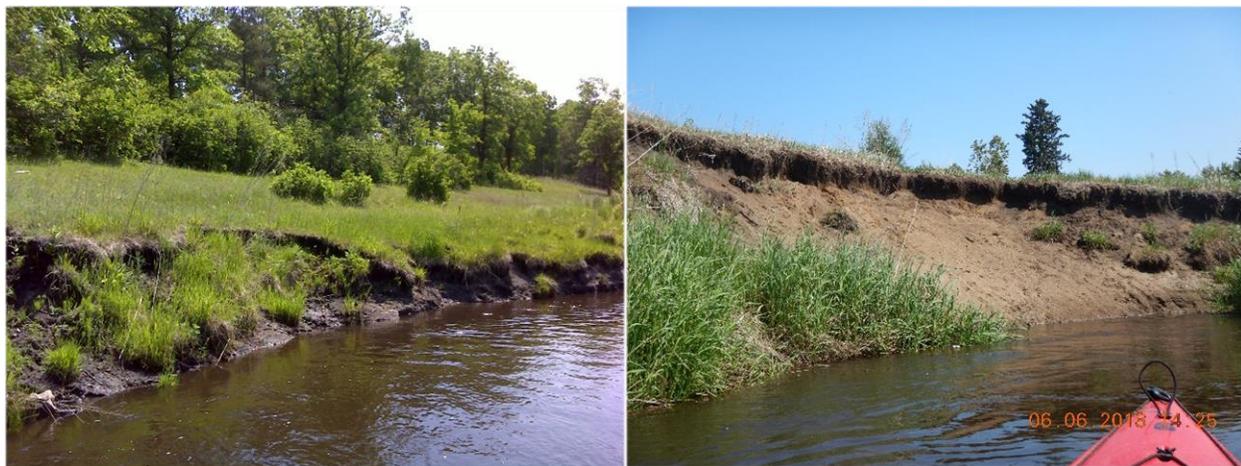
Figure 10. Images of bank erosion along the Toad River (526) on June 6, 2018, including upstream of the CR 122 crossing (left) and downstream of the State Highway 87 crossing (right).

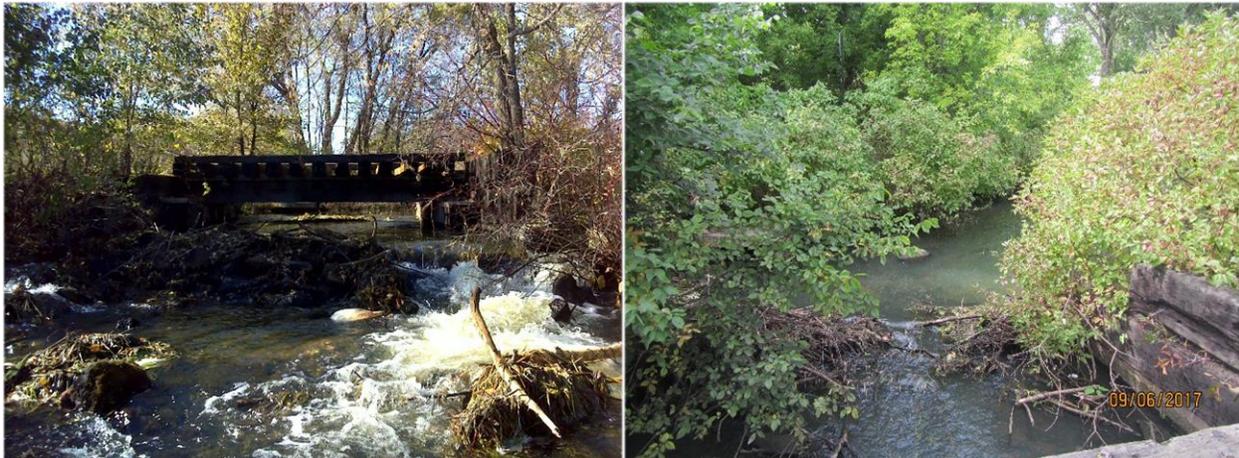
The MPCA biological monitoring staff did not observe any connectivity-related issues during their visits to Station 16RD032. According to the DNR (2014a), there are no man-made dams along the Pelican River (772). On October 18, 2018, MPCA SID staff completed a longitudinal assessment of the reach. A breached beaver dam (Figure 14) was documented at the downstream end of a trail crossing located between the U.S. Highway 10 and Corbett Road crossings. Staff also noted a beaver dam (Figure 14) at the upstream side of this trail crossing on September 6, 2017. In addition to the longitudinal assessment, MPCA SID staff performed a detailed review of a May 18, 2015, aerial photo (courtesy of Google Earth) of the reach. No connectivity-related issues were identified in the photo. Overall, there are no permanent barriers to connectivity along the Pelican River (772). However, beaver dams have the potential to limit connectivity when present.

Figure 14. Images of beaver dams located near a trail crossing between the U.S. Highway 10 and Corbett Road crossings along the Pelican River (772) on October 18, 2018 (left) and September 6, 2017 (right).

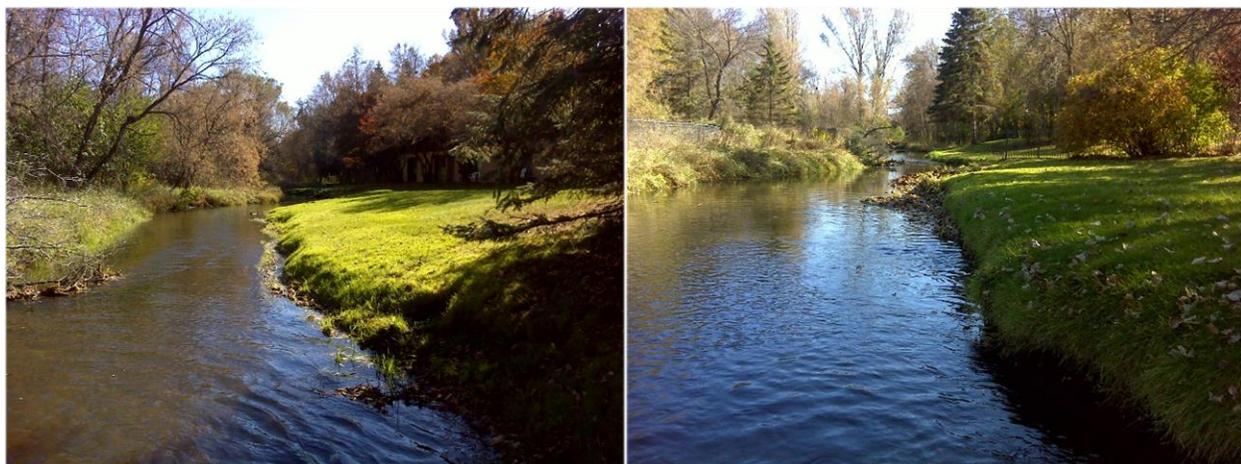
On October 18, 2018, the MPCA SID staff completed a longitudinal assessment of the Pelican River (772). Staff noted a substantial amount of sediment deposition between the US Highway 10 crossing and Site S002-176. From Station 16RD032 to Detroit Lake, staff observed several areas of quality riffle habitat and other areas of coarse substrate. Staff also identified multiple areas where landowners were maintaining their lawns to the edge of the river channel (Figure 16), thereby causing bank instability in

some instances. Lastly, staff observed a homeowner actively blowing all of the fallen leaves from their yard into the river.

Figure 16. Images of lawns being maintained to the edge of the river channel downstream of Corbett Avenue (left) and downstream of Lori Avenue (right) along the Pelican River (772) on October 18, 2018.

The evidence suggests that the biological community is limited by flow regime instability, insufficient physical habitat, high suspended sediment, and low dissolved oxygen. The reach is prone to frequent periods of low dissolved oxygen. Discharge from the Rice Lake wetland complex is a contributing factor to these conditions. The implementation of the Rice Lake Nutrient Reduction Project is intended to increase water residence time and decrease phosphorus loading to the Pelican River. Additional DO and eutrophication-related monitoring should be performed after the completion of the project to evaluate its effectiveness. During high precipitation events, the reach can be prone to extreme TSS concentrations. Identified deficiencies or failures in existing stormwater system infrastructure need to be corrected. Additionally, areas that lack sufficient stormwater controls (e.g., areas of the industrial park) should be targeted for the implementation of best management practices (BMPs). Lastly, areas along the lower extent of the Pelican River (772) would benefit from the installation of natural riparian buffers to mitigate runoff and prevent streambank instability.

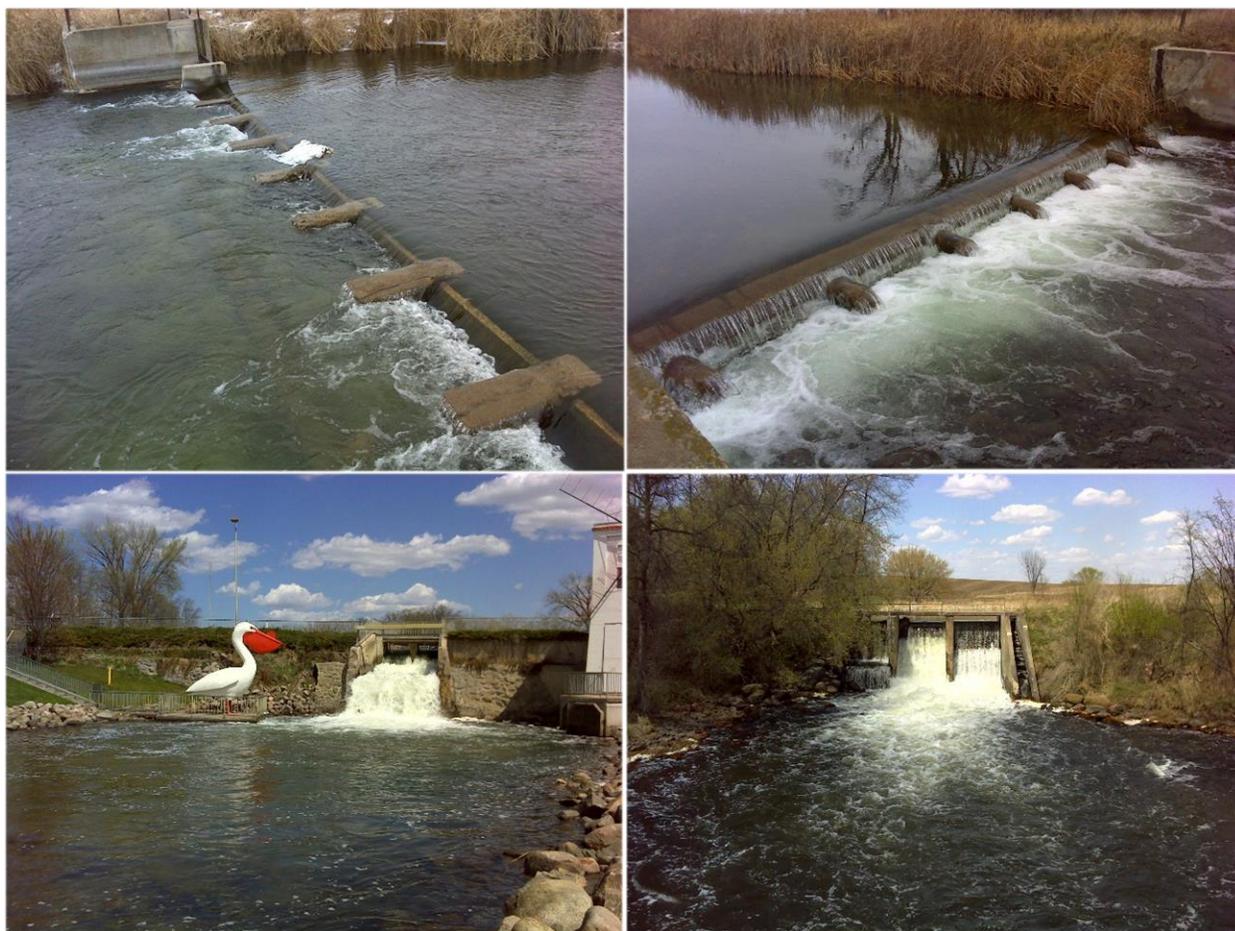
Figure 23. Images of dams affecting the Pelican River (767), including the Lake Lizzie Dam on November 28, 2018 (upper left); Prairie Lake Dam on November 1, 2018 (upper right); Pelican Rapids Dam on May 7, 2018 (lower left); and Pelican River Dam on May 7, 2018 (lower right).

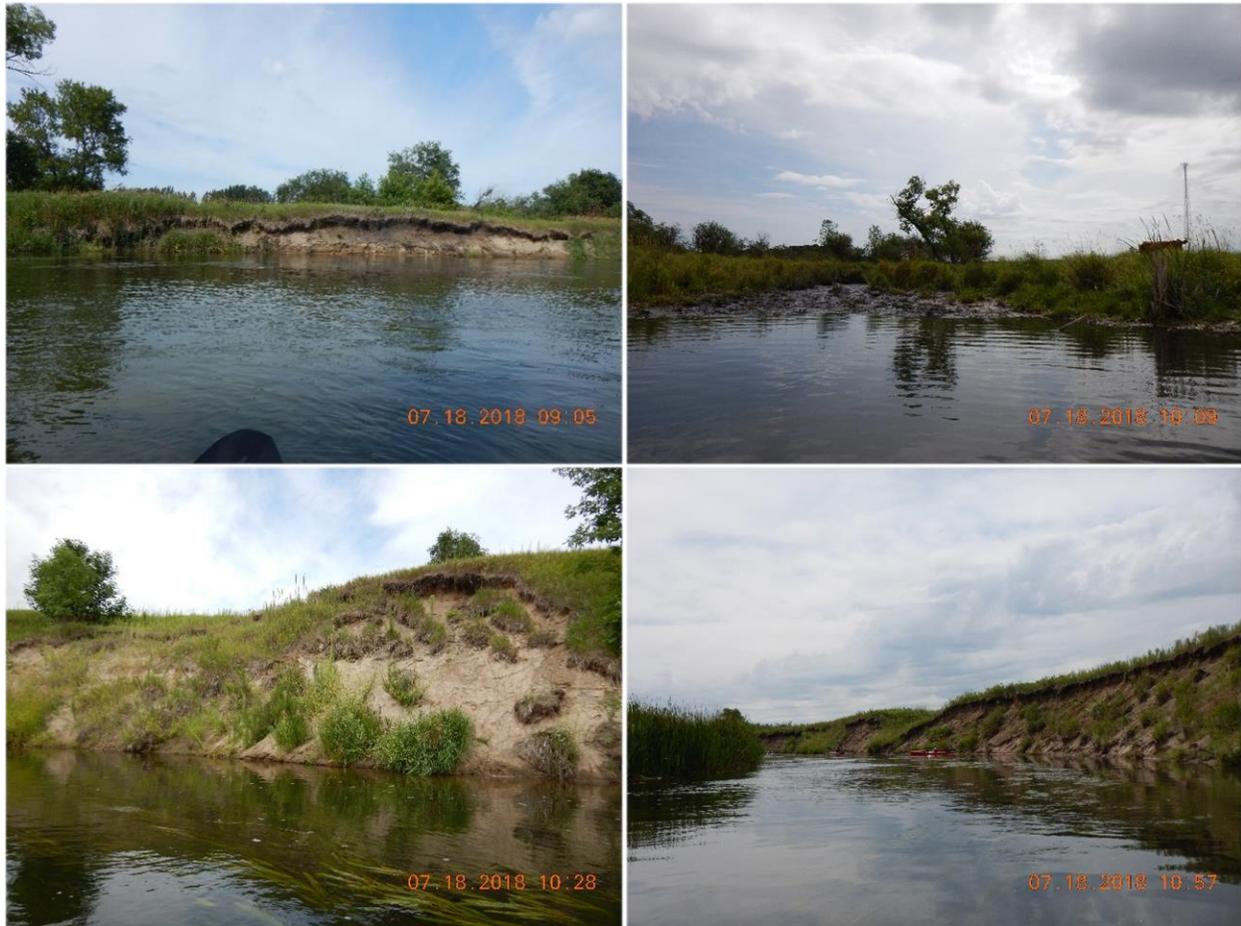
Figure 27. Images of potential sediment sources along the Pelican River (767) on July 18, 2018, including an eroded bank upstream of the 410th Street crossing (upper left); a denuded bank caused by cattle access upstream of the CSAH 28 crossing (upper right); an eroded bank upstream of the CSAH 28 crossing (lower left); and an eroded bank downstream of the CSAH 28 crossing (lower right).

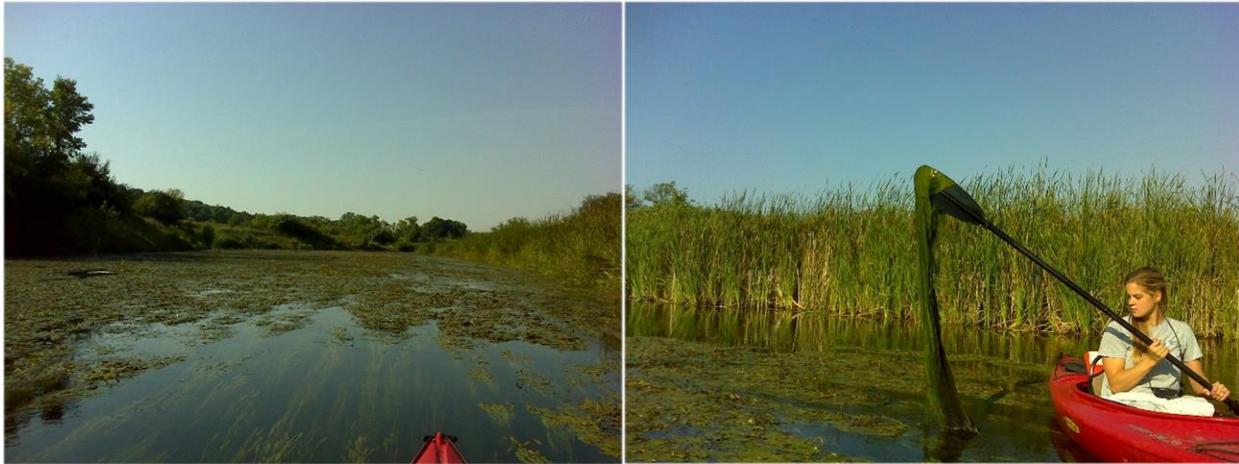
Figure 31. Images of excessive filamentous algae and macrophytes along the Pelican River (767) on August 22, 2018.

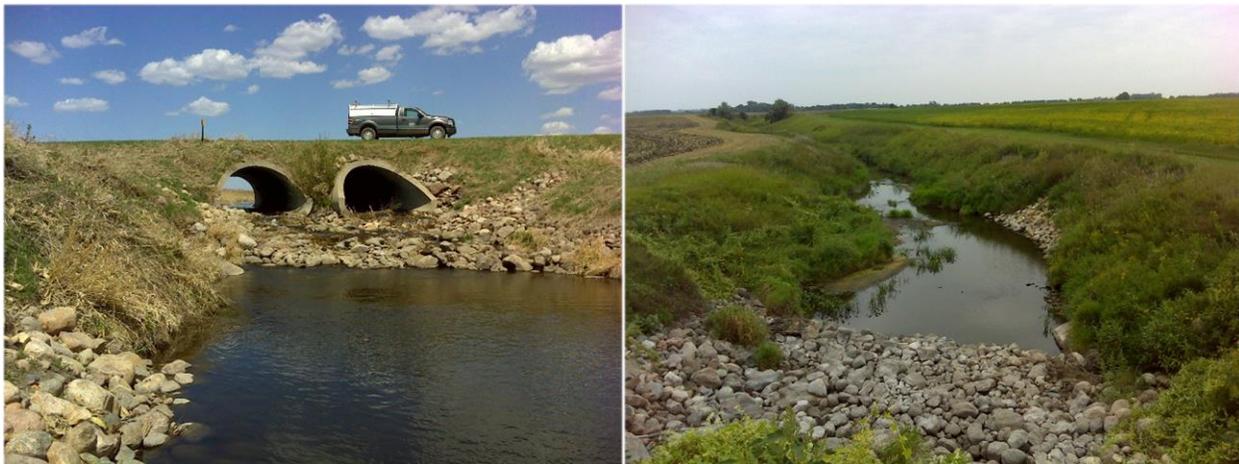
The MPCA biological monitoring staff observed and documented that the downstream end of the culverts beneath CR 160 are perched approximately four feet (Figure 33). Rocks have been installed to stabilize the grade. The perched culverts likely obstruct connectivity at most flow conditions; fish passage may be possible at high stage levels. According to the DNR (2014a), there are no man-made dams along JD 2 (764). On August 29, 2018, MPCA SID staff completed a longitudinal assessment of the reach. No additional obstructions to connectivity (e.g., beaver dams) were identified. In addition to the assessment, MPCA SID staff performed a detailed review of an August 21, 2016, aerial photo (courtesy of Google Earth) of the reach. No other connectivity-related issues were identified in the photo. In summary, the perched culverts beneath CR 160 severely limit connectivity along JD 2 (764).

Figure 33. Images of perched culverts located at the downstream end of the CR 160 crossing on May 7, 2018 (left) and August 23, 2018 (right).

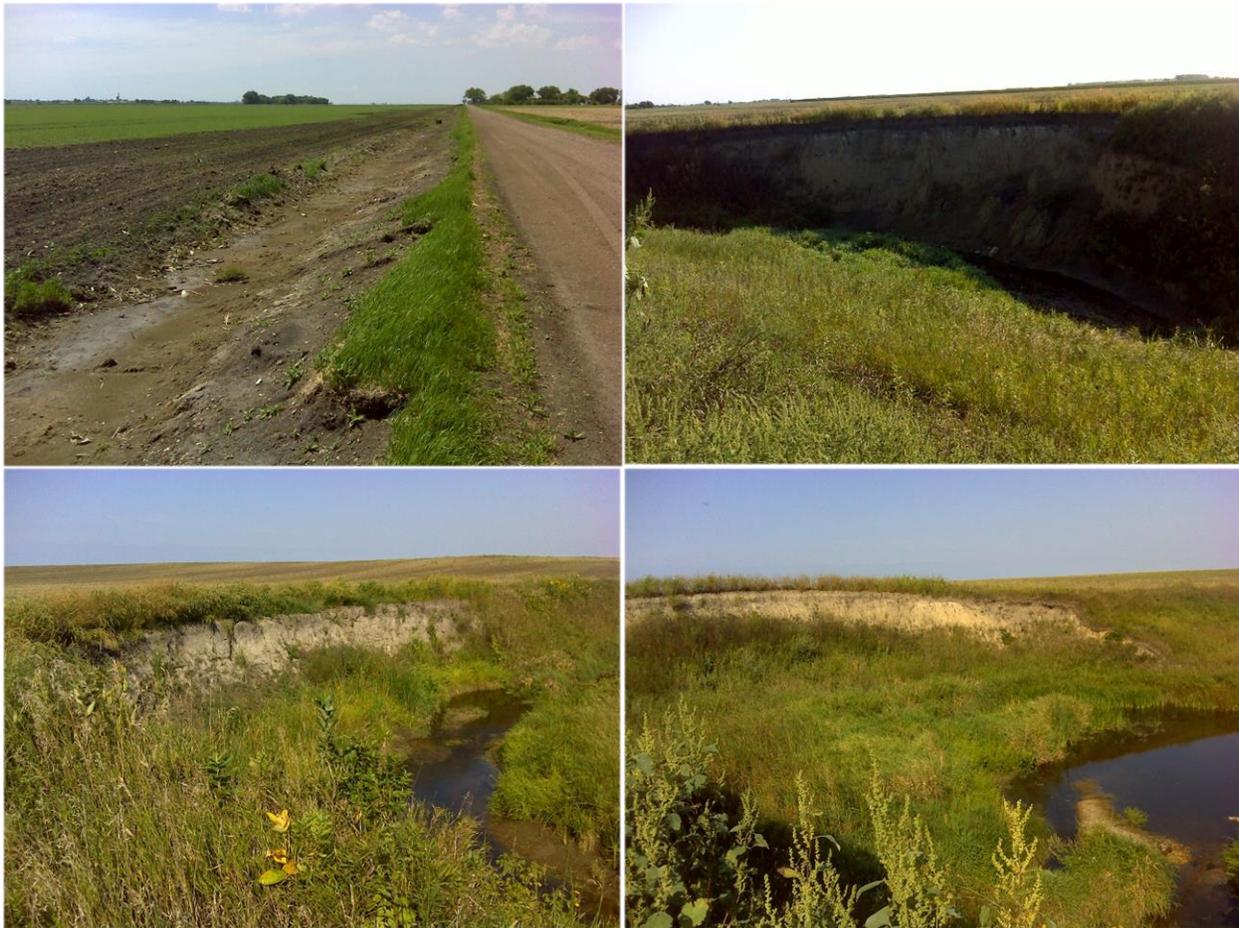
Figure 38. Images of potential sediment sources to Judicial Ditch 2, including a tributary road ditch with no buffer located along 320th Street on May 24, 2018 (upper left) and eroded banks downstream of the CR 160 crossing on August 29, 2018 (upper right, lower left, and lower right).

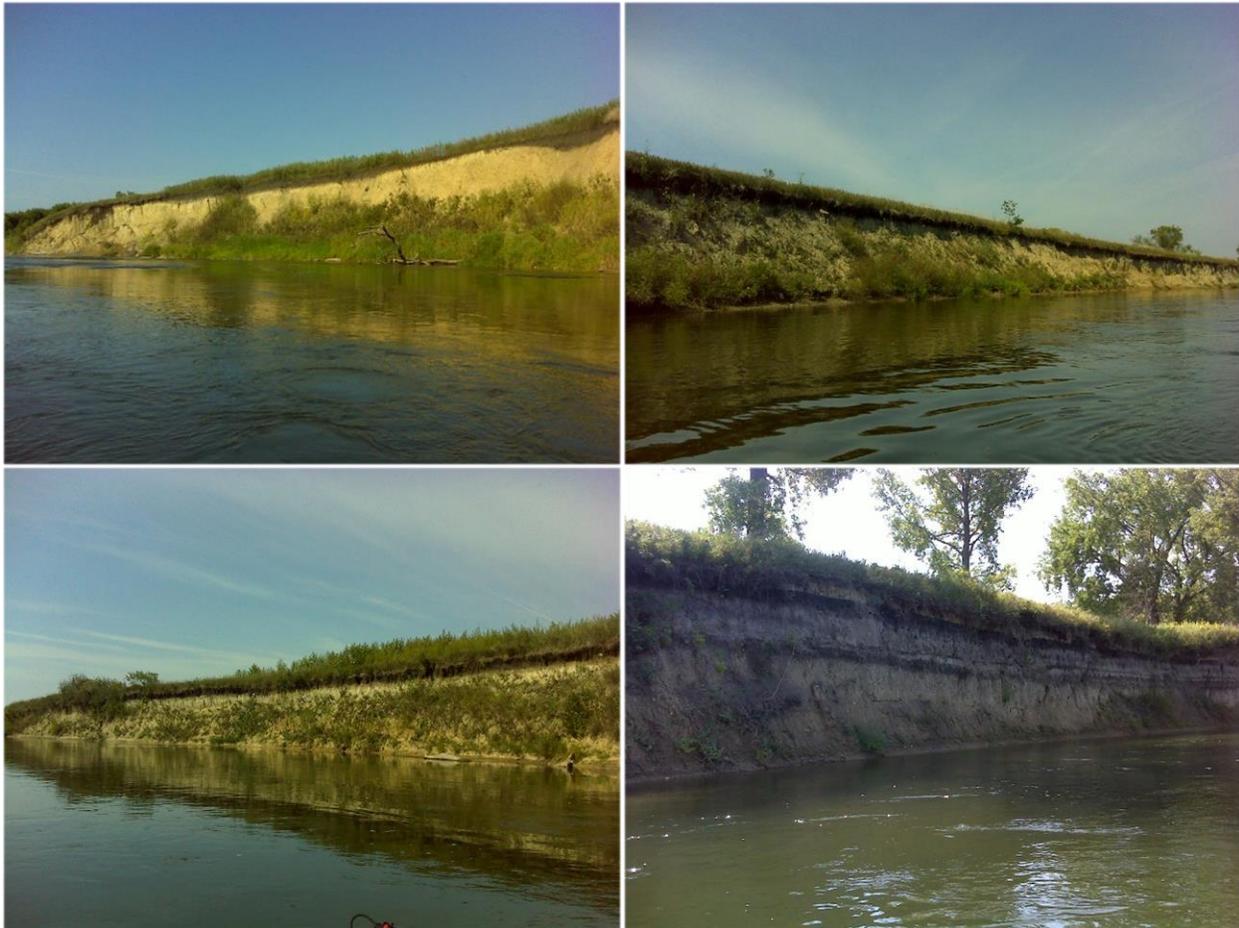
Figure 46. Images of eroded banks in the vicinity of the CSAH 19 crossing along the Otter Tail River (504) on August 29, 2018.

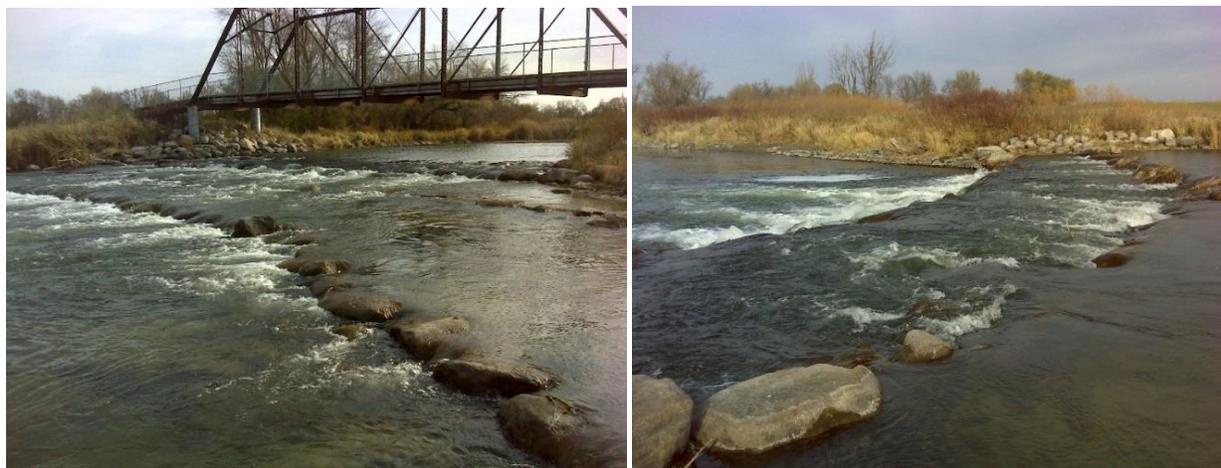
Figure 51. Images of arch rapids at the Breckenridge Lake Dam along the Otter Tail River (502) on October 24, 2018.

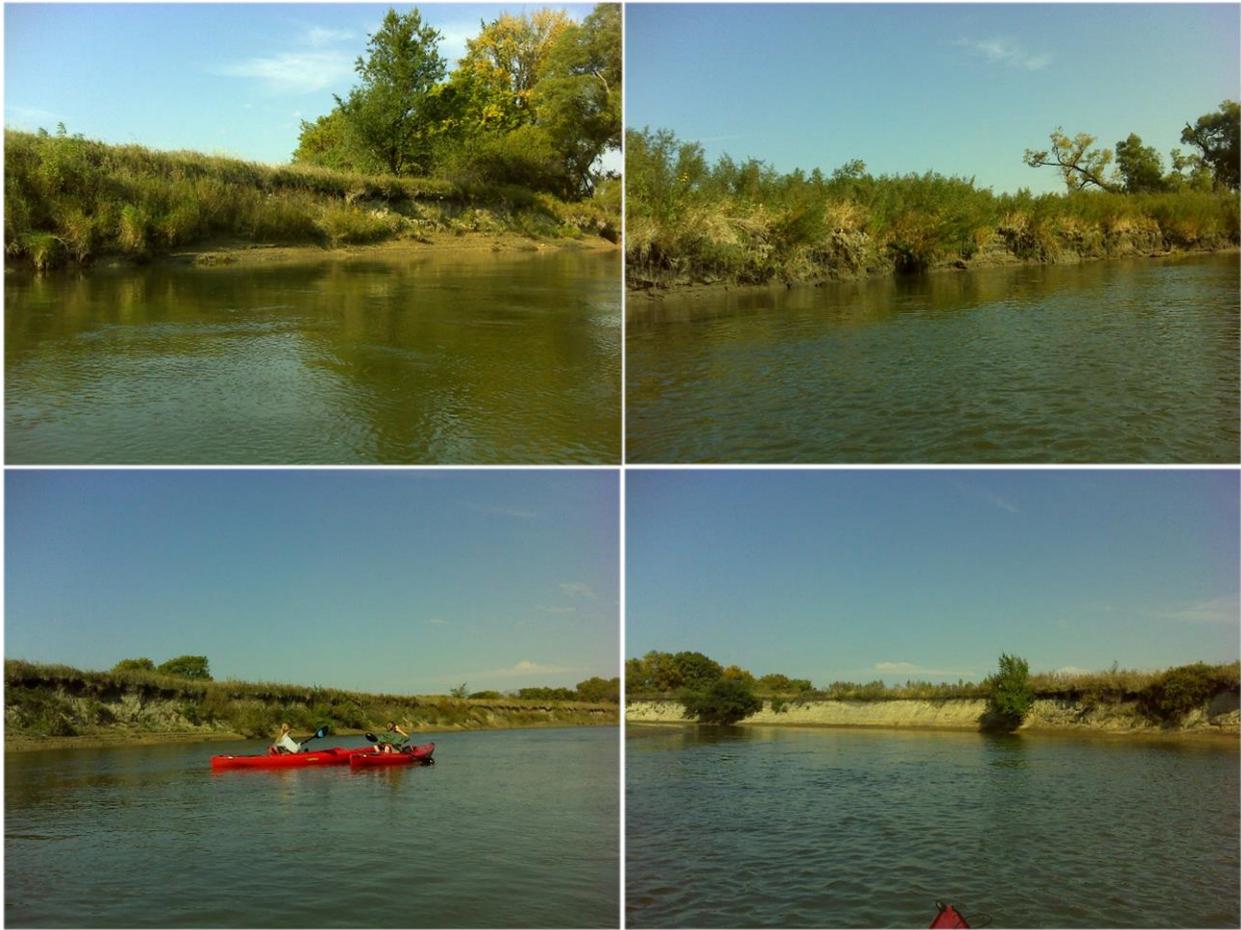
Figure 54. Images of eroded banks in the vicinity of the CSAH 10 crossing along the Otter Tail River (502) on September 12, 2018.
