Little Fork River Watershed Stressor Identification Report

A study of local stressors limiting biotic communities in the Little Fork River Watershed.

Document Number: wq-ws5-09030005

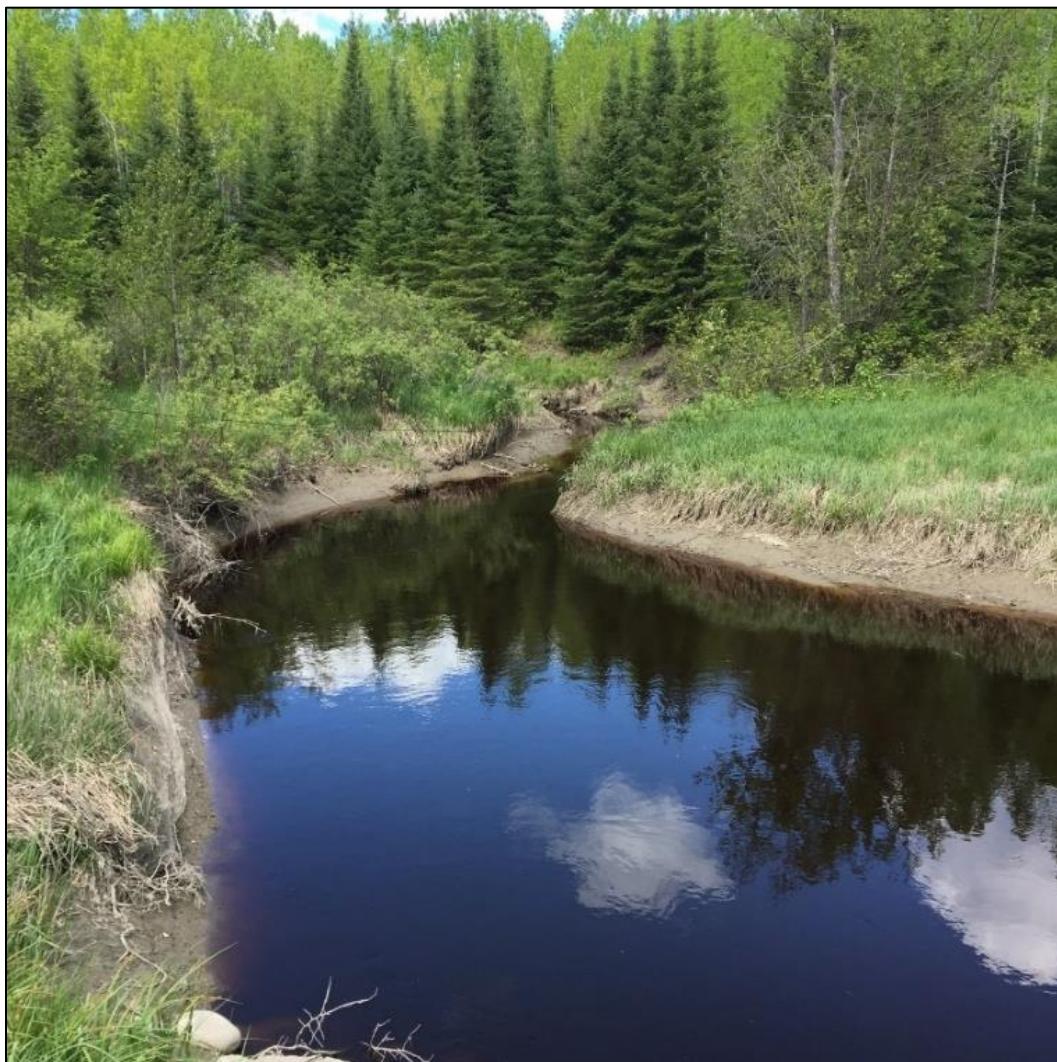
Figure 10. Looking upstream on Little Flint Creek from Olson Road.

A reconnaissance trip was made to observe Flint Creek at all of its road crossings to see if TSS appears to vary along the Creek's length and to look at the condition of banks, to help identify sediment sources or hot-spot areas of erosion. Visual observations indicated that TSS is higher in the downstream portions of the creek. Also from visual ground observations, Little Flint Creek, a tributary that enters Flint Creek at the border of AUIDs 612 and 613, appears to contribute high amounts of suspended sediment. Banks of Little Flint Creek were steep, unprotected exposed soil and the stream appeared to be incised. Some bank sloughing was observed (Figure 10 and Figure 11). Additionally, aerial photos of the confluence of Little Flint Creek with Flint Creek show much more turbid water in Little Flint Creek (Figure 12).

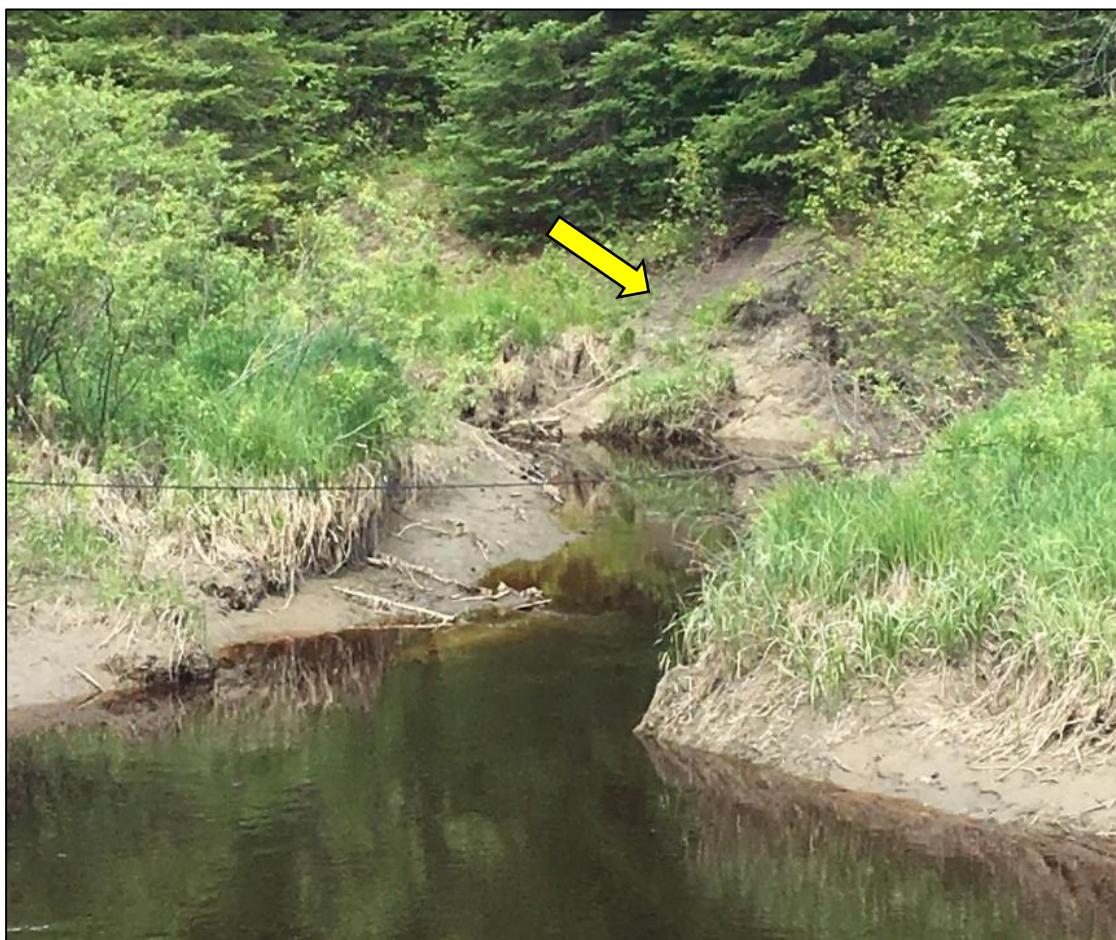
Figure 11. A closer view of a bank slump on Little Flint Creek.

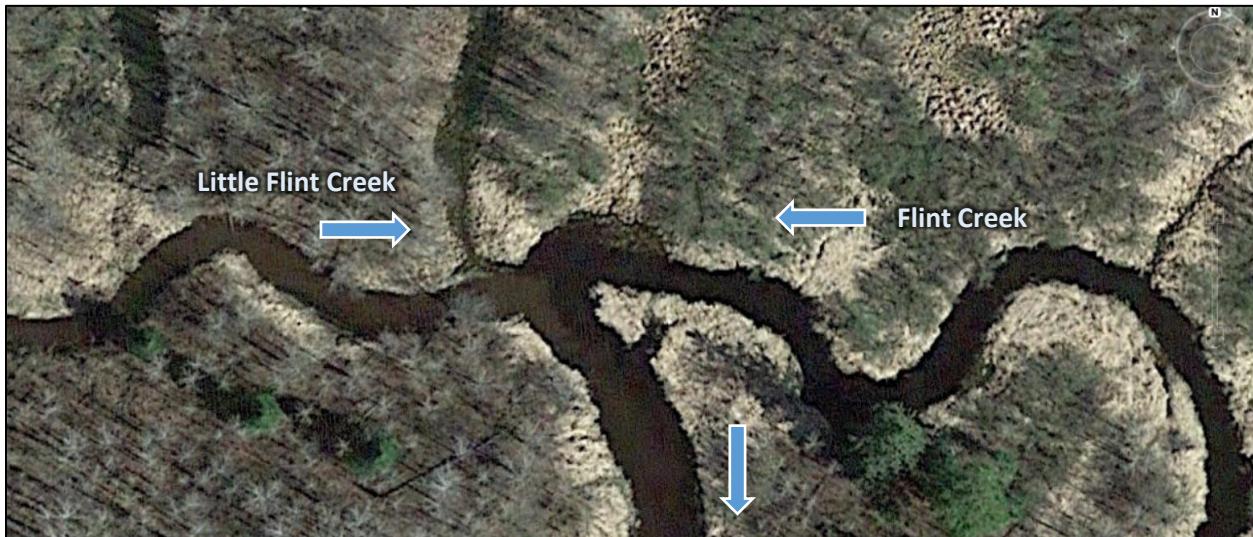
Figure 12. The confluence of Little Flint Creek with Flint Creek, showing the greater turbidity of the water in Little Flint Creek. Photo date is 5/4/2015. Arrows show flow directions.

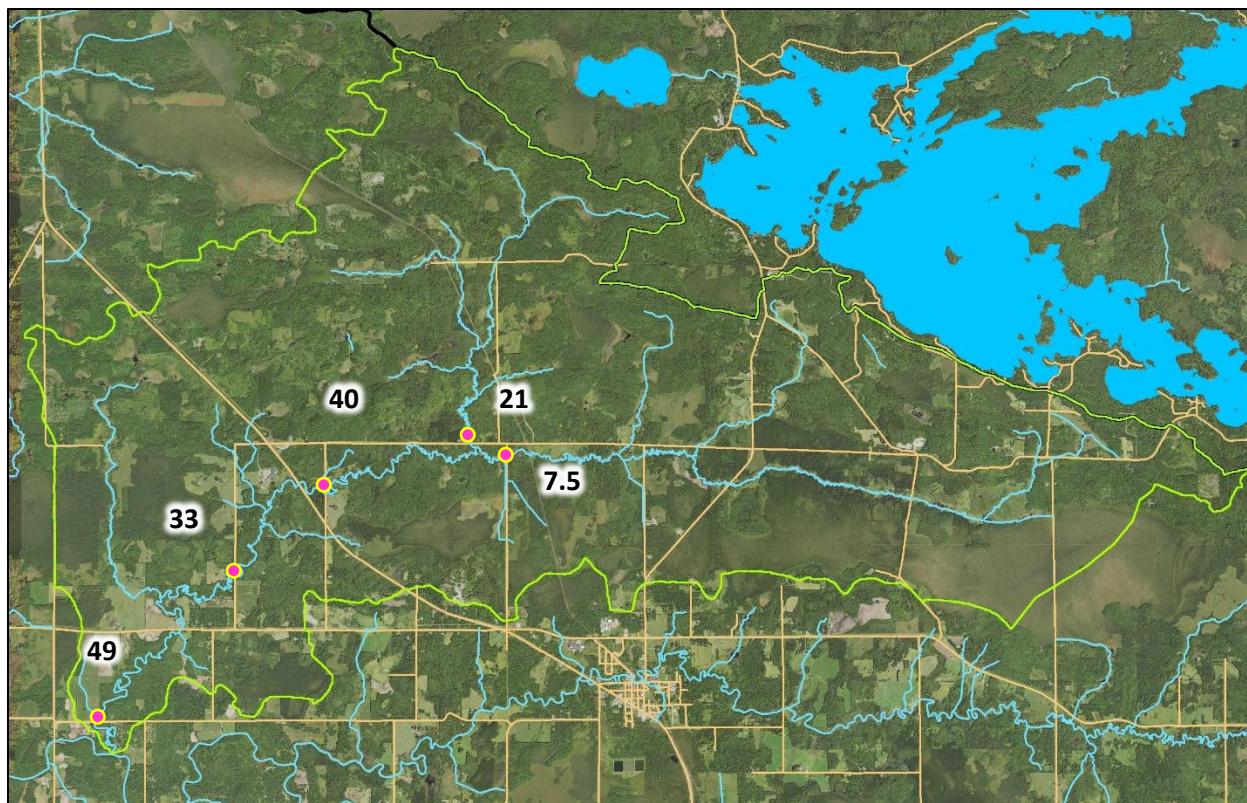
Figure 13. Map of longitudinal TSS sample sites on June 9, 2022.

Because the conclusion of the observational visit was that TSS varies along the length of Flint Creek, longitudinal TSS sampling was conducted at several crossings of Flint Creek on 6/9/2022 during baseflow conditions. Sample sites and results are shown in Figure 13 and Table 4. Sampling included a near-mouth site on Little Flint Creek, which confirmed that it has higher TSS concentration than Flint Creek does where they join. Over the full length of Flint Creek, there is a general pattern of increasing TSS from upstream to downstream, with the highest measurement at the near mouth site at Hwy-1.

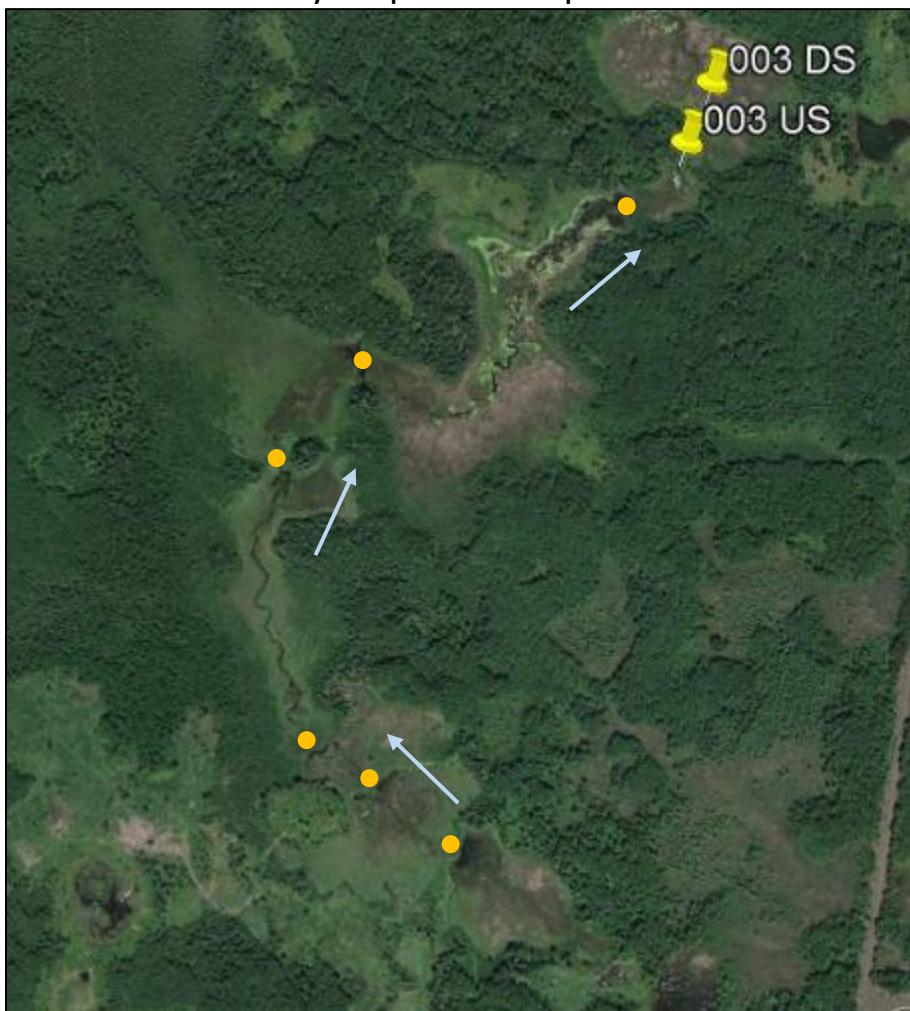
Figure 17. Stream channel upstream of 18RN003. Orange dots signify where beaver dams are located. Arrows show direction of flow. The yellow pins show the upstream and downstream ends of the 18RN003 sample reach.

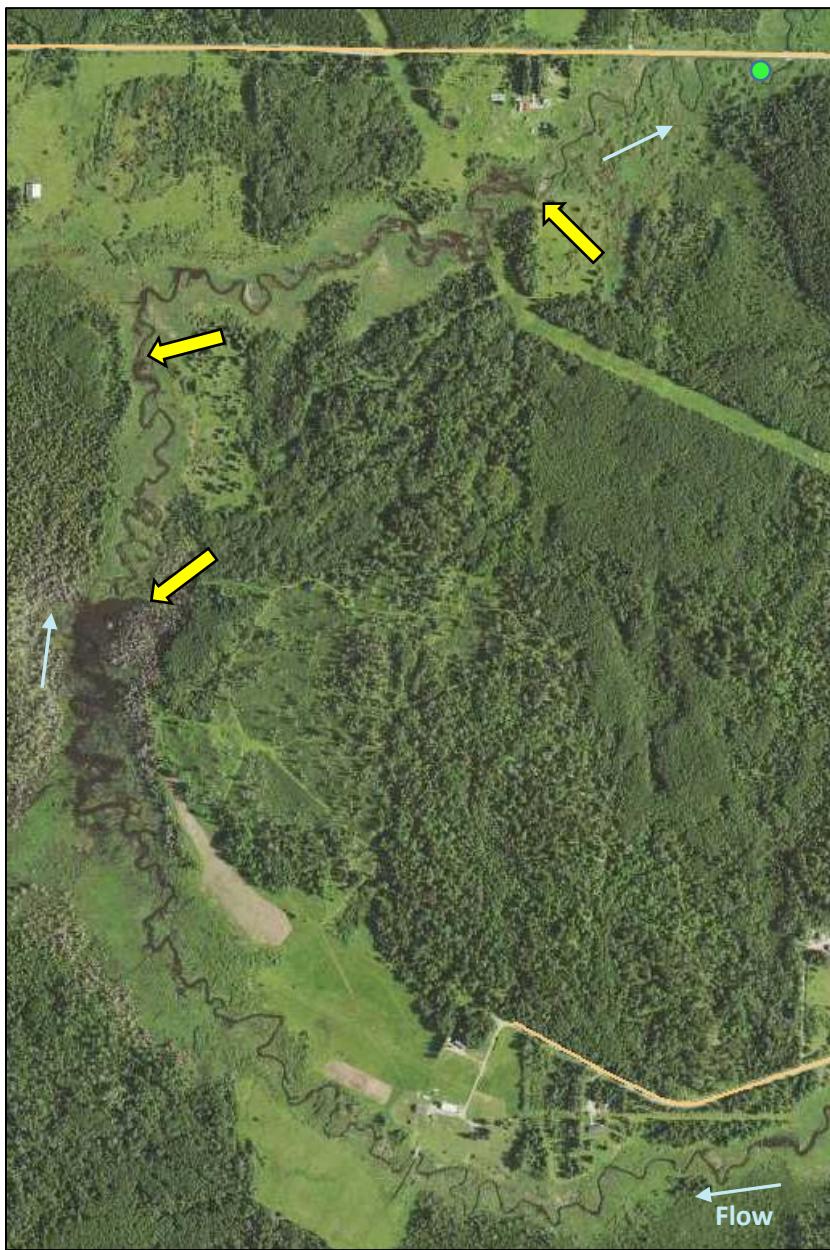
Figure 28. 2019 aerial photo, showing three beaver dams that are impounding a long stretch of the channel just upstream of the biological monitoring site 08RN011.

This is highly likely the explanation of the poor DO found in the stream in 2018, 2019, and 2020. These dams and impounded water were not present in 2008 when the first cycle biological samples were collected and IBI scores passed; the stream was free flowing at that point in time. Beaver dams are commonly found to substantially drop DO concentrations in the resulting impoundments. The low gradient nature of the channel downstream of the dams does not promote improvement of the DO concentrations by the time the water reaches the biological monitoring site.

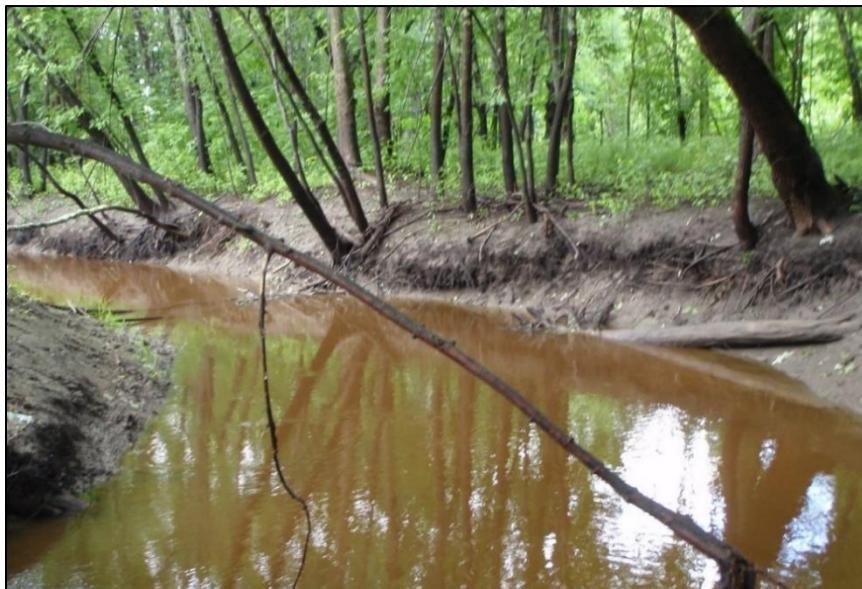
Figure 33. The channel condition at the mid-point of the 10EM129 study reach. Signs of channel instability are steep, raw soil banks, exposed tree roots, and many streamside trees tilting into the channel.

"The visual evidence suggests that this stream is incised and currently in a very unstable state. However, taking all the aspects (surveyed and observed) as a whole, the level of instability is difficult to accurately quantify. There are apparent indicators of instability such as incision, meander and deposition patterns, and channel blockage types and others that may be obscured by confounding factors (beaver activity and proximity to the main stem) which could be slowing the channel evolution process. Future repeated surveys in the area could help to clarify the situation. It seems

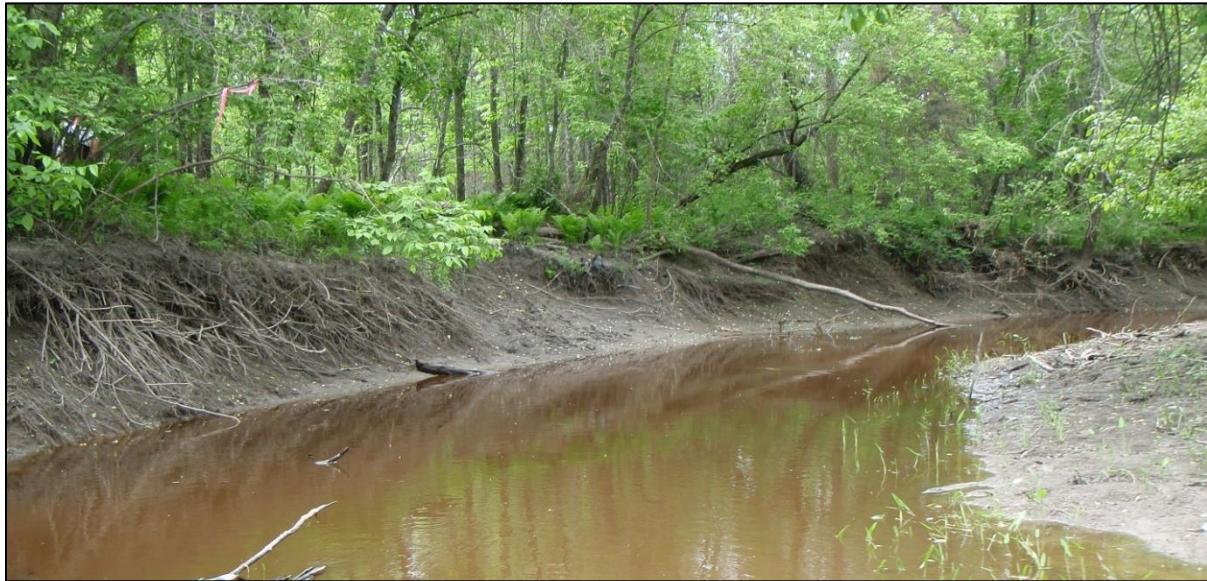
Figure 34. The Flint Creek channel at 08RN051, showing deposition of fine sediment in the middle of the channel that has accumulated smaller branches. Mid-channel sediment bars are a known sign of excessive fine sediment inputs to a stream.

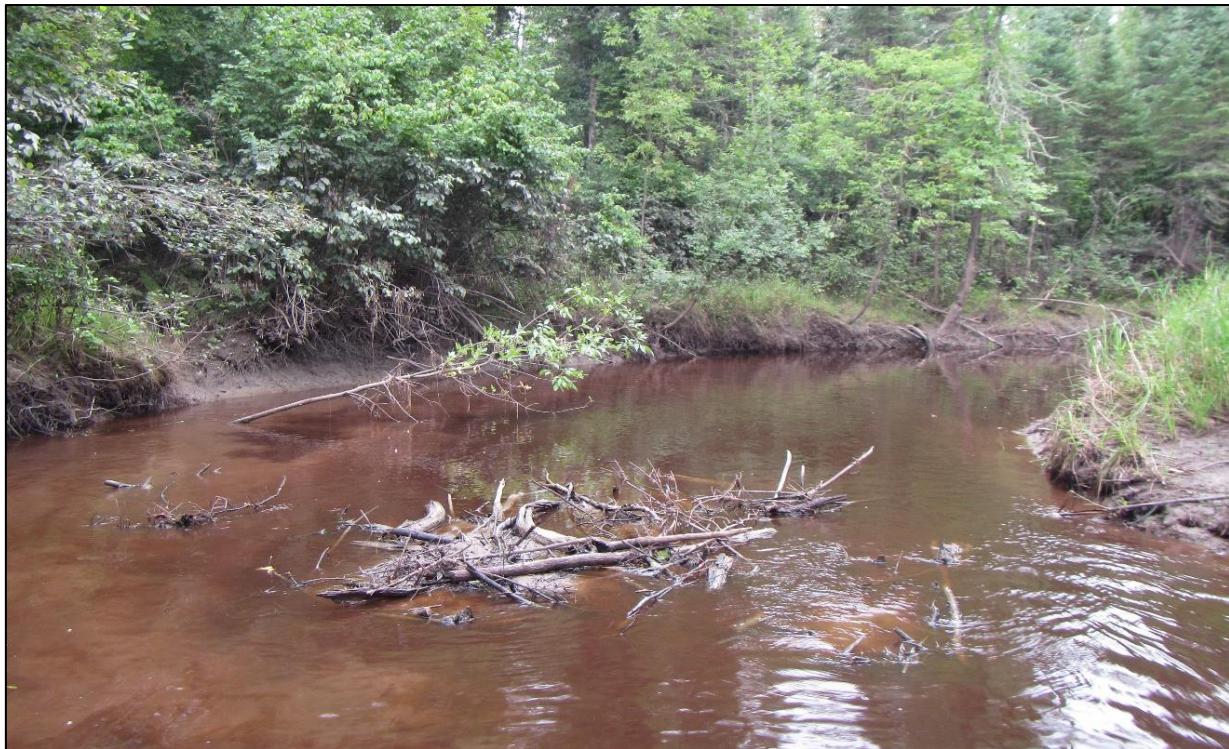
Figure 35. Substantial erosion is occurring on the outer bank, with large amounts of exposed tree roots and chunks of missing bank. Photo is at the midpoint of reach 08RN051, which is just downstream from State Highway 1.
