**FIVE-YEAR REVIEW REPORT FOR
GENERAL MILLS/HENKEL CORP SUPERFUND SITE
MINNEAPOLIS, MINNESOTA**

June 2021

**Minnesota Pollution Control Agency
Site Remediation and Redevelopment Section**

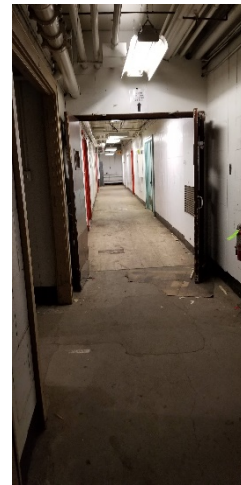
Photo 4. Tunnels of Building 10.

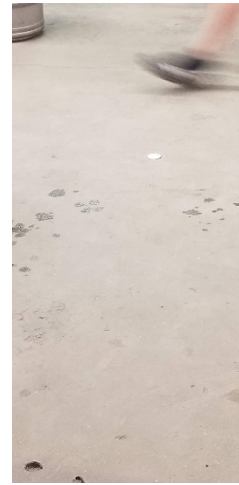
Photo 8 Sub slab vapor pin in Building 10.

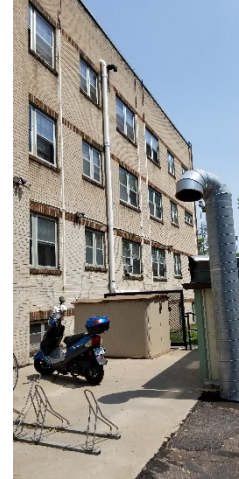
Photo 26- Varsity Apartment- commercial system.

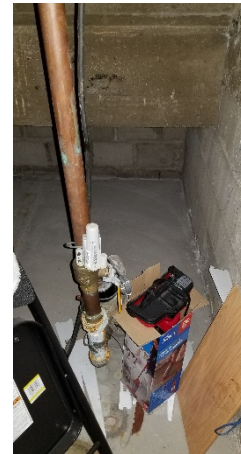
Photo 28 Varsity Apartment- commercial system.

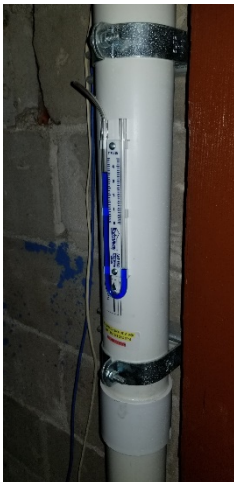
Photo 29- Varsity Apartment- commercial system.

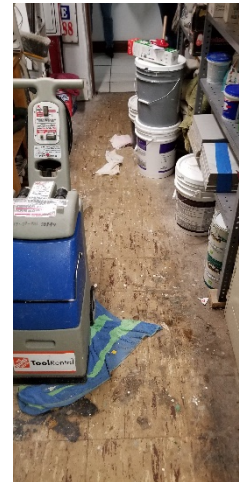
Photo 30- Varsity Apartment- commercial system.

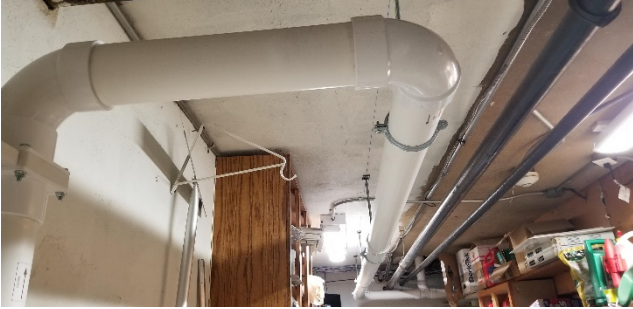
Photo 31- Varsity Apartment- commercial system.

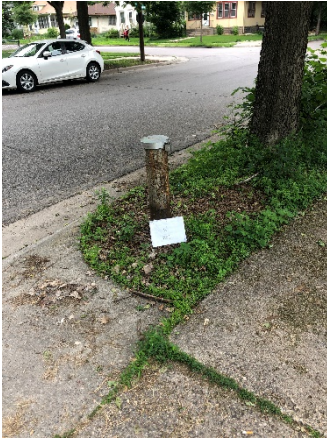
Photo 1 Well W located at 22nd and Talmadge. PVC well casing present. No bollards.

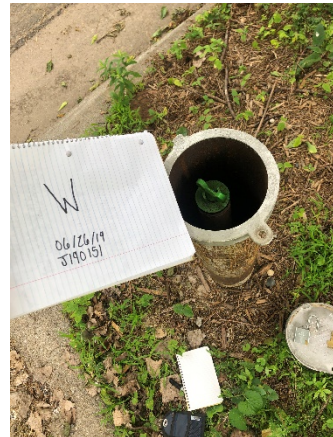
Photo 2 Well W located at 22nd and Talmadge. PVC well casing and plug present. No bollards.

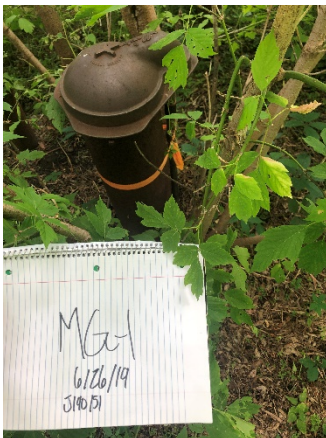
Photo 3 Well MG-1. Hidden under vegetation and behind a tree. Two bollards present, one appears to have been backed into and is slightly bent.

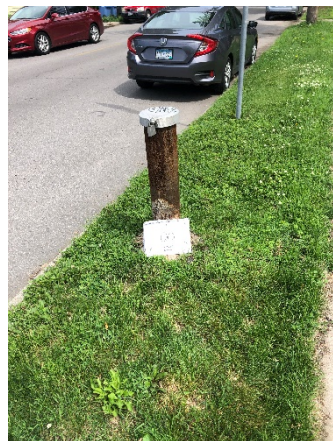
Photo 4 Well QQ. 1 1/2" well casing, plug present, no bollards.

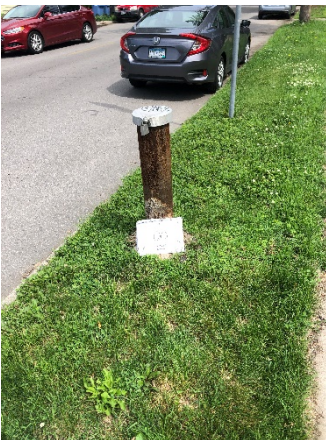
Photo 5 Well QQ. 1 1/2" well casing, plug present, no bollards.

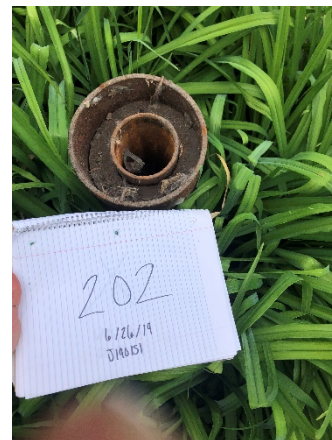
Photo 6 Well 202. 4" steel well casing, surrounded by vegetation,

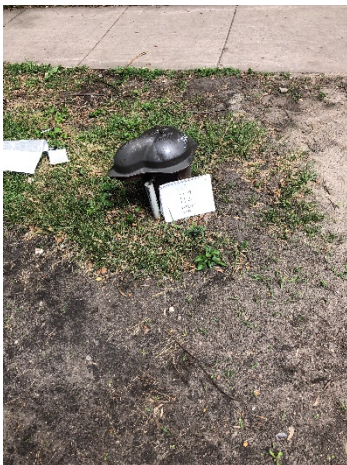
Photo 5 Well 112. 8-10" steel outer casing, electrical wires protected by PVC piping outside of well, cap bolted on, did not open. No bollards.

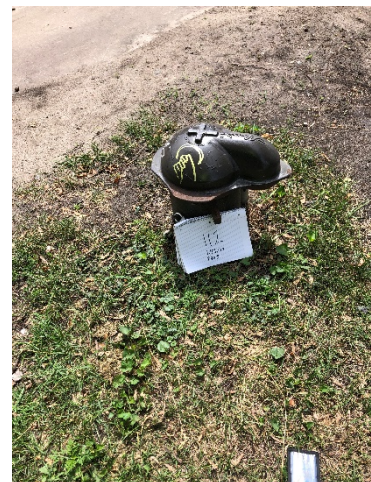
Photo 6 Well 112. 8-10" steel outer casing, electrical wires protected by PVC piping outside of well, cap bolted on, did not open. No bollards

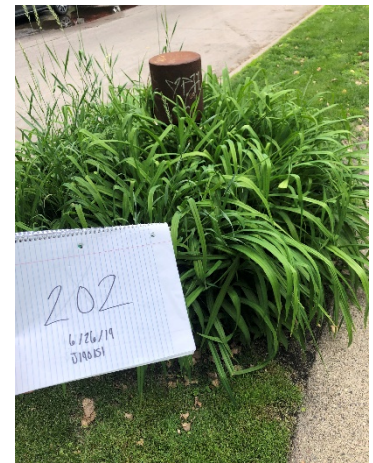
Photo 12 4" steel well casing, surrounded by vegetation, no plug/cap, no bollards.

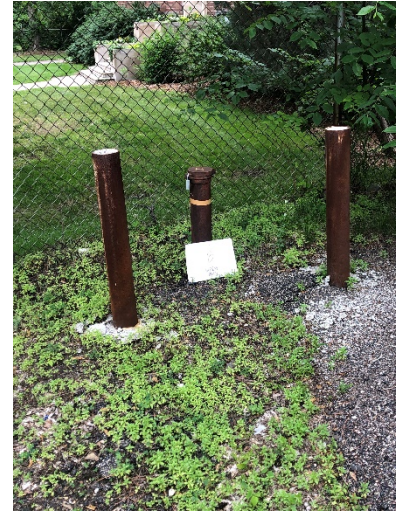
Photo 14- Well B. - ~2" PVC well casing, plug/cap present, two bollards and surrounded by fence to the south

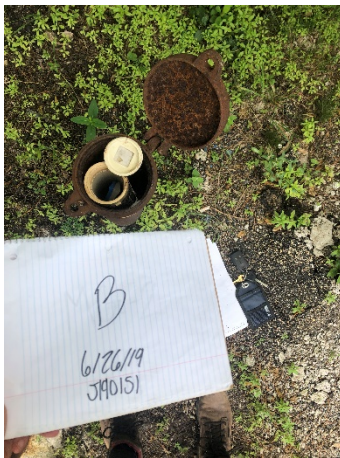
Photo 15- Well B. - ~2" PVC well casing, plug/cap present, two bollards and surrounded by fence to the south

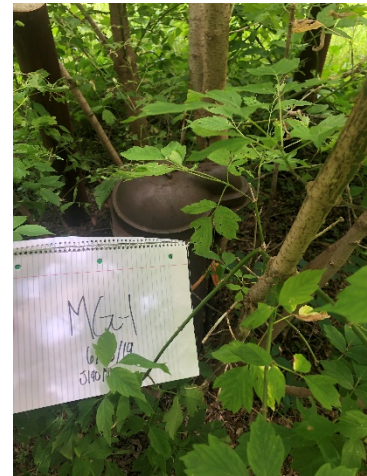
Photo 16-Well MG-1. Hidden under vegetation and behind a tree. Two bollards present, one appears to have been backed into and is slightly bent.

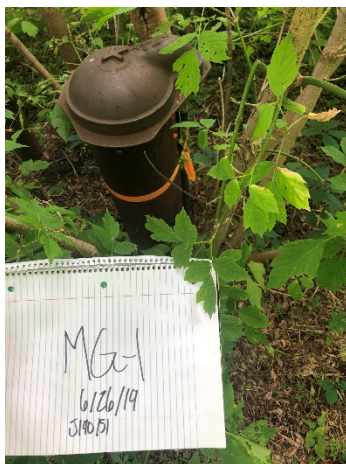
Photo 17 Well MG-1. Hidden under vegetation and behind a tree. Two bollards present, one appears to have been backed into and is slightly bent.

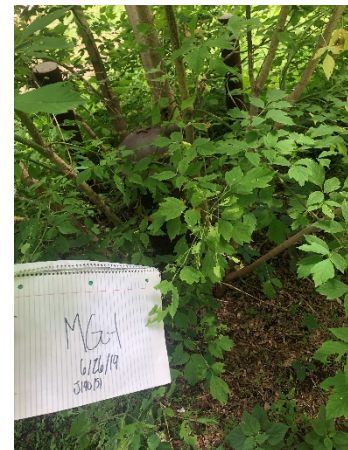
Photo 18- Well MG-1. Hidden under vegetation and behind a tree. Two bollards present, one appears to have been backed into and is slightly bent.

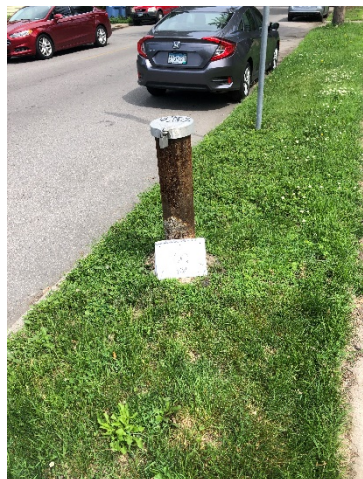
Photo 23- Well QQ. ~1 1/2" well casing, plug present, no bollards.

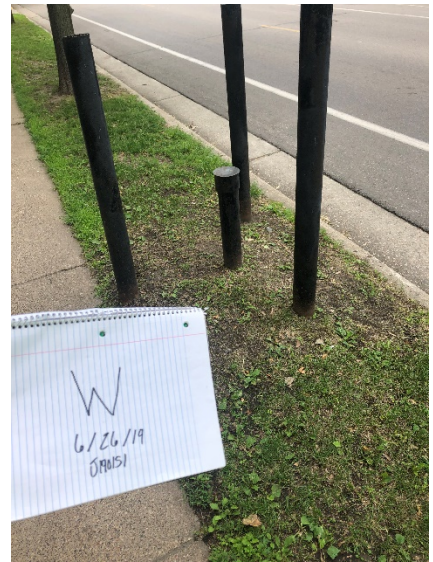
Photo 32- Well W. 2" PVC well casing, plug present, three bollards. *Two W well IDs this one located on 8th St.

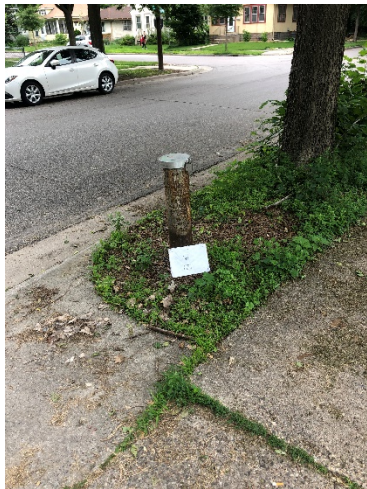
Photo 33- Well W. 2" PVC well casing, plug present, three bollards. *Two W well IDs this one located on 8th St.

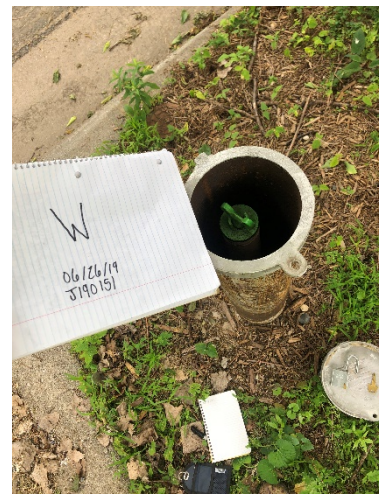
Photo 34- Well W. 2" PVC well casing, plug present, three bollards. *Two W well IDs this one located on 8th St.

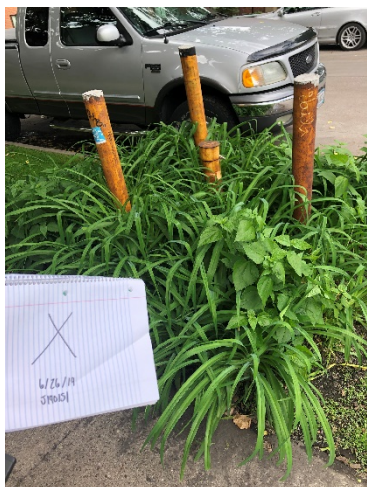
Photo 35- Three bollards, unable to remove lock.
