Swan River Channel Stability and Geomorphic Assessment

Technical Memo

Submitted to the MPCA

South St. Louis County Soil and Water Conservation District

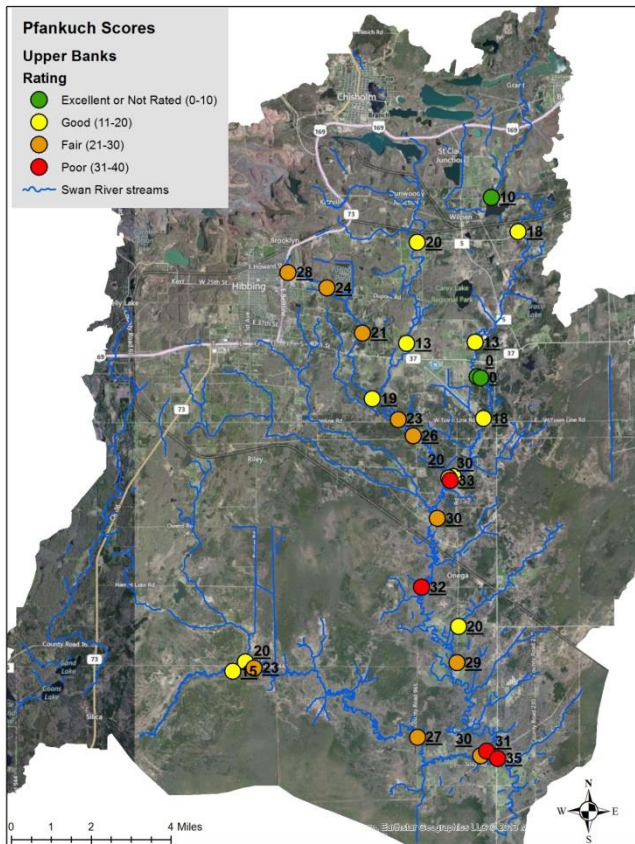
Results from these Pfankuch assessments are shown in Figure 6 through Figure 8. Generally speaking, stream instability is increasing (Pfankuch scores increase) longitudinally down the watershed. An exception to this is the upper portion of Penobscot Creek which, due to the historic channelization of that reach, has very high instability scores.

The instability of most sites is manifested in very high lower bank and channel bottom scores. Commonly, these unstable reaches had continuous bank cutting (sometimes over 24" high), extensive deposits of fine particles, accelerated point bar development, low bank rock content, evidence of shifting channel substrate, and little to no aquatic vegetation. These characteristics are indicative of an incised system that is eroding its banks and depositing material on point bars. The extensive sediment deposits in the lower reaches of this watershed suggest that perhaps the incision process has ended and the channel is now widening, aggrading, and stabilizing within the incised system. Given the cohesive nature of the banks, however, this process may take decades and continue to contribute suspended sediment in the meantime.

Figure 6: Pfkuch upper bank ratings.

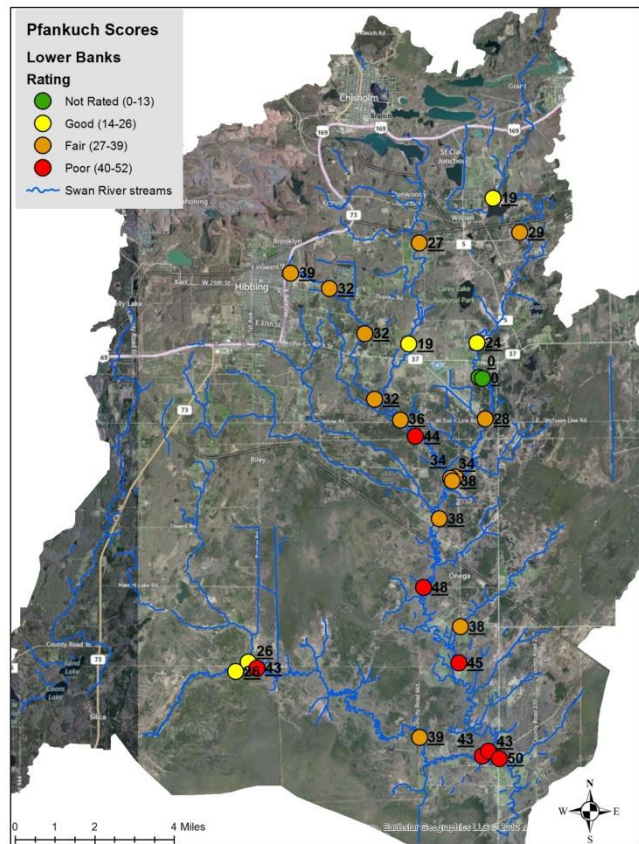
Figure 7: Pfkuch lower bank ratings.

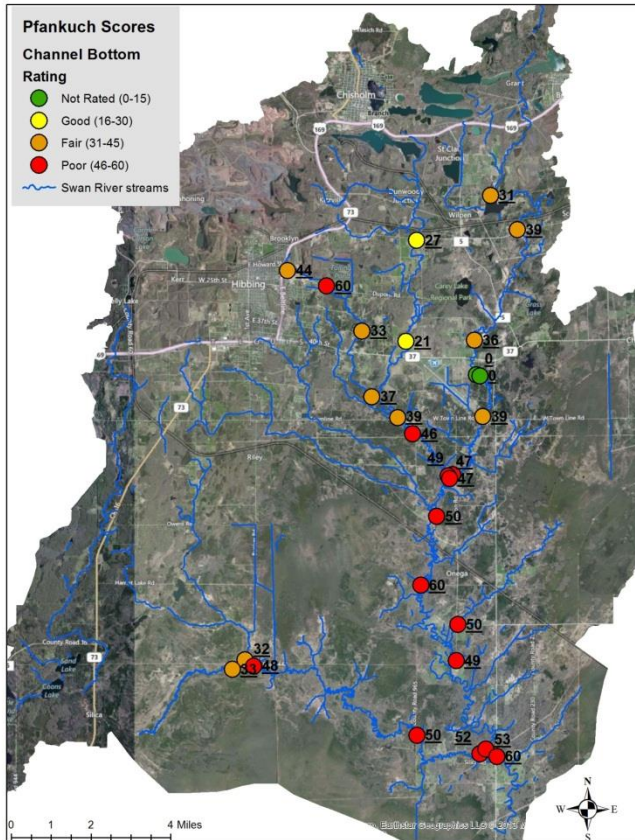
Figure 8: Pfkuch channel bottom ratings.

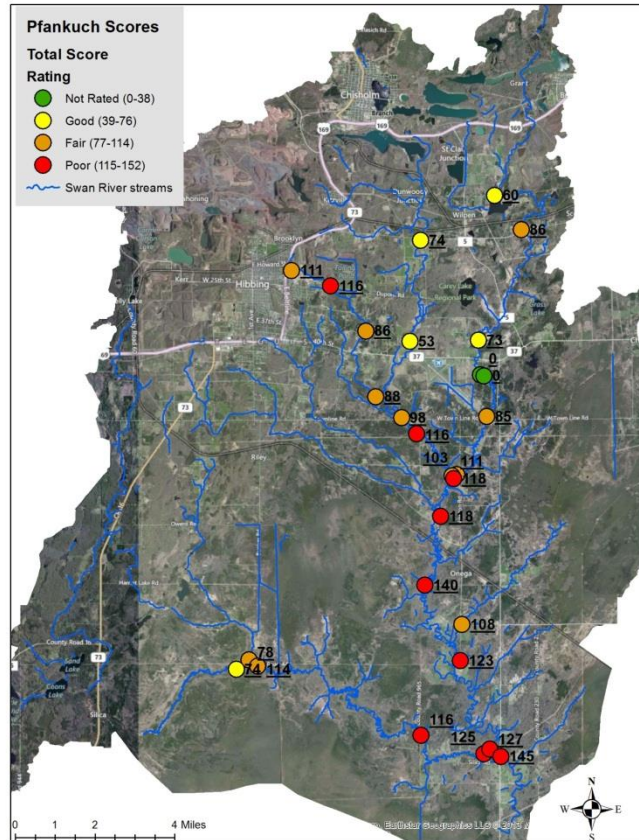
Figure 9: Pfkuch total score ratings.

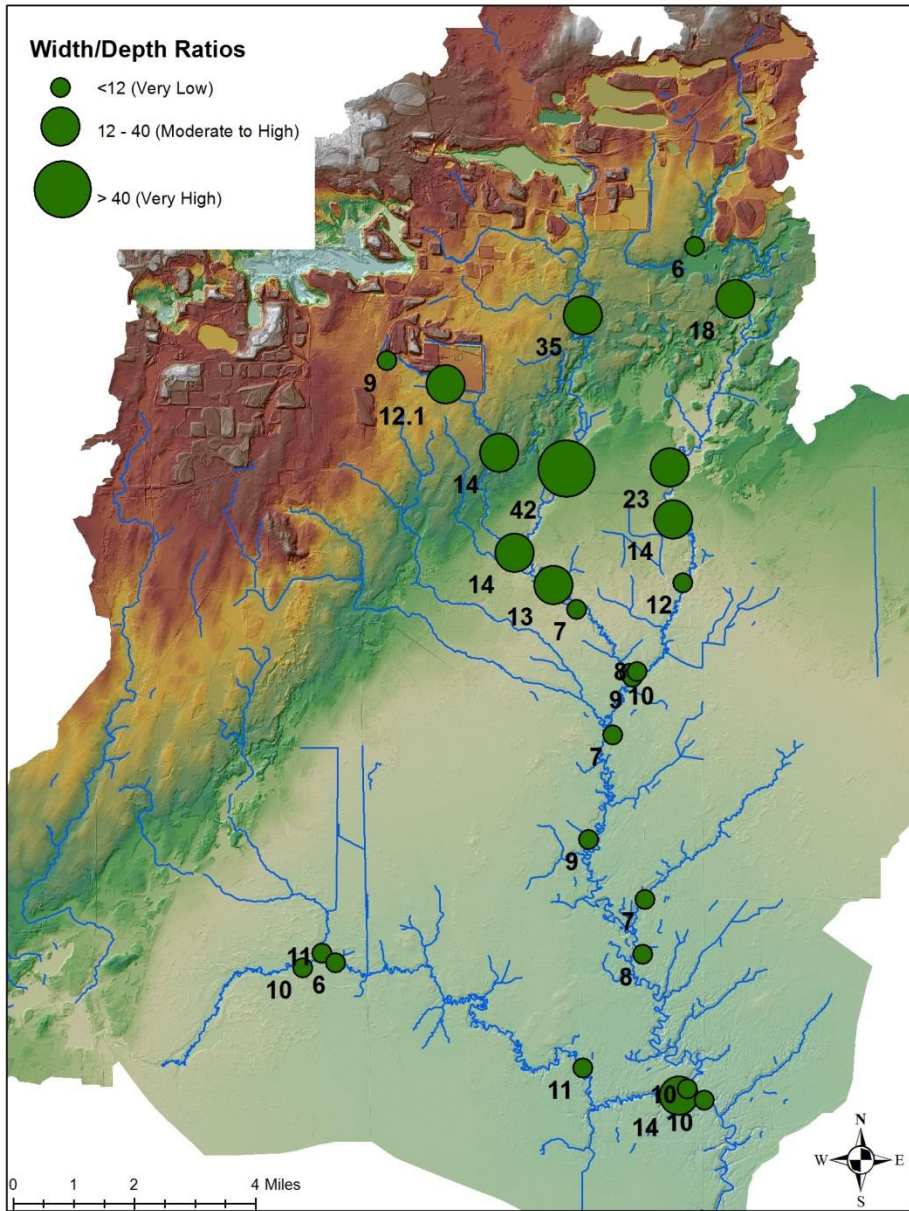
There is a general trend of decreasing W/D ratios longitudinally down the watershed. Two notable exceptions are 1) Penobscot Creek @ Hwy 73 (W/D of 9) due to channelization and 2) West Swan River at the East Swan confluence (W/D of 14) due to widening after incision.

Figure 14: Measured width/depth ratios at rapid assessment sites.

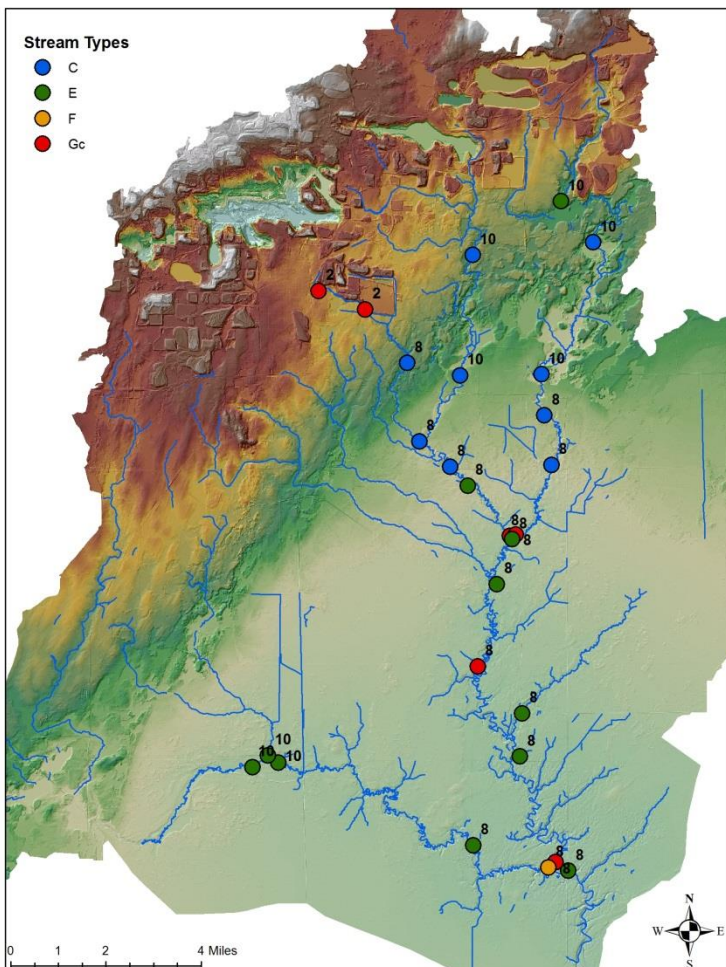
Using field observations, slope, W/D ratios, and entrenchment ratios, stream and valley types were determined for all 28 sites (Figure 19). Narrow, deep and sinuous "E" channels were most common and dominated the lower reaches of the

watershed. As stated before, many of the sites are moderately to deeply incised in the lower stretches of the Dempsey, Barber, East Swan and West Swan systems. Some of those sites are incised enough to type out as low-gradient "G" channels (highly unstable streams in lacustrine or alluvial valleys). Additionally, an unstable "F" channel was found just upstream of the West Swan River mouth – most likely this stream is widening and was previously a narrower "G" channel. Wider, less sinuous "C" channels were present in slightly higher-gradient reaches, and occurred north of Highway 16. Photo examples of each of the four stream types documented in the Swan River watershed are shown in Figure 20. It is worth noting that the "E" channels in the lower reaches were on the verge of typing out as G or F channels, and were either lacking the required incision or entrenchment ratios to properly classify as those unstable stream types. Nevertheless, the E channels in the lower half of the watershed are in poor condition, as evidenced by the Pfankuch ratings and increased levels of suspended sediment. Many of them require almost a 50-year flood event to access their floodplains.

Figure 19: Stream and valley types in the Swan River watershed. Stream types are color-coded and valley types are labeled.

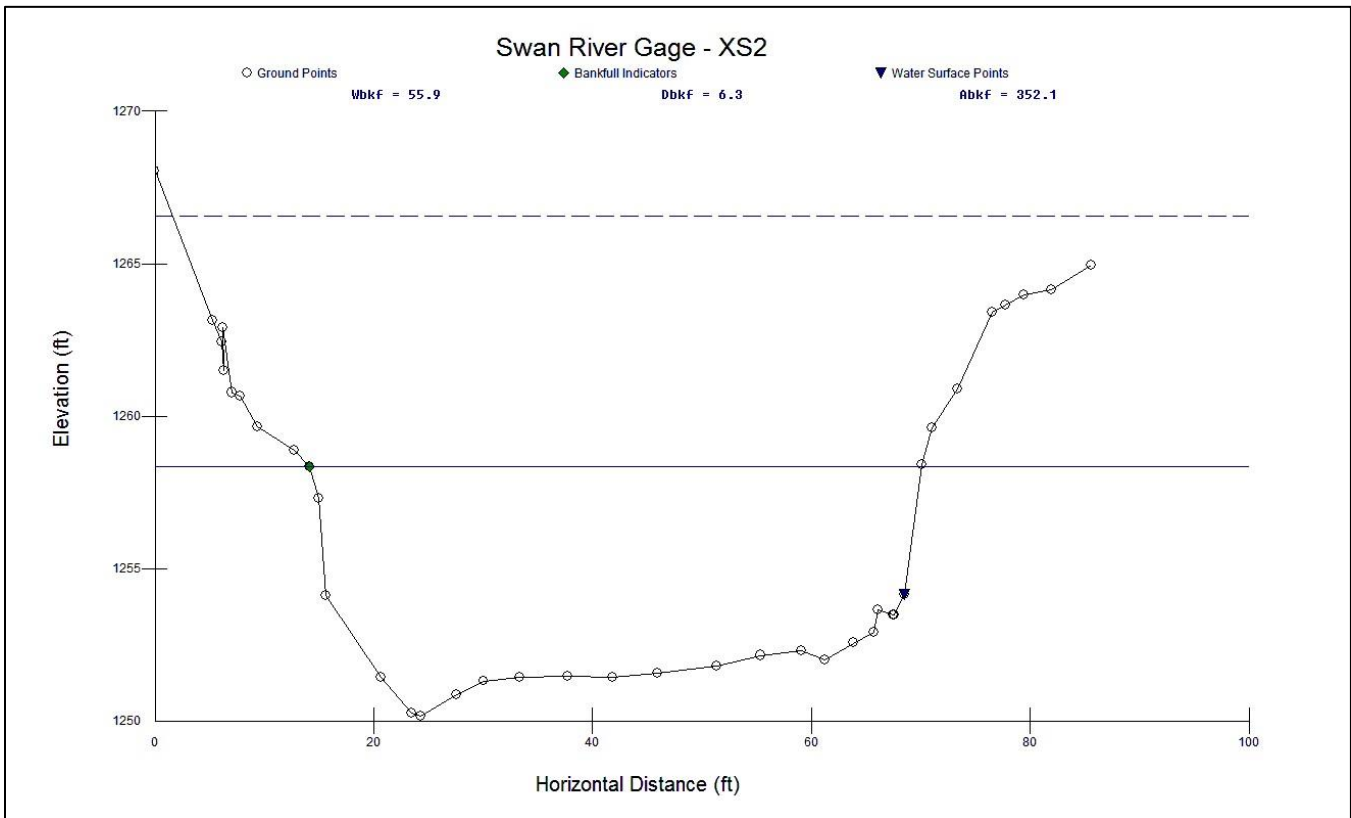
Figure 23: Cross section 2, taken at STA 4+69.

XS2 at STA 4+69 did not have a reliable bankfull indicator due to incision; therefore XS1 at STA 1+36 was used to determine the hydraulic relations for the reach. The observed bankfull elevation at XS1 was 1261.96 ft. The water surface at XS1 was measured to be 0.19 ft below the water surface at the gage station. Therefore, in order to relate the bankfull elevation at XS1 to the gage records, 0.19 ft was added for a gage bankfull elevation of 1262.15 ft. Using the rating table obtained from MN DNR (Table 1), the water surface elevation of 1262.15 ft corresponds to a discharge (Q) of between 1265 and 1284 cfs.

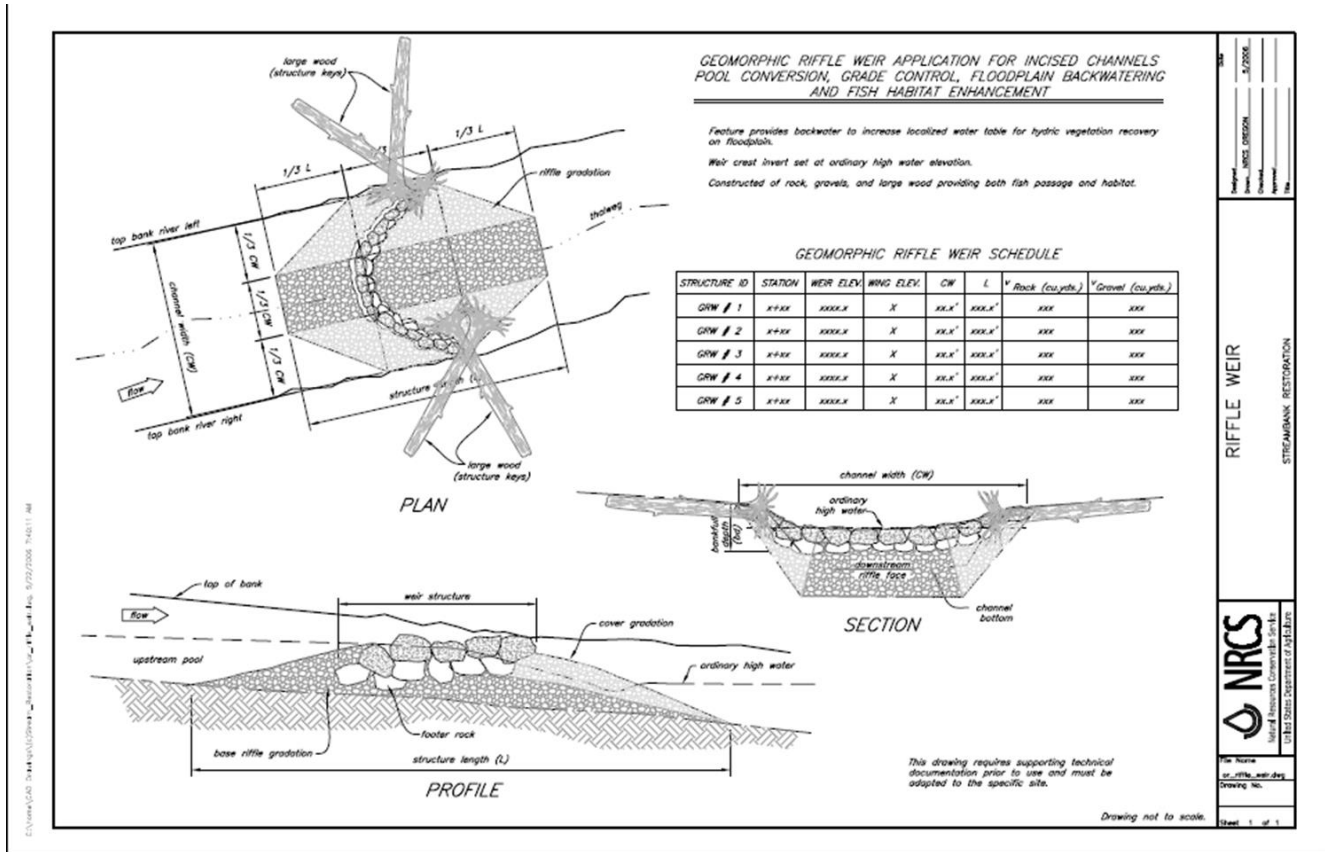
Figure 44: Example of grade control structure to halt headcut advancement.

The second option is to attempt to hinder, reverse, or accelerate channel succession. For example, in the case of channel evolution Model #5, installing grade control (Figure 44) above a headcut would prevent headcut propagation. In essence this would hinder channel succession, preventing the evolution of an “E” channel into a “G”. Installing flood-plain culverts (Figure 45) would improve flow conditions and hinder channel degradation and succession, but ultimately would not address the problem of headcut advancement. Installation of stormwater retention BMPs (Best Management Practices) throughout the watershed would also hinder channel succession by attenuating peak flows and reducing shear stresses on channel banks.

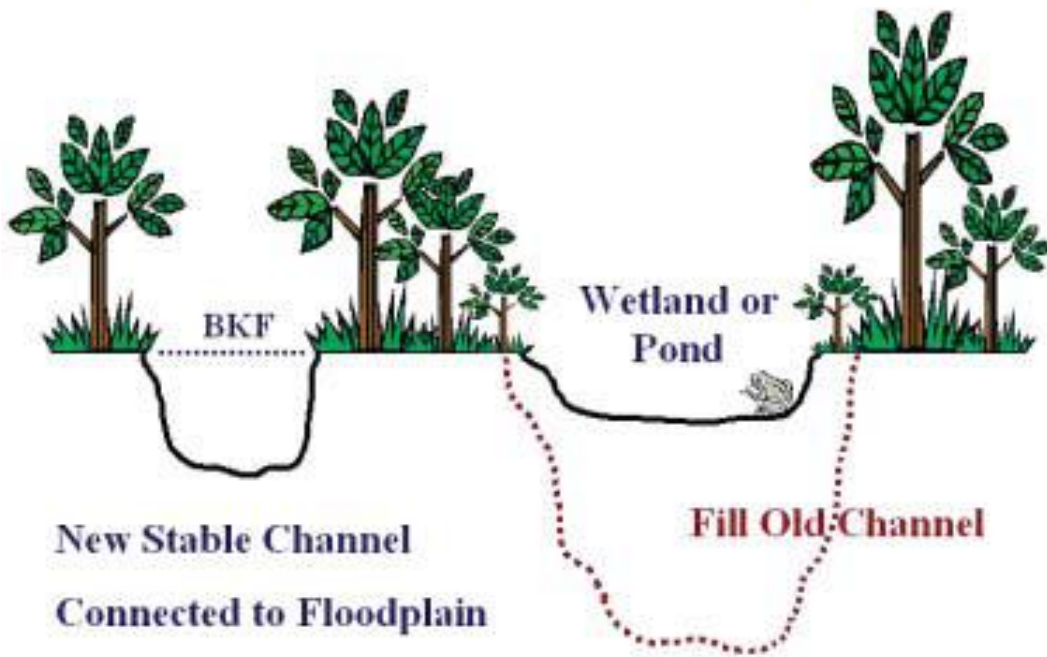
Figure 46: Channel succession can be reversed by filling in an incised reach.

Channel succession could also be reversed by installing grade control in an incised reach, and then converting the upstream “G” or “F” channel back to a stable “E” at the previous channel elevation (Figure 46). Due to the vast amount of fill material required, this scenario would probably not be cost-effective. It would, however, have the advantage of benefiting aquatic life and floodplain vegetation by raising the water table.

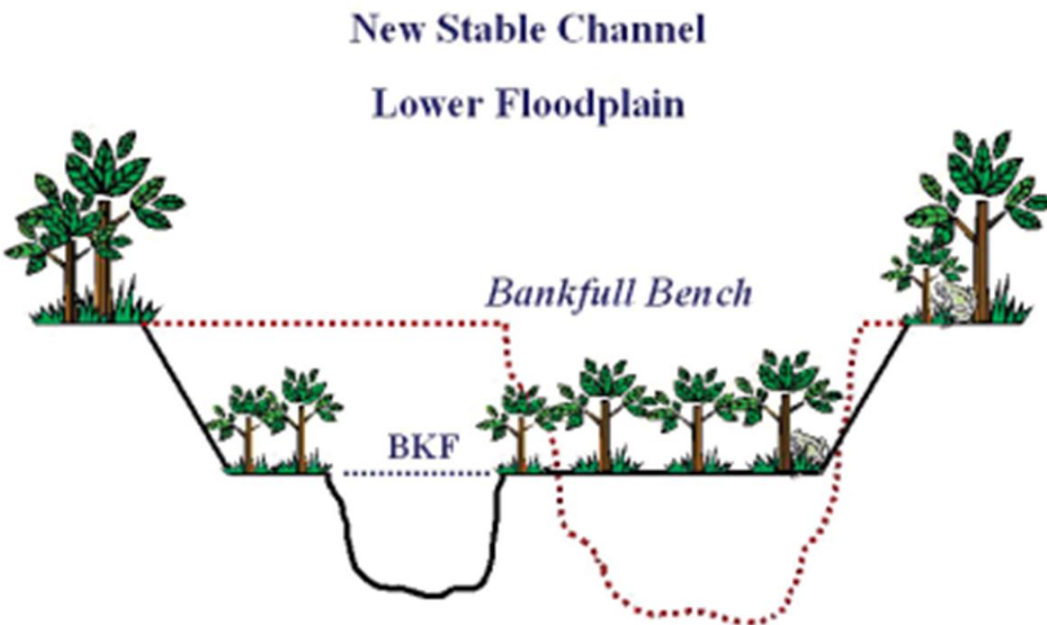
Figure 47: Channel succession can be accelerated by constructing a new channel and “jumping” to the stable end-point of the channel succession model.

The final option would be to construct bankfull benches and floodplains at the new bankfull elevation in incised reaches (Figure 47). This essentially accelerates the succession model past the unstable stages.
