FIVE-YEAR REVIEW REPORT First Review

St. Louis River Superfund Site

Date
September 2003

St. Louis River/Interlake/Duluth Tar Site, Tar Seep OU – EPA OU 01

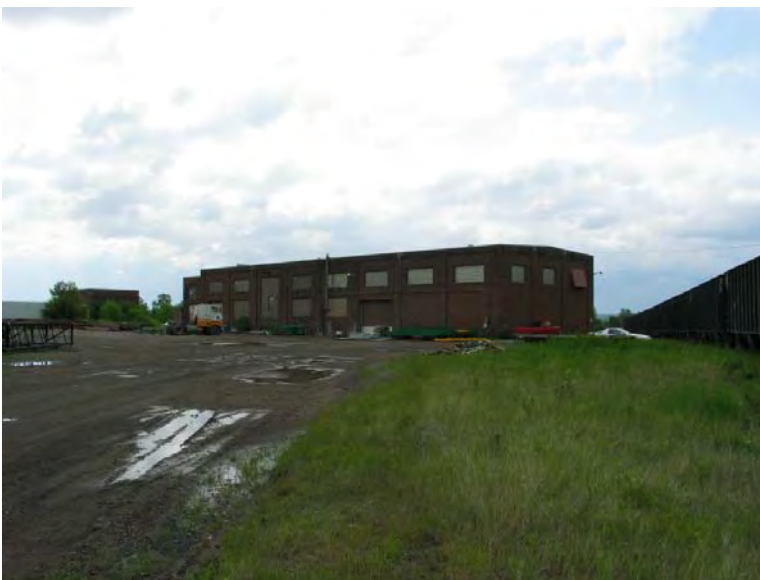
Several of the original buildings remain and are currently used by a paint shop. This photo is taken from the north of Area B looking to the southeast.

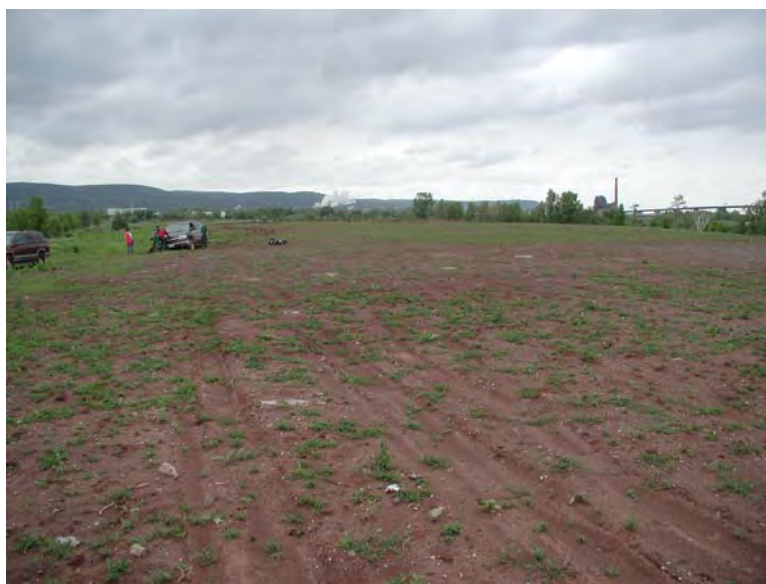
The original surface elevation that was present following the Soil OU remedial activities has been amended with several feet of additional fill placed by Hallett Dock. See Figure 7 for a cross section view of the original site elevation and this fill. The source of this loose fill is reportedly from city street projects.

A few areas of erosion were observed in the fill placed by Hallett post remedial action. These do not appear to be impacting the original remedy based on the elevation of the original cover as compared to the fill.

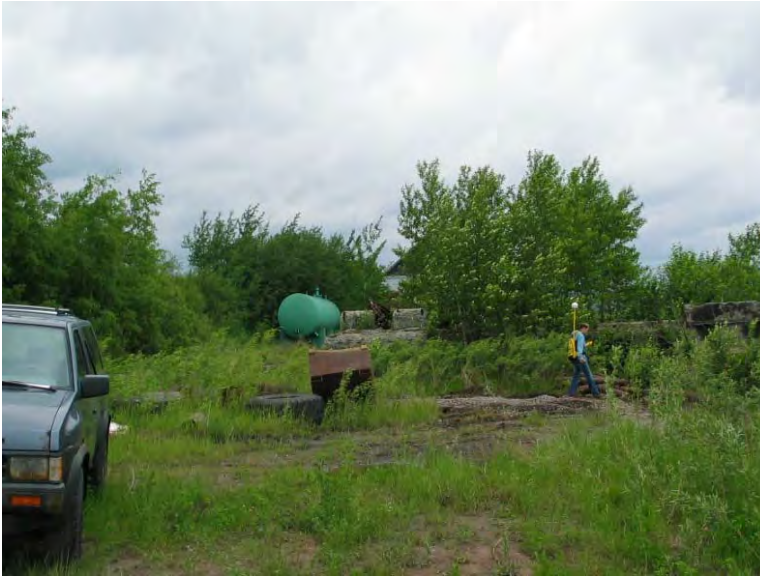
Looking north to the former location of two tanks removed during the Tar Seep remedial action is viewed to the left. This area of excavation was approximated using GPS and is shown on Figure 7 as Area D-1.

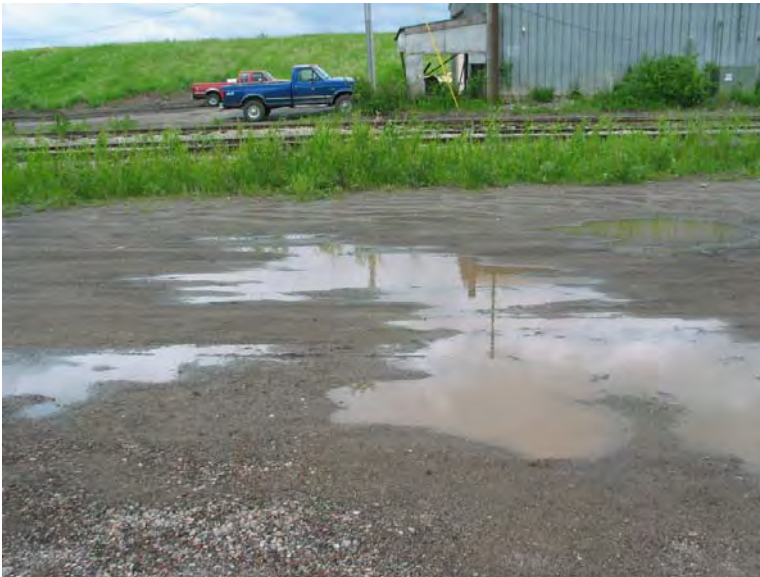
This former location of two tanks removed during the Soil OU remedial action is the location originally identified as the Area D Tar Seep. The location was marked by GPS and is shown on Figure 7 as Area D-2.

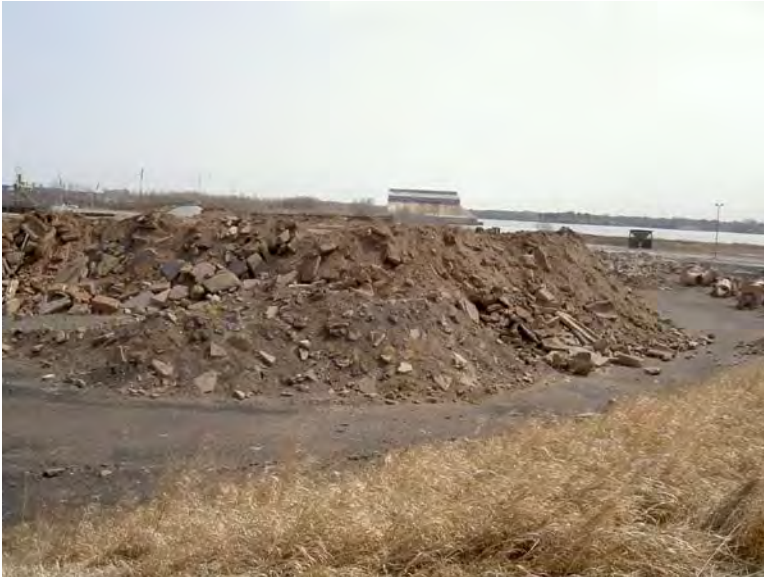
This photo is the concrete recycling operation as seen on April 24, 2003 from top of berm looking east.

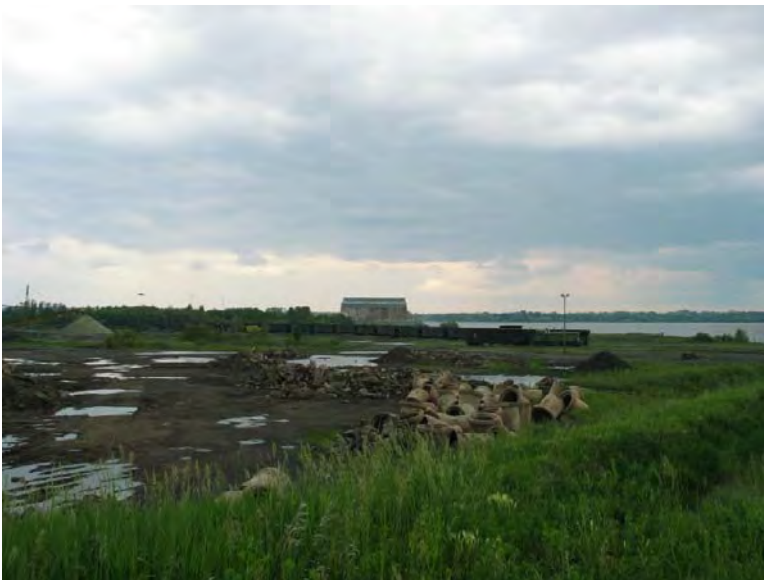
Photographed to the left is the concrete recycling operation as seen on June 25, 2003 from top of berm looking east.

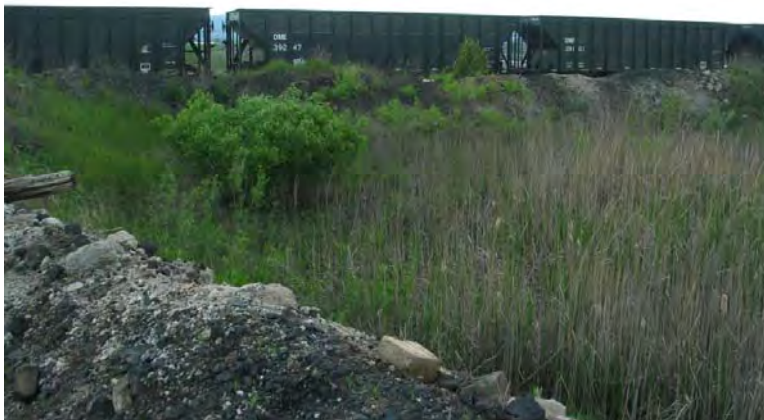
Looking northeast at a circular bermed area that is located at the southern end of the 59th Ave. peninsula.

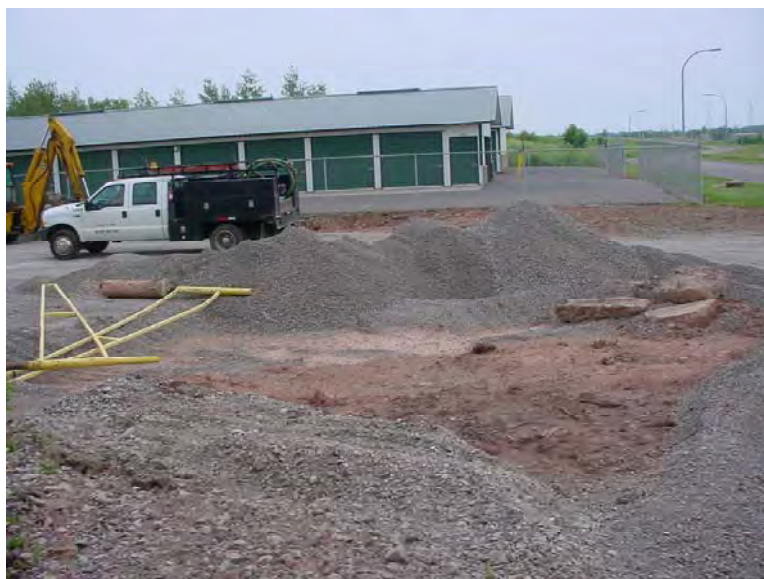
The area known as Maurices' Parking lot continues to be used for industrial purposes. Nothing of significance was noted during the June 2003 visit. A shallow excavation, to a depth of two feet or less, was observed on July 25, 2003. This activity is not in conflict with land use required by the ROD.

To the left is the backside of Maurices' Parking lot, looking east.

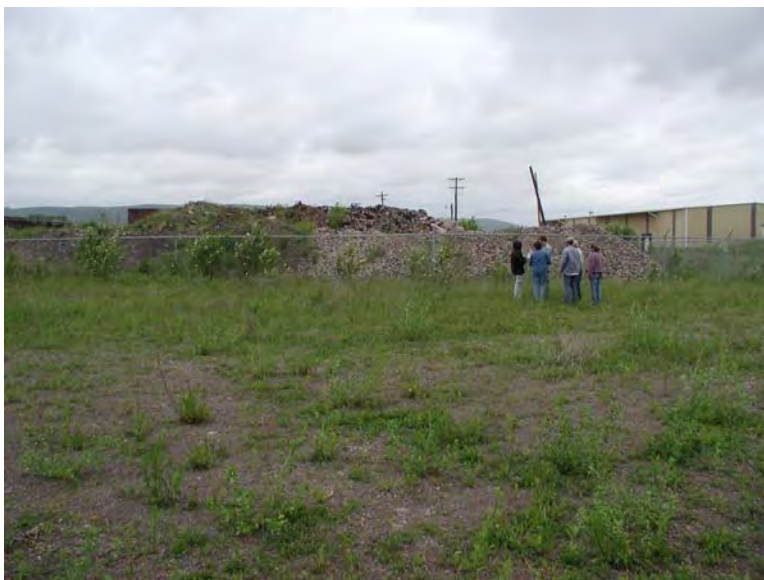
The tar seep was originally located at the fence line, approximately where the ground is standing. This point was marked using GPS and is shown as Area A/E tar seep on Figure 7

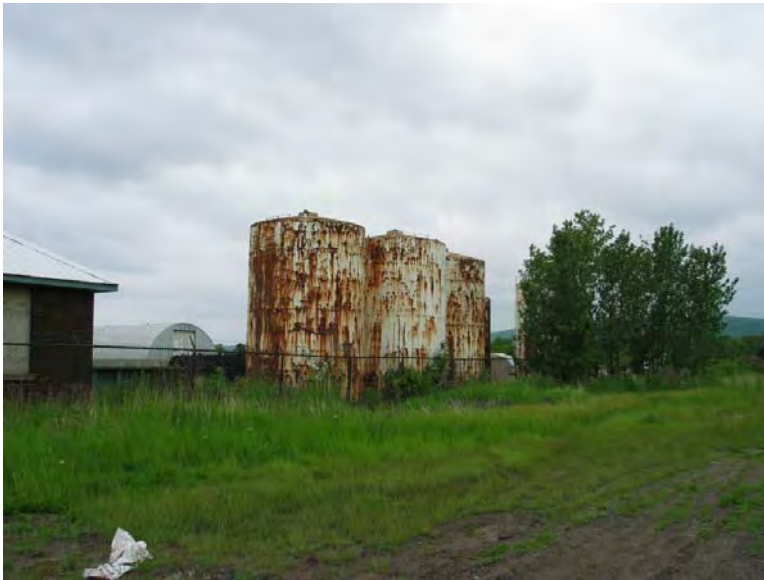
Shown to the left is the north side of Area E looking to the southwest.
