**Second Five-Year Review Report
Volume II
Attachments**

**St Louis River/Interlake/Duluth Tar Site
Tar Seep OU - EPA OU 01
Soil OU – EPA OU-3**

September 2008

Draft
SECOND FIVE-YEAR REVIEW SITE INSPECTION REPORT
St. Louis River/Interlake/Duluth Tar Site
EPA OU 01-Tar Seeps Operable Unit (TSOU)
EPA OU 03-Soil Operable Unit (SOU)
EPA OU 04-Sediment Operable Unit (SedOU)
May 5 and 9, 2008

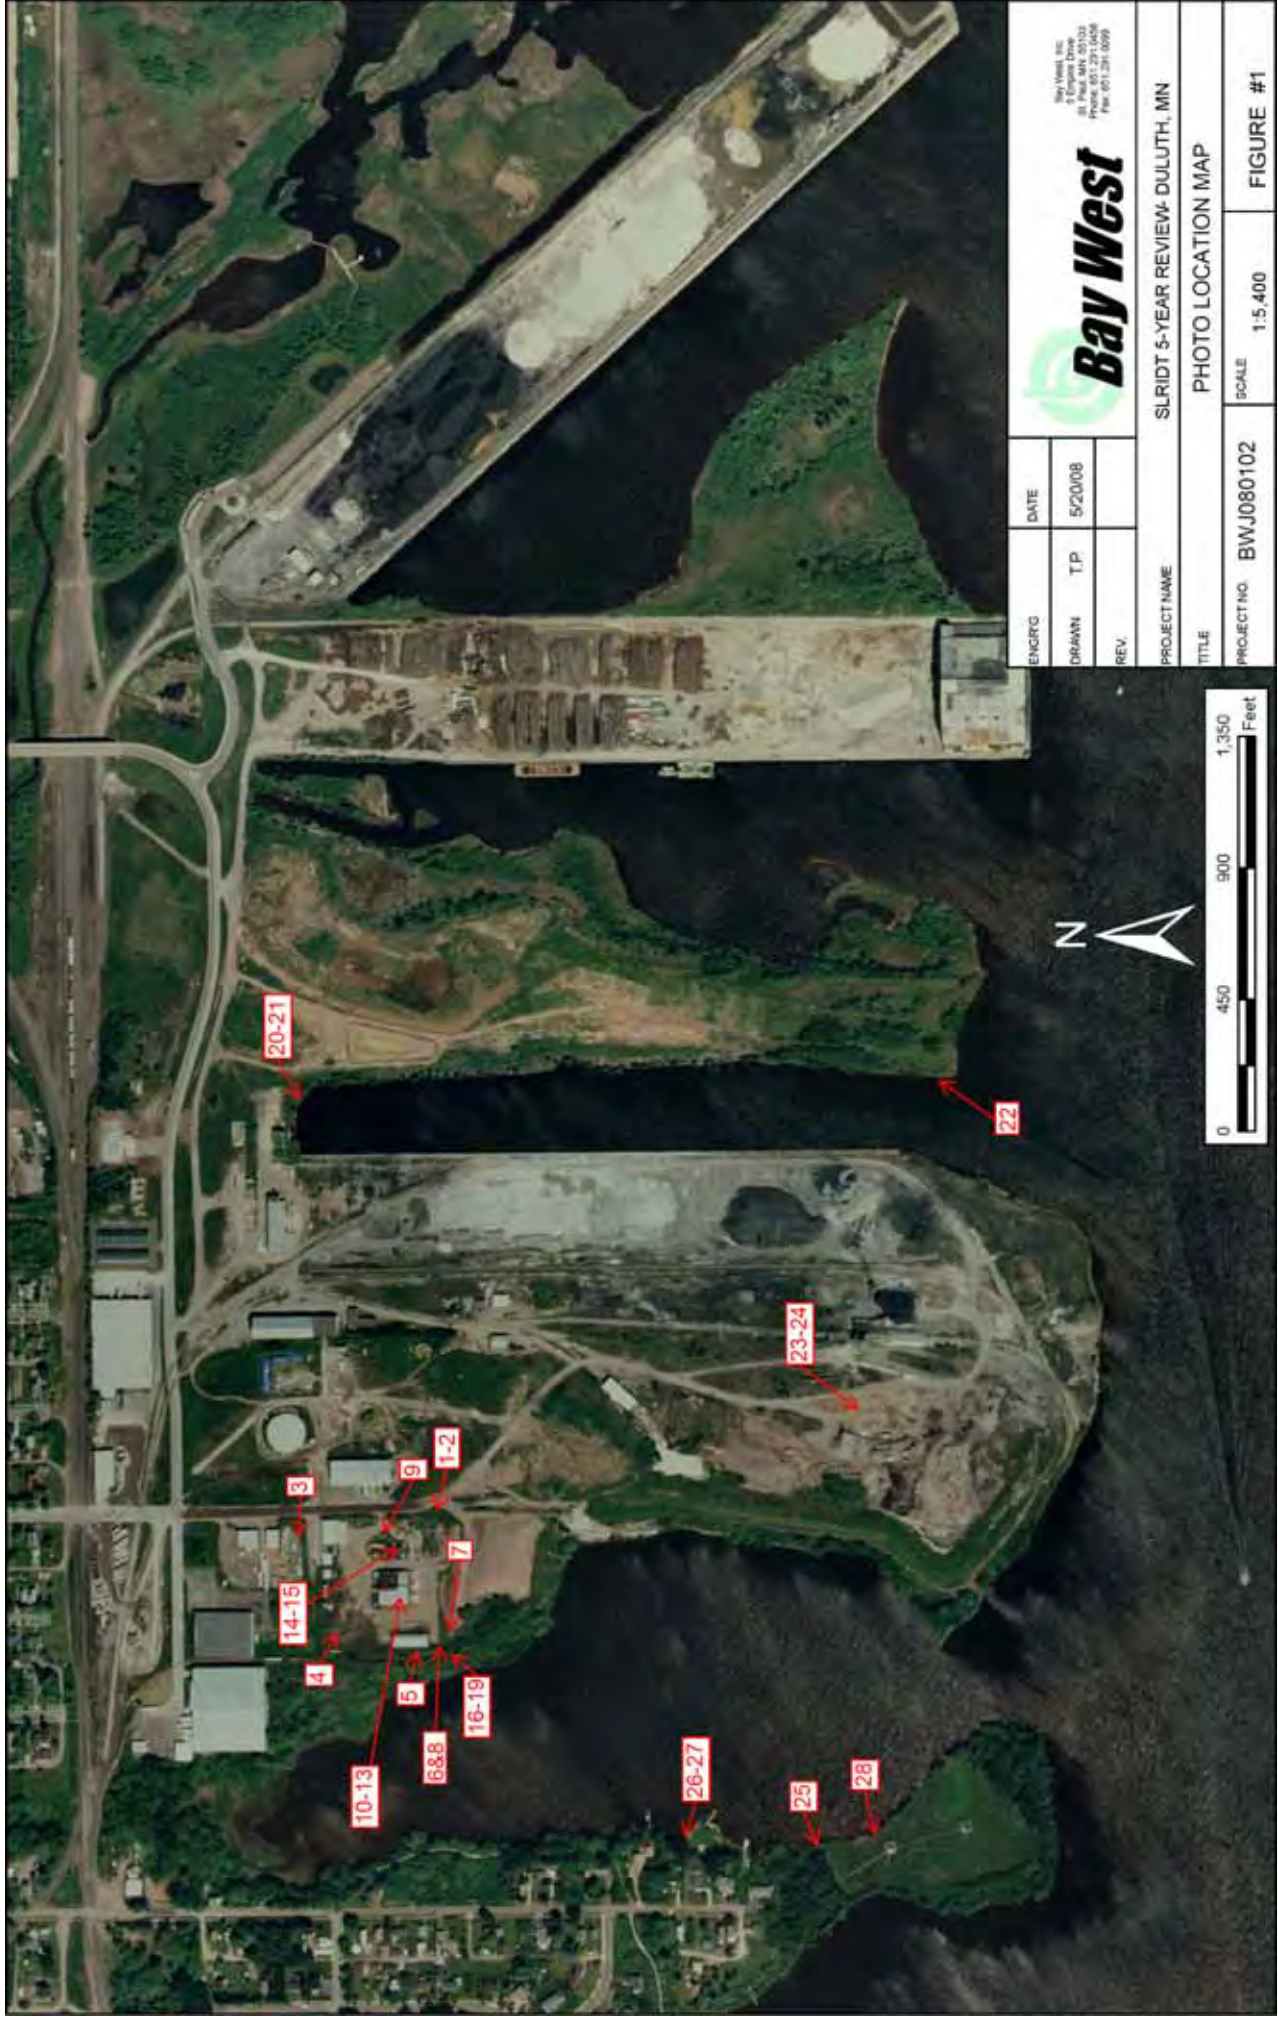
Three empty drums were also noted near the Radio Towers (Photograph 28).

28: Radio Tower area west of Stryker Bay. Two empty drums. A third drum, not pictured, is present in the same area.
