Missouri River Basin Hydrology, Connectivity, and Geomorphology Assessment Report

MINNESOTA DEPARTMENT OF NATURAL RESOURCES:
DIVISION OF ECOLOGICAL AND WATER RESOURCES

October 10, 2014

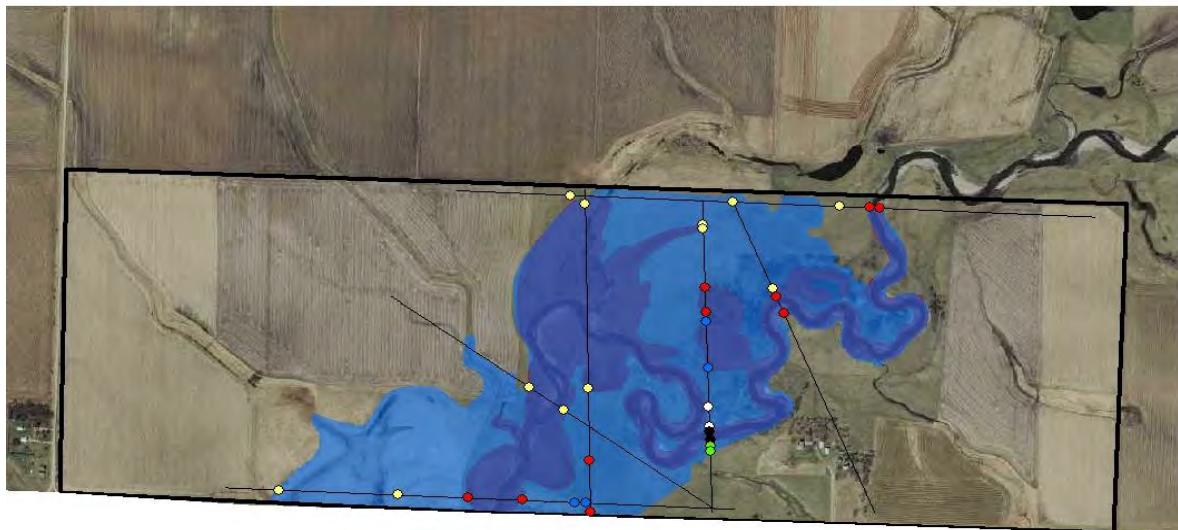
Figure 19. Polygons depicting the Q50 flood prone area (blue) and the Q20 flood prone area (red) delineated with LiDAR cross sections. Note that most oxbows in the reach appear to be recharged with the Q20 flood flows, but likely not on an annual basis.

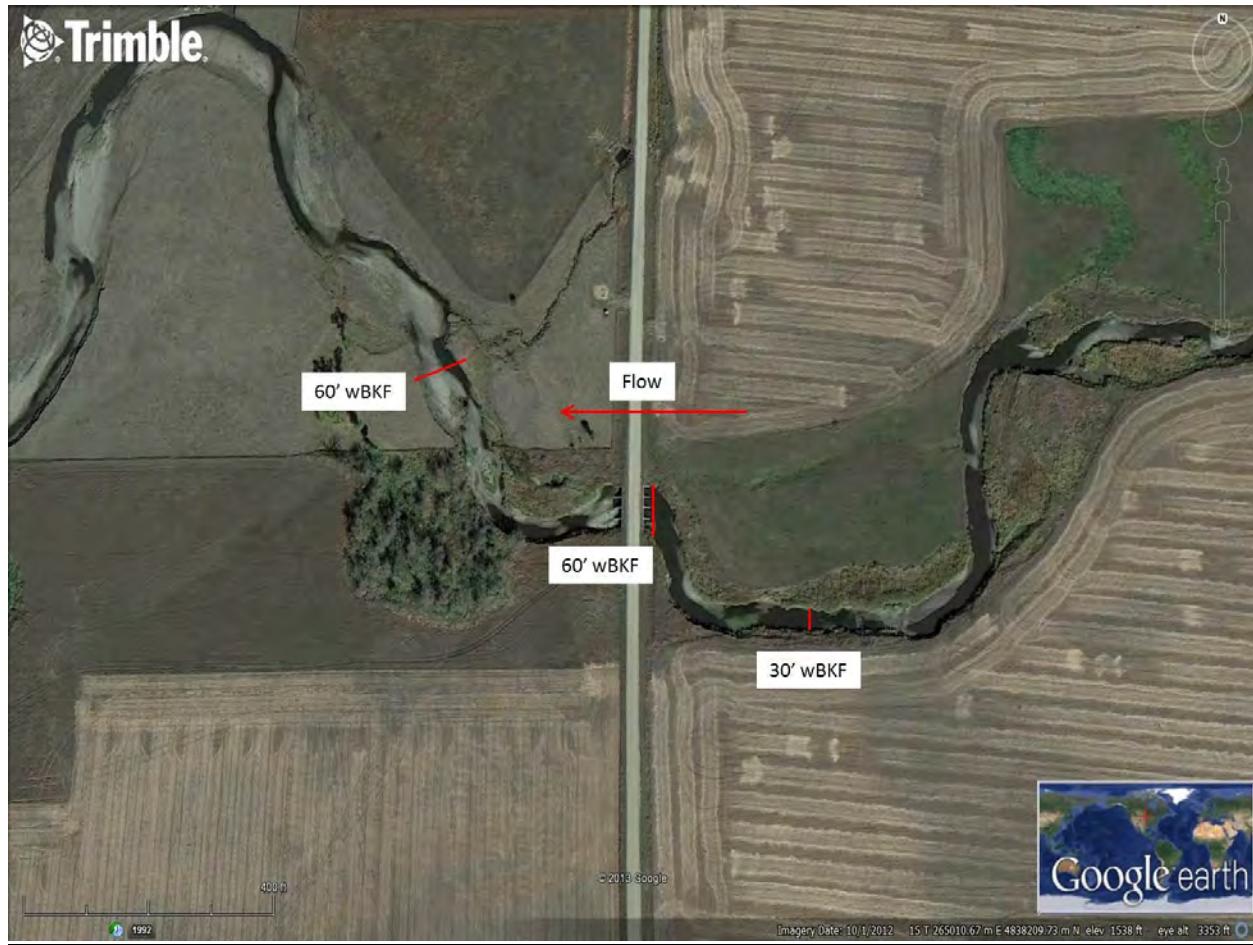
Figure 21. Aerial imagery of an oversized culvert on Kanaranzi Creek. The stream is flowing from right to left. Upstream of the culvert, the bankfull width is approximately 30 feet. The 4-barrel culvert is approximately 60 feet wide, affecting downstream bankfull widths to be twice as wide as upstream. Improper sizing of culverts can cause an excess amount of sediment downstream resulting in loss of habitat quality for a long distance downstream. Culverts should be properly sized to fit the bankfull channel and have flood relief culverts in the floodplain to handle high flows. Photo courtesy of Google Earth.

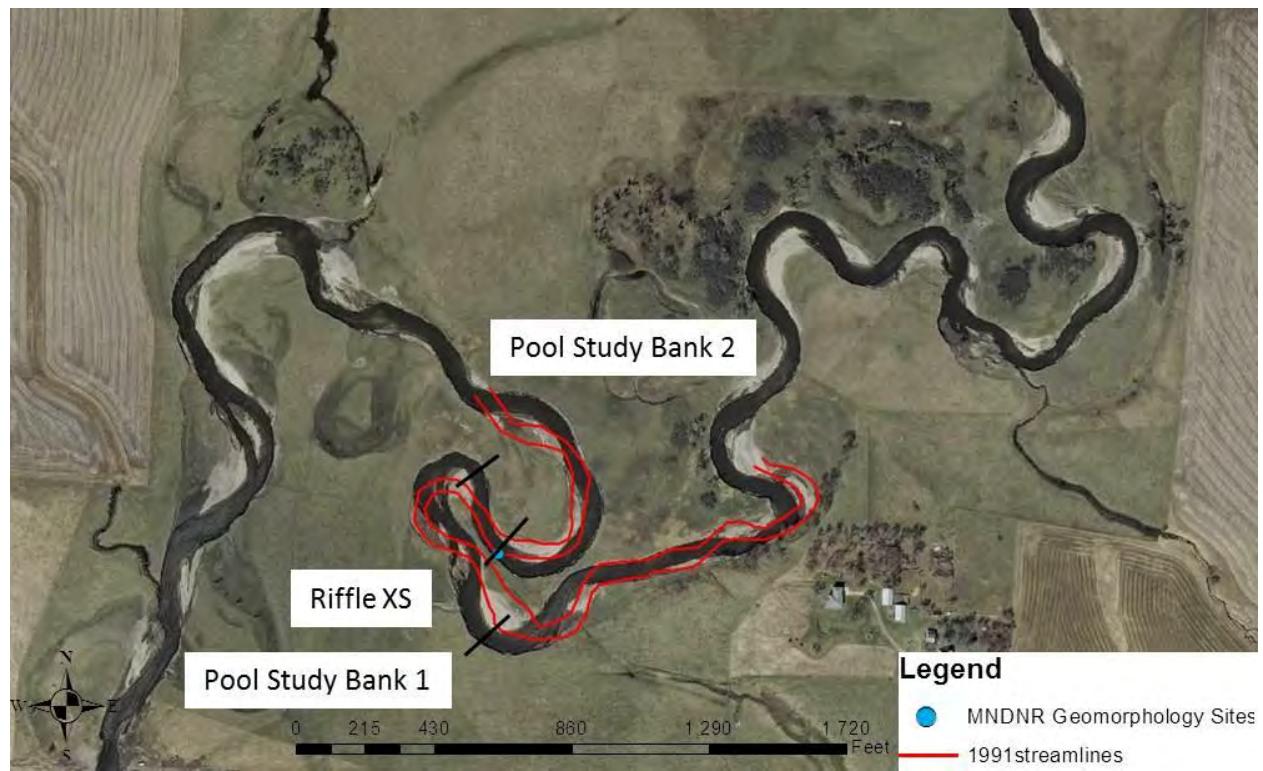
A longer reach of Kanaranzi Creek was surveyed than normal (>20X bankfull width) because of a potential for future channel cutoffs that could turn the survey reach into an oxbow. Unlike many sites in the Missouri basin, continued annual resurveying of established longitudinal profiles and cross sections at this site are going to continue until the channel cutoff occurs to learn more about the processes involved. Survey points from 2012 to 2013 already show areas where there has been significant thalweg migration (Figure 27).

Figure 25. Aerial photo of Kanaranzi Creek geomorphology site with cross section locations and 1991 stream lines.

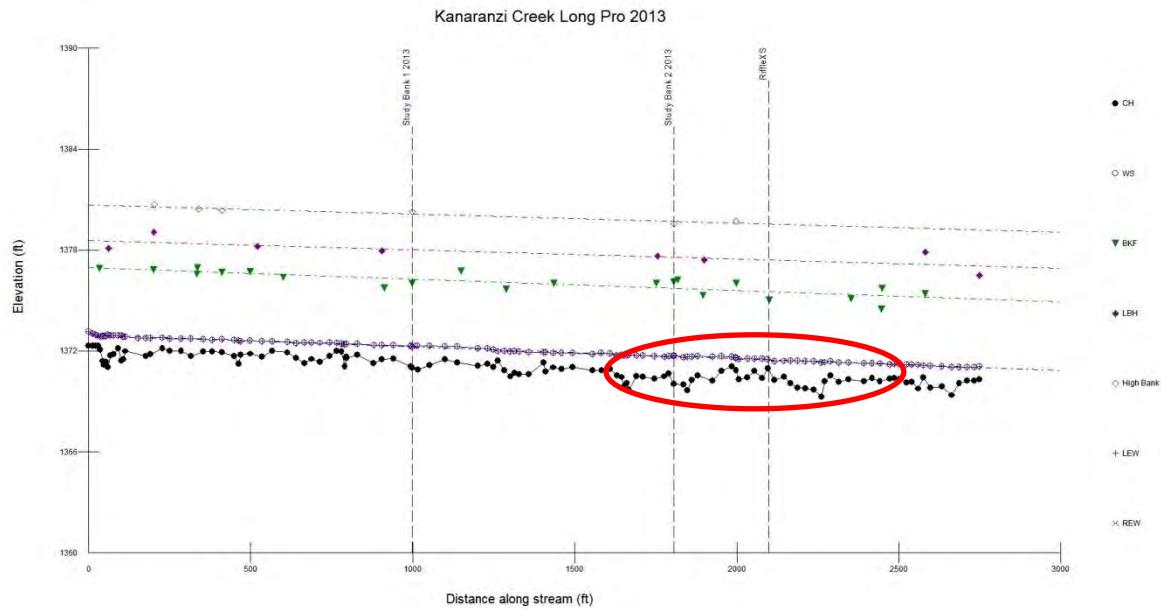
Figure 26. Longitudinal profile of the survey reach at Kanaranzi Creek. Note the lack of pool quality until the area of study bank 2 and downstream of the riffle cross section.

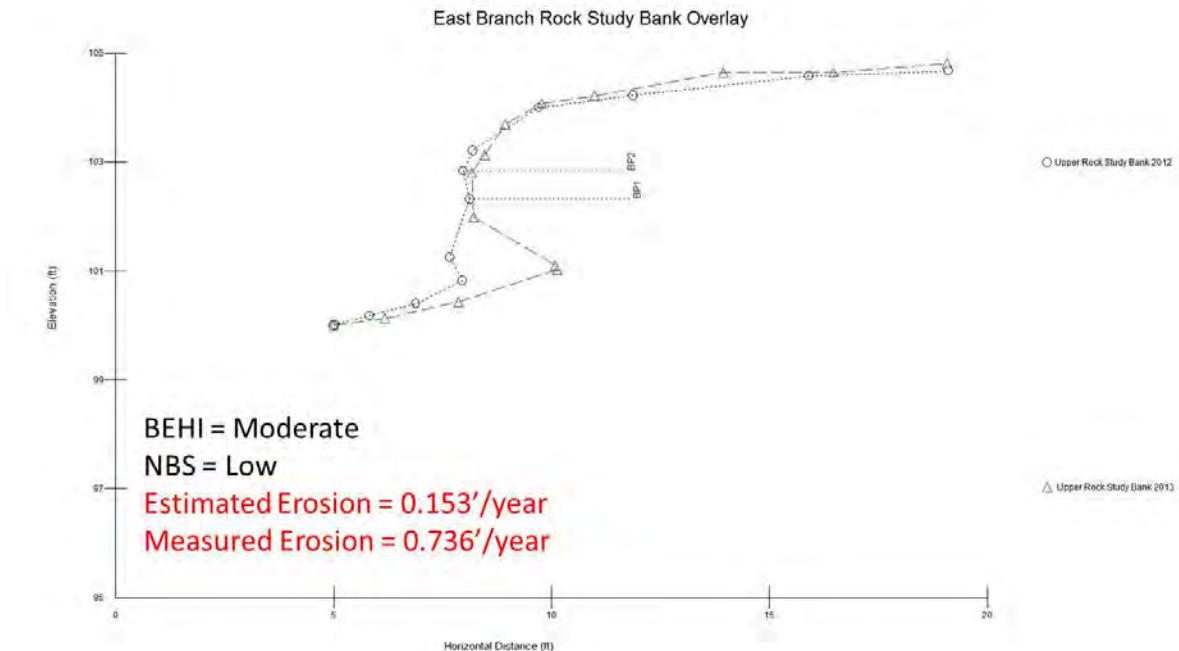
Figure 32. Study bank overlay for the East Branch Rock River site with estimated and measured erosion rates.

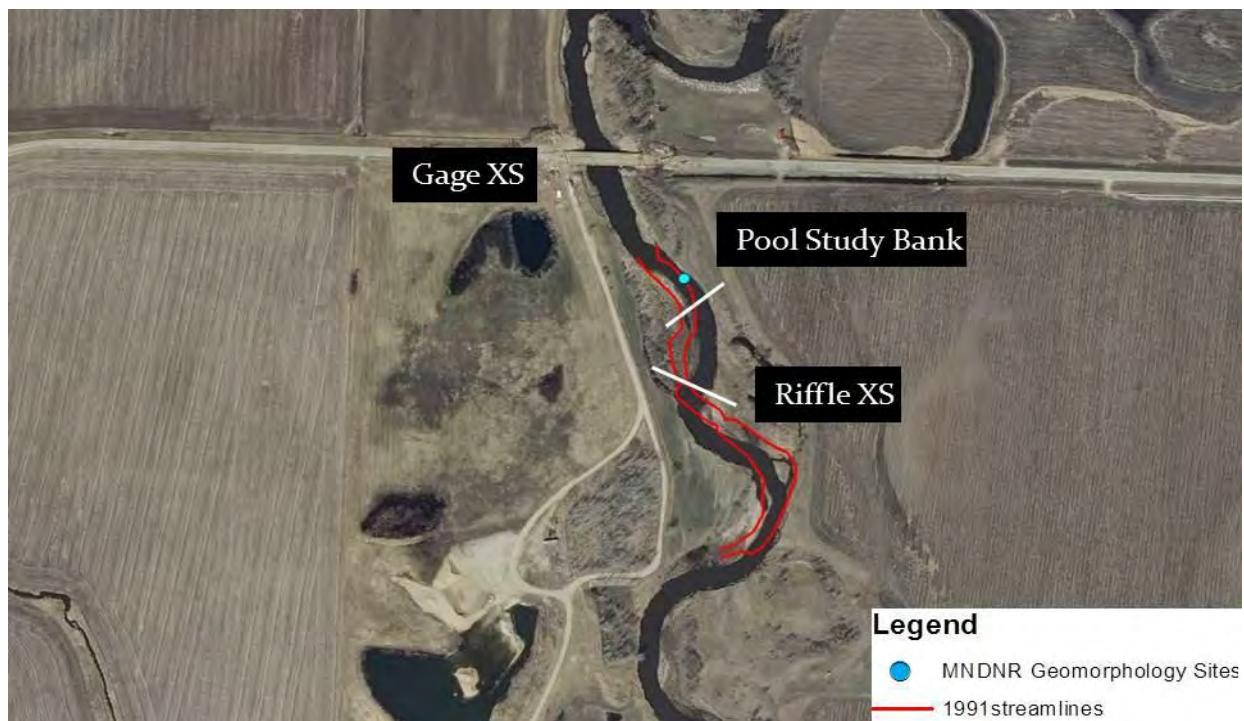
The width-to-depth ratio at the riffle is 14.93 (Figure 35), a relatively low W/D ratio for alluvial valley types. Bank height ratio at this riffle cross section is nearly 1, indicating that the channel is stable and not currently incised. Although the riparian area is relatively undisturbed, Pfankuch stability rating and aerial photo analysis suggest that there is some instability in this channel and significant lateral migration (Figure 36).

Figure 36. Aerial photo of the survey reach with labeled cross section locations and 1991 stream lines.

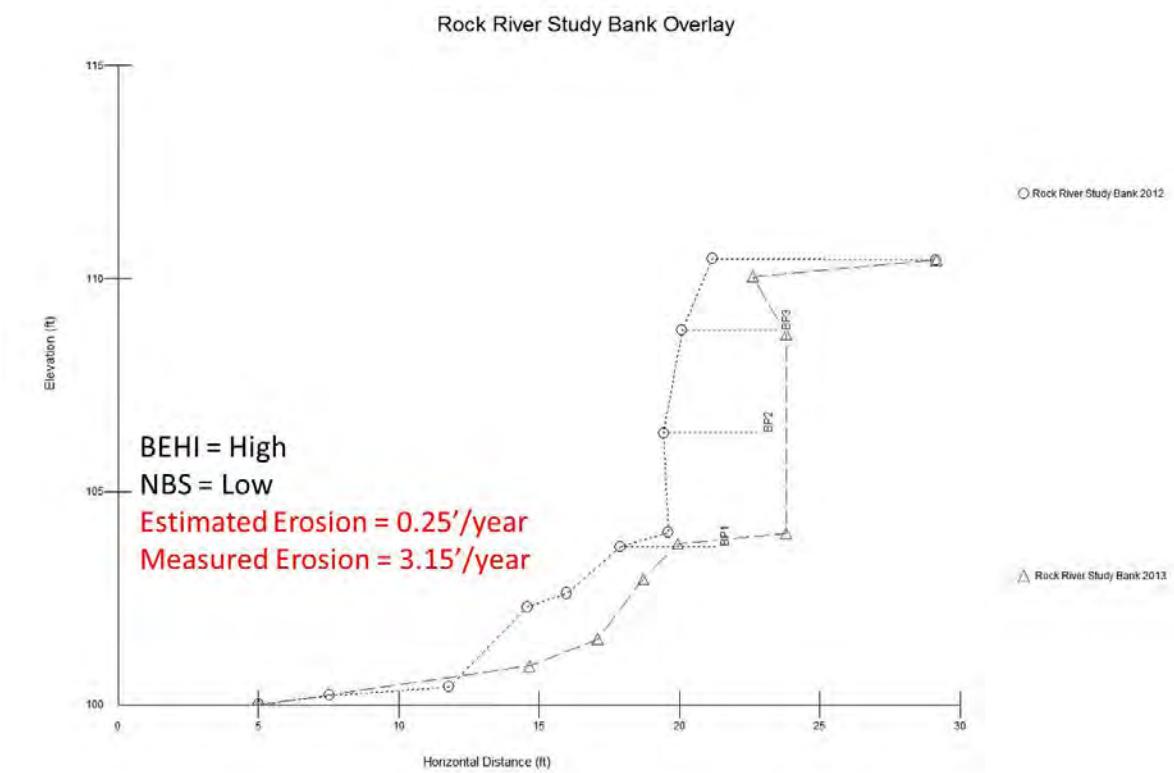
The BEHI matched with NBS model estimated that this reach is contributing 0.038 tons of sediment (76 pounds) per linear foot of stream bank annually using the Colorado erosion rate curve (Rosgen 2001a). These erosion predictions assume that this 1433' reach of stream delivers 54.45 tons of sediment (~5.4 dump truck loads) annually. There was one study bank in this reach that was resurveyed in 2013. The Colorado bank erosion model predicted 0.25-0.38' of erosion and 3.15' of erosion was measured, significantly higher than what was estimated (Figure 37).

Although riparian vegetation quality is better at the Rock River (Hardwick) gage site than at Kanaranzi Creek, high bank erosion and sediment supply was still observed (Figure 37). Much of this was due to the lack of quality vegetation, root depth, and root density; resulting in a poor weighted root density and minimal bank protection (Table 3). Bank angles throughout this reach were also too high to maintain lateral stability. With many outside banks having angles of 90° or higher, the banks already were susceptible to high bank erosion.

Figure 37. Study bank overlay for the Rock River site with estimated and measured erosion rates.

At sites like the Rock River gage, it is possible to implement bank protection using natural woody materials to protect the toe of the bank and reduce shear stress up against the bank; a practice known as toe wood protection (Appendix 3). When using toe wood, the purpose is to create bank stability by making a floodplain bench out of trees and woody material on an outside bend. This protects the toe of the bank, and also allows the river to deposit sediment and a seed source to grow natural vegetation on top of the bench. Although this has been shown to work in many cases, a systemic approach that includes better land use practices upstream is a more desirable strategy so it creates watershed stability instead of bank stability. Eroding banks tend to be a symptom of a larger issue in the Missouri River basin, and being able to address the larger issue can implement watershed-wide stream stability.

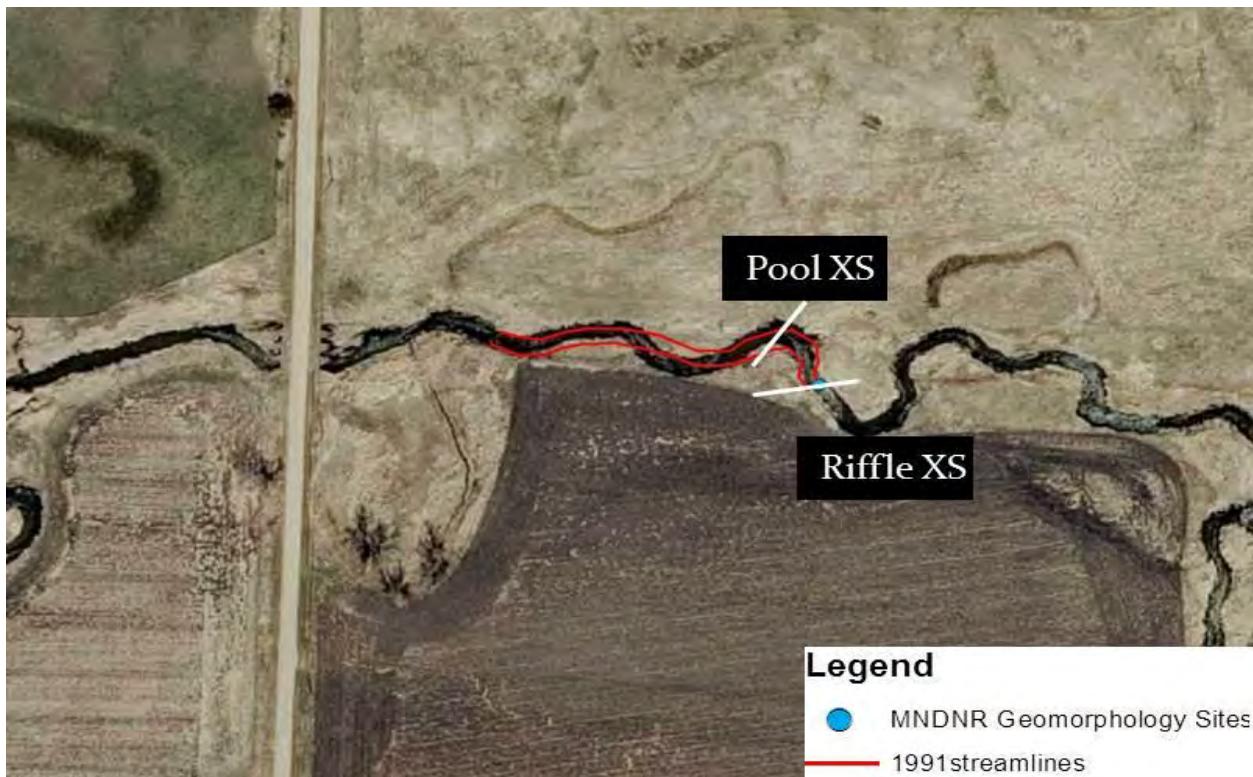
Bank height ratio at this riffle cross section is 1.22, indicating some incision, but the riffle cross section shows some possible floodplain deposition making that number higher than it really may be. Although the riparian area on the north side of this site is relatively undisturbed, the south side has row-crop agriculture nearly up to the stream banks in spots (Figure 40). The Pfankuch stability rating and aerial photo analysis suggest some instability in this channel, likely due to historical straightening to make the river go through the culverts at the road crossing (Figure 40).

Figure 40. Aerial photo of the survey reach with labeled cross section locations and 1991 streamlines.

Even though this site appears to be relatively stable compared to other sites, there are still practices worth considering that could potentially stabilize this reach. Two of the major concerns that affect stream stability at this site are culvert sizing and riparian land use on the south side of the stream. The road crossing immediately downstream of the study reach has four culverts; however, it appears that the two southern culverts are the only ones that transport water at normal to low flows (Figure 40). The amount of sediment deposited in the northern two culverts relates to the fact that the road crossing was built too wide for the bankfull channel, and the stream is developing a floodplain in the other two culverts. In order for a stream to maintain stability, it must transport the water and sediment of its watershed, so this site shows what happens when culverts are improperly sized. Ideally, sites like this would have a culvert large enough to handle the bankfull discharge, and then have floodplain relief culverts at the floodplain elevation to allow flood flows to stay on the floodplain and not be bottlenecked (Zytkovicz and Murtada 2013). An indirect impact of these culverts stems from the channelization of the stream that directed the flows straight into the culverts. Naturally, the Little Rock River is very sinuous, and in order to maintain stability it is continually working to be sinuous. Much of the lateral bank erosion noted in the study reach stems from this channelization that took place historically.

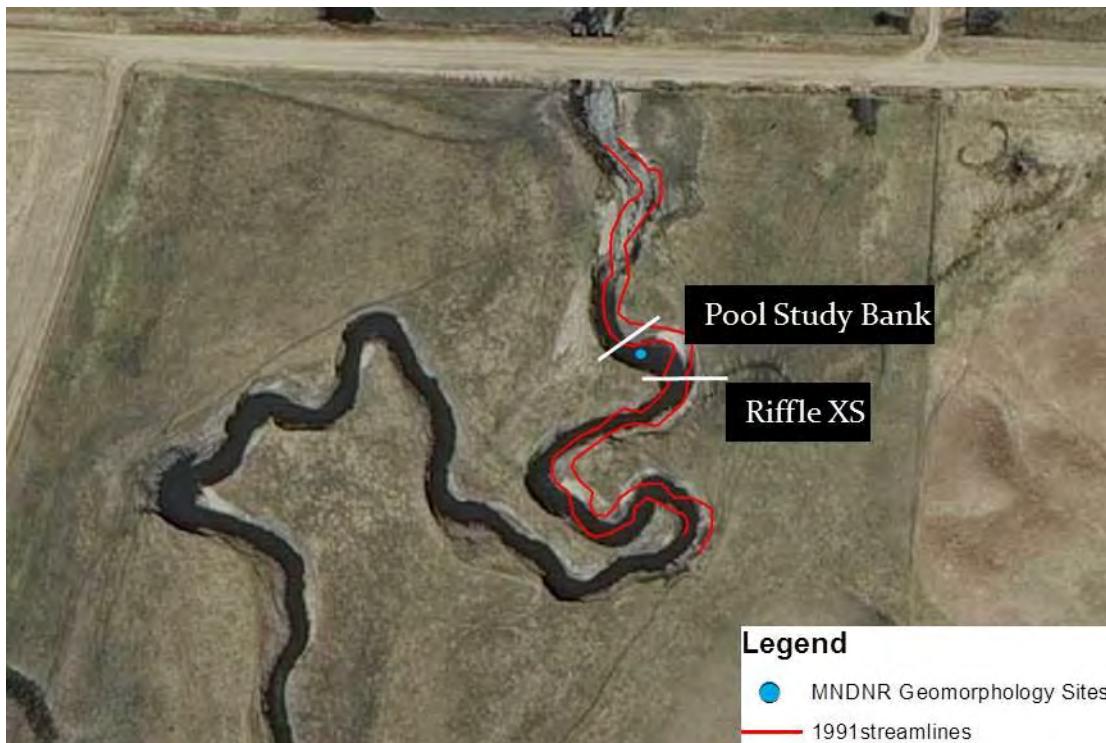
The width-to-depth ratio at the riffle is 14.64 (Figure 44), relatively low for F channels indicating that this site may have recently transitioned to this unstable stream type. Bank height ratio at this riffle cross section is 2.07, indicating that this channel is fully incised and has no access to its floodplain at 2X bankfull. Lack of riparian vegetation, Pfankuch stability analysis, and aerial photo analysis suggest that this channel is very unstable and will continue to widen out until it can make a new channel and floodplain within the existing channel (Figure 45).

Figure 45. Aerial photo of the survey reach with labeled cross section locations and 1991 stream lines.

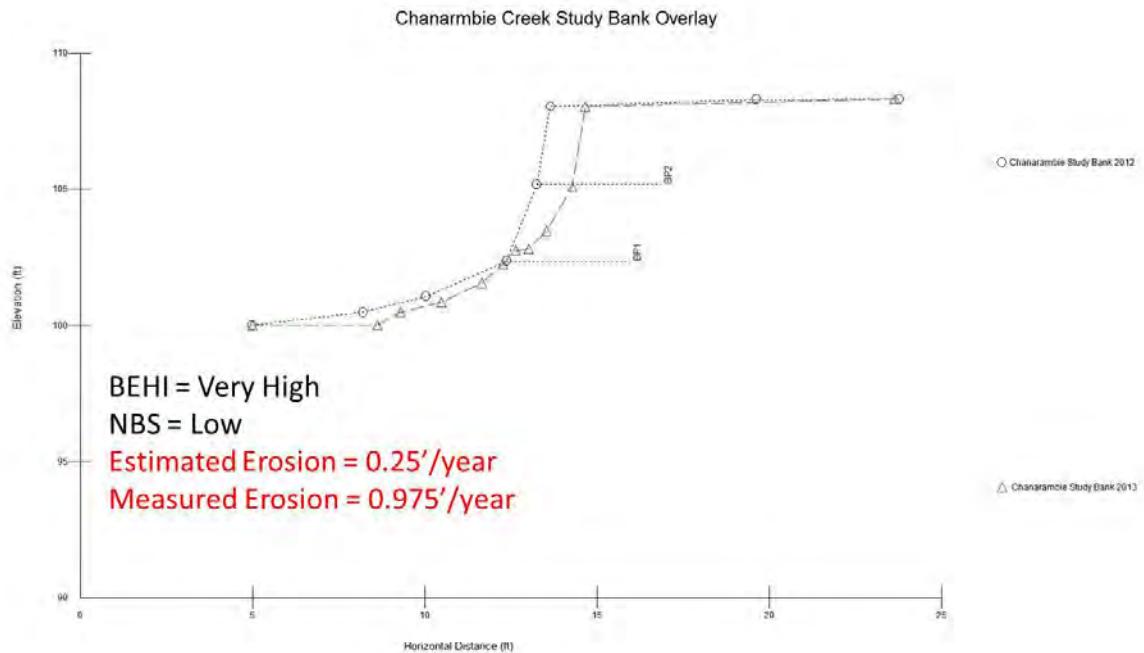
The BEHI matched with NBS model estimated that this reach is contributing 0.0166 tons of sediment (33.2 pounds) per linear foot of stream bank annually using the Colorado erosion rate curve (Rosgen 2001a). These erosion predictions assume that this 650’ reach of stream delivers 10.79 tons of sediment (~1.08 dump truck loads) annually. However, the study bank at this location suggested that the bank erosion model’s estimates were lower than what actual measurements were. The model estimated 0.25’ of bank erosion at the study bank, and 0.975’ of erosion was measured (Figure 46).

Figure 46. Study bank overlay for the Chanarambie Creek site with estimated and measured erosion rates.

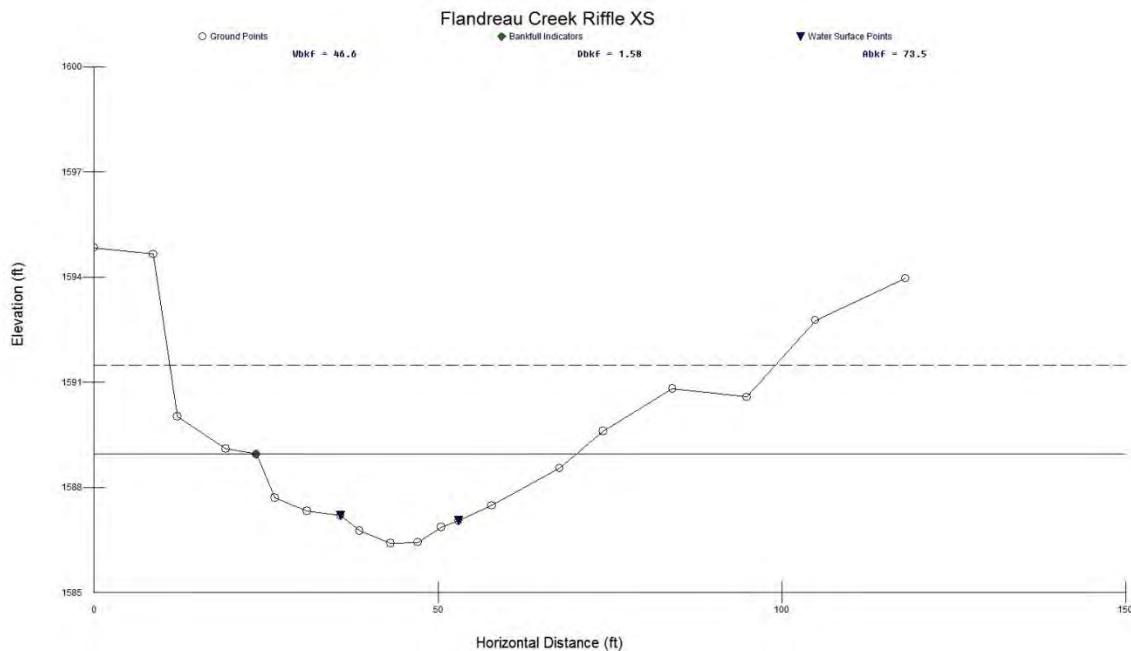
The width-to-depth ratio at the riffle is 29.51 (Figure 48), which is very high for an alluvial valley type, suggesting there may be some disturbance in this stream or bankfull calls are low. Since bankfull has not been validated, bank height ratio of the cross section is likely incorrect at

Figure 48. Graphical view of the representative riffle cross section in the survey reach at the Flandreau Creek site. Referencing the regional curve (Appendix 2), it appears the bankfull call is low on this cross section and will likely be raised.

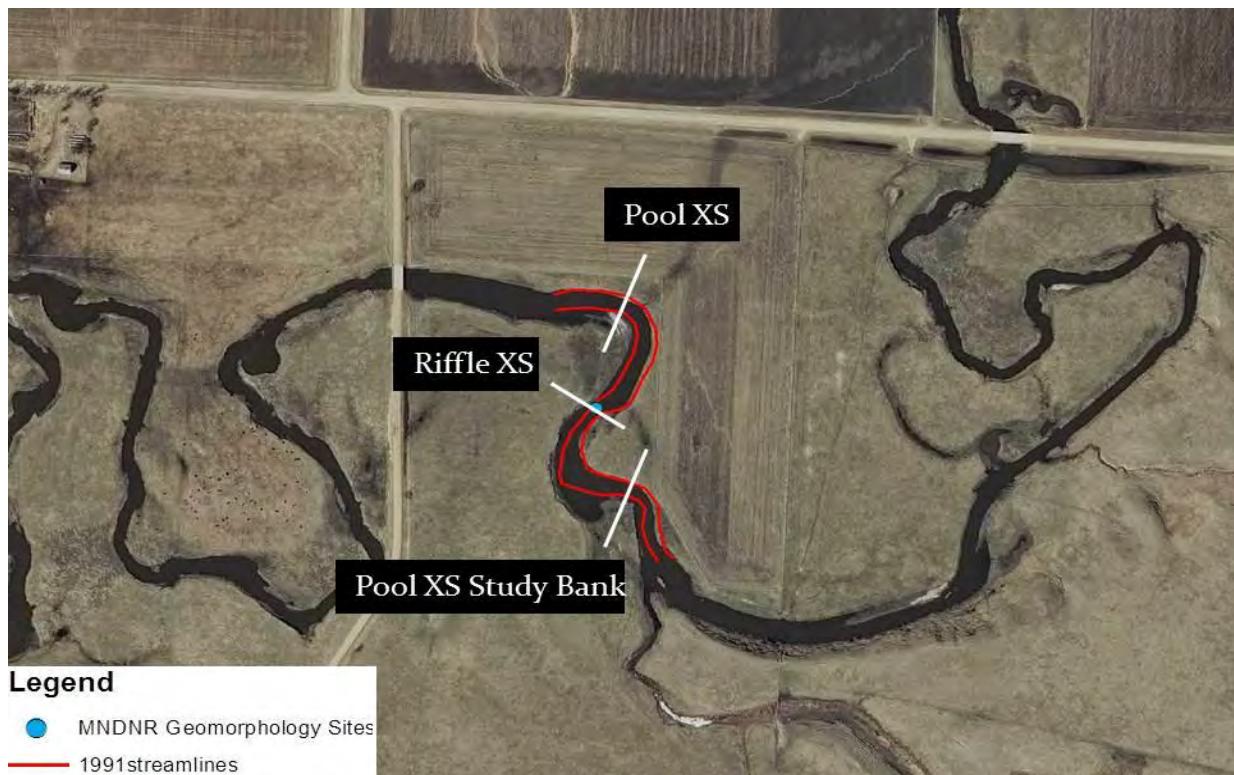
this point. Lack of riparian vegetation, Pfankuch stability analysis, and aerial photo analysis suggest that this channel is in a successional state and not stable at this time (Figure 49).

Figure 49. Aerial photo of the survey reach with labeled cross section locations and 1991 stream lines.

Given the deep pools, well vegetated riparian area, and gravel substrate, it appears that Flandreau Creek is beginning to restore itself to a stable stream type. Some areas like where the cattle have been accessing the stream could use more vegetation, but most of the stream has vegetated banks that show little cutting and erosion, also verified by aerial photo analysis. Depending on the finalized bankfull call, the rate of incision appears to be higher than what a stable stream would exhibit, so it is possible that grade control structures like cross vanes could improve floodplain connectivity and sediment transport.

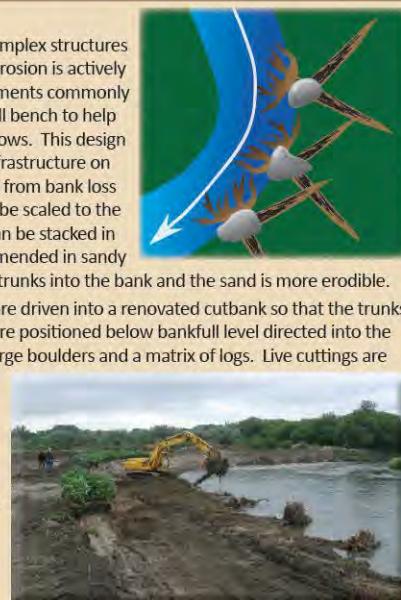
Installation of root wads using an excavator to drive tree trunks into the bankfull bench (looking upstream).

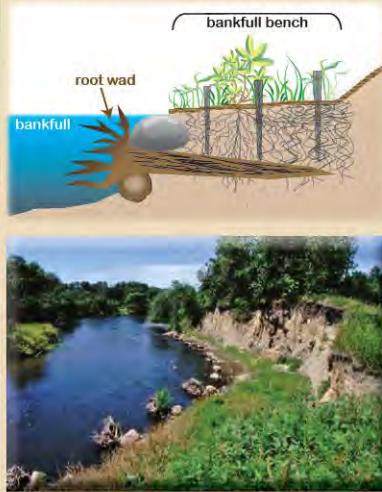
Root wad revetment and a revegetated bankfull bench built to stabilize a cutbank encroaching on Interstate 94, two years after construction (looking downstream).

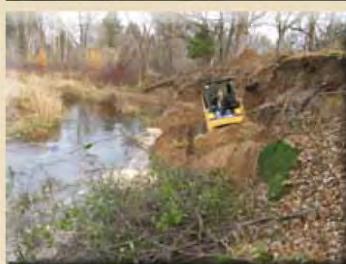
Unstable bank encroaching on a picnic shelter. Toe of bank is eroding causing slumping and stream is overwide.

Construction of bankfull bench. A layer of woody debris and fill was placed along the bank toe then covered with live willow cuttings (in foreground).

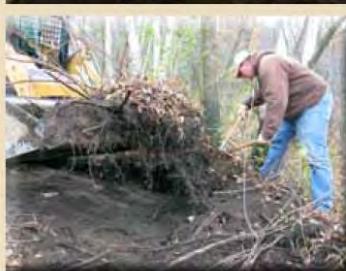
Collection of local dogwood and willow sod mats with very dense root mats.

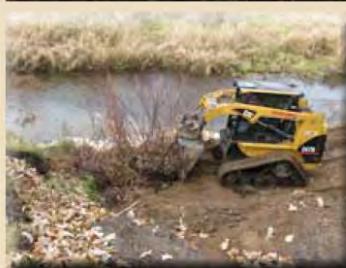
Placement of final layer of sod mats on the constructed bench at bankfull elevation.

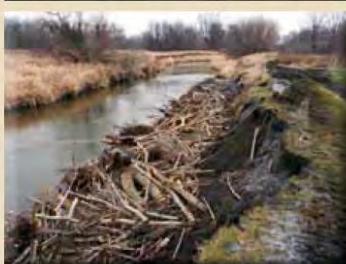
Unstable bank and failing flood control dike protecting a mobile home park. The project started with the placement of woody debris and insertion of root wads.

The completed woody debris layer with incorporated root wads. The upper bank was regraded with a more gentle slope.

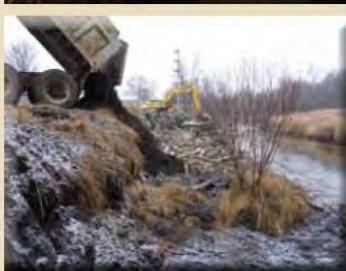
Dirt was added as fill and rooting material to the woody debris layer.

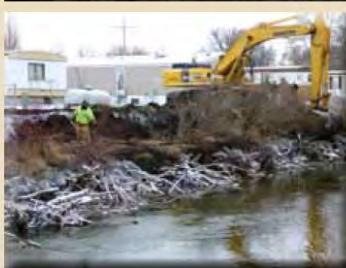
Locally collected red-osier dogwood and willow sod mats were placed on the constructed bench at bankfull elevation.

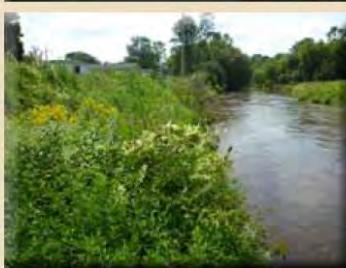
Project was completed with a vegetated bankfull bench and a re-graded upper bank seeded with native seed mix. New growth was thriving the next summer.
