July 2025

# Big Fork River Watershed Stressor Identification Report

A study of local stressors limiting the biotic communities in the Big Fork River Watershed.

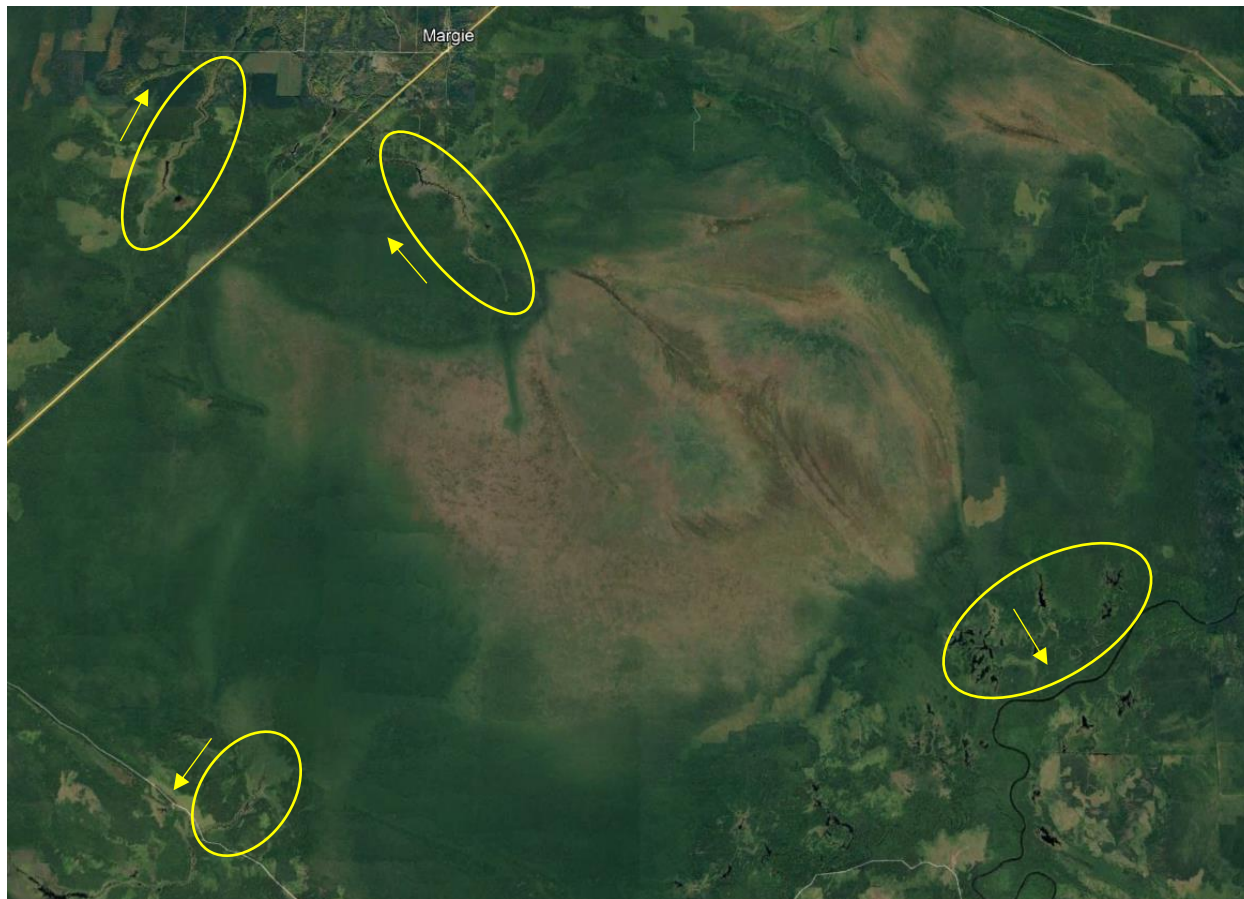
Water does gradually seep or slowly drain from peatlands, where small channels have naturally developed near the edge of the peatland (Figure 1). This drainage of the peat soils is slow because these natural channels don’t extend far into the peatland. On the other hand, the legacy ditches extend throughout a peatland, creating much, much greater surface area for water to emerge from the peat

**Figure 1. Natural drainage from an undisturbed peatland. Yellow circles surround the emerging natural channels that are on the periphery of the peatland and which flow in the direction of the arrows. Highway 71 is in the upper left corner - the channels there are the headwaters of Dinner Creek. In the lower right corner, the outlet channels flow to the Big Fork River.**

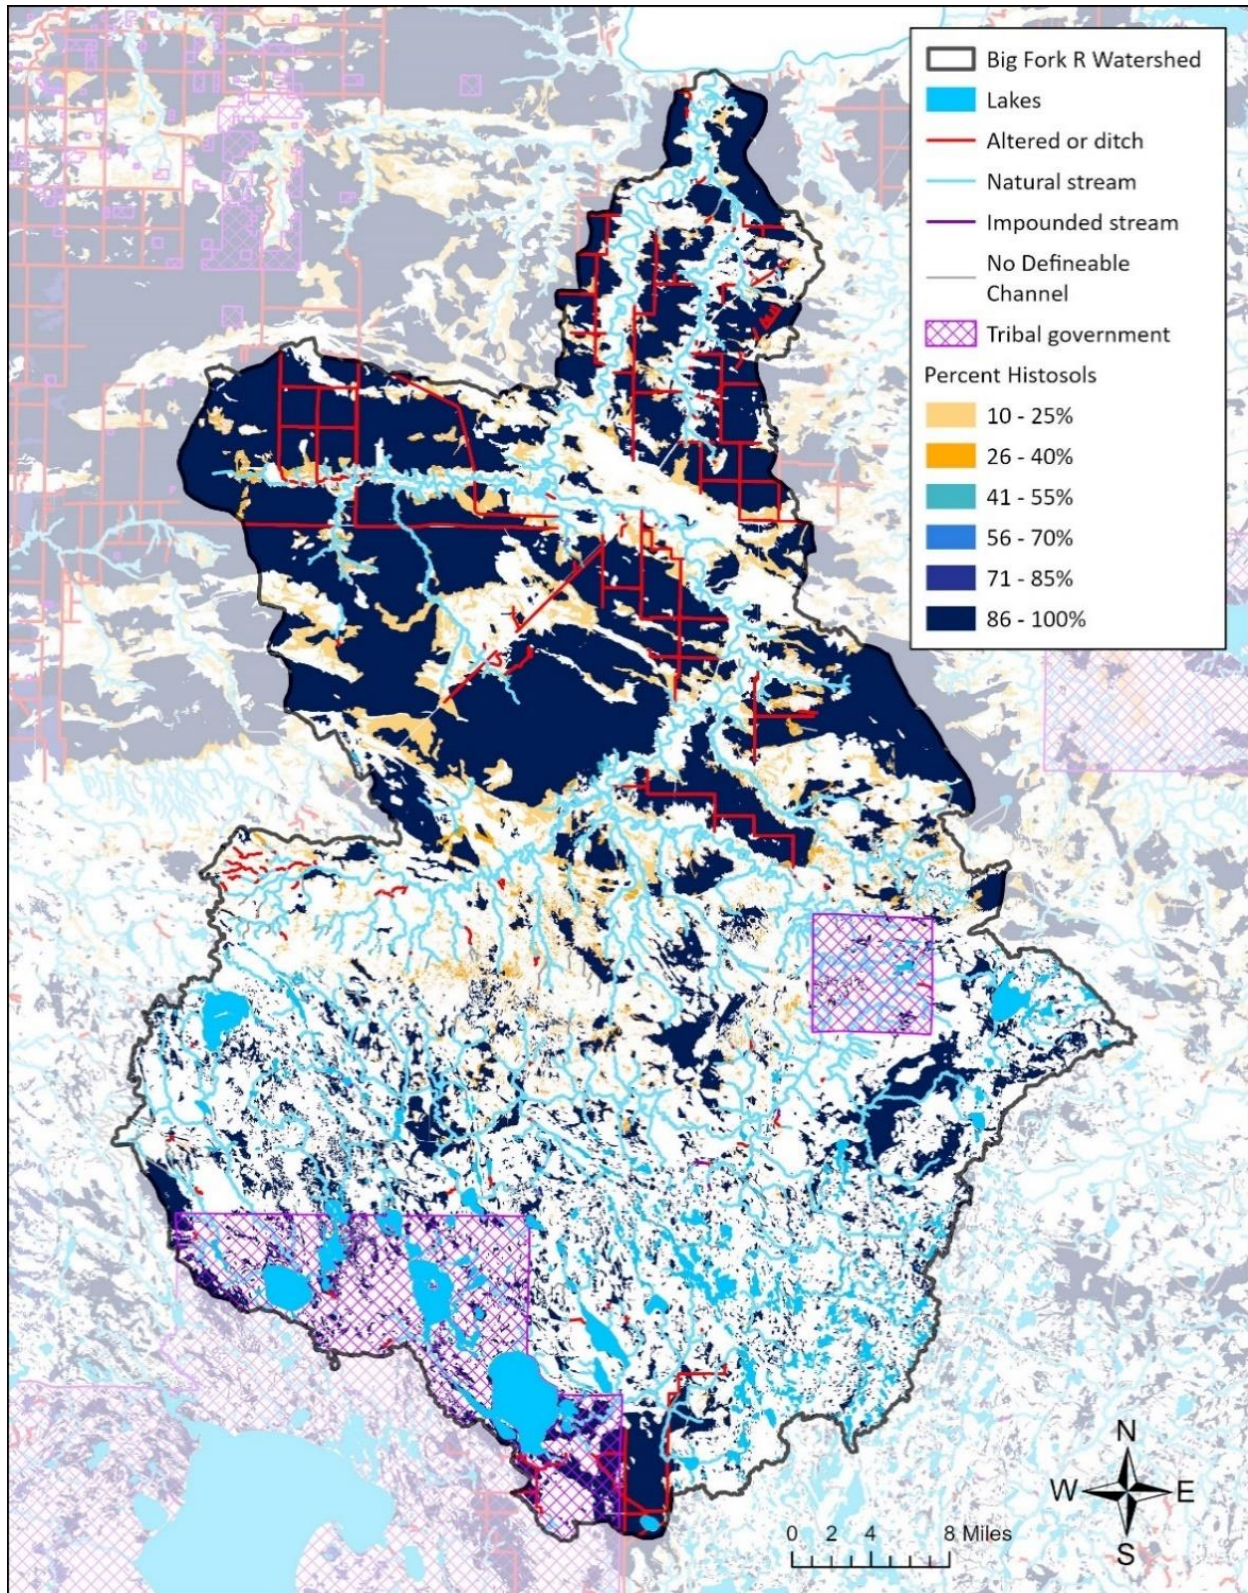
The peatland ditches of the BFRW are especially prominent in the northern half of the BFRW where hydric soils subsequently formed on the land that previously was inundated by Glacial Lake Agassiz (GLA; Figure 2). Underlying the peat is clay that was deposited on the lakebed. This is also the part of the Big Fork River that experiences elevated TSS in spring. Some of the elevated TSS is natural, as greater flow volumes (such as during snowmelt) have greater erosive ability. During these higher flows, fine sediment is either stirred up from the river bed or eroded from river banks. Phosphorus is bound to soil particles, so its erosion also brings phosphorus into the stream system. Theoretically, a reduction in the amount of high flow volumes would reduce the suspension of fine sediments and reduce erosion of soil into the river from the river's banks. There are notable large, steep eroding banks at several locations on the Big Fork River, mostly downstream from Big Falls.

**Figure 2. Big Fork River Watershed stream channels, highlighting ditched waterways. The background is hydric soils, classified by their percent organic content.**

One way to reduce peak flow volumes in the Big Fork River would be to abandon and plug/fill peatland ditches that contribute unnatural amounts of water to the river. This should also reduce phosphorus transport downstream to the Rainy River and ultimately to Lake of the Woods, which has a phosphorus problem and is impaired for excess nutrients. Such peatland restorations are few to date in Minnesota, and lessons on techniques, challenges, and solutions are currently being learned. There are many hundreds of miles of peatland ditch reaches in northern Minnesota, including in the BFRW, that are not providing any kind of benefit to residents or landowners and are just remnants of the original drainage effort in the area. These would be the first targets for restoration, most likely. DNR has begun working on peatland restoration on state-owned lands (DNR, 2025a). Opportunities are now open for private landowners who are farming high-organic (previously peatland) soils via a program recently instituted by the Minnesota Board of Soil and Water Resources (BWSR, 2024 and 2025) through the Reinvest in Minnesota (RIM) program.

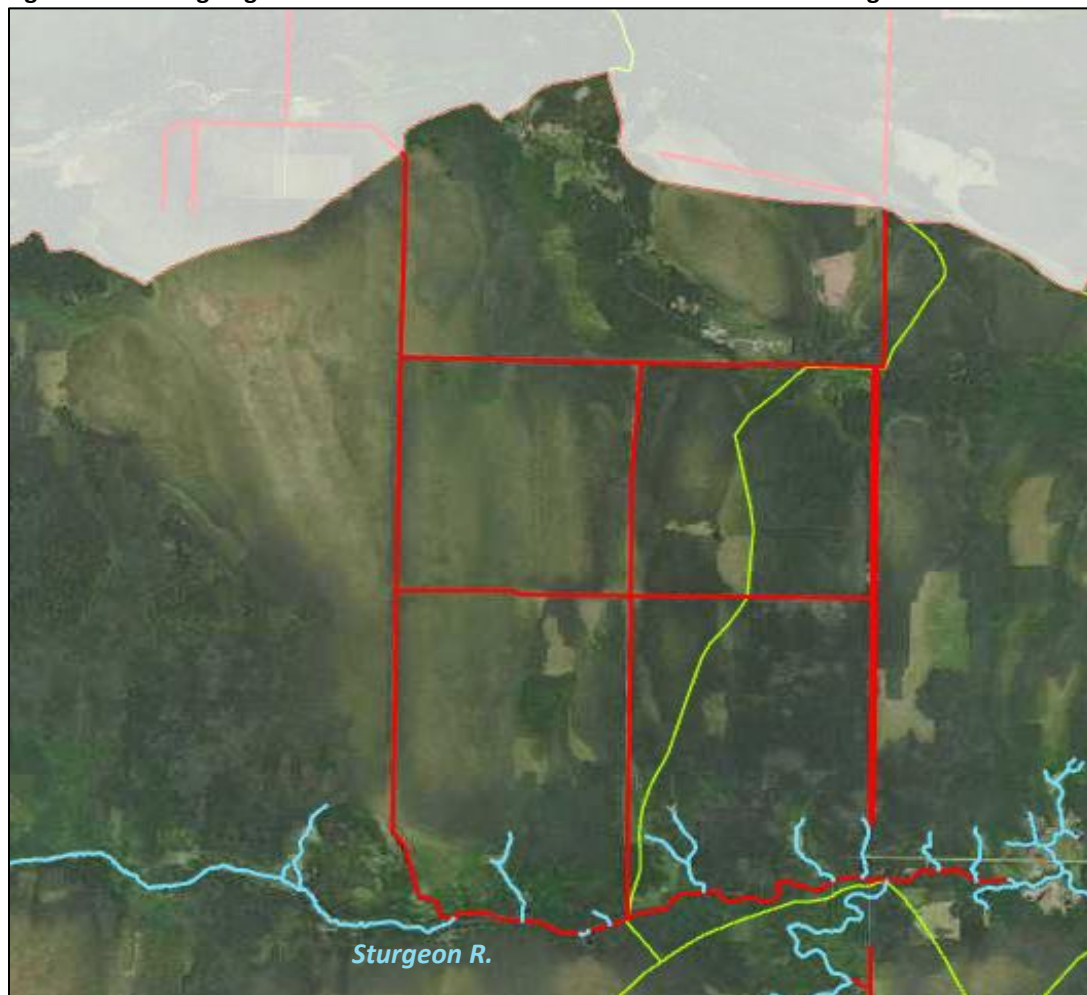
The headwaters of the Sturgeon River begin in a large, remote peatland. Ditches were dug through this large peatland and these drain to the Sturgeon River (Figure 3). There is no developed land adjacent to or upstream of these ditches. Land ownership of the affected peatland is almost all state or county-administered state land (Figure 4). The ditch running along Pine Island Road would perhaps need to remain for road protection purposes. Because some of this system of ditches cross watershed (or subwatershed - the green lines) boundaries, the direction of flow in these areas would likely need to be determined in the field. The opaque area along the top of the figure lies in the Lower Rainy River Watershed.

**Figure 3. Incoming bog ditches from the north into the headwaters of the Sturgeon River.**

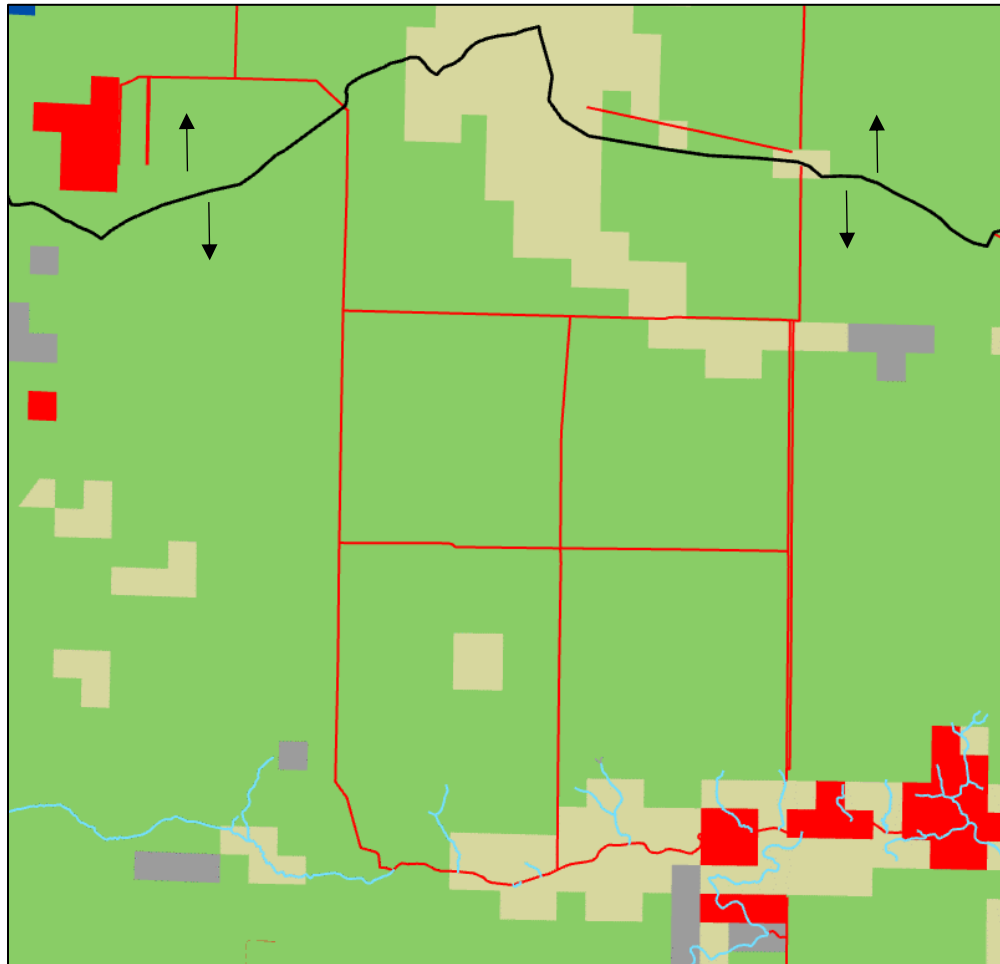
**Figure 4. Land ownership in the approximate area shown in Figure 3 having ditches that flow to the headwaters of the Sturgeon River. Ownership is State (green), County/State (khaki), Private industrial (gray), Private (red). Arrows show surface flow direction.**

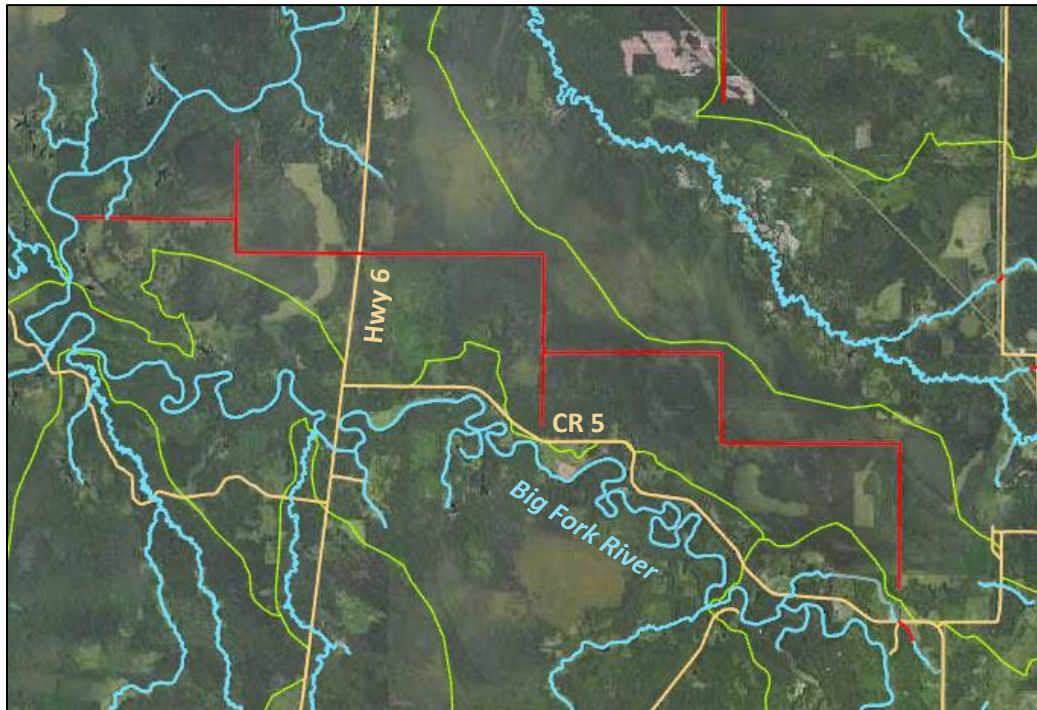
A ditch system (flowing west) runs through an undeveloped bog area between (and parallel to) the Big Fork River and Reilly Brook, north of CSAH-5, about seven miles north of Effie. Elimination of this ditch system could potentially eliminate a culvert crossing under State Hwy 6, which may be a maintenance cost benefit. Road access for bog-restoration machinery is pretty good along this ditch. No developed land would be affected by a hydrologic restoration of this legacy ditch system. The great majority of the watershed of this ditch system is state-owned, with a small amount of private industrial in an unditched area.

**Figure 5. The peatland ditch system between the Big Fork River and Reilly Brook, which drains to the Big Fork River.**

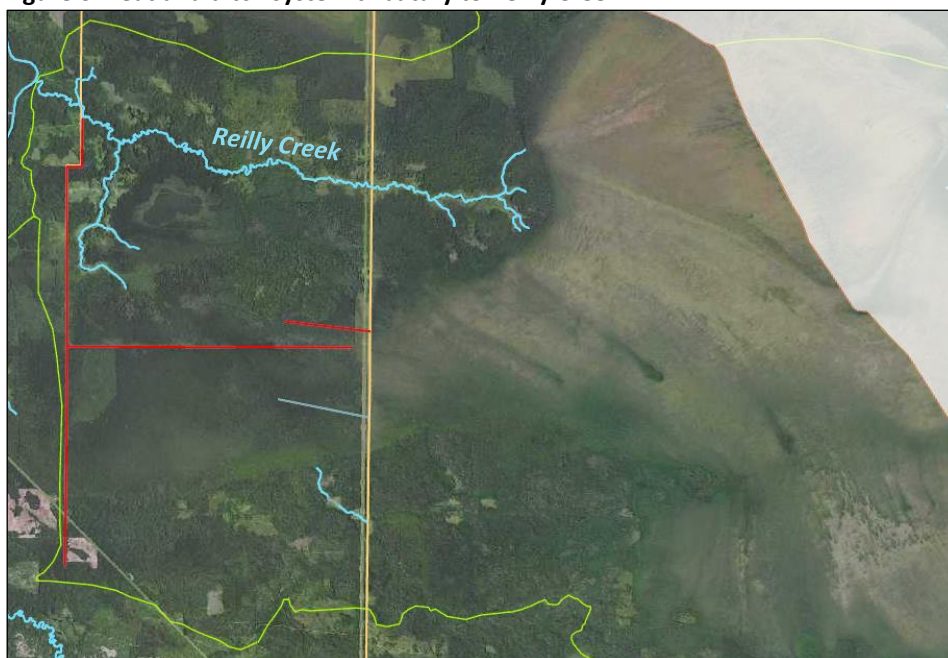
A remote ditch system enters Reilly Creek from the south (Figure 6). This area is predominantly state-owned land, especially adjacent to the ditches. The opaque area in the upper right corner is in the Little Fork River Watershed.

**Figure 6. Peatland ditch system tributary to Reilly Creek.**

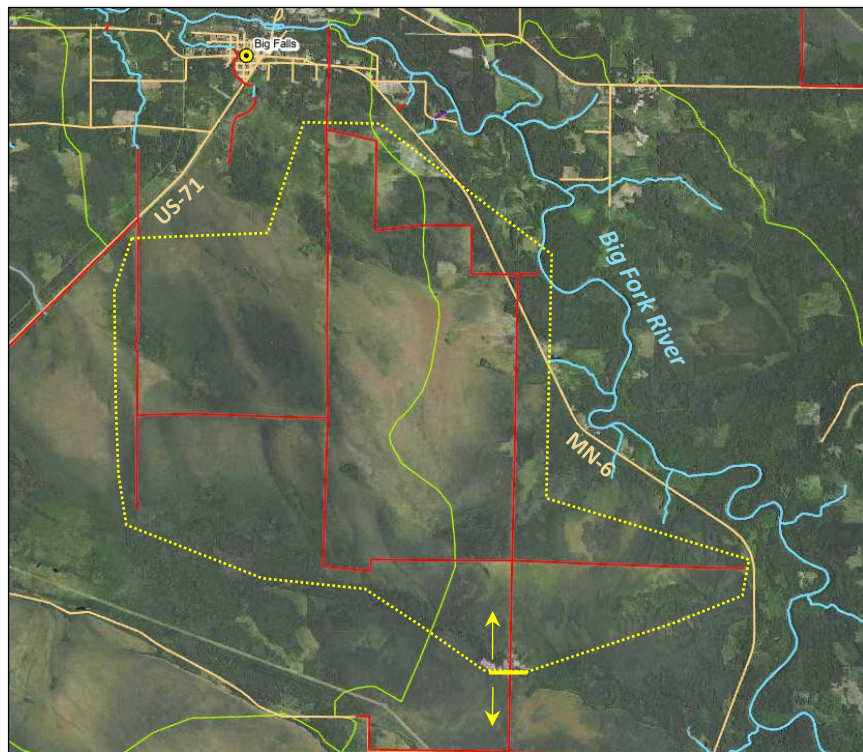
A peatland ditch system with no development exists between US-71 and State Hwy 6, just southeast of Big Falls (Figure 7). Focus perhaps on the ditches within the yellow-dotted line. Based on vegetation, it looks like the ditch near the bottom of the scene may have a divide in flow, represented by the arrows. Nearly all of the land associated with this ditch system is state-owned.

**Figure 7. Ditch complex southeast of Big Falls. The area within the yellow dotted line looks potentially restorable. Some of the downstream ditch reaches near Big Falls may need to remain. Yellow arrows show flow divide.**

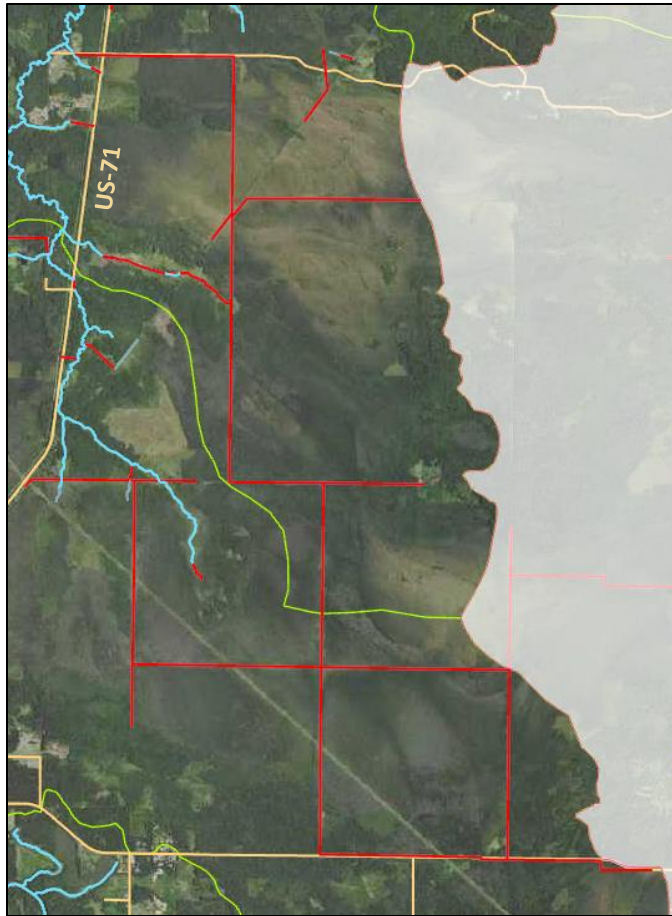
A complex of peatland ditch channels in a remote area with no development exists to the northeast of Big Falls, just east of US-71 (Figure 8). These ditches enter the headwaters of the Bear River at multiple locations. The opaque area to the left is in the Little Fork River Watershed. Nearly 100% of the land being drained by this ditch system is state-owned. A very small amount of private industrial land exists but is far from any ditch.

**Figure 8. Ditched peatland northeast of Big Falls that flow into the Bear River.**

There is some visual evidence of channel incision and overwidening farther downstream in the Bear River, which is likely at least in part due to the addition of several miles of ditch segments to the headwaters area, creating higher peak flow volumes in the river. Photos from the biological monitoring visit at site 10RN048, at CSAH-1 show trees leaning into the channel on both sides of the river (Figure 9), and the channel eroding under the root zone of woody riparian vegetation (Figure 10).

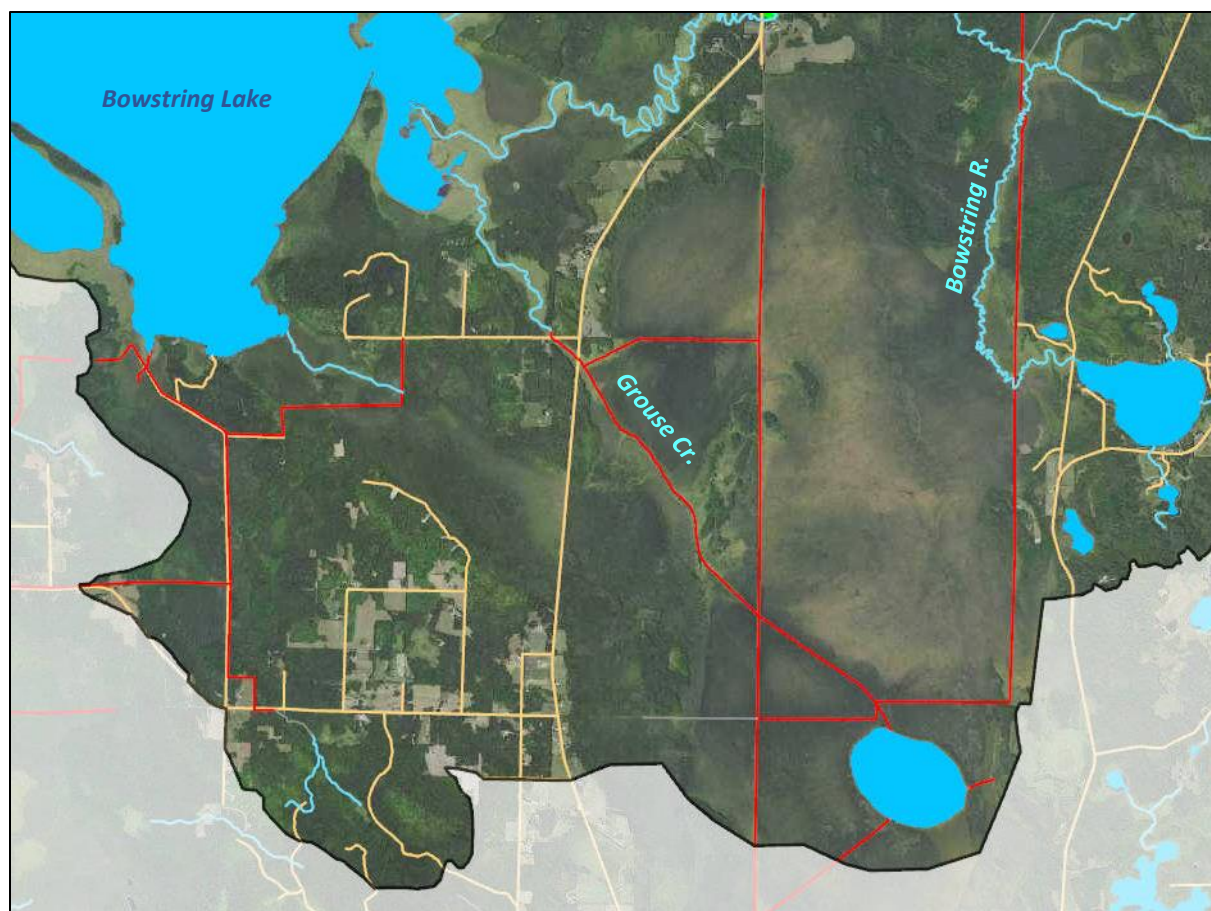
**Figure 11. Wetland/peatland ditches to the south and southeast of Bowstring Lake.**

For the protection of Bowstring Lake, restoring the ditched peatlands entering Grouse Creek (and eventually Grouse Bay of Bowstring Lake), Bowstring R., and/or the ditches directly south of Bowstring Lake may be helpful in reducing some of the loading of phosphorus into the lake (Figure 11). The ditches associated with Grouse Cr./Bowstring R. may be easier to accomplish due to there being little infrastructure or developed land associated with them. However, they appear to be small ditches, and thus may not convey much if any water in the summer, when more of the phosphorus leaks from the peatlands. The ditches that are associated with the very southern tip of Bowstring Lake are mostly associated with roads, which may make abandoning those ditches more difficult. The LLBO resources staff are monitoring Grouse Creek and at a location of the southern ditch system in 2025, including for phosphorus. The Bowstring River at Hwy - 6 has a multi-year record of phosphorus sampling, and total phosphorus (TP) is most often at a fairly low concentration relative to streams that have associations with wetlands/peatlands.

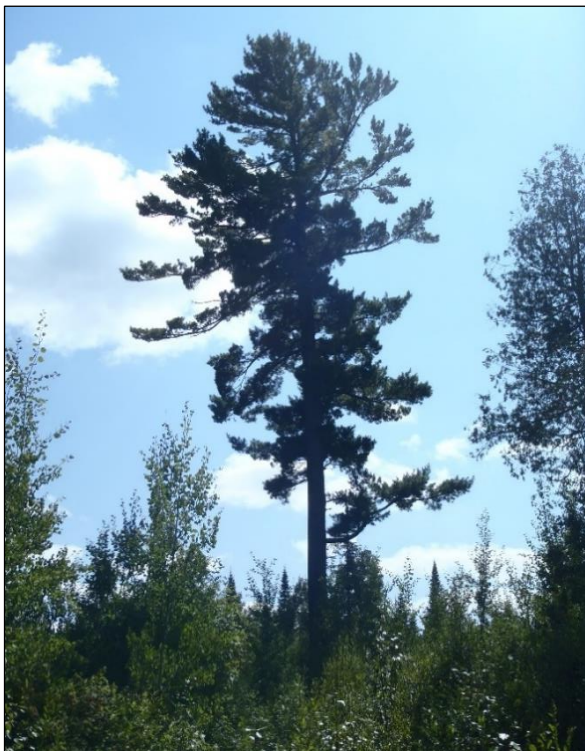
**Figure 12. An example of the change that occurred with original logging as well as change with current forest management - an old white pine, like those composing the pre-settlement forest of this area, stands in a recently harvested area, with mostly deciduous trees among the re-growth.**

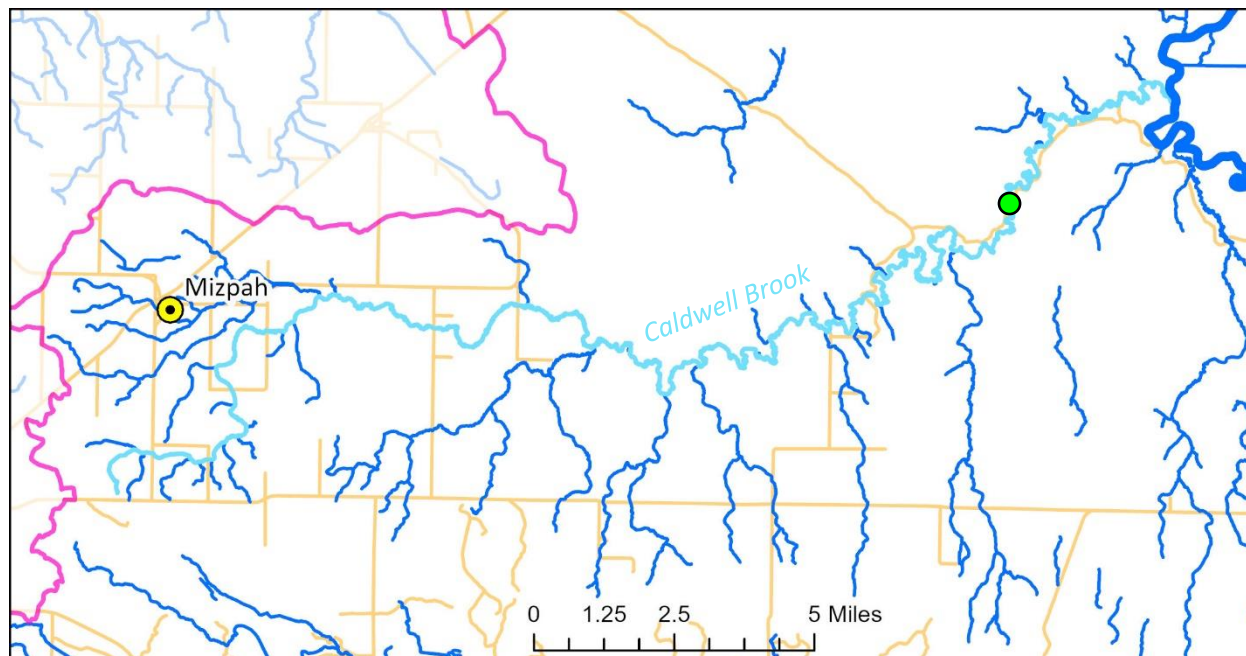
In the fall of 2023, two DNR geomorphology staff and the MPCA BFRW SID lead visited one of the biological monitoring sites (10RN024) and made observations and set up monumented cross-sections for long term monitoring of channel morphology changes (Figure 13).

**Figure 13. Caldwell Brook (light blue) and its tributaries (darker blue) with the location of the DNR/MPCA geomorphology study reach (green dot) on Caldwell Brook.**

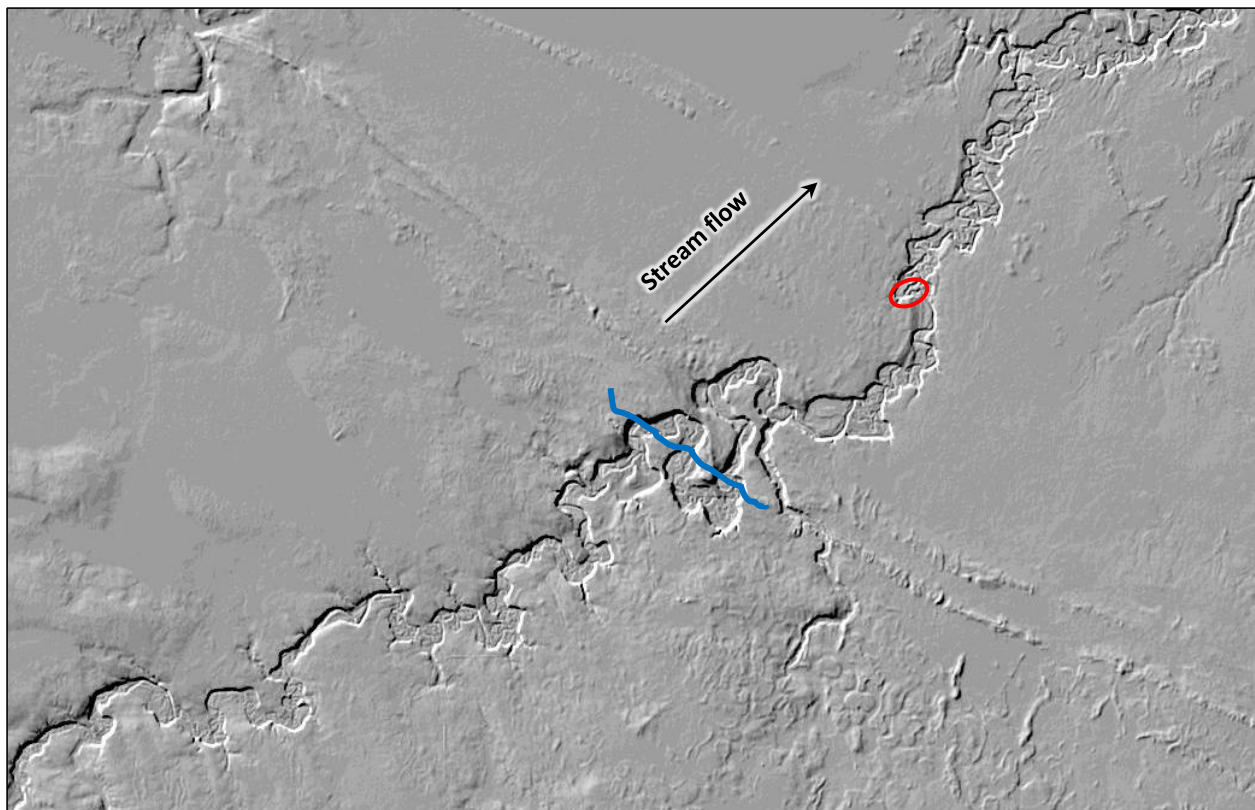
It is interesting to note that the upper portion of the Caldwell Brook subwatershed was not part of GLA, while the lower portion was. The DNR geomorphology site is a short distance from where the Minnesota Geological Survey map (2019) shows the edge of GLA was located (Figure 14). At the studied location, near the uppermost shoreline of GLA, there is still a significant component of sand in the bank material, which is less cohesive than some other soil types, such as clay, which may have made non-GLA area of Caldwell Brook more vulnerable to incision and instability. Downstream of the GLA shoreline, the brook is more sinuous. Banks here likely have more clay content, but this part of the channel has difficult access and was not observed from the ground.

**Figure 14. Shaded LiDAR elevation map of a portion of Caldwell Brook and the locations of the approximate of the highest shoreline of Glacial Lake Agassiz (blue line) and the DNR geomorphology site (red oval, approximately 2 stream miles downstream).**

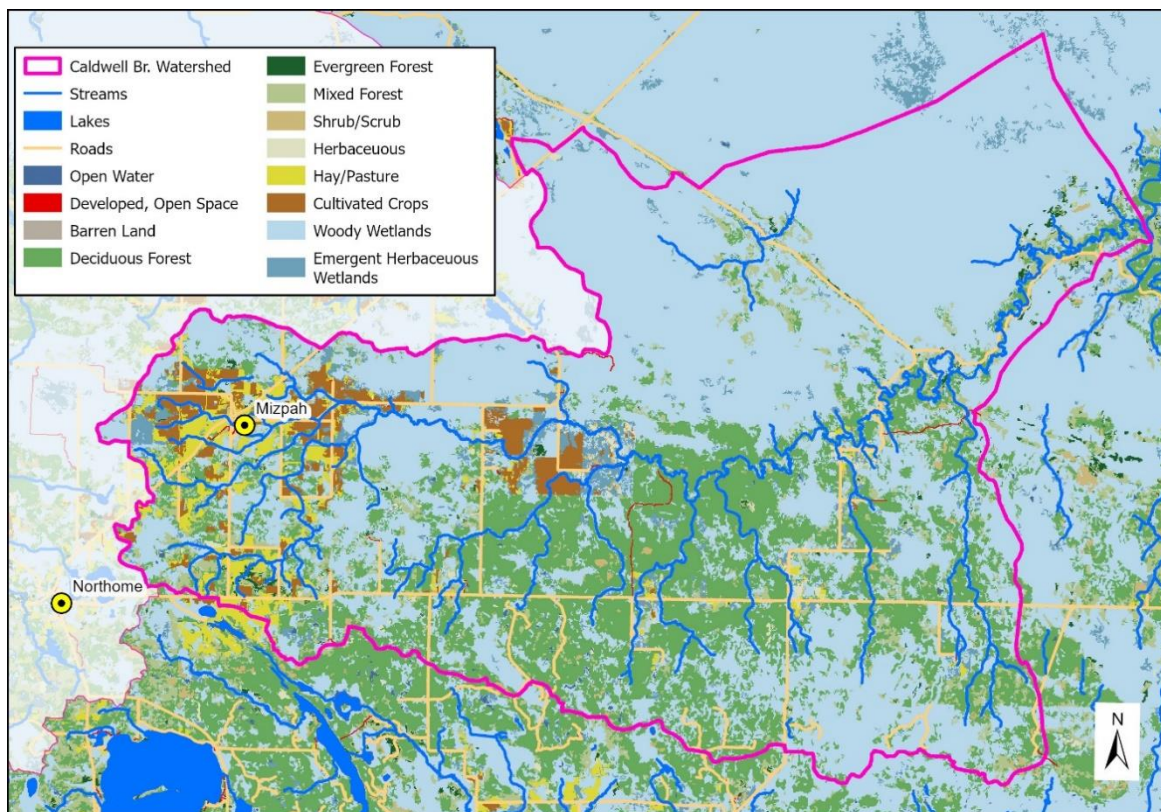
Figure 18. Land use/cover in the Caldwell Brook Watershed, from the 2016 NLCD GIS layer.

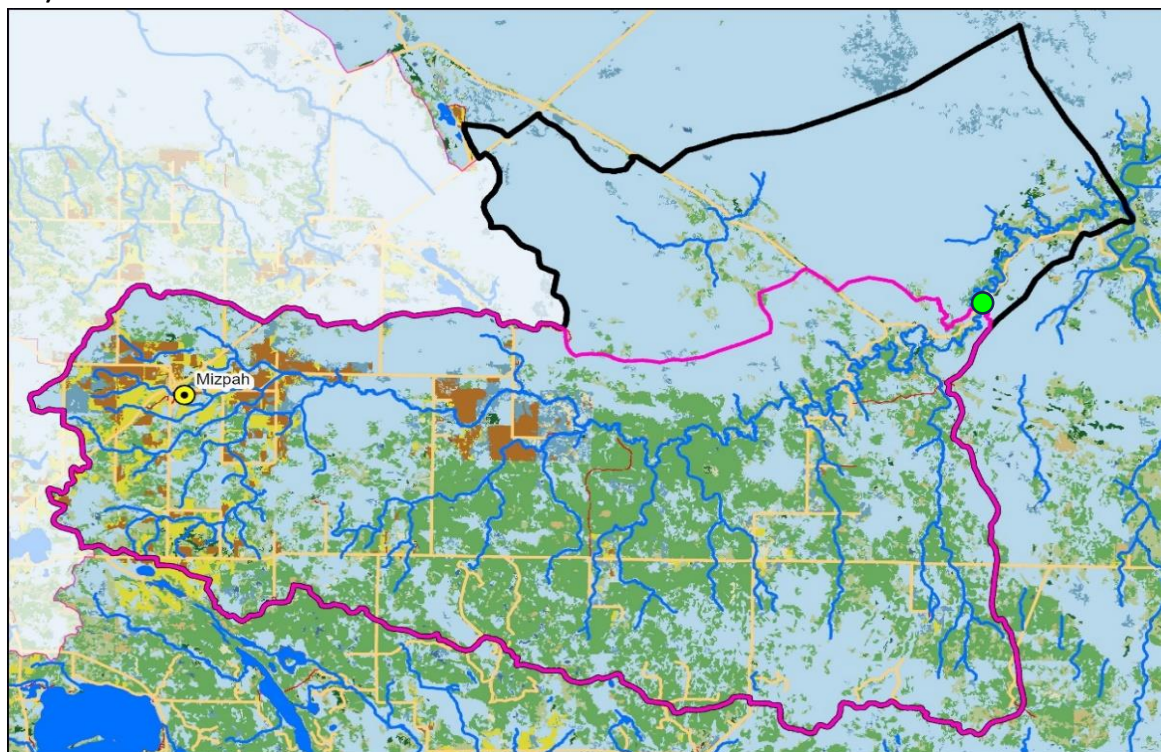
Figure 19. The Caldwell Brook Subwatershed land area contributing flow to the DNR geomorphology site (green dot).

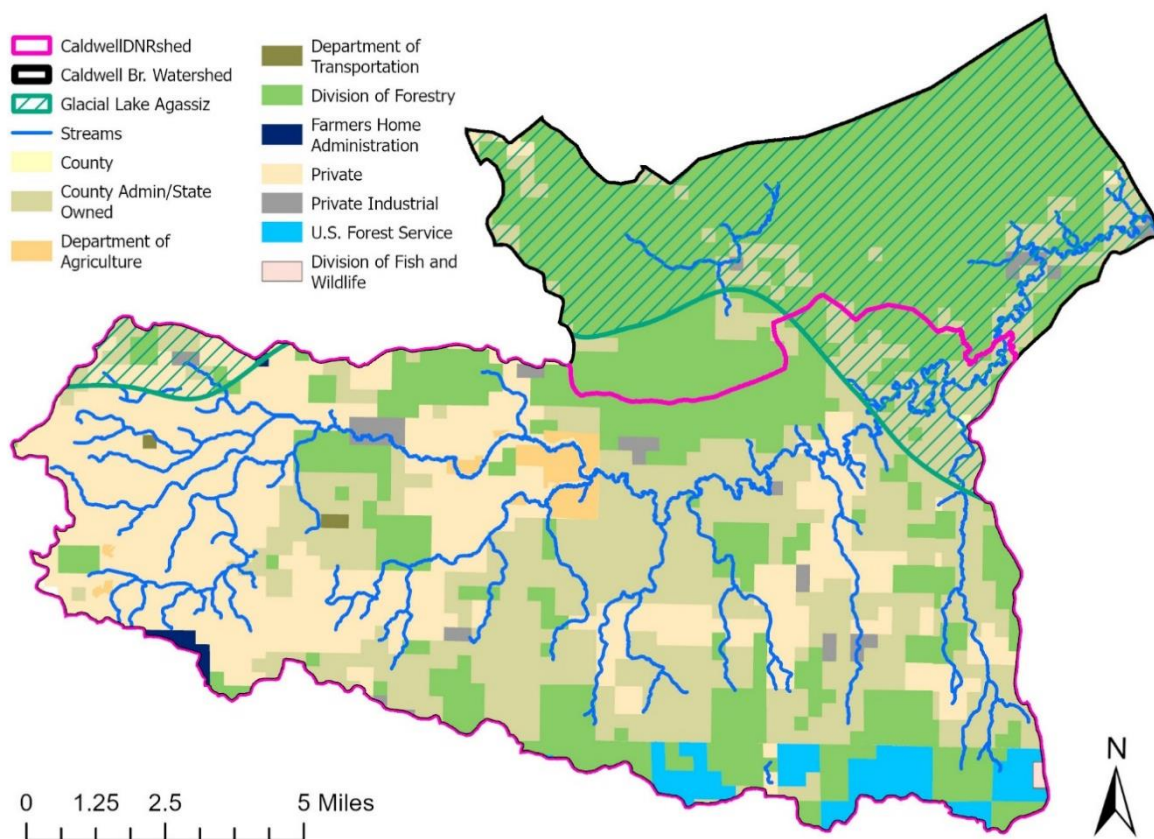
Figure 19). The two largest owners/managers are Koochiching County (as administrator of State land) and private landowners. The State (DNR administered State Forest land) is the other large landholder in the Caldwell Brook Subwatershed (for the Brook's Subwatershed that contributes to the location where DNR did the stream geomorphology survey. The remaining land that drains to the stream at the mouth is State Forest Land. Other ownership classes manage small amounts of land in the Caldwell Brook Subwatershed.

**Figure 20. Land ownership in the Caldwell Brook Subwatershed.**

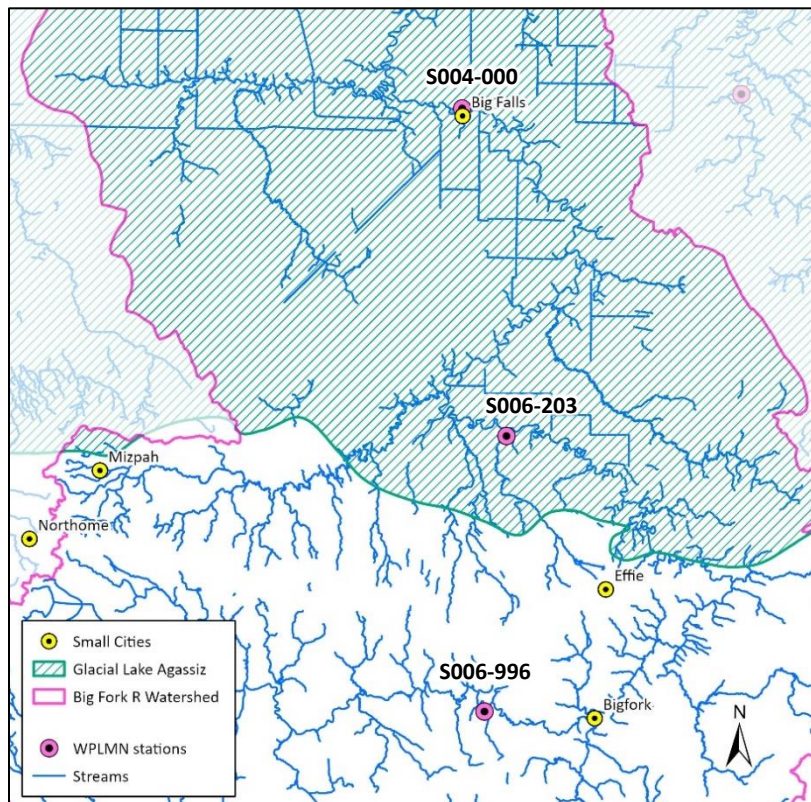
**Figure 28. The three WPLMN stations on the Big Fork River and their positions relative to Glacial Lake Agassiz and showing their EQuIS S-code identifier. The two more northern stations are within the land area previously covered by Glacial Lake Agassiz (hatched area).**

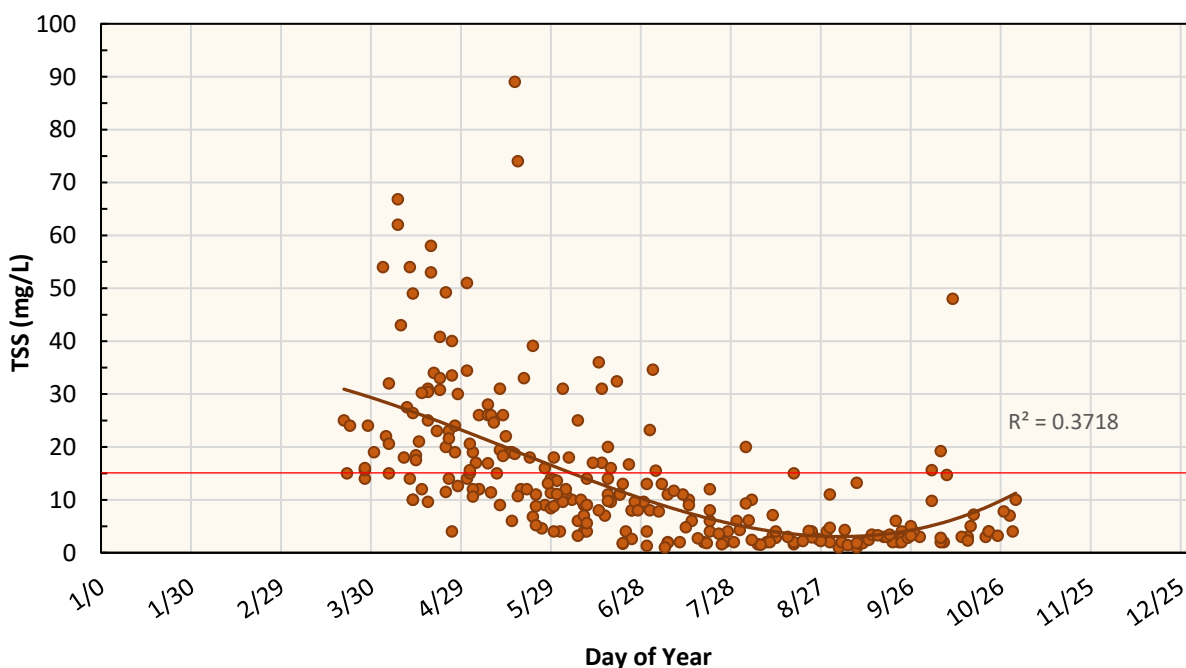
**Figure 29. Measured TSS values (2010 - 2024) during open water seasons in the Big Fork River near Craigville, MN, EQuIS station S006-203. A 3<sup>rd</sup> order polynomial regression has been applied, with  $R^2$  value shown. The red line is the Minnesota Northern TSS Standard.**

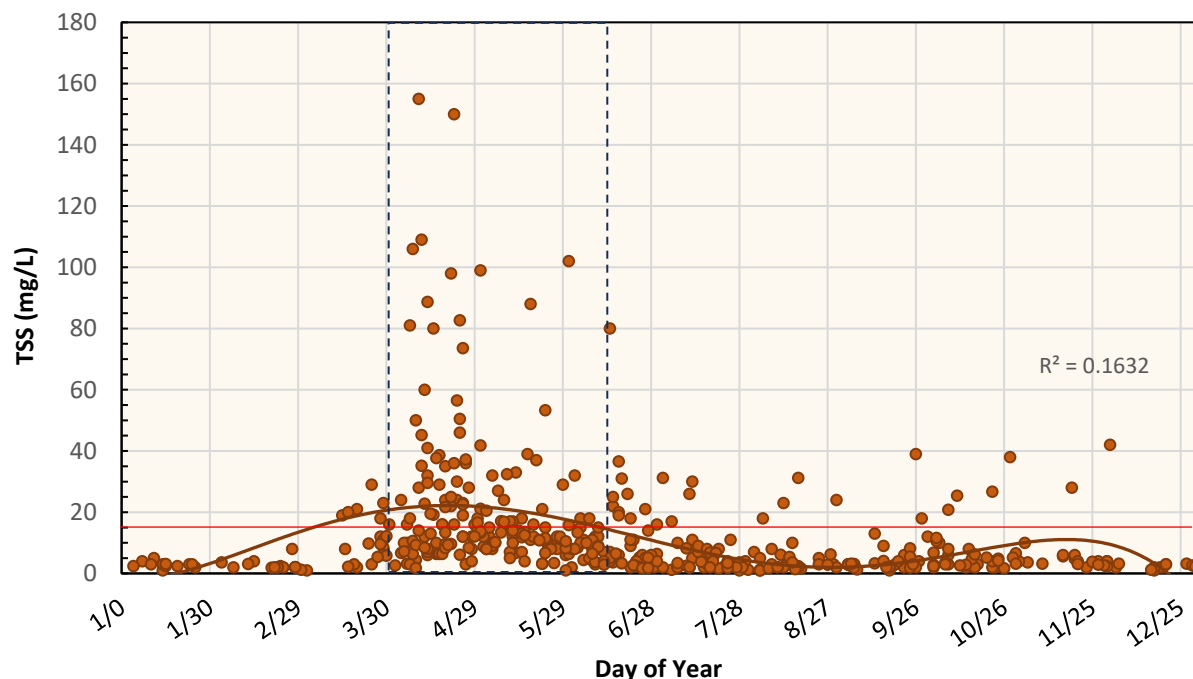
**Figure 30. Measured TSS values (2006 - 2024) during the full year in the Big Fork River at Big Falls, MN, EQUIS station S004-000. A 4<sup>th</sup> order polynomial regression has been applied, with  $R^2$  value, showing the seasonal TSS concentration pattern. The dashed box contains April 1 - June 15 samples. The red line is the Minnesota Northern TSS Standard. Note the y-axis scale is different for this graph than the other two.**

The TSS concentrations at the WPLMN station upstream of the GLA shoreline (less clay in the soils) has much lower TSS during snowmelt/spring than at either the Craigville or Big Falls WPLMN stations (Figure 30). The seasonal pattern of TSS in this area is very subtle, with just slightly higher TSS in the spring than at other times of the year (excluding bigger rain events), contrasting with the other two WPLMN sites that have much higher early-season TSS concentrations. The difference in TSS levels in the river at different locations seems to be related to whether the location is within the old GLA lake bed or not, and thus related to the difference in soil types in and out of the Lake Agassiz lake plain.

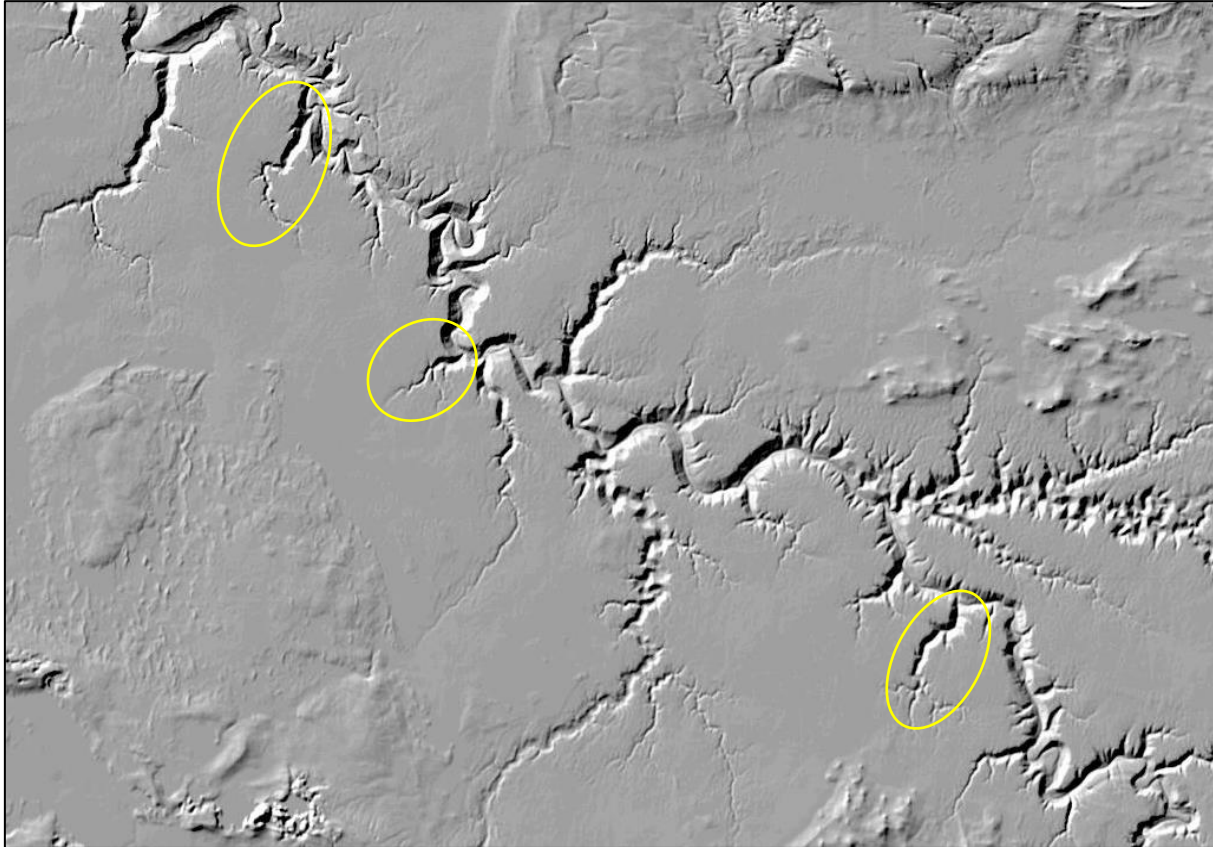
The neighboring Little Fork River Watershed also has high TSS levels, again more so in late winter and spring. USGS research (in publication) studying where neighboring Little Fork River sediment was coming from on the landscape found that most of it was from near-channel gullies and the banks of the river (see Figure 31). Big Fork River sediment levels are lower than the Little Fork's, but there is potential for similar sources of sediment in the two watersheds, as both have areas that were under GLA.

**Figure 32. LiDAR elevation map showing a section of the Little Fork River and the many short, near channel gullies (examples circled) which have been shown to be a substantial source of sediment to the Little Fork River.**

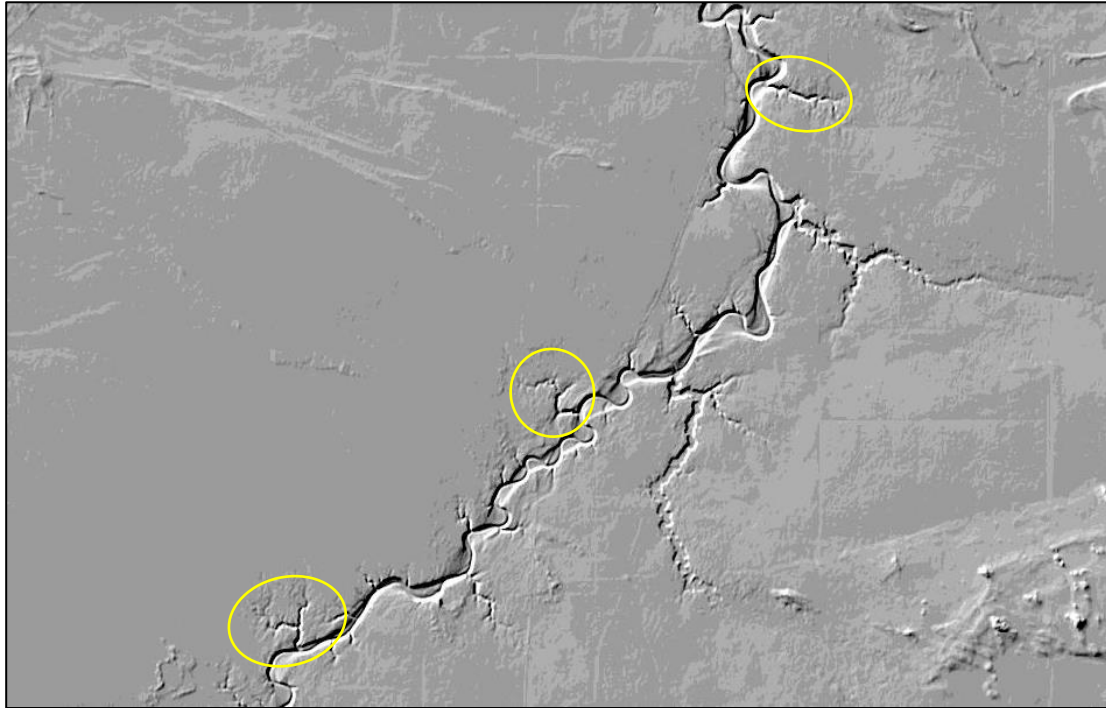
Based on viewing aerial photos, the Big Fork River has healthier river banks (i.e., more gently sloping and more vegetated) than the Little Fork River does, but there are places where Big Fork River banks are sloughing too (see bank failure section above). A review of the LiDAR elevation map for the Big Fork River does show some short, deep near-channel gullies as are found along the Little Fork River, though they seem generally smaller and less deep than at the Little Fork River (Figure 32). It would be useful for water managers to visit some of the gullies to see if there is active erosion occurring in them. Again, reducing overland runoff and the higher, more erosive flows of water in the river and tributaries should reduce bank erosion. Some of these gullies; however, are draining natural areas that have little or no human disturbance (e.g., un-ditched peatlands), and therefore there aren't options for changing management of those areas to reduce erosion in those particular gullies. A number of these have had nearby logging, and those with road crossings may be more vulnerable for eroding as they likely receive road ditch runoff (Figure 33). Deposition of sediment from these gullies can be seen in aerial photos (Figure 34), though the extent of any unnatural amounts would require on-the-ground investigation of

**Figure 33. LiDAR elevation map showing a section of the Big Fork River and numerous short, near channel gullies (examples circled) The gullies along the Big Fork River appear to be smaller and less incised than those along the Little Fork River.**
