July 2025

# Big Fork River Watershed Stressor Identification Report

A study of local stressors limiting the biotic communities in the Big Fork River Watershed.

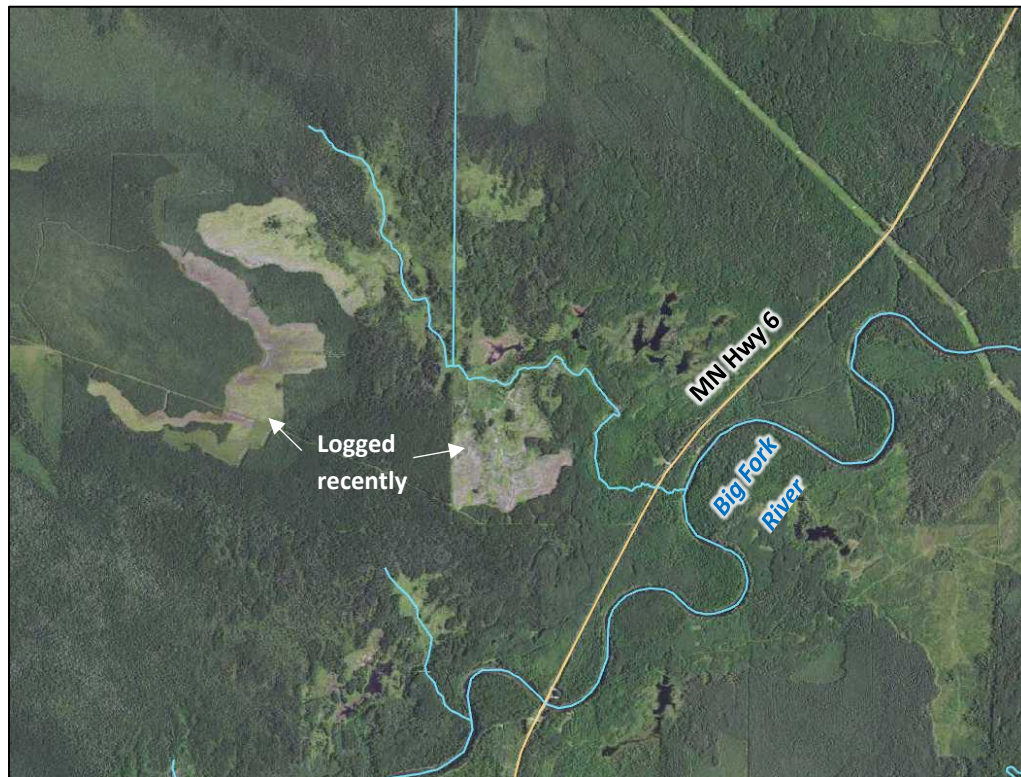
**Figure 34.** Example of short near-river-mainstem streams/gullies that are produced from natural drainage of peatlands. This area is a close-up of the center yellow circle in the previous figure: recently logged areas and re-growing previously logged plots can be seen, as well as MN Hwy 6 that likely contributes runoff to the steeper part of the gully near the river.

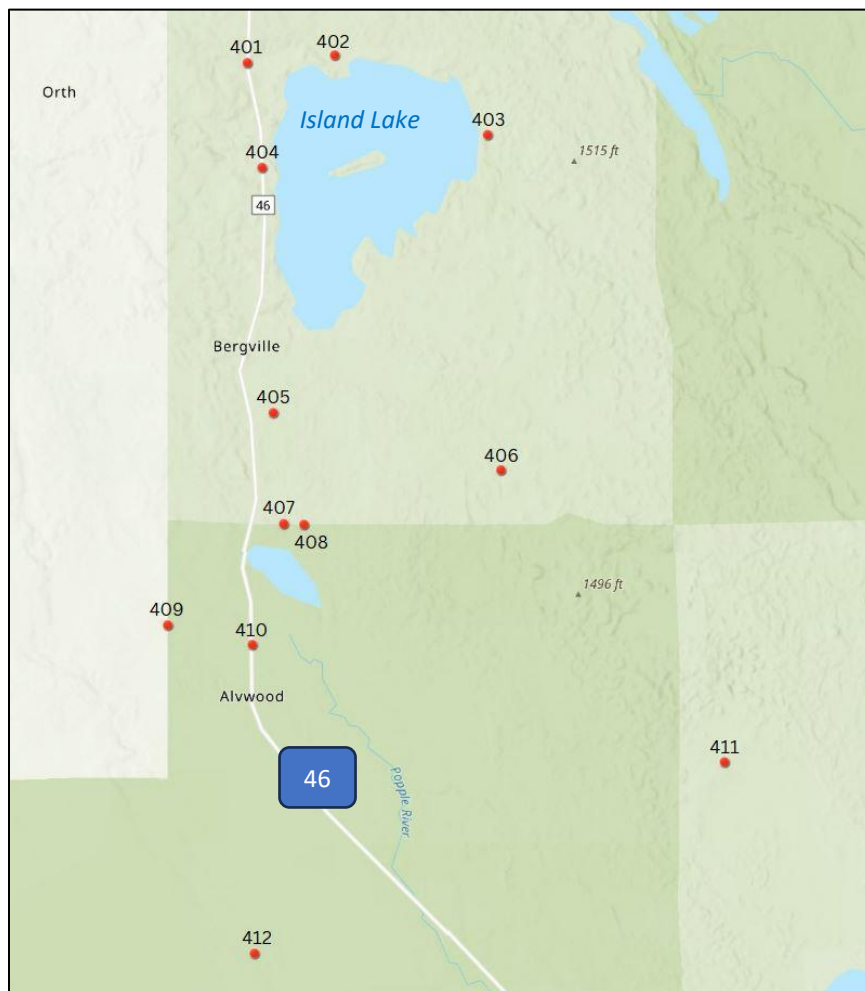
**Figure 36. Upper Popple River/Island Lake area culvert assessment.**

Itasca County SWCD staff visited and assessed 12 culverts in the Popple River HUC-10 subwatershed (0903000602), in far northwestern Itasca County (Figure 35). These assessments found that a number of the stream crossings have undersized culverts, showing signs of upstream pooling and downstream scouring, which likely contribute to bank erosion and increased sediment and phosphorus levels in the water bodies, and potential fish passage barriers at some flows. None of the culverts inventoried showed immediate signs of failure. Those assessed as relatively the most problematic were #409 and #410. Though #408 (on Forest Road 3346) was assessed to be a somewhat lesser problem, it, along with #410, is on a somewhat larger stream and may therefore be more important to fix from a fish barrier perspective (i.e., there is more fish habitat available). The assessment information collected for these culverts has been entered into the DNR online culvert database but needs to be reviewed before obtaining public availability status.

The findings of problematic road crossings should be shared with the appropriate road authorities so that at some point in the future, the problem culverts get replaced using appropriate sizing and designs (DOT, 2019). A particularly good time to do replacements is when other work (e.g., road re-surfacing) is planned at that location, and it helps road managers to know ahead of time where problematic culvert are located so they can incorporate replacements as part of related projects.

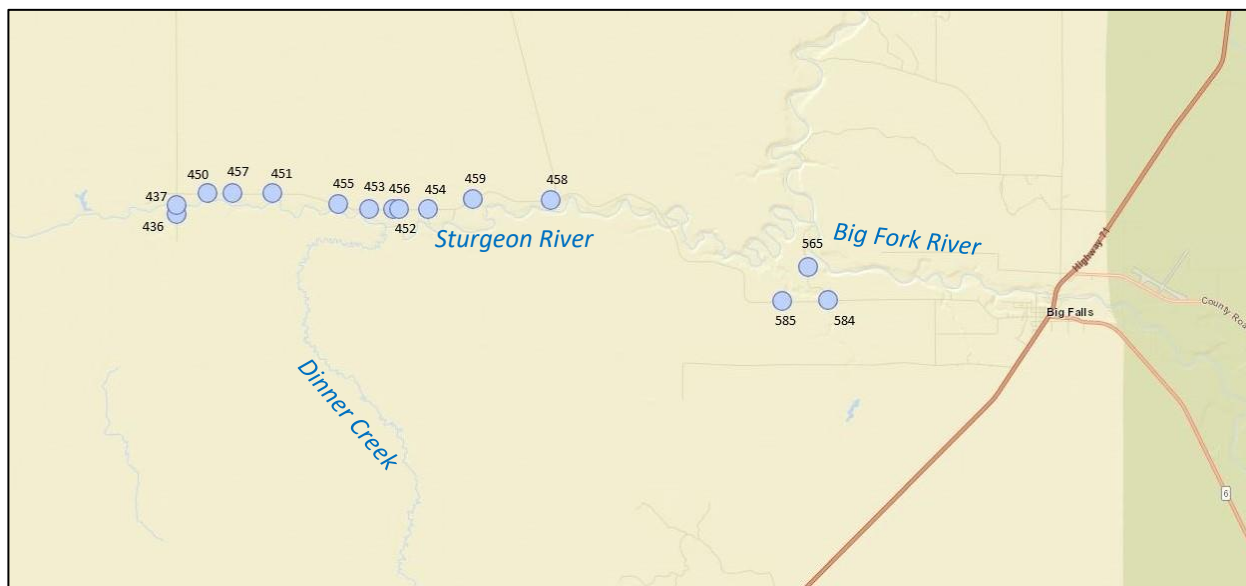
**Figure 37. Sturgeon River HUC-10 culvert assessment locations.**

Koochiching County SWCD staff visited and assessed 15 culverts in the Sturgeon River HUC-10 Subwatershed (0903000608), just west of Big Falls in Koochiching County (Figure 36), though time constraints didn't allow the full DNR protocol assessment to be completed for some. Two culverts were considered high priority due to not being properly aligned, being barriers to fish passage at some flow levels, and not containing natural substrate in the culvert. Three culverts were considered medium to high priority due to not being properly aligned. Two culverts were considered low-medium priority, one due to not being properly aligned, and the other culvert being highly impacted by beaver activity.

Eight culverts were considered low priority relative to the others, because there were no obvious problems. The assessment information collected for these culverts has been entered into the DNR online culvert database but needs to be reviewed before obtaining public availability status.
