## CHANNEL CONDITION AND STABILITY INDEX (CCSI): MPCA PROTOCOL FOR ASSESSING THE GEOMORPHIC CONDITION AND STABILITY OF LOW-GRADIENT ALLUVIAL STREAMS

### I. PURPOSE

To describe the methods used by the Minnesota Pollution Control Agency's (MPCA) Biological Monitoring Program to assess physical indicators of channel condition and stability during biological sampling for stream assessments. This protocol was developed through consulting other existing channel stability assessments (Pfankuch 1975, Simon and Downes 1995, VANR 2007, Rosgen 2006, Ohio EPA 2007, Magner et al. 2010) and includes modifications that attempt to better characterize physical indicators of channel condition and stability observed in low- to mid-gradient streams in Minnesota.

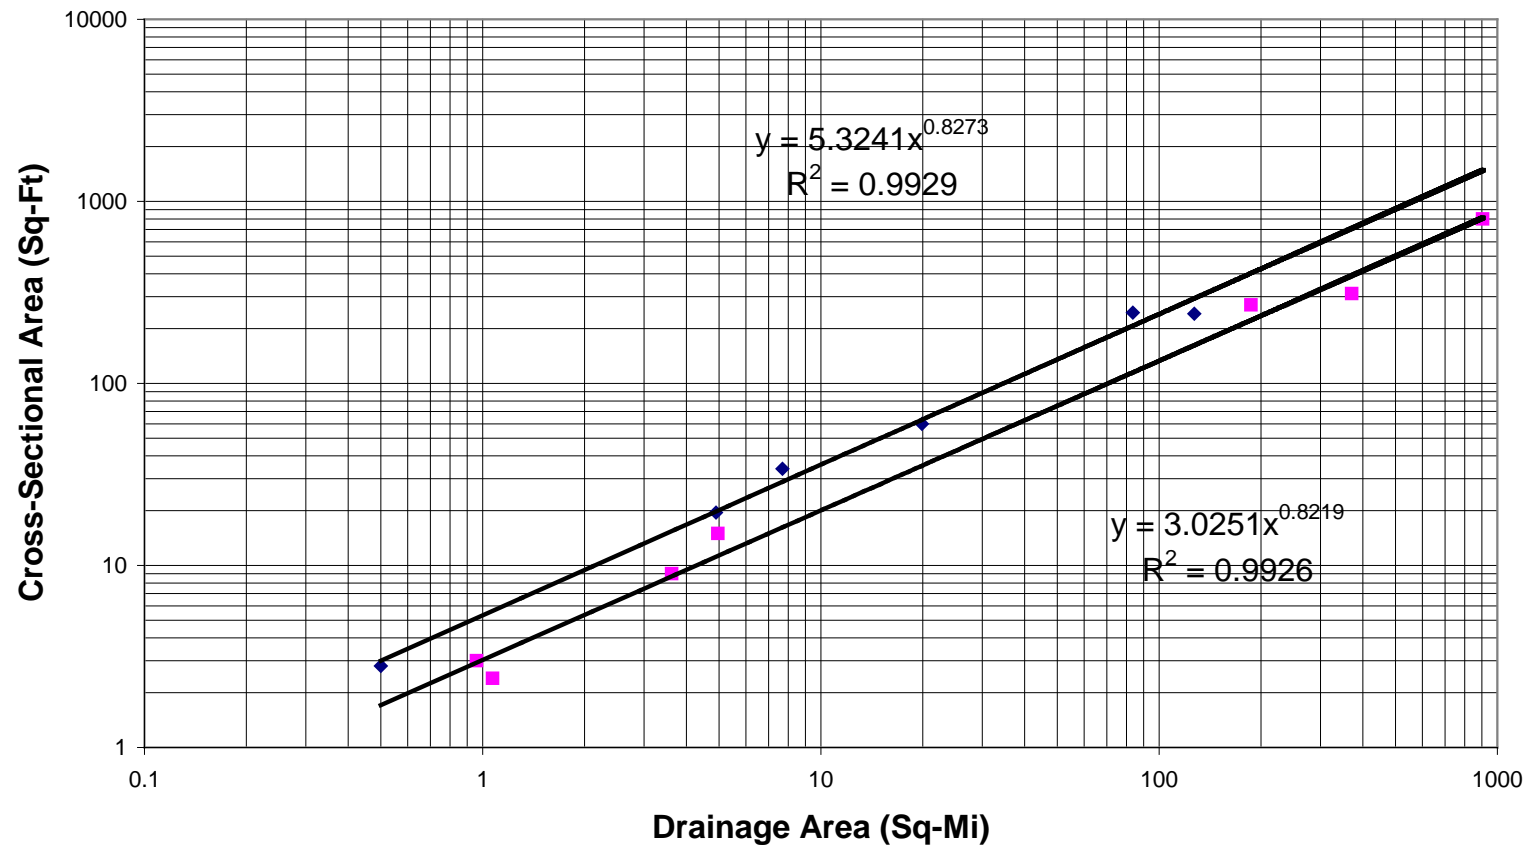
St Louis –  
 Lake Clay - North Shore Streams and Nemadji – lake clay and bedrock  
 Non-Lake Clay -

### Northeast Minnesota Regional Hydraulic Geometry Curves - Lake Clay and Non-Lake Clay Regions

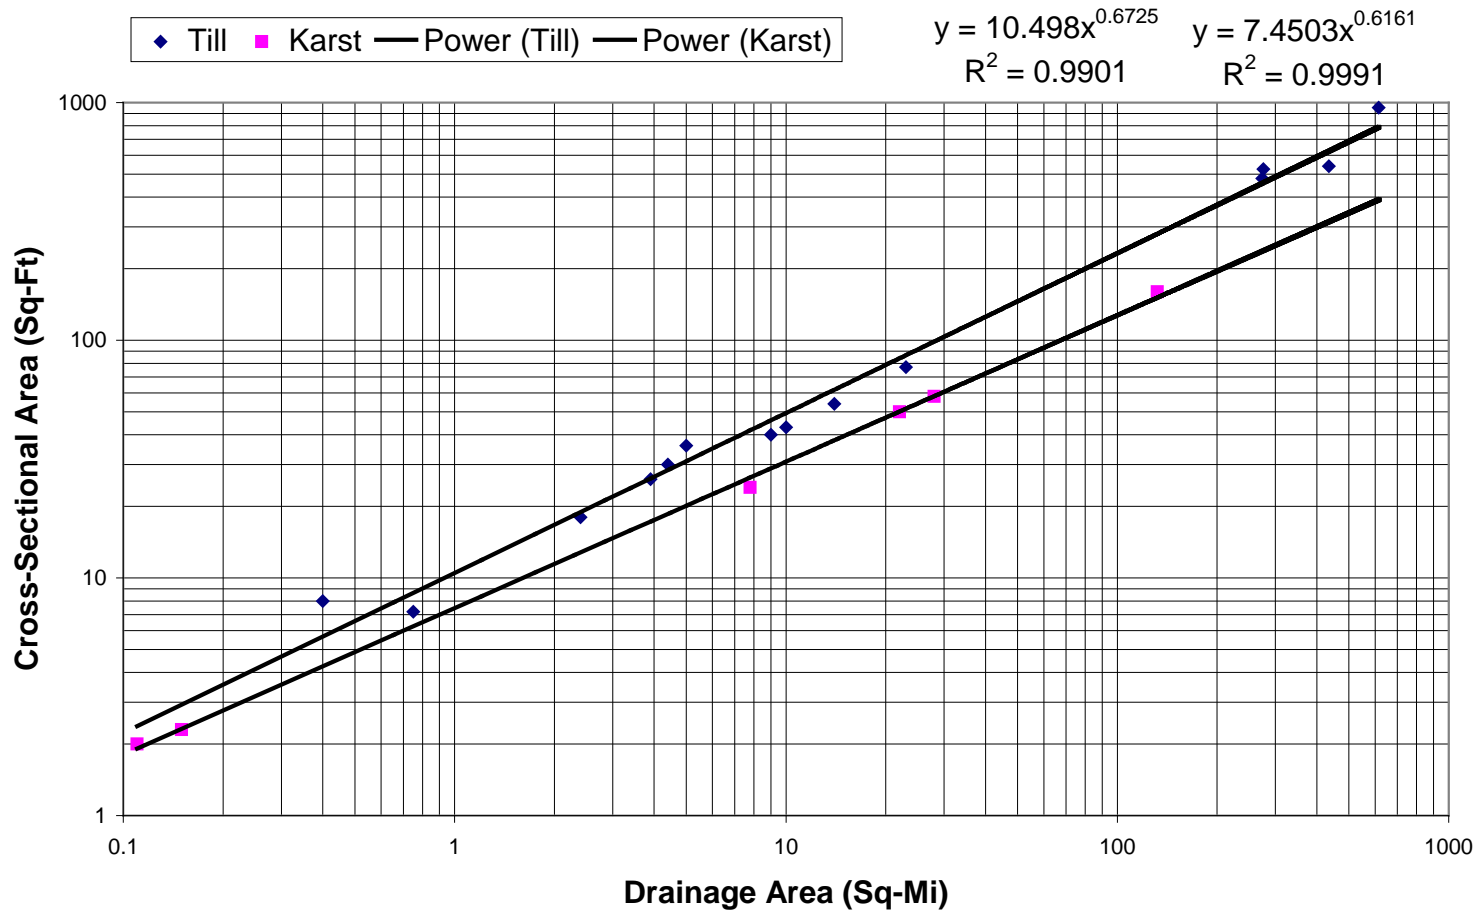
Cedar, Shell Rock (Till)

### South-eastern Minnesota Hydraulic Geometry Regional Curve

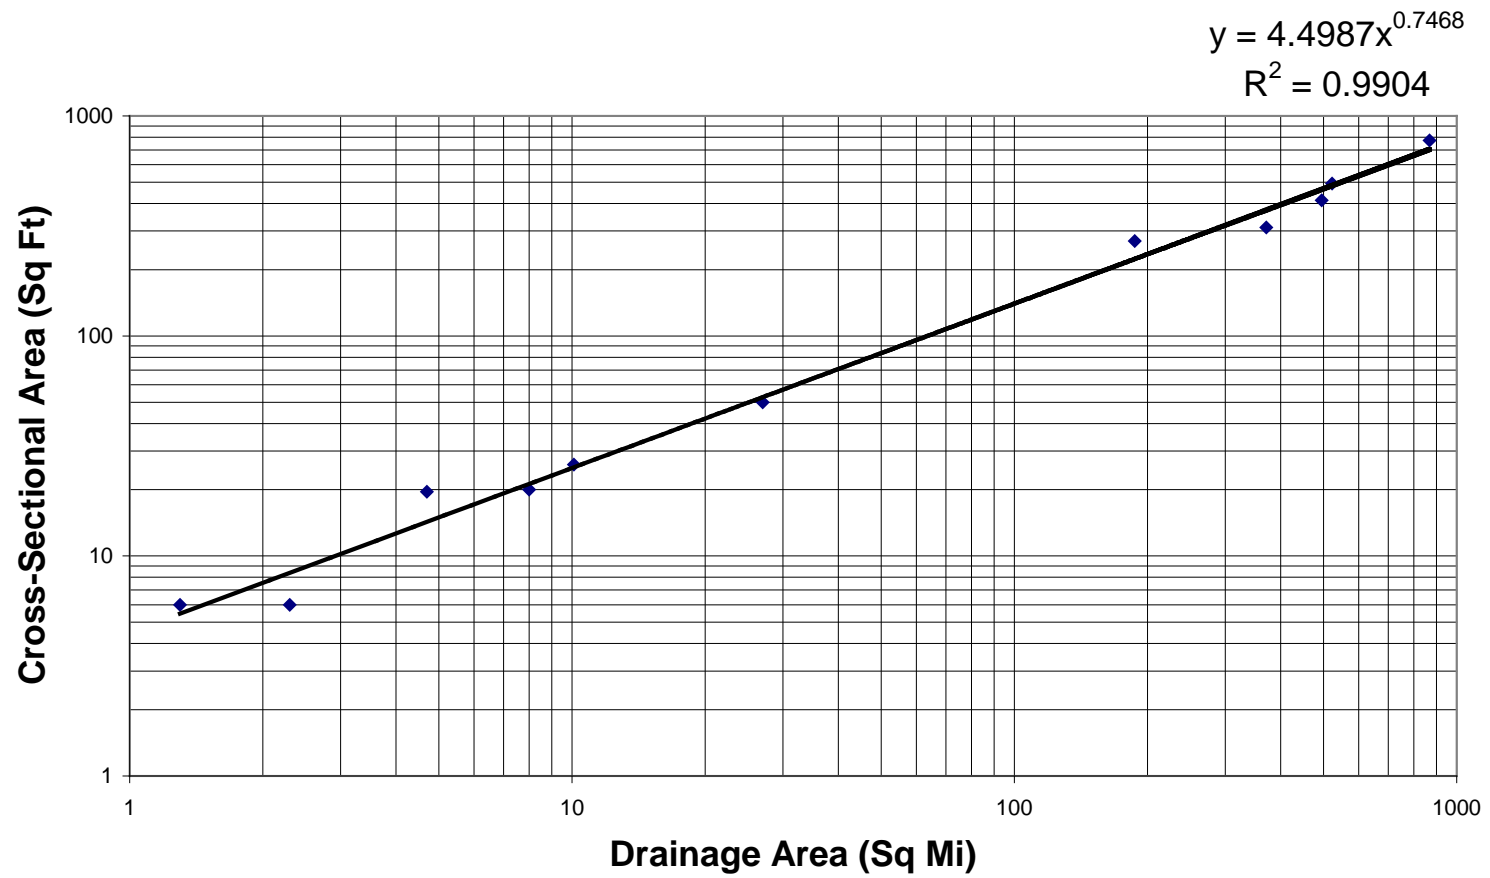
## St Croix – Stillwater and Snake River

## Cross-Sectional Area East-Central MN
